NATIONAL REGISTER OF HISTORIC PLACES INVENTORY - NOMINATION FORM

COMMON:
Leesburg

RESULTS OF THE 1982 INVENTORY

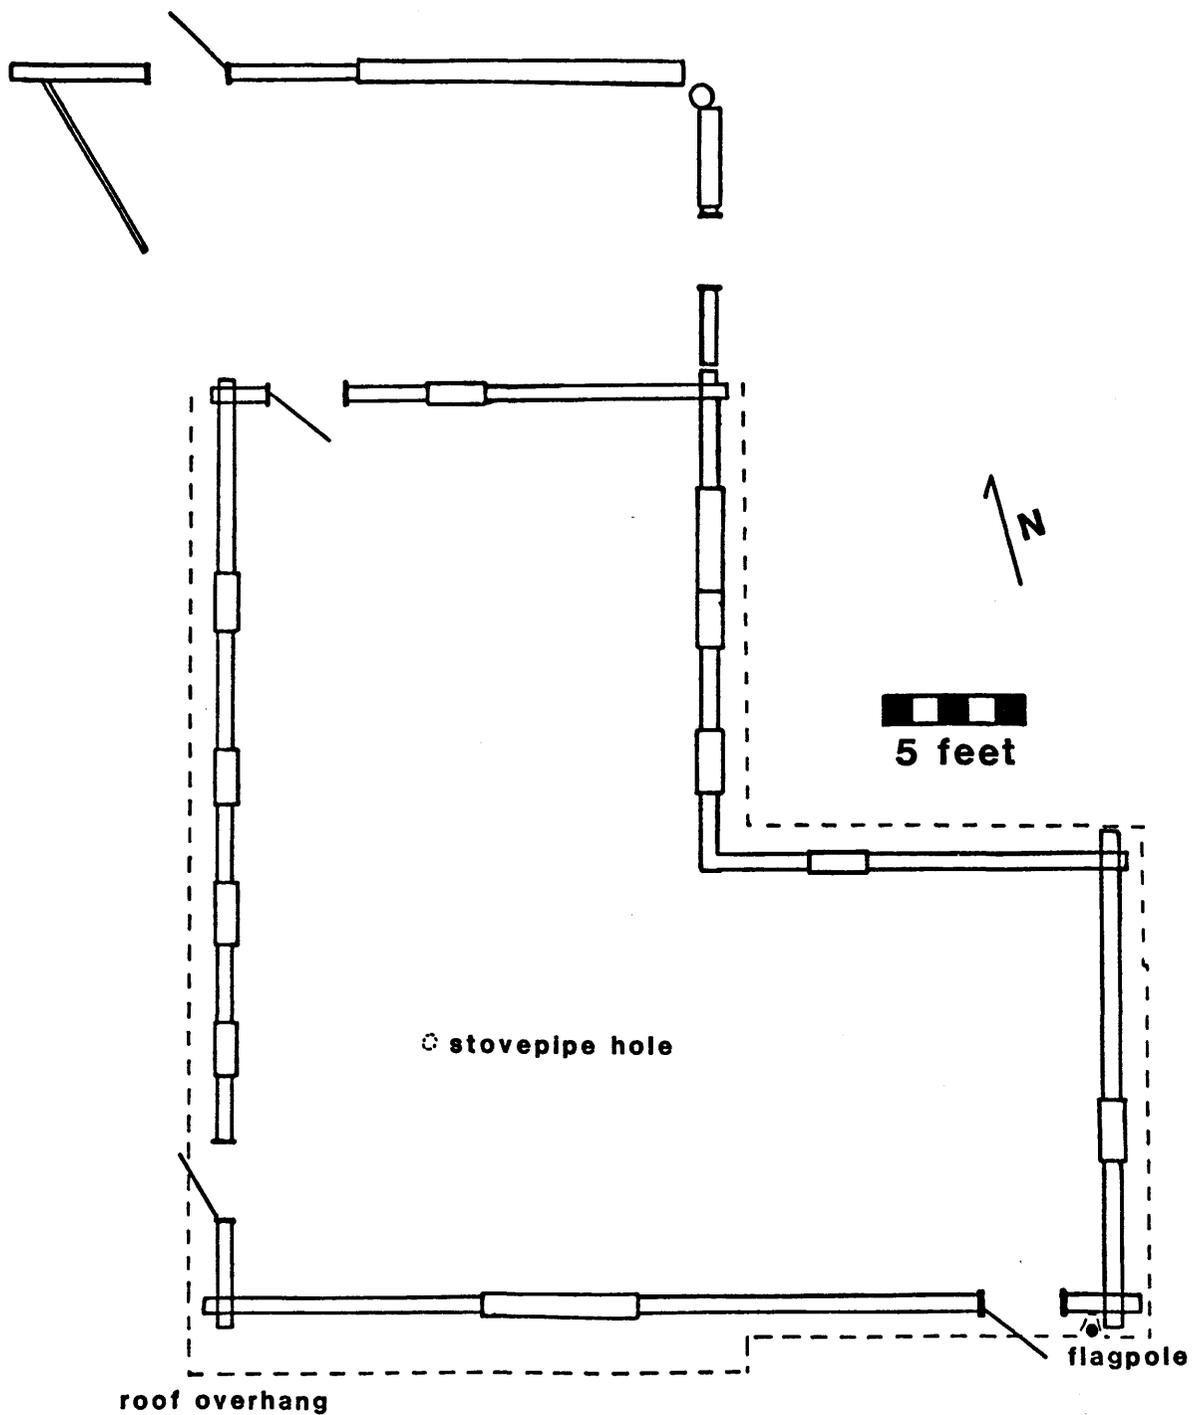
Fig. 4. Example of the type of floor plans drawn for structures at the Leesburg townsite. This is a floor plan for Feature 10.

Feature 10 is a four room, saddle-notched log structure (Fig. 9). It was built in 1937 by Mike and Maude Fraker who used it as a boarding house and post office (Paul Fitzgerald and Marjorie Sims). The building is presently being used by the Napias Mining Company as a cookhouse and boarding house. Feature 10 is in good condition due both to its comparatively recent construction and to fairly continuous maintenance.

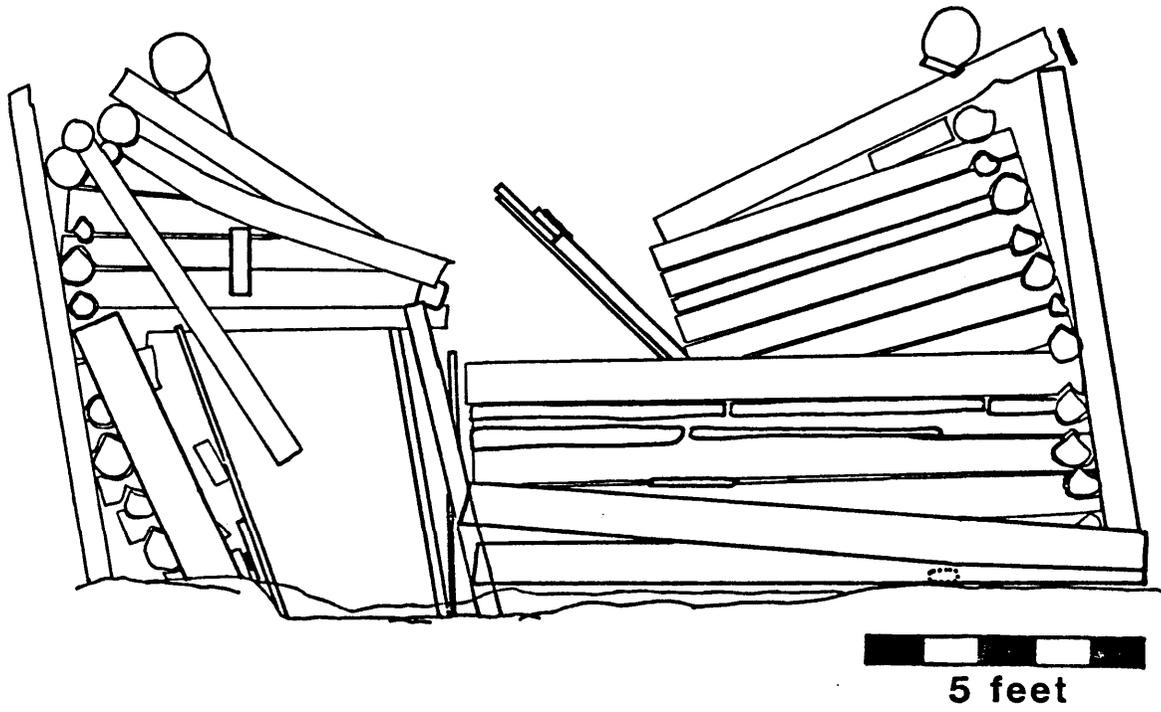
Fig. 5. Elevation of the front (north) wall of Feature 23, illustrating the collapsed condition of the structure.

Feature 23 is a one room, steeple-notched log barn with a hay loft. Dick Shoup claims that it was originally a saloon. The building was built sometime before 1908 (Anonymous 1908). It is in fair to poor condition; the roof is completely collapsed and the east wall is falling down.

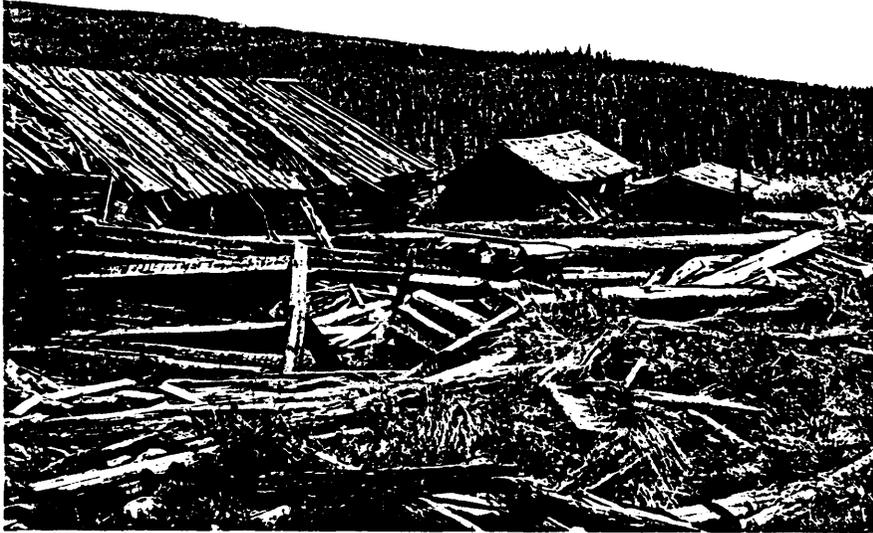
Fig. 7. View of the north and west walls of Feature 6. The building is now a ruin.

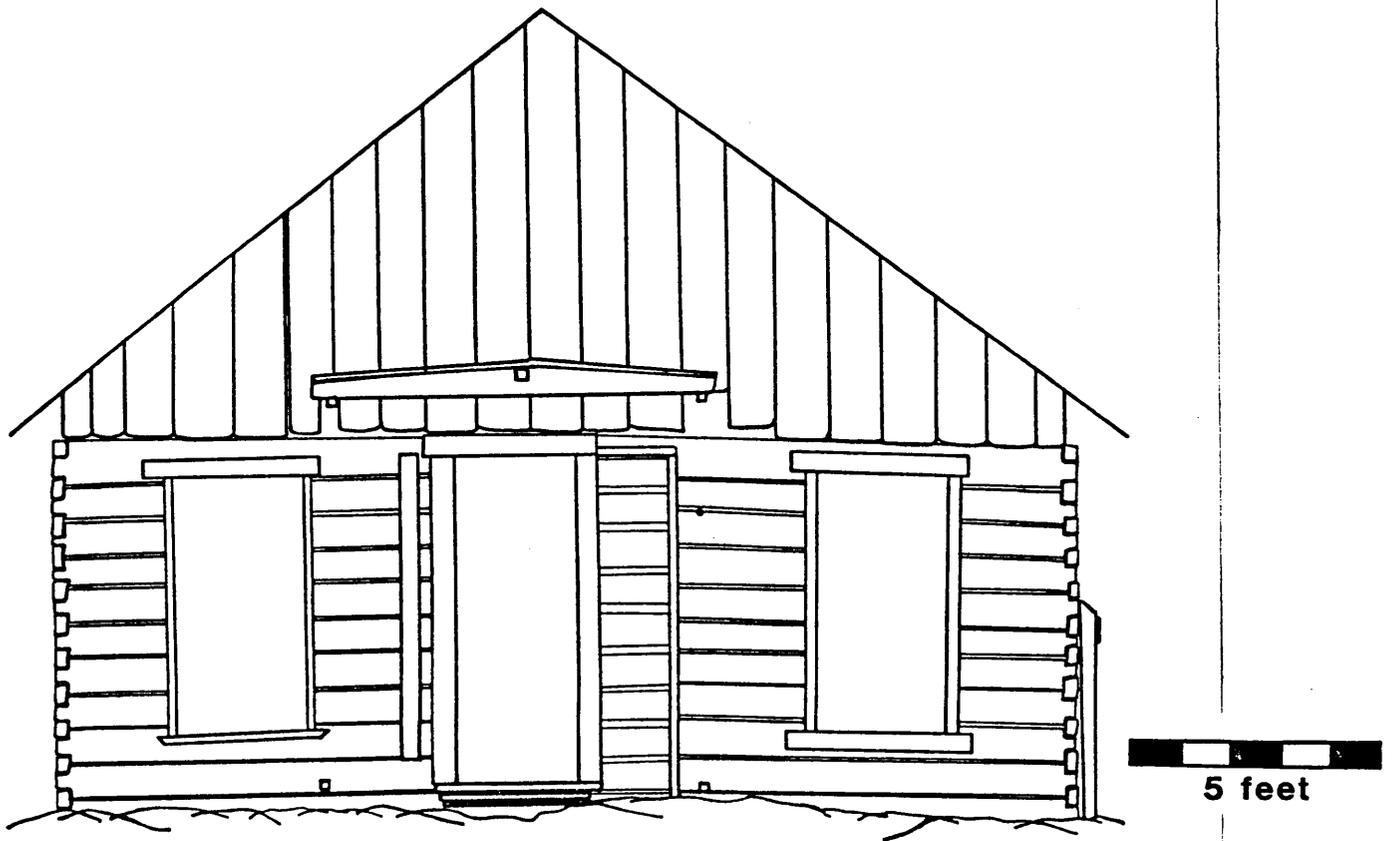
Fig. 8. Elevation of the front exterior wall of Feature 9. This building, still in fairly good condition, once served as Orion Kirkpatrick's freight depot.

The building is in fairly good condition, but about 40% of the roof shingles are missing, the west wall is bowed in, and there is some settling along the north wall.

Buildings in a poor state of repair or in ruins would not be repaired under the proposed stabilization program. Those buildings needing minor repairs to the walls or a new roof would have priority in the program. The buildings that would most benefit from a stabilization program are Feature 3 (roof), Feature 9 (roof and foundation along the north side),

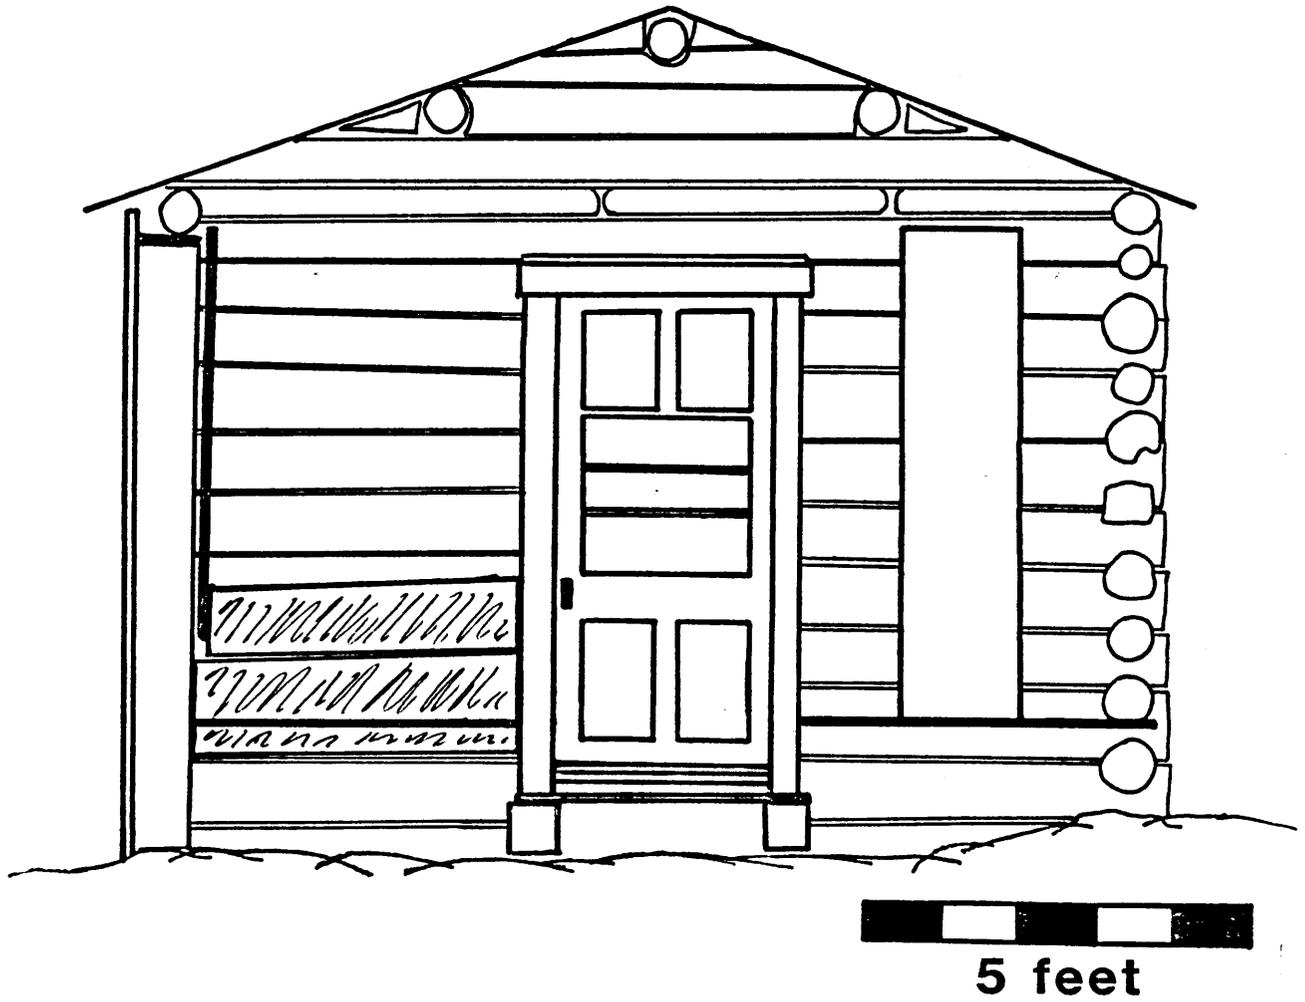
Feature 12 is a two room, saddle-notched log building (Fig. 10). It was built in 1935 by Mr. Fitzgerald and two other men to be used as a schoolhouse (Paul Fitzgerald). Napias currently uses the structure as an office, and occasionally as sleeping quarters. Feature 12 is structurally sound although the bottom wall logs are rotting and the roof and floor are deteriorating.

Fig. 10. Elevation of the front wall at Feature 12. School bench at left of doorway is shaded.

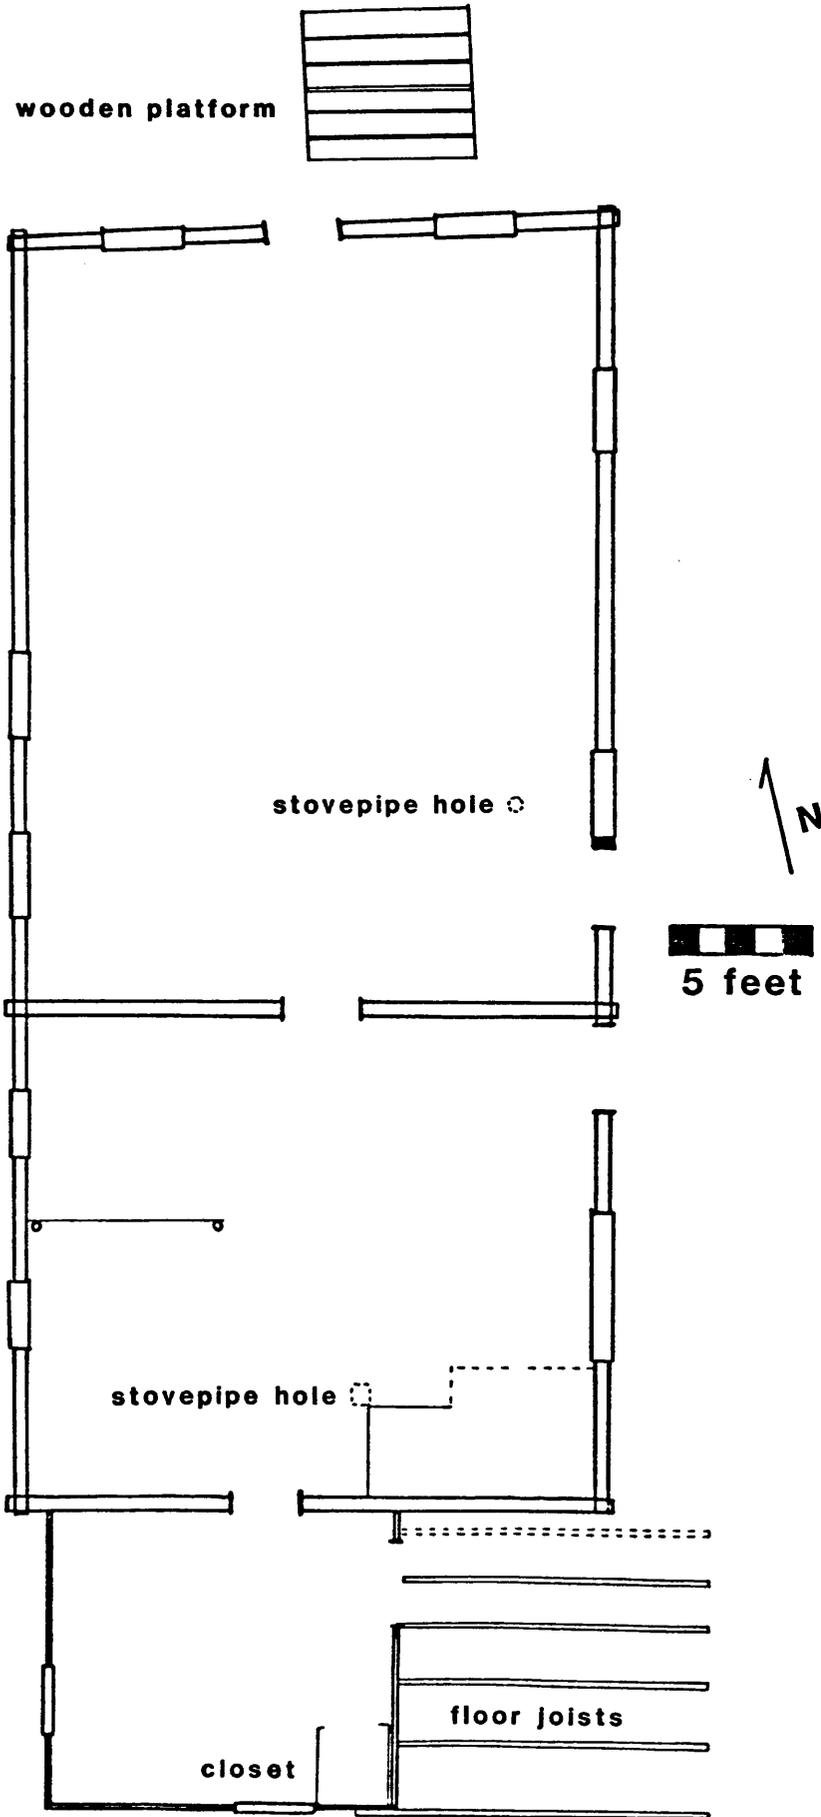
Feature 17 (Fig. 11) is a multi-room, steeple, square and saddle-notched structure used as a hotel between about 1900 and the early 1930's. The main part at the north end of the building was probably constructed in the 1890's, the second part perhaps 5-10 years later, and the third part (a shed) sometime in the twentieth century. Feature 17 is in fair condition with the roof collapsed, some of the walls collapsed, and the floors in very poor repair.

Fig. 11. Floor plan for Feature 17, formerly Alice Mahoney's hotel and post office.

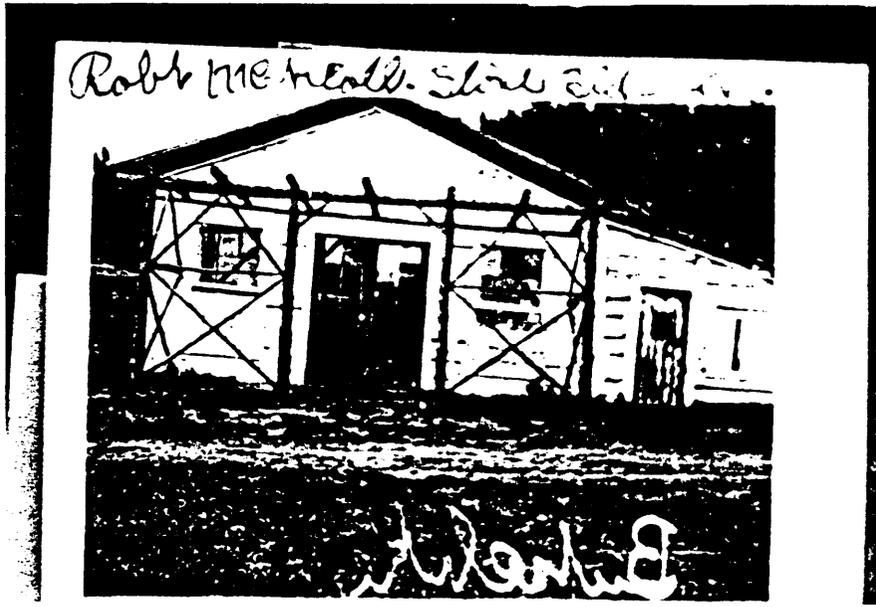
Feature 18 was a two room, square-notched log building used as a boarding house during the early twentieth century (Dick Shoup and Marjorie Simms). It is one of the oldest structures at Leesburg, dating to the 1880's or earlier (Fig. 12). It is in very poor condition with the roof and most of the walls collapsed.

Fig. 12. Historical photograph of a structure that might be Feature 18.
(Lemhi County Historical Museum, Salmon.)

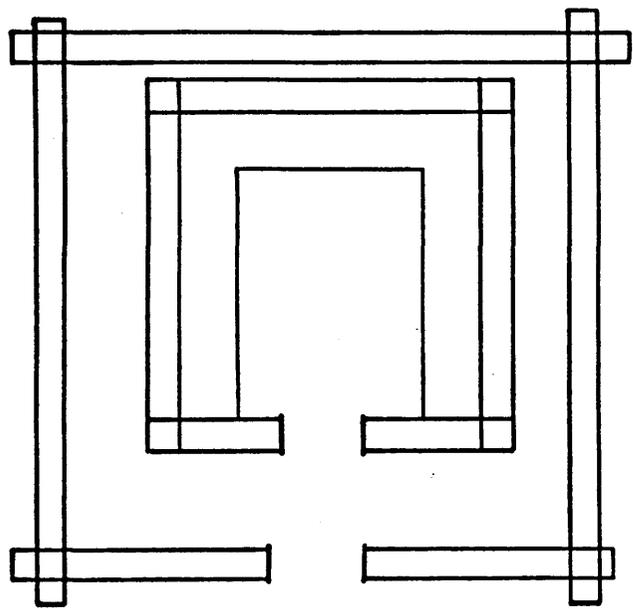
Feature 24 is a small, double walled log building at the west end of the townsite (Fig. 13). The exterior walls have saddle-notched corners, but the interior walls do not interlock in the corners. Feature 24 was built in the 1890's or later and appears to have been used for storage. It is in fair condition because the roofs and two of the exterior walls are collapsed.

Fig. 13. Floor plan for Feature 24, showing double log walls. Shelves line the interior walls.

Feature 14 (roof and back wall), Feature 20 (west wall), and Feature 24 (roof). Building new roofs for the structures is a cost-efficient "stitch-in-time-saves-nine" measure; roofless structures are more exposed to the weather and therefore deteriorate more quickly than do those with roofs.
