National Register of Historic Places Registration Form

Historic name: Fort Russell Neighborhood Historic District (Boundary Increase and Additional Documentation)

Street & number: Roughly bounded by Jefferson Street on the west, East D Street on the north, Hayes Street on the east, and East Third Street on the south

City or town: Moscow State: ID County: Latah

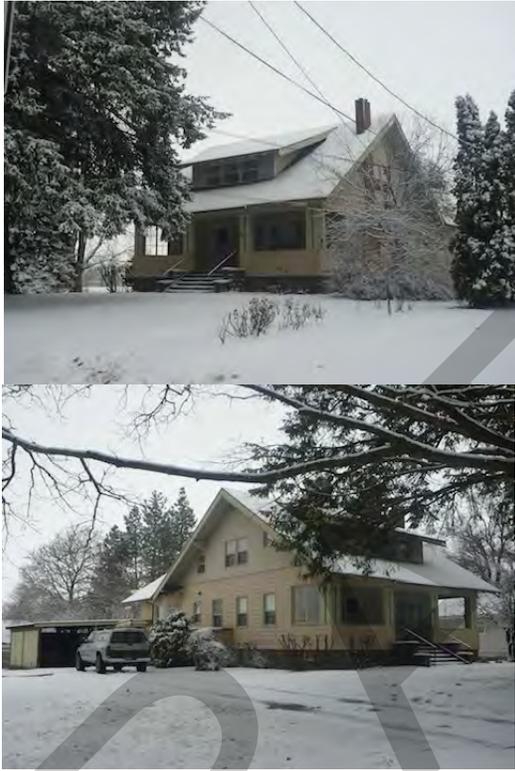
Survey Site Data	Site Photographs	Site Details
<p>Site #: 1 712 East D Street Owner: Preston Becker ca. 1915 Previous District Status: C, 42 DoE: C</p>

<p>Site 1 is a one-and-one-half story Bungalow with side gables and a shed-roofed dormer at the façade. On the porch to the west of the off-center door is a large picture window with fourteen-light upper over the large pane; to the east is a similar three-part window with small panes above large panes. The exterior wall on the porch retains the original narrow wood clapboards. The remainder of the exterior walls are covered in narrow and wide vinyl or metal replacement siding. The shed-roofed dormer features three, fifteen-over-one, double-hung windows, exposed rafter tails and wide bargeboards with birds-mouth notched ends. An exterior brick chimney is found at the east elevation. Other features include: twenty-over-one, double-hung windows, wide boxed eaves, knee-brackets, exposed rafter tails, a bay window at the rear of the west elevation, and a rusticated concrete block foundation. A modern, shed-roof carport on a concrete slab foundation is next to the house.</p>

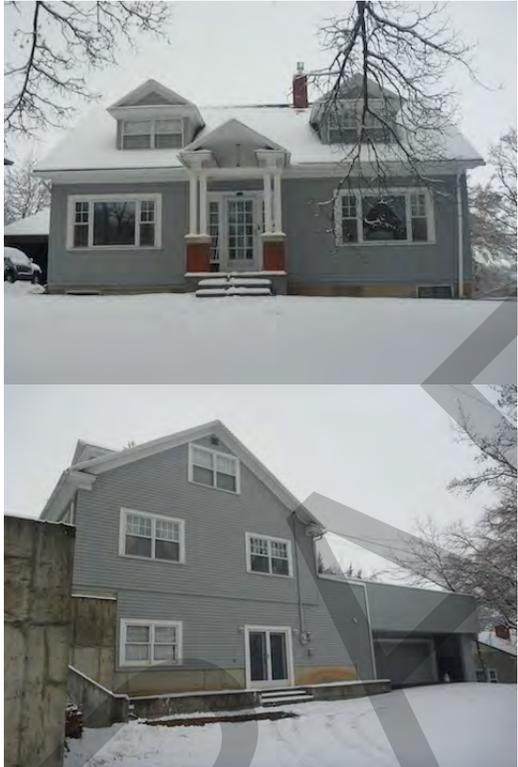
Survey Site Data	Site Photographs	Site Details
<p>Site #: 2 415 North Polk Street Owner: Roger Root ca. 1920 Previous District Status: C, 39 DoE: C</p>

<p>Site #2, the Philip H. Soulen House, is a one-and-one-half story, side-gabled Colonial Revival oriented east facing North Polk. The symmetrical façade features a central entry porch, two opposing, large three-part windows and a pair of gabled dormers. The entry porch features an open, pedimented crown with a barrel-vaulted ceiling, with cornice returns atop narrow architraves, and crossbeam supported on paired square columns on concrete-capped brick bases. The entry door is flanked by multi-light sidelights. Shingles are present only in the gable ends of the dormers, and the walls are clad with composition siding. Vinyl siding wraps the walls at the garage. A modern garage is attached at the northwest elevation basement level. A parapet wall above the garage surrounds main level rear deck. There is a two story, gable-roof addition at rear of house. All of the windows except the sidelights are vinyl.</p>

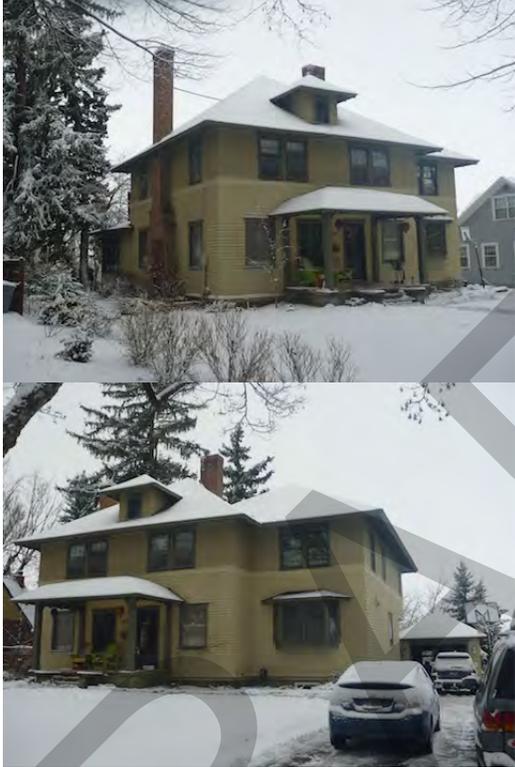
Survey Site Data	Site Photographs	Site Details
<p>Site #: 3 407 North Polk Street Owner: Steffen Werner 1909 Previous District Status: C, 38 DoE: C</p>

<p>This is a two-story, foursquare plan, Prairie style residence with a modern two-story addition attached along the north elevation. The central entry porch features a hip roof with exposed rafter tails, wide eaves, large square posts, and pilasters. At the second story of the façade are two sets of six-over-one paired windows. The first floor is sheathed in clapboards with a slight flare, while wood shingles cover the second story. A hip-roof dormer with a single small window is centered above the façade. Simple Craftsman-style trim surround the door and windows. Roofs are hipped with wide, open eaves and exposed rafter tails. A brick, shouldered chimney is located at the south elevation, and another small chimney pierces the main roof. At the rear is an enclosed porch. The addition features a hip-roof bay window at the first floor and a pair of six-over-one windows at the second story, an integral porch at the rear entrance, and materials that mimic the original. A small single-car garage is behind the dwelling. The original nomination states that this is “another Butterfield house” (Wright, 10).</p>

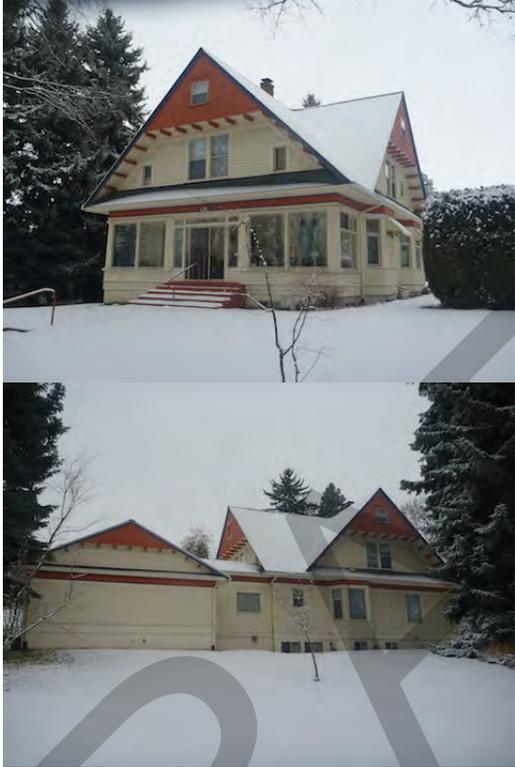
Survey Site Data	Site Photographs	Site Details
<p>Site #: 4 420 North Polk Street Owner: Ronald Meldrum 1906 Previous District Status: C, 40 DoE: C</p>

<p>This is the Harvey R. Smith House. It is a square, one-and-one-half story dwelling. Dominating each elevation is a broad gable with an enclosed, shingled triangular section in the peak, that projects beyond the wall plane. Exposed false-beams line the frieze bands in the gable ends. The façade features a full-width porch filled in with glazing in the openings between the Tuscan columns and a sliding-glass door with sidelights and transoms. The house is clad in wood clapboards and the roof is covered in composition shingles. Several of the windows are one-over-one, double-hung, wood sash. Three bay windows are found on this dwelling: one at the north elevation and two along the south side. Doors and windows feature simple classical wood trim and a wide frieze band highlights the boxed-in eaves. Numerous windows line the basement level and all appear to be vinyl. A brick chimney pierces the roof. An enclosed breezeway leads to a modern, two-car garage on the northeast corner. The garage has been constructed to mimic the style and materials of the main house.</p>

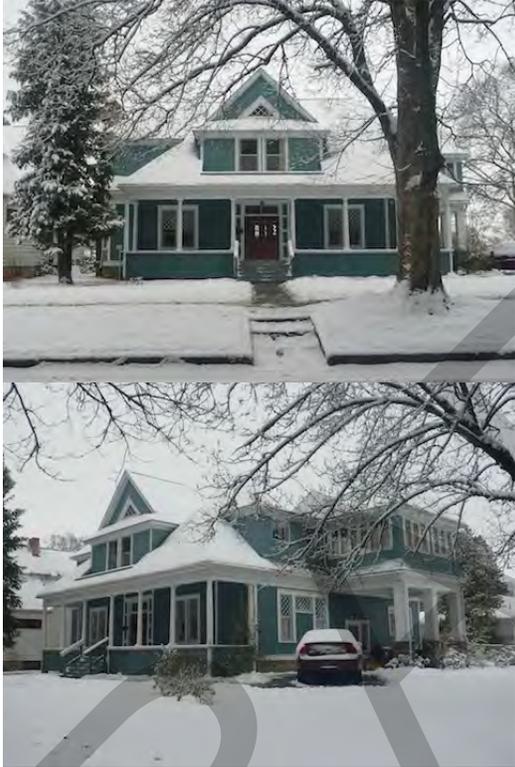
<p>The Emanuel Kaufmann House is a one-and-one-half story Queen Anne with classical elements. It has an irregular plan that was created by alterations in 1909. A large, shingled dormer on the façade features a pair of double-hung windows with a triangular window with small diamond panes. A full-width porch spans the façade. The main entry contains a set of doors with beveled-glass. Decorative wood trim flanks the doors and the transom above. At the north and the south elevations are large, shingled, hip-roof dormers with aluminum slider windows. Also found at the north elevation is a shingled, sleeping porch above a portecochere supported atop three large square columns on coursed ashlar-faced concrete-block piers.. The water table of the sleeping porch flares. A steeply pitched hip roof covers the rear porch on the west elevation. At the south elevation, eave brackets can be seen below the large dormer. Drop siding envelopes the house, while lap siding sheaths the porch surround and wood shingles wrap both the dormers and the sleeping porch. A variety of windows can be found on the residence, including: historic wood-sash, multi-diamond pane-over-single pane, double-hung, diamond pane fixed, one-over-one double-hung, and fixed picture. The dwelling features a wide fascia, corner boards and classical wood trim around doors and windows. Coursed ashlar, concrete block, and rubble foundations can be found. All roofs are covered in composition shingles. An arch-top canvas storage shed is also present.</p>

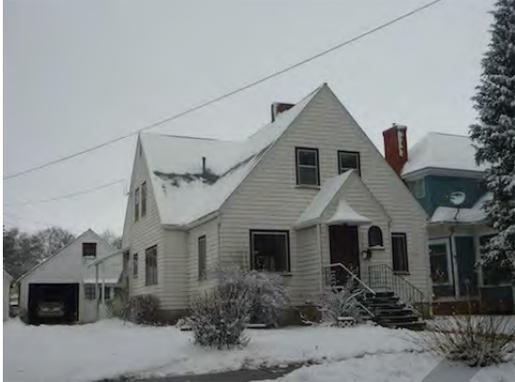
Survey Site Data	Site Photographs	Site Details
<p>Site #: 6 419 North Howard Street Owner: James Brownson 1936 Previous District Status: n/a (is within original district boundaries, but was not mentioned in inventory) DoE: C</p>

<p>This is a one-and-one-half-story dwelling oriented east facing North Howard Street. It features a steeply pitched front-facing cross gable with a single-story, enclosed, gable roof porch centered on the façade. The entry contains a wood-sash fifteen-light French door sheltered by a flared metal hood. A small arch-top, six-light window is also on the porch. The house features single and paired, six-over-one, double-hung, wood-sash windows with wood trim. Eaves are nearly nonexistent and the wood siding is replacement. The foundation is concrete. A brick double-flue chimney exits the roof at the ridge. A wood frame, front-gabled garage is at rear. It has a pull-up vehicle door and a wood inset-panel glazed shop entry door, a steeply pitched roof, original wood siding and a small four-light wood sash window.</p>

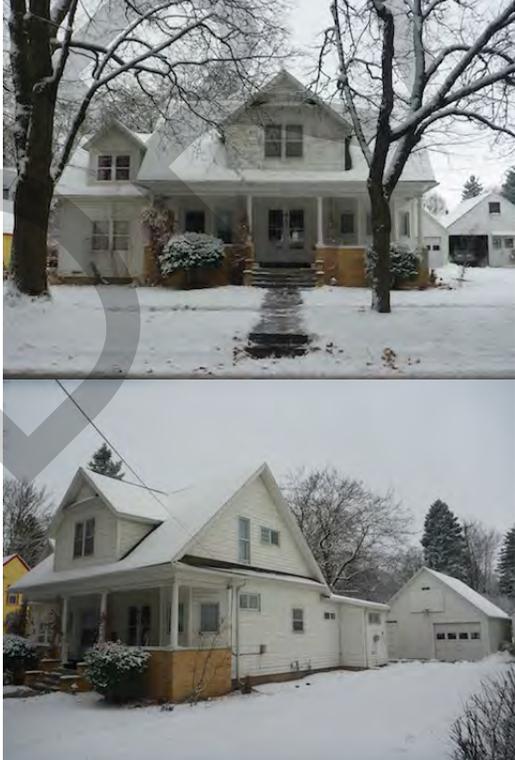
<p>Site #: 7 411 North Howard Street Owner: Von Walden 1880 Previous District Status: NC (compatible), 43 DoE: C</p>

<p>This is a one-and-one-half story dwelling oriented east facing North Howard. It is symmetrical and side-gabled with a large front-facing gabled dormer atop a full-width porch recessed under the main roof. The large front-facing dormer has a small pent roof in its peak above a pair of vinyl replacement windows. Classical porch columns sit atop a blonde brick apron and support a classic entablature with dentil molding. The porch features two bay windows that project onto the porch. The entry door is set in the bay window on the south end of the porch. Alterations include a small addition at northwest corner and large one-and-one-half story, side-gabled addition with dormer on the south. The dwelling is clad in vinyl, and few historic windows are extant. The foundation is concrete block. To the rear of the house is the garage. It is a gable roof, frame building covered in original wood clapboards with minimal eaves.</p>

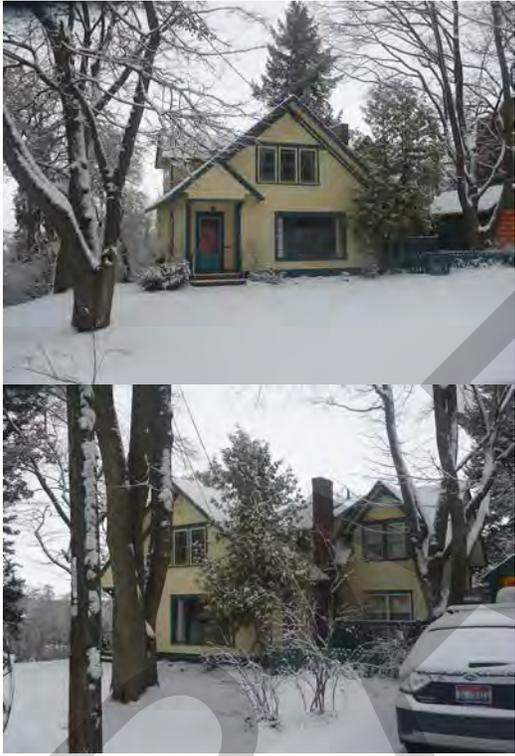
Survey Site Data	Site Photographs	Site Details
<p>Site #: 8 502 East C Street Owner: Paul Hill 1910 Previous District Status: n/a DoE: C</p>

<p>This residence is a one-and-one-half story, cross-gabled, frame dwelling oriented towards the south. The eastern portion of the house, the cross gable, is a later addition. The main floor of the façade features a front-gabled porch roof that is tied into the main roof and supported by brackets over the entry door, and a wide window with a large central pane bracketed by multiple-pane sidelights. The double outside brick chimney is shouldered. A pair of windows is found at the main floor of the wing. The front-gable end is graced with a ribbon of three windows and machine-cut cedar shingles in the peak. A wall dormer pierces the south side of the roof of the crossing gable and features a pair of double-hung windows. There is a large dormer at the west elevation with a pair of double-hung windows. The east end features a pair of windows with cedar shingles in the peak. The roof has wide boxed eaves and is sheathed in composition shingles. The exterior walls are covered in narrow lapped wood siding. Most of the windows are wood. The foundation is concrete block.</p>

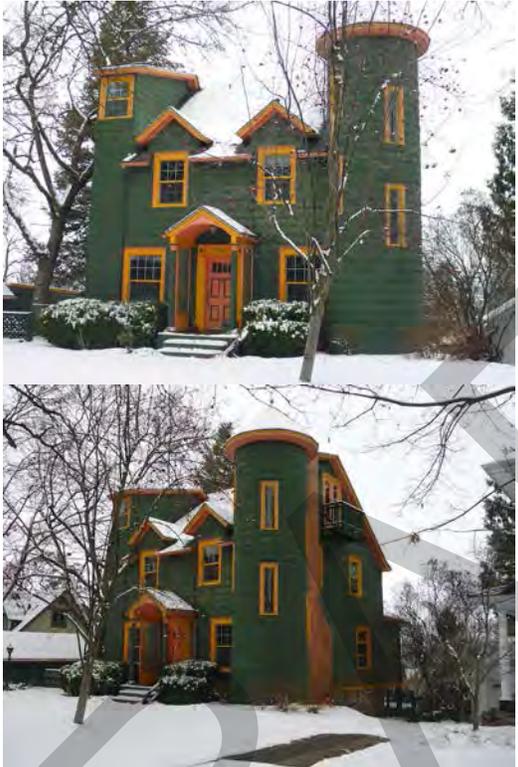
<p>This residence is a three story, altered, frame dwelling oriented towards the south. A single story, one-car garage sits to the west of the residence. The façade features a centered entry door covered by a front-gabled porch roof with an arched ceiling atop full-height columns, and two gabled wall dormers. Windows flank the entry door at the main floor. A three-story tower with six windows and a conical roof is found at the façade’s eastern corner and a narrow third-story addition is found at the south end of the west elevation. A secondary entry door and numerous windows pierce the west elevation. The eastern elevation includes windows, a pair of French doors with a Juliet balcony and a tall shouldered outside brick chimney. The roof is covered in composition shingles, the walls are sheathed in cedar shingles and the foundation is concrete block. Most of the windows are replacements.</p>

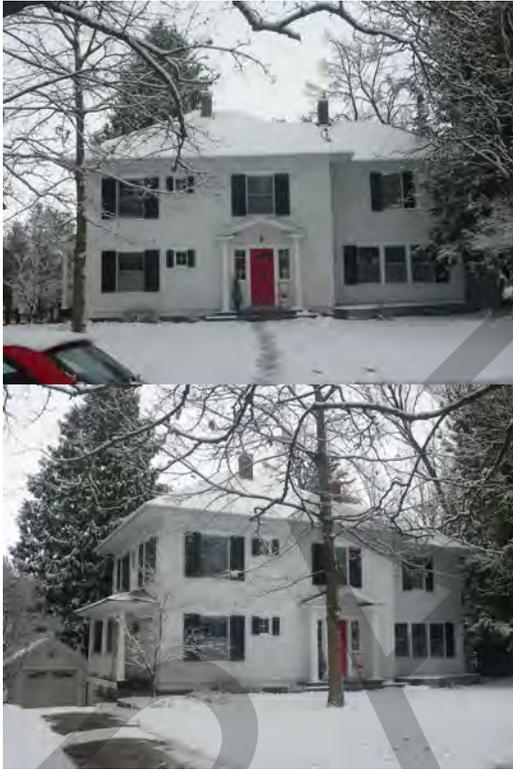
Survey Site Data	Site Photographs	Site Details
<p>Site #: 10 514 East C Street 1913 Previous District Status: n/a DoE: NC</p>

<p>This is a two-story, Neocolonial frame dwelling that is oriented towards the south. A single-story, one-car garage sits northwest of the residence. The original portion of the residence is a square plan with an offset main entrance door under an open pediment porch roof set atop fluted modified Doric columns. The entry door is wood panel with an arch top window in the upper portion, and is flanked by eight-light sidelights. There is a narrow side- entry porch on the west elevation with a hipped porch roof supported on fluted modified Doric columns and simple balustrade. The dwelling exhibits a wide fascia board and classical window and door trim. The roofs are hipped and clad in composition shingles, and the exterior walls are sheathed in narrow clapboards. The windows are vinyl. The eastern portion of the dwelling is a later addition. The house sits on a concrete foundation. Two brick chimneys pierce the roof.</p>

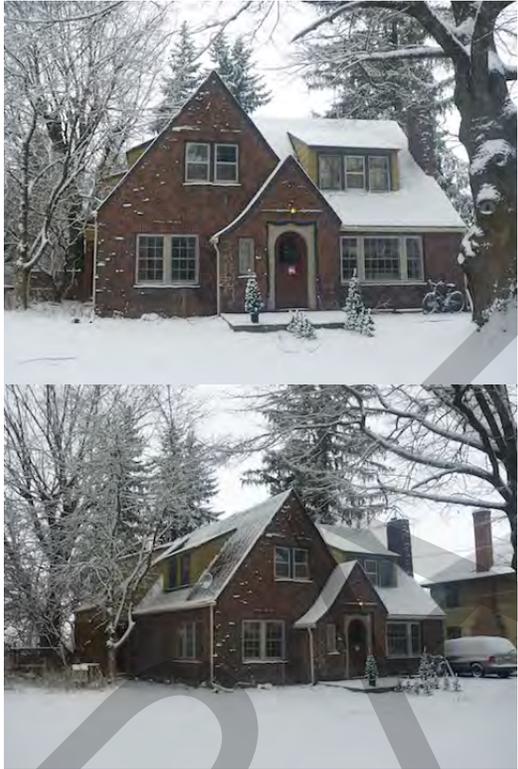
<p>This is a one-and-one-half story, cross-gabled Tudor in the “storybook” style. The façade exhibits a front gable and a smaller entry gable with a flared eave line. The entry has an arched wood door with two horizontal panels and six-light glazing. A painted wood surround with faux rustication surrounds the entry, topped by a soldier course brick lintel. To the left of the entry door is a narrow six-light window. Wood-sash windows remain. In the large shed-roof dormer is a triplet of original six-over-six windows. A smaller shed-roof dormer is found on the south elevation and exhibits two, six-over-six, double-hung, wood-sash windows. The first story is clad in clinker-brick veneer laid in an irregular, random, undulating tapestry-style bond, while the dormers and the crossing gable end are covered in wood shingles. A large clinker brick chimney with the same bond and an inset, arched niche is found on the north. At the southwest rear of the residence is a one-and-one-half story addition with a shed-roof dormer and rear entry. The addition features both stucco and shingle cladding.</p>

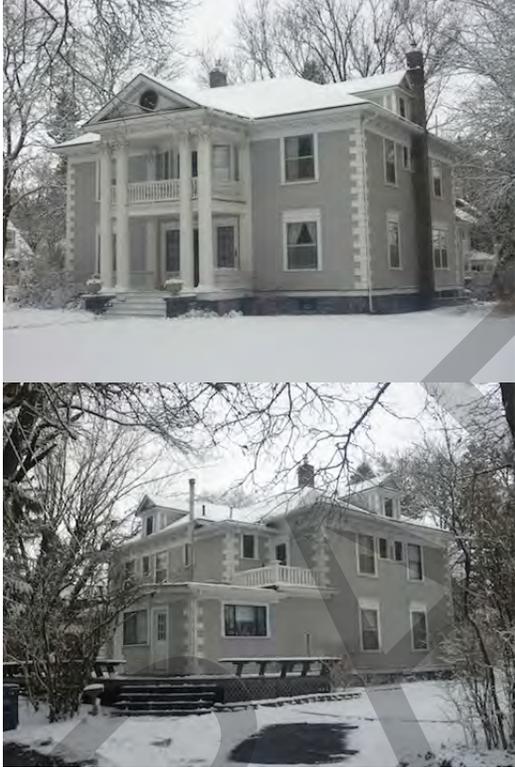
Survey Site Data	Site Photographs	Site Details
<p>Site #: 12 403 North Polk Street Owner: Christopher Schlect 1902 Previous District Status: C, 36 DoE: C</p>

<p>The Charles L. Butterfield House is a two-story Neoclassical dwelling. It showcases a dominant entry porch with a classical pediment and gabled roof, fluted full-height Corinthian columns and pilasters, and an upper porch with a spindled balustrade. The tympanum features an oculus window, and dentils and swags detail the frieze. The entry contains a glazed, wood panel door flanked by sidelights and trimmed by a classical architrave. Dormers on the truncated hip roof are present on all but the façade. Historical photographs show a widow's walk, which is no longer extant. Windows are double-hung, one-over-one, wood sash. Small windows at the second story feature a union jack design. The exterior has wood quoins, narrow board lap siding, and a coursed ashlar stone foundation. There is one interior chimney, and one outside on the north elevation that appears to have been added later. On the west is a single-story addition with a shallow-pitch gable roof, modern entry door, modern metal-frame sliding windows, metal stovepipe, wood deck, and a small second story roof-deck.</p>

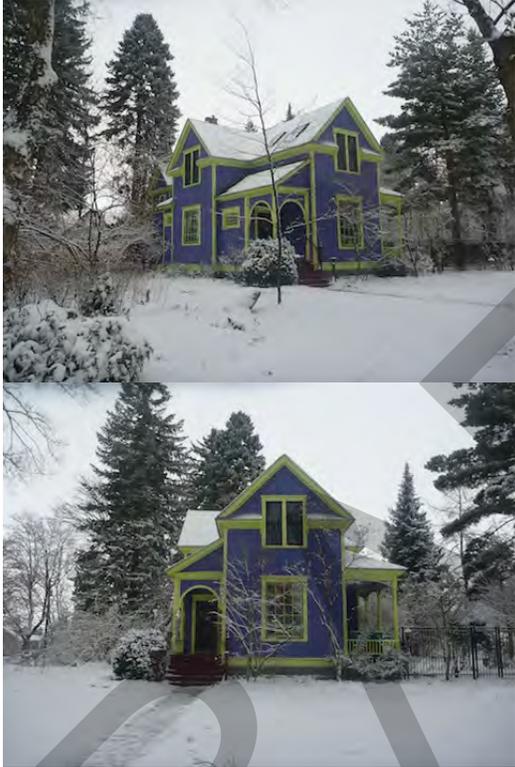
Survey Site Data	Site Photographs	Site Details
<p>Site #: 13 604 East C Street Owner: Jayne Eliza Mahle 1900 Previous District Status: C, 49 DoE: C</p>

<p>This is a one-and-one-half story Queen Anne dwelling oriented to the south. The steeply pitched roof is cross gabled and sheathed in composition shingles. The residence features a T-shaped plan with a two-story rear addition. The roof is pierced by a brick, double-flue chimney and modern skylights. The main cross gables have full-height windows through the gable ends, breaking the cornice. In the gable ends are diamond and fish scale shingles and large scroll-cut brackets supporting the cornice break. Wood drop siding covers the exterior and simple trimmed capitals top the corner boards. The original portion of the residence has a parged stone foundation while the porch at the east elevation and the addition sit on concrete blocks. At the southwest corner of the façade, a pair of round arches grace the shed- roofed main entrance springing from a single turned post to matching pilasters. At the southeast corner, a porch within the ell of the crossing gable covers a secondary entrance. Many of the original windows are present at the first floor, however the second story and the addition feature replacement windows.</p>

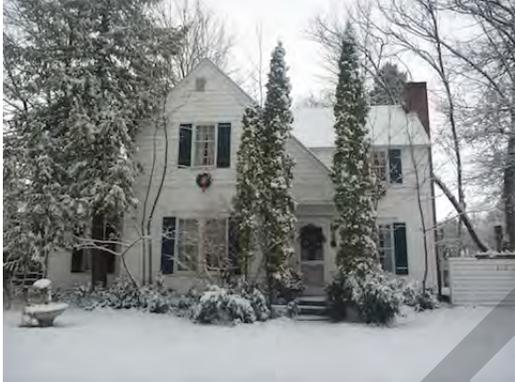
Survey Site Data	Site Photographs	Site Details
<p>Site #: 14 616 East C Street Owner: Mary Blanton ca. 1900 Previous District Status: NC (compatible), 47 DoE: C</p>

<p>This is a ca. 1900 dwelling updated with simplified Tudor detailing. The façade has a dominant front gable with varied eave-line heights and two side-gabled wings: a single story to the west, and a two-story to the east, with a large, brick, single-shouldered chimney. The roof has minimal eaves. The first floor exterior walls are covered in lap siding with corner boards while shingles cover the second story. The windows are double-hung, wood sash. At the second story they are six-over-nine and six-over-six, and nine-over-nine on the lower level. Shutters flank the windows on the façade. The main entrance features a shallow crown supported on simple pilasters framing the glazed wood panel. The foundation is concrete block and a large contemporary multi-level deck can be found at the rear.</p>

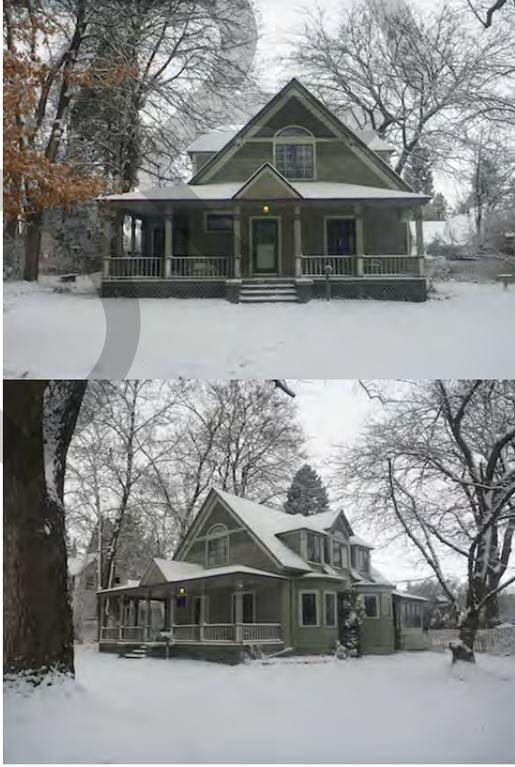
<p>Site #: 15 622 East C Street Owner: Steven McGeehan 1910 Previous District Status: NC (compatible), 46 DoE: NC</p>

<p>This is an altered, front-gable Queen Anne-styled residence. The dwelling features nonhistoric gabled dormers with modern windows and arch-top windows in the gable ends on both the west and east elevations, centered between hip-roofed dormers. A variety of patterned shingles decorate all the gable ends. The house is clad in cedar shingles. A full-width porch wraps around the façade and extends along the west elevation. It features a front-gabled peak with a sunburst decoration centered over the front entry door atop the hip roof, and original French secondary entry doors from the porch at the west elevation. The square porch posts exhibit wood trim and small corner brackets. Two bays are found at the east elevation; the bay nearest the front is historic, while the northernmost bay is contemporary and features new windows, a poured concrete foundation, and boxed eaves under a low hip roof.</p>

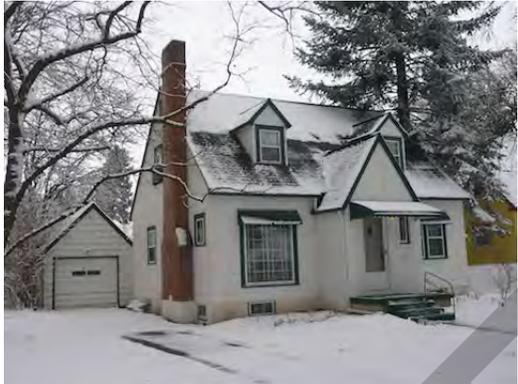
Survey Site Data	Site Photographs	Site Details
<p>Site #: 16 630 East C Street Owner: David Lee Rauk 1936 Previous District Status: NC (compatible), 45 DoE: C</p>

<p>This is a one-and-one-half-story side-gabled dwelling with an enclosed entry centered on the façade and two gabled dormers above. The entry is painted brick and has a small inset niche above the doorway. The entry also features a metal awning above. East of the door is a narrow, three-light wood window. Around both the door and window are brick surrounds set in rowlock courses for the sills and lintels, and header courses along the sides. The roof features narrow eaves, and vinyl replacement windows are found throughout. On the west is an exterior, shouldered brick chimney with a diamond pattern. Asbestos shingles cover the dwelling and the foundation is concrete. At the northwest corner of the site is a one-story, gable roof, single-car garage with a pull-up door, and wood shingles.</p>

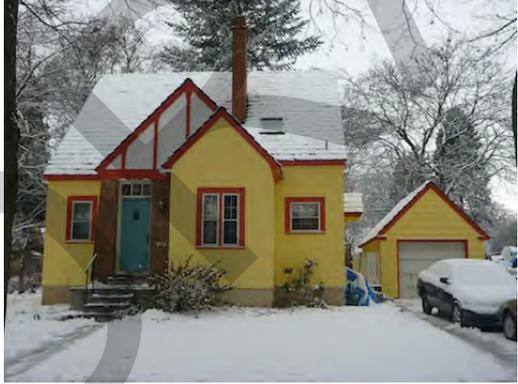
<p>Site #: 17 405 North Howard Street Owner: James Elliott Johnson 1936 Previous District Status: NC (compatible), 44 DoE: C</p>

<p>This is a one-and-one-half story, side-gabled dwelling with smaller front- and rear-facing gabled extensions. The entry gable has half-timbering and a scroll-cut fascia above the doorway. It is faced with brick veneer flanking the entry door. The entry contains a wood plank door with original hardware and a three-light transom above. An additional gable projects from the façade, with a centered pair of vinyl windows and wide wood trim. The side gable ends exhibit small cornice returns. At the north elevation the side entry door is covered with a gabled-porch roof set on knee brackets. The house is clad in asbestos shingles and the foundation is concrete. The roof is covered with wood shakes and features a tall chimney and modern skylight. A small single-car garage covered in wood shingles is also at the site. It has a front-facing gable roof with small cornice returns. It is covered in wood shingles.</p>

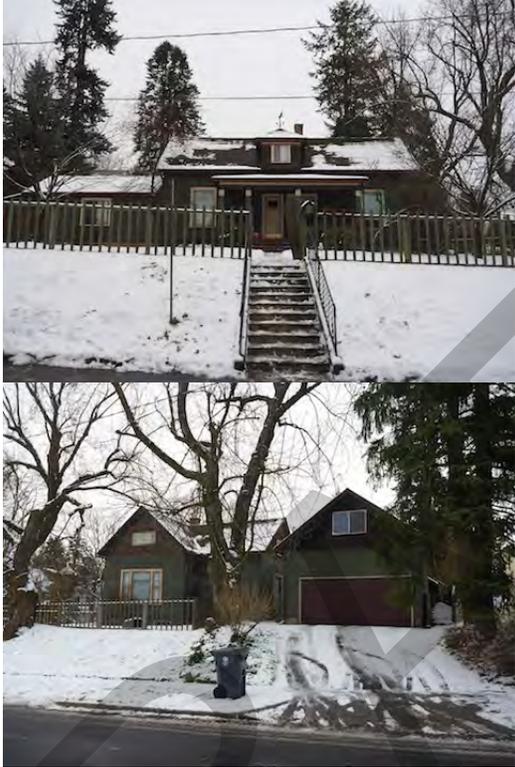
Survey Site Data	Site Photographs	Site Details
<p>Site #: 18 503 East C Street Owner: Gary Reed ca. 1890 Previous District Status: C, 32 DoE: C</p>

<p>This is a one-and-one-half story, side-gabled dwelling with a gable-roof extension to the rear and a single-story addition on the east side. The residence is oriented towards the north facing East C Street. The façade features a partial-width, central porch with a low hipped-roof supported by square columns atop shingled solid railings. The entry door is a painted wood Craftsman-style ledged door with glazing. The façade also features wood-sash, fixed pane windows on either side of the porch. A single, hip-roof dormer is centered above the porch at the roof. It contains an aluminum sliding window and wood-shingles. The east addition has a small shed roof on its east elevation, a wide horizontal sliding window at the façade, and a metal stovepipe. The roof is composition shingle, the exterior walls are clad in narrow wood clapboards, and a brick chimney exits the roof at the ridge. Also at this site is a modern one-and-one-half story, gable-front, two-car garage that is oriented towards North Van Buren Street. It features a roll-up garage door, an aluminum slider window, and narrow wood siding below with shingles above.</p>

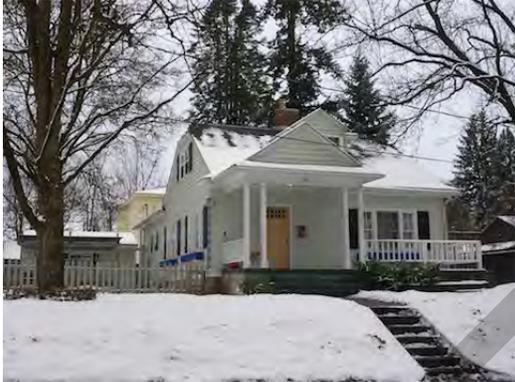
Survey Site Data	Site Photographs	Site Details
<p>Site #: 19 511 East C Street Owner: Tara Waynant 1920 Previous District Status: C, 33 DoE: C</p>

<p>This is a one-and-one-half story dwelling with a side-facing clipped-gable roof with front and rear crossing gables and a single dormer. The house has a front-facing gable entry porch with wood clapboards in the gable end, and a small pent roof atop paired square columns. The entry contains a paneled wood door with ten-light glazing. An eight-over-one, wood-sash window flanked by four-over-ones is to the west of the entry. A gable-front dormer with boxed eaves, cornice returns and a pair of vinyl windows is centered at the façade. All the windows except at the dormer have decorative shutters. The foundation is concrete and the roof is composition shingled with cornice returns and boxed eaves. Facing east to the alley is a small one-story, gable-roof, single-car garage with a metal pull-up door.</p>

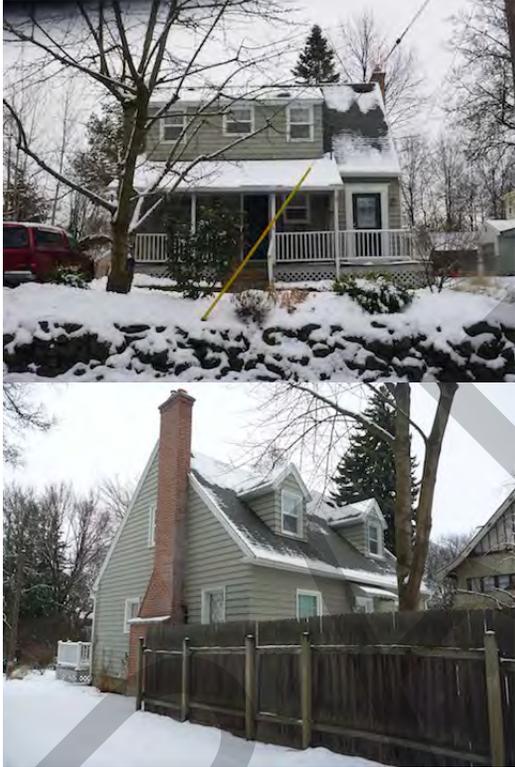
Survey Site Data	Site Photographs	Site Details
<p>Site #: 20 517 East C Street Owner: Nancy Soo Hoo 1937 Previous District Status: NC (compatible), 34 DoE: C</p>

<p>This is a one-and-one-half story, steeply pitched, side-gabled dwelling with a large shed-roof dormer at the façade. The dwelling is oriented towards the north facing East C Street. The façade features a partial-width porch with a shed roof atop 4x4 posts with a simple wood railing. An entry door is sited between a vinyl window and a projecting square bay with a wood-sash, eight-light horizontal window. The main entry door sits on the porch to the west of the covered area; it is a modern fiberglass panel door. The door surround has fluted pilasters supporting an entablature. Above the porch roof and nearly as wide, is a shed-roof dormer with three vinyl double-hung windows. A pair of gabled dormers with vinyl windows graces the roof at the rear elevation above a rear entry door. At the west elevation a pair of original, leaded, diamond-pane windows flank the chimney, which is a tall, brick, double-flue, chimney with a full-width buttress, a single shoulder and a ledge. The foundation is concrete, the roof is composition shingle, and the siding is wide, wood lap siding. The gable ends have cornice returns and the residence has minimal eaves. Most of the windows have been replaced with vinyl sashes. A modern, small, gable-roof shed with open eaves, composition shingled roof and vertical sheet paneling is to the rear at the alley.</p>

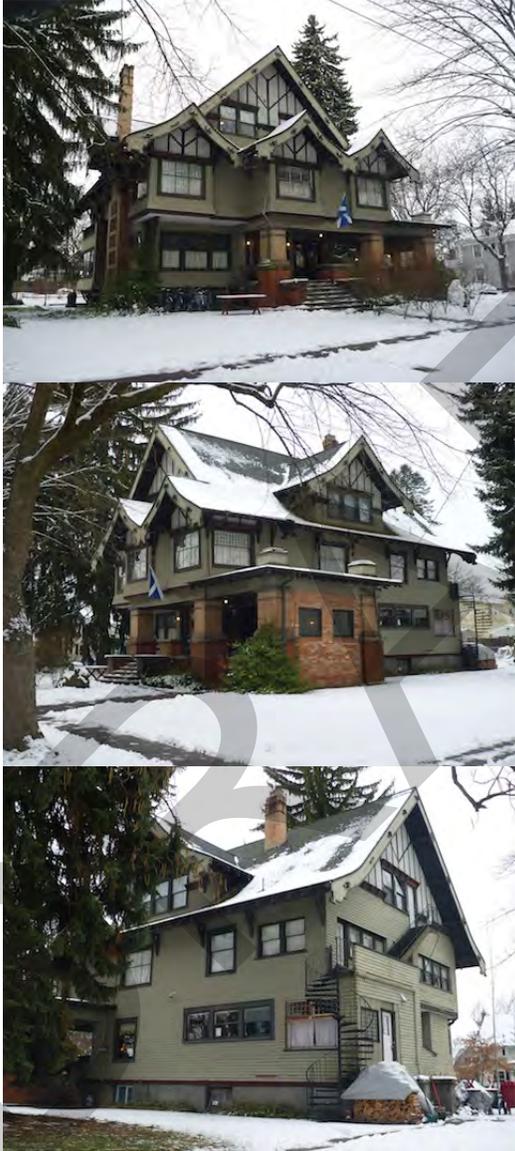
Survey Site Data	Site Photographs	Site Details
<p>Site #: 21 325 North Polk Street Owner: Evan Wilson 1911 Previous District Status: C, 35 DoE: C</p>

<p>The Mark P. Miller House, also known as the Gingerbread house or the House of Seven Gables, is a large, two-and-one-half-story, eclectic Craftsman mansion with Swiss Chalet style detailing. It has a front-facing gable roof, large dormers over both side elevations, and three staggered gable-roof projections on the second level of the façade. A partial-width porch on the façade features supports of blonde and red brick piers with cast stone caps. The wood entry door has an inset panel and beveled glazing, and is flanked by a pair of beveled glass sidelights. Door hardware is original. At both sides of the entry is a band of triplet wood-sash, double-hung windows with stained-glass uppers over a large single pane. The gables have half-timbering and detailed bargeboards. A porte-cochere rests on supports that match the porch and extend up over the roof, which is hipped with a nearly flat pitch. It has open eaves with ornately sawn rafter tails. The space between the piers at the north elevation has been filled in with brick and two square windows with small lights. At the south elevation, four wood-sash, double-hung windows are set in a cantilevered square bay window with flared water table topped by a balconet, west of a tall, blonde brick, shouldered chimney with inset and projecting details of darker brick and a crenelated top. A forty-eight-over-one window is found east of the chimney; a second window of this size can be found on the dormer over the porch. A second blonde brick chimney with similar detailing exits the roof near the ridge of the rear gable. Other details include deep, open bracketed eaves with detailed rafter tails, and ornate scroll-sawn knee braces and brackets. The house is clad in wood drop siding that flares above the foundation. All windows are original except a few at the basement. Entry doors have been installed into window openings at both the second and third floors on the rear, and a spiral staircase, balcony and straight-run stair have been installed on the back. A small gable roof shed with painted OSB walls, half-timbering, open eaves, and rafter tails is also found at the site.</p>

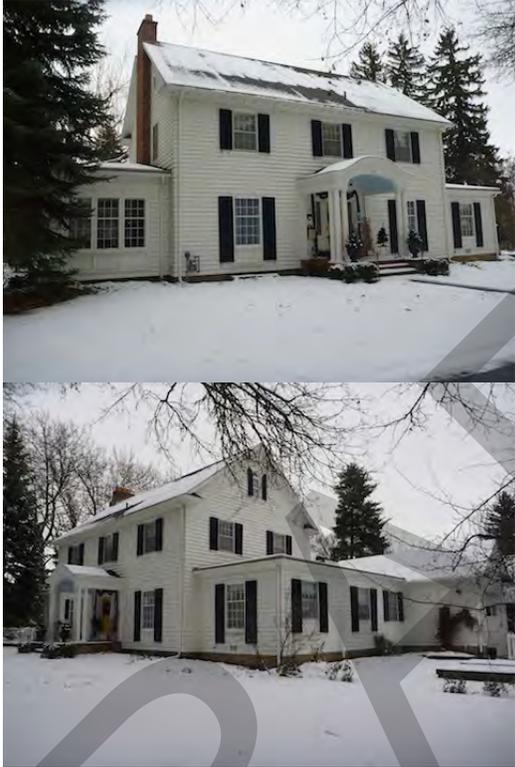
Survey Site Data	Site Photographs	Site Details
<p>Site #: 22 328 North Polk Street Owner: John Ingram 1927 Previous District Status: C, 50 DoE: C</p>

<p>This is a two-and-one-half story, side-gabled Colonial Revival dwelling, facing North Polk. It has a symmetrical façade and flat-roofed, one-story side wings. The main entry has a projecting portico with curved ceiling atop tripled Tuscan columns at the front corners, and square pilasters at the house. The entry is flanked with leaded glass sidelights and has a leaded glass fanlight above. Windows in the dwelling are multi-light, double-hung, wood-sashes with shutters; some with horizontal panels below the windows. At the north end the wing is filled with wood-sash windows. A brick triple-flue chimney is also on the north flanked by a pair of triangular windows. The wing on the south has numerous windows of varying sizes. An attached single-car garage with a front gable, cornice returns and a triangular louvered vent in the peak is found extending off the south wing facing the alley. At the rear is a hooded rear entry door with large brackets and two hip-roof dormers each with a pair of windows and modillions under the eaves. The foundation is concrete, and the siding is wide wood clapboard. Cornice returns are found at the gable ends and modillions are under the eaves. Also found at this site is a small, square shed with wood clapboards, corner boards, a hip roof with a windowed cupola, and wood plank, segmental arch-top, swing out double-doors.</p>

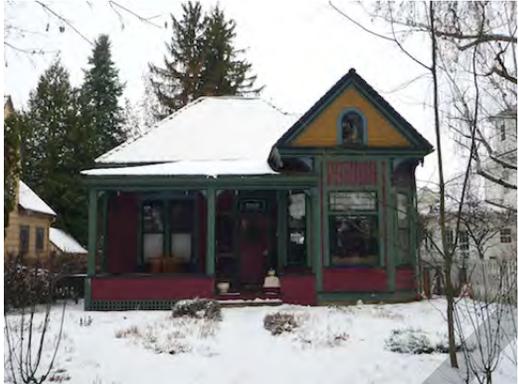
Survey Site Data	Site Photographs	Site Details
<p>Site #: 23 605 East C Street Owner: Steffen Werner ca. 1900 Previous District Status: C, 51 DoE: C</p>

<p>This is a one-and-one-half story Queen Anne dwelling, oriented north facing East C Street. It has a truncated hip roof with lower front-, rear- and side-facing gables and a partial-width porch. The porch has a low-pitched hip roof atop square wood posts with curved sunburst brackets and pendant drops at the simple cornice. The posts rest on a clapboard apron. Double-hung, wood-sash windows with elaborate surrounds remain extant. The front gable features chamfered corners with curved sunburst brackets and pendant drops. The central window has an upper narrow horizontal pane surrounded by multiple lights over a large, fixed single pane. Above the windows are textured panels over the wood siding. In the gable end are fish scale and square imbrication surrounding a stained glass, multi-light, arched window. The side and rear gables exhibit similar features to the front. The roof is covered in wood shingles and the walls are clad in wood lap siding. A nonhistoric, one-and-one-half-story, two-car garage with a louvered cupola and weathervane is found at the alley.</p>

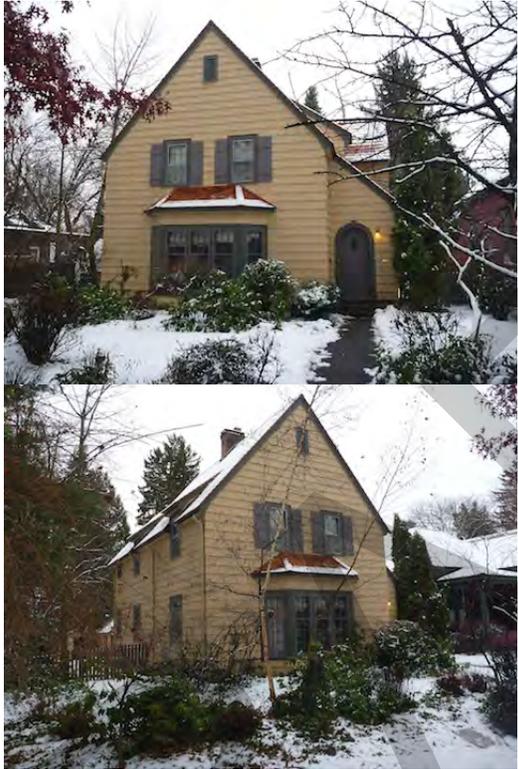
Survey Site Data	Site Photographs	Site Details
<p>Site #: 24 615 East C Street Owner: Ethan Jones 1931 Previous District Status: NC (compatible), 48 and 52 (duplicated in the original nomination) DoE: C</p>

<p>This is a tall, two-story, Tudor-inspired dwelling, oriented north facing East C Street. It features a dominant front-facing gable and a small, single-story crossing gable on the west. The main entry is stepped-back under a continuation of the steeply pitched main roof. The entry is arched and has a wood surround with a keystone. In the front-facing gable is a wide, five-window bay with a cedar shingle hipped roof. The windows are tall, fifteen-light casements. Above the bay are two six-over-six, wood-sash windows with wood surrounds and shutters. At the east elevation are two wall dormers with shallow shed roofs. On the west, a shed-roof dormer with a small, four-light, wood-sash window sits atop the roof that shelters the entry. To the south of the dormer is a lower crossing gable with an oculus window with wood surround and a keystone that is located just over a nine-light, wood-sash window. The rear elevation features a lower rear-facing gable with a large wood-sash fanlight window over a pair of eight-light, wood-sash casement windows. The exterior is clad in wood shingles with a wide reveal and the roof is covered in cedar shingles. At the rear of the site at the alley is a one-car garage. It has a modern roll-up door, shingled walls, a wood shingle roof, and a tall brick chimney.</p>

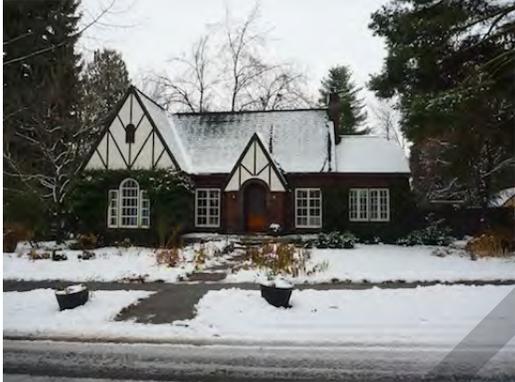
Survey Site Data	Site Photographs	Site Details
<p>Site #: 25 621 East C Street Owner: Thomson McClure Family Trust 1927 Previous District Status: NC (compatible), 53 DoE: C</p>

<p>This is a brick-veneered Tudor style dwelling with a steeply pitched, cross-gabled roof with a smaller front-facing entry gable and a shorter clipped-gable wing to the west. The arched entry has half-timbering in the gable and a projecting brick, double rowlock course arch-top header; the dark brick continues down both sides of the doorway. Semi-circular steps with brick trim and an iron handrail lead to the entry. The dominant front-facing gable has half-timbering and a triplet window with a central, arched, twenty-light window flanked by eight-light windows. The shorter clipped-gable wing features eight-light, wood-sash windows with storms and half-timbering detailing. The walls are clad in a red-tone brick veneer with a darker brick rowlock course as the window surrounds. The eaves are minimal. Piercing the roof is a large, brick, double-flue chimney. A shed-roof, covered patio area with skylights and brick knee-walls are to the rear, along with a gable-roof, two-car garage with half-timbering, brick veneer, and rowlock course brick window surrounds.</p>

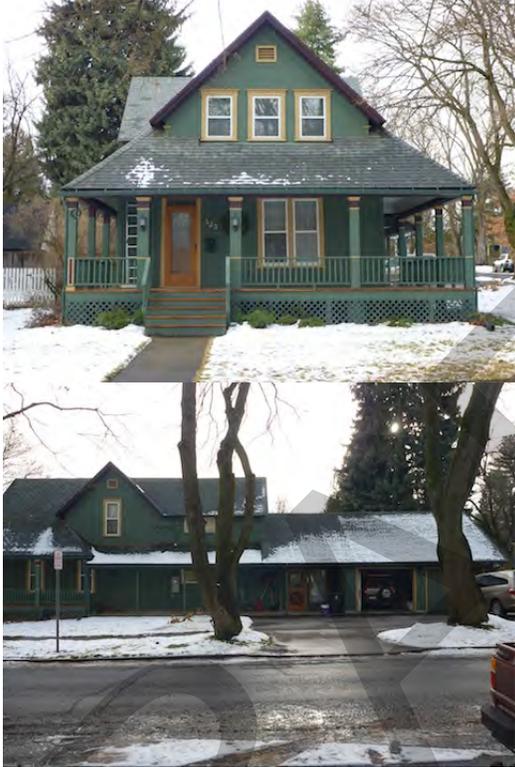
<p>Site 26 is located on the southwest corner of Howard and C Streets. It is a one-and-one-half story, cross-gabled, frame dwelling with a full-width porch spanning the façade and wrapping around both front corners. A full-height addition has been added to the rear, and a two-car garage with an additional rear entry door is found on the far rear. The original dwelling is covered in clapboard siding, while the additions exhibit vertical board siding. The porch is supported by square posts with crown molding at the top; crown molding can also be found above the windows, which contain vinyl sashes. Corner boards with crown molding and a transom above the main entry are also found on the dwelling. Though the large addition is visible along the north elevation due to the dwelling's location on a corner lot, it is to the rear, is the same or lower in height as the original portion, and is compatible in scale and material, thereby allowing the property to retain its ability to communicate as an early twentieth-century dwelling compatible with others in this area.</p>

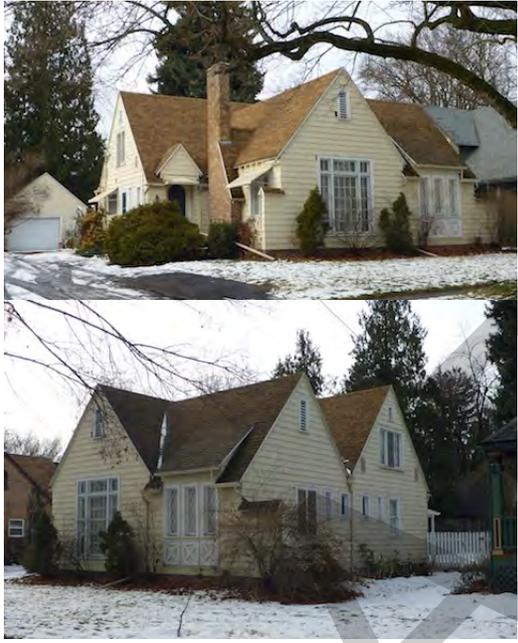
Survey Site Data	Site Photographs	Site Details
<p>Site #: 27 321 North Howard Street Owner: Rosine Boyce-Derricott 1928 Previous District Status: NC (compatible), 55 DoE: C</p>

<p>The top photograph shows a front view of a yellow house with a prominent brick chimney and a small gable roof over the front porch. The bottom photograph shows a side view of the same house, highlighting its cross-gabled roof structure and a gable-roofed garage attached to the side.</p>	<p>This is a cross-gabled, 1930s-era dwelling facing east toward Howard between B and C Streets. It features wood shingle siding, large, multi-light, wood-sash windows, and an exterior brick chimney with one shoulder. The main entry has a small gable roof over it and a metal awning above. A small shed roof pops up on the façade elevation, over three windows with diamond-shaped divisions in the glass. A side entry, with metal awning, is found on the south elevation. From the north elevation, another gable roof is visible at the rear, creating an M-shape roofline on that side. A gable-roof, frame, single-car garage is slightly southwest of the dwelling.</p>

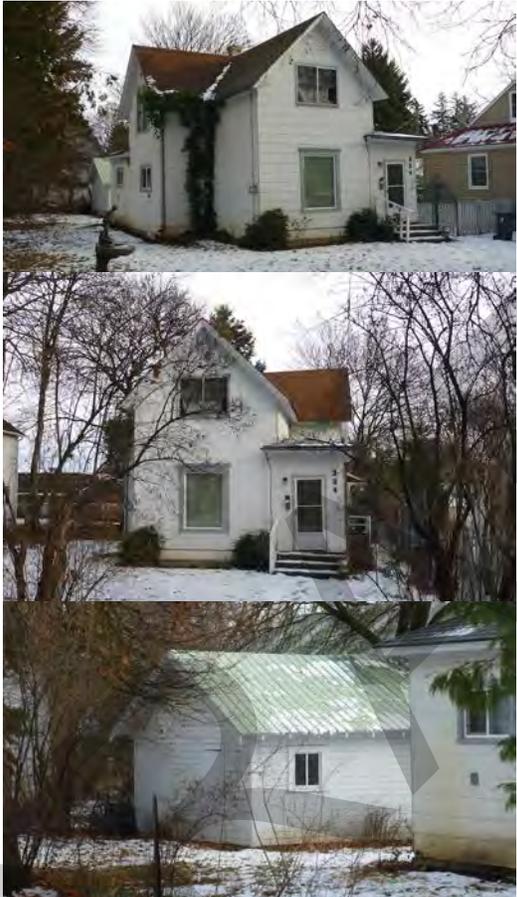
<p>Site 28 is located on the southeast corner of Howard and C Streets. It is a two-story, T-plan, cross-gabled, frame dwelling with a single-story enclosed porch on the rear. The dwelling also exhibits a small, single-story, enclosed entry porch on the southwest corner. It is covered in asbestos siding, and features nonhistoric metal windows with simple wood trims and crown molding above. A brick chimney pierces the roof near the rear of the dwelling. A small, gable-roof, frame garage is found at the rear of the property. It features weatherboard siding, corner boards, visible rafter tails, and nonhistoric V-groove metal roofing. Despite nonhistoric materials, the dwelling retains the overall character of a late nineteenth-century dwelling.</p>

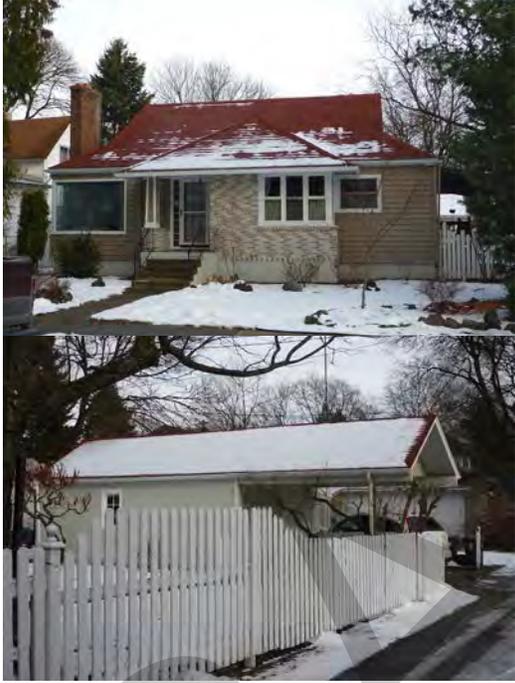
Survey Site Data	Site Photographs	Site Details
<p>Site #: 29 322 North Howard Street Owner: Johana Doyle 1946 Previous District Status: n/a DoE: NC</p>

<p>Site 29 is oriented toward the west on Howard Street, between B and C Streets. It is a single-story, gable-on-hip roof, minimal traditional dwelling. It features a partially enclosed, hip-roof extension centered on the front, which houses a recessed entryway. The entry contains a multi-light door with sidelights. The front extension has been covered in a brick veneer, while the rest of the dwelling is covered in vinyl siding. The windows are vinyl. An exterior brick chimney is found on the north elevation. A small shed roof is found on the south side, providing shelter over a patio. The south side gable end exhibits windows. A small, single-car, frame garage is found at the rear of the property. The roof extends far forward or south, providing cover over a carport. The garage is covered in weatherboard, with multi-light, wood-sash windows.</p>

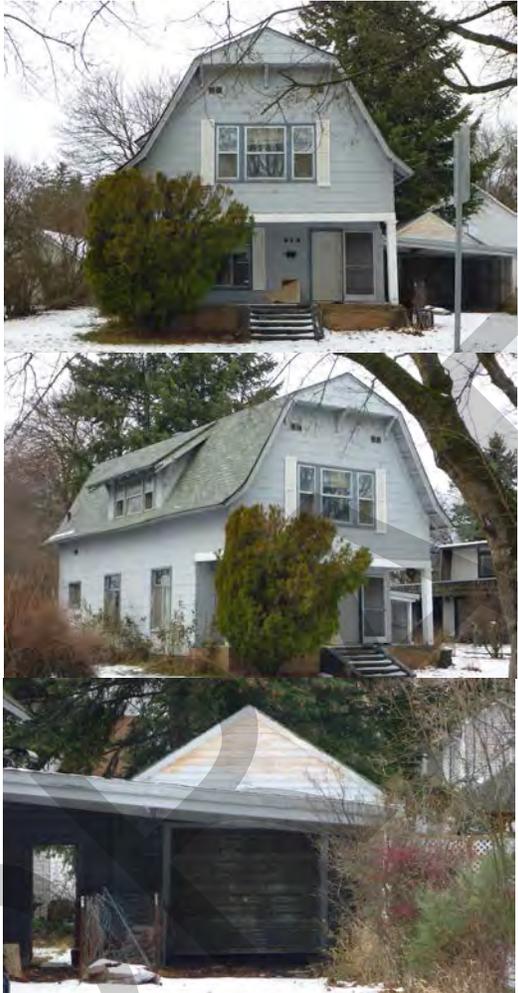
<p>Site 30 is located on the southwest corner of C and Monroe Streets. It is a one-and-one-half-story, frame, gambrel-roof dwelling with a full-width front porch sheltered beneath an overhang of the upper level. The porch is supported by full-height, square posts on a brick porch foundation. Shed-roof dormers are found above both the north and south side elevations. The dwelling is covered in asbestos shingles, and exhibits rafter tails on the dormers, and brackets on the façade elevation. The windows contain aluminum replacement windows some flanked with shutters. A gable-roof, frame, one-car garage is located at the rear corner of the dwelling. It is covered in weatherboard siding, and features a shed-roof carport in front of it, which is also connected to the house.</p>

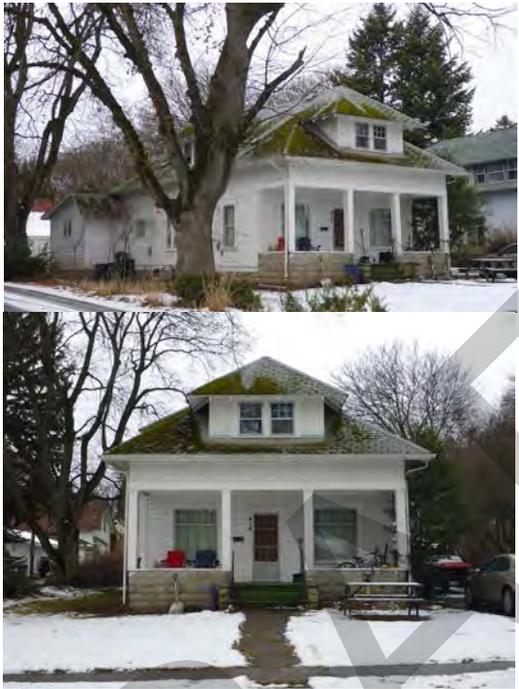
Survey Site Data	Site Photographs	Site Details
<p>Site #: 31 315 North Monroe Street Owner: Ray Jacobs 1920 Previous District Status: n/a DoE: C</p>

<p>Site 31 faces east toward North Monroe between B and C Streets. It is a one-and-one-half-story, symmetrical three-bay (w/d/w), hip-roof Bungalow, with hip-roof dormers above the façade and south side elevations, and a full-width front porch. The porch is recessed beneath the upper level, and is supported by square posts set on an apron of rusticated concrete block. The dwelling exhibits weatherboard siding, visible rafter tails, and one-over-one and six-over-one, double-hung, wood-sash windows. Larger, twelve-over-one windows are found on the façade elevation. A single-story, enclosed porch or addition is found on the rear and extends out slightly to the south. A gable roof, frame, vehicular garage is found at the rear, northwest corner of the dwelling.</p>

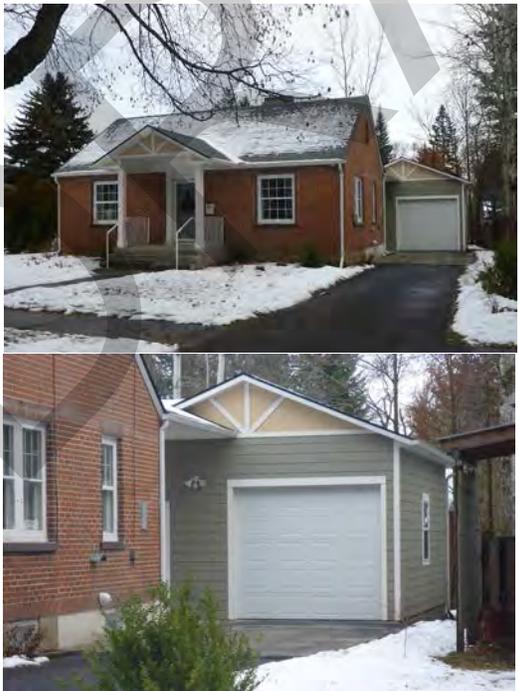
<p>Site #: 32 322 North Monroe Street Owner: Margaret Conrad 1938 Previous District Status: n/a DoE: C</p>

<p>Site 32 is located on the southeast corner of Monroe and C Streets. It is a small, three-bay (w/d/w), side-gabled, Minimal Traditional residence covered in a brick veneer. The house is set on a concrete foundation, and features a gable-roof porch centered on the façade. The main entry is flanked by fluted pilasters, while the porch is supported by square posts set on the concrete porch. The windows contain eight-over-eight and six-over-one, double-hung, wood-sash windows, some with wood storms. The windows feature brick sills and a lintel of soldier course bricks. A nonhistoric, frame, single-car garage is located on the rear southeast corner of the dwelling, connected to it by a small breezeway.</p>
