National Register of Historic Places Registration Form

Historic name: Fort Russell Neighborhood Historic District (Boundary Increase and Additional Documentation)

Street & number: Roughly bounded by Jefferson Street on the west, East D Street on the north, Hayes Street on the east, and East Third Street on the south

City or town: Moscow State: ID County: Latah

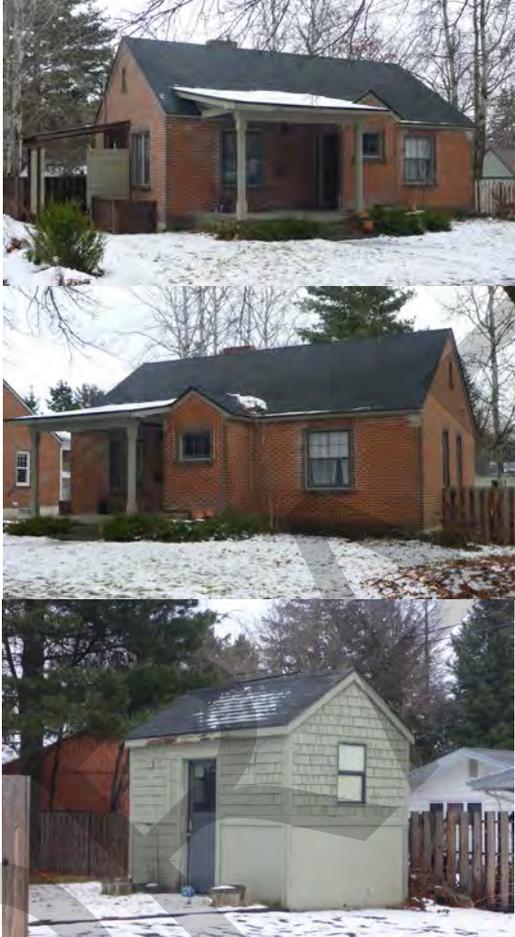
<p>Site 33 faces west toward Monroe, south of C Street. It is a side-gabled, brick veneered, single-story, minimal traditional dwelling. It features a small, gable-roof, enclosed entryway extending forward on the façade, and a shed-roof porch supported by square posts. It also features eight-over-eight and six-over-one, double-hung, wood-sash windows, and a small, fixed, six-light, wood-sash window on the enclosed entryway. Roofs are composition shingle. Brick sills and lintels are also found on this dwelling. A side entry on the north elevation is sheltered by a small shed-roof porch. A small, side-gabled frame shed is also found on the property. It features weatherboard and wood shingle siding, and a single-light, wood entry door.</p>

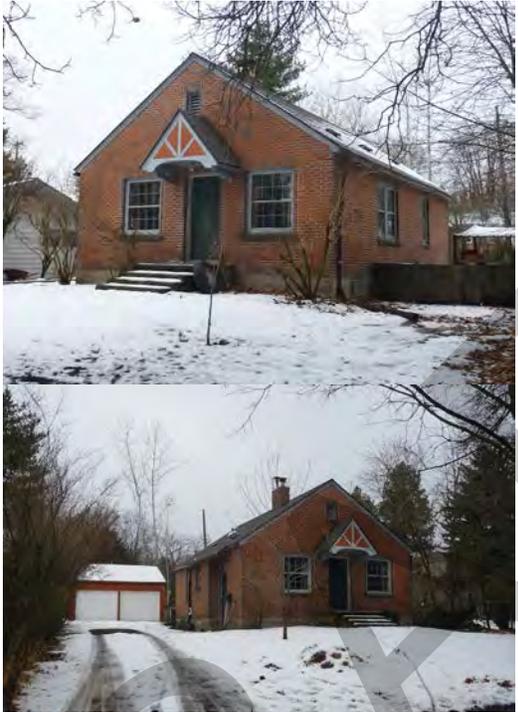
Survey Site Data	Site Photographs	Site Details
<p>Site #: 34 323 North Lincoln Street Owner: Stephen LeCuyer 1938 Previous District Status: n/a DoE: C</p>

<p>Site 34 is located on the southwest corner of Lincoln and C Streets. It is a symmetrical, three-bay (w/d/w), single-story, gable-oriented, dwelling with a brick veneer exterior. It features brick sills and brick soldier courses over the windows and entry doorway. The entryway also has a small, gabled porch roof above, with half-timbering detail. The dwelling features eight-over-eight, double-hung, wood-sash windows, and a small square bay extension on the south elevation. A brick chimney pierces the center of the roofline. The roof is composition shingle. A frame, side-gable roof, two-car garage is found at the rear of the property. It exhibits vertical board siding and overhead garage doors.</p>
<p>Site #: 35 317 North Lincoln Street Owner: Daniel Mullin 1959 Previous District Status: n/a DoE: NC</p>

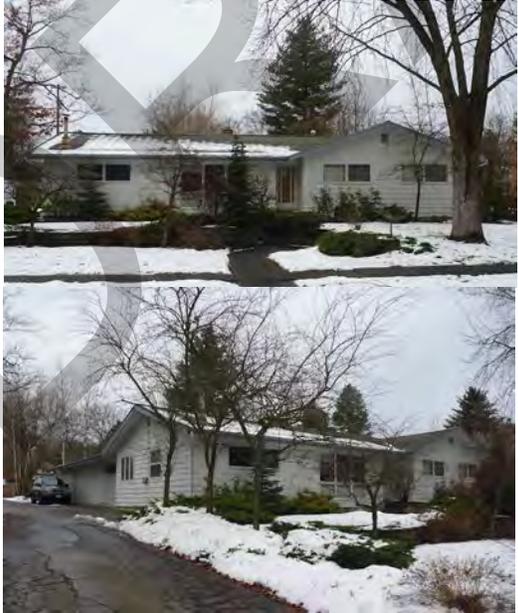
<p>Site 35 faces east toward Lincoln, south of C Street. This is a cross-gabled, single-story, Ranch house. It features an off-centered entry recessed behind the primary wall plane. It is covered in wide, composition board siding and the roofing is composition shingle. A large two-car garage has been attached to the rear of the dwelling, accessible via a breezeway from the house.</p>

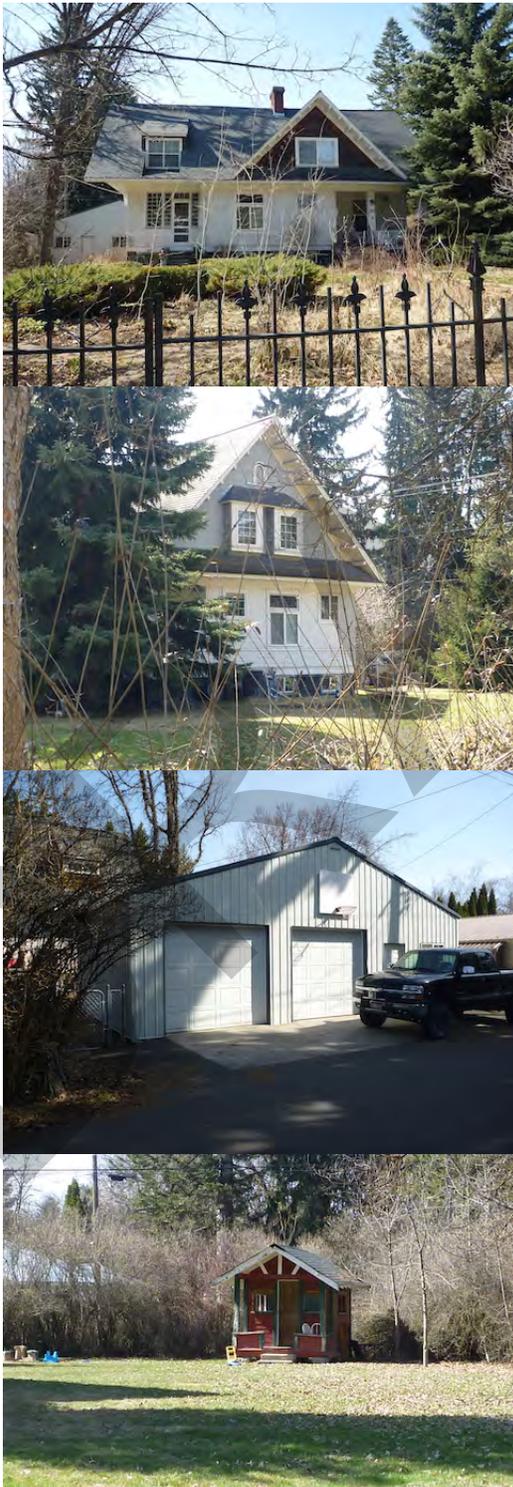
Survey Site Data	Site Photographs	Site Details
<p>Site #: 36 317 North Hayes Street Owner: Lane Oliver 1905 Previous District Status: n/a DoE: C</p>

<p>The photographs show the main house from two angles, a modern two-car garage, and a small wooden playhouse on the lot.</p>	<p>This is the Hawkin Melgard house, 1905. It is a one-and-one-half-story, side-gable, dwelling with large, closed-gable dormers over the façade and rear elevations. A full-height addition has been added to the south end of the dwelling. The addition contains a sunroom and was added in 1912 (Otness: 93). It features shed-roof dormers over both the façade and rear elevations and an entry with a multi-light transom window, sidelights, and another large, multi-light, wood-sash window. The roof over the far south end at the addition features a very deep overhang. The main entry is found within a porch recessed beneath the second-story of the house at the northeast corner. The porch is supported by large, square posts set on a clapboard-covered apron wall. The walls of the shed-roof and gable-roof dormers are covered in wood shingles, while the dwelling is clad in clapboard siding. The closed-gable dormers also exhibit modillions. The north end of the dwelling also has a similarly detailed closed gable. A hip roof covers a pair of small, bay windows on the second level within the closed gable on the north end. The windows are primarily vinyl throughout and a brick chimney pierces the center of the roof. A large, nonhistoric, metal, two-car garage and workshop is found to the rear of the house. A small, gable-roof, wood-frame playhouse or shed is also situated in the northwest corner of the lot.</p>

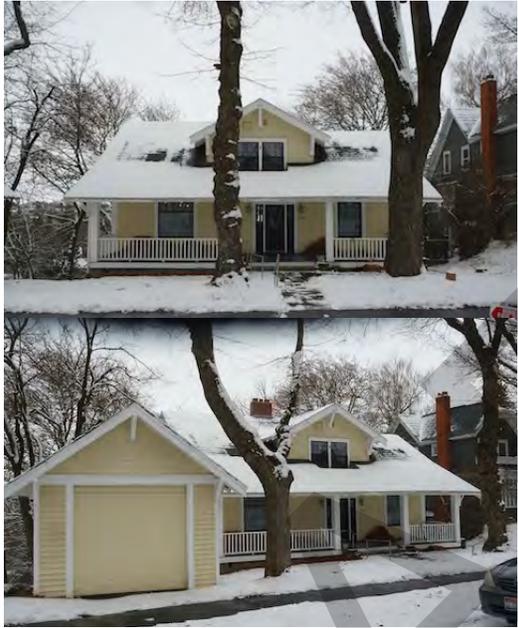
Survey Site Data	Site Photographs	Site Details
<p>Site #: 37 404 East B Street Owner: Fredric Herbold 1912 Previous District Status: C, 23 DoE: C</p>

<p>Site 37 is on the northeast corner of B and Adams Streets. It is a one-and-one-half-story, three-bay (w/d/w), frame dwelling. A full-width porch spans the façade, with square posts supporting an extension of the primary roof. An inset, gable-roof dormer is centered above the façade. Nine-over-one, six-over-one, and ten-over-one, wood-sash windows are found. The main entry is flanked by sidelights. The house also features visible rafter tails, large brackets, a small square bay on the west elevation, and a full-width porch on the rear. It is set on a concrete foundation with a basement and is covered in clapboard siding – though the dormer and gable ends have been stuccoed. A front-gabled single-car garage is extant.</p>
<p>Site #: 38 410 East B Street Owner: Paul Clark 1885 Previous District Status: C, 24 DoE: C</p>

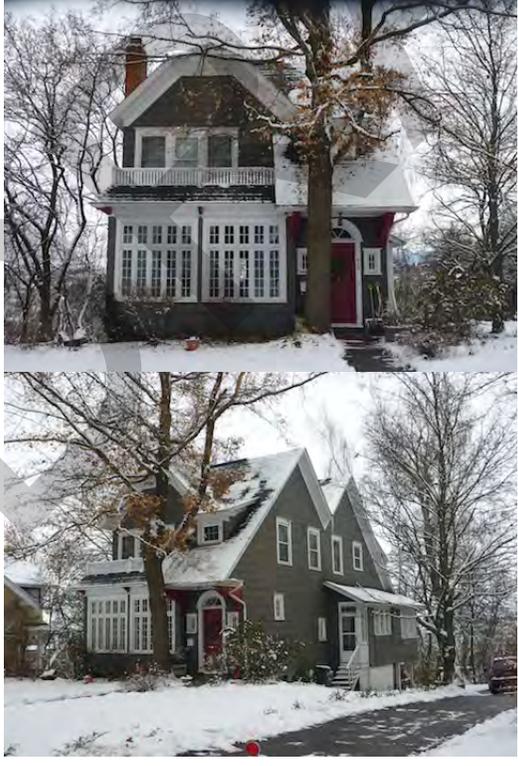
<p>The William Kaufmann Housefaces south on B Street east of Adams. It is a two-story, asymmetrical frame dwelling, with a forward facing, jerkinhead roof on the south elevation, a single gable roof on the west elevation, and two gable rooflines on the east elevation, giving the appearance of the letter M. The main entry is sheltered beneath an extension of the primary roofline on the southeast corner, which is supported by two large brackets. A three-light fanlight is above the door and two small windows are on each side. A sun porch is west of the entry, and has two sections with five, multi-light, wood-sash windows and transoms on the façade and a two window section around on the west side. A small balcony is found above. The sun porch has a slight roof overhang, with small brackets beneath. An enclosed porch is found on the east. The building is covered in wood shingle siding and retains wood windows.</p>

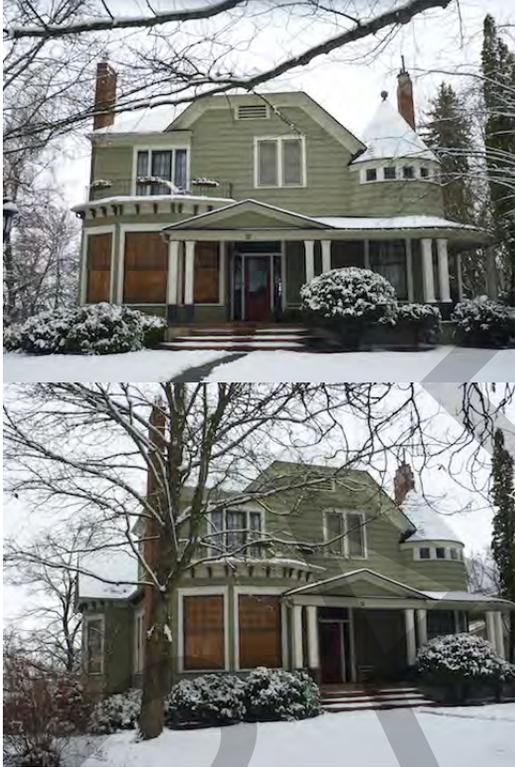
<p>The Dr. Gritman House faces south toward B Street, west of VanBuren. It is an asymmetrical, two-story, frame dwelling with a turret on the southeast corner and an open porch curving around the southeast corner. The dwelling features hipped, gabled, jerkinhead, and conical rooflines and has two, exterior brick chimneys on the east and west sides. The house has large, sixteen-over-one, wood-sash windows, and a multi-light wood door with sidelights that leads to a small second level balcony. A pair of vinyl windows is found above the main entry, while small, square windows surround the turret. The porch is supported by wood posts with a small gable above the entry, which contains a single-light door, multi-light transom, and narrow, multi-light sidelights. Scrolled brackets can be found in several locations where slight overhangs shelter the first story windows. The house is covered in wood shingles, and features a single-story portion at the rear.</p>

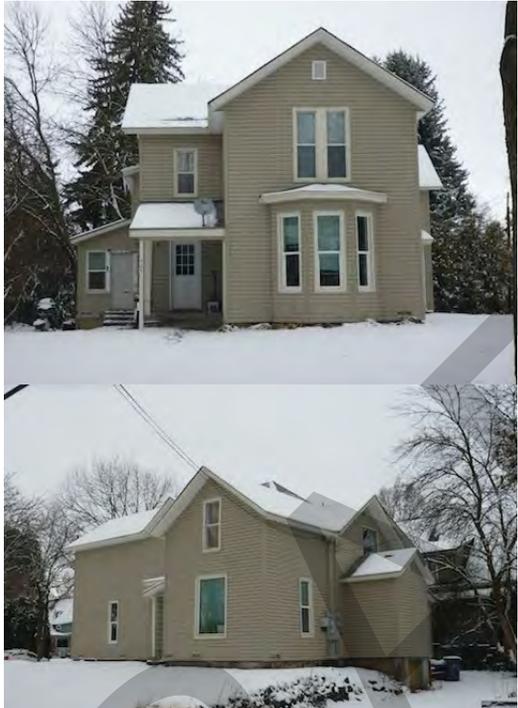
Survey Site Data	Site Photographs	Site Details
<p>Site #: 40 424 East B Street Owner: Bensen Family Trust 1888 Previous District Status: C, 27 DoE: C</p>

<p>The R. H. Barton House is located on the northwest corner of B and VanBuren Streets. It is a two-story, cross-gabled, L-plan, frame dwelling with a slightly shorter, two-story, cross-gabled addition on the rear. Though it appears the original dwelling is an L-plan, the rear addition creates an overall footprint of a T-plan. The original main entry is beneath a shed-roof porch on the south or façade elevation. Two more entries, also facing south are at the west and east ends of the rear addition. An enclosed, gable-roof extension is centered on the rear. A three-sided bay is centered on the forward extension of the original portion, with another on the east elevation. The house is covered in vinyl siding and has vinyl windows and replacement doors. The dwelling is set back within a large corner lot and rests on stone.</p>

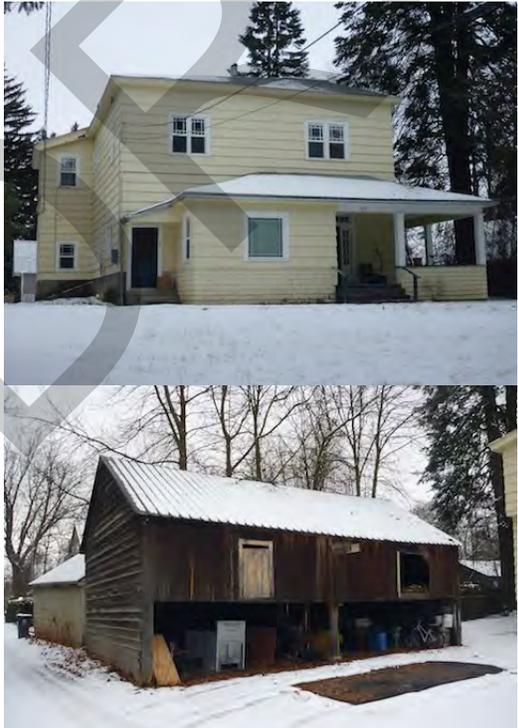
<p>Site #: 41 310 North VanBuren Street Owner: 310 North Van Buren LLC 1888 Previous District Status: C, 31 DoE: C</p>

<p>The original nomination identifies this as the Colonel Frank H. Barton House,. It is a two-story, multi-residence unit, with original full-height projections on the north and south sides and northeast corner. A hip-roof porch wraps around the southwest corner and was present by 1928; it appears to have been originally constructed partially enclosed as it currently appears. The deeply inset entry door is a wood paneled door with an oval window, eight-light sidelights, and a nine-light transom. The porch roof is set on square posts atop an apron wall. The exterior is clad in wood shingles. All of the windows have been replaced with vinyl sashes. At the southeast corner of the site is a side-gable, partially enclosed, raised barn built between 1904 and 1928. It features roughhewn wood clapboards and a metal roof.</p>

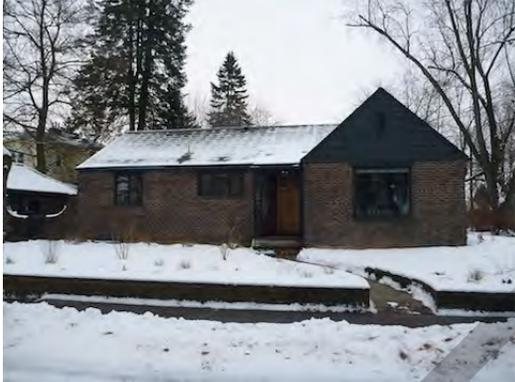
Survey Site Data	Site Photographs	Site Details
<p>Site #: 42 304 North VanBuren Street Owner: John Sullivan 1932 Previous District Status: NC (compatible), 30 DoE: C</p>

<p>Site 42 is a one-story, T-shape, cross-gable roof, Tudor-inspired dwelling. It is oriented west, facing North VanBuren Street. The dwelling exhibits a dark brick veneer with brick window sills. The façade features wide, dark painted wood planks in the gable end above a large, wood-sash, twenty-light, fixed window with minimal trim and a heavy wood lintel. A wide, brick, exterior chimney is centrally located on the east elevation. North of the front gable is a low-pitched, shed-roof porch atop wood posts with notched-in, slightly curved, wood brackets. A wood door with two, six-light windows and original hardware is found in the entry. Casement windows with heavy wood lintels are also found on the dwelling. A shingled, shed-roof addition is found at the rear. A wooden gate is set between concave-arched brick walls attached between the dwelling and the garage. A single-car garage with a wood-shake covered hip roof is also at the site. It is clad in wood shingles with irregular edges and has a metal roll-up door.</p>

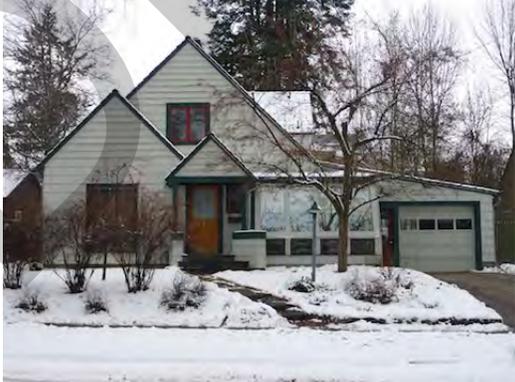
<p>Site #: 43 512 East B Street Owner: Arthur Smith 1936 Previous District Status: NC (compatible), 72 DoE: NC</p>

<p>Site 43 is a one-and-one-half story, gable-roof dwelling facing south toward East B Street. The dwelling has two front-facing gables and a gable-roof porch overhang, a greenhouse-style addition on the façade, and an attached, single-car, shed-roof garage on the east elevation. The entry porch features wood posts set on shingled knee walls. Two small dormers are located at the roof on the west elevation, while a large, two-window dormer is located at the east elevation. Most of the windows are original wood sash, though some nonhistoric windows are present. A large brick, double-flue chimney pierces the ridge of the roof.</p>

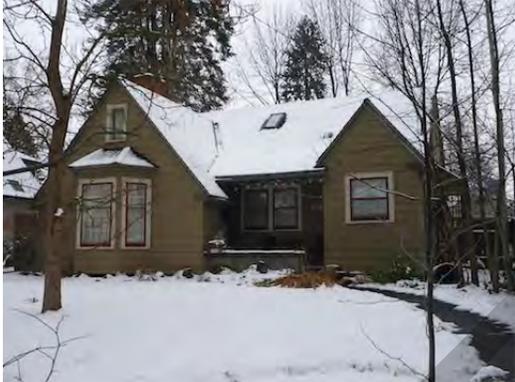
Survey Site Data	Site Photographs	Site Details
<p>Site #: 44 518 East B Street Owner: Kimberly Dahl 1933 Previous District Status: NC (compatible), 71 DoE: C</p>

<p>This is a single-story, cross-gable frame dwelling, oriented south towards East B. It features two front-facing gables of differing sizes and an inset entry porch under a deep eave. The porch also features a low, brick knee wall. Both forward gables have cornice returns, while the larger west end gable has a small, vertical wood window above a three-sided bay window. A side entry with a wood frame French door is found on the east, with a shed roof above. A large brick, double-flue chimney is located at the west end. The residence is clad in wood shingles, and two skylights are found on the roof. At the northeast corner of the property at the alley is a gable roof garage covered in wood shingles and featuring wide wood trim, narrow eaves and a metal single-car roll-up garage door.</p>

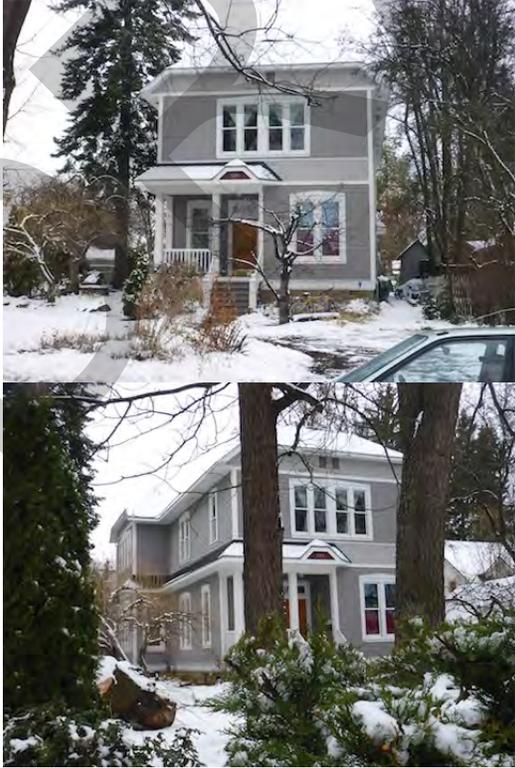
<p>The residence at Site 45 is a two-story dwelling oriented south to East B Street, and was moved here from 514 East First Street (Otness, 79). This is a tall, rectangular, clipped gable dwelling with a wide, clipped-crossing-gable and a two-story veranda at the rear. A partial-width porch with square columns and pilasters is found on the façade. All the trim and detailing mimics the Queen Anne style, but are created with modern materials. Vinyl windows are found throughout. The dwelling is clad in composite lap siding with a band of fish scale shingles between the floors. Roofing is composition shingle and the foundation is concrete. At the northwest edge of the site is a gable front garage with wood siding, metal roofing, open eaves, exposed rafter tails, a sheet of metal roofing as a siding repair, and a modern door. Northeast of the dwelling is a historic, gable-roof shed with wood siding and a wood shingle roof.</p>

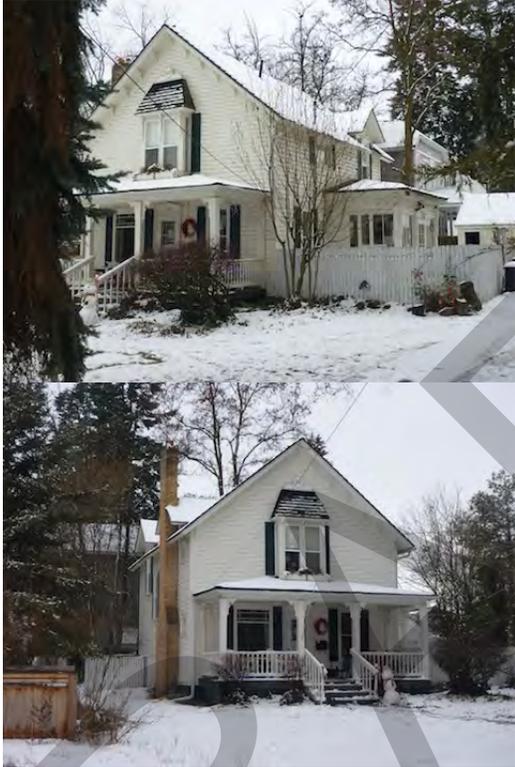
Survey Site Data	Site Photographs	Site Details
<p>Site #: 46 307 North Polk Street Owner: Jared Norman 1902 Previous District Status: C, 69 DoE: C</p>

<p>This is a one-and-one-half story, gable-oriented, rectangular plan, Italianate-styled dwelling with a single-story addition on the north. Two gable-roof wall dormers are found on the south side and one is found on the north side. A full-width porch with a low-pitched hipped roof atop square posts and pilasters with elaborate scroll-sawn brackets and turned wood balusters spans the façade. Windows have shutters and simple wood surrounds; some wood-sash windows remain. Above the porch roof is a projecting square bay with a pair of vinyl windows, brackets, corner finials, and shutters, with a small, Mansard roof capped with a dated shield. On the north is a hip-roof sunroom addition with details that mimic the residence, with multiple wood-sash windows and a single French door. On the south is a blonde brick, double-shouldered exterior chimney that rises through one of the dormers. The dwelling is clad in wood drop siding with corner boards, and has a wide fascia with brackets lining the gable ends and narrow eaves. The roof is covered in wood shingles, and the foundation is stone. At the northwest corner of the site is an L-plan, single-car garage covered in drop siding, with a modern overhead door.</p>

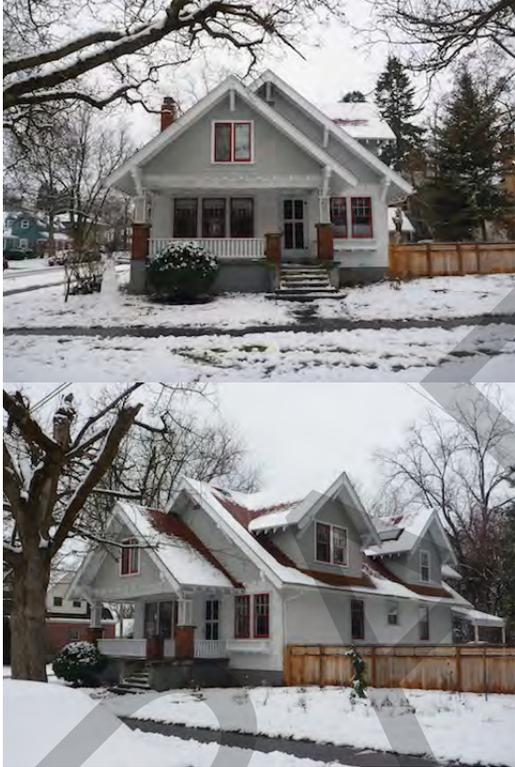
Survey Site Data	Site Photographs	Site Details
<p>Site #: 47 301 North Polk Street Owner: Christine Parent 1912 Previous District Status: C, 68 DoE: C</p>

<p>This dwelling, oriented east, is a one-and-one-half story, front-gabled Craftsman Bungalow. The façade features a full-width porch under the main roof atop square wood posts with trim detailing resting on capped, brick piers. The entry is off-centered with a glazed wood panel entry door. Both original eight-over-one, double-hung, wood-sash windows and some vinyl replacement windows are found on the dwelling. The gables have heavy knee braces, exposed rafter tails, wide eaves, exposed beam ends, and wide bargeboards. At the north elevation is a pair of steeply pitched gabled dormers. On the south elevation is a single dormer and a large, single-shouldered brick, outside chimney. The rear features a gable-roof, screened sleeping porch that extends out from the second level creating a covered breezeway below. At the southwest corner is a small square addition with a hip roof, a glass-block window, several wood-sash windows, and a brick knee-wall. The dwelling is sheathed in a narrow lap siding while the dormers and gable ends are shingled. At the northwest corner of the site is a gable-front, two-car garage with glazed wood panel sliding doors. The garage features lap siding with wood shingles and knee braces in the gable end, and a pent roof at the opening set atop heavy knee braces with exposed rafter tails.</p>

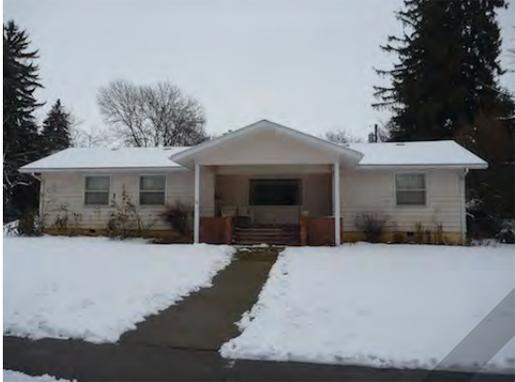
Survey Site Data	Site Photographs	Site Details
<p>Site #: 48 604 East B Street & 304 North Polk Street Owner: Nathan Palmer 1963 Previous District Status: NC (intrusion), 67 DoE: NC</p>

<p>Site 48 is a single-story, mid-twentieth-century duplex. The dwelling was originally U-shaped, but now has an infill addition at the rear. The south-facing facade on East B Street has a gable-roof porch, set atop 4x4 wood posts. Centered in the porch is a wood-frame picture window. The entry door is set in the east wall of the porch. The west elevation has an inset entry porch under the main gable roof. A wood-sash picture window is also found on the west side. Windows throughout the dwelling are wood-sash, some with metal awnings. A low brick planter runs at the foundation. Attached at the flat-roofed breezeway to the north is a side-gabled, three-car garage facing North Polk Street. The garage features three roll-up garage doors.</p>

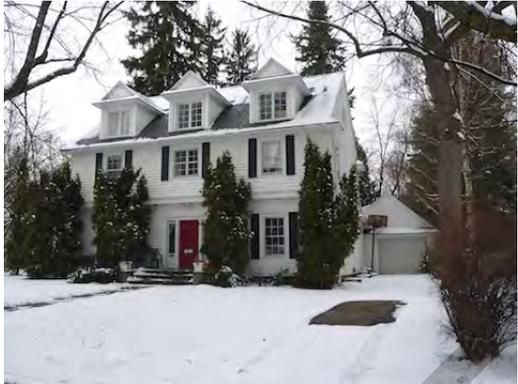
Survey Site Data	Site Photographs	Site Details
<p>Site #: 49 610 East B Street Owner: Jan Boll 1925 Previous District Status: NC (compatible), 66 DoE: C</p>

<p>This is a two-and-one-half-story Colonial Revival dwelling facing south toward East B Street. It has a symmetrical, three-bay (w/wdw/w), side-gabled façade with an overhanging second story and three gable-roof dormers. A shed roof, one-story side wing is to the west and an attached garage to the east. The main entry has a wood, inset panel door with leaded glass sidelights and wide wood trim. Wood-sash, double-hung windows, many with shutters, are found throughout. The dormers contain eight-light casement windows. The west side wing’s shed roof appears to be a later addition over the original flat roof. Also on the west side is a tall, brick, double-flue chimney flanked by a pair of triangular wood-sash windows. On the east, the attic level has a fanlight window. The gable ends feature cornice returns, and the dwelling is covered in vinyl. A small, shed-roof enclosed back porch connects the residence to the garage, which has a pent roof over the opening, a modern metal door, wide wood siding, and a shed roof addition on its west elevation.</p>

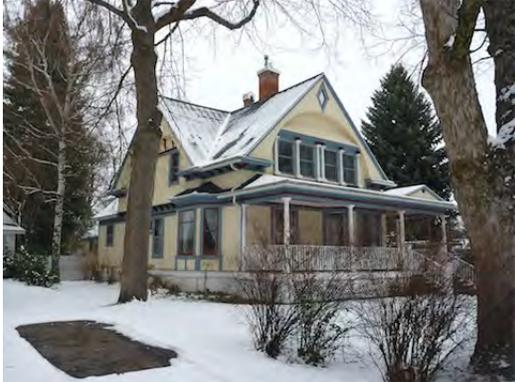
Survey Site Data	Site Photographs	Site Details
<p>Site #: 50 622 East B Street Owner: Janice Boughton 1904 Previous District Status: C, 65 DoE: C</p>

<p>The Wellington Ely House is a one-and-one-half story cross-gabled dwelling, oriented south facing East B Street. Dominating three of the elevations are broad, open gables that overhang with a flare at the junction, with the first level supported by scroll-sawn brackets. Each of the gable ends exhibit unique features, including varying shingle patterns, varying windows, some with columns between, arched insets, false timbering, and a projecting cornice detail with brackets. The gable on the façade features a diamond-shaped window in its peak. Below the gable on the façade is a full-width, hip-roof porch with a small gable highlighting the offset entry. Within the porch is a bay window with three, one-over-one, wood-sash windows, and a simple, painted wood panel entry door with glazing. Below the gable on the east are an arched, wood-sash window and a bay window with a hip roof and three one-over-one, wood-sash windows. On the west is another bay window similar to the east side. The main level is clad in wood drop siding, the foundation is brick and the roof is covered in composition shingles. The original garage is to the rear, and features an early addition, creating an L-shaped footprint. It is covered in wood clapboards. The garage features a pair of carriage doors, corner boards, wide fascia detail, cornice returns, wood sash windows, and a narrow wood panel door on the west.</p>

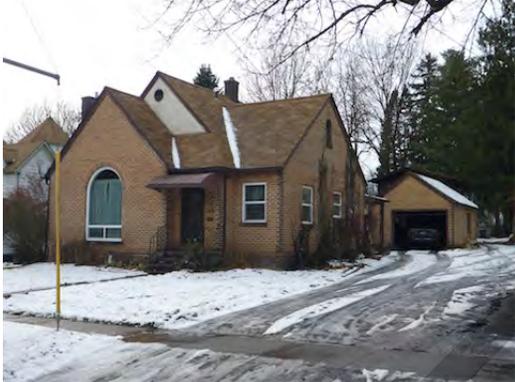
Survey Site Data	Site Photographs	Site Details
<p>Site #: 51 315 North Howard Street Owner: Richard Hart 1935 Previous District Status: NC (compatible), 56 DoE: C</p>

<p>Site 51 faces east toward Howard, north of B Street. It is a one-and-one-half-story, cross-gabled, brick dwelling. An arched window is centered on the forward extending gable, while the main entry, sheltered by a metal awning, is recessed slightly behind. A small arched window is also found on the north elevation, while a large arched opening, containing sliding glass doors, is found on the south. A gable-roof addition, similar in scale to the original dwelling, is found at its southwest corner. It features brick cladding on the side facing the street, while the rest is covered in vinyl. Vinyl windows are found throughout. The original, gable-roof, brick, single-car garage is found behind the dwelling, with a two-story, frame addition on its rear. Because the addition on the dwelling is setback from the façade, it does not detract from the historical integrity of this property.</p>

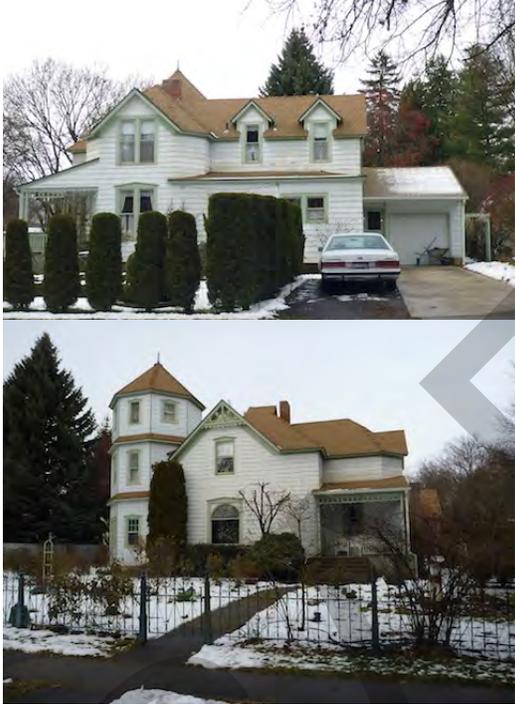
Survey Site Data	Site Photographs	Site Details
<p>Site #: 52 634 East B Street Owner: Dick Sanchez 1895 Previous District Status: NC (compatible), 57 DoE: C</p>

<p>Site 52 is on the northwest corner of Howard and B Streets. It is two-story, asymmetrical dwelling with a three-story, polygonal tower at the southwest corner. According to <i>A Great Good Country</i>, the tower was added during the early 1980s (Otness, 90). Those same owners added the millwork on the porch and the aluminum siding. According to that text, the stained-glass, arched window on the south elevation was salvaged from the Ursuline Convent building. A slight gable-roof extension, with two gabled wall dormers, is found on the rear of the dwelling. A single-story, hip-roof portion is found on the east wall of the rear extension. One-over-one, six-over-one, and eight-over-one, wood-sash windows can be found on the dwelling. A small, single-car garage is also attached to the far rear of the house. According to a neighbor, the iron fencing surrounding the yard was also salvaged.</p>

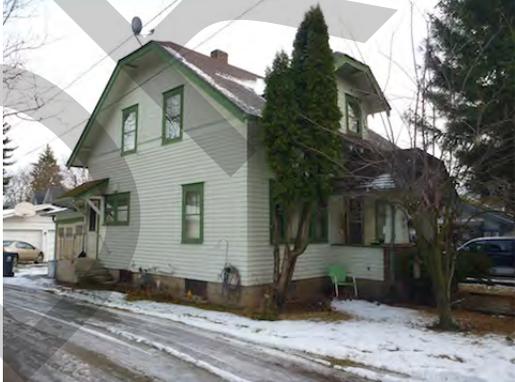
<p>Site #: 53 320 North Howard Street Owner: Paul Hedler Trustees 1924 Previous District Status: C, 58 DoE: C</p>

<p>This is a one-and-one-half-story, three-bay (www/d/w), frame Bungalow. It features clapboard siding on the lower level and wood shingles above, a jerkinhead roof over the main house as well as over a dormer above the façade and over the central entry porch on the façade. The entry is supported by flared columns on brick piers. The house is set on a concrete basement foundation. The windows on the dwelling retain six-over-one, double-hung, wood-sash windows. An early garage is attached to the rear of the dwelling, retaining multi-light, paneled, wood doors. At the rear of the property, is a nonhistoric, gable-roof, frame, two-car garage.</p>

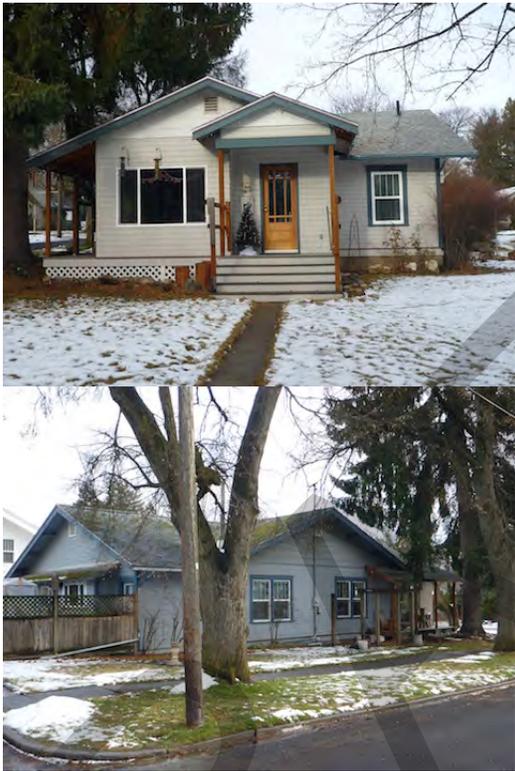
<p>Site 54 faces south on the northeast corner of Howard and B Streets. It is a single-story, cross-gabled, frame Bungalow with a nonhistoric, gable-roof addition extending on the façade. The main entry porch, featuring a gable roof above, is also found on the façade. A small deck is located on the west side of the front addition, and a small, shed-roof, enclosed porch is found on the rear. The dwelling is set on a concrete foundation, and the original portion is covered in clapboard siding with shingles in the gable ends, while the addition is covered in horizontal boards. The windows are vinyl throughout. A frame, gable-roof garage is found at the rear. It features clapboard siding, brackets, and multi-light doors. The façade addition has altered the building's original appearance, and has compromised its ability to read as a Bungalow.</p>

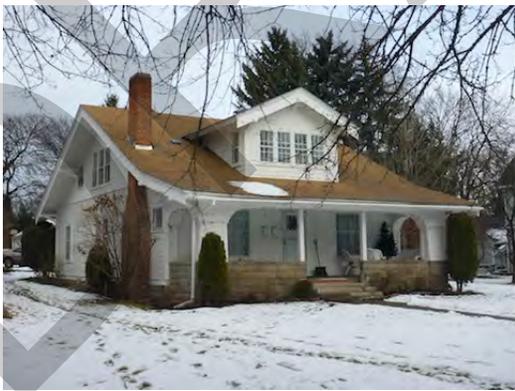
<p>Site #: 55 708 East B Street Owner: Richard Hoeft 1910 Previous District Status: C, 60 DoE: C</p>

<p>This dwelling is a one-and-one-half-story, three-bay (w/d/w), side-gable, Bungalow with a full-width porch spanning the façade. The porch is sheltered beneath an extended overhang of the primary roof, supported by square posts with curved brackets. The porch and dwelling are set on rusticated concrete blocks. A large gable-roof dormer extends above the façade. The dwelling is covered in drop wood siding, with wood shingles covering the dormer and side, gable ends. Multi-light, wood-sash windows remain. A shouldered, brick chimney is found on the west elevation. A small, square bay topped with a shed roof exhibiting rafter tails is found on the east side. A small, frame, gable-roof garage is located at the rear of the property.</p>

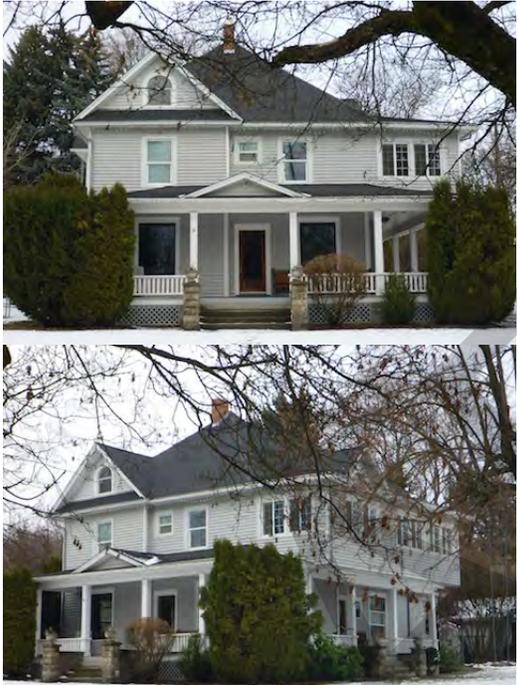
Survey Site Data	Site Photographs	Site Details
<p>Site #: 56 307 North Monroe Street & 714 East B Street Owner: Dennis McGreevy 1909 Previous District Status: C, 61 DoE: C</p>

<p>Site 56 is located on the northwest corner of B and Monroe. It is a large, two-and-one-half-story, frame dwelling with a gable roof extending above the southwest and southeast corners, and a gable roof ell extending toward the rear. A hip-roof porch spans the full façade and wraps around to the east elevation. An enclosed sun porch rests above the porch on the east elevation. The porch is supported by square posts with crown molding at the top. The dwelling is covered in vinyl siding, but retains some original doors and windows, including leaded glass windows on the main level. A small arched window and small half-moon window can be found at the attic level. A small, gable-roof, single car garage is found at the rear of the property. It is covered in vinyl siding, and retains a multi-light, wood-sash window.</p>

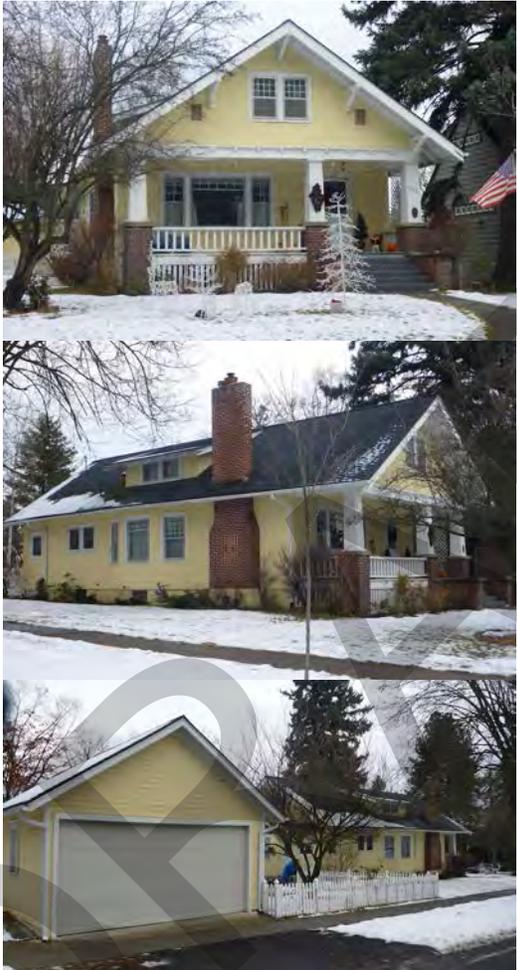
<p>Site 57 is located on the northeast corner of B and Monroe Streets, oriented south. It is a one-and-one-half-story, two-bay (www/d), gable-oriented Bungalow, with a full-width porch spanning the façade. The porch is recessed beneath the upper level, and is supported by flared posts on brick piers. Shed-roof dormers pierce the roof over the east and west elevations. A shouldered, exterior brick chimney is found on the west elevation, along with a three-sided bay window on the first level. The dwelling exhibits visible rafter tails, brackets, and bargeboards with birds-mouth elaborated ends. The house is covered in asbestos siding and retains multi-light, wood-sash windows. A small, gable-roof overhang shelters a rear entry. A large, frame, nonhistoric, two-car garage covered in horizontal boards is located behind the house.</p>

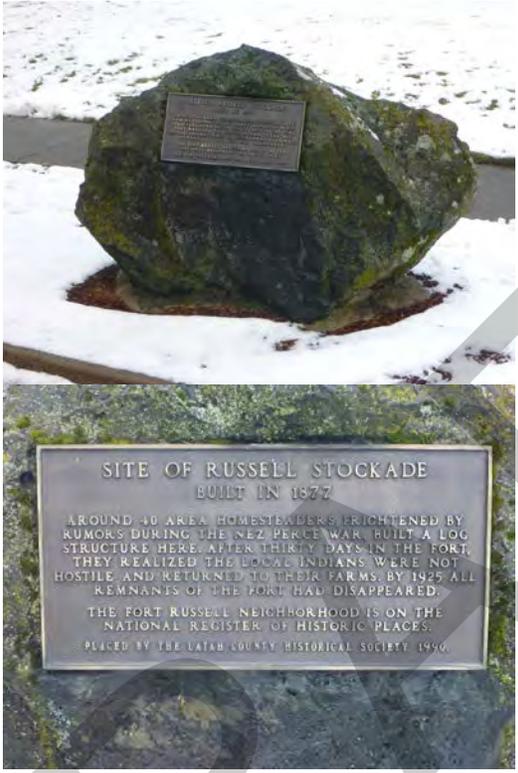
Survey Site Data	Site Photographs	Site Details
<p>Site #: 58</p> <p>East B Street, between North Monroe and North Lincoln Streets</p> <p>Owner: City of Moscow</p> <p>1990</p> <p>Previous District Status: n/a</p> <p>DoE: NC</p>

<p>Site 58 is located on East B Street, between Monroe and Lincoln. It is situated in front of 810 East B Street. This is a boulder, set in the grass strip between the sidewalk and the street in this location. It features a marker on it that reads “Site of Russell Stockade, Built in 1877. Around 40 area homesteaders, frightened by rumors during the Nez Perce War, built a log structure here. After thirty days in the fort, they realized the local Indians were not hostile and returned to their farms. By 1925 all remnants of the fort had disappeared. The Fort Russell neighborhood is on the National Register of Historic Places. Placed by the Latah County Historical Society 1990.” Though the marker itself dates at less than 50 years of age, it is marking a spot that is much older, and which carries with it great historical significance for the area and most notably for this neighborhood and district that bears its name.</p>

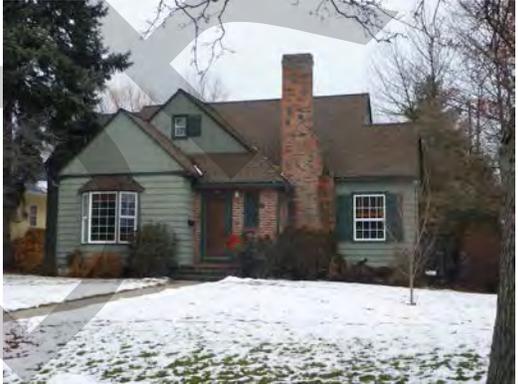
<p>Site #: 59</p> <p>810 East B Street</p> <p>Owner: Sanford Eigenbrode</p> <p>1935</p> <p>Previous District Status: n/a</p> <p>DoE: C</p>

<p>Site 59 faces south toward B Street, and is a single-story, asymmetrical, cross-gabled, frame. It features two forward extending gables on the façade, and a small gabled extension on the east side. A small, full-height addition is found on the west side. The house is clad in horizontal boards, with vertical boards within the gables. The windows are vinyl, though a leaded-glass window with a diamond pattern is found next to the main entry in an area clad in brick. A single-shouldered, exterior brick chimney is also found next to the entry. Some windows feature wood shutters.</p>

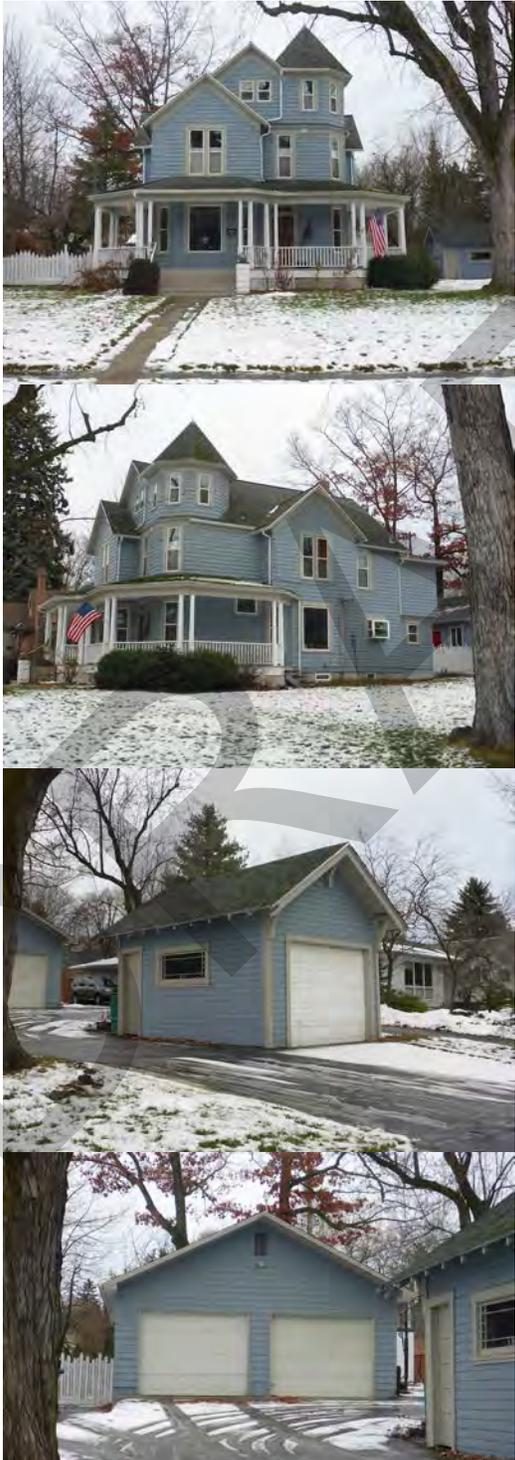
<p>This is the Jesse Randall house, located on the northwest corner of B and Lincoln. It is a two-and-one-half-story, cross-gable-roof, Victorian-era, frame dwelling. It features a conical turret at the top of the southeast corner, and several gable roof extensions surround the dwelling each exhibiting a square bay shape extension on the upper level, and chamfered corners on the lower level. Pendants hang from the second-story overhangs above the chamfered corners. A single-story, hip-roof porch surrounds the southwest and southeast corners and crosses the whole façade. Rusticated concrete blocks flank the steps to the front entry porch. The house is covered in composite siding and features vinyl windows. According to <i>A Great Good Country</i>, the dwelling had wood-sash windows with small, colored glass lights surrounding the upper sashes on the lower level of the dwelling (Otness: 92). A two-story, hip-roof extension is found on the rear. Northeast of the dwelling is an original garage, which is a small, gable-roof, single-car garage covered in weatherboard, exhibiting visible rafter tails, brackets, and notching in the bargeboard. A larger, nonhistoric two-car garage is found behind the dwelling in the location of a second, non-extant, original outbuilding.</p>

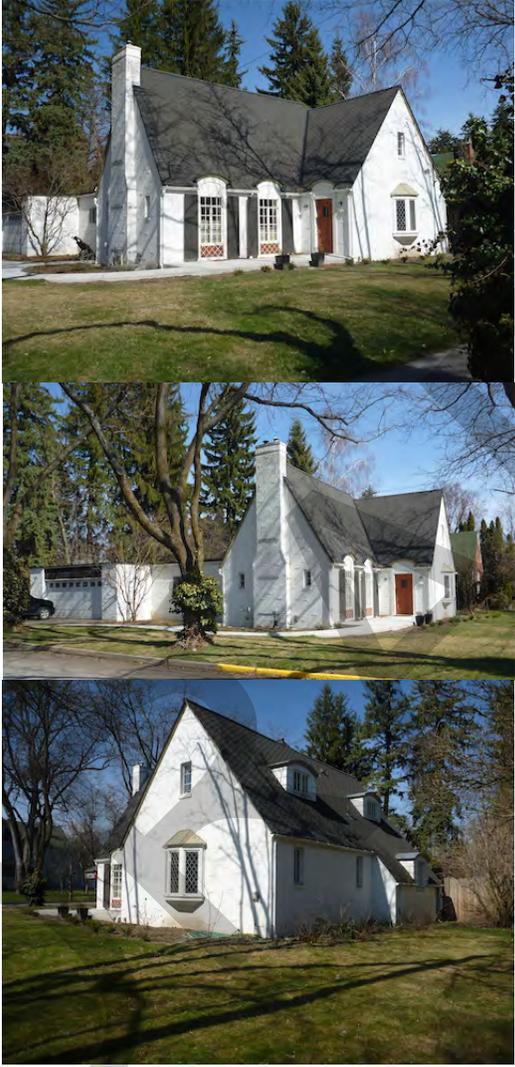
Survey Site Data	Site Photographs	Site Details
<p>Site #: 61 902 East B Street Owner: Spencer Martin 1936 Previous District Status: n/a DoE: C</p>

<p>Site 61 is situated on the northeast corner of East B and North Lincoln Streets. It is a one-and-one-half-story, asymmetrical, dwelling with a white-painted brick exterior. It exhibits a French-revival cottage style with a steeply-pitched, cross-gable roof, segmental arches breaking the eave line over the windows and primary entry on the façade, segmentally-arched dormers over the east elevation, and a three-sided oriel window on the forward gable on the south elevation. A small, single-story, enclosed extension on the east elevation also features a segmentally-arched dormer above. Two paired, eight-light, wood-sash windows with four-light transoms are found on the façade above panels with diamond-shaped detailing. The windows are flanked by wood shutters. The windows within the oriel are diamond-shaped, leaded-glass, casements. Small, narrow, two-light, wood-sash windows flank the exterior, shouldered chimney on the west elevation, while a small, three-light, wood-sash window is found above the oriel. A small, flat-roof breezeway connects the northwest corner of the dwelling with a two-car garage. An additional, segmentally-arched dormer is found over the west side of the breezeway. Geometric wood shingles cover the wall over the garage door.</p>

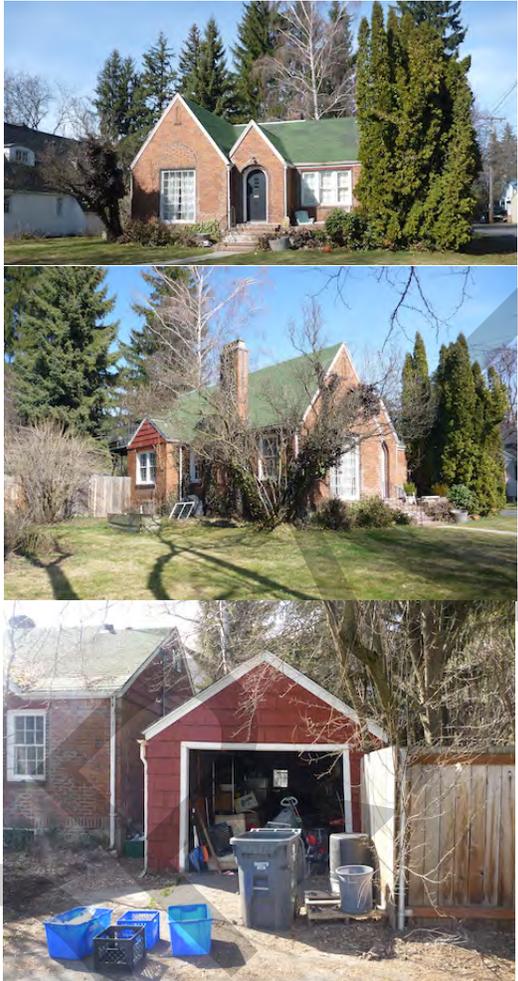
Survey Site Data	Site Photographs	Site Details
<p>Site #: 62 910 East B Street Owner: Brett Woodland 1935 Previous District Status: n/a DoE: C</p>

<p>This is a one-and-one-half-story, cross-gable roof, brick, English Cottage-style residence with an attached garage on the northeast corner. A large, thirty-light, wood-sash window is found below a large brick arch on a forward-facing extension on the south elevation. Next to this gable is an enclosed, gable-roof porch with an arched wooden door set slightly back within a brick arch. A triple window containing three, four-over-four, double-hung, wood-sash windows is found on the façade elevation of the side-gabled section. A small, single-story, gable-roof, square bay is found on the west elevation. The gable roof on the east and rear elevations and the gable over the bay on the west are all filled with wood shingles. A wide, exterior brick chimney is also found on the west elevation. Multi-light, double-hung, wood-sash windows are found throughout the remainder of the dwelling. A soldier course of bricks is found along the cornice line as well as just above the concrete foundation. An original gable-roof, single-car garage is attached by a hyphen at the northeast corner of the house. It is covered in wood shingles.</p>

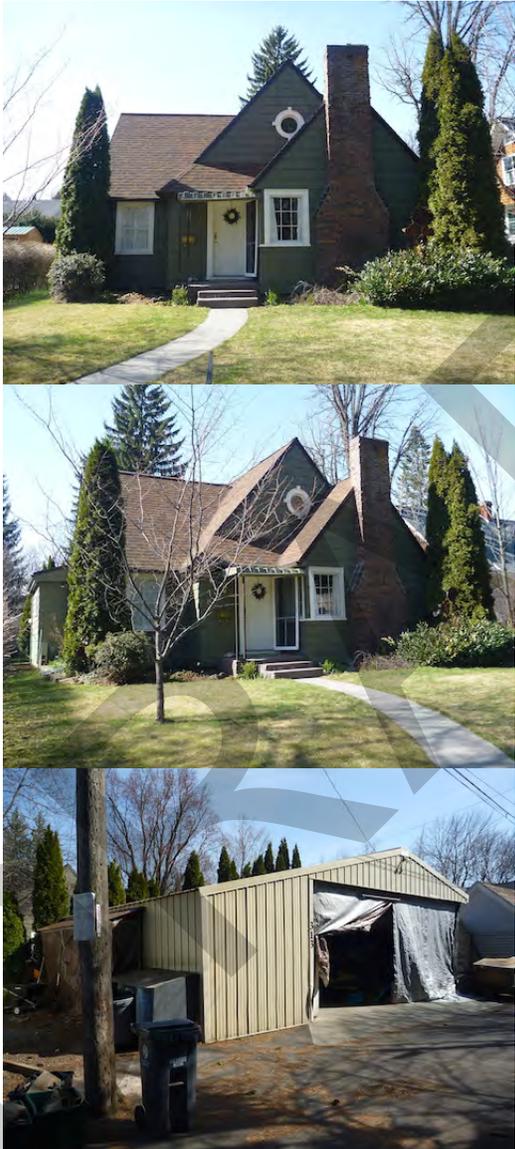
Survey Site Data	Site Photographs	Site Details
<p>Site #: 63 313 North Hayes Street Owner: Lane Oliver 1935 Previous District Status: n/a DoE: C</p>

<p>The top photograph shows a front view of a green house with a brick chimney and a gable roof. The middle photograph shows a side view of the same house. The bottom photograph shows a detached metal garage with a concrete driveway.</p>	<p>This is a one-and-one-half-story, cross-gabled, frame dwelling. It features a full-height, gable-on-hip extension with a slightly smaller, gable-roof extension on its façade elevation. The main entry on the façade is sheltered by a small, nonhistoric, metal awning. An exterior, brick, shouldered chimney is found on the forward most extension on the façade, while a small, wood-sash oculus window is found on the forward wall of the larger, forward extension. The dwelling is covered in wood shingles and contains multi-light, double-hung, wood-sash windows and replacement vinyl windows. A small, single-story addition has been added to the southwest side of the house. A large, nonhistoric, metal garage and workshop is set rear of the dwelling.</p>

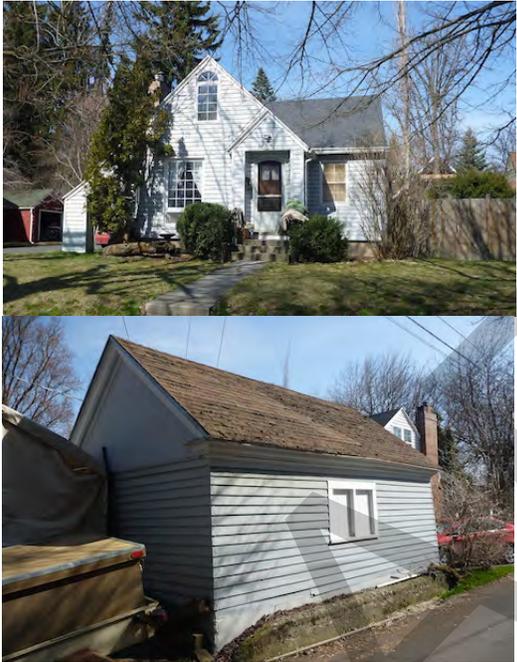
Survey Site Data	Site Photographs	Site Details
<p>Site #: 64 920 East B Street Owner: Harriet McQuarie 1939 Previous District Status: n/a DoE: NC</p>

<p>This is a one-and-one-half-story, cross-gable-roof dwelling. It has a side-gable roof over the main block, a forward-facing gable roof on the façade elevation, a gable-roof porch off-centered on the façade, and a single-story addition on the rear. The main entry is slightly recessed within the front porch and contains a segmental arched doorway with original wooden door. The dwelling is clad in vinyl siding and has vinyl replacement windows. An original, frame, gable-roof, single-car garage is located rear of the dwelling. It is covered in clapboards, has small windows on the side that have been filled with wood boards, and exhibits small cornice returns on the gable ends.</p>

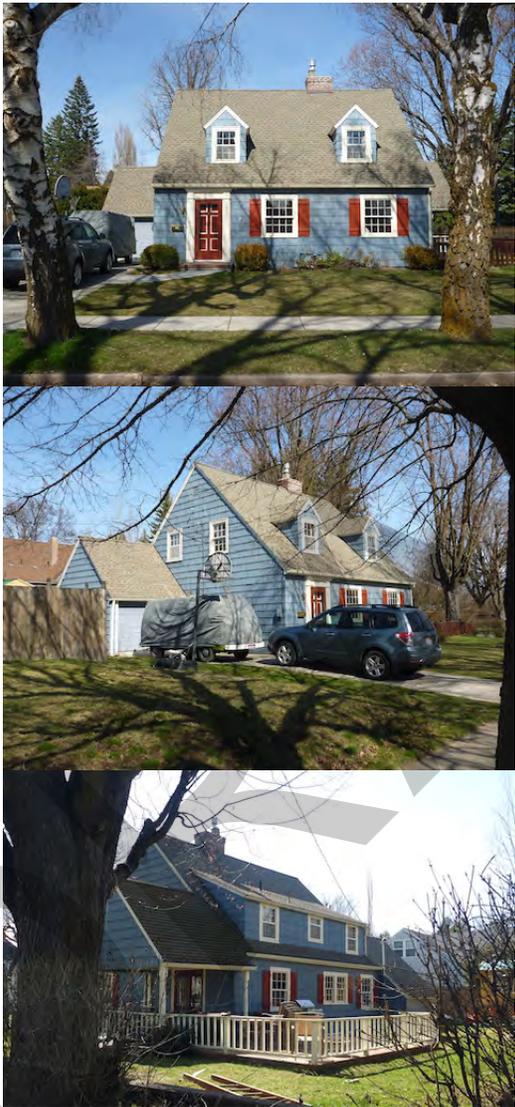
Survey Site Data	Site Photographs	Site Details
<p>Site #: 65 922 East B Street Owner: Jason Dearien 1929 Previous District Status: n/a DoE: C</p>

<p>The photographs show the exterior of a blue house with a side-gable roof, two dormers, and a garage. The house is surrounded by trees and a lawn.</p>	<p>Site 65 is an early, Cape Cod dwelling. It is a one-and-one-half-story, side-gable roof, frame residence with two gable-roof dormers over the façade and a small, single-car garage attached to the west side elevation. A small, gable-roof, covered patio is found on the northeast corner; according to Sanborn maps this feature was original or was a very early addition to the dwelling. A shed-roof dormer spans the entire width over the rear elevation. A brick chimney is off-centered on the ridgeline. The dwelling is covered in raked, wood shingles and retains six-over-six and eight-over-eight, double-hung, wood-sash windows. Many of the windows are flanked by wood shutters. The main entry contains a wood paneled door flanked by fluted pilasters beneath a wide entablature with crown molding above.</p>
