National Register of Historic Places Registration Form

Historic name: Fort Russell Neighborhood Historic District (Boundary Increase and Additional Documentation)

Street & number: Roughly bounded by Jefferson Street on the west, East D Street on the north, Hayes Street on the east, and East Third Street on the south

City or town: Moscow State: ID County: Latah

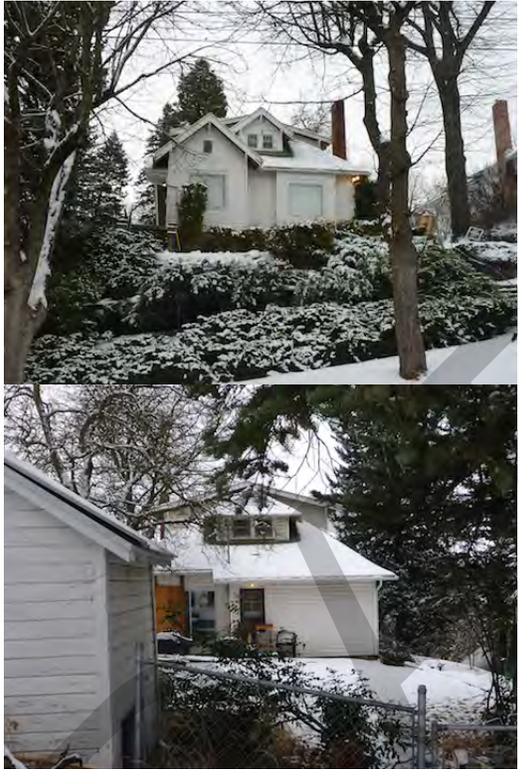
<p>Site 66, located on Jefferson, north of A Street, is a one-and-one-half-story, hip roof dwelling, with a gable-roof extension on the façade or west elevation. A small square bay is also found on the façade, and dormers are found above both the façade and rear elevations – gable-roofed on the façade, and hip-roofed on the rear. Large, shed-roof dormers rise above both the south and north elevations. The dwelling is covered in vinyl siding, and exhibits multi-light, wood-sash windows and aluminum windows, with an aluminum sliding door on the rear. An exterior brick chimney rises on the south elevation. The dwelling also exhibits wood brackets and bargeboards with decorative notched ends. A small, concrete, gable-roof garage is found at street level just south of the dwelling. A small shed roof shelters the wooden garage door, and is supported by curved brackets. A small, frame, gable-roof shed covered in clapboard siding is located at the rear of the property.</p>

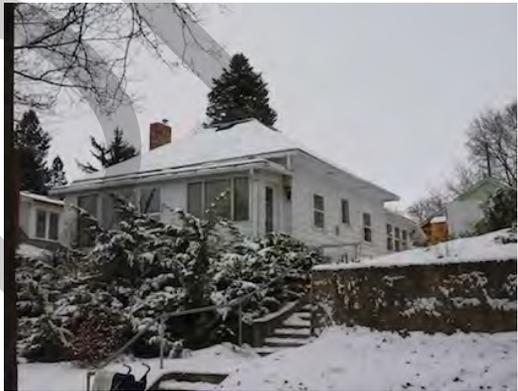
<p>Site #: 67 226 North Jefferson Street Owner: 226 N Jefferson LLC 1915 Previous District Status: C, 13 DoE: C</p>

<p>Site 67 faces west toward Jefferson, north of A Street. It is a single-story, frame dwelling with a truncated hip roof, and a single-story, enclosed porch on both the façade and rear elevations. The dwelling is covered in wood shingle siding, with simple wood window surrounds around replacement, vinyl windows. At the rear of the property is a large, frame, gable-roof vehicular garage with two entry bays – one containing sliding doors, and the other with hinged doors. The garage is covered in clapboard and retains wood doors.</p>

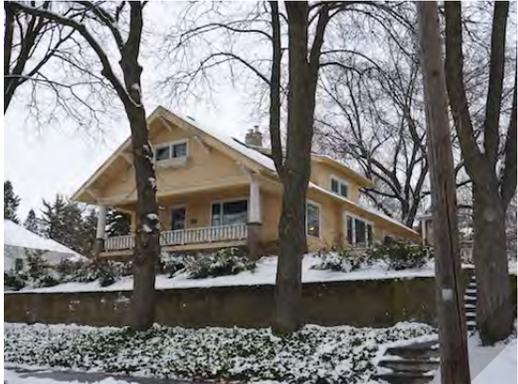
Survey Site Data	Site Photographs	Site Details
<p>Site #: 68 220 North Jefferson Street Owner: Brian Thie 1907 Previous District Status: C, 12 DoE: C</p>

<p>Site 68 faces west onto Jefferson Street north of A Street. It is a one-and-one-half-story, three-bay (w/d/www), gable-oriented, frame Bungalow. A full-width porch spans the façade, sheltered by an extension of the upper story, supported by Tuscan columns set on stone block piers. A wooden balustrade spans the porch. A multi-light, wood door is centered on the façade. Large brackets support the wide eaves. The dwelling is clad in clapboard on the main level and wood shingles on the upper level. Multi-light, wood-sash windows can be found on the house. A shed roof dormer is located on the south elevation above a square bay that extends from the main level. A shed-roof, enclosed porch spans the entire rear elevation. A large, gable roof, frame, vehicular garage, with one, single-car garage door is found to the rear of the property.</p>

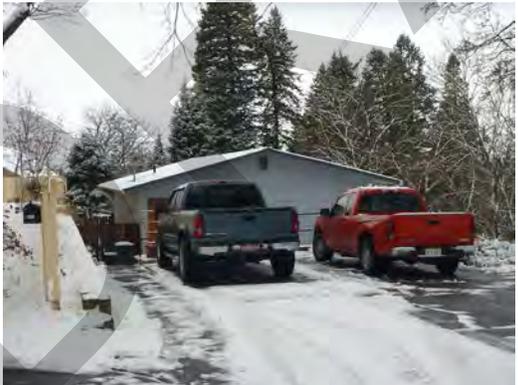
<p>Site #: 69 223-225 North Adams Street Owner: Michael Jennings 1971 Previous District Status: n/a DoE: NC</p>

<p>Site 69 faces east toward the intersection of Adams and B Streets. It is a nonhistoric, single-story, gable-roof, frame duplex dwelling covered in horizontal boards, with vertical boards filling the gable end. Only a single entry door is visible on the east elevation. No windows or entries are found on the south elevation. Private property access and the severely sloping property line prohibited access to photograph remaining elevations.</p>

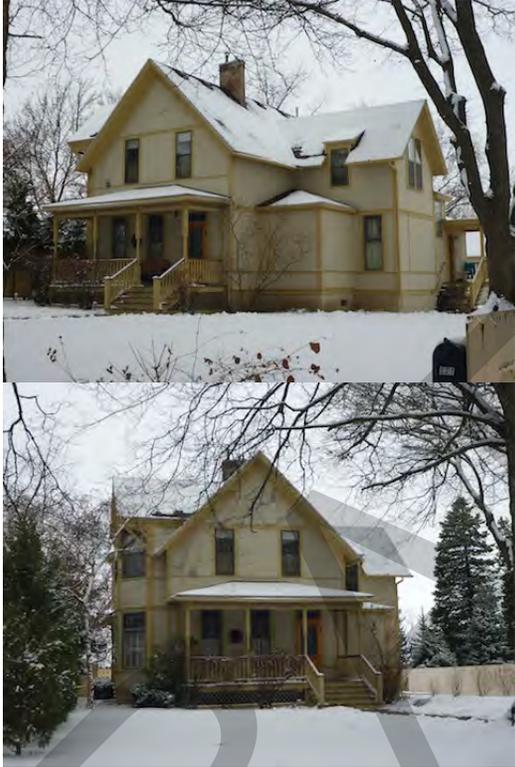
Survey Site Data	Site Photographs	Site Details
<p>Site #: 70 221 North Adams Street Owner: David Aron Petersen 1890 Previous District Status: C, 22 DoE: C</p>

<p>The old Henry Dernham House faces east toward the intersection of Adams and B Streets. It is a two-story, cross-gabled, frame Queen Anne Victorian, with a slightly shorter, gable-roof extension on the north elevation and a single-story addition or enclosed porch behind the extension on the rear. A single-story, hip-roof enclosure is found in the ell between the forward gable and the north extension. The façade features a forward-facing gable roof, and a single-story, hip-roof porch with turned posts. The south side elevation features a full-height, three-sided bay with a gable roof supported by brackets, and a three-sided bay with a hip roof. An entry, beneath a shed-roof porch with turned posts and decorative brackets is found at the rear of the south elevation. The rear of the house is covered in vinyl or aluminum. Some one-over-one, wood-sash windows with small stained-glass lights can be found on the house. On the façade and side elevations, the house is covered in clapboard siding on the lower level, with both fish scale and diamond shingle imbrication above. A nonhistoric, gable-roof, single-car garage is located at the rear of the lot.</p>

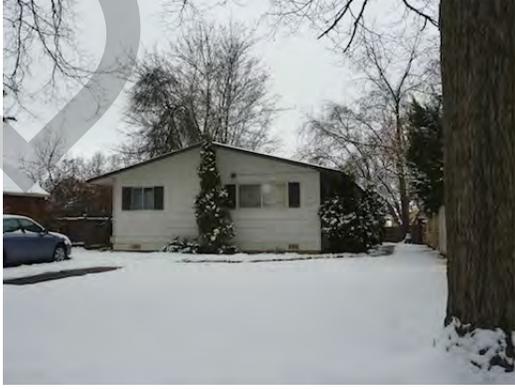
<p>Site #: 71 215-217 North Adams Street Owner: David Potter OR/ 1970 Previous District Status: NC (intrusion), 21 DoE: NC</p>

<p>Site 71 is a nonhistoric residence, facing east on Adams south of B Street. It is a single-story, gable-roof, frame, duplex dwelling with entries on the north and south sides. The building exhibits a combination of vinyl and aluminum windows, nonhistoric shutters, and aluminum or composite siding.</p>

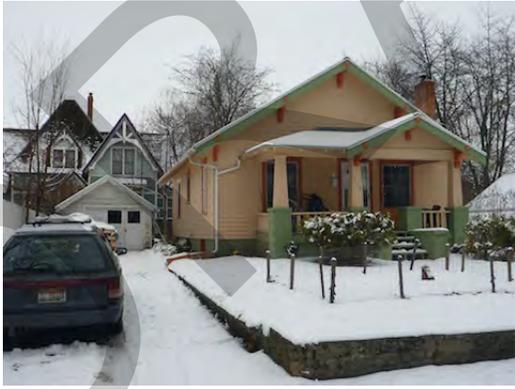
<p>Site 73 faces west toward Adams south of B Street. It is a single-story, gable-oriented, three-bay (w/d/w), Bungalow with a gable-roof porch supported by flared posts set on concrete bases. It exhibits clapboard siding, wood window and door surrounds with crown molding above, wood-sash windows, and an exterior brick chimney on the south elevation. The house is set on a concrete foundation, with non-egress basement windows. A frame, gable roof, single vehicle garage is located to the rear. It is covered in clapboard siding, and features three paneled wood doors.</p>

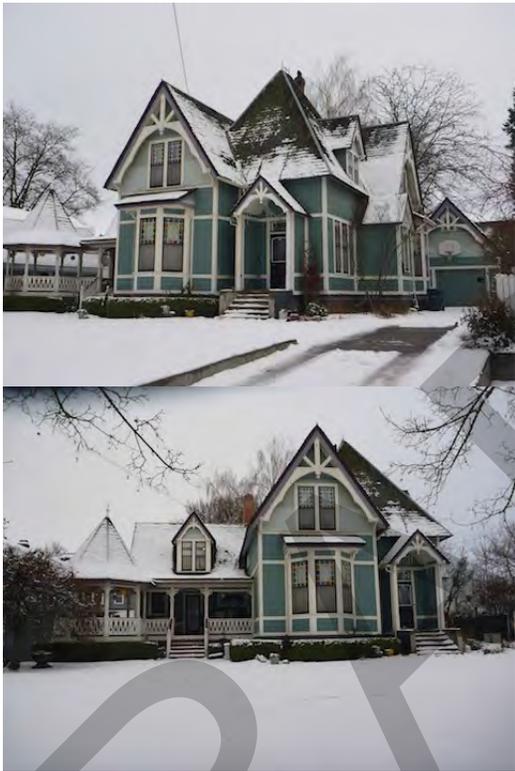
Survey Site Data	Site Photographs	Site Details
<p>Site #: 74 411 East B Street Owner: Robert Ting 1888 Previous District Status: C, 25 DoE: C</p>

<p>According to <i>A Great Good Country</i>, this dwelling originally faced Adams Street and its property took up the entire block (Otness, 84). It is a one-and-one-half-story, frame dwelling exhibiting Queen Anne elements. It features a steeply pitched hip roof, with gable-roof extensions toward the north and west. Shed roofs cover three-sided bays on the north and west sides. There is a gable-roof entry porch on the north side, and an enclosed, gable roof extension on the west. A gable-roof dormer is found on the west side. A slightly shorter, one-and-one-half-story, gable-roof section is found on the east side. It features a gable-roof dormer, a highly decorated porch across its full width, and a round deck off the northeast corner with a conical roof and finial. A narrow brick chimney extends from the original hip-roof portion of the house, while two more brick chimneys are found between the original rear elevation and east addition. The house is covered in clapboard, with fish scale imbrication within the gable ends. Heavy brackets and one-over-one, wood-sash windows with small stained glass lights around the edges also remain. A gable-roof, two-car garage exhibiting similar materials to the dwelling is found at the southwest corner.</p>

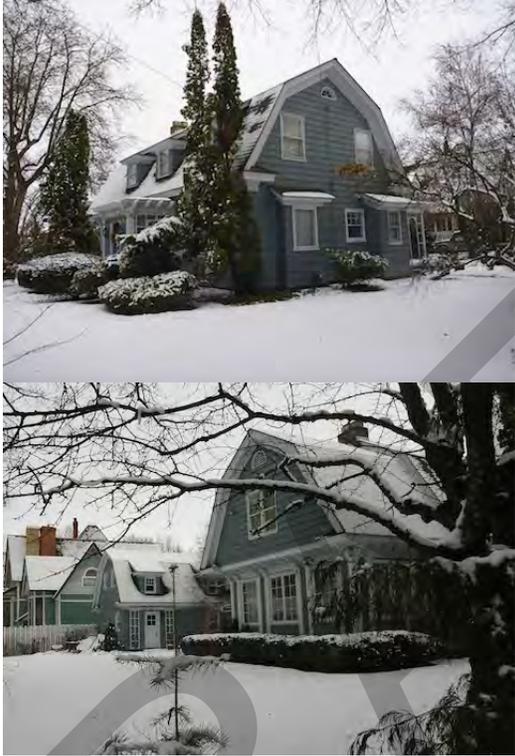
Survey Site Data	Site Photographs	Site Details
<p>Site #: 75 215 North VanBuren Street Owner: Gregory Moller 1917 Previous District Status: C, 28 DoE: C</p>

<p>Site 75 sits on the southwest corner of VanBuren and B Streets. It is a one-and-one-half-story, gambrel-roof, Dutch Colonial Revival dwelling. A flat roof, enclosed porch extends from the façade, while a full-height addition constructed to match the original dwelling extends on the south side. The addition exhibits rafter tails beneath the overhang of the upper level. The dwelling is covered in wood shingles, and exhibits six-over-one, eight-light, and twelve-light, wood-sash windows. Some windows on the main level of the façade are flanked with wood shutters with an incised cross design. Three shed-roof dormers are found above the façade elevation. Two shed roof, square bays extend from the main level on the north elevation and a wood-sash, half-moon window is found on the north side in the attic level. A brick chimney pierces the roof. A one-and-one-half-story, frame, gambrel-roof, vehicular garage is found behind the house. It features six paneled, wooden hinged doors with four-light windows, six-over-one wood-sash windows, shed-roof dormers, and a paneled pedestrian door.</p>

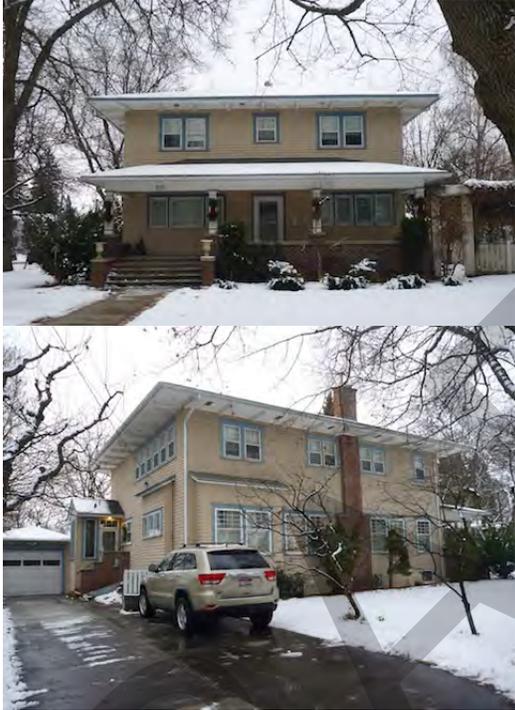
Survey Site Data	Site Photographs	Site Details
<p>Site #: 76 220 North VanBuren Street Owner: William Woolston 1912 Previous District Status: C, 29 DoE: C</p>

<p>The Homer David House is a large, two-story, Prairie-style dwelling oriented west facing North VanBuren. The house features a low-pitched, hip roof with deep, boxed eaves with modillions, and a full-width hipped-roof porch spanning the façade. The porch roof is supported by square posts atop brick piers with concrete caps. A concrete-capped brick wall surrounds the porch. South of the door is a ribbon of four, wood-sash casement windows each with four lights above a single, larger pane. Double-hung and casement, wood-sash windows are found throughout. At the north elevation, a tall, shouldered, brick, chimney pierces the eave to rise above the roof. Both the north and east elevations feature square bay windows with a shallow shed roof. A ribbon of six, wood-sash, double-hung, nine-over-one windows is found on the second level on the dwelling's rear. Also on the rear is a gable-roof, enclosed porch with a French door with a three-light transom. The roof is composition shingle and the walls are clad in narrow lap siding. At the southeast corner is a small, single-car garage with a hip roof, wood lap siding, an overhead door, and wide wood trims.</p>

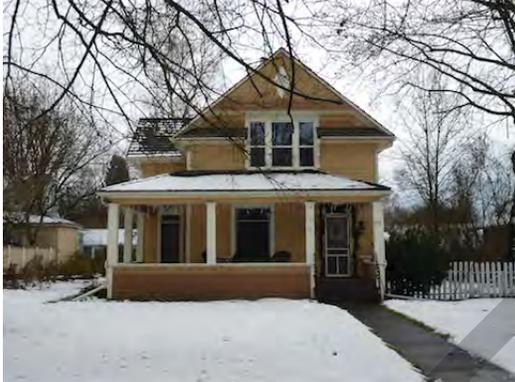
Survey Site Data	Site Photographs	Site Details
<p>Site #: 77 210 North VanBuren Street Owner: Robert Hieronymus ca. 1900 Previous District Status: C, 90 DoE: C</p>

<p>Site 77 is a one-and-one-half-story Queen Anne with a cross-gabled roof, oriented west facing North VanBuren. The façade features a dominant front-facing gable exhibiting scalloped, square and diamond shingles. A three-part window breaks the pent roof, which is supported on large elaborate scroll-sawn brackets. The hip-roof porch wraps around the northwest corner, atop square posts set on an apron with decorative shingle cladding. The off-centered entry door is a wood panel door with beveled glazing and a transom. Around the corner is a secondary entry with similar features. The north-facing gable exhibits similar features as the front. Both wood-sash and vinyl windows are found on the dwelling. The residence features wood lap siding, corner boards, a wood shake roof, narrow boxed eaves, and a classical wood door and window surrounds. A tall, painted brick chimney pierces the roof. At the rear of the site is a gable roof, double-car garage. It has a low-pitched roof, composite lap siding, a wide roll-up garage door, and an attached shed-roof greenhouse.</p>

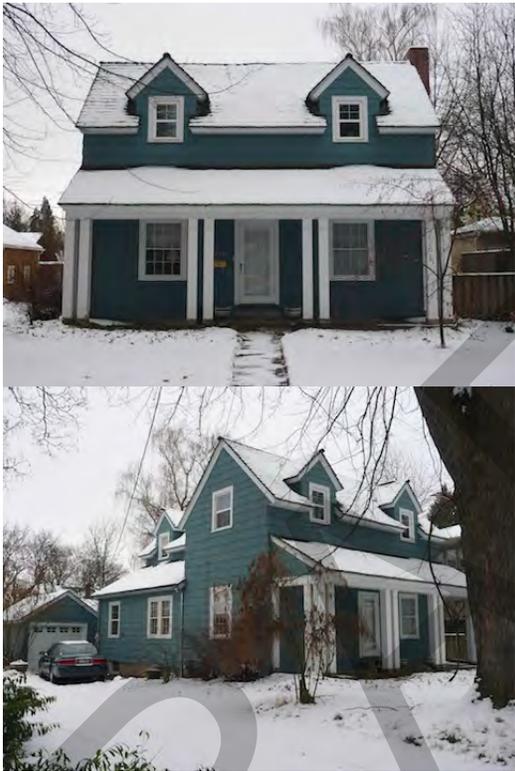
<p>The residence at Site 78 is a one-and-one-half story, side-gable roof I-house with two wall dormers on the façade and additions at the rear. The dwelling is oriented north facing East B Street. The symmetrical, three-bay (w/d/w) façade features a full-width shed roof porch atop square columns that are paired in the center and tripled at the corners. The entry door is wood with inset panels. Double-hung, eight-over-eight, wood-sash windows and wood surrounds remain, though vinyl windows are found on the east elevation and in the two dormers. The west elevation features a brick, shouldered, double-flue, chimney. A one-and-one-half-story, gable-roof ell addition is found on the rear, and features a single-story shed-roof extension spanning the east side. The house sits on a concrete foundation, the walls are clad in machine-cut wood shingles, and the roof is covered in wood shakes. At the rear of the site is a single-car garage with a gable roof, shake roofing, wood shingle siding, and a fiberglass door.</p>

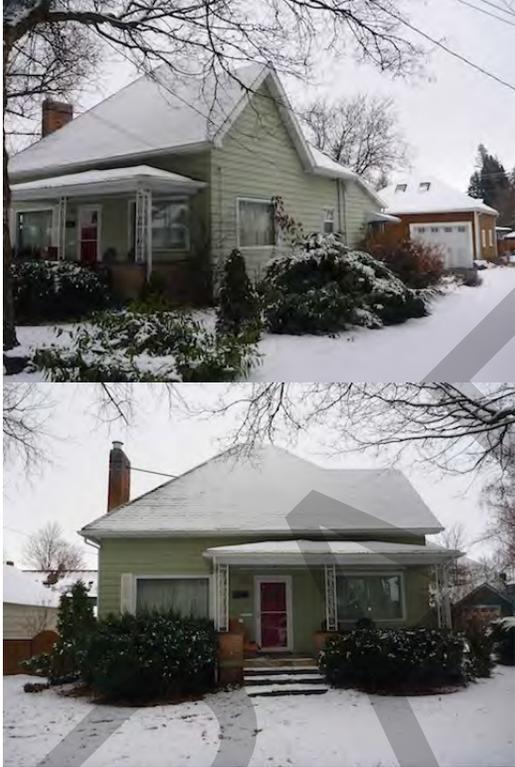
Survey Site Data	Site Photographs	Site Details
<p>Site #: 79 519 East B Street Owner: Martha Stolbert 2013 Trust 1890 Previous District Status: NC (intrusion), 74 DoE: NC</p>

<p>This residence is a pyramidal-roof dwelling with a steep side-facing gable and rear additions. The residence is oriented towards the north facing East B Street. The façade features a partial-width, hip-roofed porch set atop metal posts on concrete capped Roman brick piers on a concrete porch topped with slate tile. On either side of the entry are large aluminum, picture windows; one with shutters. At the east elevation is a tall, shouldered, double-flue, brick, chimney and vinyl and metal sash windows. At the west elevation under the tall gable is an aluminum picture window and to the south a small vinyl window and a side entry door with a metal awning. The dwelling has wide aluminum siding and a composition shingle roof. To the rear is a pyramidal-roof, single-car garage that faces north. The garage features new machine-cut shingles, wood window and door surrounds, a modern metal roll-up garage door and skylights.</p>

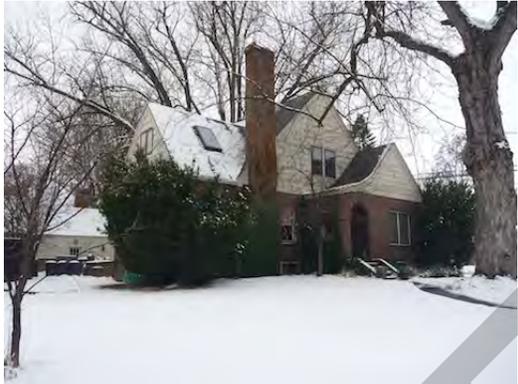
Survey Site Data	Site Photographs	Site Details
<p>Site #: 80 221 North Polk Street Owner: David Lien 1932 Previous District Status: NC (compatible), 75 DoE: C</p>

<p>This is a one-and-one-half-story, cross-gabled dwelling with brick veneer at the first level and shingles above. The façade, facing east, features a dominant front gable and another smaller, front-facing gable that contains a porch, inset through an arched entryway. The front door is wood panel with a soldier-course brick header and rowlock course bricks at either side. North of the entry is a pair of six-over-one, wood-sash windows with rowlock course brick surrounds. Rowlock bricks also run around the dwelling as a water table. A tall, double-flue, single-shouldered brick chimney is also found at the façade. A modern skylight pierces the roof over the façade. Eaves are minimal, and both double-hung and casement, wood-sash windows remain. A shingle-clad dormer is found over the north elevation. The rear elevation features an additional entry, and an oriel window with multiple diamond panes and a hip roof atop a pair of scroll-cut bracket. The residence has a basement. Behind the dwelling is a wide, two-car garage with a doublewide, fiberglass roll-up door, wood shingle and wide lap siding, and minimal eaves.</p>

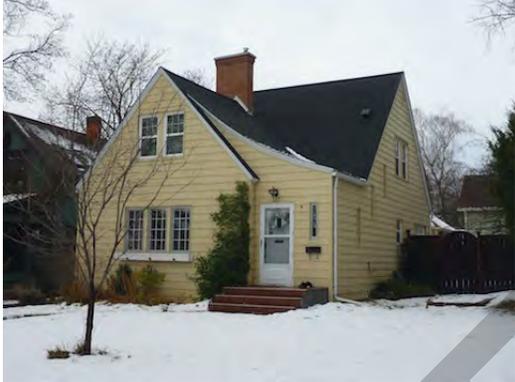
Survey Site Data	Site Photographs	Site Details
<p>Site #: 81 217 North Polk Street Owner: Jon Robert Hegglund 1936 Previous District Status: NC (compatible), 76 DoE: C</p>

<p>Site 81 is a cross-gabled, Tudor-inspired dwelling, oriented east toward North Polk Street. The façade features a tall, steeply pitched front gable that projects past the sweeping eave of the enclosed entry. Brick stairs lead up to a brick landing at the entry door, which is a wood mid-century door with a stair-step glazing pattern. Vinyl and aluminum windows are found throughout. The dwelling features a composition shingle roof, wide wood clapboards, minimal eaves, and a wide, brick, double-flue, chimney that exits the roof at the ridge of the front-facing gable. At the north elevation are three, narrow, three-light windows that follow the rise of an interior staircase. At the south side, a metal awning covers the side entrance door. Also found is a two-car garage with a gable-front roof, minimal eaves, wide wood clapboards, and a metal panel roll-up door.</p>

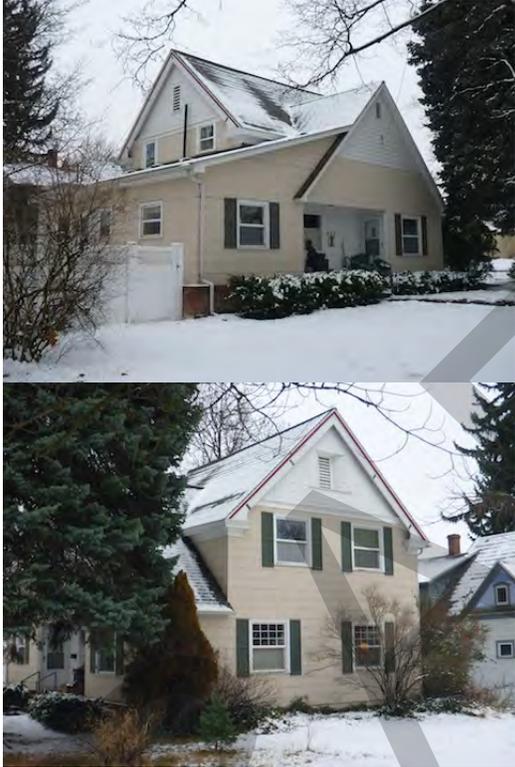
Survey Site Data	Site Photographs	Site Details
<p>Site #: 82 605 East B Street Owner: Thomas Hipple ca. 1900 Previous District Status: NC (compatible), 77 DoE: NC</p>

<p>Site 82 is a one-and-one-half-story, side-gable dwelling with a single-story enclosed entry and a shed-roof addition on the east. The dwelling, oriented north toward East B Street, originally faced North Polk as indicated by Sanborn maps. The entry is inset under the front-facing gable with entry doors in both the east and west walls, and a large picture window facing north. The entry porch is clad in vertical sheet paneling, the body of the residence is clad in wide asbestos shingles, and the gables are covered in painted wood shingles. The east and west side gables exhibit patterned shingles, a slight flare at the window header, and feature altered bargeboards and classical cornice returns. Windows are vinyl. The foundation is concrete and the roofing is composition shingles. At the rear of the site sits a gable front, two-car garage with two fiberglass roll-up doors, wide asbestos shingle siding, and a composition shingle roof.</p>

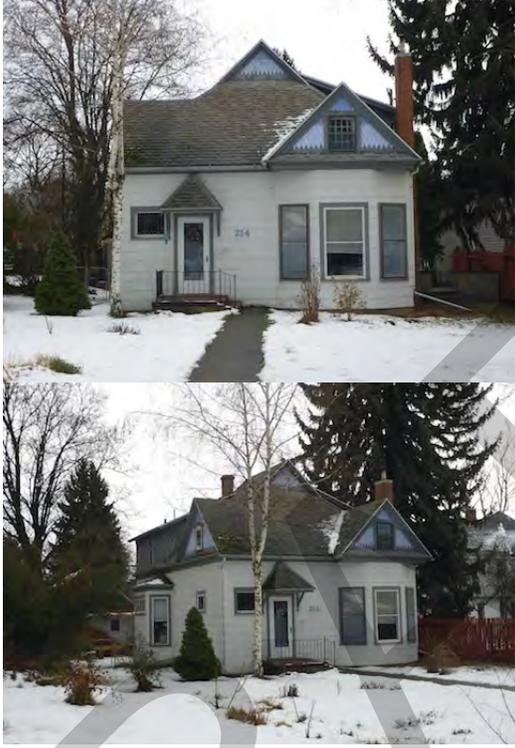
Survey Site Data	Site Photographs	Site Details
<p>Site #: 83 214 North Polk Street Owner: Michael Osterholz 1905 Previous District Status: NC (compatible), 78 DoE: C</p>

<p>Site 83 is oriented west toward North Polk, south of B Street. It is a single-story Queen Anne cottage with an attic, a gable-on-hip roof, and is generally rectangular in plan. A three-sided bay is found at the southwest corner with a small gable roof above. The off-centered entry on the façade elevation has a small hip-roof hood above. The gable ends are filled with scalloped and diamond-shaped shingles. A shed-roof dormer has been added over the south elevation, next to an exterior, shouldered brick chimney. The roof over the northeast corner has been raised; these walls are covered in wood shingles. A small, single-story bay is also found on the north elevation. The dwelling is covered in asbestos shingles, and retains some wood-sash and leaded-glass windows. A large, gable-roof, frame, two-car garage covered in wide wood boards is found to the rear.</p>

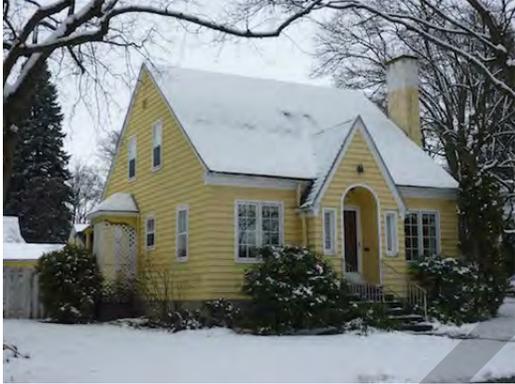
Survey Site Data	Site Photographs	Site Details
<p>Site #: 84 217 North Howard Street Owner: Richard Nielsen 1940 Previous District Status: NC (compatible), 64 DoE: C</p>

<p>Site 84 is a symmetrical, one-and-one-half story, side-gable roof dwelling. It has a steeply pitched front-facing gable with an arched doorway flanked by a pair of vertical four-light wood-sash windows with simple wood surrounds. The enclosed porch features a wide trimmed fascia and small cornice returns. On both sides of the entry are paired, eight-light, wood casement windows. A tall, double-flue, parged and painted brick chimney graces the north elevation. Double-hung, wood-sash windows are found on the side and rear. At the south elevation is a porch hood with scroll-sawn brackets. The exterior is clad in lap siding. On the rear elevation a hyphen leads to the small, attached, one-car garage that has a wide fascia, cornice returns, and a metal tilt-up garage door. At the southwest corner of the site is a shed with lap siding, wood windows, wood barn-style sliding doors, and a shed roof.</p>

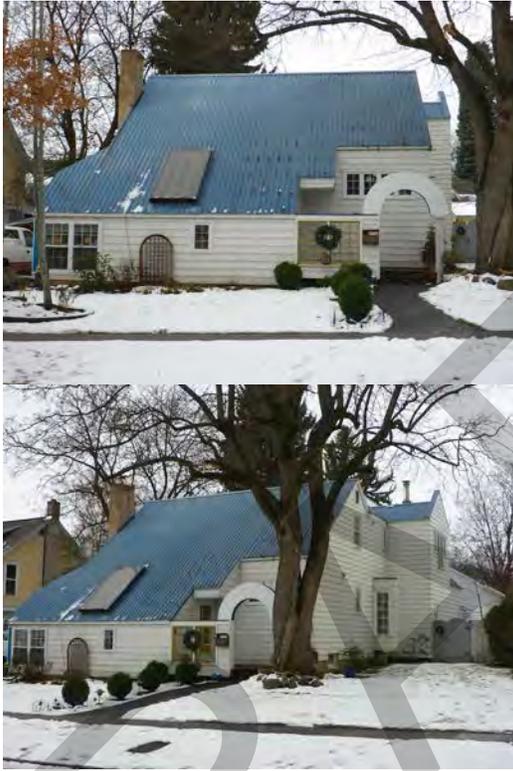
<p>Site 85 faces east toward Howard Street, south of East B Street. It is an altered, one-and-one-half-story, side-gable roof frame dwelling. This was originally a rectangular dwelling, with a small extension at the southwest corner. The small extension remains, though a multi-part addition has been added along the façade beneath an extension of the primary roof, creating a large overall roof plane. A large skylight is found on the roof in this addition. The wall plane of the addition continues north until it reaches an opening with an arch over it, leading to the main entry. A small wall with a narrow vertical window in it extends on the north elevation. A chimney on the south has been parged. A large, two-story addition is also found on the rear. The building is clad in vinyl or aluminum siding, and the roof is covered in metal. The windows are vinyl throughout. A large, nonhistoric, two-car garage is found to the rear.</p>

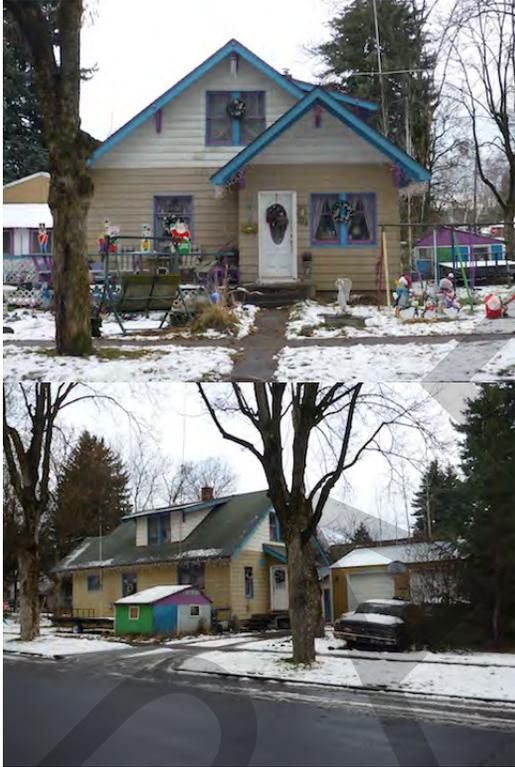
Survey Site Data	Site Photographs	Site Details
<p>Site #: 86 703 East B Street Owner: Lavetta Williams 1918 Previous District Status: NC (compatible), 63 DoE: C</p>

<p>This is a one-and-one-half-story, gable-oriented, frame Bungalow with an enclosed, gable-roof porch on the façade elevation. It features three-over-one and two-over-one, wood-sash windows, brackets and rafter tails and is covered in aluminum siding. A shed-roof dormer, with brackets, rafter tails, and original windows, is found over the west elevation. An enclosed, shed-roof porch is centered on the rear. It rests on a concrete foundation, and has three-part, wood-sash basement windows. A large, gable roof, metal, two-car garage is at the southeast, rear corner of the property. It features a shed-roof, plywood and frame extension on its north side. The original, smaller, single-car garage remains at the northeast corner of the property. It exhibits clapboard siding, and wood shingles within the gable as well as brackets, and a two-part, hinged wooden door. A small, frame and plywood, children's playhouse is located west of the house.</p>

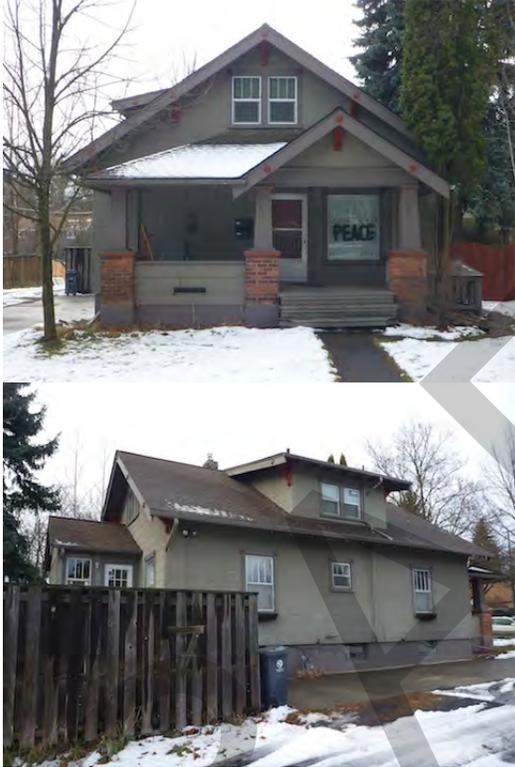
<p>Site 87 faces north toward B Street, east of Howard. It is a one-and-one-half-story, gable-oriented, frame Bungalow, with a hip-roof porch spanning the façade. A gable roof extends up from the porch over the primary entry. The porch is supported by flared posts, set on brick piers. The house is set on a concrete foundation and is covered in asbestos siding – though the wall inside the front porch is covered in vertical siding. Visible rafter tails and brackets are also found on the dwelling. Four-over-one, double-hung, wood-sash windows remain on the dwelling and are surrounded with simple wood trimfeaturing square wooden ornamental pieces at the top corners. A large metal sash window is found at the front porch. A shed-roof dormer is found over the east elevation, while a square bay topped by a gable roof is found on the west side. An enclosed, gable-roof porch is found on the rear. A concrete-block, two-car garage with brackets is found behind the house.</p>

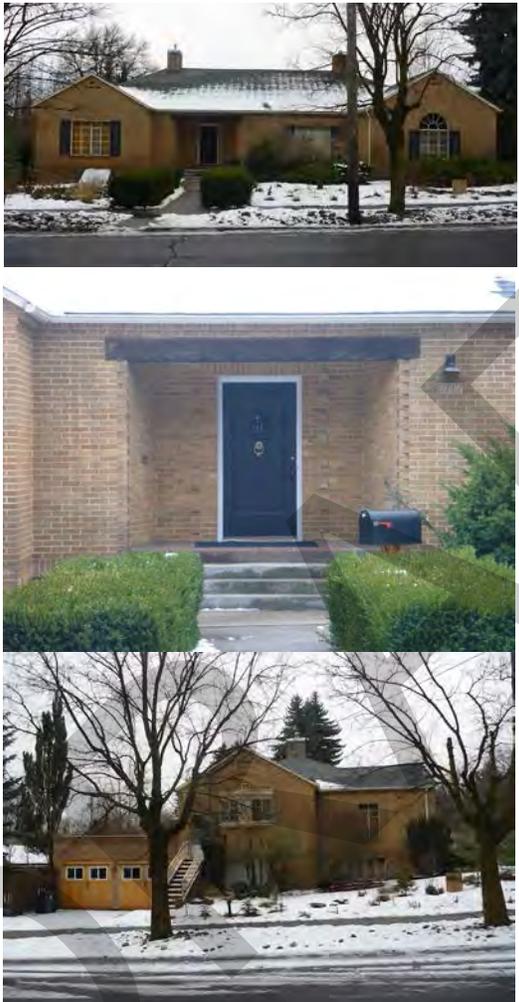
Survey Site Data	Site Photographs	Site Details
<p>Site #: 88 717 East B Street Owner: Stephen Katz 1937 Previous District Status: n/a DoE: C</p>

<p>Site 88 is on the southwest corner of Monroe and B Streets. It is a single-story, very early Ranch dwelling with a brick veneer exterior. It features a hip roof, with gable-roof sections extending forward at both corners on the façade, rear on the southwest corner, and out to the east on the southeast corner. Multi-light, steel windows remain, some flanked by shutters. The gable extension on the northwest corner features a metal-sash, fanlight window above the main window. The windows feature brick sills, and soldier course brick lintels above. The primary entry is recessed from the primary wall plane, off-centered on the façade elevation. A large wood header is found above the entryway to the porch. Two brick chimneys pierce the roof, one at each end of the main, hipped roofline. A small, bow window is found in the gabled extension on the east elevation, next to a side entry accessible via a set of brick stairs. The dwelling features an integrated back deck, surrounded by a brick awning. The deck sits on top of two, single-car garages that exhibit wooden doors. A portion of the deck area is recessed from the rear wall plane, while a portion of it is sheltered by a mid-century, metal awning.</p>

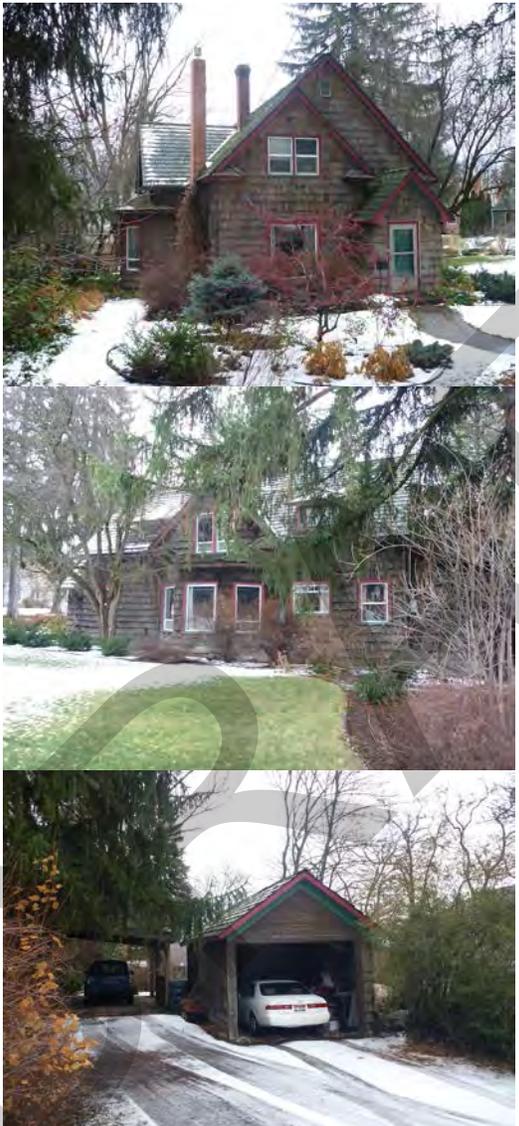
Survey Site Data	Site Photographs	Site Details
<p>Site #: 89 801 East B Street Owner: James Gary Williams ca. 1900 Previous District Status: n/a DoE: NC</p>

<p>The 'Site Photographs' column contains three vertically stacked photographs. The top photo shows a front view of a one-and-a-half-story house with a cross-gabled roof and wood shake siding. The middle photo shows a side view of the same house, highlighting its gable roof and multiple windows. The bottom photo shows a small, single-car garage with a gabled roof, situated on a driveway with snow patches.</p>	<p>Site 89 is located on the southeast corner of Monroe and B Streets. This is a one-and-one-half-story, frame, cross-gabled dwelling covered in wood shake. A single-story, gable-roof, enclosed entry porch is found on the northwest corner, and single-story, three-sided bays are found on both the east and west side elevations. An exterior brick stack is found on the east, while an older brick chimney pierces the roof over the dwelling. Vinyl windows and cornice returns are also found on the house. The original house on this site predated the 1904 Sanborn map, though the current house has a different footprint. The older brick chimney indicates this may be a remodel, as opposed to a new dwelling. A small, gable-roof, frame, single-car garage is located behind the house.</p>

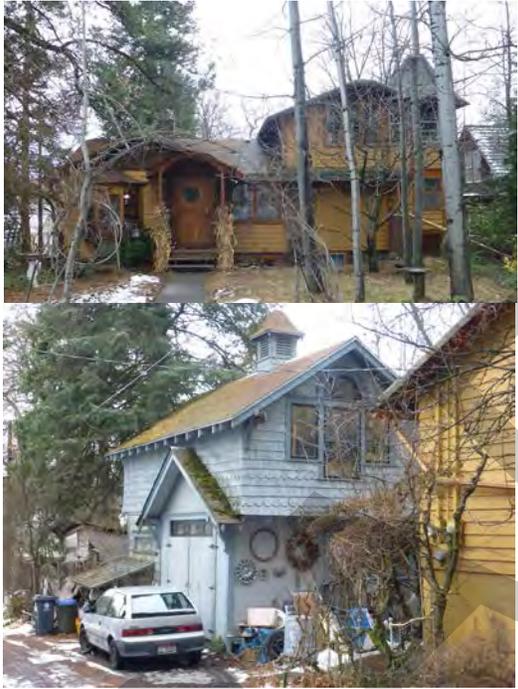
Survey Site Data	Site Photographs	Site Details
<p>Site #: 90 809 East B Street Owner: Roberta Radavich 1950 Previous District Status: n/a DoE: NC</p>

<p>Site 90 faces north toward B Street, east of Monroe. It is a single-story, side-gable dwelling, with a two-story addition on the northwest corner. The addition features a turret extending up from its corner. Originally a small, rectangular, single-story dwelling with a small porch at the northeast corner, this house has been altered and now exhibits a storybook cottage style with roof shingles that wrap around the fascia. The porch has a small, clipped-gable extension on the front exhibiting a sunburst motif within it. A new, gable-roof entry porch has been added beside it and a bay window added below it. A two-story, gable-roof outbuilding is found behind the dwelling, exhibiting weatherboard siding, square and scalloped shingles on the second level, and a cupola on the roof. It also features wood-sash windows, and an entry with hinged doors and a small gable roof line over it.</p>

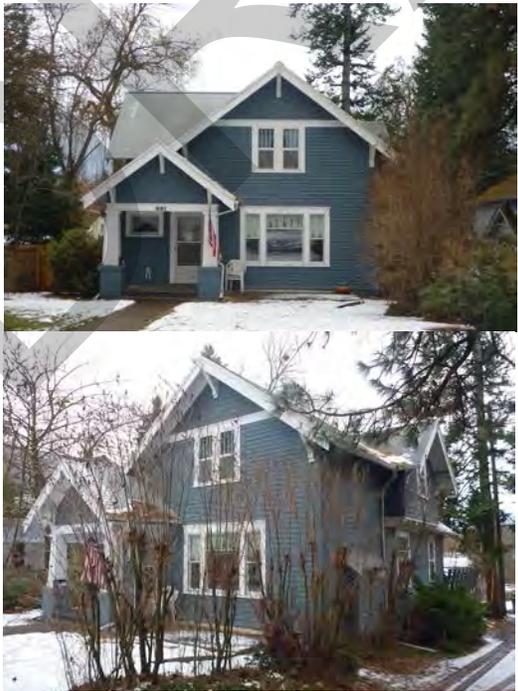
<p>Site #: 91 821 East B Street Owner: Arvo Smith et al Life Estate ca. 1900 Previous District Status: n/a DoE: C</p>

<p>Site 91 faces north toward B, west of Lincoln. It is a two-story, cross-gabled, frame dwelling exhibiting elements common to some Bungalows of the era. It features large brackets, heavy wood window surrounds, and flared wood posts supporting a single-story, gable-roof porch off-centered on the façade. The house is covered in weatherboard, with shingles in the highest gable end. One-over-one, and four-over-one, wood-sash windows remain. A gable-roof, square, oriel window is found on the west elevation with extensions of the support rafters visible below. A single-story extension or enclosed porch is found on the rear, and is original to the dwelling. It exhibits rafter tails, which are also found on a small shed-roof awning over a side entry door on the west side.</p>

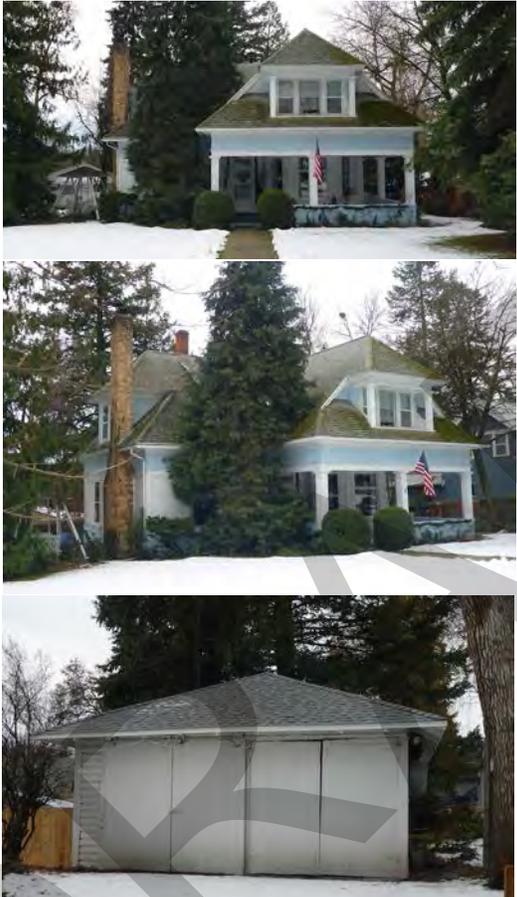
Survey Site Data	Site Photographs	Site Details
<p>Site #: 92 823 East B Street Owner: Jean Currin 1903 Previous District Status: n/a DoE: C</p>

<p>The photographs show a white, one-and-a-half-story house with a green roof and a large porch. A brick chimney is visible on the side. A large, white garage is attached to the rear of the property.</p>	<p>Site 92 is located on the southwest corner of B and Lincoln Streets. It is a one-and-one-half-story, L-shape, frame dwelling with hip-roof dormers over all four elevations. A recessed, L-shape porch is found around the northwest corner, and is supported by square posts with decorative molding around the top, that are set on an apron covered in wood siding. The house features horizontal boards, weatherboard, and both square and sawtooth shingle imbrication. The corners of the dormers exhibit square corner posts with the same decorative molding as the porch. Wood-sash windows remain, as does a transom above the main entry. A single-shouldered, exterior, brick chimney is found on the east elevation, while another brick stack pierces the roof at the rear of the house. A small, single-story, shed roof, enclosed porch is found on the rear. A large, hip-roof, frame garage is found behind the dwelling. It features drop-wood siding, and horizontal sliding wood doors.</p>

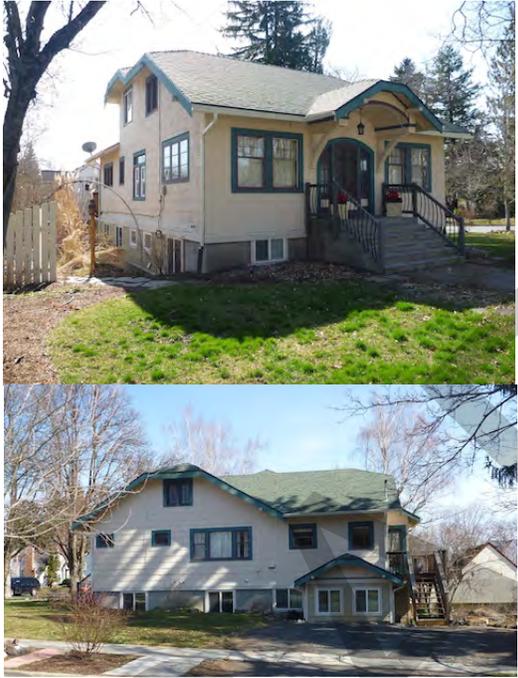
Survey Site Data	Site Photographs	Site Details
<p>Site #: 93 901 East B Street Owner: Jeffrey Sowle 1926 Previous District Status: n/a DoE: NC</p>

<p>This is a one-and-one-half-story Bungalow with a cross-gabled, jerkinhead roof. The dwelling has a small, clipped-gable porch centered on the façade with an arched ceiling over the entry and large brackets supporting the porch roof. The main entry is segmentally arched and contains a paneled wood door flanked by multi-light sidelights. The house has a second-story addition that extends the roofline upward on the east elevation. A small, clipped-gable addition is also found on the basement level on the west elevation. Paired, eight-over-one, double-hung, wood-sash windows flank the entry on the façade elevation. Both original, wood-sash windows and nonhistoric vinyl windows are found throughout the remainder of the dwelling. The house is set on a poured-concrete basement foundation, which is partially covered in nonhistoric siding on the east elevation. The dwelling itself is covered in asbestos shingles and retains some straight braces beneath the eaves. An exterior, wooden staircase and porch is found on the rear providing access to an enclosed, rear porch.</p>

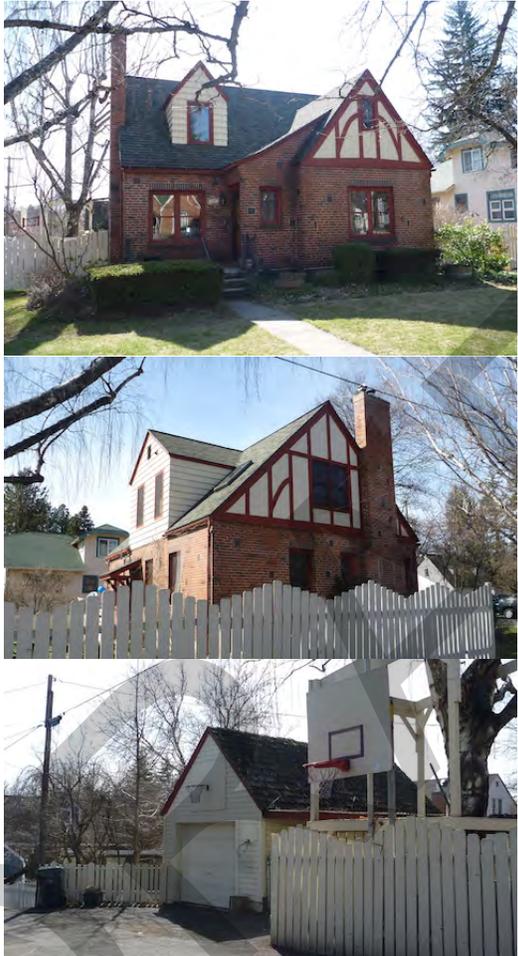
<p>Site 94 faces north toward B Street east of Lincoln. It is a one-and-one-half-story, cross-gable roof, Tudor-revival style dwelling. It features an enclosed porch in the crux between the crossed gables on the façade elevation beneath a shed-roof swooping down from the forward-facing gable. A gable-roof dormer is found above the façade elevation and a large, gable-roof wall dormer is centered on the rear. It features a clinker brick exterior, though the dormers are covered in aluminum siding and the forward and side gable ends are covered in half-timbering and stucco detail. A large, shouldered, exterior, brick chimney is found on the east elevation. Multi-light, double-hung, wood-sash windows remain on the dwelling. They feature brick sills and soldier-course brick lintels. A skylight has been added over the west side of the forward-facing gable. A small, shed-roof overhang supported by brackets shelters an entry on the rear elevation. A small, single-car, gable-roof garage is located at the rear of the property. It is covered in drop-wood siding with wood shingle roof sheathing and a nonhistoric overhead door.</p>

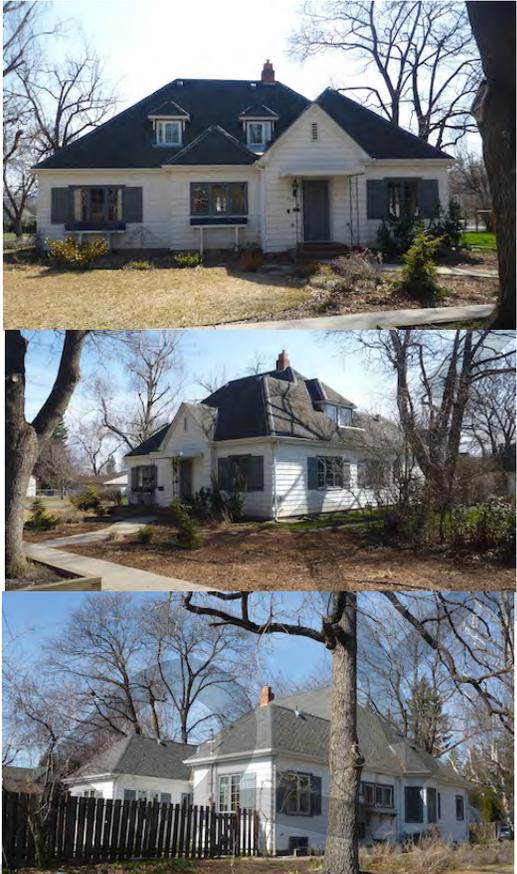
<p>Site 95 is an asymmetrical, one-and-one-half-story frame dwelling. It features a hip roof over the central portion, and a small, single-story, hip-roof, bay window extending on the façade elevation directly east of a larger, hip-roof extension on the northwest corner. An enclosed, gable-roof porch is situated on the east side of this extension. Two small, hip-roof dormers are found above the façade elevation, while a slightly larger one is located over the west elevation. A three-sided bay window is found on the east elevation, and two single-story, hip-roof additions have been added onto the rear creating a U-shaped courtyard. The house is covered in aluminum siding and contains both multi-light, wood-sash windows and vinyl windows. Many of the windows are flanked by nonhistoric shutters. A brick chimney pierces the center of the roof. A flat-roof canopy with scrolled metal posts shelters the main entry. A hip-roof, two-car garage also covered in aluminum siding is found to the rear of the dwelling.</p>

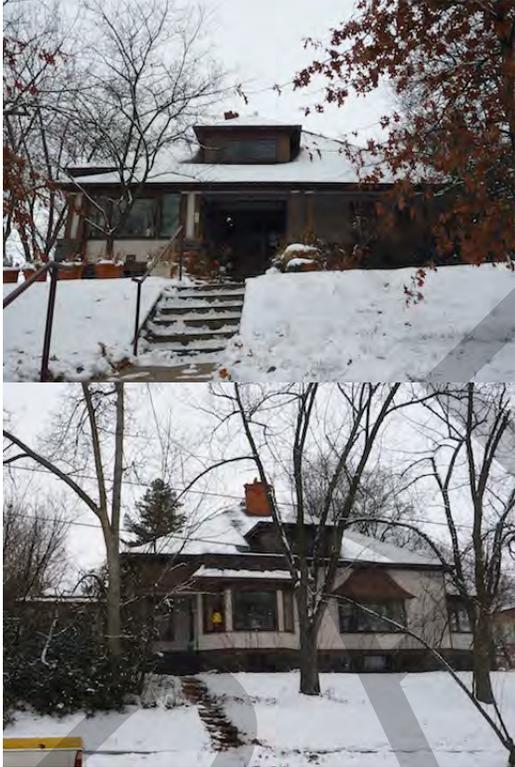
Survey Site Data	Site Photographs	Site Details
<p>Site #: 98 304 East A Street Owner: Linda Blackwelder Pall 1907 Previous District Status: C, 11 DoE: C</p>

<p>Site 98 is on the northeast corner of A and Jefferson Streets. It is a one-and-one-half-story, frame Bungalow characterized by a broad and low form. It features a single-light, wood entry door with leaded-glass sidelights, accessed within a large porch that spans nearly the width of the façade. The porch is supported by paired, square posts. The west end of the porch is an enclosed sun porch with wood-sash windows. A hip-roof dormer is centered above the façade and contains leaded-glass windows and visible rafter tails. The west elevation has a matching dormer above. The west side also has a three-sided bay and a three-part window. A single-story enclosed porch is found at the rear, while a portion of the east elevation extends a full one-and-one-half-story and is topped by a jerkinhead roof, which is slightly flared. The dwelling is set on a mortared, stone foundation pierced by small basement windows. A brick chimney pierces the roof over the west elevation.</p>

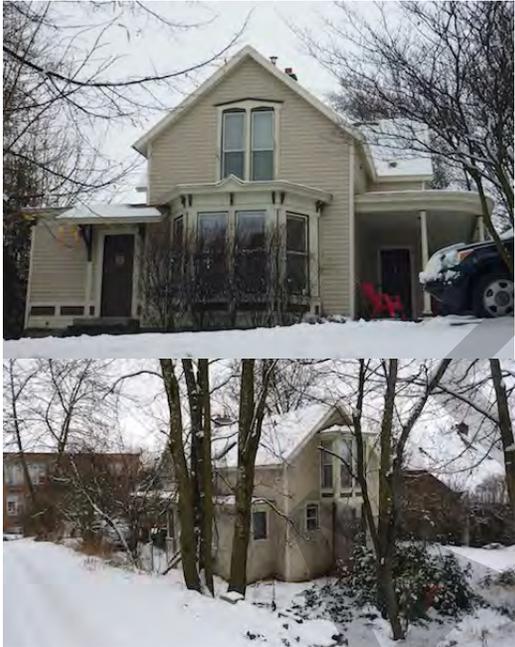
Survey Site Data	Site Photographs	Site Details
<p>Site #: 99 310 East A Street Owner: Seeley 2009 Family Trust 1893 Previous District Status: C, 15 DoE: C</p>

<p>Site 99 faces south toward A Street, east of Jefferson. It is a two-story, cross-gabled, Italianate dwelling with a curved porch atop Tuscan columns on the southeast corner, a small shed-roof porch over an entry in a single-story extension on the west end of the façade, and a three-sided bay centered on the façade, which features brackets and a small peak above the windows and recessed panels below. On the far rear of the building, an oriel window is found on the second story, which exhibits similar recessed panels below the windows as the bay on the front. The rear portion and single-story extension at the southwest corner appear to be additions. The house contains vinyl windows and has been covered in vinyl siding, though characteristics of the original Italianate design and original ornamentation remain.</p>

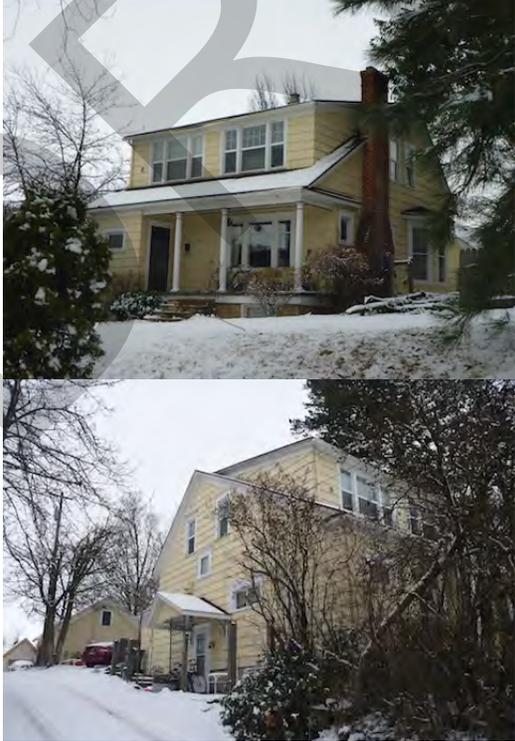
<p>Site #: 100 320 East A Street Owner: Justin Bonner 1912 Previous District Status: NC (compatible), 16 DoE: C</p>

<p>Site 100 faces south toward A Street, west of Adams. It is a one-and-one-half-story, frame dwelling. A nearly full-width porch spans the façade, with round posts supporting an overhang of the primary roof; an enclosed entry is found at the west end of the porch. A large shed-roof dormer spans nearly the width of the house above the façade. A three-sided bay is located on the east side, while an entry to the daylight basement is found on the west. The house has a combination of wood and vinyl windows, and is set on a concrete foundation. It is covered in wood shingle siding and has an exterior, shouldered, brick chimney on the east side. A large, frame, gable-roof garage or outbuilding is located to the rear. It is covered in clapboard siding and exhibits multi-light, wood-sash windows.</p>

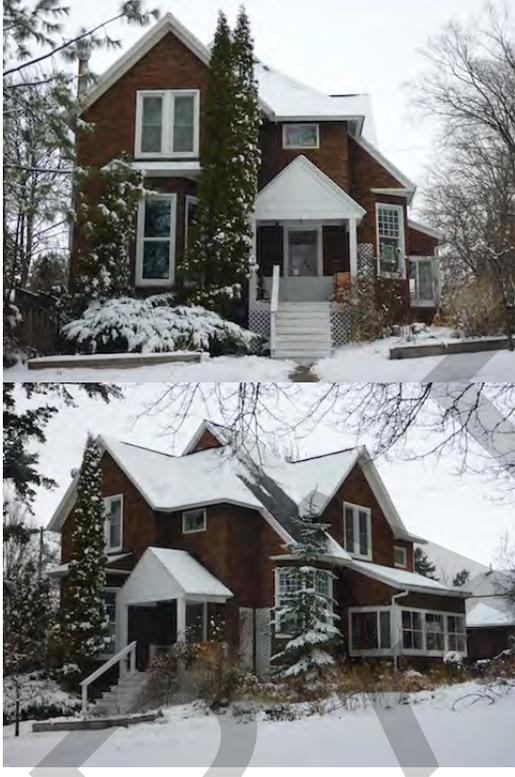
Survey Site Data	Site Photographs	Site Details
<p>Site #: 101 326 East A Street Owner: Cynthia Magnuson 1881 Previous District Status: C, 17 DoE: C</p>

<p>The Henry Baker House, 1884, is on the northwest corner of Adams and A Streets. It is a two-story, cross-gabled dwelling with a gable-on-hip roof at the highest point. It exhibits brick veneer cladding, and a combination of multi-light or single-light, wood-sash windows and aluminum windows. A gable-roof porch covers the entry on the south elevation, and a three-sided, single-story bay beneath an extension of the primary roof extends from the southeast corner. Another three-sided bay beneath a small shed roof is on the façade. A slightly shorter, one-and-one-half-story, gable-roof extension is found on the rear, and a single-story, hip-roof addition is found on the east. The rear extension has a shed-roof dormer with horizontal board siding over its east elevation. A rear entry is sheltered by a hip roof with brackets. A nonhistoric, single-car garage, set on concrete with horizontal board siding is to the rear.</p>

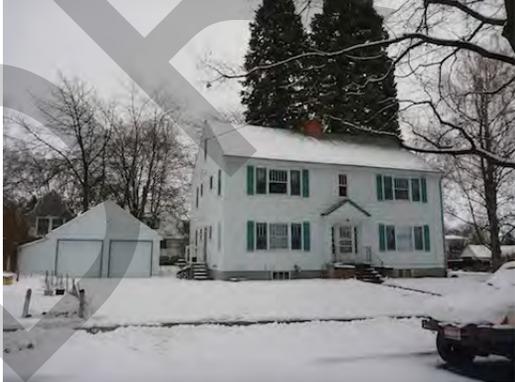
<p>Site #: 102 204 North Adams Street Owner: 204 North Adams LLC 1936 Previous District Status: NC (compatible), 18 DoE: C</p>

<p>Site 102 is located on the northeast corner of Adams and A Street. It is a large, two-and-one-half-story, symmetrical, three-bay (www/wdw/www), side-gable, frame dwelling on a concrete, basement foundation. The building features three-over-one, six-over-one and one-over-one, wood-sash windows, some flanked by nonhistoric shutters. It is covered in wood shingles, and has a brick entry porch and small gable roof over the porch. The building has a three-light, wood door with multi-light sidelights. A brick chimney pierces the center of the roofline. Secondary entries are found on the north and east elevations. A frame, gable-roof, two-car garage is located northeast of the dwelling. It features wood shingle siding, and a small, shed-roof addition on the north.</p>
