National Register of Historic Places Registration Form

Historic name: Fort Russell Neighborhood Historic District (Boundary Increase and Additional Documentation)

Street & number: Roughly bounded by Jefferson Street on the west, East D Street on the north, Hayes Street on the east, and East Third Street on the south

City or town: Moscow State: ID County: Latah

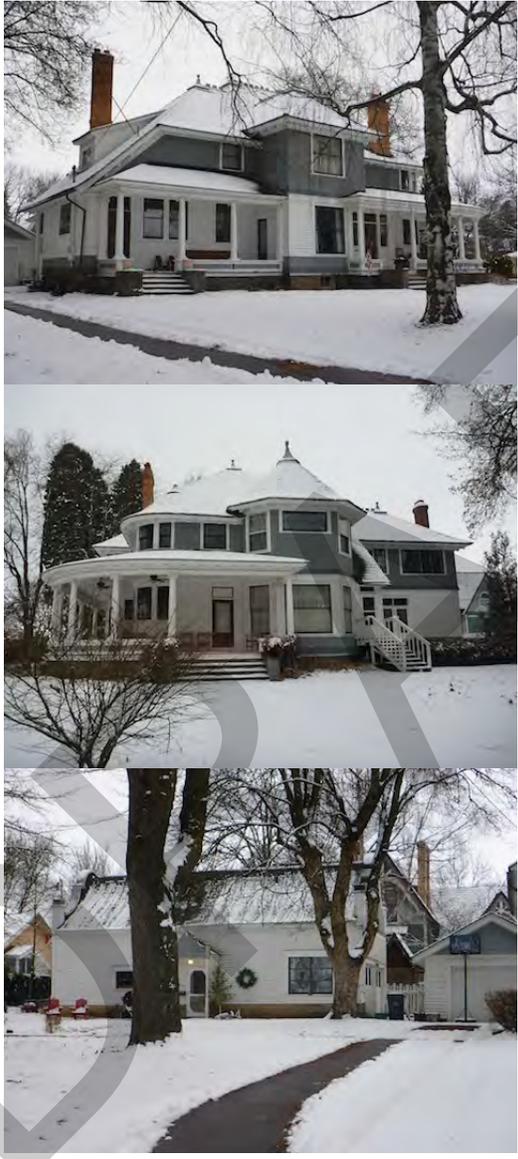
Survey Site Data	Site Photographs	Site Details
<p>Site #: 103 430 East A Street (dwelling) 203 North VanBuren Street (apartment in dwelling) 424 East A Street (carriage house) Owner: Timothy S. Kinkeade 1910 Previous District Status: C, 19 DoE: C</p>

<p>The Jerome J. Day House features a main dwelling, a carriage house, and a modern garage. The dwelling is a large, asymmetrical, Queen Anne with a full-height, square bay on the south elevation, a rounded southeast corner, and a full-height, three-sided bay with a turreted roof on the east elevation. A shorter, two-story portion is found on the rear and houses a separate apartment. The main level is covered in clapboard, while the upper levels exhibit diamond shingle imbrication – some of which is also below the windows on the bays. One-over-one, wood-sash windows remain; some of which exhibit ornate beveled glass. Scrolled brackets are found beneath the eaves on the upper levels as well as the curved porch, which is supported by Ionic columns. Iron finials and cresting top the rooflines. The main entry on the south elevation contains a single-light, wood door with sidelights and a transom. Two more entries are found within the hip-roof porch at the southwest corner. A small, shed-roof dormer is located above the west side. Two large, brick chimneys pierce the roof. A frame, gable-roof, carriage house is found in the northwest corner of the property. It has a bell-curved roofline, and Spanish-inspired parapets on the north, east and west sides as well as over the main entry porch centered on the south elevation. Multi-light wood-sash windows, and clapboard siding remain. A small, circular window is found above two entry doors on the east elevation. The entries contain multi-light wood doors. A small, nonhistoric, gable-roof, garage is found northwest of the dwelling. It is covered in horizontal board siding with fish scale shingles above.</p>

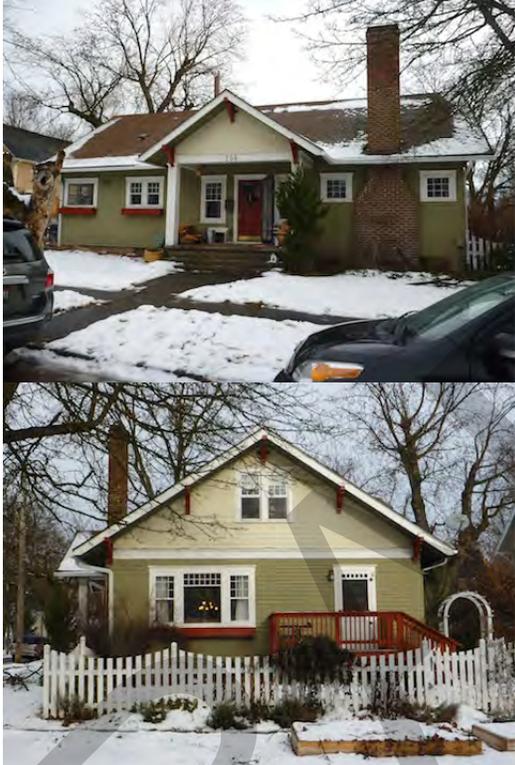
Survey Site Data	Site Photographs	Site Details
<p>Site #: 104 502 East A Street & 206 North VanBuren Street Owner: Joshua Branen 1922 Previous District Status: NC (compatible), 89 DoE: C</p>

<p>Site 104 is a one-and-one-half-story, rectangular, side-gable roof Bungalow with a front-gabled entry porch. The dwelling, oriented west facing North VanBuren, features wood shingles in the peaks of the gables and open eaves supported on knee braces. The porch roof rests on square wood posts. The door and windows exhibit wood surrounds. South of the entry is a brick, shouldered, exterior chimney flanked by two small, high-nine-light, wood-sash windows. Varying patterns of multi-light, wood-sash windows are found throughout. A side entry door with wood deck, stairs and railing is found on the south. The roof is composition shingle, the walls are clad in wood lap siding, and the foundation is concrete. A single-car garage is located at the northeast corner of the site. It features a gable-front roof with composition shingles, wood clapboard siding, a metal panel roll-up door, and knee braces.</p>

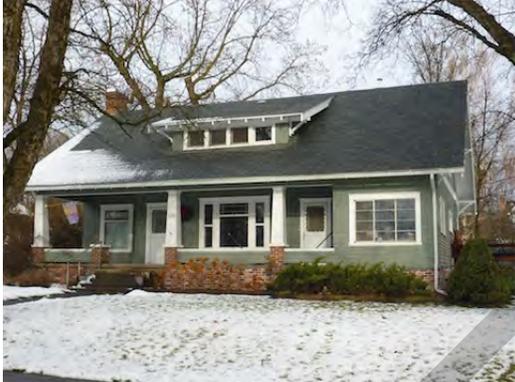
Survey Site Data	Site Photographs	Site Details
<p>Site #: 105 506 East A Street Owner: Michael Gaffney 1889 Previous District Status: C, 88 DoE: C</p>

<p>This is a one-and-one-half-story, side-gabled, Bungalow with a shed-roof dormer over the façade. A partial-width porch is recessed from the façade. It has battered wood posts set on brick piers. Two wood panel entry doors with glazing are found on the porch, with a triplet window between. The central sash has small colored-glass lights around a horizontal pane; similar colored glass is found in a window to the west. Fixed and double-hung, wood-sash windows are found throughout. Faux brick covers the foundation, and the house is clad in narrow wood lap siding. The gable ends and dormer feature wide cornice trim, open eaves, knee braces, wood shingles, visible rafter tails, and bargeboards. A brick chimney rises through the eave on the west side. To the rear is a gable-roof, two-car garage with open eaves, exposed rafter tails, knee braces, narrow wood lap siding, wood shingles, and a metal garage door.</p>

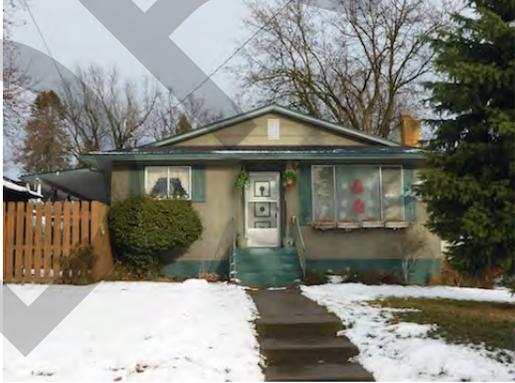
<p>Site #: 106 522 East A Street Owner: Gregory Blanchard 1973 Previous District Status: NC (intrusion), 84 DoE: NC</p>

<p>Site 106 is a small, Ranch house, oriented south facing East A Street. It is a front-facing gable-on-hip roof dwelling, with a rectangular plan. The façade features a central entry inset under the main roof. Aluminum-sash windows are found on the dwelling. Siding is T1-11 sheet paneling. The foundation is concrete. The gable peak is filled with horizontal board siding and a louvered attic vent. A light stone, double-flue, chimney is found at the east elevation. At the northwest corner of the site along the alley is a two-car garage. It features a gable-on-hip roof, metal panel roll-up door, and T1-11 paneling.</p>

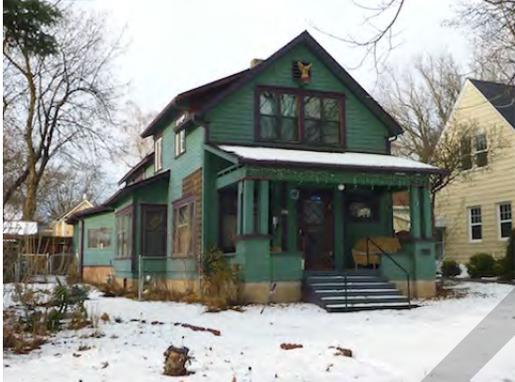
Survey Site Data	Site Photographs	Site Details
<p>Site #: 107 211 North Polk Street Owner: Frank Rodriguez ca. 1900 Previous District Status: C, 79 DoE: C</p>

<p>This is a gable-oriented frame dwelling with a full-width front porch and a shed-roof wall-dormer on the south side. The porch features a shed roof atop tripled square posts, and clapboard covered piers and apron. The entry door is set in a square projecting bay with a wood panel door with diamond glazing and a classical wood surround. Wood-sash windows, some with diamond-shaped leaded glass above, and aluminum windows are found on the dwelling. On the south side, a square bay with shed roof set with six windows is found beneath the wide, shed-roof wall dormer. A brick chimney pierces the roof near the ridge, while a shorter brick chimney is found to the west. The foundation is concrete, and the wall sheathing is clapboard. Located to the rear is a modern, two-car garage with faux log siding, a projecting front-gable roof, and a metal garage door.</p>

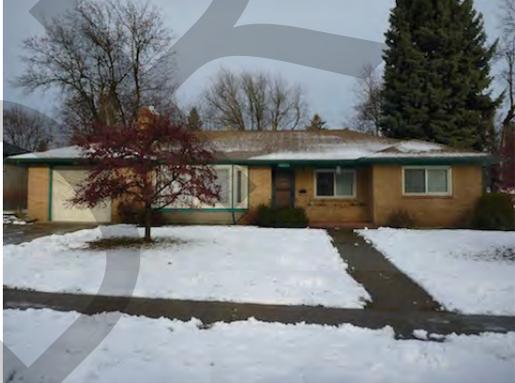
<p>Site #: 108 528 East A Street Owner: James Papineau 1951 Previous District Status: NC (intrusion), 85 DoE: NC</p>

<p>This is a wide, low Ranch style dwelling that is oriented south, facing East A Street. It features raked-brick veneered exterior walls, a low-pitched hip-roof with projecting hip roof extensions at each corner, and a low, raked-brick, inside chimney. A single-car garage with a roll-up metal door is located at the west end of the façade. A wide, four-window, bay is next to the garage. Rowlock course raked brick creates the window sills. The roof is composition shingle, and the foundation and stoop are concrete. All windows are vinyl. Located northeast of the house is a small gable-front shed. It features wood drop siding, corner boards, composition shingle roof, and two vinyl windows.</p>

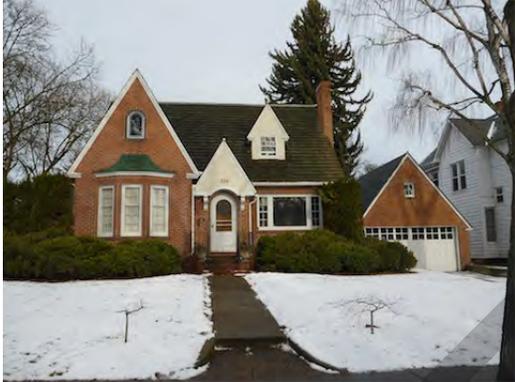
Survey Site Data	Site Photographs	Site Details
<p>Site #: 109 604 East A Street Owner: Asaph Cousins 1936 Previous District Status: C, 80 DoE: C</p>

<p>Site 109 is a one-and-one-half-story, cross-gabled, masonry dwelling with a steeply pitched gable roof and steep gables over the forward projection, the enclosed porch, and the dormer above the façade. It features an arched doorway within the entry porch, multi-light wood-sash windows, and a picture window flanked by multi-light windows. A small arched window with brick surround is found above a three-sided bay on the forward -gabled projection, and an exterior chimney is found on the east elevation. The walls of the dormer and the peak of the entry gable are stuccoed. Scrolled brackets support the overhanging gable at the entry. Soldier course brick lintels and sills are found on many of the windows. A shed roof dormer is found above the rear elevation. A shed roof shelters a patio at the back of the house. A two-car, gable-roof garage with similar detailing is directly east.</p>

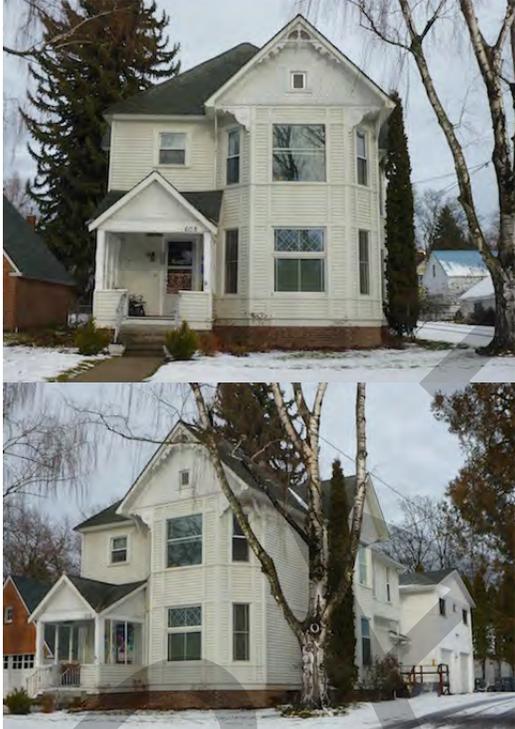
Survey Site Data	Site Photographs	Site Details
<p>Site #: 110 608 East A Street Owner: LNW Residence LLC ca. 1900 Previous District Status: C, 81 DoE: C</p>

<p>This is a two-story, multi-unit residence. It sits on a generally rectangular footprint, and has a hip roof with full-height gable-roof extensions centered on the east and west elevations, as well as one on the southeast corner, featuring chamfered corners. An open, gable-roof porch is found on the southwest corner. The dwelling is covered both in vinyl and aluminum siding, and contains vinyl replacement windows. The foundation is brick and concrete. The forward gabled extension features decorative brackets, pendants, and bulls eyes, and both scalloped and diamond imbrication. A large, gable-roof, two-car garage covered in vinyl siding, with a residential unit above is found to the rear.</p>

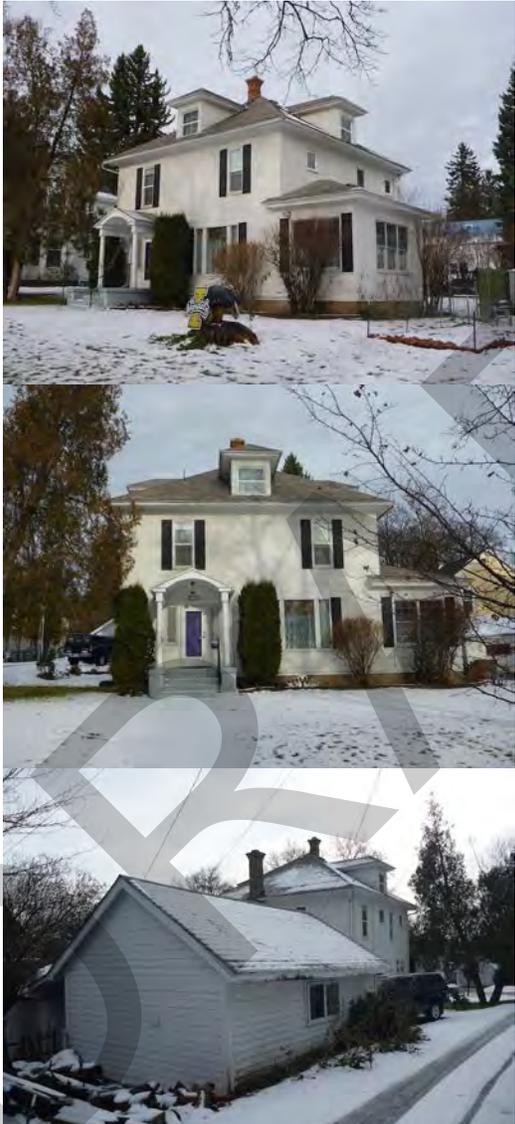
Survey Site Data	Site Photographs	Site Details
<p>Site #: 111 610 East A Street Owner: Clint Colvin 1915 Previous District Status: n/a DoE: C</p>

<p>The photographs show a two-story white house with a porch, a side view of the house, and a detached garage. The house has a hip roof with dormers and a brick chimney. The garage is a single-car structure with a gable roof.</p>	<p>Site 111 is oriented south toward East A Street. This is a two-and-one-half-story American Foursquare set on a parged foundation. It features a hip roof, with hip-roof dormers over the east, west, and façade elevations. A single-story, hip-roof addition is found on the east elevation, and a small, gabled porch with a barrel-vaulted ceiling and supported by Tuscan columns is off-centered on the façade. A shed-roof overhang shelters a rear door. A brick chimney pierces the center of the roof, while an exterior brick chimney is found on the rear. The dwelling is covered in asbestos tiles, and features vinyl windows, some flanked by nonhistoric shutters. A gable-roof, single-car garage is found to the rear. It features a metal overhead door, corner boards, and wide horizontal board siding.</p>

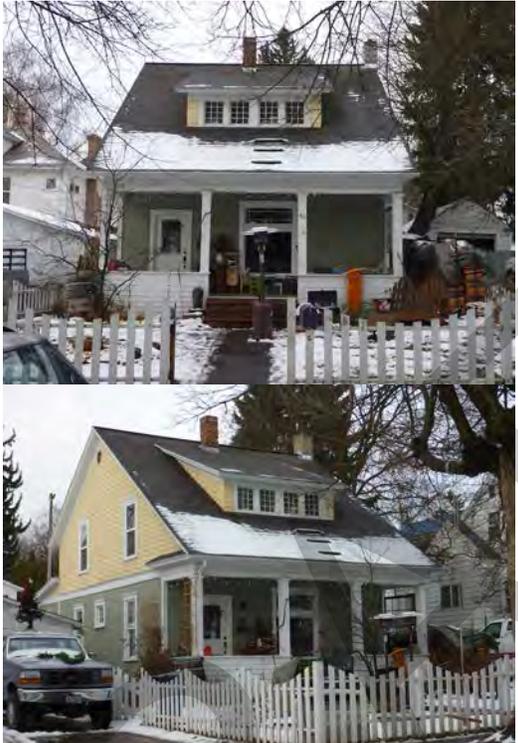
Survey Site Data	Site Photographs	Site Details
<p>Site #: 112 209 North Howard Street Owner: Erik Perryman 1910 Previous District Status: n/a DoE: C</p>

<p>This is a one-and-one-half-story, early-twentieth-century, side-gable roof Bungalow. It features a full-width porch recessed beneath the main roof, and a shed-roof dormer above the façade. The porch is supported by square posts, resting on a shingled knee-wall. Wood-sash windows remain throughout, some with numerous small divided lights, some double-hung sash, and some with small divisions in the upper portion. All of the windows, except those in the dormer, exhibit simple wood surrounds with crown molding above. A chimney on the north elevation has been replaced with a concrete-block stack. A brick stack pierces the roof over the façade. A single-story, enclosed porch spans the rear. The dwelling is covered in wood shingles, while the cornice line over the porch runs along both side elevations visually dividing the upper and lower levels.</p>

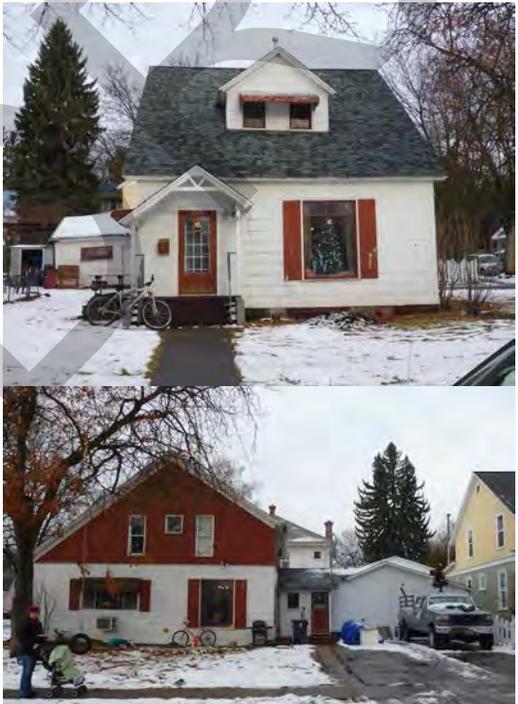
<p>Site #: 113 650 East A Street Owner: Adam Raines ca. 1900 Previous District Status: n/a DoE: NC</p>

<p>Site 113 is located on the northwest corner of Howard and East A. It is a one-and-one-half-story, side-gable roof, frame, simple Bungalow. A small, gable-roof dormer is centered above the façade, while a small, gable-roof overhang shelters the off-centered entry on the façade. An original, full-width porch is no longer extant. The dwelling retains wood-sash windows, some of which are large, single windows with bands of small lights across the top. Two multi-light, metal-sash windows are found on the west elevation. Some windows are flanked with nonhistoric shutters, and some exhibit metal awnings. An enclosed rear porch is found on the northwest corner, leading to an attached garage. The dwelling is covered in asbestos shingles, with wood cladding remaining on half of the attached garage.</p>

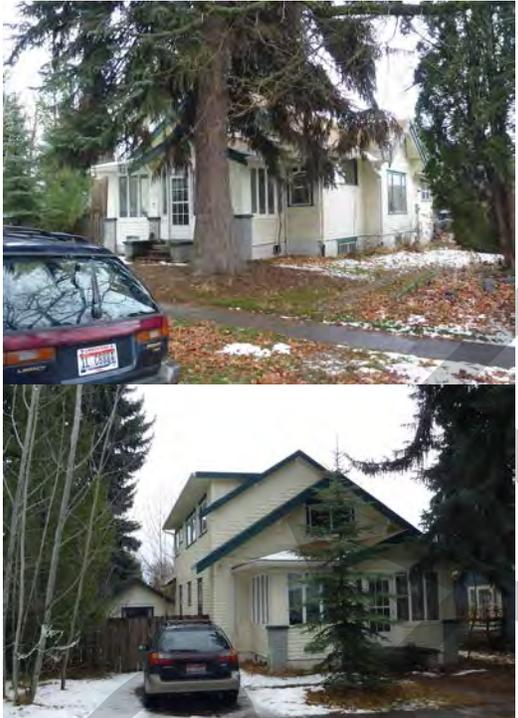
Survey Site Data	Site Photographs	Site Details
<p>Site #: 114 228 North Howard Street Owner: Frederick Gittes 1925 Previous District Status: n/a DoE: NC</p>

<p>This is a 1925 frame, gable-oriented Bungalow with a large gable-roof, second-story addition. The addition is very visible from the façade essentially overtaking the original form and reducing the dwelling’s ability to communicate its type, form or period. The addition features a flat or shed-roof wall dormer spanning its entire length. The original entry porch on the façade, supported by flared columns on brick piers with a weatherboard apron around it, has been enclosed and now exhibits modern windows all around. The main level still exhibits weatherboard siding, while the gables are covered in wood shingles. Vinyl windows are found throughout. A small, gable-roof, square bay extends on the south elevation.</p>
<p>Site #: 115 206 North Howard Street Owner: Charles Morrison 1935 Previous District Status: n/a DoE: C</p>

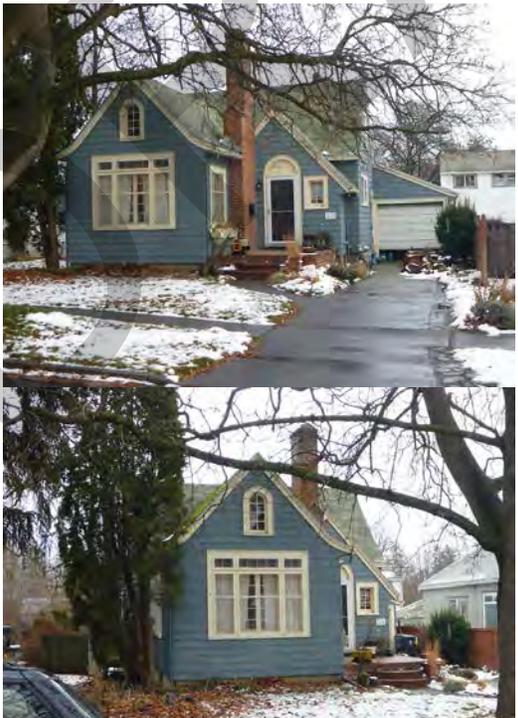
<p>This house faces west on Howard, north of A Street. It is a one-and-one-half-story, cross-gabled, frame dwelling with a gable-roof, enclosed porch on the façade. It is covered in wood shingle siding, and features an exterior brick chimney on the south side of the forward-gabled extension, next to the main entry door. The main entry is arched, though the arch has been filled. The front porch is concrete and brick, and is accessed by semi-circular brick steps. Multi-light, wood-sash windows remain, some also having wood storms. A small, arched, wood-sash window is found in the forward gable. A small, shed-roof, single-car garage has been attached at the dwelling’s southeast corner.</p>

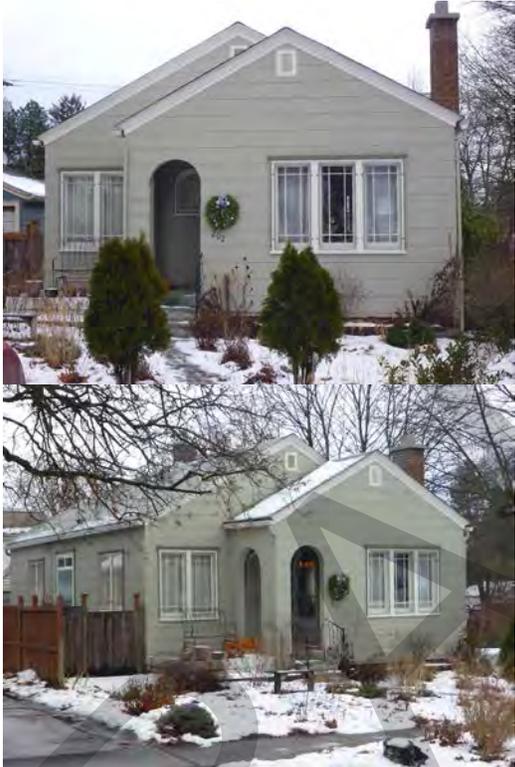
<p>Site 116 faces west on the northeast corner of Howard and A. It is a small, single story, frame Bungalow. A gable roof extension, slightly lower than the main roofline, extends on the façade, housing the recessed main entry. A small, gable-roof, square bay is also found on the south side in addition to an exterior brick chimney, flanked by two small windows. Another brick stack extends from the center of the roof. Single, paired, and three-part, wood-sash windows with typical Bungalow divisions in the glass remain on the house. They feature minimal surrounds, with small crown molding above. The house rests on a concrete foundation, and has been covered in asbestos siding. Arched entries on two sides of the porch lead to the main door, also arched. A small, arched, multi-light wood window is found within the porch. Basement windows are also found on the house.</p>

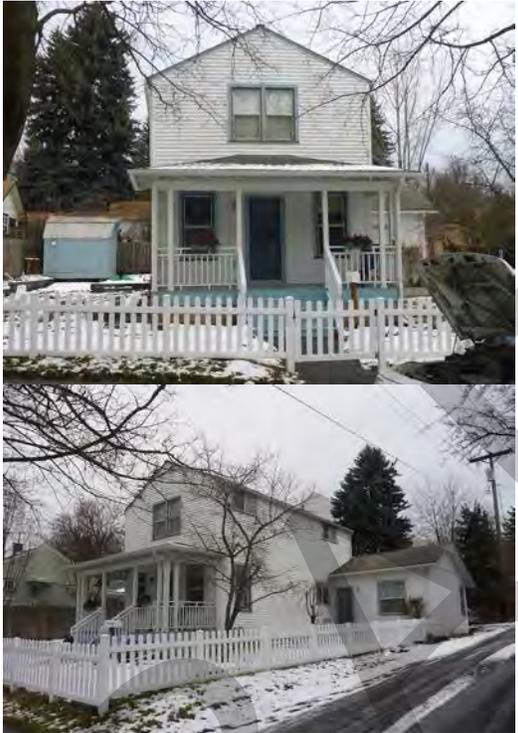
Survey Site Data	Site Photographs	Site Details
<p>Site #: 117 708 East A Street Owner: Elizabeth Cassel ca. 1900 Previous District Status: n/a DoE: C</p>

<p>Site 117 faces south toward A Street, east of Howard. It is a narrow, two-story, gable-oriented, frame dwelling. It features a single-story, gable-roof extension on the northeast corner, and a small, single-story, gable-roof portion built of rusticated concrete blocks on the far rear. According to the Sanborn maps, both these sections were original to the dwelling. A single-story, hip-roof porch spans the width of the façade, and exhibits small wood support posts and visible rafter tails. The dwelling is covered in vinyl siding, and features vinyl windows. The extension on the northeast corner is covered in asbestos shingles and features a separate entry. A small, gambrel roof, prefabricated shed is found at the rear.</p>
<p>Site #: 118 716 East A Street Owner: James Tunca 1939 Previous District Status: n/a DoE: NC</p>

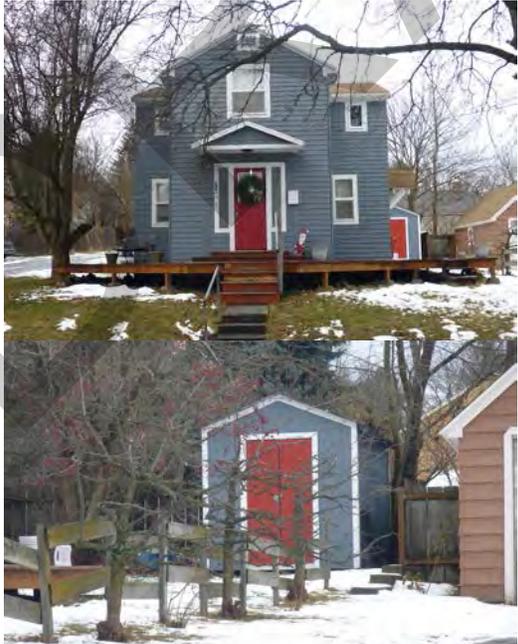
<p>Site 118 faces south toward A Street, west of Monroe. This is a two-story, T-shape, frame dwelling with a small, gable roof awning over the front entry, and another supported by brackets over a side door on the east elevation. A wooden deck surrounds the façade and front corners. A small, prefabricated shed is also associated with the site. According to historical Sanborn maps, the dwelling in this location was a square, single-story house with a small porch centered on the facade facing A Street. It appears the current dwelling is a replacement or modification of the original house.</p>

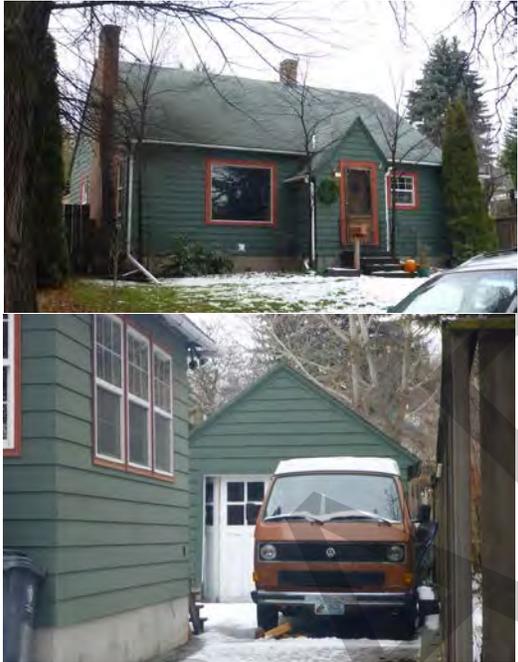
Survey Site Data	Site Photographs	Site Details
<p>Site #: 119 209 North Monroe Street Owner: James Randal Morasch 1938 Previous District Status: n/a DoE: C</p>

<p>Site 119 is oriented toward the east on Monroe Street, north of A Street. It is a side-gabled, single-story, frame, English Cottage style dwelling. It features horizontal board siding, and vinyl windows with simple wood surrounds. Typical of the style, it features an enclosed entry porch, with an asymmetrical, swooping roofline. The main entry contains a door with an arched detail in it, behind a wooden screen door. A small, single-story, hip-roof extension is found on the north elevation. An exterior, shouldered brick chimney is located on the south elevation, while another brick stack pierces the roof toward the north end of the house. A small, frame, gable roof, single-car garage is located northwest of the dwelling.</p>

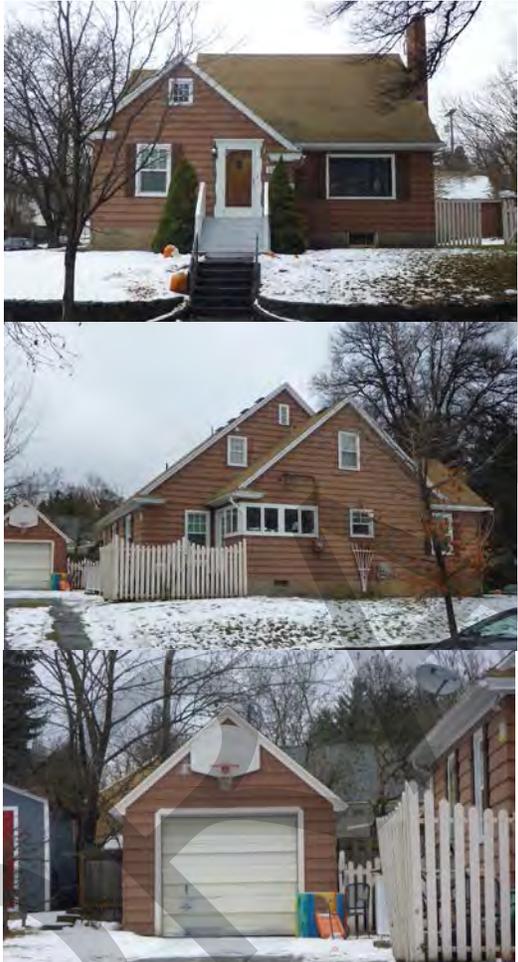
Survey Site Data	Site Photographs	Site Details
<p>Site #: 120 205 North Monroe Street Owner: Jennifer Johnson Leung 1938 Previous District Status: n/a DoE: C</p>

<p>The photographs show a one-and-a-half-story house with brown siding and a gable roof. The front view shows a white door with a wood surround and a small porch. The side view shows a brick chimney and a white picket fence. The garage view shows a white garage door and a white picket fence.</p>	<p>Site 120 is located on the northwest corner of Monroe and A Streets. It is a one-and-one-half-story, gable-roof, frame dwelling with a forward-facing, gable-roof extension on the southeast corner and a gable-roof portion, slightly shorter than the main roofline, on the south elevation. The dwelling is covered in wide wood boards or a composite siding, and features vinyl windows – some with nonhistoric, wood shutters. Three-light, wood-sash basement windows can be seen within the concrete foundation level. An exterior brick chimney, with one shoulder, is found on the north side. The main entry features a wood surround decorated with quoins and crown molding. Cornice returns are also found on the dwelling. A small, frame, gable roof, single-car garage is found to the rear.</p>

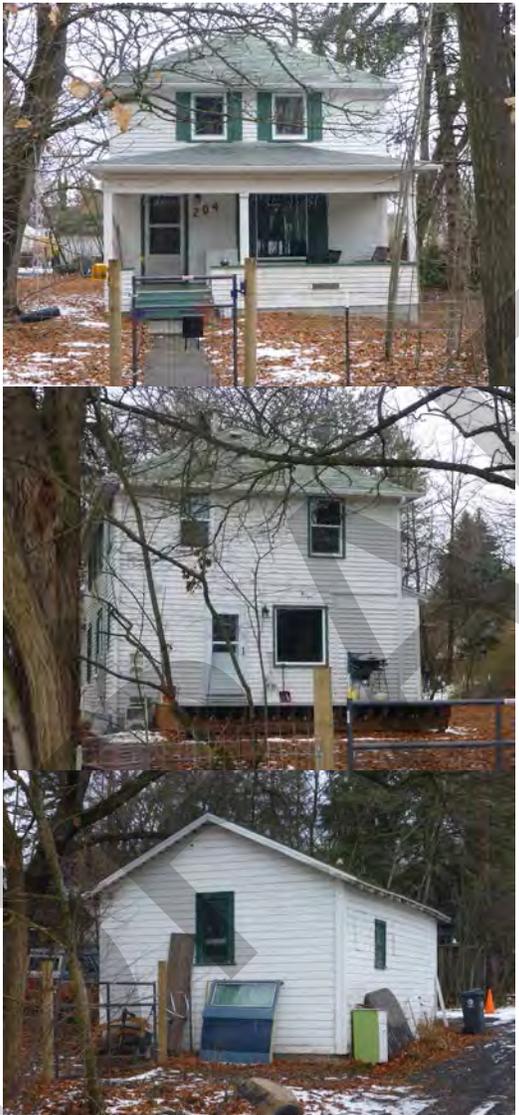
<p>Site 121 is located on the northeast corner of A and Monroe Streets. It is a two-story, hip roof, two-bay (d/w), frame dwelling with a full-width, hip-roof front entry porch. It features weatherboard siding and vinyl windows. The front porch is set on square posts. Nonhistoric wood shutters flank the windows, some of which exhibit crown molding above. A small, gable roof, frame garage is found to the rear. The garage appears to date to the 1930s or 1940s, and features horizontal board siding, visible rafter tails, and simple wood window surrounds. This house is set on a large, heavily wooded lot.</p>

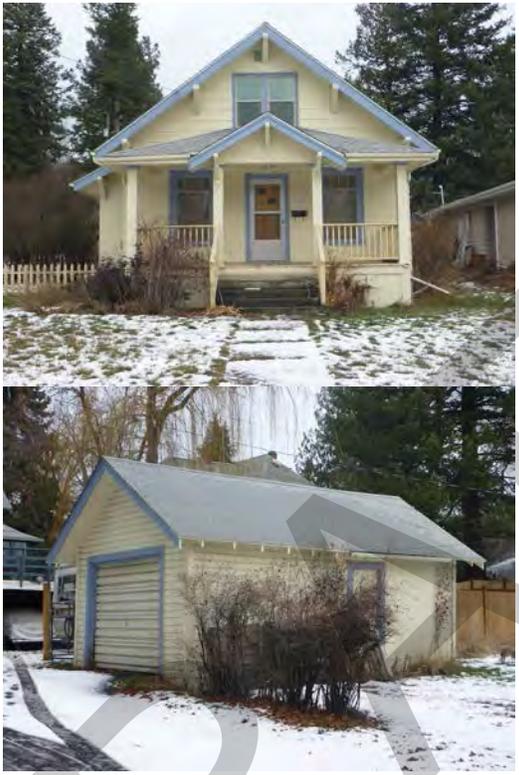
<p>Site 122 faces south toward A Street, west of Lincoln. It is a one-and-one-half-story, gable-oriented, frame Bungalow. It features a gable-on-hip front porch spanning the façade, and a shed roof extension on the west elevation following the dwelling’s original footprint. The house is covered in composite or hardiboard siding, and retains large brackets. Wood windows remain, some with wood storms. They exhibit simple wood surrounds. The house is set on a parged foundation. A gable-roof, single-car garage is found to the rear. It features both horizontal boards, and drop-wood siding, as well as visible rafter tails, and a nonhistoric, overhead door.</p>
<p>Site #: 123 207 North Lincoln Street Owner: Luke Sheneman 1949 Previous District Status: n/a DoE: NC</p>

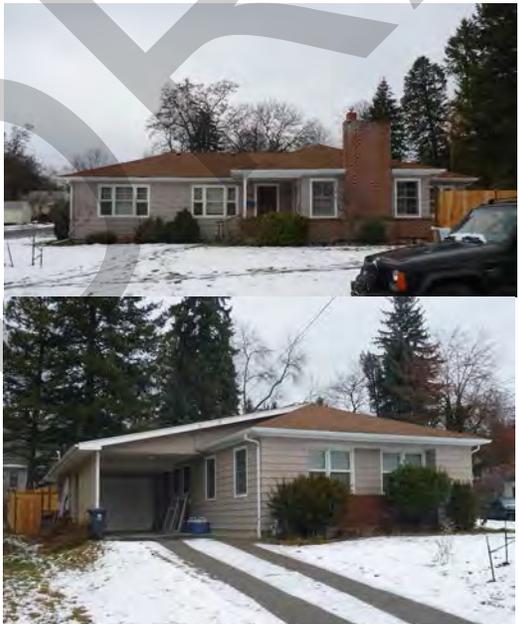
<p>Site 123 is on the northwest corner of Lincoln and A Streets, facing east. It is a single-story, cross-hip-roof dwelling. A front porch is recessed beneath the corner of a hip roof extension on the façade elevation. The house is covered in wood or composite siding, with brick covering the lower portion of the forward extension, which also features a wide, exterior brick chimney. The windows are vinyl. Two paired windows are found recessed from the primary wall plane on the south elevation; the bottom portion of this wall is also clad in brick. A single-car garage is attached to the rear of the dwelling, and is accessible through a carport covered by a shed roof extension added over the dwelling’s original roof.</p>

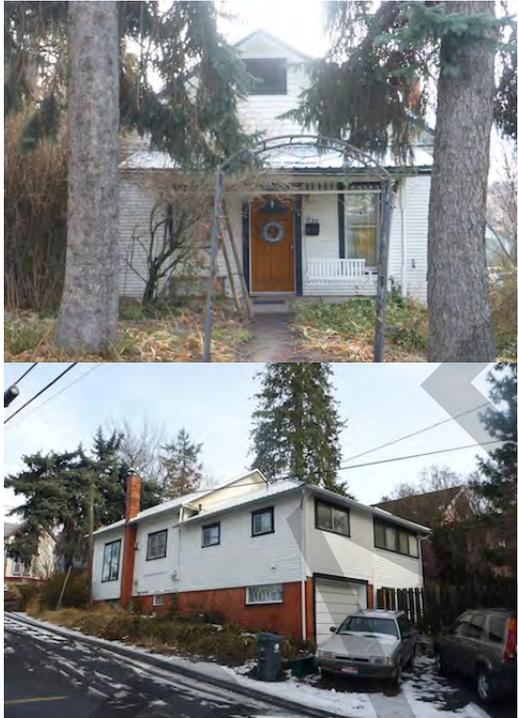
Survey Site Data	Site Photographs	Site Details
<p>Site #: 124 215 East A Street Owner: Hilary Lane ca. 1900 Previous District Status: C, 8 DoE: C</p>

<p>Site 124 is a one-and-one-half-story, gable-oriented, simple Bungalow with a partial-width front porch and a hip-roof addition on the rear as large in size as the main dwelling, which was added between the 1904 and 1928. The southeast corner is L-shaped, wrapping around the rear addition, which extends at the southwest, rear corner. A single-car, basement level garage is found on the southwest corner. The main dwelling and rear addition are set on brick foundations and are covered in clapboards, while the L-shaped section on the southeast corner exhibits a basement level covered in a slightly wider wood siding. Wood-sash windows and metal windows are found on the dwelling. The main entry porch features a shed roof with turned posts at the corners, and large, arched braces. A straight, exterior brick chimney is found on the west elevation.</p>

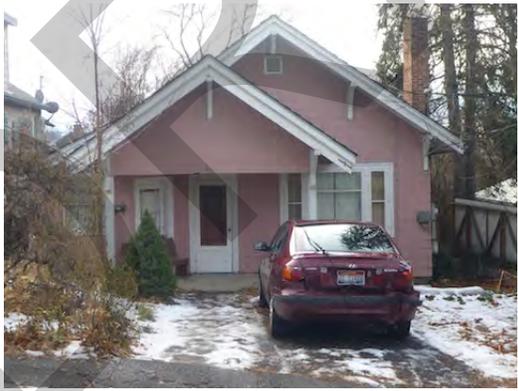
<p>Site #: 125 221 East A Street Owner: Bryan Brooks 1910 Previous District Status: C, 7 DoE: C</p>

<p>This is a single-story, gable-oriented, frame dwelling. It features a gable-roof entry porch off-centered on the façade, which has an enclosed gable over the porch. A small, shed-roof addition is found on the northeast corner. The dwelling features multi-light, wood-sash windows and an exterior brick chimney on the west elevation. Brackets are found on the gable ends, and the exterior walls are covered in asbestos shingles. The roof is covered in wood shingles.</p>

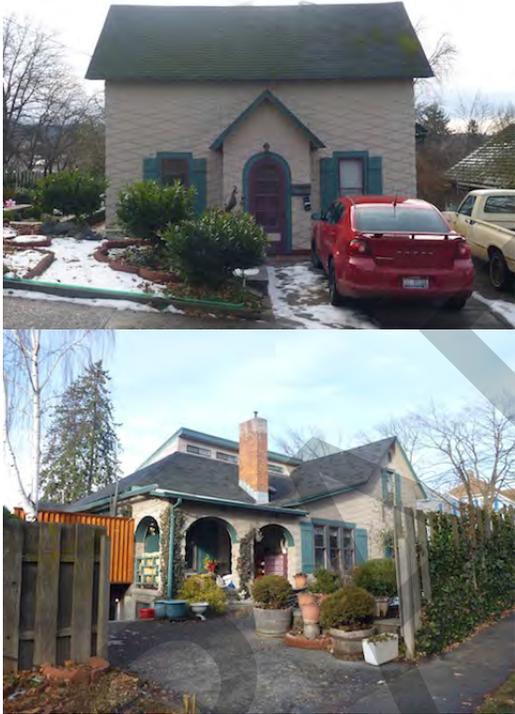
Survey Site Data	Site Photographs	Site Details
<p>Site #: 126 225-227 East A Street Owner: Larry Martin ca. 1900 Previous District Status: C, 6 DoE: C</p>

<p>This is a one-and-one-half-story, side gable, frame dwelling with a single-story, shed-roof extension across the rear and an original ell extending to the rear. The rear extension has been added onto along its east side with a shed roof, open porch accessible via two large, arched openings. The rear ell also has a second-story addition appearing as a dormer on the north side, creating a row of clerestory windows visible on the east side. A single-story, gable-roof, enclosed entry porch has been added on the façade. The dwelling features nonhistoric shutters, an arched doorway in the front porch, one-over-one, wood-sash windows as well as nonhistoric windows contained in the addition, and a brick chimney piercing the roof over the porch addition on the rear. The dwelling is covered in unique, multi-sized wood shingles creating a geometric pattern on its outside walls. A nonhistoric, shed-roof outbuilding is situated rear of the dwelling.</p>

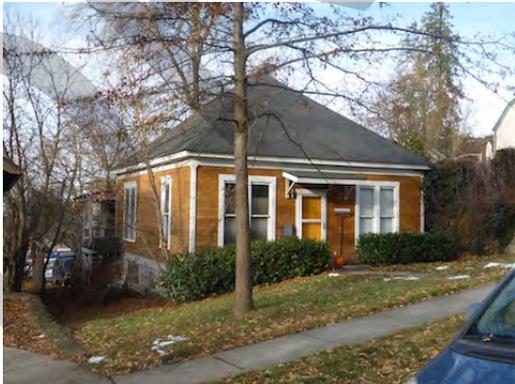
<p>Site #: 127 113 North Jefferson Street Owner: Phillip Mead 1912 Previous District Status: C, 4 DoE: C</p>

<p>This is a single-story, three-bay (ww/d/ww), hip-roof dwelling, oriented east on North Jefferson Street. It has a small, shed roof awning over the main entry, and an original, partial-width, enclosed porch on the rear. The dwelling contains one-over-one, double-hung, wood-sash windows with simple wood surrounds – some with crown molding, narrow wood siding, corner boards with simple capitals, and a simple wood cornice. The foundation level is covered in wider, lap siding. A small, brick chimney pierces the roof near the central ridgeline.</p>

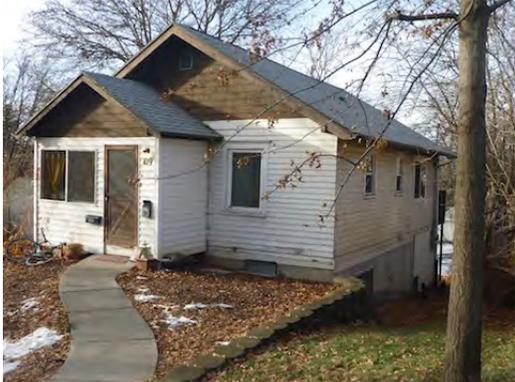
Survey Site Data	Site Photographs	Site Details
<p>Site #: 128 109 North Jefferson Street Owner: Andrea Masom 1920 Previous District Status: n/a (within original district boundaries, but not included in inventory) DoE: NC</p>

<p>This is a single-story, gable-oriented, frame dwelling with an enclosed, gable-roof porch off-centered on the façade elevation and a small, gable-roof bay on the south elevation. Originally, this dwelling featured a full-width porch across the façade and an extension to the north creating an L-shaped footprint; neither feature remains today. The residence is covered in clapboard siding, with shingles filling the peaks of the gables. It rests on a concrete or parged basement foundation, covered with some vinyl siding at the west end. A rear deck is found on the west.</p>

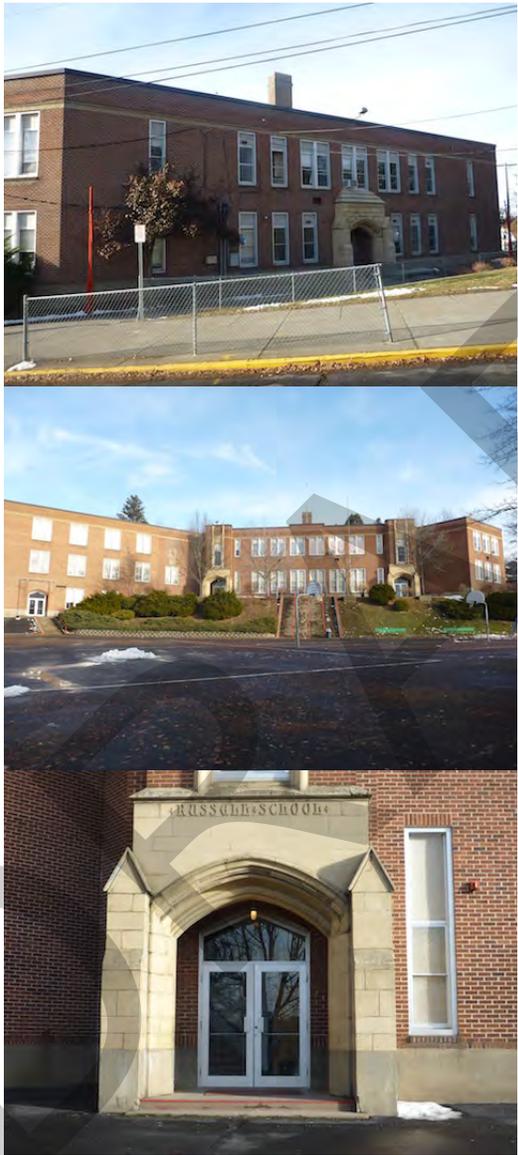
Survey Site Data	Site Photographs	Site Details
<p>Site #: 129 119 North Adams Street Owner: City of Moscow 1928 Previous District Status: C, 5 DoE: C</p>

<p>This is the John Russell Elementary School, or the Russell School. The original portion of the building is a rectangular central block, flanked by small wings. The building is situated diagonally crossing the northeast corner at the corner of Adams and A Street. A rectangular wing was added at the west end of the building parallel to A Street between 1928 and 1962. The building features a raked brick veneer, and a poured-concrete foundation. It exhibits elements of the Collegiate Gothic style, including cast stone surrounds around the entries, with pilasters exhibiting peaked stones at the top, and Gothic arches over both the cast stone and brick entries. The building has soldier course brick lintels and sills. A soldier course of blonde bricks runs above the second-story windows. The windows throughout have been replaced with metal sashes, with the top of the window openings being filled in. The addition exhibits features similar to the original, except that the veneer is laid in a six-row common bond. The building's doors have been replaced with metal frame doors, retaining the peaked transom windows. A large, brick chimney extends over the center of the roof in the center of the original building. The roofline is capped in metal. A nonhistoric, single-story, prefabricated portable building is located west of the building. Two doors on the east side are accessible via a wooden stairway and ramp.</p>

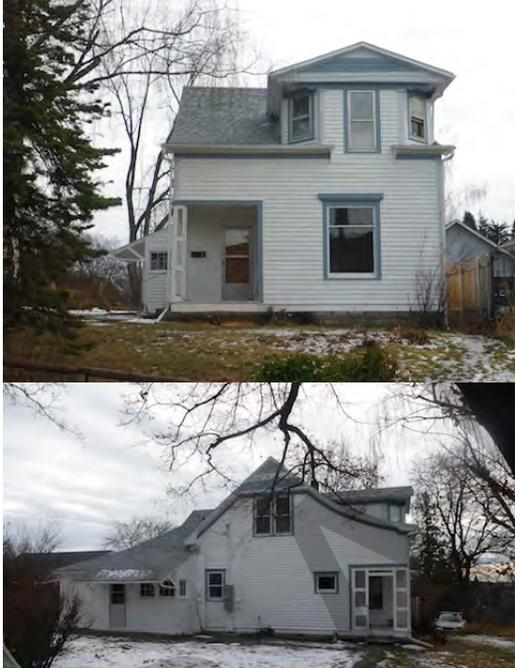
Survey Site Data	Site Photographs	Site Details
<p>Site #: 130 403 East A Street Owner: Merritt Decker ca. 1900 Previous District Status: NC (compatible), 93 DoE: C</p>

<p>Site 130 is oriented west on the southeast corner of A and Adams Streets. It is a one-and-one-half-story, side-gable, frame dwelling. It features a prominent gable roof bay with chamfered corners that was added later at the southwest corner. A porch recessed beneath an extension of the main roof on the northwest corner and a large hip-roof addition on the rear behind the original rear porch were both added during the same period. A shed roof extension shelters a rear entry on the south side. Wood-sash windows covered with are found on the dwelling. The residence is covered in clapboard siding and features fish scale and square shingles in the peaks of the gables, as well as pilasters on the gabled bay. An early twentieth-century, frame, gable-roof, single-car garage is behind the dwelling.</p>

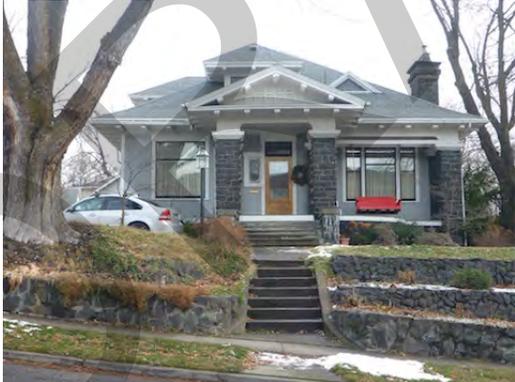
<p>Site #: 131 120 North Adams Street Owner: Patricia Ann Bowen 1908 Previous District Status: C, 94 DoE: C</p>

<p>This is a one-and-one-half-story, hip-roof Bungalow. It features an open entry porch centered on the façade, supported by basalt rock piers supporting a pedimented roof filled with lattice-like detailing and modillions above. The porch extends along the east end of the façade, with a basalt pier at the east end. The main entry contains a single-light, wood door with a transom, and a small stained-glass window next to the door. Stone pilasters flank the entry. A hip-roof dormer and small triangular window are found above the façade. One-over-one, double-hung, wood-sash windows remain throughout. A large basalt stone chimney extends on the south elevation. The dwelling is covered in narrow, clapboard siding and exhibits modillions throughout. Another hip-roof dormer and additional chimney are found above the north elevation. A frame, gable-roof, two-car garage is found at the northeast corner.</p>

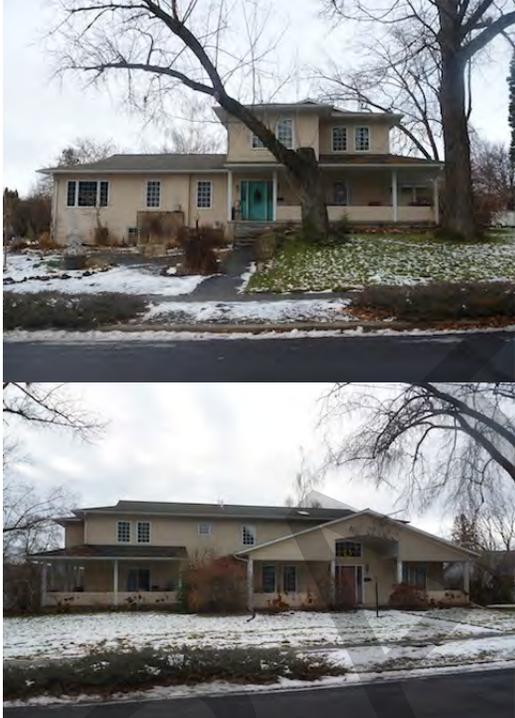
Survey Site Data	Site Photographs	Site Details
<p>Site #: 132 133 North VanBuren Street & 415 East A Street Owner: Robert Shepard 1994 Previous District Status: NC (compatible), 92 DoE: NC</p>

<p>Site 32 is located on the southwest corner of A and VanBuren Streets. It is an asymmetrical, eclectic, multi-unit, multi-height dwelling with a number of separate sections and additions. A single-story, gable-on-hip roof section extends to the south, a long, two-story, gable-on-hip section runs east-west along the north side and a single-story section with a broad gable roof is found on the northwest side. A single-story porch wraps around the northeast corner. The house exhibits all modern materials. A gable-roof outbuilding or garage is found west of the dwelling. It is covered in vertical metal panels and wide, horizontal wood boards.</p>

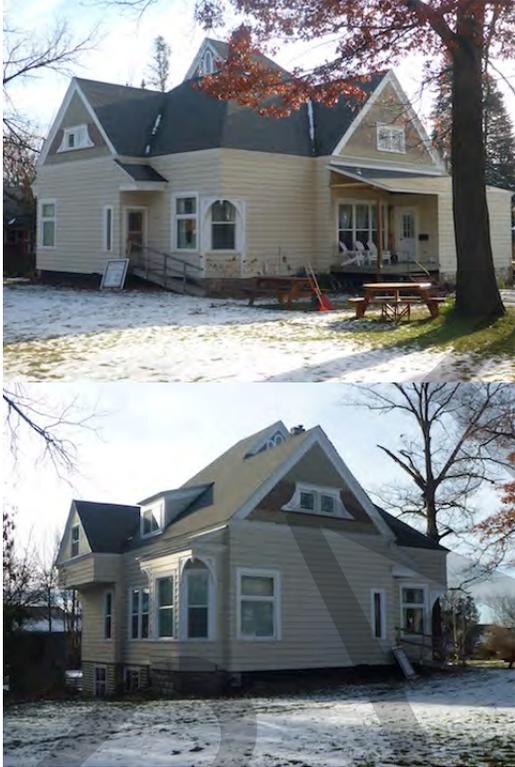
<p>Site 133 is located on the southeast corner of A and Van Buren. This is the “old Spotswood House” and is a single-story, Queen Anne dwelling. The center portion of the house features a gable-on-hip roof, with gabled extensions on the façade and both side elevations, and a three-sided bay on the northeast corner. An enclosed porch spans the rear and wraps around the southwest corner. The northwest corner is chamfered, with decorative brackets exhibiting a floral motif and a pendant that match those found on the bay. According to Sanborn maps, this footprint is original – though a front porch has been removed and a ramp has been added up to the doorway. A roof covering the west side entry has also been added. Two shed-roof dormers are found above the rear elevation. The dwelling sits on brick piers, with rusticated concrete blocks filling the spaces between the piers. Diamond and scalloped shingles are found in the gable ends, and the windows are vinyl except for two leaded glass windows on the façade.</p>

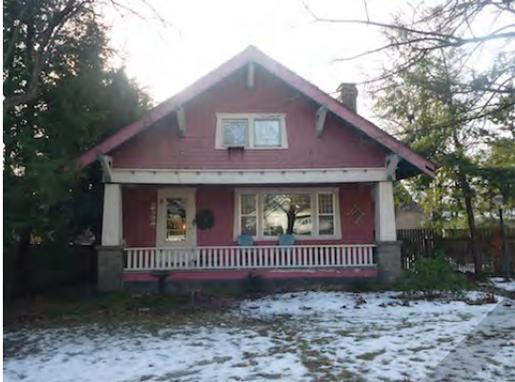
Survey Site Data	Site Photographs	Site Details
<p>Site #: 134 515 East A Street Owner: Richard Gomulkiewicz 1911 Previous District Status: C, 87 DoE: C</p>

<p>Site 134 faces north toward A Street, east of Van Buren. It is a one-and-one-half-story, gable-oriented Bungalow. It features a full-width porch recessed beneath the upper level. The porch is set on flared posts at the corners, on top of stone piers. The porch and dwelling foundation are stone blocks. The door and window trims are flared. The dwelling exhibits weatherboard siding, rafter tails, wood shingles in the gable end, large brackets, and multi-light, wood-sash windows. The bargeboards have notched ends. An exterior brick chimney extends up at the northwest corner near a shed-roof dormer over the west elevation. An addition is found on the rear, southwest corner. The addition is set back from the street, is subordinate to the original dwelling, and is largely blocked by vegetation. A nonhistoric, frame, gable-roof playhouse elevated up from the ground is found in the yard.</p>

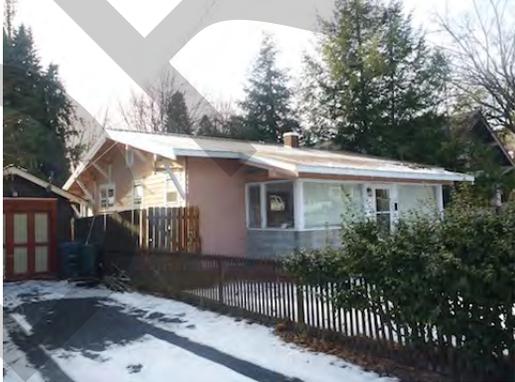
<p>Site #: 135 517 East A Street Owner: Properties & Development, Inc. 1913 Previous District Status: NC (intrusion), 86 DoE: NC</p>

<p>Site 35 is a dwelling located near the corner of A and Van Buren Streets and is a small, square plan, single-story, side-gabled, frame house. It has an enclosed porch spanning nearly the full-width of the façade, which is covered by a shed-roof extension of the main roofline. The front porch features concrete block below, and wood-framed windows above. The house is covered in wood shingles, and retains wood-sash windows. A brick chimney pierces the center of the roof. Large brackets are found on the side elevations.</p>

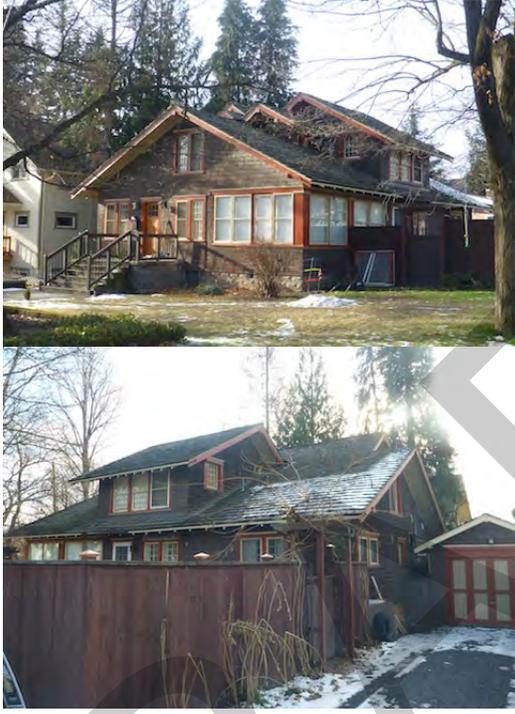
Survey Site Data	Site Photographs	Site Details
<p>Site #: 136 121 North Polk Street Owner: John Sullivan 1914 Previous District Status: C, 83 DoE: C</p>

<p>Site 136 is set on the southwest corner of A and Polk facing east. It is a one-and-one-half-story, gable-roof Bungalow with several additional gable-roof dormers extending up from the roof. It is set on a foundation of rusticated concrete blocks, and features wood shingle siding, visible rafter tails, and notched bargeboards. Multi-light, wood-sash windows remain – exhibiting very small, square divisions in the glass. A small porch at the front entry no longer remains; the entry is now accessible via a larger staircase with no shelter overhead. An exterior, shouldered, brick chimney is found on the south elevation extending up along the front corner of one of the roof extensions. The original, small, gable-roof, frame garage is found behind the dwelling. It features shingle siding and original, multi-section wood doors.</p>

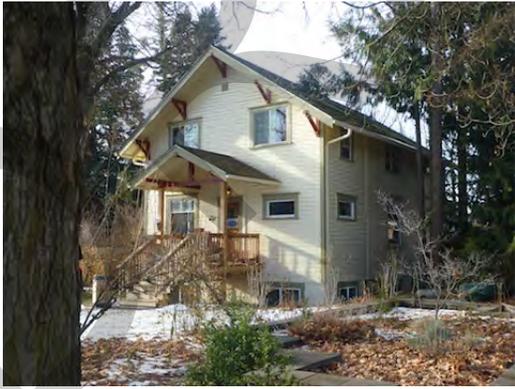
<p>Site #: 137 115 North Polk Street Owner: Andriette Pieron 1915 Previous District Status: C, 112 DoE: C</p>

<p>Site 137 faces east toward Polk Street, south of A Street. It is a two-story, gable-oriented, frame dwelling with a small, gable-roof porch centered on the façade. The dwelling retains drop wood siding, large brackets, and simple wood window trims with crown molding. Basement level windows have been added, and the foundation has either been redone or parged. A basement entryway has been added on the south elevation. A nearly full-width, enclosed rear porch remains, though an upper level deck has been added over it. A small, gable-roof, frame outbuilding with materials similar to the main house is found in the southwest corner of the property.</p>

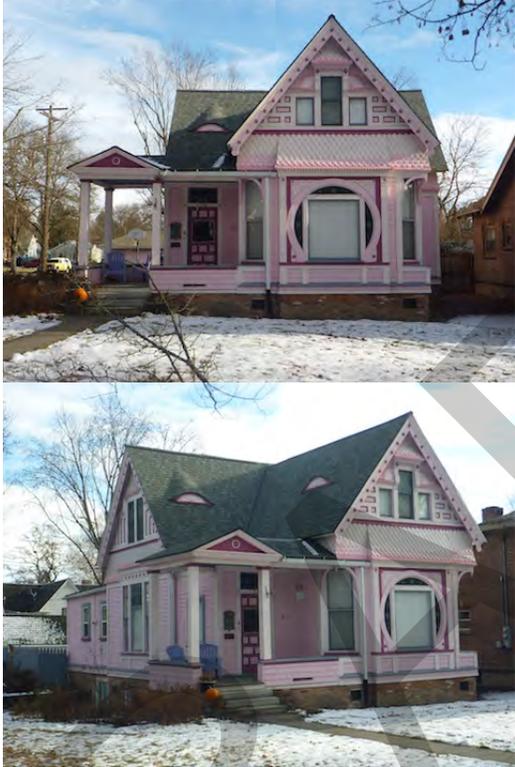
Survey Site Data	Site Photographs	Site Details
<p>Site #: 138 124 North Polk Street Owner: Patrick Carter 1892 Previous District Status: C, 82 DoE: C</p>

<p>This is a cross-gabled, one-and-one-half-story, Queen Anne dwelling. It exhibits an asymmetrical form, extensive ornamentation including diamond-shaped and scalloped imbrication, recessed panels, and rosettes. The forward gable features chamfered corners with brackets above, and a semi-circular window trim with small stained-glass windows filling in the curves. Four eyebrow dormers with sunburst designs are found on the house. A porch at the northwest corner has square posts, a shingled apron, and a small gable-roof over the entry stairs. A hip-roof, enclosed porch wraps around the rear, northeast corner. The dwelling is clad in weatherboard, and features both vinyl and wood-sash windows. A three-part window is found on the gable extension on the north elevation. The house rests on a brick foundation, with a daylight basement visible on the north elevation. A small, original, hip-roof, frame, single-car garage is found at the rear of the property. It features drop-wood siding and hinged wooden doors. A prefabricated, gambrel-roof shed sits up against the back wall.</p>
