National Register of Historic Places Registration Form

Historic name: Fort Russell Neighborhood Historic District (Boundary Increase and Additional Documentation)

Street & number: Roughly bounded by Jefferson Street on the west, East D Street on the north, Hayes Street on the east, and East Third Street on the south

City or town: Moscow State: ID County: Latah

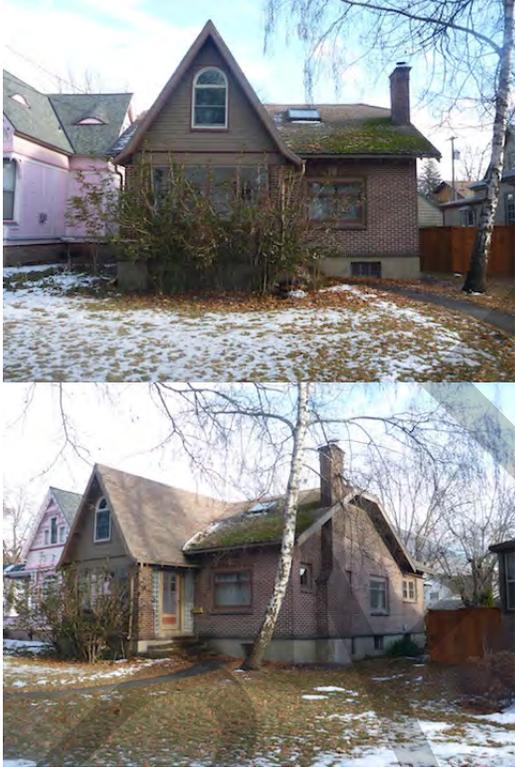
Survey Site Data	Site Photographs	Site Details
<p>Site #: 139 120 North Polk Street Owner: SW4 LLC 1926 Previous District Status: C, 111 DoE: C</p>

<p>This is a one-and-one-half-story, Bungalow exhibiting a brick exterior. A large, gable-roof, enclosed entry porch extends from the north end of the façade and features brick posts at the corners, with multi-light, wood-sash windows on the north and east elevations. A multi-light, wood entry door is found on the south side of the porch, flanked by glass-block sidelights. The dwelling is set on a concrete or parged foundation with a brick water table above. Wood-sash windows remain and exhibit brick sills and jack arches with keystones. The forward facing gable is covered in wood shingles, with both scalloped and saw-tooth imbrication around an arched vinyl window. The roof over the main dwelling exhibits clipped gables. An exterior, shouldered brick chimney is found on the south elevation, and a partial-width, enclosed, hip-roof porch is off-centered on the rear. A gable-roof, frame, single-car garage is at the rear of the property. It features wood shingles, multi-light, wood-sash windows, visible rafter tails, and paneled wooden doors.</p>

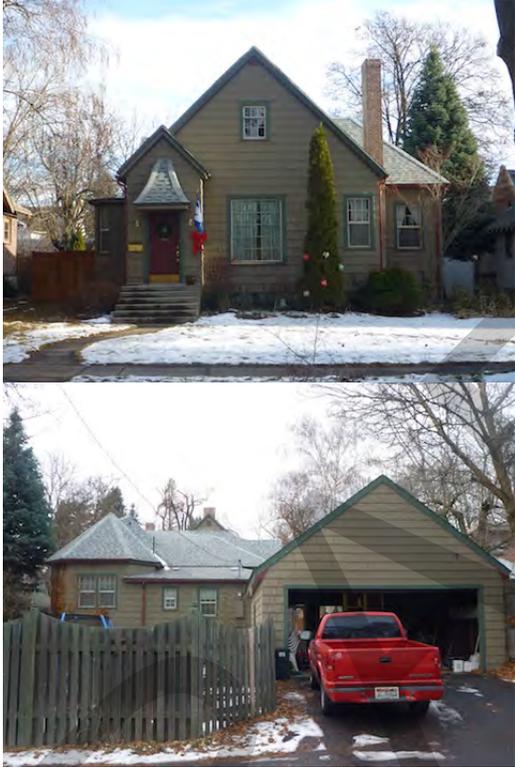
<p>Site 140 is located mid-block facing Polk, between A and First Streets. It is an asymmetrical frame dwelling featuring a single-story, hip-roof portion in the center, a one-and-one-half-story, forward facing, gable-roof section, and a small, enclosed gable roof porch off-centered on the façade. A single-story, three-sided bay window extends on the north elevation. A small gable-roof dormer is found over the north side. On the rear, a partial-width, hip-roof, enclosed porch and a single-story turret on the southeast corner. A three-over-six, wood-sash window remains in the front gable, however, the other windows on the dwelling have been replaced with vinyl. The dwelling rests on a parged stone foundation and is clad in wood shingles. A small, bell-cast roof shelters the main entry. An exterior brick chimney is found on the south elevation. A large, two-car, frame garage exhibiting similar materials and characteristics as the house is found to the rear.</p>

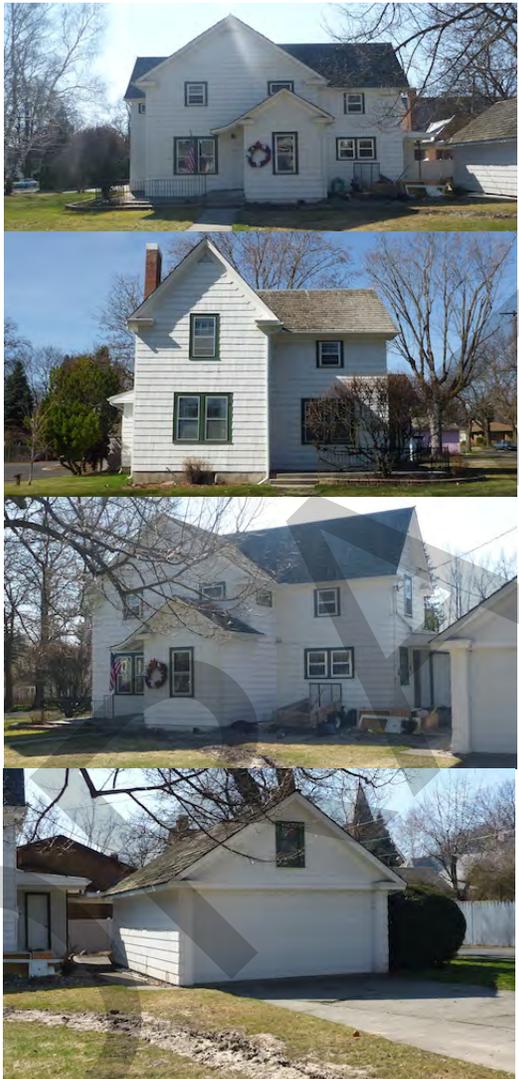
Survey Site Data	Site Photographs	Site Details
<p>Site #: 141 621 East A Street Owner: Catholic Church ca. 1900 Previous District Status: n/a DoE: C</p>

<p>This is a two-story, cross-gable dwelling. A front-gable section featuring paired window with six-over-six-light, double-hung, wood sash windows projects from the side-gable section near its east elevation. It features a wide cornice and cornice returns with a small, triangular vent at the top. A concrete deck with a partially enclosed metal railing spans the width of the façade of the side-gable portion of the dwelling and wraps around to a one-story, gable-roof projection on its east elevation. It features cornice returns on the gable end and an elongated, slightly curved roof overhang sheltering the main entry. Individual and paired windows with multi-light, double-hung, wood sashes are found throughout. A one-story, partially enclosed shed-roof porch addition is found on the west side. A concrete and brick chimney pierces the roof slope of the east elevation of the front-gable portion of the dwelling. The roof is sheathed in wood shingles and features wide overhang and cornice returns on the gable ends. The exterior walls of the dwelling are clad in wood shingles and the house rests on a poured concrete foundation. A one-bay, gable-oriented garage featuring a wood shake roof with a wide cornice and cornice returns is found just to the rear of the dwelling.</p>

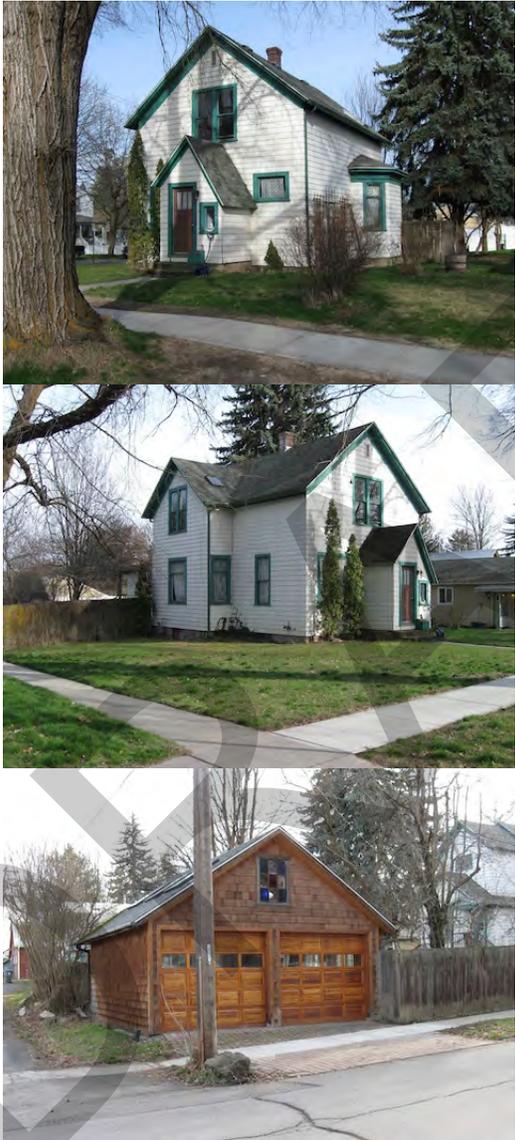
Survey Site Data	Site Photographs	Site Details
<p>Site #: 142 124 North Howard Street Owner: Monique Lillard ca. 1900 Previous District Status: n/a DoE: C</p>

<p>The photographs show the house from three different angles: a side view from the street, a front view, and a view of the wooden garage with two roll-up doors.</p>	<p>This is a, one-and-one-half story, cross-gable dwelling with an overall rectangular plan that is oriented west facing North Howard Street. The façade features a pair of one-over-one, double-hung, wood-sash windows in the gable end above an asymmetrical, Tudor style entry vestibule that has varied eave heights. A Bungalow style wood door and a small, low window is found within the porch, which replaces an original porch in this same location. The crossing gable on the north elevation contains original wood-sash windows and a skylight. The south elevation features a three-sided bay window with wood-sash windows. Also found at this site, is a contemporary, gable front, two-car garage that faces north. The garage features stained wood shingle siding, composition shingle roof, skylights, a multi-paned colored glass window in the peak and two wood roll-up garage doors.</p>

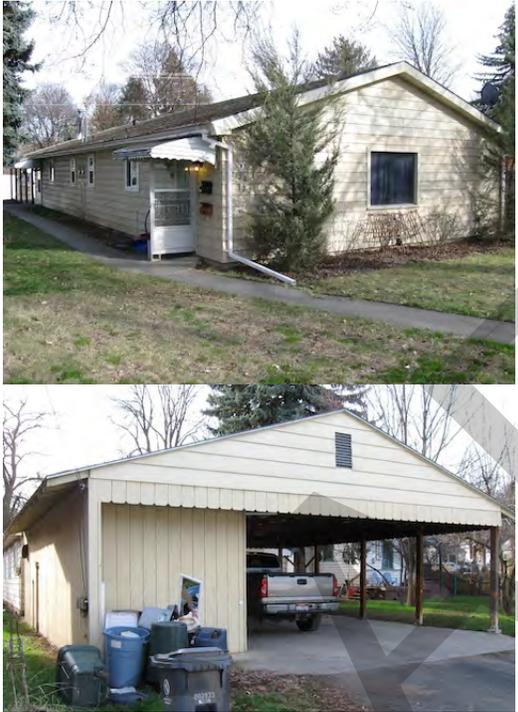
Survey Site Data	Site Photographs	Site Details
<p>Site #: 143 120-122 North Howard Street Owner: Monique Lillard 1967 Previous District Status: n/a DoE: NC</p>

<p>The top photograph shows a one-story duplex house with light-colored siding and a gable roof. The bottom photograph shows a large, open-sided carport with a gable roof and sheet siding, with a truck parked underneath.</p>	<p>Site 143 is a one-story, gable front duplex with a rectangular plan. The façade features a single, aluminum-sash, picture window. The entry doors to the two units are located on the north elevation under metal awnings. Windows punctuate the south elevation. Windows are a combination of vinyl and metal sash, the roof is composition shingle and the exterior sheathing is wide composite clapboard. To the rear of the dwelling is a wide, gable front carport. The carport has T1-11 sheet siding, a composition shingle roof and storage units along the interior of the south wall of the structure.</p>

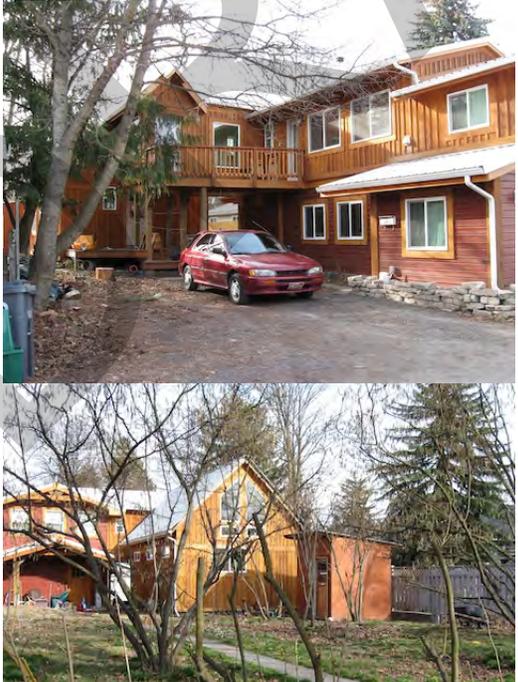
<p>Site #: 144 116 North Howard Street Owner: Tyler Stone 1950 Previous District Status: n/a DoE: NC</p>

<p>The top photograph shows a large, multi-story wooden house with a complex roofline, including gables and a porch. A red car is parked in the driveway. The bottom photograph shows a smaller, shed-roofed structure with plywood walls and a metal roof, situated in a yard with trees.</p>	<p>This is a contemporary, one-and-one-half story dwelling with numerous roof styles and an irregular plan. The building is oriented towards the west facing North Howard Street deeply set on its lot. The façade features two, front-facing gables with differing roof pitches. The entry is under a low-pitched, gable-front, full-width porch set atop large square posts. There are post-and-beam style details in some of the gable ends. The walls are clad in a combination of board-and-batten and wood clapboards. The roofing is metal and the windows are vinyl. At the rear of the dwelling is a secondary entrance under a second story deck. Also located at this site at the front of the lot is a shed-roofed shed with plywood walls, metal roofing and an entry door.</p>

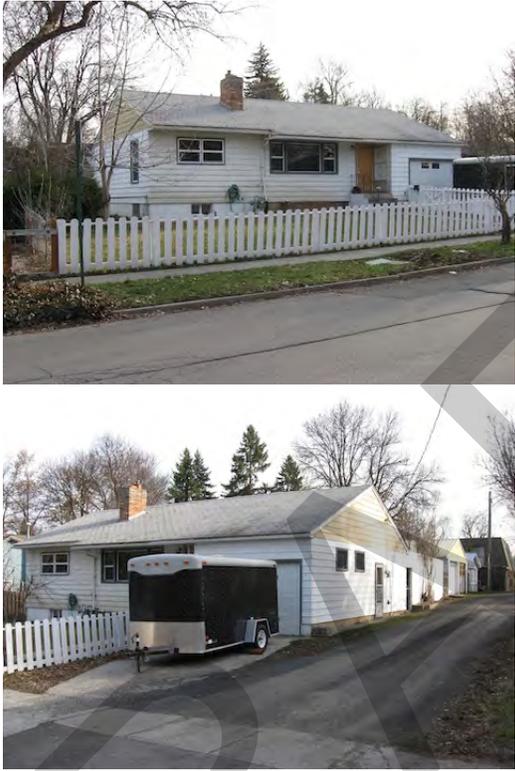
Survey Site Data	Site Photographs	Site Details
<p>Site #: 145 717 East A Street Owner: Ethan Atwood 1956 Previous District Status: n/a DoE: NC</p>

<p>Site 145 is a one-story, side gable, early Ranch style dwelling with a basement and an L-shaped plan. The asymmetrical façade features an off-center entry containing a solid-core, flush, wood door. East of the door is a wide, triple window and a paired set of windows. To the west of the door is a single-car garage that projects slightly from the plane of the house. A brick chimney pierces the north slope of the roof. The west façade features two, small, high windows and a secondary entry door in the garage wall. To the rear is a flat-roofed addition. The building is wrapped in aluminum siding, and both vinyl and metal windows are found on the dwelling. The roofing is composition shingle and the foundation is concrete. At the alley to the rear of the dwelling is a front gable, two-car garage with metal roofing, metal siding, one metal roll-up door, and one wood roll-up door with glazing.</p>

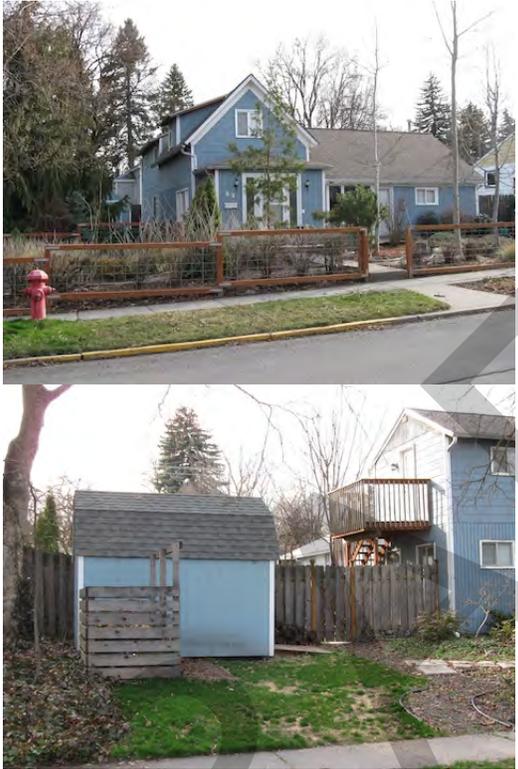
Survey Site Data	Site Photographs	Site Details
<p>Site #: 146 723 East A Street Owner: Tyler Wright Kee ca. 1900 Previous District Status: n/a DoE: NC</p>

<p>Site 146 is an altered, one-and-one-half story, gable-front-and-wing dwelling with a two story addition at the rear. The residence is located on the southwest corner of East A Street and North Monroe Street, facing north towards East A Street. The façade features an enclosed, filled-in entry porch under a hip roof on the front facing gable, with a fiberglass entry door with sunburst glazing and sidelights. A slider window is in the peak of the gable. Modern windows and a fiberglass door are located in the elongated and widened wing to the west. The east elevation features a shed-roof dormer with off-center slider window and the two-story addition at the rear of the gable. At the south elevation a second-story wood deck highlights the rear of the addition covered in both horizontal and vertical sheet siding. Roof is composition shingle. Also on this site is a small, gambrel-roofed, pre-fabricated shed with T1-11 siding and composition shingle roof.</p>

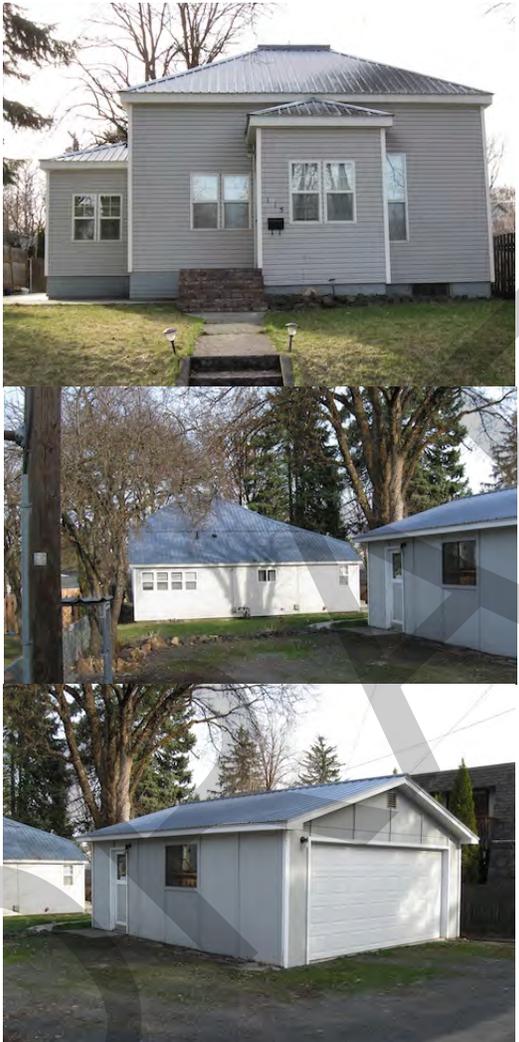
Survey Site Data	Site Photographs	Site Details
<p>Site #: 147 115 North Monroe Street Owner: Evan Holmes ca. 1900 Previous District Status: n/a DoE: NC</p>

<p>Site 147 is an altered, single-story, truncated-hip roof dwelling oriented east facing North Monroe Street. The façade features a central, enclosed entry vestibule under a hipped roof with the entry door in the south facing wall and a pair of windows in the east-facing wall. A pair of windows is located south of the entry and a single window to the north. The projection at the south elevation is hip roofed and features a pair of windows. At the rear of the house is an historic, full-width, shed-roofed extension that exhibits a number of windows. The house has been wrapped in vinyl siding, the roof is metal and all the windows are vinyl replacements. At the alley is a contemporary, two-car, gable front garage. It features plywood sheet-and-batten siding, a metal roof, metal slider windows, glazed, wood entry door, and a composite, roll-up garage door.</p>

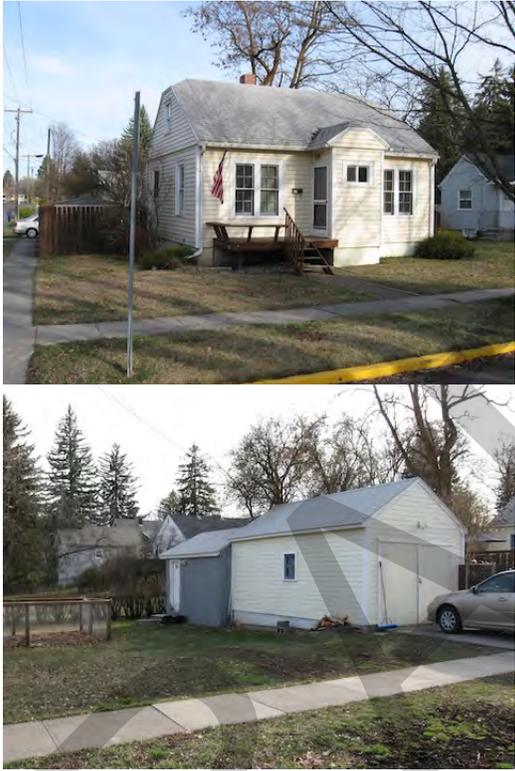
Survey Site Data	Site Photographs	Site Details
<p>Site #: 148 126 North Monroe Street Owner: Margaret Harlow 1937 Previous District Status: n/a DoE: NC</p>

<p>The top photograph shows the front of the cottage, featuring a clipped gable entry with a door and a window, and a small deck. The bottom photograph shows the side of the property, including a white garage with a gable roof and a sliding glass door.</p>	<p>This is a one-and-one-half-story, clipped-gable, cottage on the southeast corner of East A and North Monroe Streets. The façade features an enclosed, front-facing, clipped gable entry with the entry door in the north facing wall and a slider window in the west-facing wall. A wood deck is located north of the entry door. Paired windows flank the entry. Small windows are found in the peaks of the gable ends. At the east elevation is a contemporary wood deck and a shed-roof projection containing a sliding-glass door. A brick, interior chimney is found on the east slope of the roof. The building has vinyl siding, vinyl windows, composition shingle roof, and a concrete foundation. Also at this site is a gable-front, one-story garage with a pair of plywood swing-out doors, wood-sash windows, wood drop siding, and composition shingle roof. A small, metal-sided, gable-roof addition is found at the rear of the garage.</p>

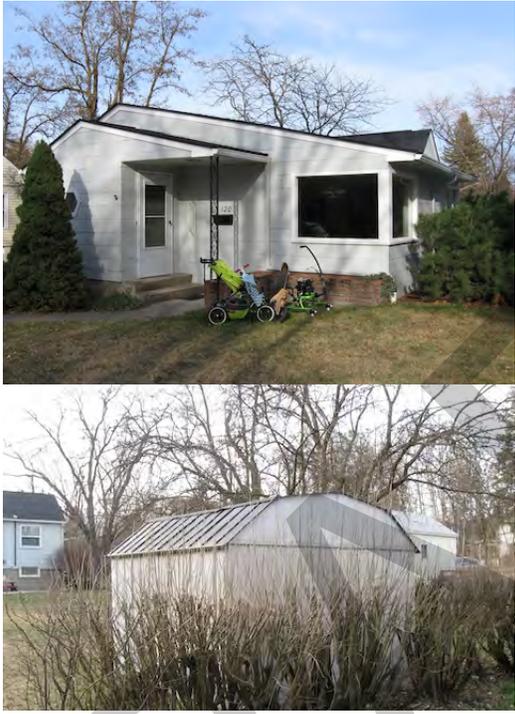
Survey Site Data	Site Photographs	Site Details
<p>Site #: 149 120 North Monroe Street Owner: Jacquelyn Rigg ca. 1940 Previous District Status: n/a DoE: NC</p>

<p>This is an altered, single-story, cross-gable dwelling, oriented west facing North Monroe Street. The façade features a secondary front gable with the roofline elongated to the south to shelter the entry door. A small, hexagonal window is nearly centered on the west-facing wall of the entry. In the main gable, which is also elongated towards the south, is a large corner window and one smaller window. A gable-front hood shelters a side entry door at the north elevation. The siding is wide composite clapboards, the roof composition shingle and the foundation is concrete block. At the rear of this site is a gambrel-roof, prefabricated metal shed.</p>

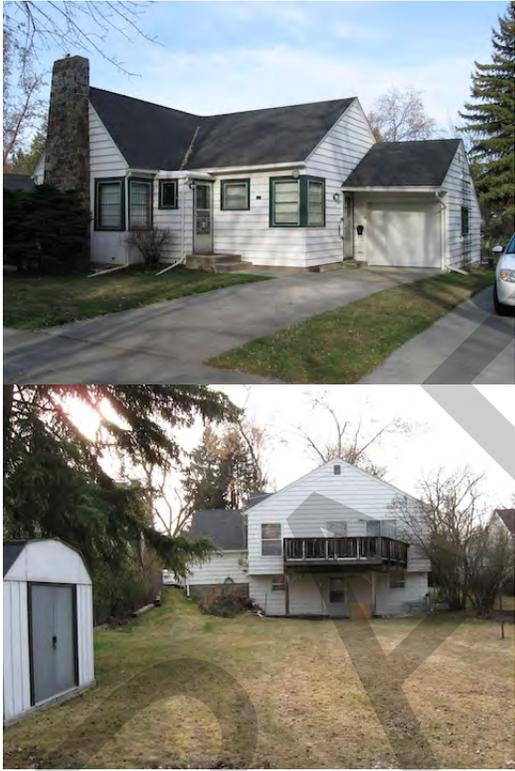
<p>Site 150 is a one-story, cross-gable-roof dwelling with a daylight basement and a small, gable-roof, single-car garage attached to the south side. A wide, gable-roof addition has been added to the rear. The façade features a small, flat-roofed, square, enclosed entry vestibule within the inside corner. The entry retains an original wood-sash window and entry door. Two wood-sash corner windows are found at each of the southwest corners of the house. A tapered, stone-veneered, exterior chimney is found centered on the front gable. The dwelling features wide wood clapboards, composition shingle roofing and a parged concrete foundation. At the east elevation, the addition features aluminum windows, narrow eaves, wide, composite, lap siding, a wood deck at the second level, and an entry door and two windows at the basement level. Also at this site is a gambrel-roof, pre-fabricated metal shed.</p>

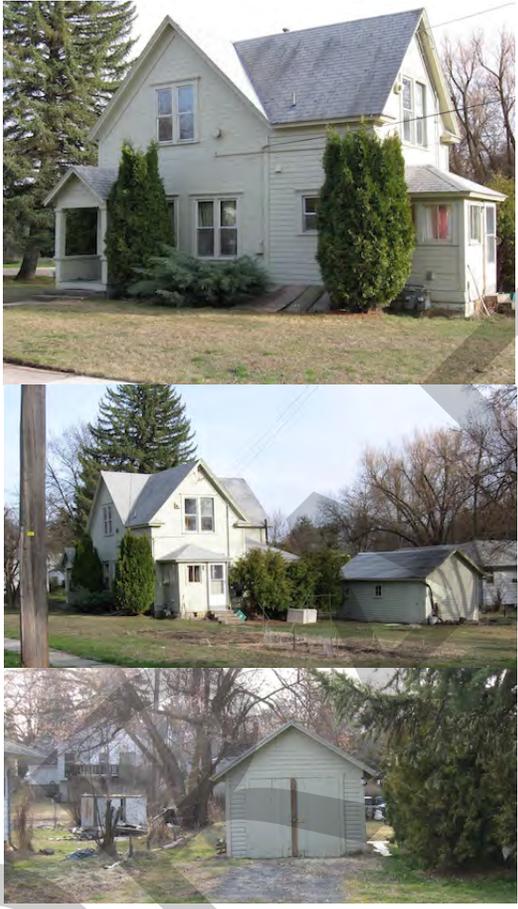
Survey Site Data	Site Photographs	Site Details
<p>Site #: 151 823 East A Street Owner: Timothy Daulton ca. 1900 Previous District Status: n/a DoE: C</p>

<p>This is a one-and-one-half story, cross-gabled, Vernacular dwelling oriented north facing East A Street. The façade features a gable-front entry porch supported by square, trimmed posts on closed porch rails with a single-glazed, horizontal panel, wood door. To the west of the entry are two pairs of windows, and a single window. Window surrounds are classical wood trim. In the gable peak is a pair of windows. The west elevation features an off-center, hip-roofed rear porch wrapped in wood-sash windows. A pair of windows and cornice returns are found in the rear gable end above the rear porch. At the east elevation is another gable-roof porch flanked by windows. The walls of the dwelling are clad in wood drop siding, most of the windows are metal sash, the roof is composition shingle, and the foundation is rusticated concrete block. Also on this site, is a one-story, gable-front, single-car garage. It features wood drop siding, wood-sash windows, felt roofing, a nonhistoric entry door, and wood plank, swing-out garage doors.</p>

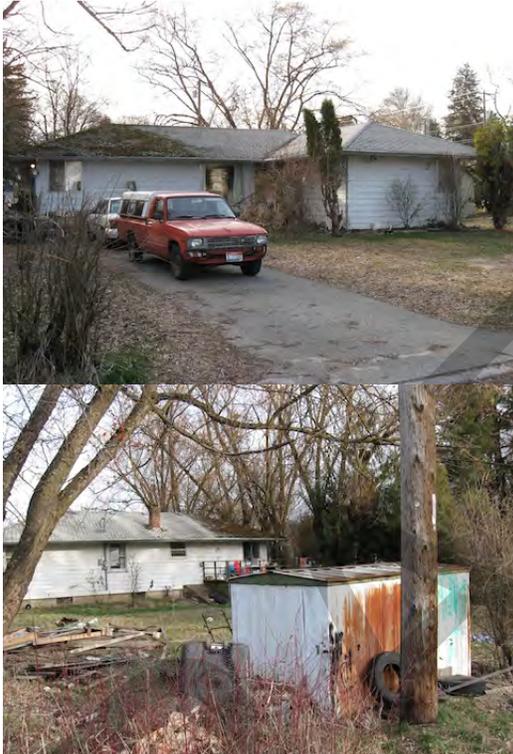
Survey Site Data	Site Photographs	Site Details
<p>Site #: 152 115 North Lincoln Street Owner: Lynn Marie Everett 1951 Previous District Status: n/a DoE: NC</p>

<p>This is a one-story, L-shape, hip-roof Ranch style dwelling oriented towards the east facing North Lincoln Street. The integral garage has been closed in and converted to living space. The façade features an inset entry under the main roof in the forward extension, and both a large picture window and a slider window in the south-facing wall. A small window is found at the northeast corner of the house. Three windows line the north elevation and a raised wood deck wraps the southwest corner at the rear of the dwelling. A brick, interior chimney pierces the roof on the west slope. One double-hung window is on the west elevation. The windows are a combination of vinyl and metal sash, the siding is aluminum, the roof is composition shingle, and the foundation is concrete. Also at this site is a gable-roof, pre-fabricated, metal shed.</p>

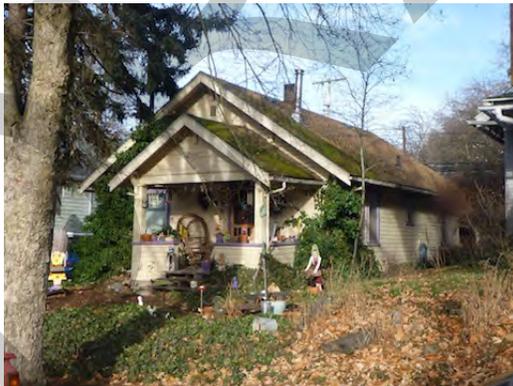
<p>Site #: 153 216 East First Street Owner: Carol Shultzman-Hill 1915 Previous District Status: C, 1 DoE: C</p>

<p>This is a single-story, frame, gable-oriented Bungalow facing south toward First Street. An open, gable-roof porch is off-centered on the façade, supported by square posts set on a clapboard-covered apron. An enclosed porch, is found on the northwest corner with multi-light, fixed, windows. The dwelling is covered in clapboards, and exhibits brackets supporting the gables. Wood-sash windows remain throughout. A brick chimney pierces the center of the roof, while a metal stovepipe exits the roof above the east elevation. An gable-roof, frame garage is located behind the dwelling. It is clad in wood boards, has a single entry on the south side flanked by small windows, and a vehicular entry on the west side with a two-part, hinged, wooden door.</p>

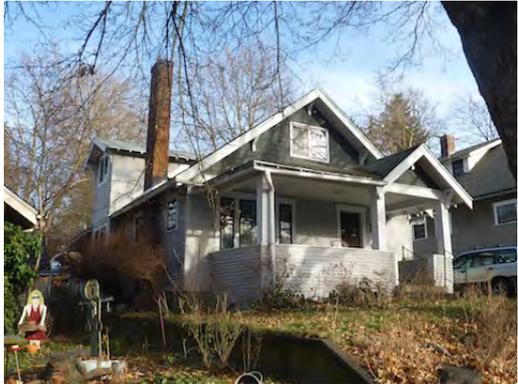
Survey Site Data	Site Photographs	Site Details
<p>Site #: 154 220 East First Street Owner: Lucas Roy Hugie 1915 Previous District Status: C, 2 DoE: C</p>

<p>Site 154 is located mid-block, facing south toward First Street west of Jefferson. It is a one-and-one-half-story, gable-oriented Bungalow with a nearly full-width front porch across the façade and a full-height, gable-roof wall dormer centered on the west elevation. The main entry porch exhibits a hip roof with a gable over the main entryway. The house is covered in clapboards, with shingles filling the gable ends. One-over-one, double-hung, wood-sash windows remain. A three-part window is found on the façade with a large single-light window flanked by one-over-one sashes. A brick chimney extends up on the west elevation. The main porch has square posts with brackets beneath the gable roof. The posts sit on a clapboarded apron wall. An original, frame, gable-roof, single-car garage is found at the northeast corner of the site featuring materials and characteristics similar to the dwelling, and contains a three-part, hinged, glazed, paneled wood door.</p>

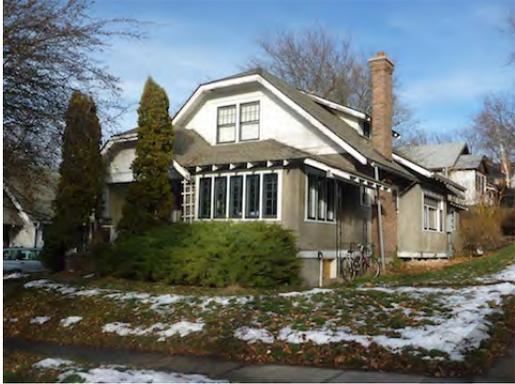
Survey Site Data	Site Photographs	Site Details
<p>Site #: 155 103 North Jefferson Street & 226 East 1st Street Owner: Stephen Cooke 1916 Previous District Status: C, 3 DoE: C</p>

<p>This is a one-and-one-half-story, Bungalow with a front-facing, clipped-gable roof over the main dwelling, a clipped gable of the entry porch on the southwest corner, and a hip roof over a enclosed porch at the southeast corner. A square bay under a shed roof, which pops up from the main roofline is centered on the east side, beneath a small shed roof dormer above. A similar dormer is found on the opposite side. A full-width, hip-roof, enclosed porch spans the rear, and a single-car garage with a clipped gable roof is attached at the dwelling's northwest corner. The dwelling is covered in aggregate, while the gable ends and dormers are clad in wood shingles. Multi-light, wood-sash windows, some fixed and some double-hung, are found on the dwelling. An exterior, shouldered, brick chimney is found on the east side. The dwelling also exhibits visible rafter tails and a basement entry on the southeast corner. An additional small brick chimney pierces the roof over the west elevation.</p>

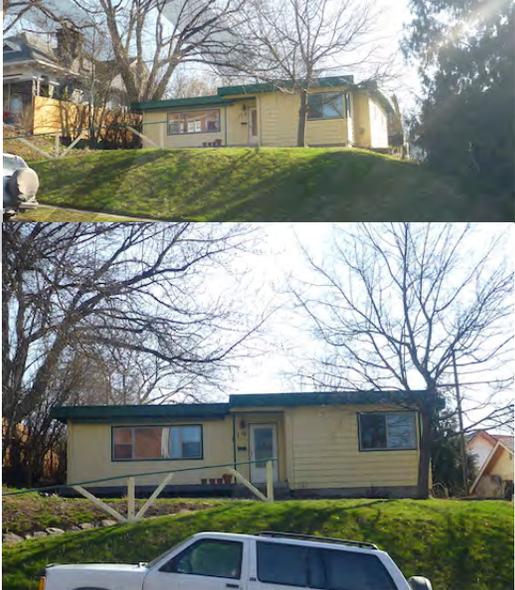
<p>Site #: 156 114 North Adams Street Owner: Jonathan Lyle Gallup 1958 Previous District Status: n/a DoE: NC</p>

<p>This is a small, single-story, Contemporary Style dwelling. The dwelling features a very low-pitched roof, horizontal emphasis, large windows, a combination of horizontal and vertical cladding, and heavy, overhanging eaves. A small, rectangular bay extends from the south elevation. It features replacement windows, but retains an original, mid-century front door with three stepped windows. It rests on a poured-concrete foundation, and features an uncovered entry porch spanning the west portion of the façade. The main entry is sheltered by a small extension of the primary roof. A shed-roof outbuilding covered in lattice is found behind the dwelling.</p>

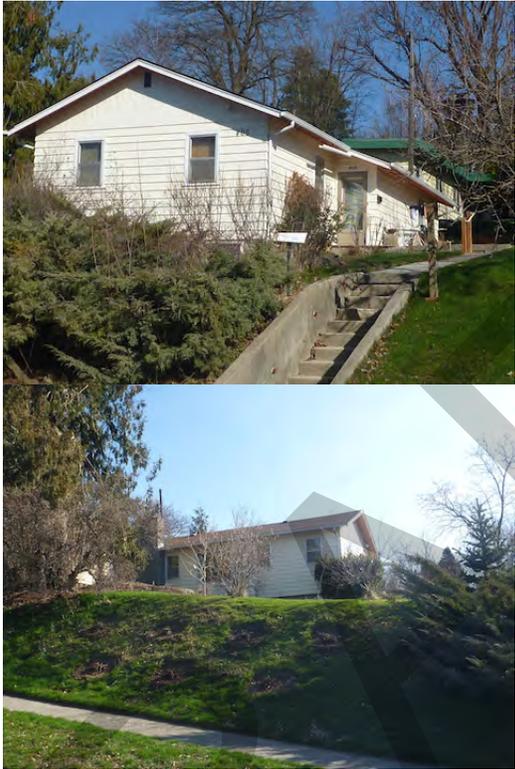
<p>Site 157 is a single-story, gable-roof, contemporary dwelling constructed in place of a ca. 1900 dwelling originally on this site. It exhibits wide, horizontal board siding with paneling within the gable ends appearing as vertical boards. An enclosed porch is found on the east elevation, beneath an extension of the primary roof. A large, exterior, concrete-block chimney is found on the west side. A small, shed-roof outbuilding is behind the dwelling.</p>

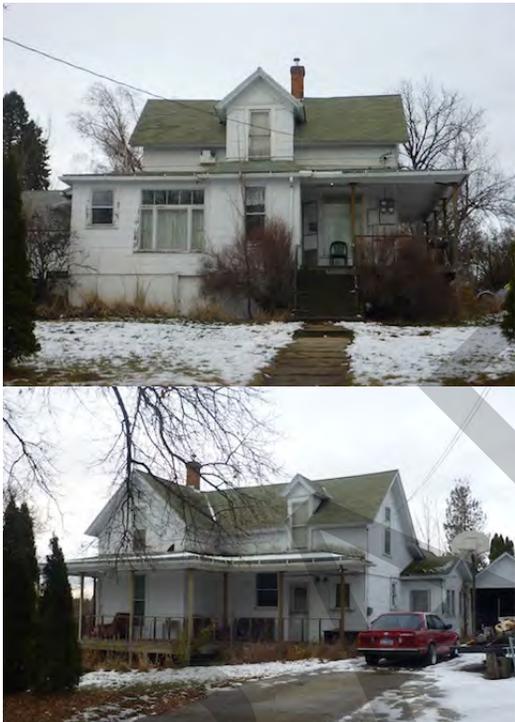
Survey Site Data	Site Photographs	Site Details
<p>Site #: 158 426 East First Street Owner: Roger Crozier 1890 Previous District Status: NC (compatible), 95 DoE: C</p>

<p>This is a one-and-one-half-story, T-plan, frame dwelling. It features a full-height rear ell, two, single-story extensions to the west, and a porch that wraps around the southeast corner and extends up the east side. A full-height, gable-roof addition centered on the façade and a single-story addition on the southwest corner of the main block were added by 1928. A narrow, gable roof wall dormer is found over an entry on the east side of the rear ell, and a brick chimney extends above the roofline of the main block of the dwelling. A gable-roof, enclosed porch is found on the rear. The dwelling retains wood-sash windows, and has been covered in asbestos siding. The foundation is concrete block. A small, gable-roof, frame, single car garage constructed by 1928 is located directly northwest of the dwelling.</p>

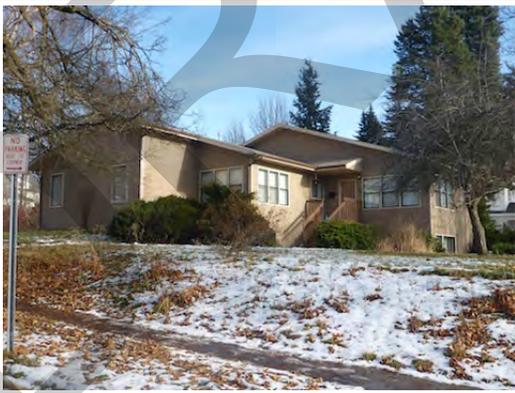
<p>Site #: 159 106 North VanBuren Street Owner: James Tangen-Foster 1986 Previous District Status: C, 113 DoE: NC</p>

<p>Site 159 is located on the northeast corner of First and VanBuren Streets and contains a dwelling (Site #159) and a barn (Site #160). This is a contemporary dwelling, which has replaced the 1890 Frank A. David House. It features multiple gable-roof sections and is set on a basement foundation.</p>

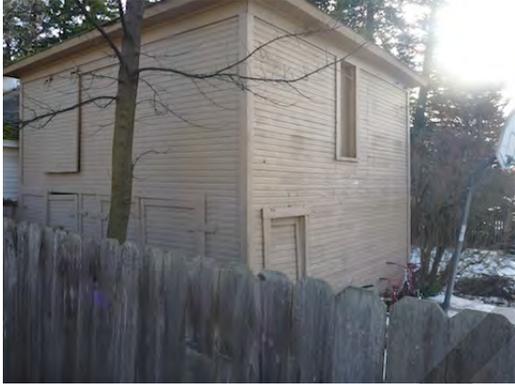
Survey Site Data	Site Photographs	Site Details
<p>Site #: 160 106 North VanBuren Street Owner: James Tangen-Foster ca. 1900 Previous District Status: n/a DoE: C</p>

<p>Site 160 is located on the northeast corner of First and VanBuren Streets and contains a dwelling (Site #159) and a barn (Site #160). Site 160 is the original two-story, hip-roof barn though the original dwelling is no longer extant. It features a square footprint, and several wooden entry doors on both the lower and upper levels. A wooden door on an overhead sliding track is found on the north elevation over paired, hinged doors. The building is covered in drop wood siding and retains wood corner boards and cornice with small crown molding detail. Though the dwelling no longer remains, the barn retains the historical character that makes it a part of the story of this district.</p>
<p>Site #: 161 514 East First Street Owner: Brian Johnson 1906 Previous District Status: C, 114 DoE: C</p>

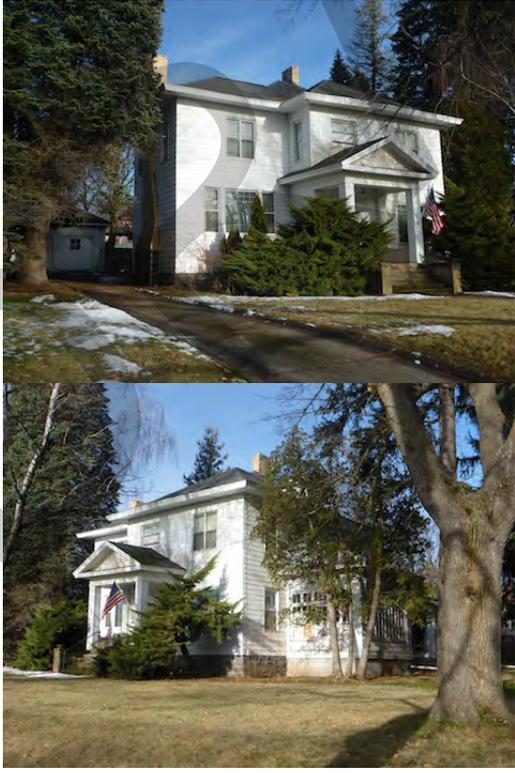
<p>Site 161 faces south toward East First, west of Polk Street. This is the W.L. Paine House, and is a large, asymmetrical, cross-hipped-roof, two-story, frame dwelling. It has a heavy, gable-roof entry porch supported by square posts with a starburst design in the gable end. The house is set on a stone block foundation. An exterior, blonde brick chimney is found on the west elevation and a blonde brick chimney pierces the roof. The house, has been covered in aluminum siding and the windows have been replaced with metal-sashes. A single-story sunroom is found on the east elevation. It is set on a concrete or parged foundation and has multi-light, wood-sash windows. A single-story addition with a gable roof and bay window is found on the rear northeast corner. A hip-roof, frame carriage house with a cupola, weatherboard siding, and sliding, paneled wood doors is found at the rear.</p>

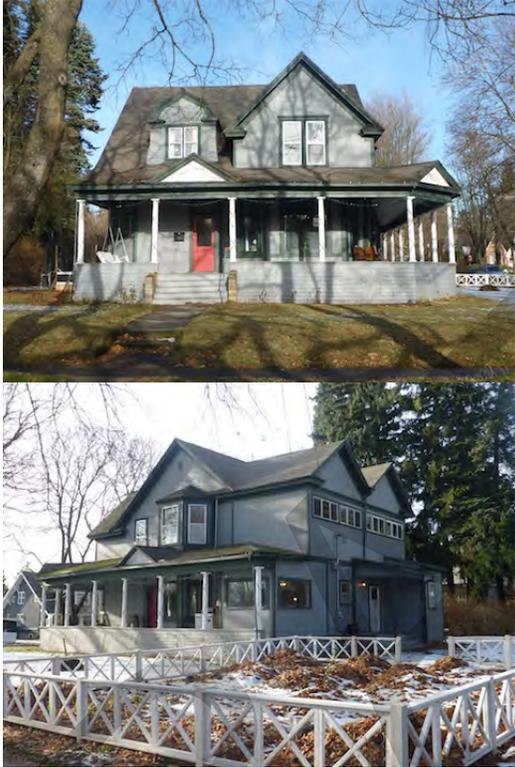
Survey Site Data	Site Photographs	Site Details
<p>Site #: 162 506 East First Street Owner: James Tangen-Foster 1891 Previous District Status: C, 115 DoE: C</p>

<p>Site 162 is set on the northwest corner of Polk and First Streets. This is a large, cross-gabled, two-story, frame dwelling. It features a single-story, hip-roof porch crossing the façade and wrapping around to span the east elevation. Small gable-roof extensions rise above the porch over both the front and side entries, as well as at the corner. The porch is surrounded by an apron covered in wood shingles with diamond patterns regular intervals. Tuscan columns support the porch. The house is covered in weatherboard siding, with scalloped imbrication within the gables. A two-story, three-sided bay is found on the east side elevation. The southeast and southwest corners of the house are chamfered. Cornice returns are also found on the gable-roof sections. A small, gambrel-roof dormer is found off-centered, above the façade elevation. An enclosed porch spans the rear elevation, with an added upper level exhibiting double gable roofs. A shed-roof porch overhang shelters the rear entry next to a small shed roof addition. A small, gable-roof garage with wood siding, brackets, elaborated bargeboards, and three wood doors with wood-sash windows is located at the rear of the property.</p>

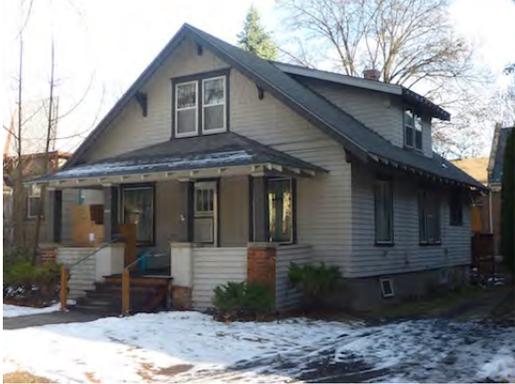
Survey Site Data	Site Photographs	Site Details
<p>Site #: 163 110 North Polk Street Owner: Catholic Church ca. 1930 Previous District Status: C, 109 DoE: C</p>

<p>Site 163 is located just north of St. Mary's Catholic Church, facing west toward Polk Street. It is a three-bay (w/d/w), one-and-one-half-story, gable-oriented, frame Bungalow. It features a nearly full-width, hip-roof porch across the façade, supported by square posts with crown molding atop brick piers, the center two of which have been partially covered. The dwelling is clad in weatherboard with wood shingles in the gable end. Shed roof dormers are found above the north and south elevations. Brackets, visible rafter tails, and multi-light, wood-sash windows are extant. A small shed roof supported by brackets serves as the back porch. The house has a concrete basement foundation. A single-car garage with wide horizontal board siding, visible rafter tails, and four paneled wood doors is at the rear. .</p>

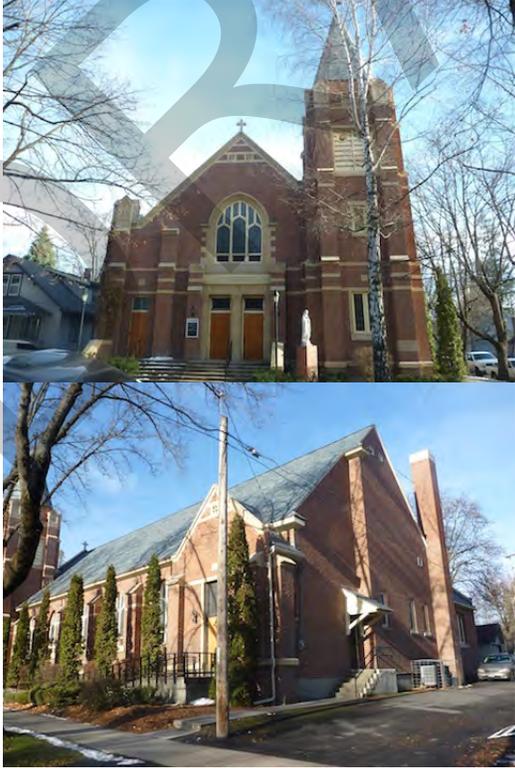
<p>Site 164 is St. Mary's Catholic Church, located on the northeast corner of First and Polk Streets. The building is L-shaped, with a large rectangular portion running east-west along First, a small extension at the northeast, rear corner, and a square tower at the southwest corner. It features a red brick exterior, slate or rubber tile roof, and stone detailing including sills, a water table, window trims, and cornice detailing. Additional stone detail is found on top of the buttresses and at the top of the pilasters on the tower. Further evidence of the building's Late Gothic Revival style includes pointed arched stained-glass windows and the restrained use of detail. A number of leaded-glass windows can also be found. The building also features hopper windows beneath the stained glass windows and cornice returns.</p>

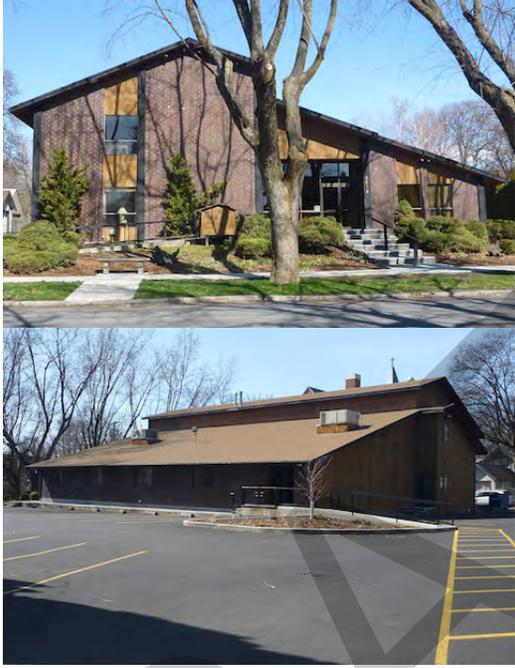
Survey Site Data	Site Photographs	Site Details
<p>Site #: 165 618 East First Street Owner: Catholic Church Contemporary Previous District Status: n/a DoE: NC</p>

<p>Site 165, oriented to the south, is a large, multilevel, brick structure known as St. Mary's Family Center. This shed style, contemporary building has a large, two-story, asymmetrical front-facing gable section on the façade with a lower, elongated, shed-roof section that spans the width of the east elevation of the building. It features a modern, double-leaf entry with full-light metal doors surrounded by a large, open, full glass entry section on the façade. Wide, full-height vertical sections with modern, metal-frame windows and wood paneling in between are featured on the facade, with vertical wood paneling and metal frame windows exhibited throughout the building. The roof of the building, featuring wide, angled overhangs, is sheathed in asphalt shingles.</p>

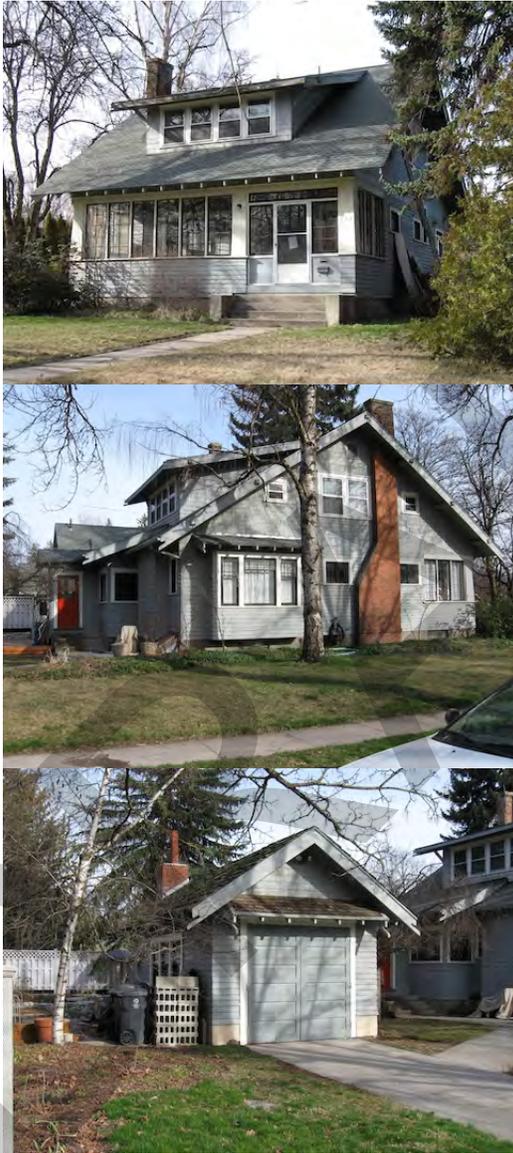
Survey Site Data	Site Photographs	Site Details
<p>Site #: 166 704 East First Street Owner: Patricia Hart 1915 Previous District Status: n/a DoE: C</p>

<p>This is a one-and-one-half story, side gable, Craftsman style dwelling that is oriented towards the south facing East First Street. The façade features a full-width, integral porch under the main roof. The porch is supported by tapered square columns atop an apron wall. The porch openings are filled with ten-light, wood-sash windows and an aluminum-frame storm door. The off-center entry door is a glazed, wood-ledged door and shares the porch with three, large windows. Shed-roof dormers are found over the north and south elevations each with a ribbon of four windows. The north elevation features a shed-roofed, square bay with three windows and a brick, outside chimney flanked by a pair of small, windows. The gable ends feature half-timbering with painted cedar shingles between. At the rear of the dwelling is a secondary entry door within a gabled projection. A single-flue, brick, chimney pierces the north slope of the roof. Details include elaborated barge boards, knee braces, deep eaves, and exposed rafter tails. Windows are original wood sash. The first-floor is clad in clapboards, and the dormers in cedar shingles, and the roofing is composition shingle. Also on this site is a gable front, single-car garage. It features a pent roof over the wooden, swing-out, garage doors. Wood clapboards cover the walls while wood shingles fill the gable ends. The garage exhibits exposed rafter tails, elaborated bargeboards, shingled roof and a brick chimney.</p>

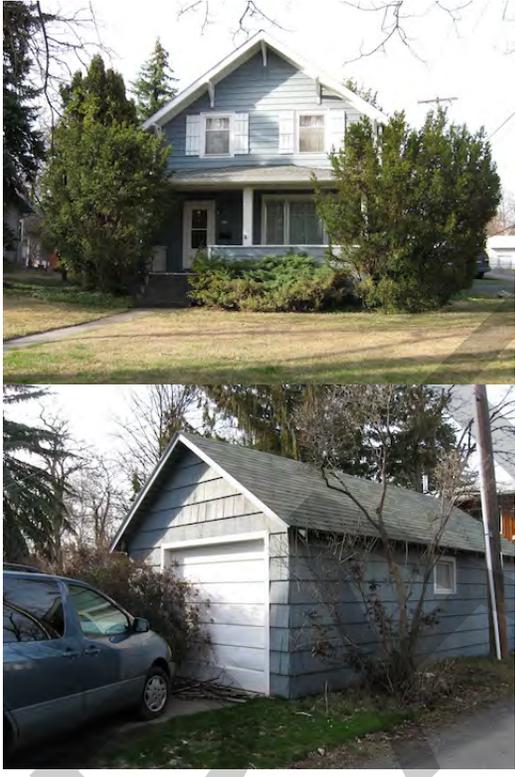
Survey Site Data	Site Photographs	Site Details
<p>Site #: 167 718 East First Street Owner: Richard Penticoff ca. 1900 Previous District Status: n/a DoE: C</p>

<p>This is a one-and-one-half story, front gable dwelling with an irregular plan that is oriented towards the south facing East First Street. The façade features a full-width, hip-roof porch atop square posts on a closed railing. The entry door is a glazed, ledged, wood door. An original wood-sash, triple window shares the wall with the entry. Above the porch is a pair of wood-sash windows with nonhistoric shutters. Knee braces support the eaves in the gable ends. A single, brick, interior chimney pierces the west slope of the roof. A small greenhouse has been added to the west elevation at the hip-roof addition. The walls are clad in aluminum siding and the roof is covered in composition shingles. The foundation is concrete. Also on this site at the alley is a one-story, front gable, single-car garage with walls sheathed in machine-cut shingles, a composition shingle roof, and a metal roll-up garage door.</p>

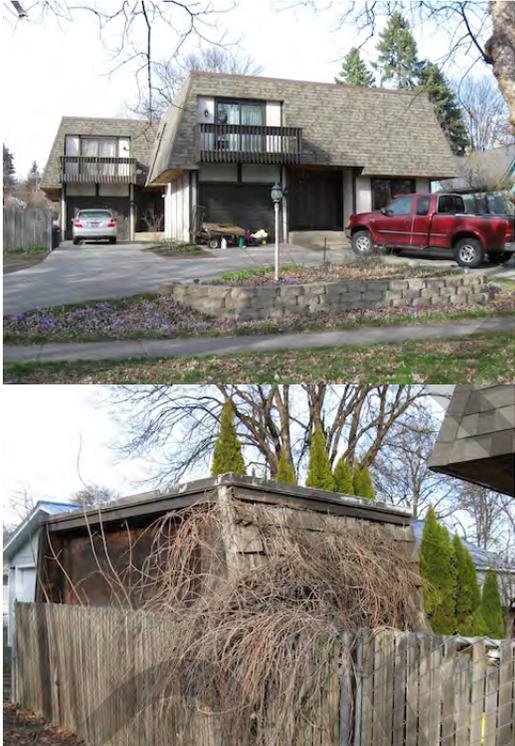
Survey Site Data	Site Photographs	Site Details
<p>Site #: 168 720 East First Street Owner: Gayle Rogalski 1971 Previous District Status: n/a DoE: NC</p>

<p>Site 168 is a two-story, contemporary, Neo-Mansard duplex that is oriented towards the south facing East First Street. The façade of each unit features double wood doors, a large picture window, a single-car, roll-up garage door, and a second story balcony with sliding-glass doors. Through-the-cornice windows are featured at the west and east elevations, and those at the east with small balconies. A small, Mansard roof shed is found at the rear of the site.</p>

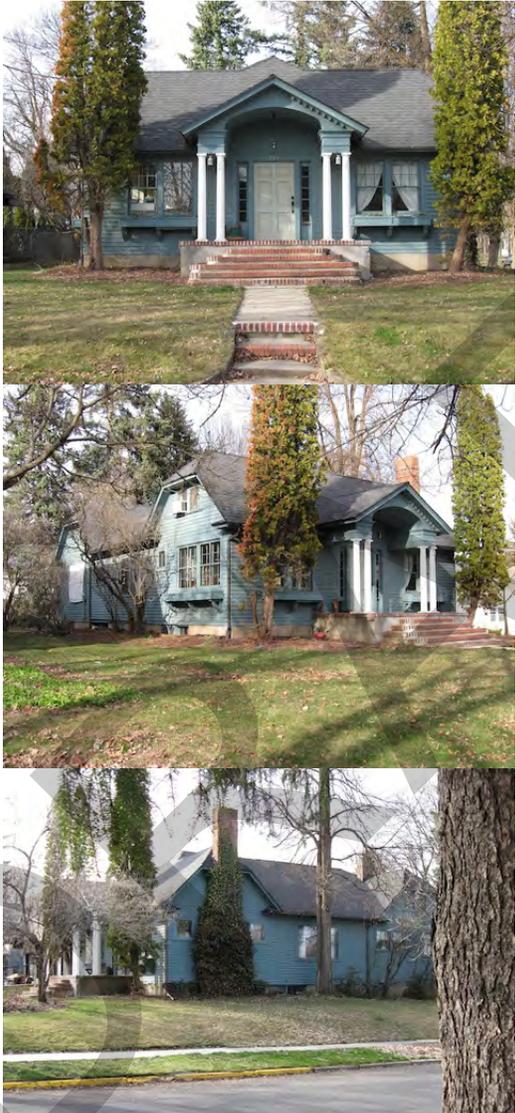
Survey Site Data	Site Photographs	Site Details
<p>Site #: 169 724 East First Street Owner: Ellery Blood 1926 Previous District Status: n/a DoE: C</p>

<p>The photographs show a light blue, one-and-a-half-story house with a dark roof and a prominent front porch supported by columns. The house is set on a grassy lot with trees in the background.</p>	<p>Site 169 is a one-and-one-half story, clipped gable dwelling with on a basement foundation, located on the Northwest corner of North Monroe Street and East First Street, facing East First Street. The H-shaped plan is created by a pair of clipped, side gables connected by a slightly taller linear portion of the building. The façade features a Colonial Revival style, gable-roof entry with curved ceiling. The porch is set atop a wide entablature supported by paired, classical columns. Dentils detail the cornice. The wide, front entry door is paneled wood and is bracketed by five-light sidelights. Paired windows with window boxes flank the entry. At the west elevation are paired windows of varying sizes. At the east elevation is a tall double-flue, brick, exterior chimney that breaks the clipped eave. The chimney is flanked by small, square, six-light, wood-sash windows. A second chimney pierces the center of the ridge of the rear clipped side gable. The windows are all original wood-sash, and most are six-over-one, double-hung. The foundation is parged and the roof is composition shingle.</p>

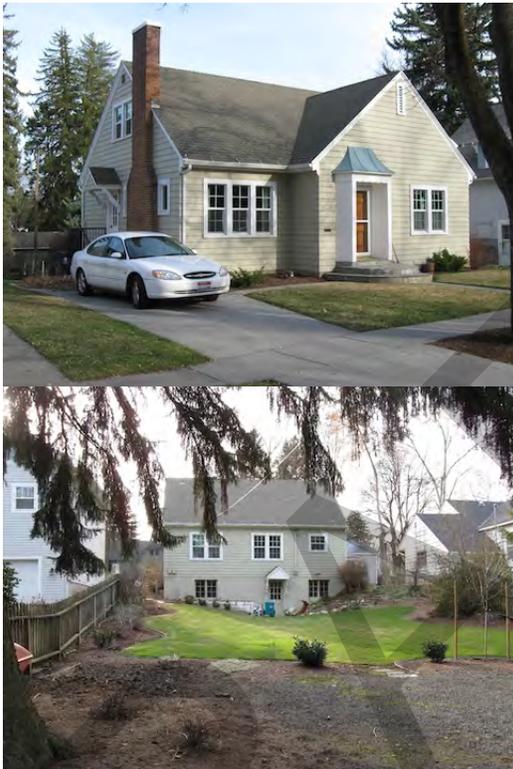
Survey Site Data	Site Photographs	Site Details
<p>Site #: 170 108 North Monroe Street Owner: Doris Billingsley Rev Trust 1937 Previous District Status: n/a DoE: C</p>

<p>This is a one-and-one-half story, cross-gable roof dwelling oriented towards the west facing North Monroe Street. The forward gable extension features an off-center entry door with a flared metal hood atop wood-trimmed side walls, a pair of windows, and a louvered vent in the peak. North of the entry is a triplet of windows. On the north elevation is a tall, double-flue, brick, outside chimney. A number of windows and a gable-front hood atop carved brackets sheltering the side entry door are also found on the north elevation. All the windows at the first and second levels are vinyl replacements, the siding is wide wood clapboards, and the roof is composition shingle. Original, wood-sash, casement windows and rear entry door are extant at the basement level at the east elevation. Sanborn maps indicate this dwelling retains its original footprint.</p>
