National Register of Historic Places Registration Form

Historic name: Fort Russell Neighborhood Historic District (Boundary Increase and Additional Documentation)

Street & number: Roughly bounded by Jefferson Street on the west, East D Street on the north, Hayes Street on the east, and East Third Street on the south

City or town: Moscow State: ID County: Latah

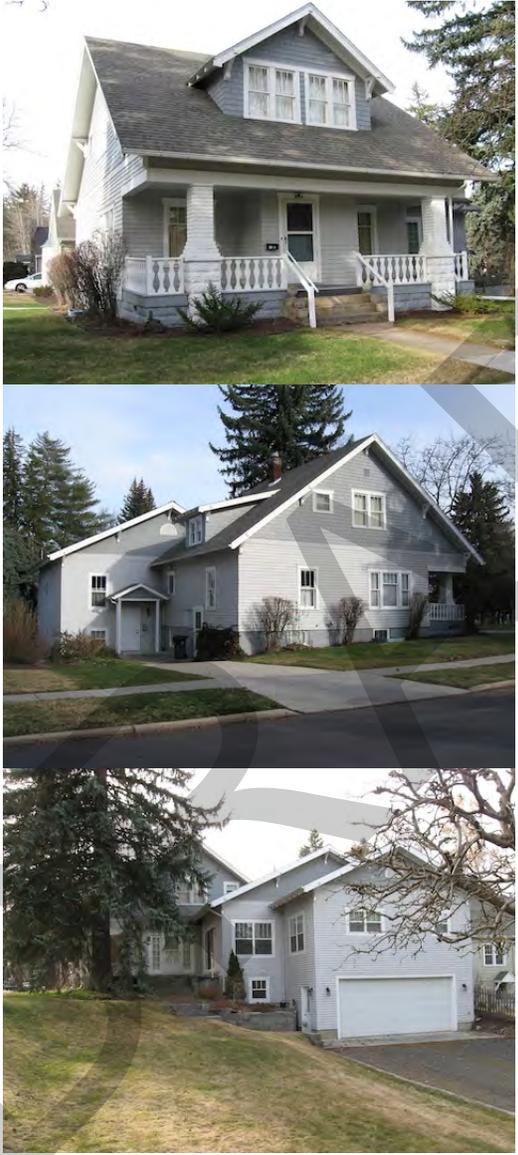
Survey Site Data	Site Photographs	Site Details
<p>Site #: 171 804 East First Street Owner: Patrick Brausen 1923 Previous District Status: n/a DoE: C</p>

<p>This is a one-and-one-half story Craftsman Bungalow with an irregular plan. It is oriented towards the south facing East First Street. The façade features a full-width integral porch under the main roof, which is supported on two brick columns that taper at the bases and sit atop rusticated concrete-block piers. The porch features decorative wood balusters. An off-centered entry bay projects forward within the porch containing the entry door, which is flanked by large, five-over-one wood-sash windows. Centered above the front porch is a wide, front-gabled dormer with two pairs of three-over-one wood-sash windows, knee braces and exposed rafter tails. At the rear elevation, a shed-roof dormer with a pair of windows and a single-flue, brick, chimney are found on the north slope of the roof. An entry door and several windows are located at the first floor and a window is found at the basement level. Wood clapboards cover the first level and shingles clad the gable ends and the dormers. At the west elevation, a gable front roof on square posts shelters an entry door to the two-story addition that is attached to the original building's southeast portion. East of this addition is a two-story, gable-roof addition with living space above a two-car garage. The additions were constructed with materials that appear similar to the original. Roofs are composition shingle and foundations are concrete.</p>

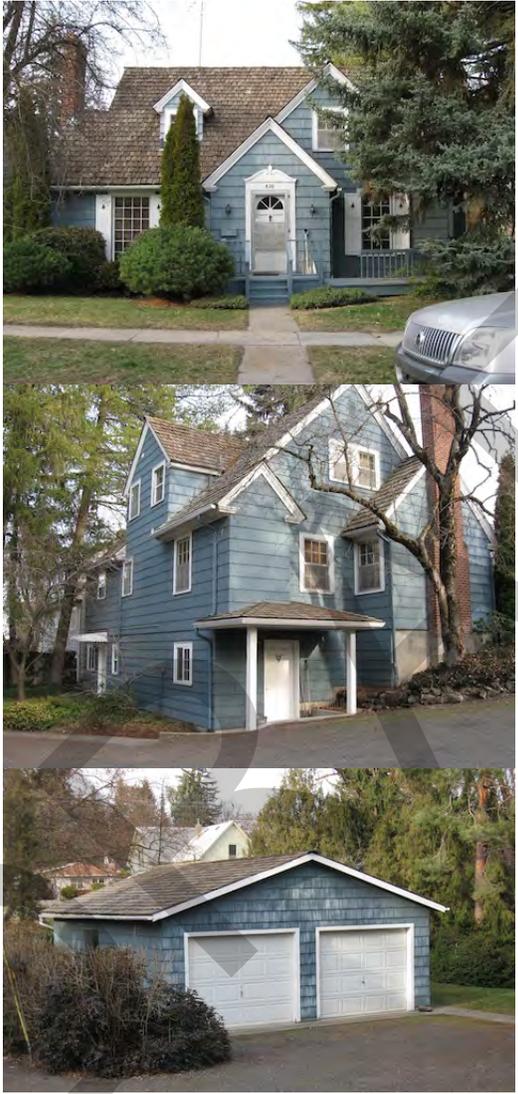
Survey Site Data	Site Photographs	Site Details
<p>Site #: 172 820 East First Street Owner: George B Hatley Trust 1932 Previous District Status: n/a DoE: C</p>

<p>This is a one-and-one-half story, side-gable English Cottage with two front-facing gables on the façade. The larger forward gable features a six-over-six window in its peak above a tall six-over-nine window with shutters. Projecting from this gable is a lower, smaller entry gable with a central entry door with fanlight glazing and pedimented trim atop fluted pilasters. To the west of the entry is a large, twenty-four-light window with shutters and a small, shingled, gable-front dormer with a six-over-six window at the roof. A tall, brick, outside chimney is at the west elevation at a lower projecting side gable. Another small side gable punctuates this elevation above a hip-roofed secondary entry door. A rear-facing, gable-roof wall dormer is located at the north elevation. A rear entry door with a metal awning is at the walkout basement with three vinyl windows. Windows are wood sash except at the basement level. The exterior walls are covered in painted cedar shingles and the roof is sheathed in cedar shingles. The foundation is concrete and concrete block. Gable ends exhibit cornice returns. At the rear of the site is a gable-front, shingled, two-car garage with composition shingle roof and two metal roll-up doors.</p>

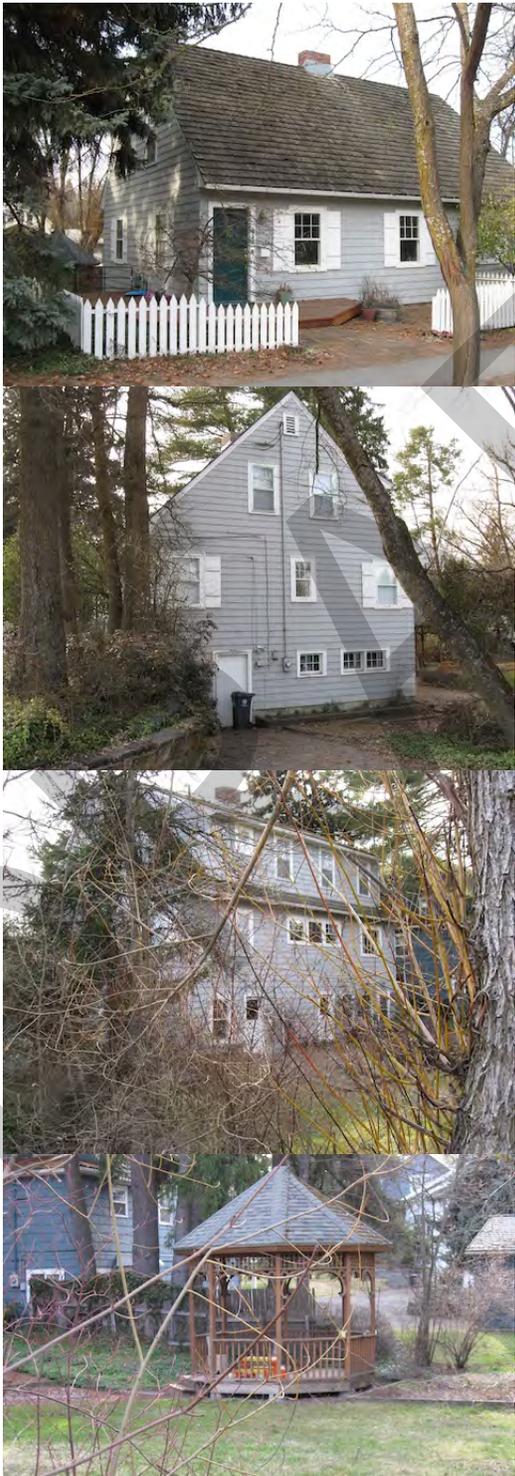
Survey Site Data	Site Photographs	Site Details
<p>Site #: 173 824 East First Street Owner: Jeffrey Hicke 1936 Previous District Status: n/a DoE: C</p>

<p>This is a one-and-one-half story, side-gabled, Cape Cod styled dwelling with a square plan located on the northwest corner of East First and North Lincoln Streets. The façade features a low eave height over the entry door located at the west end of the façade, and three, six-over-one, double-hung, wood-sash, windows with and shutters. The entry door is an inset panel wood door with brass wicket. A central double-flue, brick, inside chimney pierces the ridge. The house is clad in painted cedar shingles. The west elevation features a pair of windows near the peak above a pair of windows at the first level. The east elevation features an entry door into the walkout basement and three small, six-light, wood-sash windows. At the first floor are three windows and a pair are located at the second floor. A small louvered vent is in the peak. At the north elevation a full-width, shed-roofed dormer is at the roof highlighted with four windows. Numerous windows and two entry doors to the basement also are located at this elevation. The roof is cedar shingled. At the rear of the site is an octagonal gazebo with composition shingle roof, wood railings and wood deck.</p>

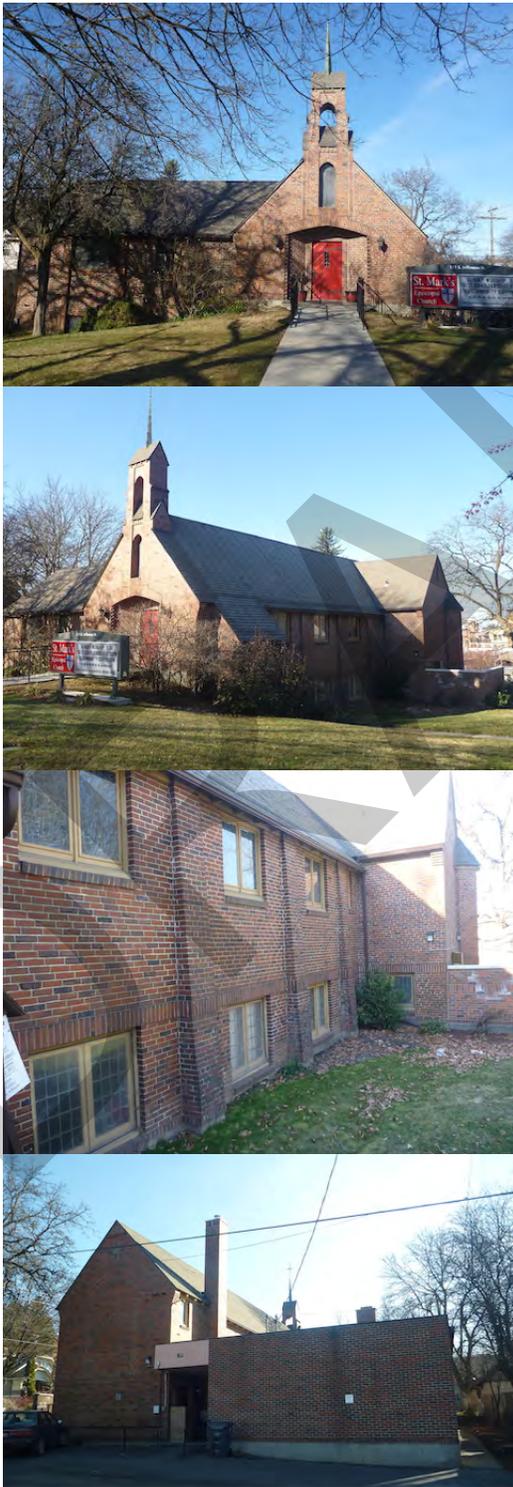
Survey Site Data	Site Photographs	Site Details
<p>Site #: 174 111 South Jefferson Street Owner: Church, Episcopal Ca. 1930s Previous District Status: n/a DoE: C</p>

<p>St. Mark's Episcopal Church is located on the southwest corner of Jefferson and First. It is a single-story, brick, cruciform plan church set on a basement foundation. The main block has a gable roof, with a brick steeple extending up on the front elevation. A full-height, gable-roof extension is found toward the west end of the north elevation, and a small, shed-roof extension on the northeast corner. A gable-roof addition is found at the south elevation with a flat-roof extension on the rear. The building is of masonry construction, with a six-row, common bond brick exterior with a water table of soldier-course bricks. The main entry is recessed from the primary wall plane flanked by angled brick walls. The entry door is wood set in a chevron pattern, with a leaded-glass window. A Gothic-arched, stained-glass window is found above a Gothic arch detail above the entry. A copper steeple is found at the top. Stained-glass, wood-sash, casement windows are found around the main level, while 20-light, leaded-glass, wood-sash, casement windows are found on the basement level. The side elevations feature brick buttresses set nearly flush with the walls. A small, three-sided bay is found on the east end of the north side. Small rafter tails are also visible along the side elevations. A single-story, brick wall at the northwest corner creates an area for the Jane Dunham Fellowship Garden established in 2002.</p>

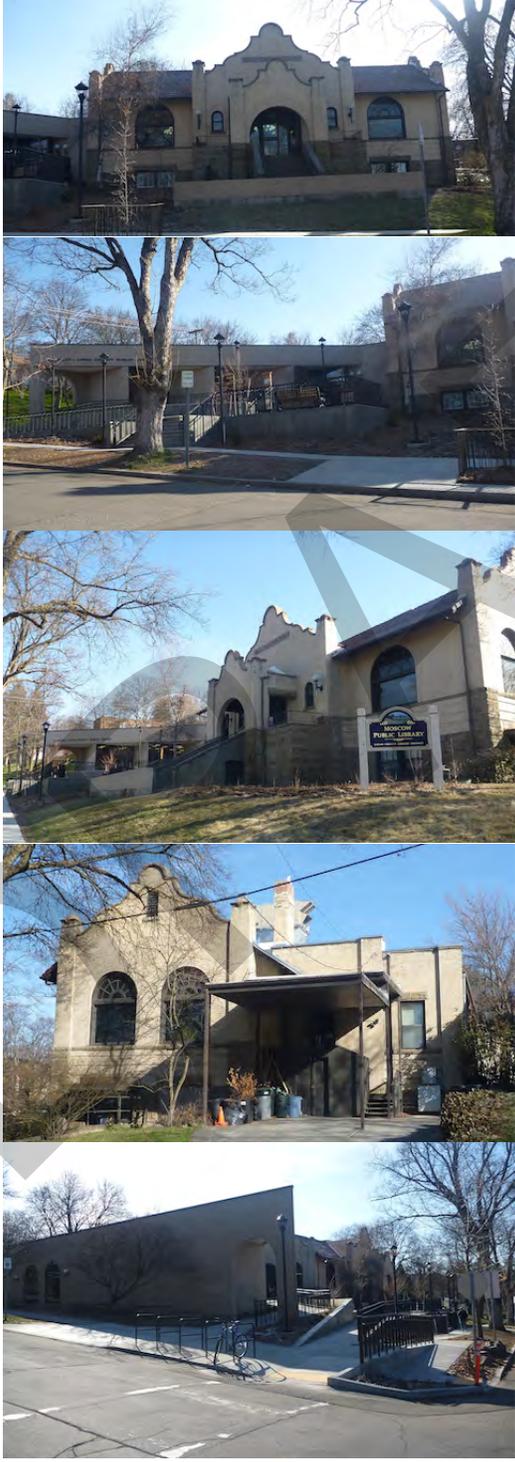
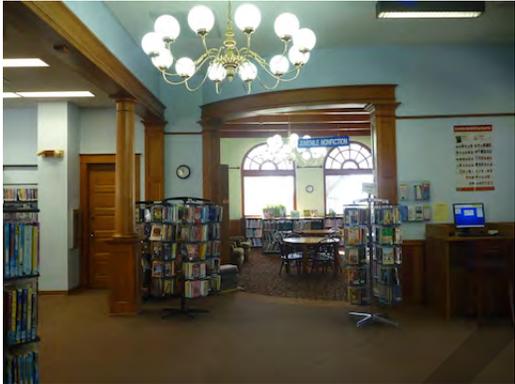
Survey Site Data	Site Photographs	Site Details
<p>Site #: 175 110 South Jefferson Street Owner: City of Moscow 1906 Previous District Status: n/a DoE: C</p> <p>Previously Listed Individually to the NRHP: 6/18/1979</p>

<p>Site 175 is the Moscow Branch for the Latah County Library District. The original portion of the building is a Mission style Carnegie Library. It is a side-gable roof, brick building with Mission style parapets on both sides as well as a parapet extending over the main entry centered on the façade. The entry is recessed behind a large, arched opening with an additional parapet. The entry contains a nonhistoric door but retains sidelights and transom windows. Two small, arched windows flank the entry porch while two very large single-light, wood-sash windows with fanlights above are found on each side of the façade. All of the arched windows exhibit large, soldier-course brick arches above. Two large windows are also found on the south elevation. The windows exhibit narrow stone sills, which continue around the building. Between the sills and the basement foundation, the bricks run in bands with a narrow band of recessed brick between. The roof is covered in tile. The building is set on a mortared, stone block foundation with paired, three-light, wood-sash windows in the basement level toward the north and paired, three-over-one, wood-sash windows toward the south. A basement entry with a flat porch roof is found on the south side. On the rear of the building is a small, flat-roof, brick addition constructed in the 1930s according to the previous survey form. The addition exhibits a similar light-colored brick as the original building, as well as stone sills and lintels at the windows. The rear of this addition is finished in red brick with four recessed portions with corbelling above and pilasters between. On the north side of the original building, is a large, single-story, flat-roof 1980s addition. It is</p>

<p>asymmetrical and extends out at an angle toward the northwest. It mimics the original building's design with a similar light-colored brick and large arched windows. The building is now accessed via this addition. The interior of the original portion of the building is quite intact, retaining woodwork and molding, two fireplaces, columns, two round rooms in the front corners, and two small, original washrooms tucked between the rounded front rooms and the main foyer. It was listed individually to the NRHP in 1979. Despite the large addition, the original portion of the building with its 1930s addition appears to remain eligible for continued inclusion in the NRHP. The 1980s addition, though compatible, is notably different and was designed with a simple and clean appearance so that it does not compete with the more ornate original building. It is recessed from the façade of the original building at the point where they are connected, only extending forward at an angle as it proceeds away from it. Despite the additions, the original building, both on the exterior and in the interior, is remarkably intact and retains high levels of historical integrity.</p>

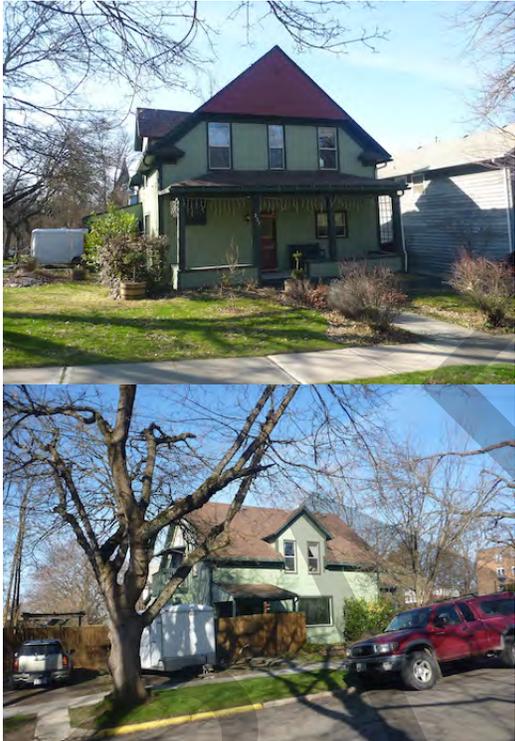
Survey Site Data	Site Photographs	Site Details
<p>Site #: 176 327 East First Street Owner: Barbara Cosens 1906 Previous District Status: n/a DoE: C</p>

<p>This is a one-and-one-half-story, gable-oriented, frame dwelling. It features a hip-roof, full-width porch across the façade, a gable-roof wall dormer on the east elevation, an open, single-story, shed-roof porch on the southeast corner, and an enclosed porch centered on the rear. A second-story balcony sheltered with a shed-roof overhang is on top of the rear porch. The house is covered in composite siding and exhibits vinyl windows. The front porch is supported by rectangular posts set atop an apron wall. The front of the forward gable is filled and covered in siding. Cornice returns are found on both the front and rear gable ends. Though this dwelling exhibits replacement materials, it retains its original footprint and fenestration and as such, still represents its original form and period of construction.</p>

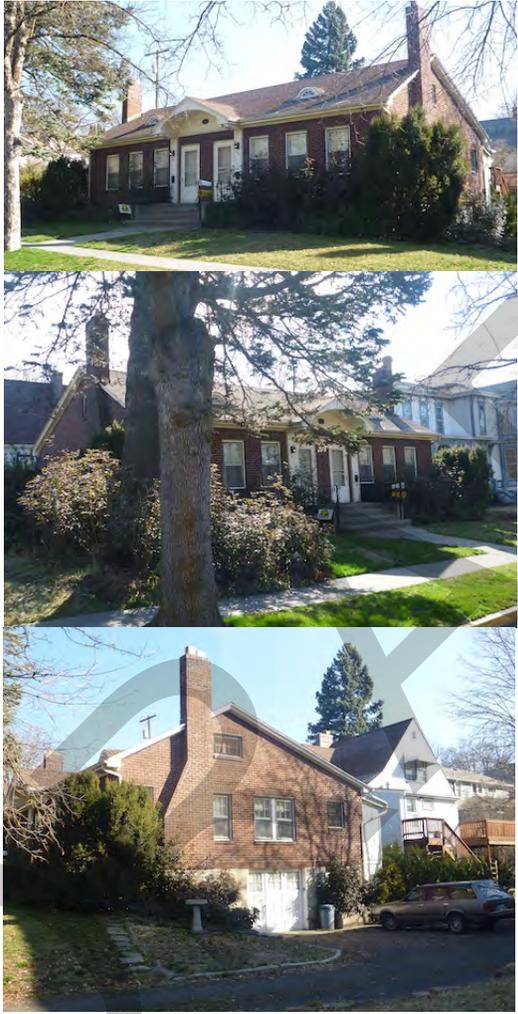
Survey Site Data	Site Photographs	Site Details
<p>Site #: 177 104-106 South Adams Street Owner: John Smiley 1928 Previous District Status: n/a DoE: C</p>

<p>Site 177 is a single-story, side-gabled Bungalow duplex set on the southeast corner of Adams and First. The residence has brick veneer exterior walls. A cantilevered, gabled porch hood is centered on the façade elevation with straight braces and pilasters beneath each side. Two entry doors are sheltered by the hood. They retain paneled wood doors. Six-over-one, double-hung, wood-sash windows are found across the façade and south side elevation, while three-over-one, wood-sash windows are found on the both the north and south side elevations. Paired, six-light, wood-sash windows are found in the attic level on the gable ends and fanlight windows are found within two eyebrow dormers over the façade. Other than the dormers, all of the windows exhibit brick sills and lintels. A single-shouldered, exterior, brick chimney is located on each end of the dwelling. The dwelling is set on a poured-concrete foundation, which features a small garage on the south elevation where the grade slopes downward. The garage exhibits three hinged, paneled wooden doors with four-light windows. A narrow, shed-roof, frame addition is found on a portion of the rear elevation.</p>

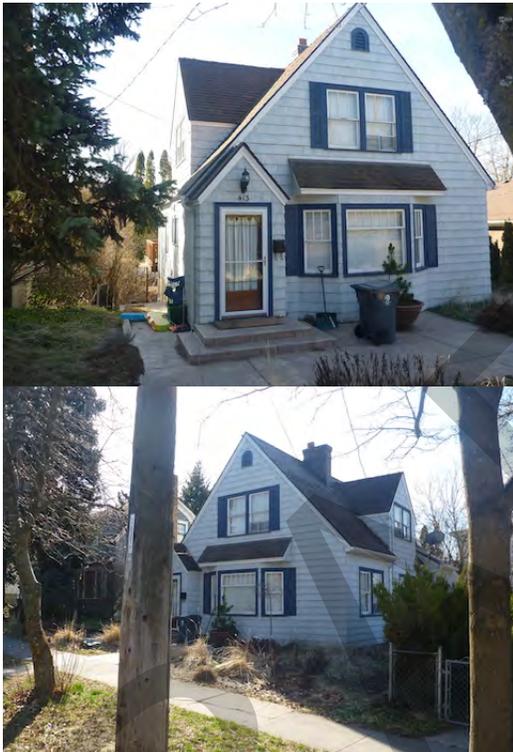
Survey Site Data	Site Photographs	Site Details
<p>Site #: 178 413 East First Street Owner: Pine Country Homes LLC 1930 Previous District Status: n/a DoE: C</p>

<p>Site 178 is a one-and-one-half-story, gable-oriented frame dwelling with gable-roof wall dormers extending over both the east and west side elevations, an enclosed, gable-roof porch extending from the façade elevation, a covered shed-roof, three-sided bay on the lower level of the façade, and a small, single-story, shed-roof extension on the southwest corner. A brick chimney pierces the roof over the west side of the dwelling and a wooden deck is found on the rear. The house is set on a poured-concrete foundation and exhibits raked shingle siding. Three-over-one, double-hung, wood-sash windows are found on the dwelling, some flanked by shutters. The center window on the three-sided bay on the façade is a larger, seven-over-one, wood-sash window. The front entry retains a multi-light, wooden door and a small, arched vent is located within the peak of the gable on the façade.</p>

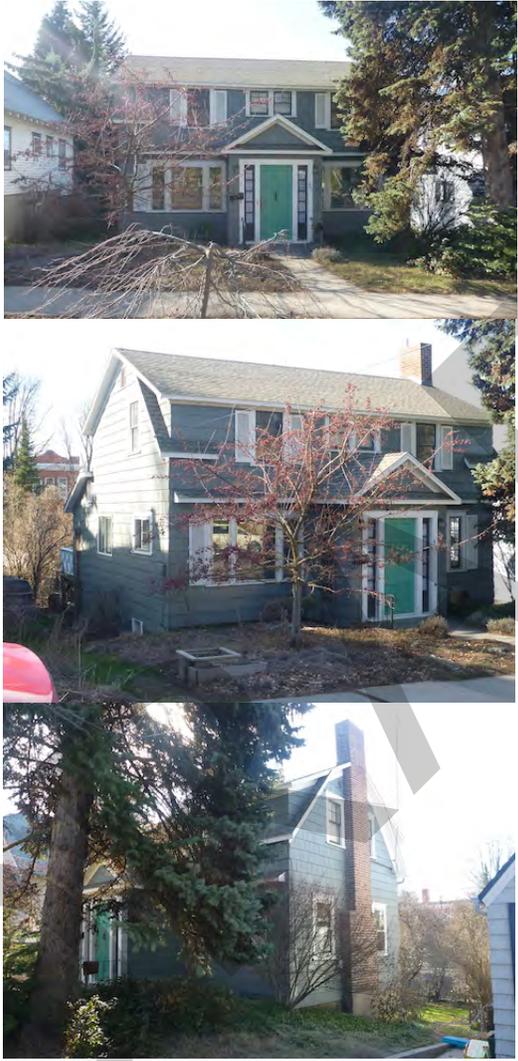
Survey Site Data	Site Photographs	Site Details
<p>Site #: 179 415 East First Street Owner: James Robert Reece 1926 Previous District Status: n/a DoE: C</p>

<p>The 'Site Photographs' column contains three photographs of a house. The top photo is a front-facing view showing a green door and a large dormer. The middle photo is a side view showing the gable roof and a chimney. The bottom photo is a rear view showing a brick chimney and a wooden deck.</p>	<p>This is a one-and-one-half-story, gambrel-roof, frame dwelling. A nearly full-width wall dormer extends over both the façade and rear elevations, while a single-story, shed-roof enclosed porch or addition spans the entire rear in place of the original small, centered porch. A single-story, enclosed, gable-roof porch extends from the center of the façade. The front entry is flanked by five-light, wood-sash, sidelights. Six-over-one and four-over-one, double-hung, wood-sash windows remain on the dwelling, some of which are flanked by shutters. The windows all exhibit simple wood surrounds with crown molding. A small, pent roof extends across the façade above the first level windows, along the same horizontal line as the lower pent of the closed gable on the front entry porch. An exterior, shouldered brick chimney is centered on the west elevation and a wooden deck is found on the rear.</p>

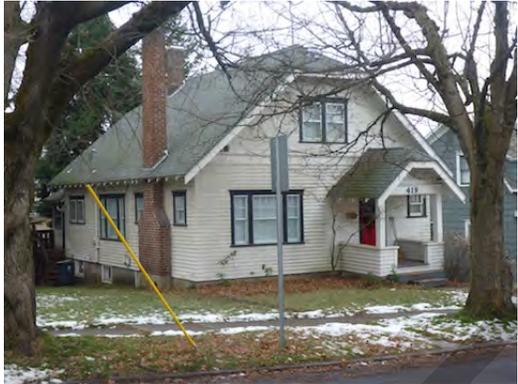
Survey Site Data	Site Photographs	Site Details
<p>Site #: 180 419 East First Street Owner: Anne Lawrason Marshall 1926 Previous District Status: C, 97 DoE: C</p>

<p>This is a one-and-one-half-story, gable-front Bungalow with a clipped-gable roof over the main dwelling as well as over the open porch, off-centered on the façade. It sits on a concrete basement foundation. The dwelling exhibits numerous multi-light, double-hung, wood-sash windows. The entry porch is set on square wood posts atop clapboard knee-walls. The dwelling is covered in clapboards, with shingles filling the gable ends. The windows exhibit simple wood surrounds with crown moldings. Rafter tails are found at the eaves, and a brick, shouldered chimney is located on the east elevation. A single-story, enclosed porch is also located toward the east end of the rear elevation.</p>
<p>Site #: 181 103 South VanBuren Street Owner: John Sturgul 1925 Previous District Status: C, 96 DoE: C</p>

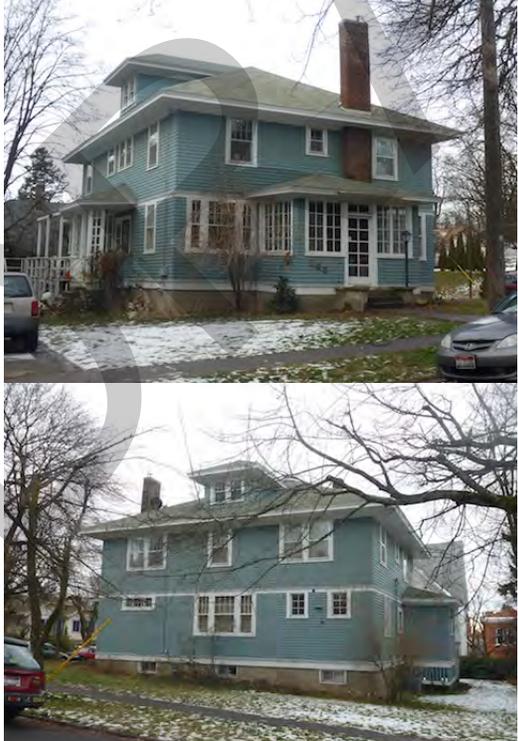
<p>Site 181 is oriented east on the southwest corner of First and VanBuren. It is a two-and-one-half-story, hip-roof, American Foursquare dwelling. It features an enclosed, hip-roof entry porch on the east, an open porch on the south side, and an enclosed rear porch. A small porch extends west from the south side porch. Hip-roof dormers are found above the north and south elevations, and an exterior brick chimney extends up piercing the roofline on the façade. Multi-light, double-hung, wood-sash windows remain throughout. The dwelling is covered in clapboards, and sits on a parged foundation. The dormers are covered in wood shingles. A simple wood trim piece with crown molding wraps around the house at the cornice line dividing the lower and upper levels. Similar trim is found above the foundation and over the upper level windows at the cornice.</p>

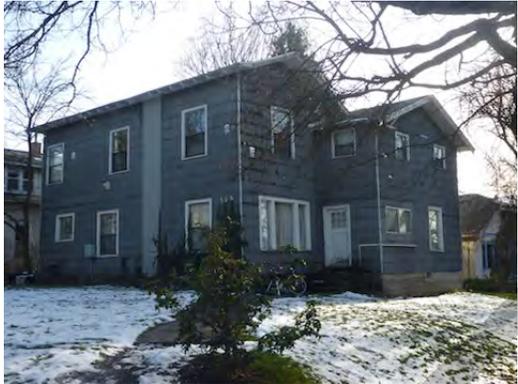
Survey Site Data	Site Photographs	Site Details
<p>Site #: 182 505 East First Street 106 South VanBuren Street Owner: First Van Buren LLC 1904-28 Previous District Status: NC (compatible), 101 DoE: NC</p>

<p>Site 182 is located on the southeast corner of First and VanBuren Streets. It is a two-story, gable-roof, multi-family dwelling. A slightly shorter, gable-roof section is found at the west end, which contains a door on the entry. It is set on a rusticated concrete block foundation, and retains numerous curved brackets beneath the eaves. The building is covered in asbestos and has replacement windows.</p>
<p>Site #: 183 509 East First Street 1912 Previous District Status: C, 102 DoE: C</p>

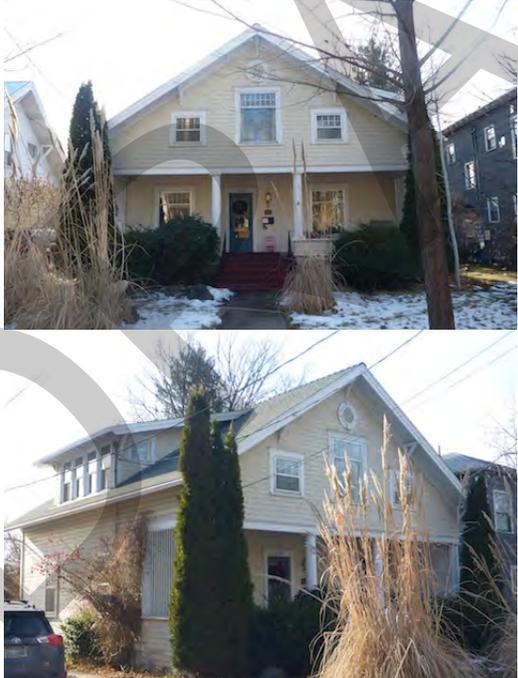
<p>Site 183 faces north toward First Street and is a one-and-one-half-story, gable-oriented Bungalow. The dwelling has a full-width porch recessed beneath the upper level, which is supported by Tuscan columns set on an apron covered in saw-tooth shingles. The lower level of the house is covered in wood drop siding, while the upper level gable end exhibits wood shingle siding. Multi-light, wood-sash windows remain. A round vent opening is found at the peak of the forward gable. Two large, shed-roof dormers are found on the house; one above each side elevation. Large brackets and visible rafter tails also remain. An original, single-car garage is found at the rear. It features a gable roof, wood drop siding, and an overhead garage door.</p>

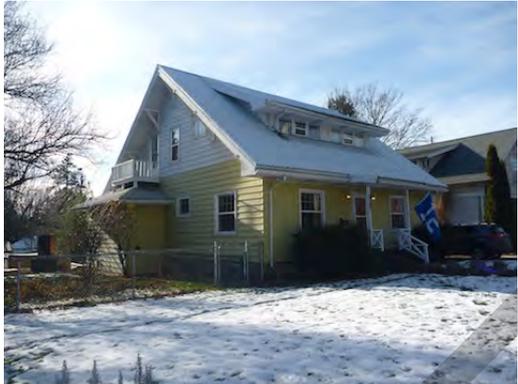
Survey Site Data	Site Photographs	Site Details
<p>Site #: 184 517 East First Street Owner: Philip Gray 1928 Previous District Status: C, 103 DoE: C</p>

<p>Site 184 is a one-and-one-half-story, side-gable roof, frame Bungalow. It features a small shed-roof porch centered on the façade, and an original, single-story, enclosed, hip-roof, rear porch on the southeast corner. A small balcony has been added over the rear porch. A shed-roof dormer is found over the façade elevation. The house rests on a concrete foundation, and has aluminum siding. The roof is sheathed in V-groove metal panels and the windows are vinyl. A small, gable-roof, one-car garage was added to the property after 1928.</p>
<p>Site #: 185 521 East First Street Owner: Richard Howe 1926 Previous District Status: C, 104 DoE: C</p>

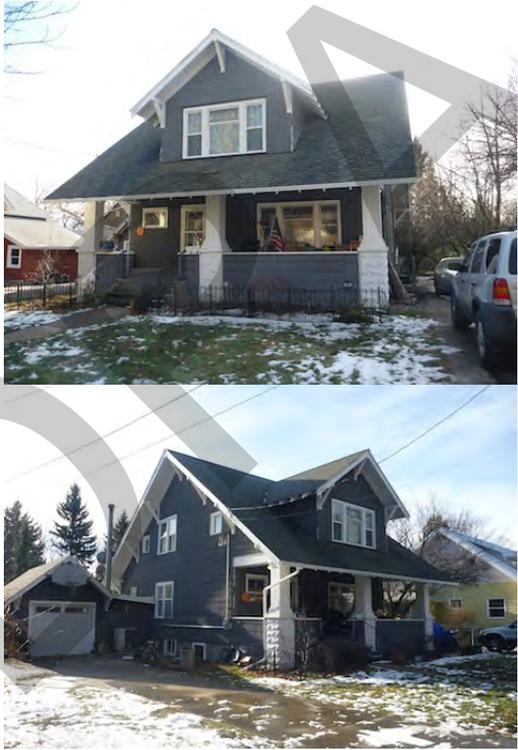
<p>Site 185 is a one-and-one-half-story, side-gabled Bungalow with a full-width porch recessed beneath the the primary roof. The roof is supported by brick columns that flare out at both the base and top, which are set on mortared, stone block piers. A large, forward-facing, gable-roof dormer is found above the façade elevation. The house exhibits visible rafter tails, large brackets, and some leaded-glass windows – though most of the sashes have been replaced with vinyl windows. The dwelling is clad in composite shingles and rests on a parged basement foundation. A gable-roof, single-car garage is attached to the dwelling’s southeast corner.</p>

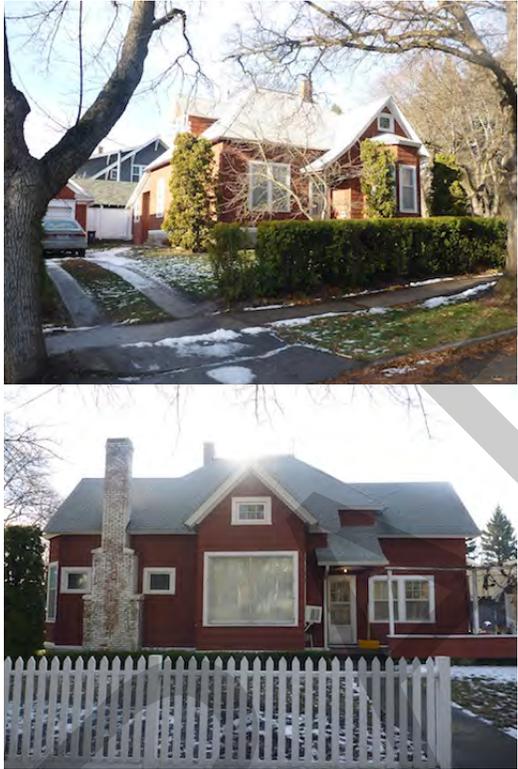
Survey Site Data	Site Photographs	Site Details
<p>Site #: 186 103 South Polk Street Owner: Edwin Helmstetter 1889 Previous District Status: NC (compatible), 105 DoE: C</p>

<p>This is a single-story, frame dwelling that was originally built as a traditional Queen Anne. The central block features a truncated hip roof with a mock widow's walk on the top. Gable-roof extensions are found on the north side, and northeast corners, and were original per Sanborn maps. A three-sided bay on the façade was also original. The roofline on the forward-facing gabled section has been extended down to provide shelter over the main entry.. A shed-roof, enclosed porch is found on the rear, southwest corner. An additional gable-roof addition is also found on the rear. A side door with a small, shed-roof extension of the rear addition roof line serves as a porch for the rear entry. The house is clad in raked cedar shingles and retains wood windows. An exterior brick chimney is found on the north elevation, while an additional brick stack pierces the roof near the widow's walk. A small, gable-roof, single-car garage is found to the rear. It exhibits cornice returns and drop wood siding.</p>

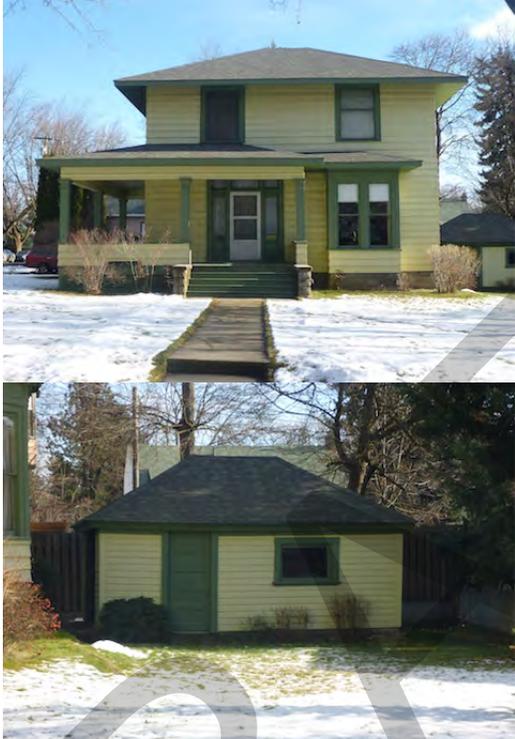
Survey Site Data	Site Photographs	Site Details
<p>Site #: 187 106 South Polk Street Owner: Kay French ca. 1900 Previous District Status: C, 106 DoE: C</p>

<p>This is a two-story, frame dwelling and is a modest representation of an American Foursquare. It features a truncated hip roof, a single-story, hip-roof porch wrapping around the northwest corner, and a single-story, three-sided bay window on the façade elevation. The main entry contains a single-light, wood door with sidelights and transoms. One-over-one, double-hung, wood-sash windows remain. The house rests on a rusticated concrete block foundation and is clad in metal or composite siding. The porch sits on square wood posts with crown molding. A small, three-sided bay window is also found on the south elevation.. A small, original, frame garage is also associated with the site. It has a hip-roof, drop wood siding, a paneled wood entry door on the west, an overhead single-car garage door on the north, and wood sash windows.</p>

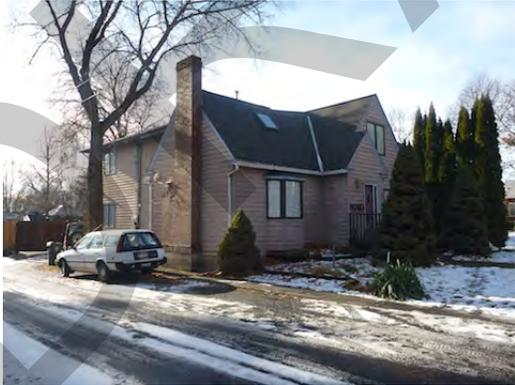
<p>Site #: 188 611-613 East First Street Owner: Theresa Hanford 1939 Previous District Status: NC (compatible), 107 DoE: NC</p>

<p>Site 188 faces north toward First Street, east of Polk Street. It is a one-and-one-half-story, cross-gabled residence with a large, gable-roofed, two-story addition on the rear. The façade exhibits a forward-facing gable, a small, single-story, enclosed, gable-roof entryway, and a nonhistoric, three-sided bay window. A single-shouldered, exterior, brick chimney is found on the east elevation. The house is covered in horizontal boards with replacement windows. Due to a number of modifications and additions, this house no longer represents its original period or characteristics.</p>

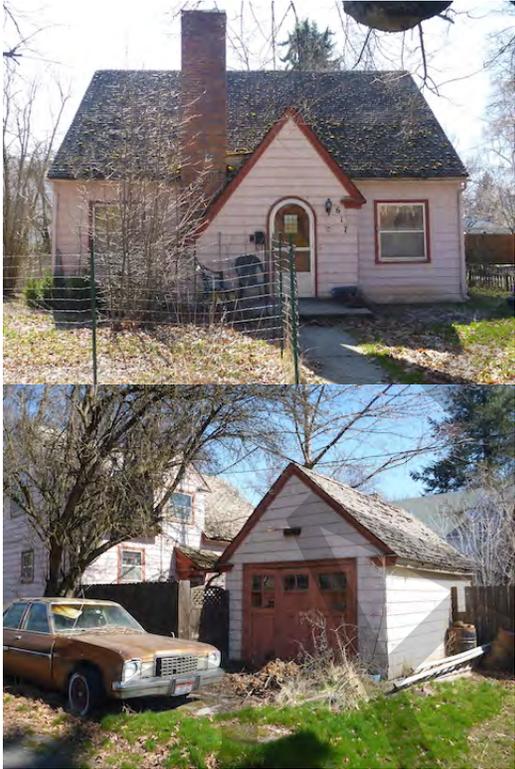
Survey Site Data	Site Photographs	Site Details
<p>Site #: 189 617 East First Street Owner: Merle Butler 1936 Previous District Status: n/a DoE: C</p>

<p>This is a one-and-one-half-story, three-bay (w/d/w), side-gable, English cottage style dwelling. An exterior brick chimney and an asymmetrical, one-story, front-gabled enclosed porch with the main entry is centered on the façade of the dwelling. It features an arched wood door with a small, twelve-light opening. The brick chimney rises from the elongated, slightly curved, east roof slope of the porch. The roof of the projection features a wide cornice and cornice returns. The entry is flanked by ten-over-one-light, double-hung, wood sash windows. Similar windows with varying multi-light, wood sashes are exhibited throughout the dwelling. A gable-roof wall dormer and an entry sheltered by a shed-roof awning with brackets are found on the rear elevation. The roof is asphalt shingles and features cornice returns. The exterior is clad in wood shingles. The house rests on a concrete foundation. A gable-oriented, one-bay garage is found to the rear of the house, and features three, four-light, wood panel doors a wide cornice and cornice returns.</p>

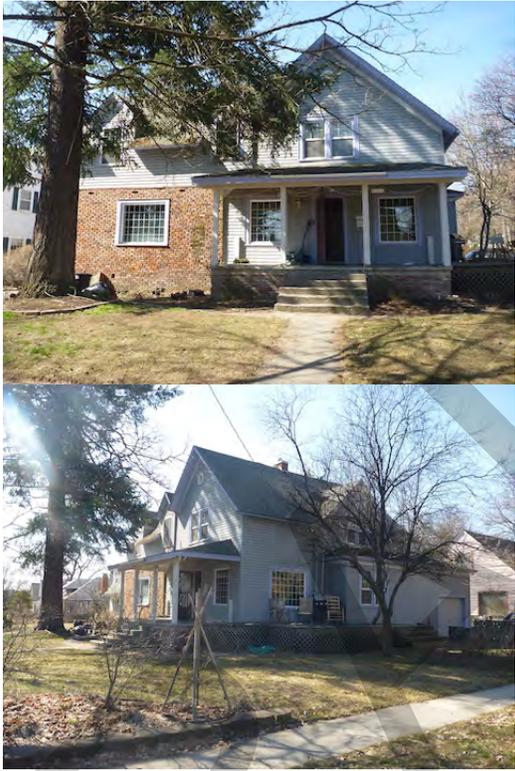
Survey Site Data	Site Photographs	Site Details
<p>Site #: 190 103 South Howard Street Owner: Jack Colliflower ca. 1900 Previous District Status: n/a DoE: NC</p>

<p>The top photograph shows a front view of a two-story house with a brick veneer on the lower level and white vinyl siding on the upper level. It features a multi-gabled roof and a front porch with a large multi-light door. The bottom photograph shows a side view of the same house, highlighting a large multi-light picture window and a nonhistoric wood deck.</p>	<p>Site 190 is a one-and-one-half-story, highly altered, multi-gable brick and frame dwelling, oriented to the north. A one-story, hip-roof porch spans partially across the facade. The porch shelters an entry with a multi-light wood door flanked by two large, twenty-five-light, nonhistoric windows. A portion of the façade exhibits a brick veneer on the lower level and features a large, multi-light picture window with two, gable-roof wall dormers above. Large, multi-light windows and paired, six-over-six-light windows are found throughout the dwelling. A nonhistoric wood deck and one-story, hip-roof addition featuring one garage bay spans the dwelling's west elevation. The roof of the dwelling is sheathed in asphalt shingles and the exterior walls are clad in vinyl. An interior brick chimney pierces the ridgeline of the front-gable section of the dwelling.</p>

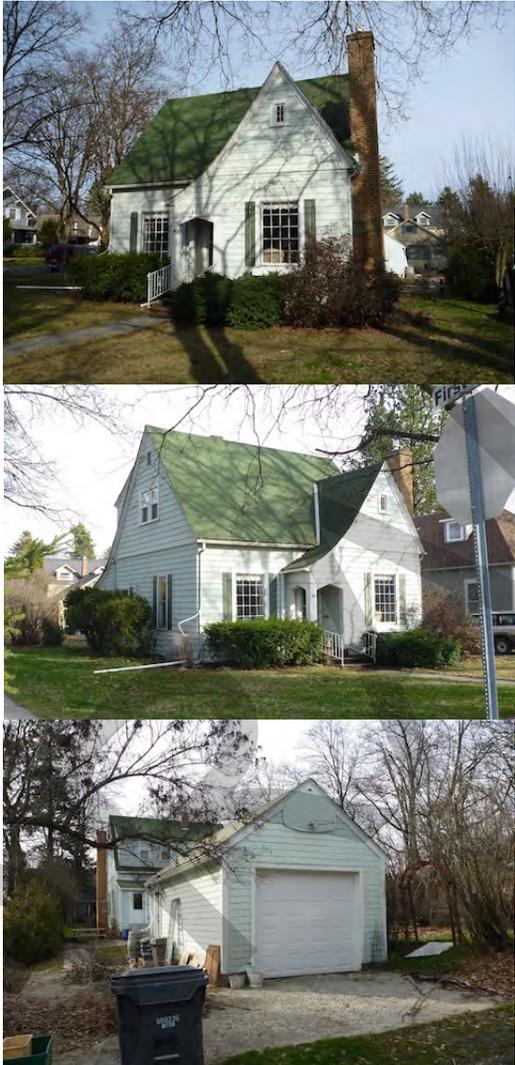
Survey Site Data	Site Photographs	Site Details
<p>Site #: 191 102 South Howard Street Owner: Ryanne Pilgeram ca. 1935 Previous District Status: n/a DoE: C</p>

<p>The photographs show a Tudor-style house with a green gabled roof, a prominent brick chimney, and a white garage. The house is surrounded by trees and a lawn.</p>	<p>This is a one-and-one-half story, side gable Tudor style dwelling with a gable-roof extension on the façade elevation. The façade's front gable features a small, six-light, wood-sash window with colored glazing in the peak and varied eave heights. A curving slope of the roof shelters the peaked entry opening and a wood-panel entry door with six-light glazing. Two, twenty-light, wood-sash windows with shutters flank the entry. A large, double-flue, outside chimney is located at the south elevation and a second chimney pierces the rear slope of the roof. The east elevation features a large shed-roofed dormer with four windows, a sloping-shed roofed extension and a hip-roof rear entry. Windows are a combination of original wood-sash and vinyl replacements. The exterior walls are sheathed in painted wood shingles and the roof is composition shingle. The foundation is concrete. Also on this site is a single-car, gable front garage that features wood clapboards, a composition shingle roof and a metal roll-up garage door.</p>

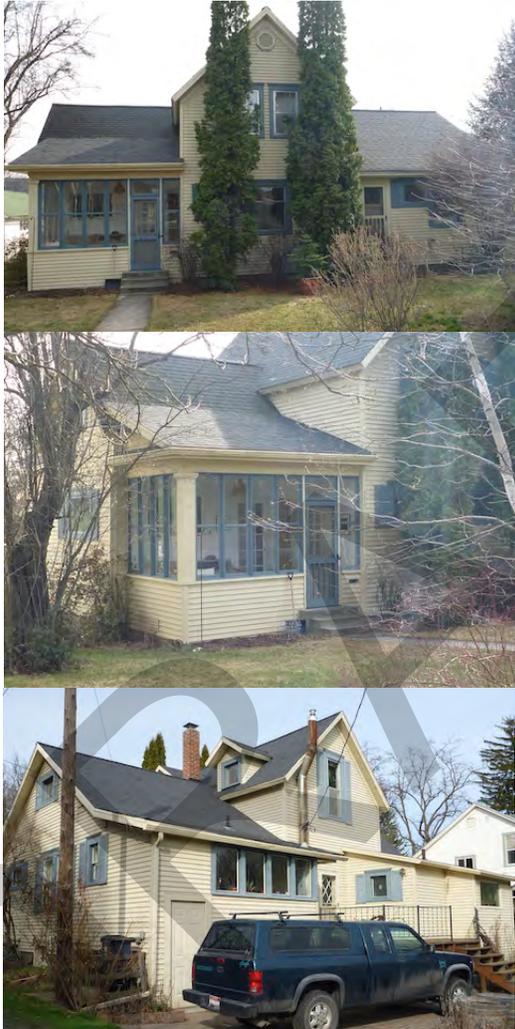
Survey Site Data	Site Photographs	Site Details
<p>Site #: 192 717 East First Street Owner: Lynn Wolfe Murray 1922 Previous District Status: n/a DoE: C</p>

<p>The photographs show a two-story house with a gabled roof and a central front porch. The top photo is a front-facing view. The middle photo shows a side view of the porch and a bay window. The bottom photo shows the rear of the house with a dark pickup truck parked in the driveway.</p>	<p>This is a one-and-one-half-story, gable-front, central block with wing dwelling that is oriented towards the north facing East First Street. The façade features the central, front-facing gable that contains wood- and aluminum-sash windows and an octagonal louvered attic vent. The filled-in entry porch is also found on the façade at the east wing. Two gable-front dormers are located on the west slope of the gable roof. The porch features one-over-one, wood-sash windows and a glazed, wood-panel door with transom. A single, French-style entry door with sidelight and a horizontal wood-sash window give entry to the house. The side-gabled west wing features a secondary entry door, three windows at the façade and a number of windows at the west elevation. At the rear of the dwelling extending from both of the wings are shed-roof additions, each with an entry door and windows. The dwelling has vinyl siding, composition shingled roofs, and a concrete, basement foundation.</p>

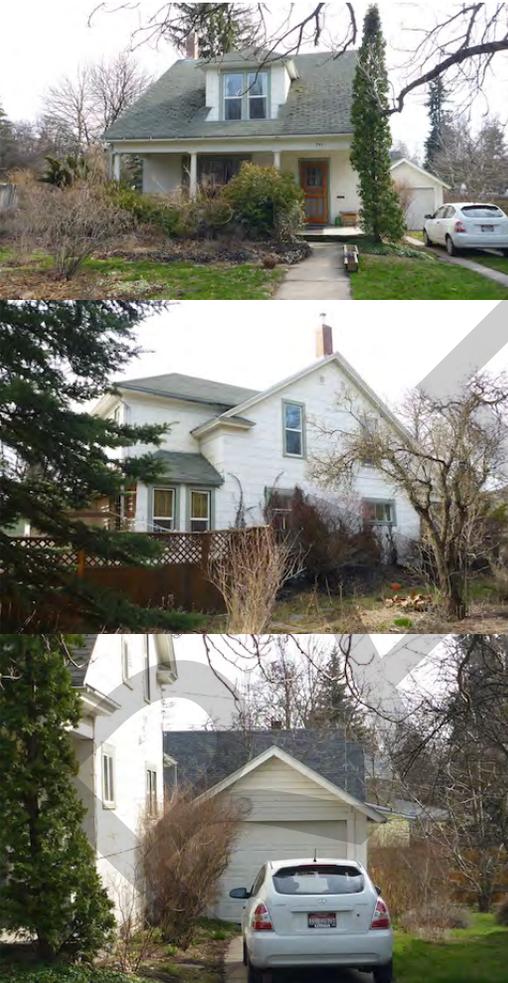
Survey Site Data	Site Photographs	Site Details
<p>Site #: 193 721 East First Street Owner: Joseph De Angelis 1911 Previous District Status: n/a DoE: C</p>

<p>The photographs show a two-story white house with a green roof. The top photo is a front view showing a porch with columns and a central door. The middle photo is a side view showing a dormer window and a chimney. The bottom photo shows a single-car garage with a white roll-up door and a white car parked in front.</p>	<p>Site 193 is a one-and-one-half story, side-gable dwelling with a full-height, hip-roof addition on the rear. The dwelling is oriented towards the north facing East First Street. The façade features a full-width porch inset under the main roof, which sits atop Tuscan-style columns. The off-center entry door is glazed wood panel and shares the porch with a wood-sash, triplet window. Also at the façade is a central, hip-roofed, inset dormer with a pair of windows. A brick, interior chimney pierces the ridge above the east elevation. A shed-roofed patio and a small shed-roofed addition are found at the rear elevation. Windows are a mix of wood-sash and vinyl, and the siding is asbestos. The roof is clad in composition shingles and features cornice returns. The foundation is rusticated concrete block. Also on the site, to the rear of the residence is a gable front, one-story, single-car garage with wood clapboards and composition shingle roof. The garage has wood-sash windows and a metal roll-up door. A linear addition to the rear of the garage has a hip roof.</p>

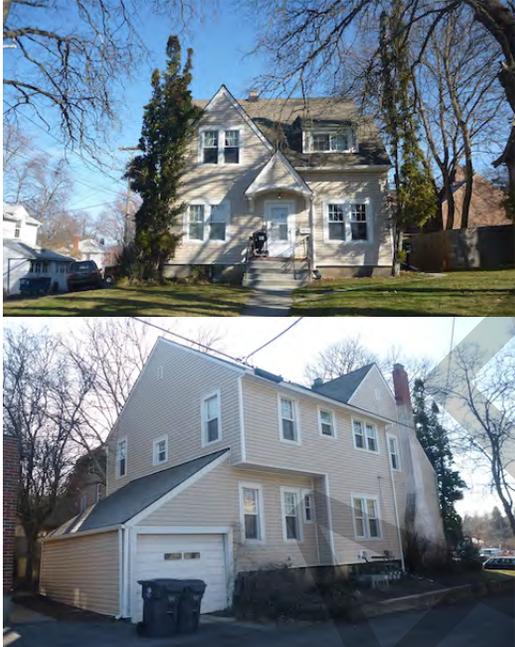
Survey Site Data	Site Photographs	Site Details
<p>Site #: 195 216-218 East Second Street Owner: Claire Chin 1937 Previous District Status: n/a DoE: C</p>

<p>Site 195 is a two-story, cross-gable-roof frame dwelling with a forward gable on the southwest corner, a small gable-roof overhang sheltering the main entry on the façade, a shed-roof dormer over the façade, and a full-height, gable-roof addition extending off the rear. A small, single-story shed-roof single-car garage is found on the far rear of the building. An exterior, enclosed, gable-roof porch is found for a side entry on the east elevation. The dwelling rests on a concrete, basement foundation and has a shouldered, brick chimney on the west elevation. The dwelling is covered in vinyl siding and exhibits vinyl windows. Scrolled brackets support the front porch roof. An additional brick chimney pierces the center of the ridgeline.</p>

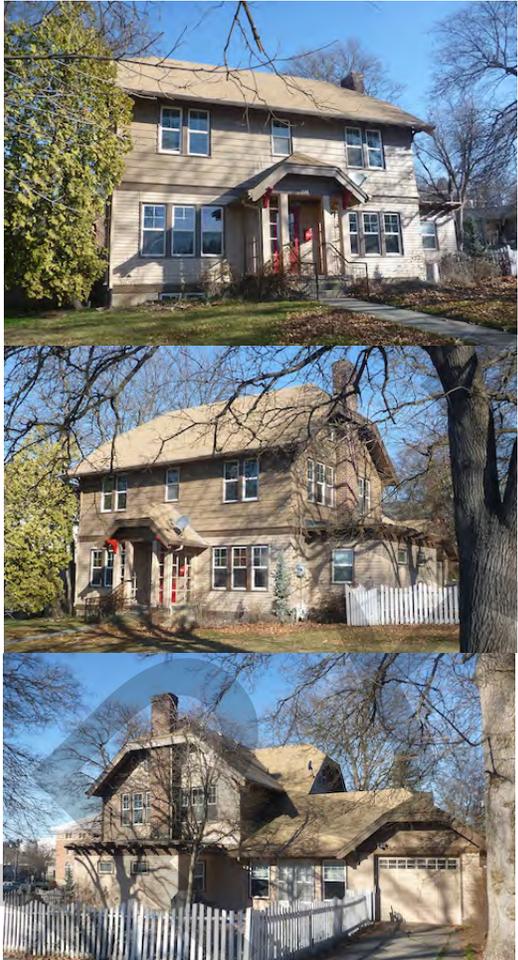
Survey Site Data	Site Photographs	Site Details
<p>Site #: 196 226 East Second Street Owner: Church, Episcopal 1904-28 Previous District Status: n/a DoE: C</p>

<p>This is a two-story, clipped-gable-roof dwelling dating to the first quarter of the twentieth century. It has a single-story, flat-roof extension on the east elevation, and a full-height extension on the rear with a single-story extension behind it that leads to a small, attached, single-car garage on the far rear: all of these extensions are original to the dwelling. A single-story, clipped-gable roof porch is centered on the façade. It is supported by square, wood posts with small, spaced-out, horizontal, wood pieces spanning between them. The dwelling is clad in clapboards on the first level, and wood shingles on the upper level. The house sits on a concrete, basement foundation and also features visible rafter tails. An exterior brick chimney extends up on the east elevation between the main block and the flat-roof extension. All the windows are vinyl and the roof is composition shingle.</p>

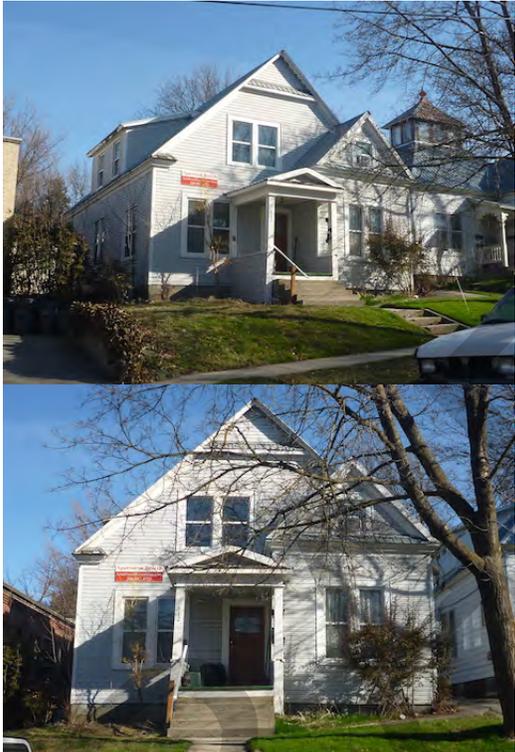
Survey Site Data	Site Photographs	Site Details
<p>Site #: 197 312 East Second Street Owner: Idaho Apartment Rentals LLC ca. 1900 Previous District Status: n/a DoE: C</p>

<p>This is a one-and-one-half-story, gable-oriented dwelling with a slightly smaller, closed-gable roof extension on the southeast corner. A small porch is centered on the façade and features a closed gable above. A shed-roof dormer is found over the west elevation. A single cornice return is found on the southwest corner on the façade elevation. The dwelling is covered in vinyl siding, contains vinyl windows, and V-groove metal roofing.</p>

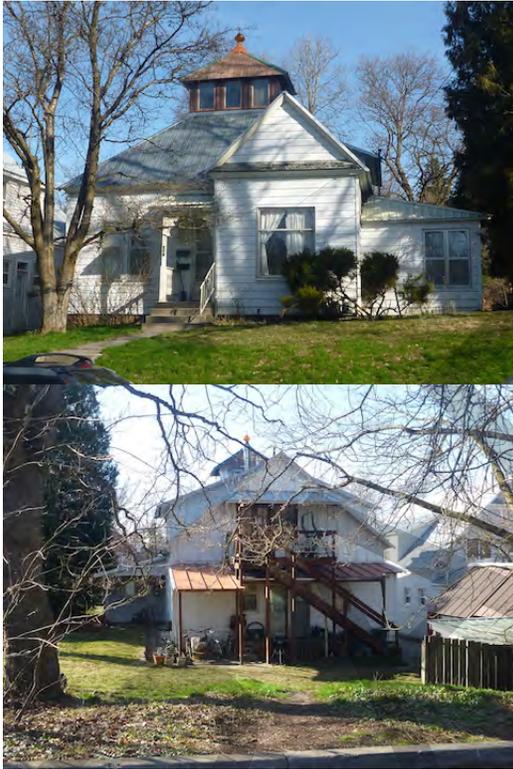
Survey Site Data	Site Photographs	Site Details
<p>Site #: 198 314 East Second Street Owner: DR2 Rentals LLC ca. 1900 Previous District Status: n/a DoE: NC</p>

<p>This is a one-and-one-half-story, truncated, hip-roof dwelling with a pyramidal-roof extension centered over the top. This early dwelling features a generally square footprint, with an original, forward-facing, gable-roof extension on the southeast corner. Originally a porch was centered on the rear, later, a larger, full-width addition was built around it. The rear addition currently features a second story with its own entry accessible via an exterior wooden staircase. A shed-roof porch spans the far rear. Two shed-roof dormers have also been added to the dwelling, one above each side elevation. A small, hip-roof, single-story addition has also been added on the east elevation. The dwelling is covered in aluminum siding. A wide porch at the southwest corner no longer remains—a small, shed-roof overhang shelters the entry. A small, gable-roof, metal shed is found at the rear of the property.</p>

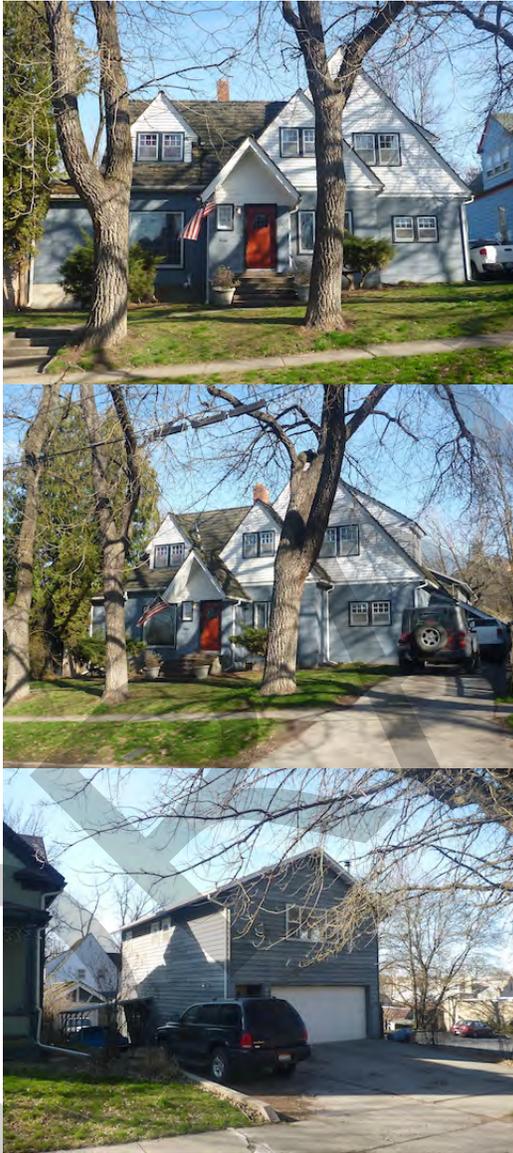
Survey Site Data	Site Photographs	Site Details
<p>Site #: 199 320 East Second Street Owner: David McIlroy ca. 1900 Previous District Status: n/a DoE: NC</p>

<p>This is a one-and-one-half-story, asymmetrical, multi-height, frame dwelling. It features a side-gabled main block, a forward-facing, gable-roof entry porch, a forward-facing, gable-roof extension beside the porch, and a larger, forward-facing, gable-roof extension on the east end. A small, single-story, side-gabled addition is found on the west elevation, and a single-car garage has been added to the basement level on the rear, northeast corner where the grade is lower in the back yard. A gable-roof dormer is found above the façade elevation, while a low-pitched, shed-roof dormer is found above the east elevation. A small, shed-roof overhang supported by scrolled brackets shelters a side entry on the east elevation. The main level of the residence is covered in asbestos shingles, while the upper level gables are clad in weatherboard. The roof is covered in wood shingles. Most of the windows in the dwelling feature vinyl sash, however, some original windows remain on the lower level, façade elevation – some with diamond-shaped panes. The garage addition on the rear is constructed of rusticated concrete block. A large, two-story, gable-roof garage with a residential unit above is found at the far rear of this lot. It features a shed-roof carport on the east side, a two-car overhead door, horizontal board siding, vinyl windows, and a small, shed-roof overhang on the west side.</p>
