National Register of Historic Places Registration Form

Historic name: Fort Russell Neighborhood Historic District (Boundary Increase and Additional Documentation)

Street & number: Roughly bounded by Jefferson Street on the west, East D Street on the north, Hayes Street on the east, and East Third Street on the south

City or town: Moscow State: ID County: Latah

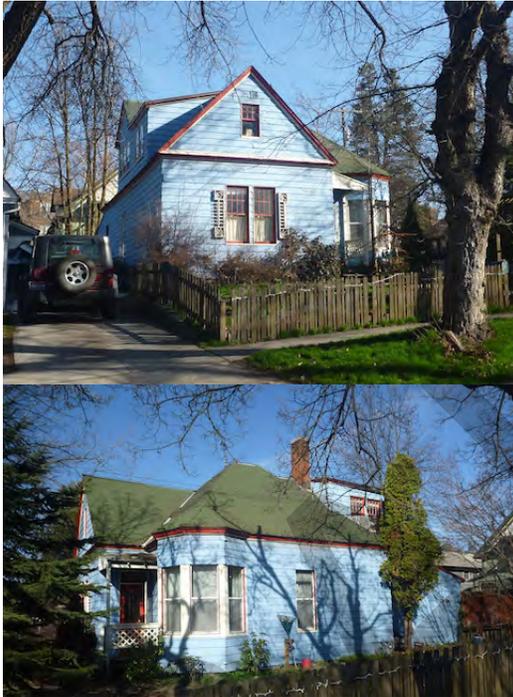
Survey Site Data	Site Photographs	Site Details
<p>Site #: 200 328 East Second Street Owner: Kelly Nolan 1907 Previous District Status: n/a DoE: C</p>

<p>This is a one-and-one-half-story, truncated hip-roof dwelling with a forward-facing, closed gable on the façade, a multi-sided bay extending on the southeast corner, a shed-roof dormer over the east elevation toward the rear, and a single-story, full-width, enclosed porch across the rear. A dormer is also found over the west elevation featuring both a gable roof and a shed roof. The dwelling is covered in aluminum siding, and retains double-hung, wood-sash windows. A small, shed-roof porch is found on the east side of the forward-facing gable. The main entry exhibits a transom window. A brick chimney extends up from the roof near the rear, shed-roof dormer. According to the 1904 and 1928 Sanborn maps, this dwelling retains its original footprint with the exception of a porch.</p>

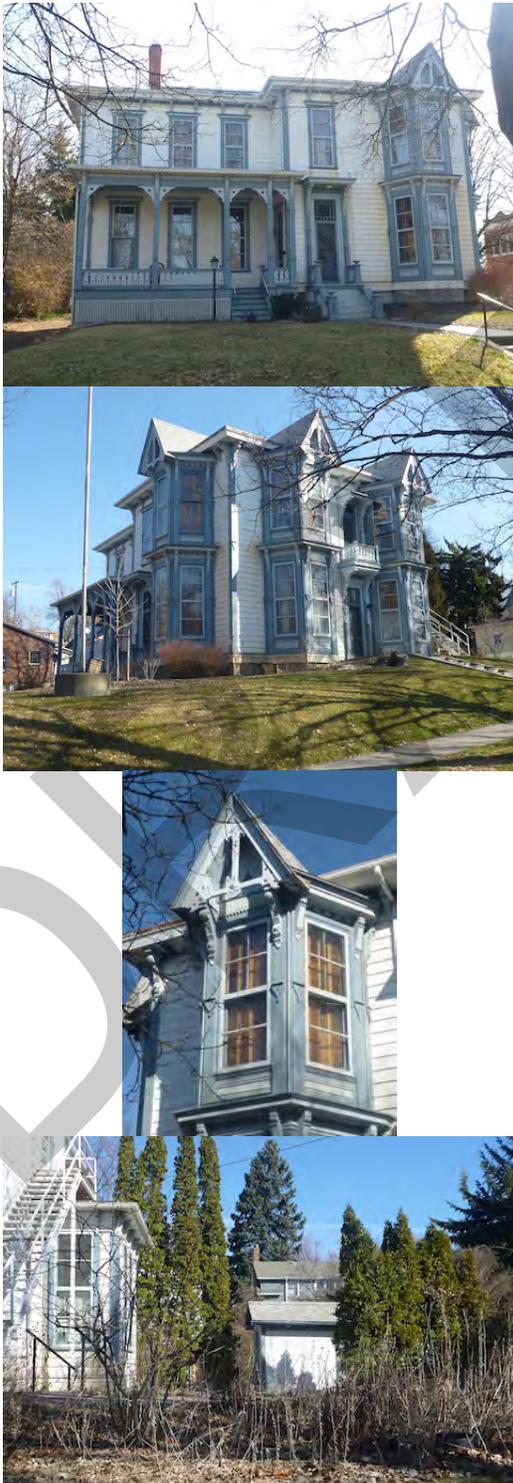
Survey Site Data	Site Photographs	Site Details
<p>Site #: 201 110 South Adams Street Owner: Latah County Historical Society 1886 Previous District Status: n/a DoE: C Previously Listed to the NRHP: 11/21/1974</p>

<p>This is the W. J. McConnell House, 1886, currently housing the McConnell Mansion Museum for the Latah County Historical Society. It was listed individually to the NRHP in 1974. It is a two-story, T-plan, frame dwelling with a hip roof and featuring a mix of Victorian-era styles including Eastlake, Italianate and Gothic-revival.. Two, full-height, three-sided bays extend out on the south elevation while one extends on the west elevation. These bays exhibit very steeply-pitched gable roofs with extensive ornamentation including detailed brackets, sawtooth imbrication, dentils, and other carved wood ornamentation. Similar brackets and carved wood ornamentation can be found throughout the dwelling. A partial-width, single-story porch is found on the west elevation, while a narrow entry door is found on the south. A second-level entry is found on the rear, accessible by an exterior staircase that extends above a single-story sun porch. The dwelling is covered in aluminum siding and retains double-hung, wood-sash windows. Some small, stained-glass windows also remain. A small, gable-roof, frame shed or garage is found to the rear. It is covered in clapboards. The McConnell Mansion appears eligible to remain listed individually on the NRHP. The building retains integrity of design, workmanship, feeling, association, and many of its materials and continues to serve as a notable and significant Victorian-era dwelling in this area.</p>

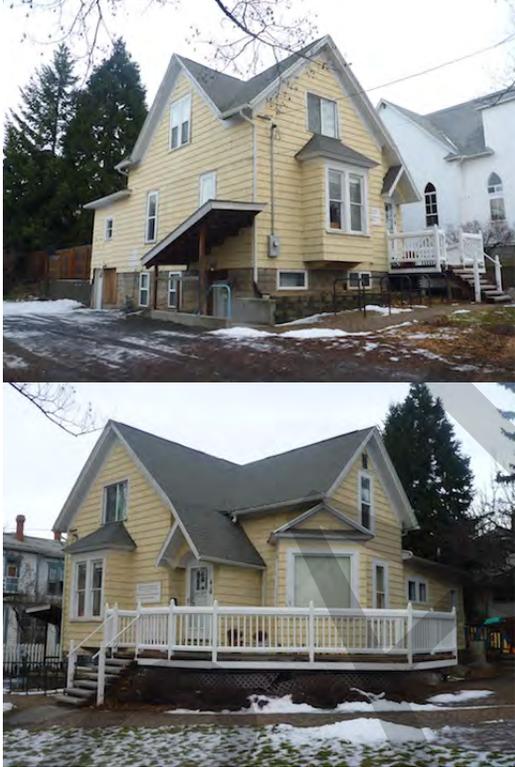
Survey Site Data	Site Photographs	Site Details
<p>Site #: 202 414 East Second Street Owner: Church, Unitarian 1904-28 Previous District Status: NC (compatible), 98 DoE: NC</p>

<p>This is a one-and-one-half-story, cross-gable roof, frame dwelling with original single-story extensions on the northwest and northeast rear corners. As indicated by Sanborn maps, the single-story bay window on the façade elevation, the enclosed porch beneath an extension of the roof on the façade, a corner, gable-roof bay on the southeast corner, and a covered stair on the west side are all nonhistoric alterations. Originally, an L-shaped porch wrapped around the southeast corner; today a rounded deck is found at that corner. The building is set on a rusticated concrete-block foundation with a basement, and the exterior is covered in wood shingles. Both wood-sash and metal windows are present. This house is currently known as “The Yellow House,” serving as the Religious Education Building for the Unitarian Universalist Church of the Palouse, located next door.</p>

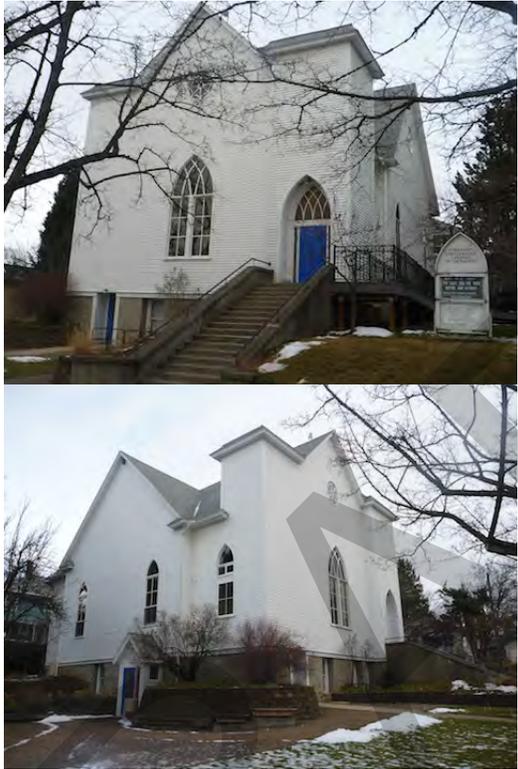
Survey Site Data	Site Photographs	Site Details
<p>Site #: 203 420 East Second Street Owner: Church, Unitarian 1905 Previous District Status: C, 99 DoE: C</p>

<p>This is the Unitarian Universality Church, situated on the northwest corner of East Second and VanBuren. It is a large, cross-gable roof frame building constructed as the Emmanuel Lutheran Church, replacing the earlier Swedish Lutheran Church on this site. It features a cross-roof plan, with full-height towers flanking the gable on both the southwest and southeast corners. The building contains Gothic-arched windows with paired, six-light, wood-sashes below and either single-light or tracery sashes above. Some windows contain vinyl replacement sashes. Original wood-sash, rose windows are found in the peak of the south and east gables. The building also exhibits small cornice returns. The main entry is recessed within a Gothic arch on the east end of the south elevation. Secondary entries are located on the northeast corner, and the basement level on the west side. The building is covered in vinyl siding and rests on a parged foundation. An ADA accessible ramp is found on the east elevation and an exterior brick chimney is centered on the north.</p>

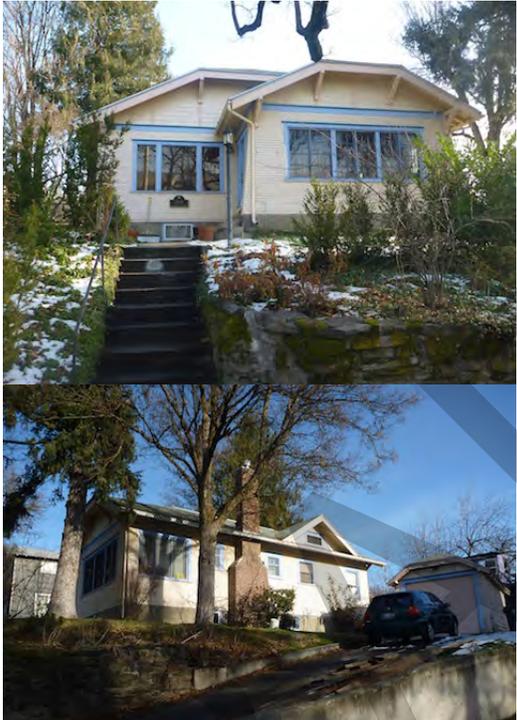
Survey Site Data	Site Photographs	Site Details
<p>Site #: 204 110 South VanBuren Street Owner: Sandra Reineke 1923 Previous District Status: C, 100 DoE: C</p>

<p>This is a one-and-one-half-story Bungalow with an L-shaped footprint. The dwelling features a jerkinhead roof on both the main block and the enclosed porch extension. The porch exhibits three twelve-light, wood-sash windows, while the main entry door exhibits fifteen lights and is flanked by multi-light sidelights. The lower portion of the porch walls flare. The dwelling is clad in weatherboard with wood shingles in the gable ends. Details include brackets, visible rafter tails, wood-sash windows, and wood trim with crown moldings. A gable-roof dormer and an exterior, shouldered, brick chimney are found on the south elevation. A one-car garage is found at the southeast corner of the house exhibiting details and materials similar to the house. A nonhistoric, shed-roof outbuilding and a plywood tree house are also found at this site.</p>

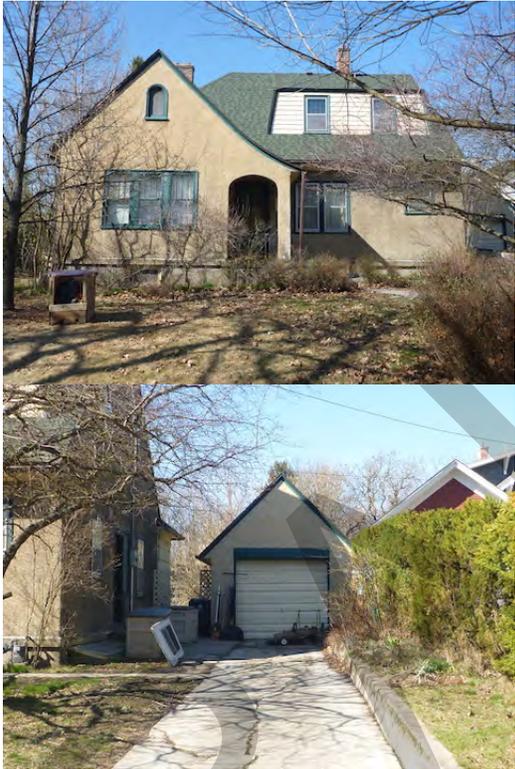
Survey Site Data	Site Photographs	Site Details
<p>Site #: 205 115 South Polk Street Owner: Brian Johnson 1928 Previous District Status: n/a DoE: C</p>

<p>This is a one-and-one-half-story, four-bay, cross-gable, English cottage dwelling. It features a front-gable projecting from a truncated hip-roof section and a rear addition. The front-gable exhibits a curved east roof slope, which shelters a porch entry featuring an arch entryway and supported by a wide post with a metal railing. A set of three, four-over-one, double-hung, wood-sash windows are found south of the entry with a small arched window in the gable peak. Individual and paired wood-sash windows are exhibited throughout the dwelling. A dormer with two windows and horizontal board siding is found on the front roof slope. A one-story, rear addition clad in horizontal board siding spans the dwelling's rear elevation. Brick chimneys pierce both ridgelines of the house. The roof is asphalt shingles, the exterior walls are clad in aggregate and the foundation is concrete. A one-bay, gable-roof garage with a metal door and aggregate siding is found adjacent to the house.</p>

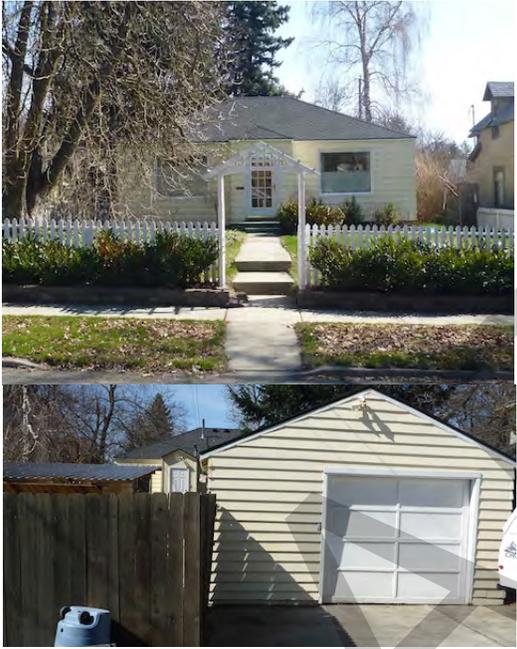
Survey Site Data	Site Photographs	Site Details
<p>Site #: 206 114 South Polk Street Owner: Thomas Whitney 1947 Previous District Status: n/a DoE: NC</p>

<p>Site 206, oriented the west, is a one-story, three-bay, hip-roof, Minimal Traditional dwelling. A small, enclosed, hip-roof entry porch is centered on the façade and features an entry with a nonhistoric, fifteen-light door. The small entry porch is flanked by two large picture windows. The roof of the dwelling is sheathed in asphalt shingles and the exterior walls are clad in horizontal board siding. The house rests on a concrete foundation. The one-bay, gable-roof garage is located just northeast of the house. It is similar in appearance and materials to the dwelling and is also clad in wide, horizontal boards.</p>

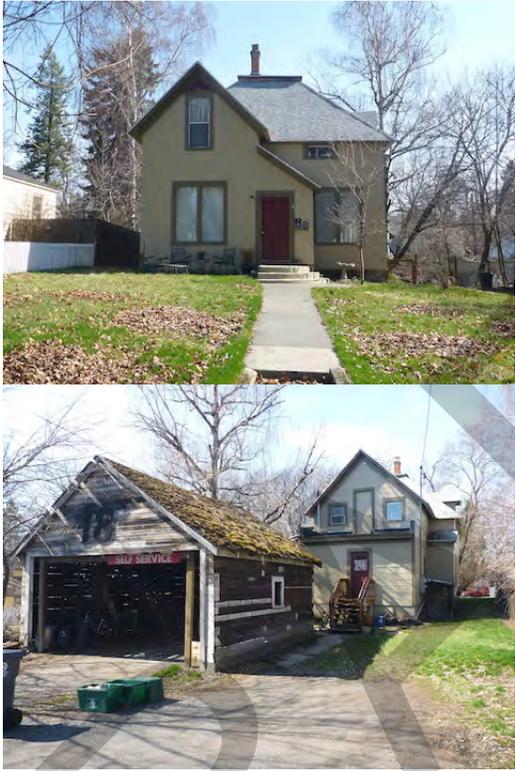
Survey Site Data	Site Photographs	Site Details
<p>Site #: 207 120 South Polk Street Owner: Brenda Truelove 1914 Previous District Status: n/a DoE: C</p>

<p>This is a one-and-one-half-story, three-bay (w/d/w) dwelling that features a main, truncated-roof section with a front-facing, gable projection. A one-story, enclosed porch is found on the façade. A single-leaf entry with a simple surround and a large vertical, two-light window is featured on the façade. A similar, two-light window is found on the façade of the dwelling's pyramidal roof section. One-over-one windows and one-light windows are exhibited on the dwelling. Gable-roof dormers pierce the ridgeline of the dwelling's north and south roofs. A brick chimney rises from the, truncated hip roof. Multi-height additions span the rear of the dwelling. Two entries provide access on lower and upper levels of the rear additions. The house rests on a brick foundation while the rear additions rest on concrete. The roof of the dwelling is sheathed in asphalt shingles and the exterior walls are clad in asbestos siding.. A gable-roof, frame garage is found to the rear of the dwelling and exhibits exposed rafter tails, horizontal, wood board siding and rests on a concrete block foundation.</p>

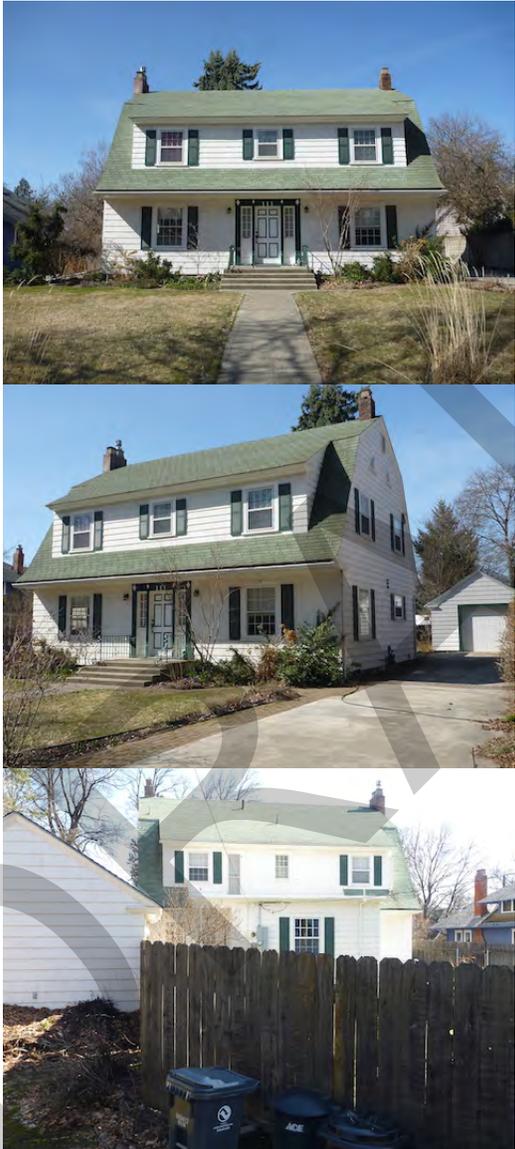
Survey Site Data	Site Photographs	Site Details
<p>Site #: 208 111 South Howard Street Owner: Eric Engerbretson 1934 Previous District Status: n/a DoE: NC</p>

<p>Site 208 is a two-and-one-half-story, three-bay (w/d/w), gambrel-roof dwelling. The central, main entry door with painted trim is flanked with eight-light, paneled sidelights and exhibits pilasters and wood trim featuring diamond cut outs. The entry is flanked by eight-over-eight, double-hung windows. The wide eave of the gambrel roof's front slope shelters the lower level of the façade. A large, shed-roof dormer with a wide cornice featuring three windows is situated at the facade. Eight-over-eight-light, double-hung windows are exhibited throughout the dwelling. A shed-roof projection spans the majority of the dwelling's rear roof slope and features a single-leaf entry that leads to the roof of a one-story, rear extension. Brick chimneys pierce the ridge line. Half-fanlight windows flank the chimneys. The roof of the dwelling is sheathed in asphalt shingles and the exterior walls are clad in wood shingle siding. The house rests on a concrete foundation. A front-gable, one-bay garage featuring wide cornice returns is located in close proximity to the house.</p>

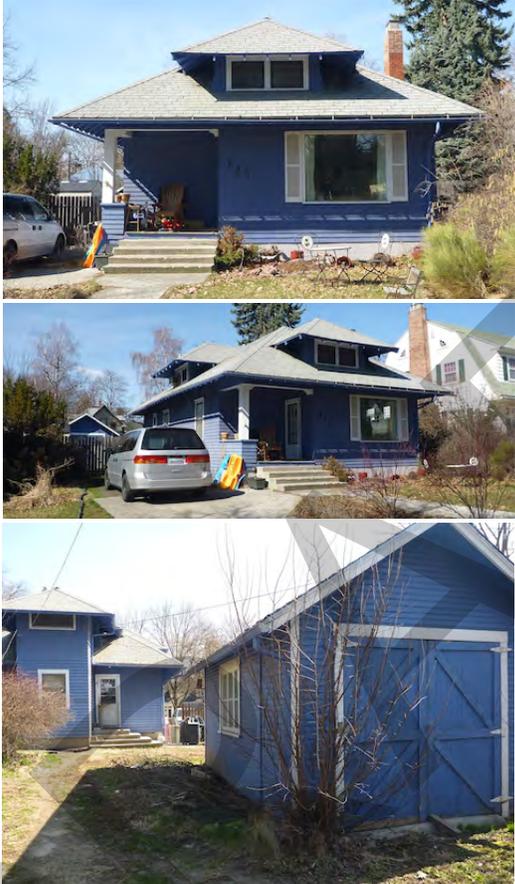
Survey Site Data	Site Photographs	Site Details
<p>Site #: 209 117 South Howard Street Owner: Sunil Ramalingam 1915 Previous District Status: n/a DoE: C</p>

<p>This is a one-and-one-half-story, hip-roof Bungalow. The façade features a recessed porch is on the southeast corner and a picture window with fixed shutters to the north. The porch features one large, square post that rests atop an enclosed railing and shelters the entry door. The dwelling exhibits deep, angled roof overhangs with exposed rafter tails that extend below the eaves. This feature is replicated on the large, hip-roof dormers with paired, multi-light, windows found over the façade, north and south elevations. Individual and paired, multi-light, wood-sash windows are found throughout. A narrow, two-story, hip-roof projection extends from the central section of the rear elevation. The roof is sheathed in asphalt shingles and the exterior walls are clad in clapboards. The house features two brick chimneys on its north and rear sides. The dwelling rests on a concrete block foundation. A gable-roof garage with a pair of doors and a shed are found to the rear of the dwelling.</p>

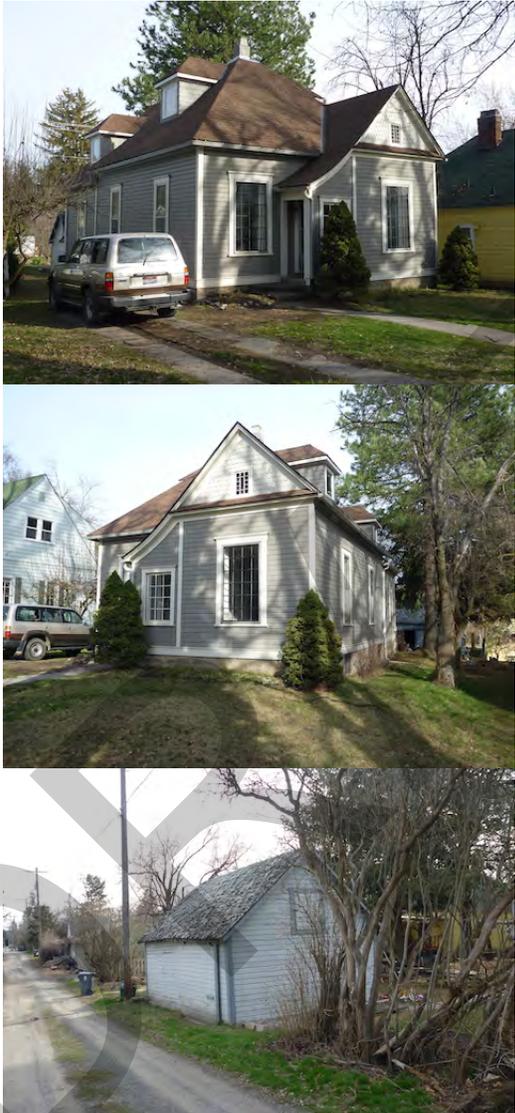
Survey Site Data	Site Photographs	Site Details
<p>Site #: 210 104-108 South Howard Street Owner: Joel Penney 1920 Previous District Status: n/a DoE: C</p>

<p>Site 210 is a one-and-one-half story, hipped-roof Queen Anne style dwelling with a gable-roof projection on the façade. The façade features fish-scale, wood shingle imbrication and a colored, multi-light, wood-sash window in the closed, front-facing gable. Two large, twenty-four-light, wood-sash windows are located flanking the porch at the first level. The porch was altered to a Tudor-style roofline that creates an enclosed entry with a multi-light window in the exterior wall and shelters the entry door. The tall, main roof has four, hipped-roof dormers with fish scale shingles; two on the north slope and two on the south. Each dormer contains a single, vinyl window. A central chimney pierces the roof at the ridge. The foundation is rusticated concrete block, the walls are clad in wood drop siding and the roof is composition shingle. Windows are original with classical wood surrounds. Also on this site at the rear of the property is a side gabled, single-car garage. The garage features wood drop siding, composition shingle roof, a small attic access hatch, and a wood-sided sliding barn-style door. Though the façade of this dwelling has been altered with a Tudor porch, this change is now historic itself and did not diminish the dwelling's original form, style or most character-defining features.</p>

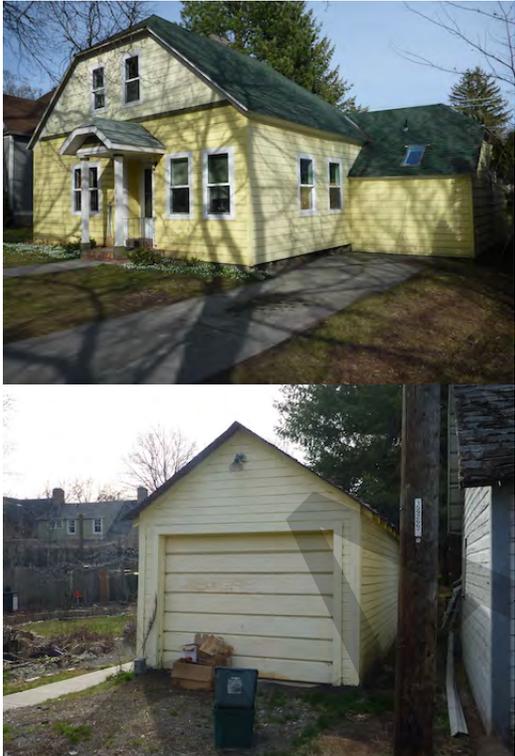
Survey Site Data	Site Photographs	Site Details
<p>Site #: 211 114 South Howard Street Owner: James Wilson 1923 Previous District Status: n/a DoE: C</p>

<p>This is a one-and-one-half story, gable-oriented dwelling with a clipped-gable roof and a smaller, single-story, clipped-gable-roof addition. The façade features a clipped gable porch roof atop square posts sheltering an inset, wood panel entry door. Windows are vinyl replacements, siding is wide composite clapboard with machine-cut wood shingles in the gable ends, and a skylight is noted in the west-facing slope of the addition's roof. A hip-roof addition is found at the rear of the dwelling. A double flue brick inside chimney is located on the north slope of the main roof. Also at this site is a gable-front, single-car garage with wood, drop siding, exposed rafter tails, composition shingle roof, and a metal, roll-up garage door.</p>

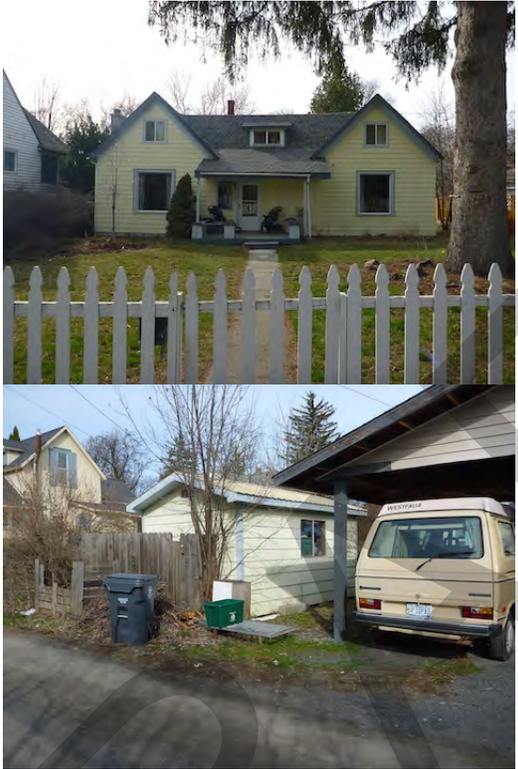
Survey Site Data	Site Photographs	Site Details
<p>Site #: 212 113 South Monroe Street Owner: David Tank ca. 1900 Previous District Status: n/a DoE: NC</p>

<p>This is an H-shape dwelling with twin, front-facing gables connected by a crossing roofline. The symmetrical façade features an entry porch sheltered by a nonhistoric shed roof supported unevenly on square posts; one that rests on the porch deck and one that sits on a concrete pier on the ground. The off-center entry door and a fixed pane window are flanked by the front-facing gables that feature picture windows at the first level and horizontal slider windows in the peaks. A small, shed-roof dormer with a slider window is centered on the front-facing roof slope above the porch. The windows are metal and vinyl replacements. The walls are covered in painted cedar shingles. A concrete block chimney is found at the south elevation and a brick chimney is on the rear slope of the roof. A small, gable-front shed with composite board siding, metal roof and aluminum frame windows is found at the rear of the site.</p>

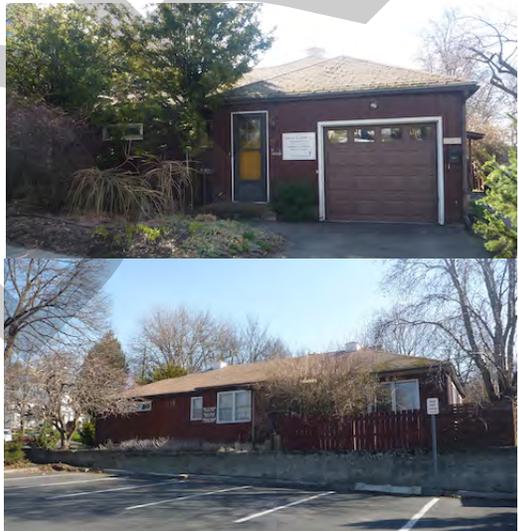
<p>Site #: 213 309-311 East Second Street Owner: Geary-Kirsch, LLC 1950 Previous District Status: n/a DoE: NC</p>

<p>This is a single-story, hip-roof, frame, Ranch house, which is being utilized as commercial space housing a law office. Several sections extend out slightly from the primary wall planes on both the northeast and southwest corners. A single-car garage extends forward from the northwest corner. This forward extension also houses the main entry, which retains a glazed wooden door. The dwelling is covered in vertical boards. Double-hung, wood-sash windows remain. Two small extensions are found over the ridgeline on the main block of the dwelling. They feature hipped roofs, and may be either capped chimneys or decorative cupolas. A side entry is found on the west elevation sheltered by a shed-roof overhang.</p>

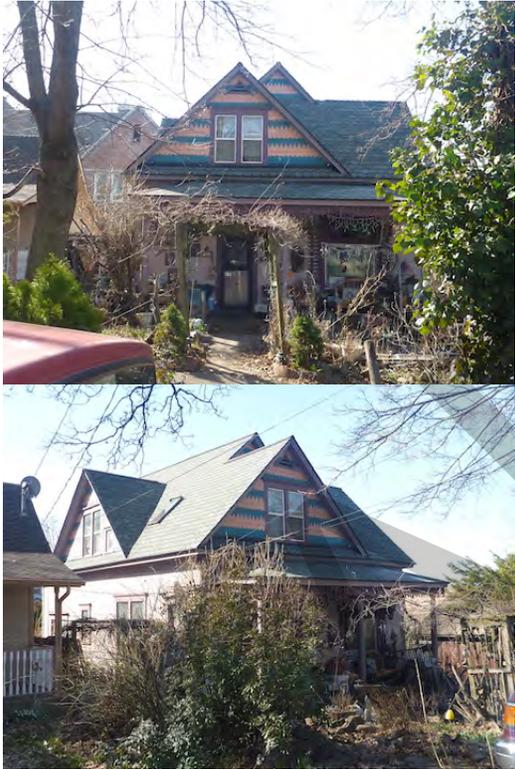
Survey Site Data	Site Photographs	Site Details
<p>Site #: 214 315 East Second Street Owner: Ellyn Kerr 1910 Previous District Status: n/a DoE: C</p>

<p>Site 214 is a gable-oriented, one-and-one-half-story, Victorian. It features a large gable over the façade, a small, forward-facing, gable-roof peak above the main roofline, a side-facing, gable-roof extension on the northwest corner, and a gable-roof dormer over the east elevation. The gables are filled with scalloped and sawtooth shingles, while the main level clad in narrow clapboards. The windows on the house contain vinyl replacement sashes, but retain simple wood surrounds with crown molding; many of the windows are paired. A small, stained-glass transom is found above a large single-light window on the façade. The roof is sheathed in composition scalloped shingles resembling slate tile. A full-width porch spans the façade, while a partial-width, enclosed porch is found on the rear. The front porch is decorated with ornamentation. A small bay window extends on the west elevation. A small, gable-roof garage is found behind the house. It exhibits similar materials as the dwelling.</p>

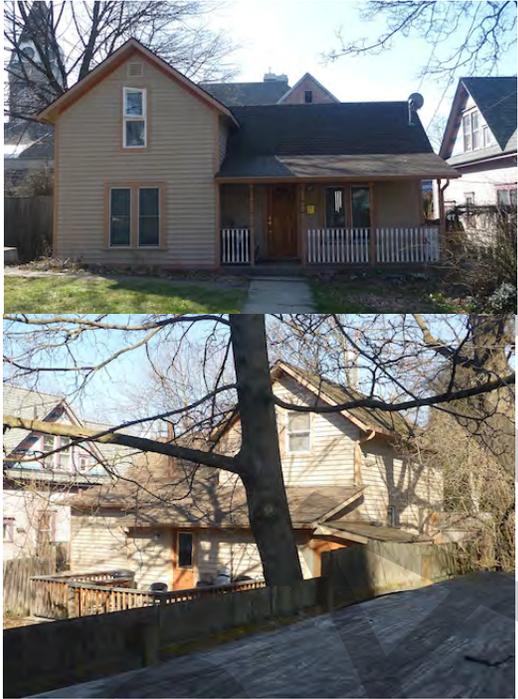
Survey Site Data	Site Photographs	Site Details
<p>Site #: 215 319 East Second Street Owner: Matt Ruck ca. 1900 Previous District Status: n/a DoE: C</p>

<p>This is an Upright and Wing house, with a one-and-one-half-story, forward-facing, gable-roof section on its east and a single-story, side-gabled section on its west side (creating a T-plan). A single-story porch beneath a shed-roof extension of the primary roof expands across the width of the single-story section. An original, enclosed section is found on the rear of the single-story section, while an additional enclosed porch has been added to the rear of the upright section. A small, shed-roof enclosure has also been added on the rear, southeast corner of the dwelling. The house is covered in clapboard siding with wood corner boards. The windows have been replaced with vinyl and a wooden deck has been added on the rear. The turned posts and balustrade on the front porch appear to be nonhistoric replacements.</p>

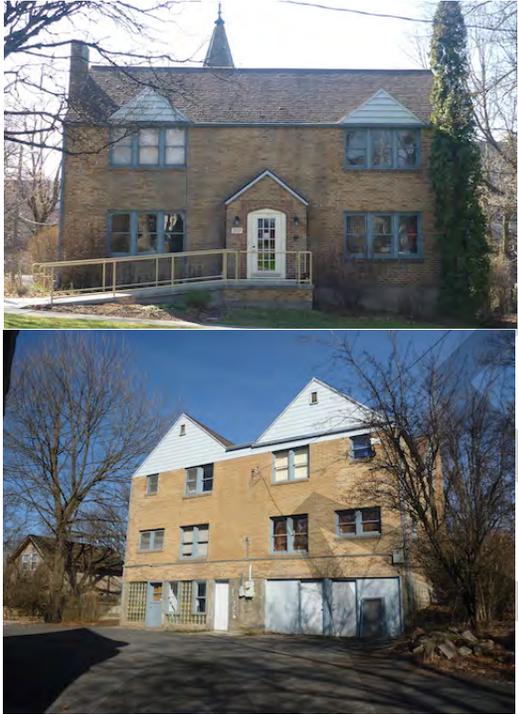
Survey Site Data	Site Photographs	Site Details
<p>Site #: 216 327 East Second Street Owner: Latah County Historical Society 1937 Previous District Status: n/a DoE: C</p>

<p>This is the Centennial Annex, a building being utilized by the Latah County Historical Society for archives and offices. It is a 1937 multi-unit dwelling with two stories set on a basement foundation. It features a side-gabled section toward the front, and two rear facing gables on the back. It is a frame building finished with a brick veneer exterior. It exhibits a symmetrical, three-bay (www/d/www) façade with a centered, gable-roof, enclosed entry. Small forward-facing gables rise above the triplet windows on the second level. One-over-one, double-hung, wood-sash windows remain throughout. An exterior, shouldered, brick chimney is found on the east elevation. Basement level carports or garages on the rear elevation have been enclosed and an enclosed rear porch was removed due to structural issues. All the gables are covered in horizontal boards. This building was determined ineligible for individual inclusion in the NRHP in 1988, but is being recommended here as a contributing element to an expanded Fort Russell Historic District.</p>

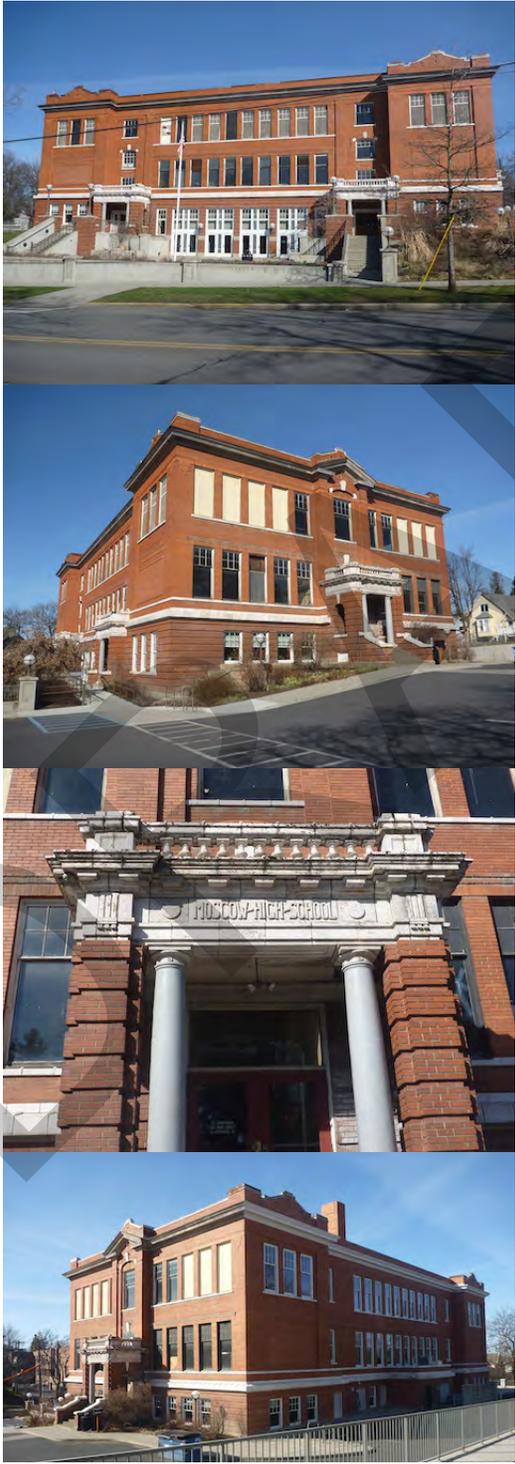
Survey Site Data	Site Photographs	Site Details
<p>Site #: 217 410 East Third Street Owner: City of Moscow 1912 Previous District Status: n/a DoE: C</p> <p>Previously Listed to the NRHP: 5/5/1992</p>

<p>This is the old Moscow High School, built in 1912 designed by Spokane architect Clarence Hubbell, which was listed to the NRHP in 1992. It is a two-story building set on a raised basement foundation. It has an H-shape plan with gabled parapets on each of the four corner extensions and full-height entry porticos centered on the east and west sides. A flat-roof entry porch extends out from each of these sides, each with granite pillars, terrazzo flooring, and terra cotta ornamentation including a wide entablature and small balustrade surrounding the top. The entries are accessed by concrete stairs flanked by brick knee walls that are capped with terra cotta tiles. Two additional similar porches are found on the south side. A metal cornice and a terra cotta water table surround the building. On the basement elevation the brick runs in bands, with narrow recessed areas between. Soldier coursed bricks run above the windows, some of which retain wood-sashes though some have been replaced or are boarded over. The sides of the entry porches exhibit arched openings with terra cotta keystones. The terra cotta detailing exhibits a splattered decorative finish. Keystones are also found above segmentally-arched windows found above the entries. The building currently houses the 1912 Center, a community arts facility.</p>

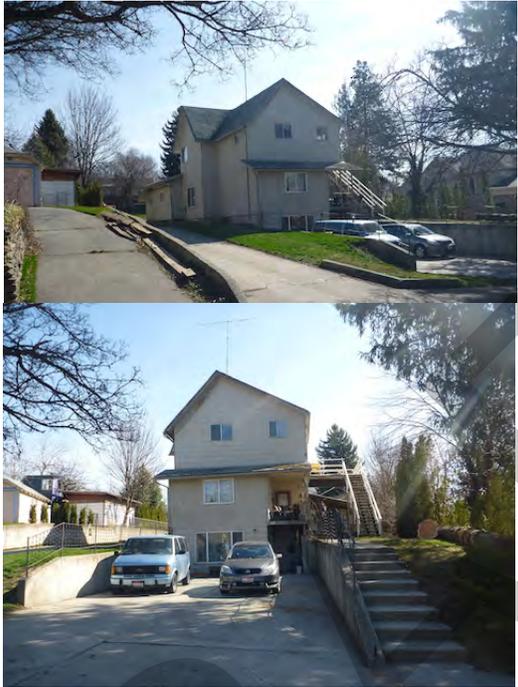
Survey Site Data	Site Photographs	Site Details
<p>Site #: 218 122 South VanBuren Street Owner: Marietta Davis et al Trust ca. 1900 Previous District Status: n/a DoE: NC</p>

<p>The Wylie A. Lauder house is a two-story, significantly altered, cross-gable dwelling, oriented to the west. The residence features an asymmetrical, two-story front-gable section projecting from a two-story, side-gable section with multi-level additions. A poured-concrete driveway flanked with concrete walls leads to a fully above ground basement entrance accessed by a lower-level, shed-roof addition that spans the width of the dwelling's front-gable section. This section features recessed porches with entries on the southeast corners and nonhistoric windows. Wood steps lead to a small wood deck with railings on the upper level of the dwelling's east elevation. One-story, shed-roof additions are also found on the east and rear elevations of the dwelling. The house features aluminum windows throughout and is clad in asbestos shingles and, vertical board siding. The roof is sheathed in asphalt shingles.</p>

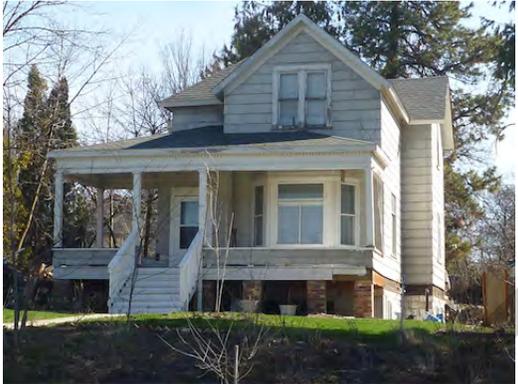
Survey Site Data	Site Photographs	Site Details
<p>Site #: 219 204 South VanBuren Street Owner: Kjelda Berg 1921 Previous District Status: n/a DoE: C</p>

<p>This is a two-story, frame dwelling with a main, side-gable section with a front-gable section projecting from a pyramidal roof portion found on its south elevation. A two-story, front-gable section spans the width of the main side-gable block's rear elevation, with a hip-roof addition extending from its rear elevation. A one-story, hip-roof porch spans the façade of the dwelling. The porch rests on brick piers, is supported by square wood posts and features dentil molding. The main entry is located on the façade of the dwelling, with a bay window spanning the majority of the front-gable section under the porch. The house features one-over-one, wood-sash windows and is clad in asbestos shingles. The roof of is sheathed in asphalt shingles and the house rests on a foundation of rusticated blocks. A small, prefabricated, metal shed is situated at the rear of the lot.</p>

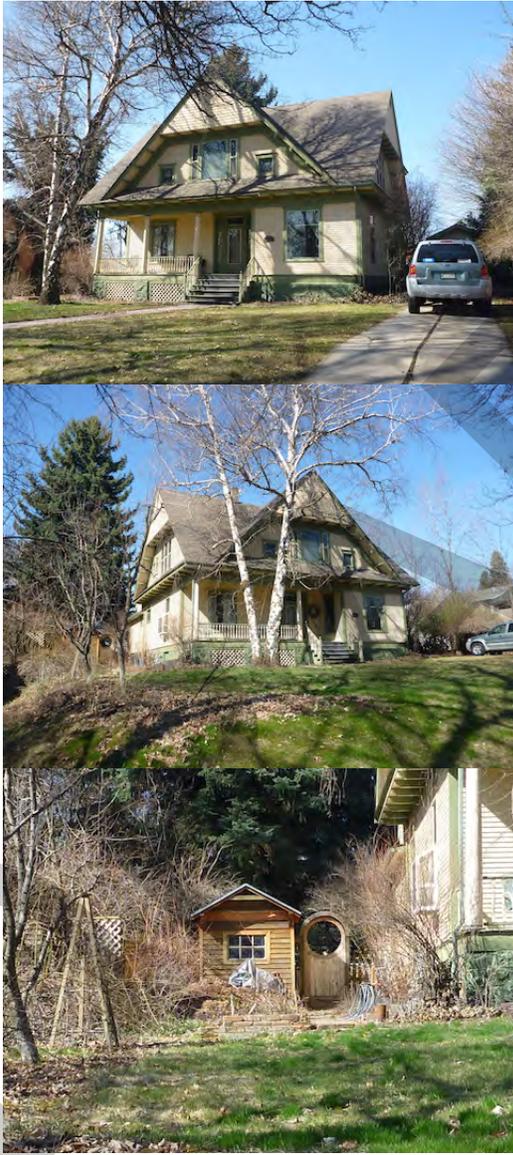
Survey Site Data	Site Photographs	Site Details
<p>Site #: 220 123 South Polk Street Owner: Jay Hunter 1902 Previous District Status: n/a DoE: C</p>

<p>The photographs show a two-story house with a prominent gable roof. The top photo is a front view showing a porch and a large window. The middle photo is a side view showing the house's profile and a tree. The bottom photo shows a small, gabled outbuilding with a circular window.</p>	<p>This is a one-and-one-half-story, three-bay, steeply pitched, cross-gable roof, frame dwelling. A large, central, front-facing gable spans the majority of the east roof slope on the façade of the dwelling. A triplet window is centered within the portion of the gable recessed from the wide eaves with decorative, straight braces. A smaller, square, diamond-pane leaded glass window is found on either side of the triplet window. These features are found in all of the gable ends of the dwelling. Large picture windows and a recessed porch span the central and south section of the dwelling's façade. The porch is supported by round posts. Narrow spindled railings enclose the porch. The main entry features a full-light door flanked by single-panel, full-light sidelights and a full-light transom above with a decorative door surround. All windows feature simple wood surrounds. The rear roof slope exhibits a smaller, gable-roof projection to compliment the façade. The roof of the dwelling is sheathed in asphalt shingles with exposed rafter tails below the wide eaves. The exterior walls are clad in weatherboard and the house rests on a stone foundation. A gable-oriented garage is located northwest of the dwelling and features a one-bay garage door entry and is clad in weatherboard siding. A small, gable-roof, wood outbuilding is found just south of the dwelling.</p>

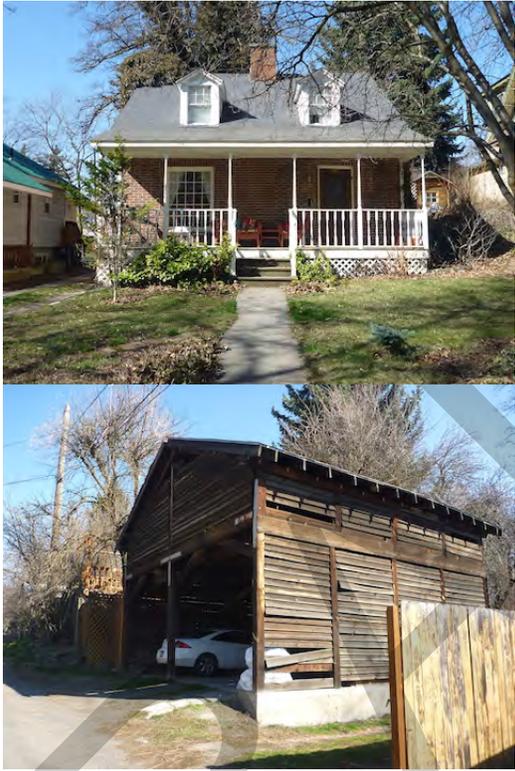
Survey Site Data	Site Photographs	Site Details
<p>Site #: 221 203 South Polk Street Owner: Lindsey Pinson 1917 Previous District Status: n/a DoE: NC</p>

<p>This is a one-and-one-half-story, two-bay, brick, Cape Cod dwelling. A shed-roof porch spans the width of the façade and is supported by spindle posts with spindle railings that rest on a raised wood deck. The façade features a large, twenty-five light picture window and the main entry door. A central brick chimney with a stone cap pierces the ridgeline of the dwelling, and two gable-dormers with six-over-one-light, double-hung, wood sash windows are found above the porch. Multi-light, double-hung, wood sash windows are exhibited throughout the dwelling and feature flat brick coursing and sills. The house rests on a partially raised, poured-concrete foundation that features fixed-light windows. The roof of the dwelling is sheathed in asphalt shingles. A horizontal board, wood post barn with exposed beams is located to the rear of the dwelling. The structure features a metal roof with exposed rafter tails that extend below the eaves and rests on a concrete block foundation.</p>

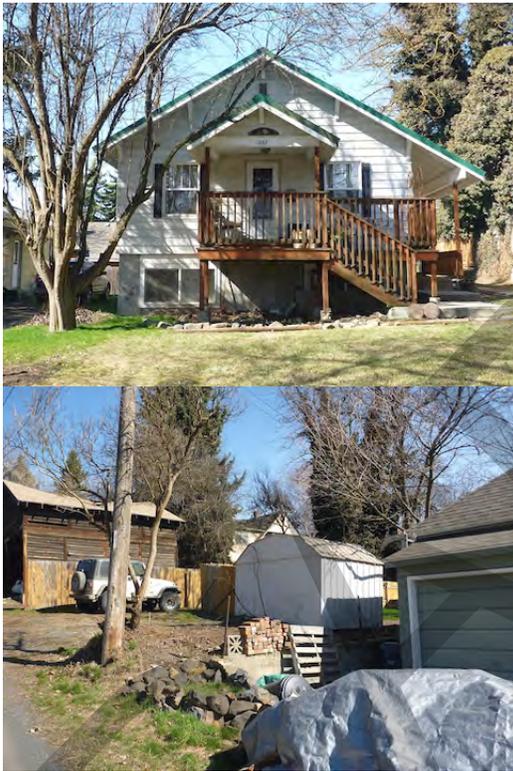
Survey Site Data	Site Photographs	Site Details
<p>Site #: 222 207 South Polk Street Owner: Erika Frances Iiams 1928 Previous District Status: n/a DoE: NC</p>

<p>This is a one-story, three-bay, front-gable dwelling that rests on a raised, poured-concrete basement. Wood steps ascend to a wood deck supported by square wood posts on concrete blocks with a wrap-around railing. The entry is sheltered by a front-gable roof with exposed rafter tails beneath the extended eaves. Vinyl windows flank the façade's central entry. The concrete basement exhibits large, aluminum windows. The dwelling's elongated north roof slope spans the width of the elevation and is supported by wood posts connected by a wood-post railing. The railing extends above a below-grade basement entry on the north elevation, accessed by descending concrete steps. The roof is sheathed in nonhistoric, V-groove metal panels with exposed rafter tails extending below the eaves and exhibit supporting brackets. A small, prefabricated, gambrel-roof shed is set rear of the dwelling.</p>

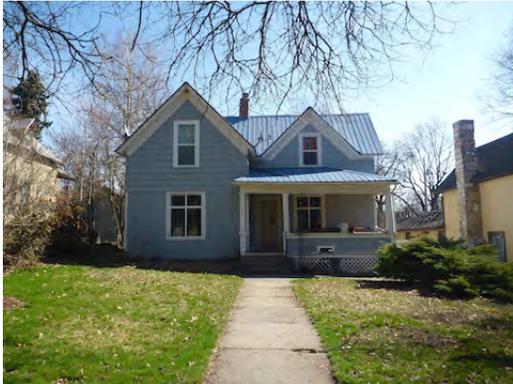
Survey Site Data	Site Photographs	Site Details
<p>Site #: 223 124 South Polk Street Owner: Aaron Anawalt ca. 1900 Previous District Status: n/a DoE: C</p>

<p>This is an early, one-and-one-half-story, three-bay (w/d/w), cross-gable dwelling with a full-height rear addition. A gable projection next to a smaller, gable-roof, wall dormer form the roofline on the façade. A one-story, hip-roof porch spans just over half of the façade of the dwelling. The raised porch is supported by square posts on an enclosed railing. The porch is supported by concrete piers. The main entry door is a two, vertical light, wood panel door. Large, four-light windows are found the lower level of the façade, with one-over-one windows featured on the façade's upper gable ends. The roof of the house is sheathed metal panels. Wide fascia boards are exhibited below the eaves. A central brick chimney pierces the ridgeline of the side-gable section of the house. The exterior walls of the dwelling's upper level is clad in wide, horizontal board siding and the lower level is clad in vertical boards.</p>

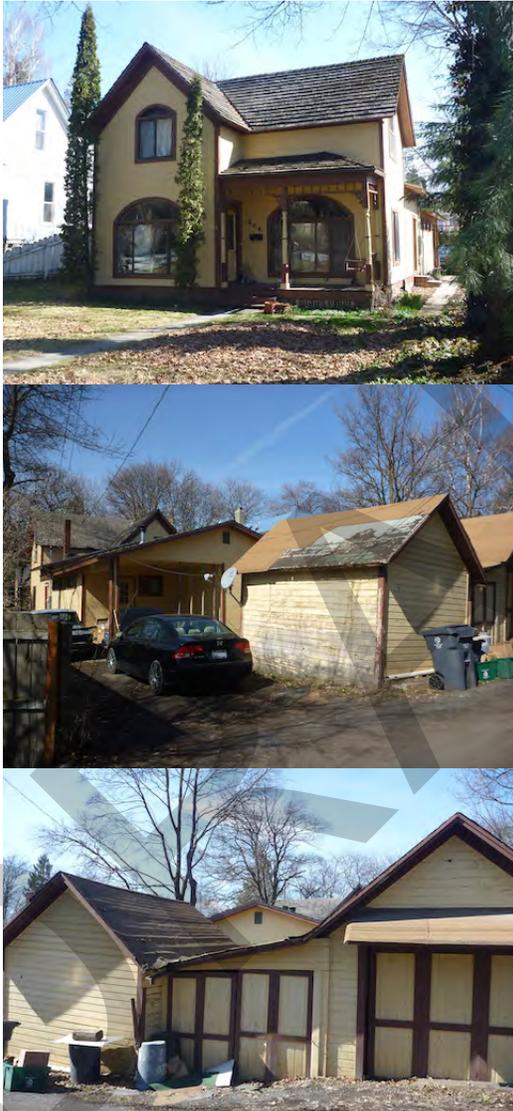
Survey Site Data	Site Photographs	Site Details
<p>Site #: 224 204 South Polk Street Owner: Timothy Hull ca. 1900 Previous District Status: n/a DoE: NC</p>

<p>The first photograph shows the front facade of a two-story yellow house with a dark roof and a prominent front gable. The second photograph shows a side view of a garage structure with a shed roof. The third photograph shows a rear view of the house featuring a recessed porch supported by decorative posts.</p>	<p>This is a two-story, cross-gable, frame dwelling with several rear additions. The front-gable section features a large, three-light picture window with a arched transom on the first story, and a similar two-light window above. A hip-roof porch spans the façade of the side-gable portion of the dwelling and shelters an identical three-light, arched picture window. Large, vertical windows are found throughout the dwelling with simple wood surrounds. The porch is supported by decorative turned posts that rest on a wood deck. The roof of the porch is sheathed in wood shingles. The entry door is found on the front-gable section's south elevation. A large nonhistoric stone or stone veneer, chimney projects from the eave of the north elevation. The roof of the house is sheathed in wood shingles. The exterior walls are clad in weatherboard siding and the foundation is concrete. Multiple, one-story, gable-oriented additions extend to the rear of the dwelling with a recessed porch found within one of them. Three buildings combine to create a garage (two gable-roof sections connected by a shed-roof section) clad in weatherboard siding and vertical board door entry doors is found to the rear of the dwelling.</p>

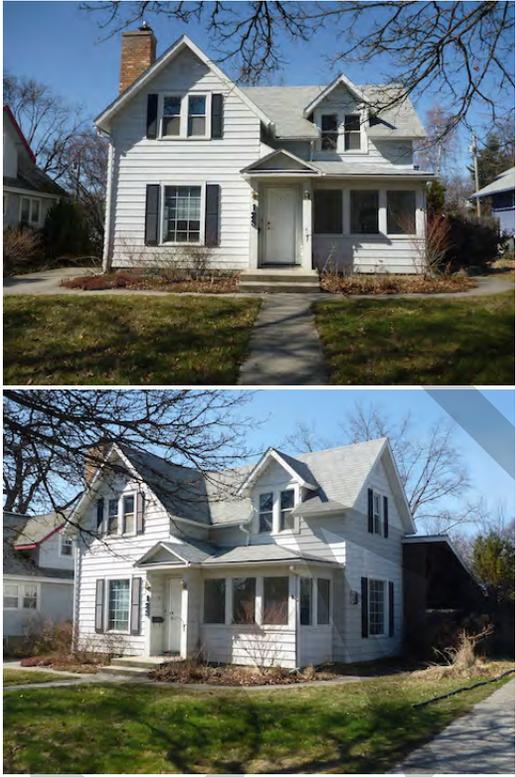
Survey Site Data	Site Photographs	Site Details
<p>Site #: 225 123 South Howard Street Owner: Barry Lerandau-Hillman ca. 1900 Previous District Status: n/a DoE: C</p>

<p>This is a one-and-one-half-story, three-bay (w/d/www), cross-gable dwelling. An enclosed, hip-roof porch spans the side-gable portion of the façade, with a front-gable section of the facade forming the dwelling’s south side. The main entry is sheltered by a simple, closed gable. The one-story, enclosed porch exhibits three windows. A gable-roof wall dormer with paired one-over-one-light windows is found above the porch. Similar windows with fixed shutters are found on the upper portion of the front-gable end, with a large window below. An interior brick chimney and shed-roof wall dormer are on the south elevation. A one-story, shed-roof patio addition spans the rear. The roof is sheathed in asphalt shingles and the exterior wall, soffits and decorative surrounds covered in vinyl. Vinyl replacement windows are found throughout. The house rests on a rusticated block foundation.</p>

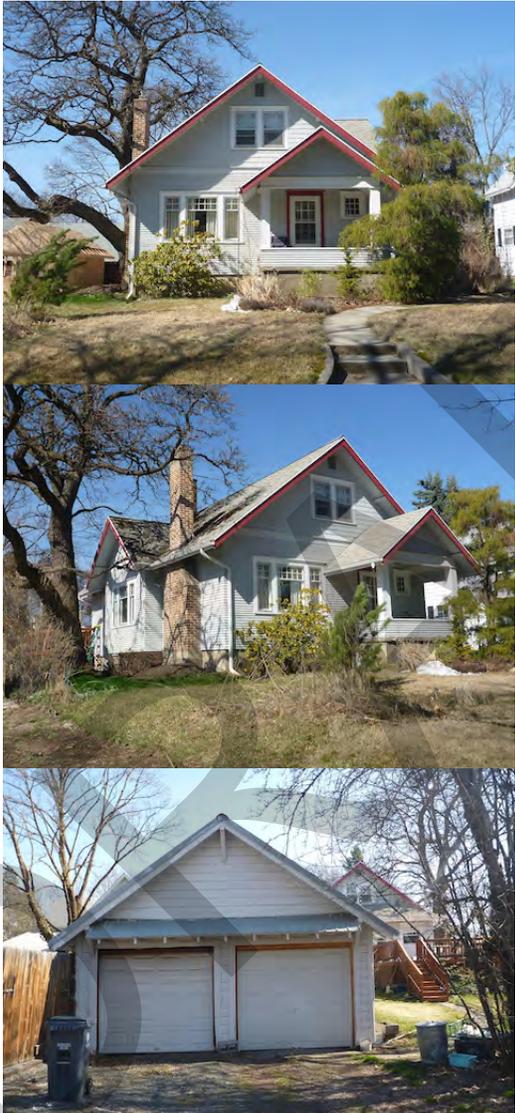
Survey Site Data	Site Photographs	Site Details
<p>Site #: 226 203 South Howard Street Owner: Paul Muneta 1929 Previous District Status: n/a DoE: C</p>

<p>This is a one-and-one-half-story, three-bay, original bungalow. A front-gable porch set on a raised concrete foundation shelters the main entry and a small nine-light, wood-sash, square window on the façade of the dwelling. The entry features a multi-light door. The roof of the porch is supported by square posts that rest on an enclosed railing. A triplet window with multi-light panes in the window's upper sections, is located south of the porch. The triplet window is replicated on the south elevation. Paired windows with six-over-one, double-hung sashes are found in the facade gable end as well as additional gables on the dwelling. Individual and paired multi-light-over-one windows are exhibited throughout the dwelling. An exterior brick chimney with a stone base pierces the wide eave of the south elevation. A one-story, hip-roof addition spans the width of the rear elevation of the house and features a wood deck with a wood post railing. The roof of the house is sheathed in asphalt shingles and the foundation is concrete. The exterior walls of the upper gables of the dwelling are decorated with wood shingles, while the remainder of the walls are covered in clapboards. A gable-roof, two-bay, frame garage found to the rear of the dwelling features a metal panel roof with exposed rafter tails, brackets and board siding.</p>

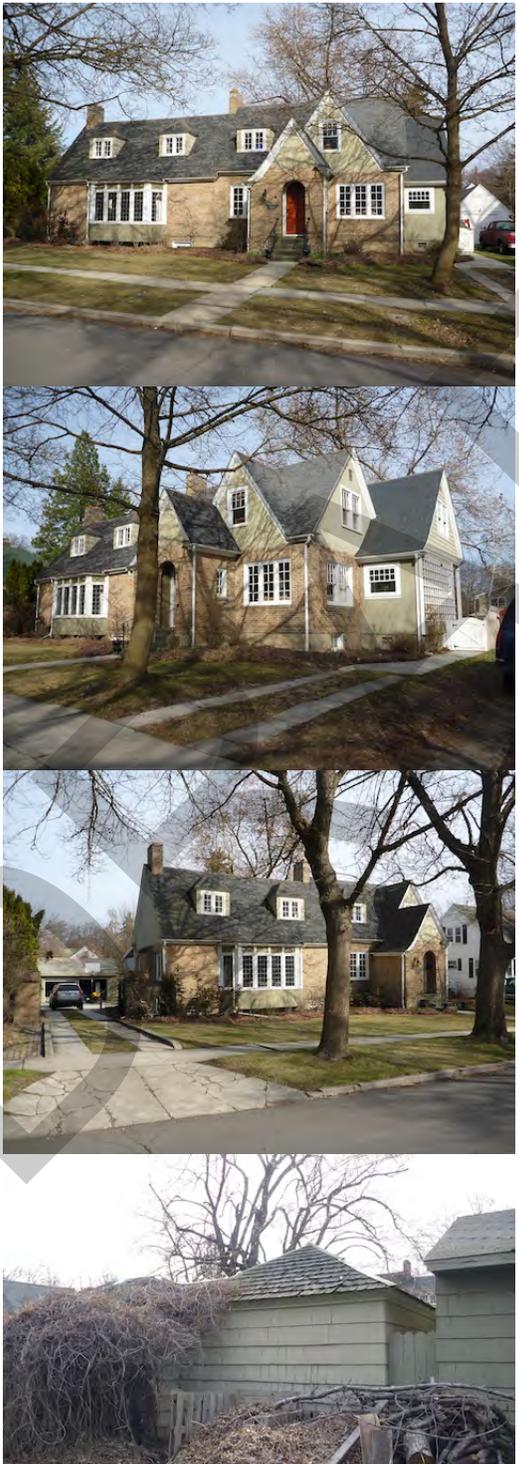
Survey Site Data	Site Photographs	Site Details
<p>Site #: 227 122 South Howard Street Owner: Daniel Costello 1930 Previous District Status: n/a DoE: C</p>

<p>The photographs show the house from four different perspectives: a front view, a side view, a rear view, and a view of a shed in the backyard.</p>	<p>This is a one-and-one-half story, side-gabled, brick-veneered, Tudor style dwelling with a linear plan. The façade features a tall, steeply pitched, front-facing gable with a six-over-one, wood-sash window in its stuccoed peak and a wood-sash, triple window below. Another smaller, front-facing entry gable projects out from the large gable. The entry gable has varied height eaves, a round-arched opening and a round-arched wood door. In the south wall of the vestibule is a small, six-light, wood-sash window. The façade also features three hip-roof dormers with paired, wood-sash casement windows and a large, hip-roof, stuccoed bay window, with six, twenty-one light, leaded-glass windows. Added at the south elevation is a stepped-back, side-gabled addition clad in stucco. The north elevation features two, paired, diamond-pane, leaded-glass, casement windows that flank the projecting chimney base. The roofline steps down at the central chimney and continues north to another chimney. Both chimneys are double-flue, brick, interior chimneys. The foundation is concrete and the roof is composition shingle. Also at this site are a contemporary, shingled, two-car, side-gable garage and an historic, single-car garage with shingled walls and a cedar-shingled hip roof. Also located at this is a metal-roofed, pre-fabricated shed.</p>
