National Register of Historic Places Registration Form

Historic name: Fort Russell Neighborhood Historic District (Boundary Increase and Additional Documentation)

Street & number: Roughly bounded by Jefferson Street on the west, East D Street on the north, Hayes Street on the east, and East Third Street on the south

City or town: Moscow State: ID County: Latah

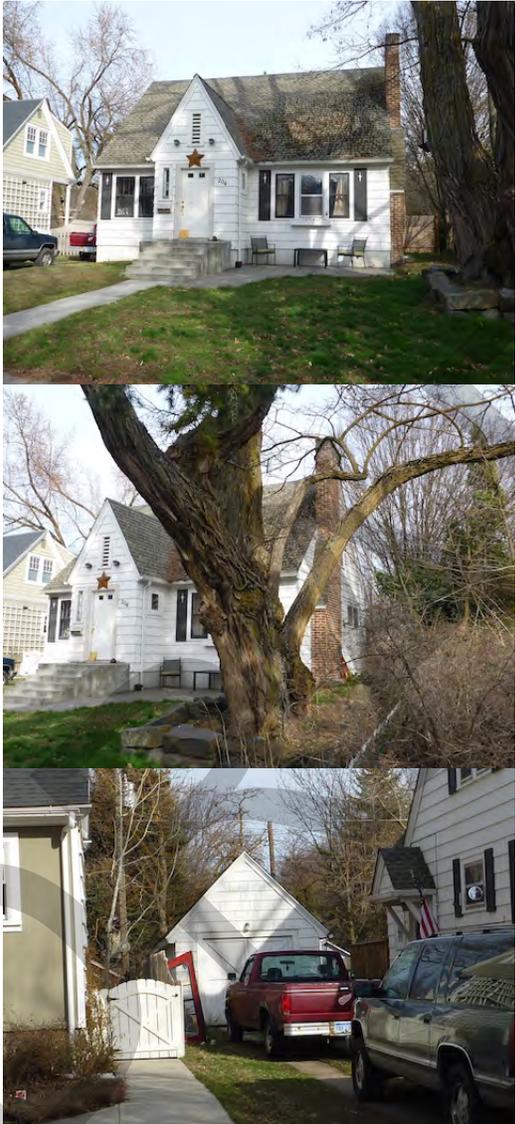
Survey Site Data	Site Photographs	Site Details
<p>Site #: 228 204 South Howard Street Owner: Jeffrey Antkowiak 1931 Previous District Status: n/a DoE: C</p>

<p>The photographs show a white Tudor-style house with a gabled roof and a brick chimney. The top photo is a front view showing the gabled entry vestibule and windows. The middle photo shows the house partially obscured by a large, mature tree. The bottom photo shows a white garage with a roll-up door, a red pickup truck, and a silver SUV parked in the driveway.</p>	<p>This is a side-gabled, one-and-one-half story, Tudor style dwelling. The façade features an off-center, steeply-pitched, front-facing, gabled entry vestibule with a contemporary entry door, a narrow wood-sash window with a storm window, and a louvered vent in the peak. A triple window is to the south of the entry gable and a double window to the north. Windows are three-over-one, wood sashes with nonhistoric shutters. At the south elevation is a tall, double-flue, brick, exterior chimney. At the north elevation are a number of windows and a small, gable-front roof on knee braces over the side entry door. Walls are covered in cedar shingles, the roof is composition shingle and the foundation is concrete. Also on this site is a one-story, gable front, single-car garage that has been extended with a linear, slightly taller addition towards the east at the alley. The early part of the garage features shingled walls, wood swing-out garage doors and composition shingle roof. The addition is clad in T1-11 sheet siding and has a single-car composite roll-up garage door.</p>

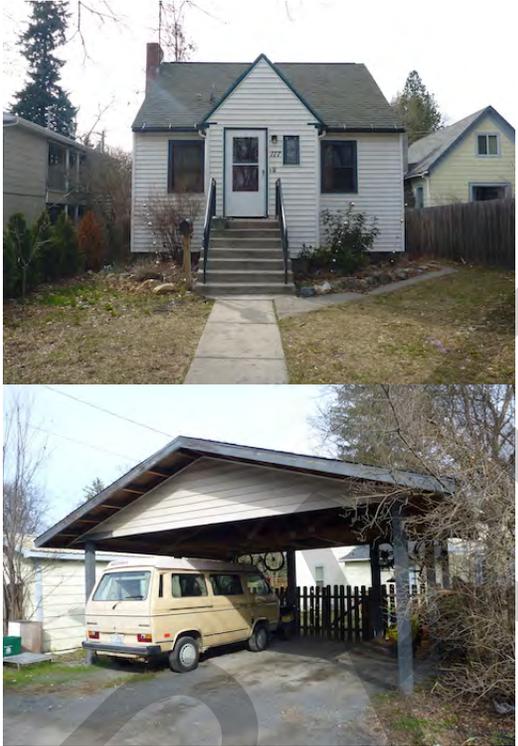
Survey Site Data	Site Photographs	Site Details
<p>Site #: 229 117 South Monroe Street Owner: Dennis DeHart 1937 Previous District Status: n/a DoE: C</p>

<p>This is a small, nearly symmetrical, side-gabled dwelling that is one-and-one-half stories with a rectangular plan and a basement. The façade features a projecting, front-gabled, entry vestibule that contains the entry door and two small narrow windows: one alongside the door, and the other in the south wall. The entry door is a glazed, wood panel door. The vestibule is flanked by a pair of six-over-one windows. A double-flue, brick, exterior chimney and a pair of windows grace the south elevation and a number of windows punctuate the north elevation. At the rear elevation is a one-and-one-half story, gabled extension with a rear entry door. Windows are wood sash, wall sheathing is vinyl, and the roof is composition shingle. At the rear of the site is a front-gabled, double carport. It is set atop square posts and has clapboards in the gable ends.</p>

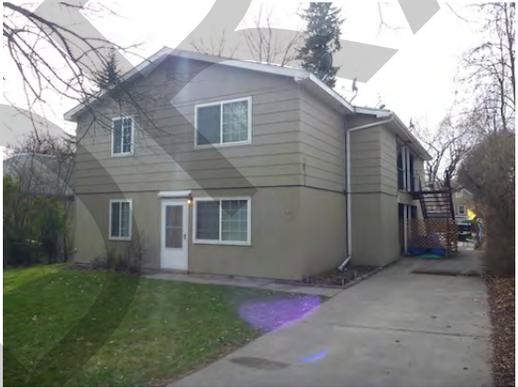
<p>Site #: 230 123 South Monroe Street Owner: Brian Lande 1968 Previous District Status: n/a DoE: NC</p>

<p>This is a contemporary, two-story, front-gabled, multi-unit dwelling with a rectangular plan. The façade features an entry door with flashing above, flanked by vinyl slider windows at the first floor. The second story features a pair of windows. The gable ends and the first level are clad in T1-11 sheet siding, while the second story is sheathed in wide composite boards. At the north elevation is a two-story shed-roofed extension that houses entry doors accessed by a metal staircase, with storage below. Attached at the rear of the site, is a single story, hip roofed unit.</p>

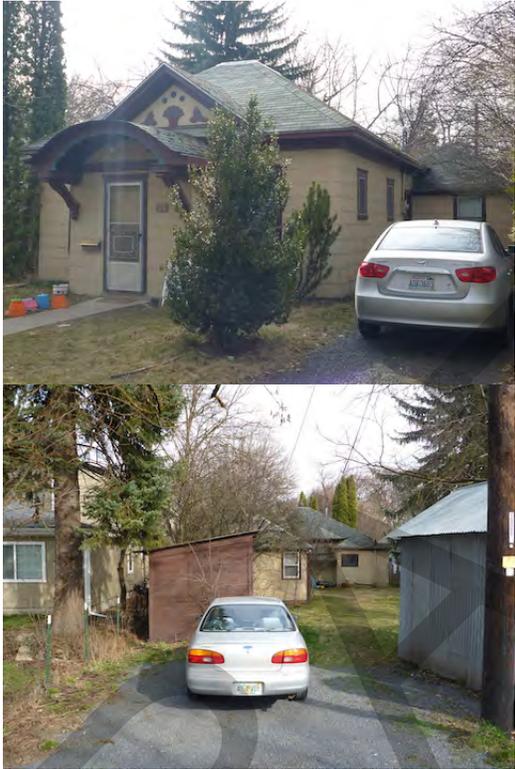
Survey Site Data	Site Photographs	Site Details
<p>Site #: 231 203 South Monroe Street Owner: DRM Rentals LLC ca. 1900 Previous District Status: n/a DoE: NC</p>

<p>This is a small, pyramidal-roofed dwelling with a square plan. The façade features a closed, front-facing gable with applied decorations in its tympanum that is centered above the entry. The enclosed entry porch projects out from the front of the house and is sheltered under an arched porch roof atop carved, bracketed knee-braces. The entry contains a solid-core flush door. A pair of dissimilar windows flanks the entry. Windows are a combination of wood, metal and vinyl sash. The walls are covered in asbestos shingles and the roof is composition shingled. A single-story, hip-roof addition is found off the northwest corner of the dwelling; the addition is visible from the façade elevation. At the rear of the site is a shed-roofed, wood frame shed. It features wood clapboards, a metal roof and a wide opening. Also at the rear of the site is a gable front, corrugated metal shed with a fiberglass entry door and a corrugated metal roof.</p>

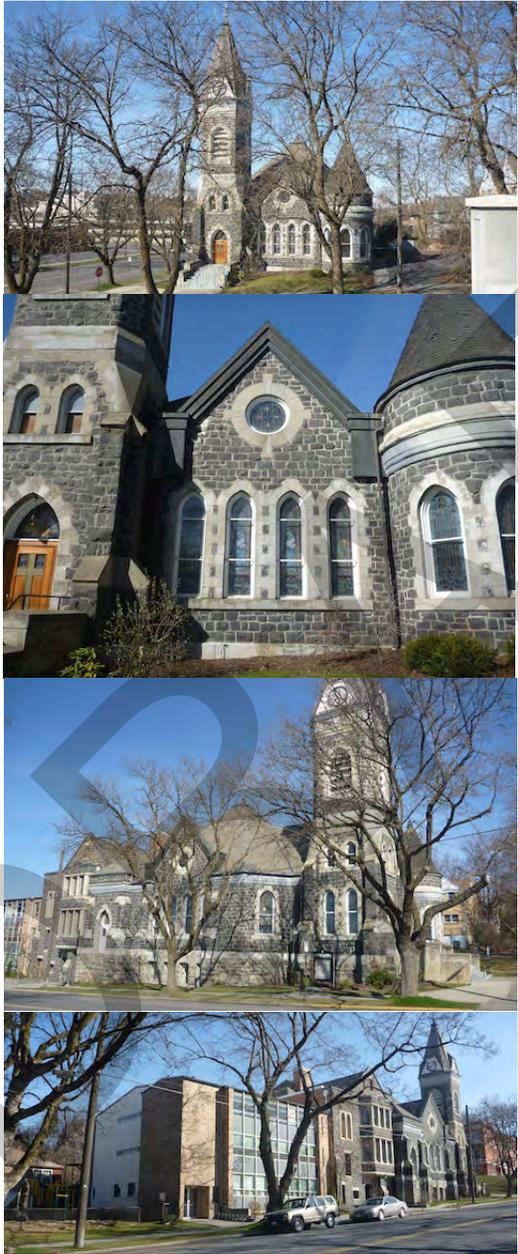
Survey Site Data	Site Photographs	Site Details
<p>Site #: 232 322 East Third Street Owner: Methodist Church 1904 Previous District Status: n/a DoE: C Previously Listed to the NRHP: 10/5/1978</p>

<p>This is the Moscow First Methodist Church, listed individually to the NRHP in 1978. It is an asymmetrical Gothic Revival style church exhibiting a mortared stone exterior and concrete-over-brick surrounding the Gothic-arched windows, entries and oculus window found on the south elevation. The windows retain ornate stained-glass wood sashes. A rounded turret is found on the southeast corner, while a square clock tower rises from the southwest corner. The tower exhibits Gothic-arched vents and clocks on all four sides. An extension with a gable-roof parapet is found on the south side and buttressed pilasters are found throughout. A ca. 1950s addition, exhibiting red brick on the north elevation and stone similar to the original building on the south elevation, is found west of the original building. It is similar in appearance to the original building facing busy East Third Street. A windowed bay extends from the main and upper level of this addition on the south side above a recessed basement level entry. Some of the windows contain leaded-glass. Another addition is found on the far west of the building. It is mid-century modern in appearance, exhibiting a stone or faux stone veneer and ribbons of metal-sash windows with grey colored panels between. Its north wall is plain with small metal-sash windows. A small, gable-roof, frame shed is found at the northwest corner of the site, sheathed in clapboards with exposed rafter tails. Despite the additions, the original portion remains a highly intact, significant architectural example of its era.</p>

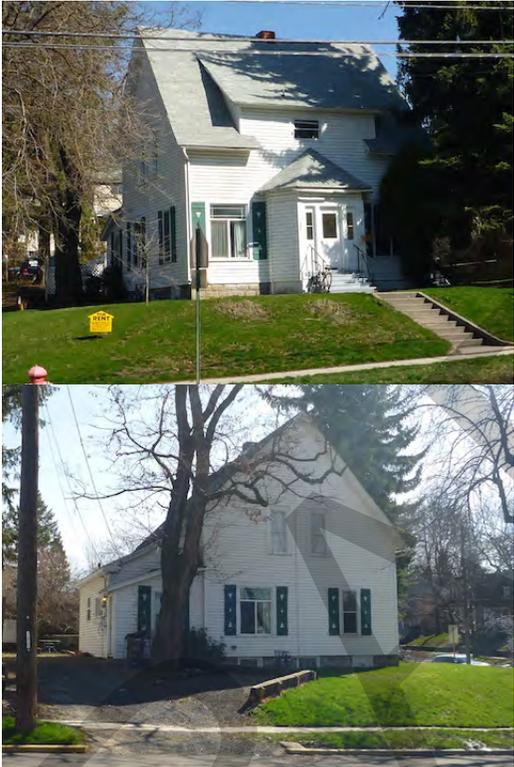
Survey Site Data	Site Photographs	Site Details
<p>Site #: 233 504 East Third Street Owner: Five Star Equity Inc. 1910 Previous District Status: n/a DoE: NC</p>

<p>This is a two-and-one-half-story, three-bay, side-gable, frame dwelling. A central, enclosed one-story, pyramidal, entry porch is found on the façade. The porch features an entry with a wood panel door flanked by two-light sidelights. Windows featuring vertical, two-light panes with one horizontal pane above flank the porch. One-over-one, wood-sash windows are found throughout the dwelling. The lower-level windows exhibit decorative shutters. A large, wide, shed-roof wall dormer with a small, two-light window is above the entry porch. A one-story, shed-roof addition spans the width of the rear elevation while a double-deck with lattice and small, gable-roof side entry is found on the dwelling's east elevation. A central brick chimney pierces the ridgeline. The roof is sheathed in asphalt shingles and the exterior walls are clad in vinyl siding. The house rests on a rusticated block foundation.</p>

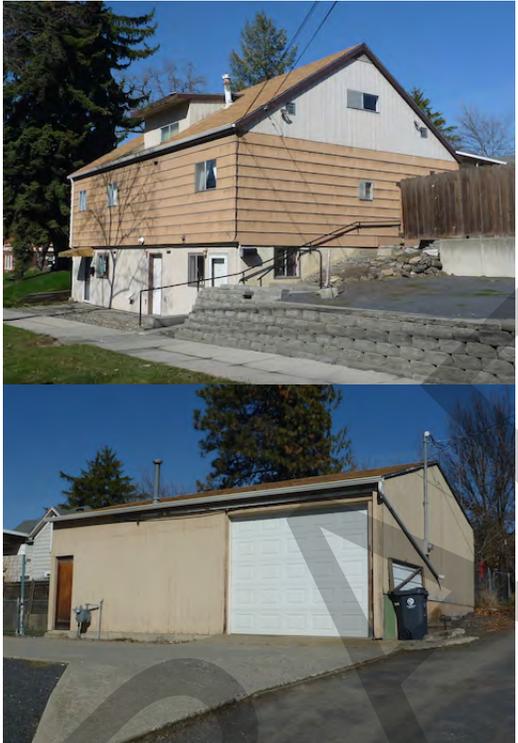
Survey Site Data	Site Photographs	Site Details
<p>Site #: 234 510-510A East Third Street Owner: Marie Annette Taylor 1964 Previous District Status: n/a DoE: NC</p>

<p>Site 234 features a one-and-one-half-story, side-gable residence featuring a below-grade, fully exposed basement on the south side with three entries. An awning shelters the entry near the west elevation. A shed-roof dormer with an aluminum-frame slider window rises from the south roof slope. A metal flue is next to the dormer. Two-pane, aluminum frame windows are exhibited throughout the dwelling. The roof of the dwelling is sheathed in asphalt shingles. The exterior walls on the central section of the dwelling are clad in asbestos shingles while the lower level and gable ends are clad in vertical board siding. A gable-roof garage is found northeast of the dwelling. The building features one large, metal garage door and a single entry on its south elevation. The roof is clad in asphalt shingles the exterior walls are vertical board siding and the foundation is concrete.</p>

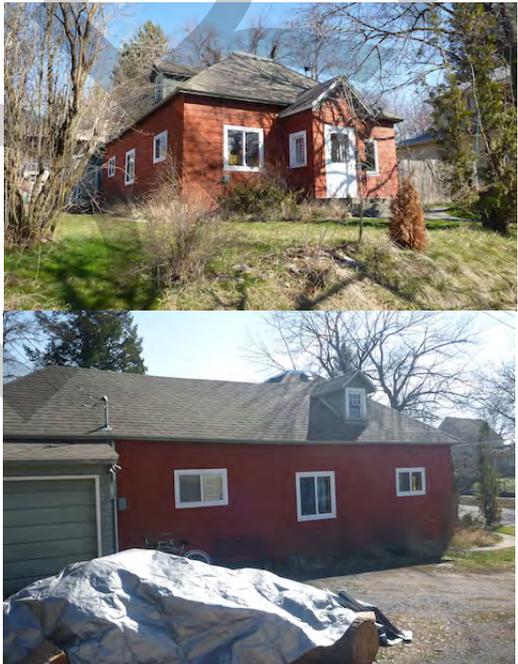
<p>Site #: 235 520 East Third Street Owner: Sonja LaPaglia ca. 1900 Previous District Status: n/a DoE: C</p>

<p>Site 235 is a one-and-one-half story, three-bay, truncated-roof dwelling with a rear addition. Concrete steps lead to an enclosed, gable-roof entry porch. A twelve-light, wood-sash window is found on either side elevation of the porch. A large picture window and fixed, vertical, two-pane window flank the entry. Two-light, sliding windows are exhibited throughout the dwelling. A small, gable-roof dormer with a six-over-one-light, wood-sash window pierces the dwelling's west roof slope. A nonhistoric, metal flue projects from the east roof slope of the dwelling. A shed-roof addition with a one-car garage is found on the east elevation at the rear of the house. The roof is sheathed in asphalt shingles, the walls are clad in wide, horizontal boards, and the house rests on a concrete foundation.</p>

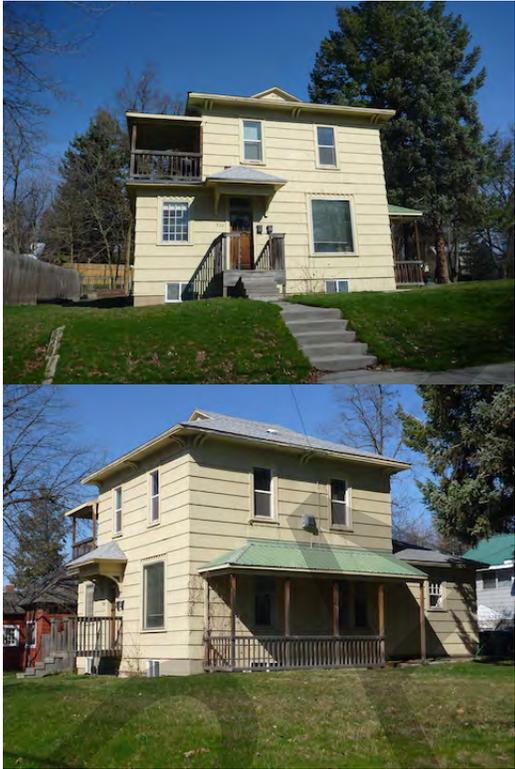
Survey Site Data	Site Photographs	Site Details
<p>Site #: 236 528 East Third Street Owner: Randy Rauch 1911 Previous District Status: n/a DoE: NC</p>

<p>This is a two-story dwelling with additions. Off-centered on the façade, a hip-roof awning with brackets shelters an entry with a transom above. A fixed, twenty-light window and a larger picture window flank the main entry. A gable-roof extension projects from the truncated roof. The main block features a wide overhang supported by decorative, paired brackets. One-over-one windows are found on both levels of the dwelling, with six-over-one-light windows found on the house's lower level. The windows have simple wood surrounds with decorative dentils above. A one-story, hip-roof porch spans the width of the east elevation. The porch is supported by wood posts with a simple wood railing. The roof of the porch is V-groove metal panels. A small, shed-roof porch with wood posts and railing, is located above the one-story section on the west side. The porch roof is sheathed in metal. A one-story, gable-on-hip roof addition spans the width of the rear elevation. The roof of the house is sheathed in asphalt shingle, the exterior walls are clad in asbestos shingles and the foundation is concrete.</p>

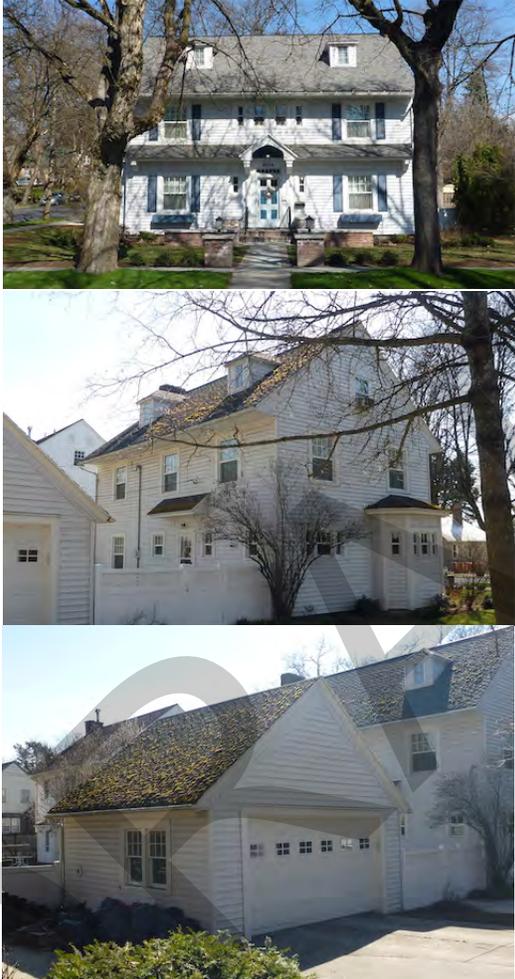
Survey Site Data	Site Photographs	Site Details
<p>Site #: 237 604 East Third Street Owner: Douglas Adams 1922 Previous District Status: n/a DoE: NC</p>

<p>Site 237 is a two-and-one-half-story, three-bay (w/d/w), side-gable, Colonial Revival dwelling. The stone and brick steps that lead to the main entry feature iron railings and are flanked with higher brick piers with concrete caps. Accentuated with a decorative gabled pediment, the central entryway features a wood panel door with two square lights at the top and a six-light transom above. The entryway is flanked by small, vertical, two-light windows. Two small, hip-roof dormers are centered on both the north and south roof slopes of the house. An enclosed bay projection with small vertical windows is found on the dwelling's west elevation, while an exterior brick chimney with stone accents pierces the ridgeline on the dwelling's east gable end and is flanked by half-fanlight windows. The roof of the dwelling is sheathed in asphalt shingles, the exterior walls are clad in vinyl and vinyl windows are found throughout. The house rests on a stone foundation. A gable-roof, vinyl clad garage featuring a large, six-light garage door and six-over-one-light, double-hung windows is found to the rear of the dwelling.</p>

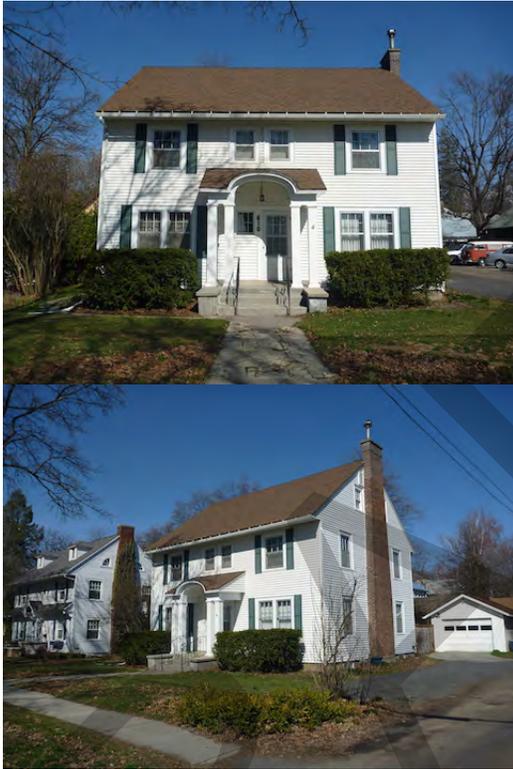
Survey Site Data	Site Photographs	Site Details
<p>Site #: 238 610 East Third Street Owner: Kelly Harkins 1926 Previous District Status: n/a DoE: NC</p>

<p>Site 238 is a two-and-one-half-story, side-gable dwelling. The shed-roof porch with a semi-elliptical hood is supported by paired square posts and shelters the main entry and a fixed, six-light window. The entry features a twelve-light, wood panel door. Paired, six-over-one light, wood-sash windows with fixed shutters flank the main entryway, with individual six-over-one-light windows with fixed shutters are found on the upper level. A set of smaller two, six-over-one-light windows are featured above the main entryway. Windows with six-over-one-lights are on the first and second stories and on both upper gable ends. An exterior brick chimney is on the east end. The roof is sheathed in asphalt shingles and the exterior walls are clad in vinyl. The house rests on a poured concrete foundation. A gable-oriented garage featuring a four-light, metal garage door is found just northeast of the dwelling. The structure has an asphalt shingle roof and is clad in vinyl siding.</p>

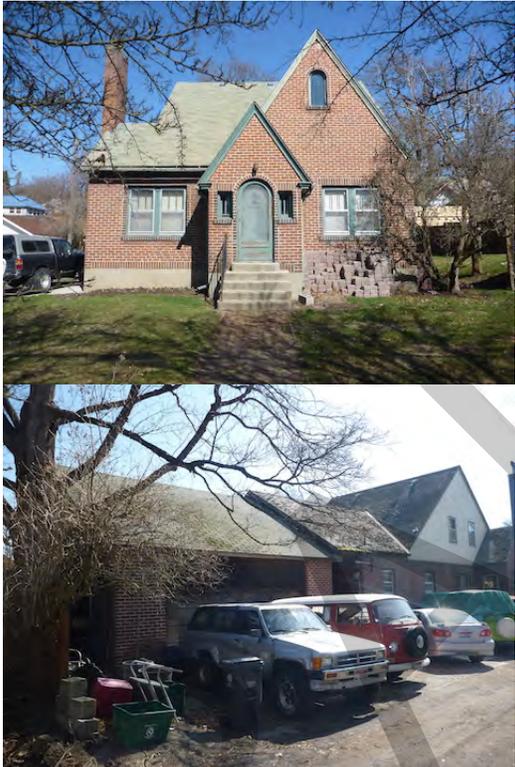
Survey Site Data	Site Photographs	Site Details
<p>Site #: 239 616 East Third Street Owner: Roger Crozier 1935 Previous District Status: n/a DoE: C</p>

<p>This is a one-and-one-half-story, three-bay, English cottage brick dwelling. It features a steeply-pitched gable projection with a small, arch window at the peak and paired windows with brick lintels and sills found at the first level. A centered, one-story, front-gabled entry projects from the taller gable. An arch entry door framed with a brick surround and flanked by small, vertical two-light windows is featured on the façade. A simple cornice with returns decorates the front-facing gables. The windows contain vertical, three-over-one, double-hung wood sashes. Individual and paired windows are found throughout the dwelling. A one-story, gable-roof projection extends from the rear elevation of the dwelling. A brick, gable-roof garage addition extends from the rear gable. The roof of the house is sheathed in asphalt shingles. The upper gable ends are clad in aggregate. The house rests on a partially raised concrete basement.</p>

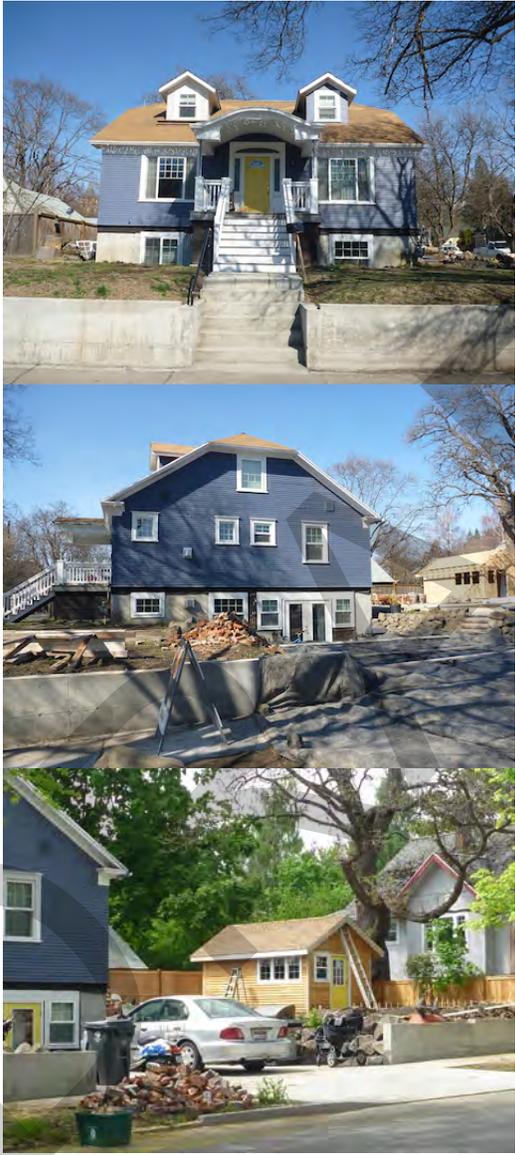
Survey Site Data	Site Photographs	Site Details
<p>Site #: 240 620 East Third Street Owner: Timothy Van Den Broek 1929 Previous District Status: n/a DoE: NC</p>

<p>Site 240, is a one-and-one-half story, three-bay, clipped gable-roof bungalow. The dwelling rests on a partially raised concrete foundation accessed by a full walkout basement with a double entry on its east elevation. Centered on the façade is a curved roof porch supported by slender poles atop square posts enclosed with wood post railings. The entry is a modern door with sidelights and a fanlight. Modern, vinyl triplet windows are found on either side of the main entrance on the façade of the dwelling. Two gable-roof dormers with two-over-one windows set on the front roof slope of the dwelling. Various, modern windows are found throughout the house. The dwelling's rear elevation features a wide shed-roof dormer with a series of five windows on the north roof slope of the house. Wood steps and deck provide access to the rear elevation. The entry is sheltered by a shed roof supported by brackets. The roof of the dwelling is sheathed in asphalt shingles and features cornice returns. The exterior walls are clad in weatherboard siding. A newly constructed, gable-roof shed is found in close proximity to the dwelling. Per the property's owner, the dwelling was raised and given a new foundation due to structural issues with the original foundation. The original brick chimney on the east elevation was removed, and the bricks are being reused in the landscaping.</p>

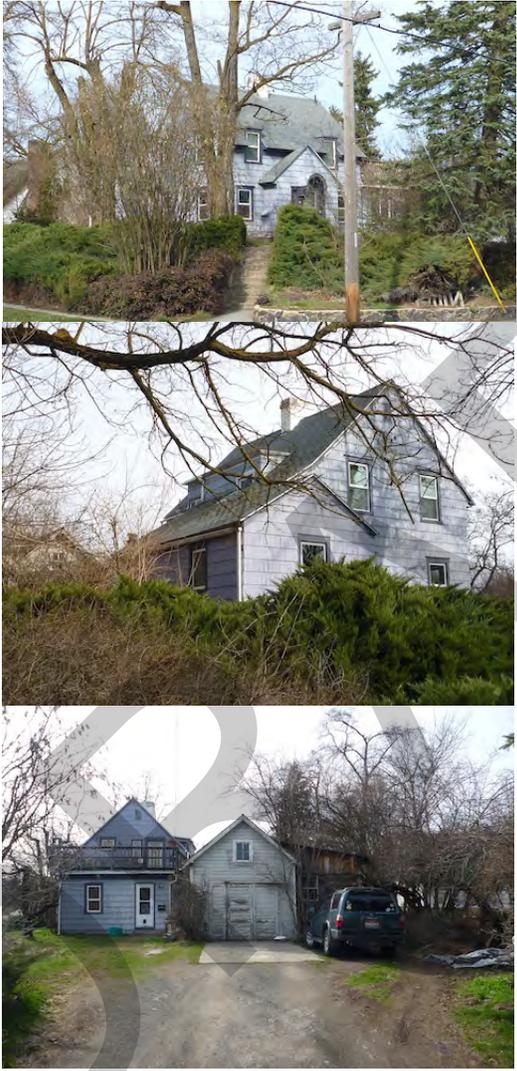
Survey Site Data	Site Photographs	Site Details
<p>Site #: 241 704 East Third Street Owner: Mark Solomon 1913 Previous District Status: n/a DoE: C</p>

<p>Site 241 is a large, one-and-one-half story, side-gabled dwelling. The façade features a projecting, front-gabled entry vestibule with a round-arch hood on carved brackets upon classical pilasters. The wood-panel entry door has sidelights outside the pilasters and a fanlight above within the hood. The façade also features a pair of nearly flat, shed-roofed, through-the-cornice wall dormers and a double-flue, brick, inside chimney centered at the ridge. A flat-roofed wing at the east elevation is balustraded and functions as a roof deck. At the first level is a side entry door. A small, side-gabled, single-story addition extends from the west elevation and a shed-roof, two-window dormer is found on the roof slope at the rear of the dwelling. The eaves are minimal, the windows are vinyl, and the roof is composition shingle. The walls are clad in wide-reveal cedar shingle. Also at the site is a one-story, gable-front single-car garage. It features wood clapboards, wood-sash window, a composition-shingled roof, wood, swing-out doors, and a shed-roof addition at the north elevation.</p>

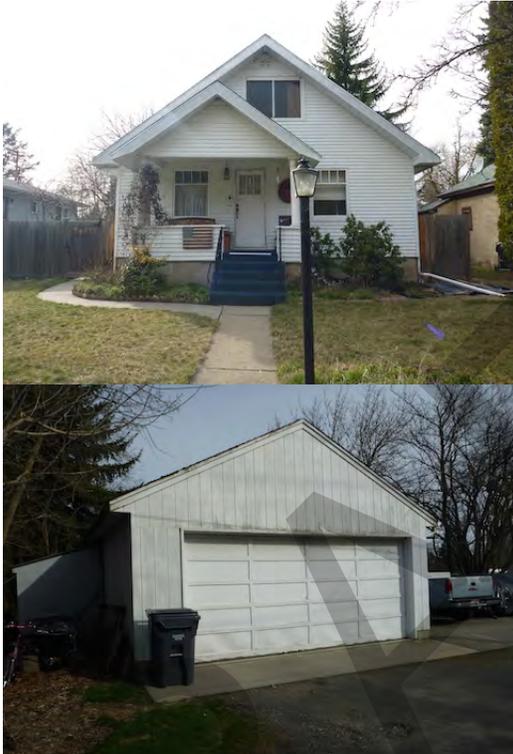
Survey Site Data	Site Photographs	Site Details
<p>Site #: 242 207 South Monroe Street Owner: Art Moen 1931 Previous District Status: n/a DoE: NC</p>

<p>Site 242 is an altered, one-and-one-half-story, front-gabled Bungalow with a rectangular plan. The dwelling is oriented towards the east facing South Monroe Street and East City Park. The façade features a front facing, gable, entry porch roof that sits atop a pair of Tuscan style columns and a closed porch rail. The entry has a painted wood, ledged door with glazing that is flanked by four-over-one, wood-sash windows. In the gable peak, the fenestration has been altered to accept a large, horizontal-sliding window. At the south elevation is a square, projecting bay with a pair of four-over-one, wood-sash windows. The exterior walls, eaves and gable ends are covered vinyl siding. The foundation is concrete. Also on the site facing the alley, is a two-car garage with T1-11 sheet siding, composition shingle roof, and a composite roll-up garage door.</p>

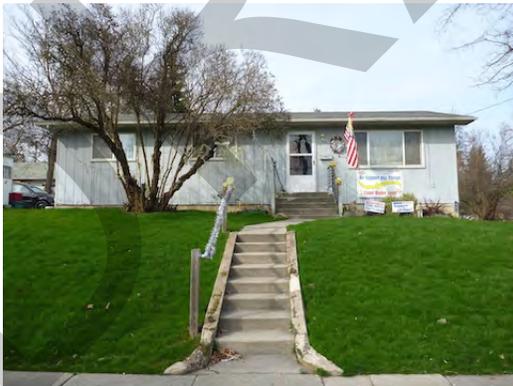
<p>Site #: 243 726 East Third Street & 213 South Monroe Street Owner: Wai Family Living Trust 1968 Previous District Status: n/a DoE: NC</p>

<p>Site 243 is a side-gabled, one-story dwelling, with a rectangular plan and a basement unit. The façade of the dwelling is asymmetrical and features an off-center entry door and three windows. The east elevation features the entry to the basement unit and windows, while the north elevation features windows and a sliding glass door. The walls are clad in T1-11 sheet siding and the roof is covered in composition shingle.</p>

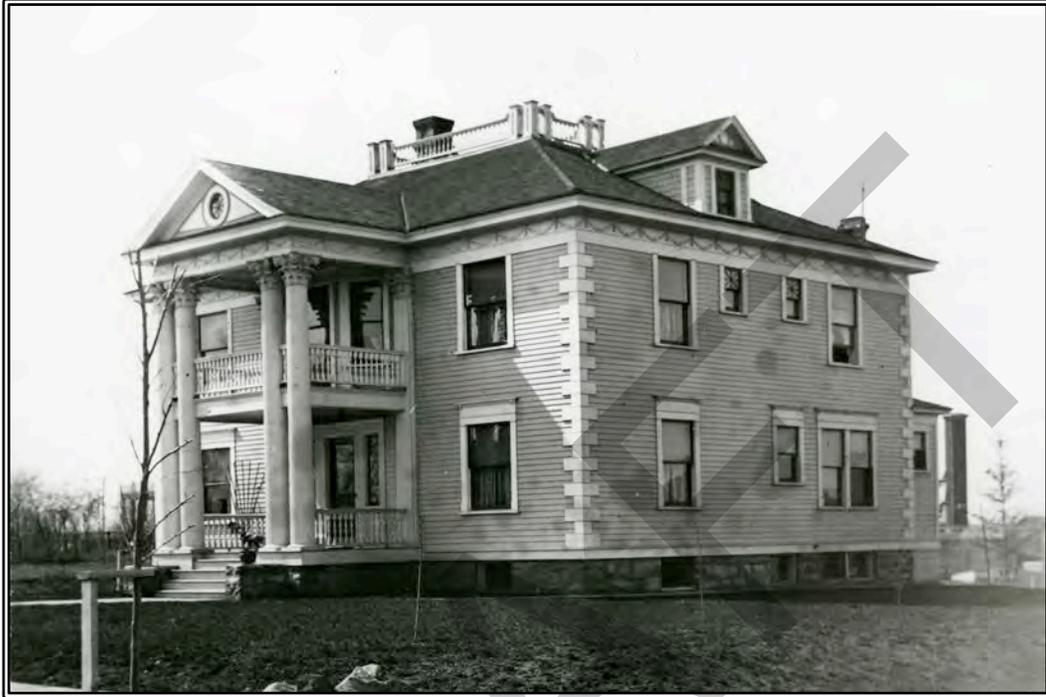
1: Site 12, Charles L. Butterfield House (LCHS)

- Charles L. Butterfield House (1902-03) (403 North Polk Street), a two-story, Neoclassical dwelling with a dominant entry porch with a classical pediment, fluted, full-height, Corinthian columns and pilasters, and an upper porch with a spindled balustrade. Dormers are found on the truncated hip roof on all elevations but the façade;

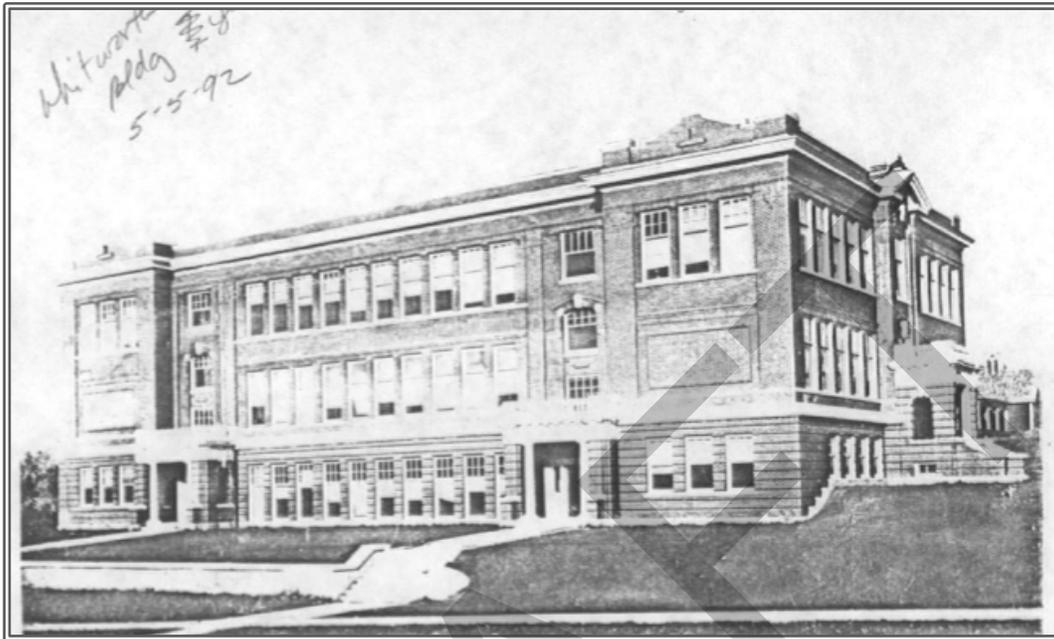
7: Site 217, old Moscow High School (LCHS)

<p>This is the old Moscow High School, built in 1912 designed by Spokane architect Clarence Hubbell, which was listed to the NRHP in 1992. It is a two-story building set on a raised basement foundation. It has an H-shape plan with gabled parapets on each of the four corner extensions and full-height entry porticos centered on the east and west sides. A flat-roof entry porch extends out from each of these sides, each with granite pillars, terrazzo flooring, and terra cotta ornamentation including a wide entablature and small balustrade surrounding the top. The entries are accessed by concrete stairs flanked by brick knee walls that are capped with terra cotta tiles. Two additional similar porches are found on the south side. A metal cornice and a terra cotta water table surround the building. On the basement elevation the brick runs in bands, with narrow recessed areas between. Soldier coursed bricks run above the windows, some of which retain wood-sashes though some have been replaced or are boarded over. The sides of the entry porches exhibit arched openings with terra cotta keystones. The terra cotta detailing exhibits a splattered decorative finish. Keystones are also found above segmentally-arched windows found above the entries. The building currently houses the 1912 Center, a community arts facility.</p>

- The old Moscow High School (1912) was designed by Spokane architect Clarence Hubbell in the Neoclassical style. It is a two-story building set on a raised basement foundation with an H-shape plan and with gabled parapets on each of the four corner extensions and full-height entry porticos centered on the east and west elevations. A flat-roof entry porch extends out from each of these elevations, each with granite pillars, terrazzo flooring, and elaborate terra cotta ornamentation including a wide entablature and small balustrade surrounding the top. This building is now known as the Whitworth Building and is listed individually in the NRHP.

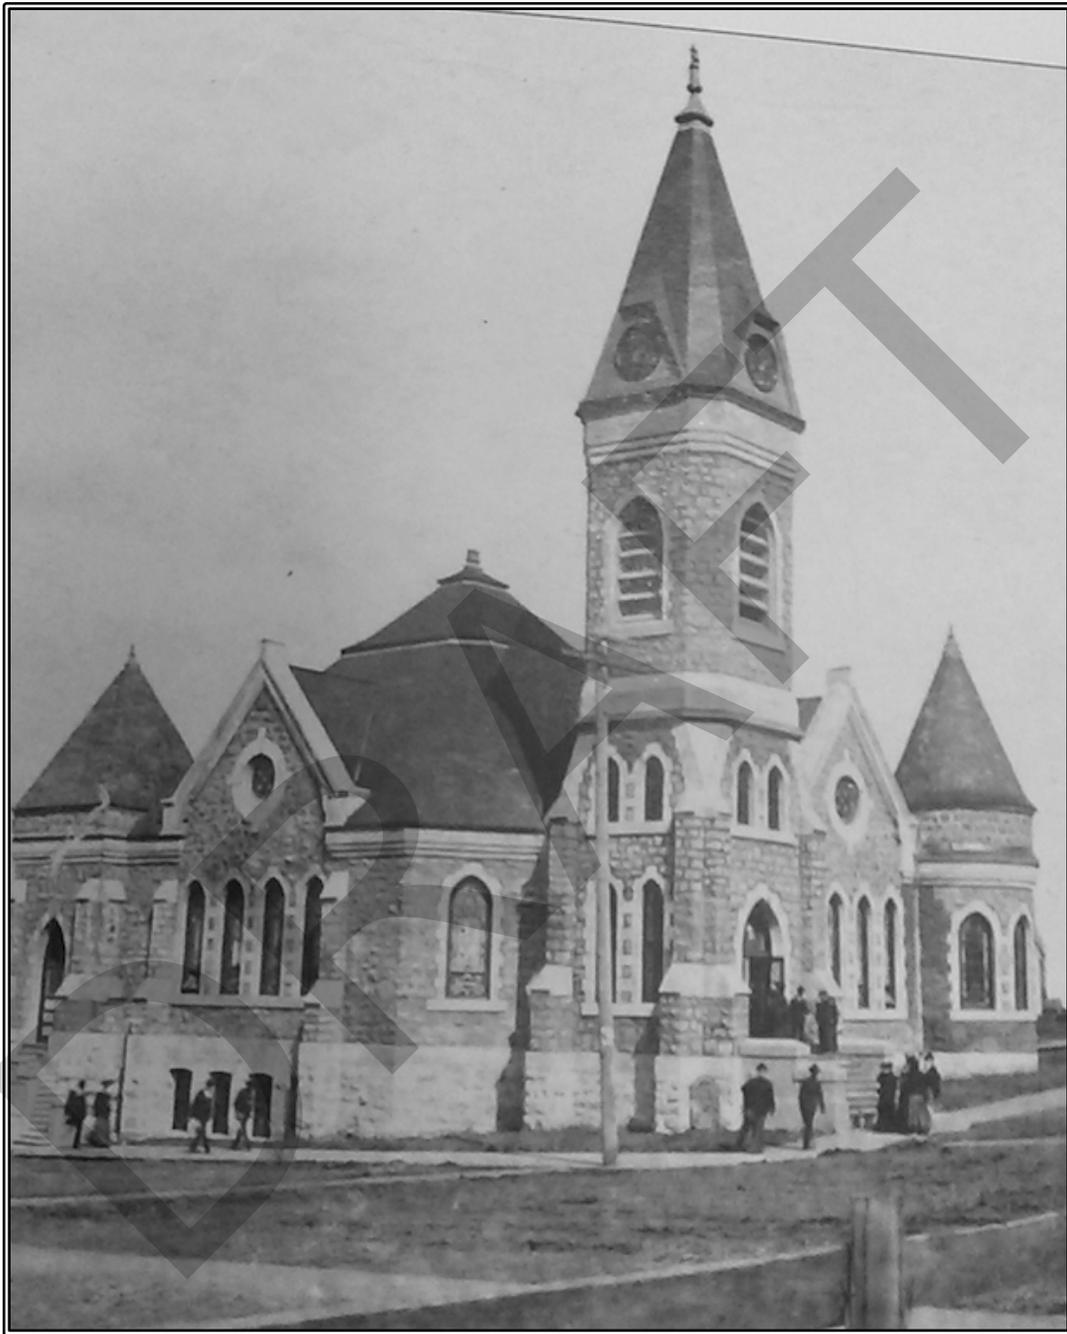
11: Methodist Church, Site 232 (Monroe, 2006: n.p.)
