UNITED STATES DEPARTMENT OF THE INTERIOR  
NATIONAL PARK SERVICE**NATIONAL REGISTER OF HISTORIC PLACES  
INVENTORY -- NOMINATION FORM**

Bishop Mountain Lookout

Forest Road 80120

The Bishop Mountain Lookout is located at the end of Forest Road 80120, approximately five air miles west of U.S. Highway 20 (Map 1). It consists of four buildings; a steel lookout tower, a log cabin, a garage and a frame pit toilet (Map 2). There are no other buildings or structures in the vicinity, and the setting is rural and remote.

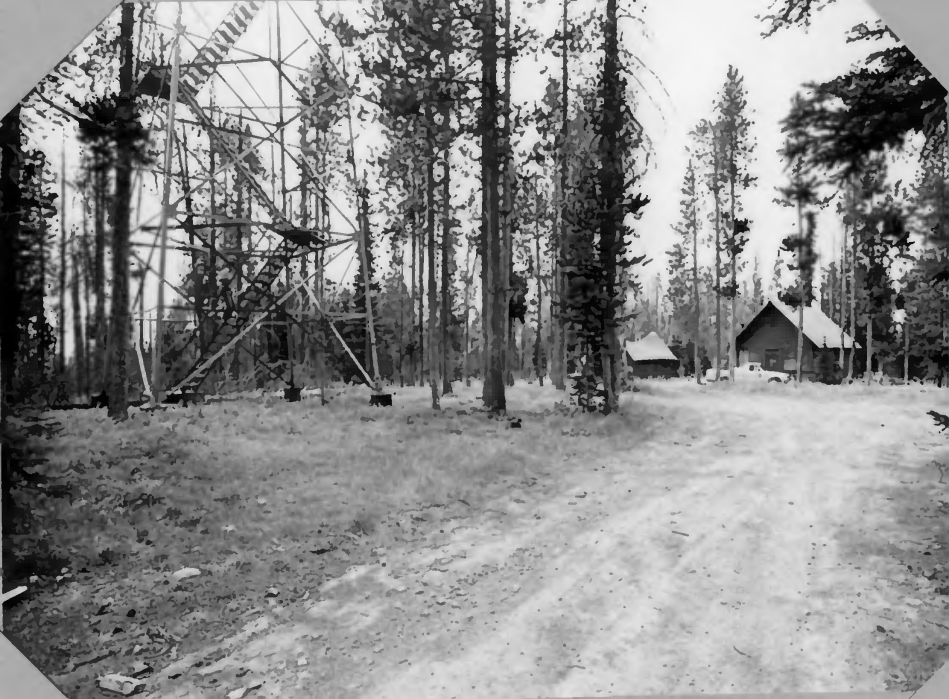
Photograph 1 of 5

Grounds, view from SE

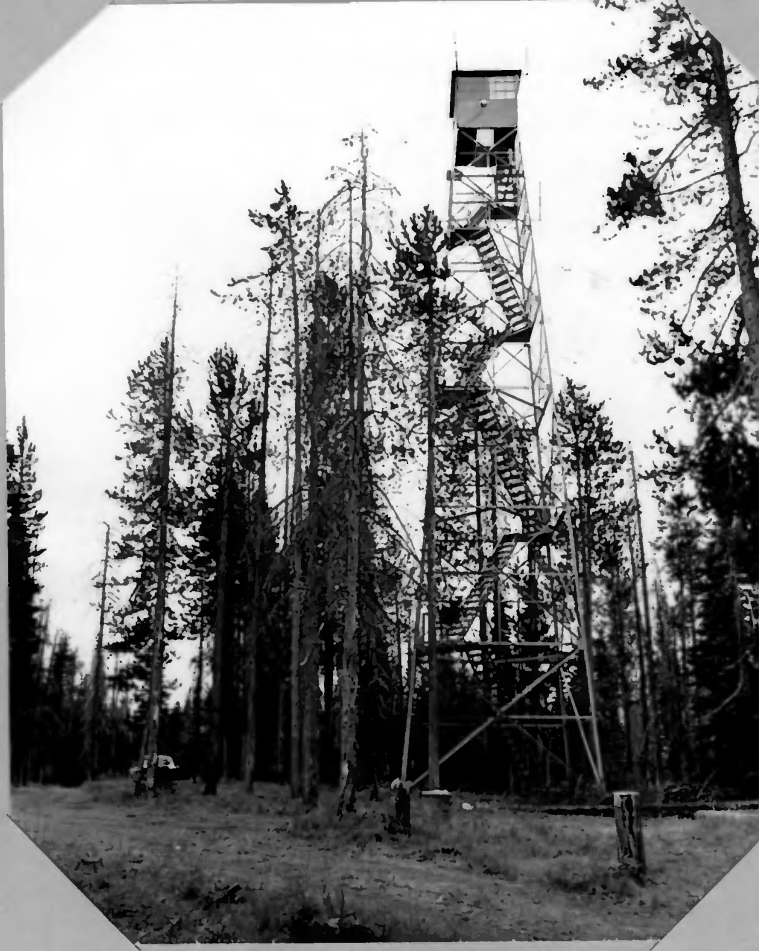
Photograph 2 of 5

Tower (Map 2, Building No. 1616): The lookout tower is a 72'-high gray steel structure with a 7'x7' enclosed steel cab. It was manufactured by the Aermotor Company of Chicago using their plans MC-39 and MD-79. It does not conform to any

standard architectural style. The tower legs are an open steel framework. Entry to the cab is through a trap door. The lower halves of the cab walls are steel panels. The upper halves consist of two square windows, with nine lights arranged in rows of three. One of each pair of windows is pivoted to swing out at the bottom. The roof is pyramidal.

The tower is in generally good condition. The concrete footings developed cracks, which were repaired with epoxy in 1983. Inspection of the steel framework revealed no serious defects. The interior of the cab is in fair condition, with floor covering needed. The fire-finder is present, and is in need of a new map.

Tower, view from N

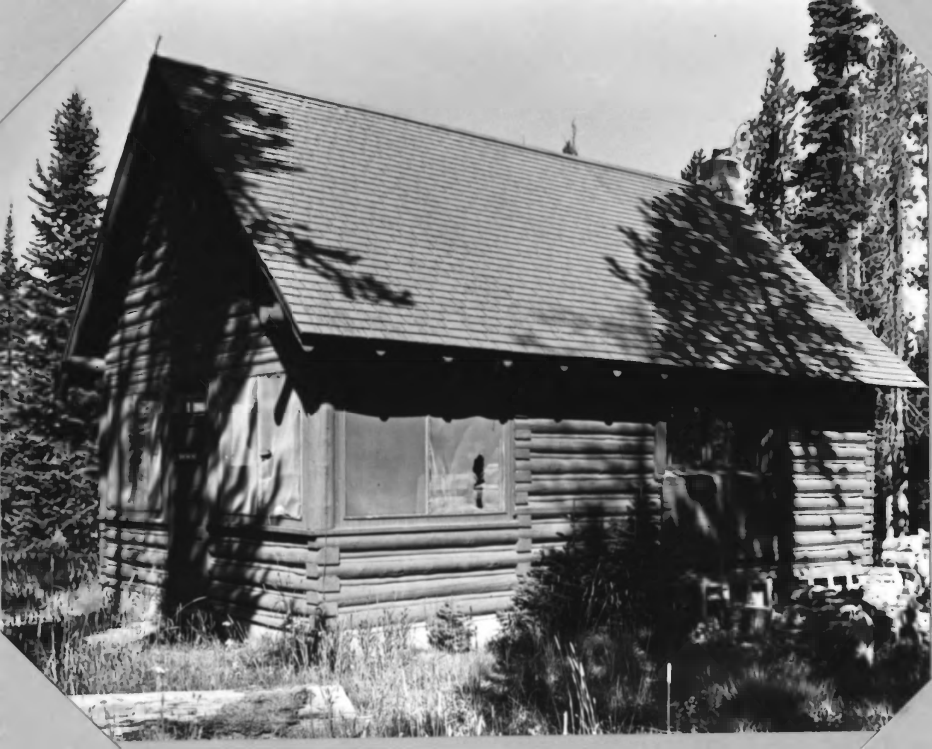
Photo 3 of 5

Cabin (Map 2, Building No. 1116): The cabin is a 16'x24' one-room log building with a screend porch on the south end. It does not conform well to standard architectural styles, but has been characterized as "neo-colonial" (McDonald 1985). It was built using Intermountain Region Plan R4-4, recommended for facilities used more than 45 days but less than three months (USDA Forest Service, Intermountain Region 1935: BP-12).

The foundation is concrete. The logs are square-notched, chinked with concrete and stained brown. There are rectangular, sliding-sash windows with six lights per sash in the east and west walls. A porch runs the length of the south facade, is partially enclosed, and screened. Entry to the cabin is by a single, flush swinging door off-center to the west on the south end. The porch has a single, centered, flush swinging door. The porch columns are round posts. There is a concrete-block chimney on the north end of the building. This replaces an earlier stovepipe that projected through the northwestern portion of the roof. The cabin has a gable roof covered with green wood shingles. The eaves overhang. There are arched louvres under the gables. The interior is finished with painted plywood panels.

Aside from the chimney, the building is unmodified and is in a good state of repair.

Cabin, view from SE

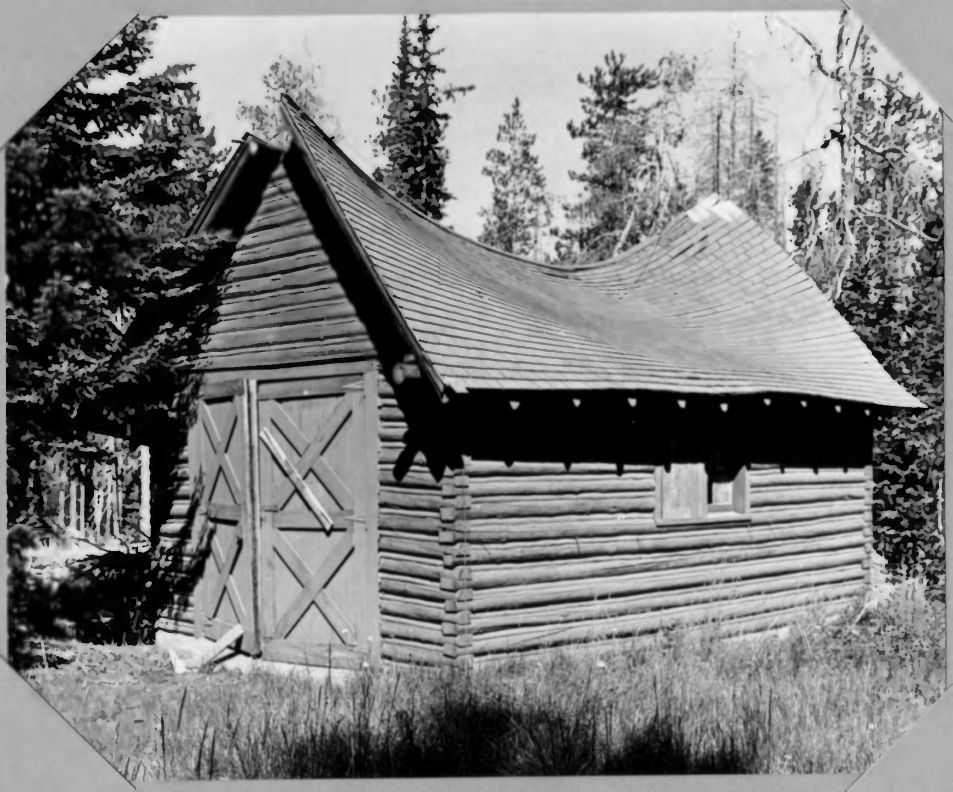
Photograph 4 of 5

Garage (Map 2, Building No. 1310): The garage is a 14'x20' single-car building constructed in the same style as the cabin. Intermountain Region Plan R4-24 was used in the construction, but was modified by deleting the side door.

The garage has a concrete foundation and floor. The logs are square-notched, chinked with concrete and stained brown. There is one window, a fixed sash type with four panes per sash, in the east side. Entry for both people and vehicles is by double swinging doors set flush in the south end of the building. The garage has a gable roof with overhanging eaves. It is covered with green wood shingles. The interior is not finished.

Several years ago, snowloads caused the roof to slip to the west. The roof was then hit by a falling tree. Many rafters and roof planks were broken. The rafters consisted of a native lodgepole pine logs, peeled and planed on the top surface. They were replaced in 1985 with duplicate materials (McDonald 1985b). The planks were 1" x 6 7/8" tongue-and-groove boards. They were replaced with 1" x 7" plain boards. The Grade 3 fine cut exterior shingles were replaced with Grade 2 shingles. At the same time, the lodgepole tie beams were replaced with duplicate materials and a ridgepole and braces placed under the roof to prevent future snow damage. The most serious problem remaining is a separation of the top of the southeast corner that occurred when the roof slipped.

Garage, view from SE

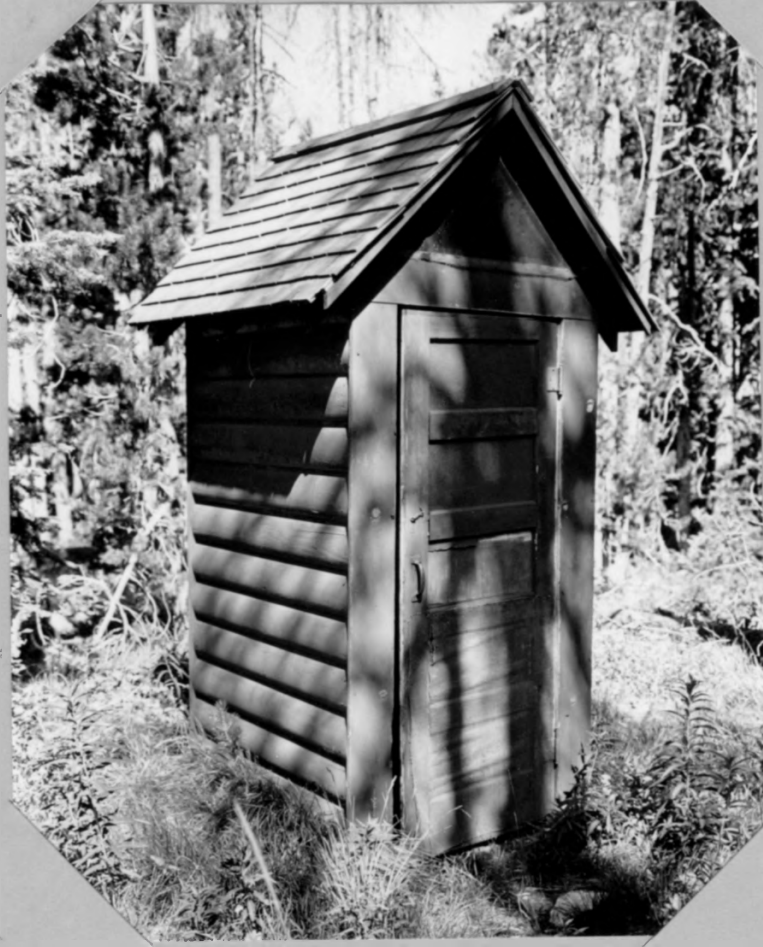
Photograph 5 of 5

Toilet (Map 2, Builindg No. 1605): The toilet is a 3' x 4' frame building with false log siding. The siding is painted brown. There is no foundation. The roof is a gable type, with overhanging eaves and green-painted wood shingles. There are triangular screened vents under the gables. The door is a single, swinging door.

The toilet is in fair condition. The original wood bench seat has been replaced with a metal riser and plastic seat. The panels on the door have begun to warp.

Toilet, view from SE

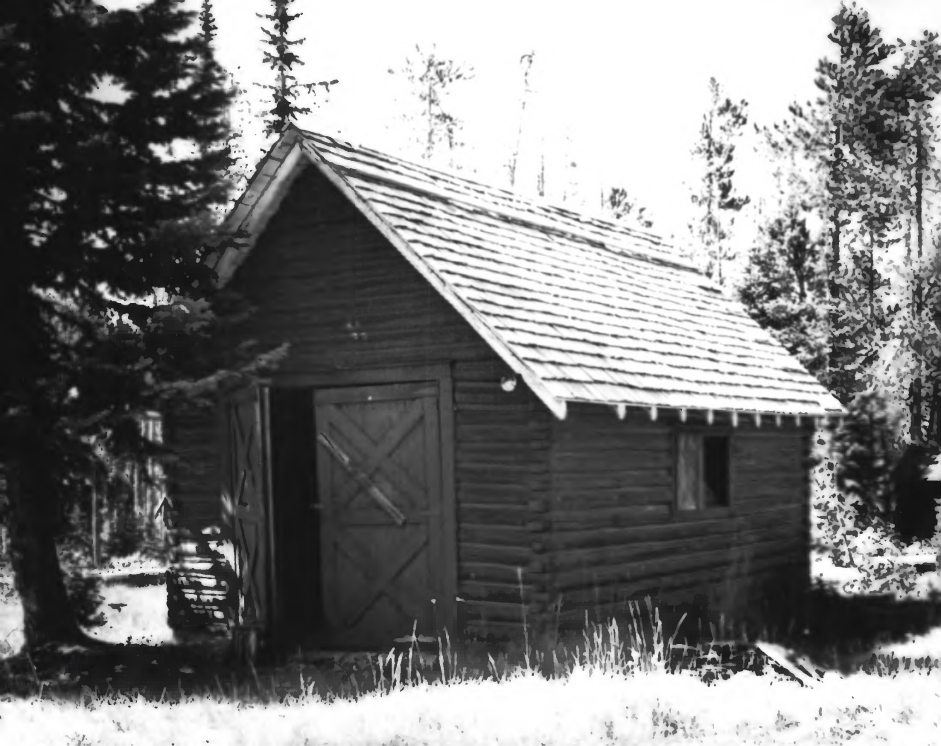
Photograph 1 of 2

Garage, view from SE. Following repairs.

Replacement materials unpainted.

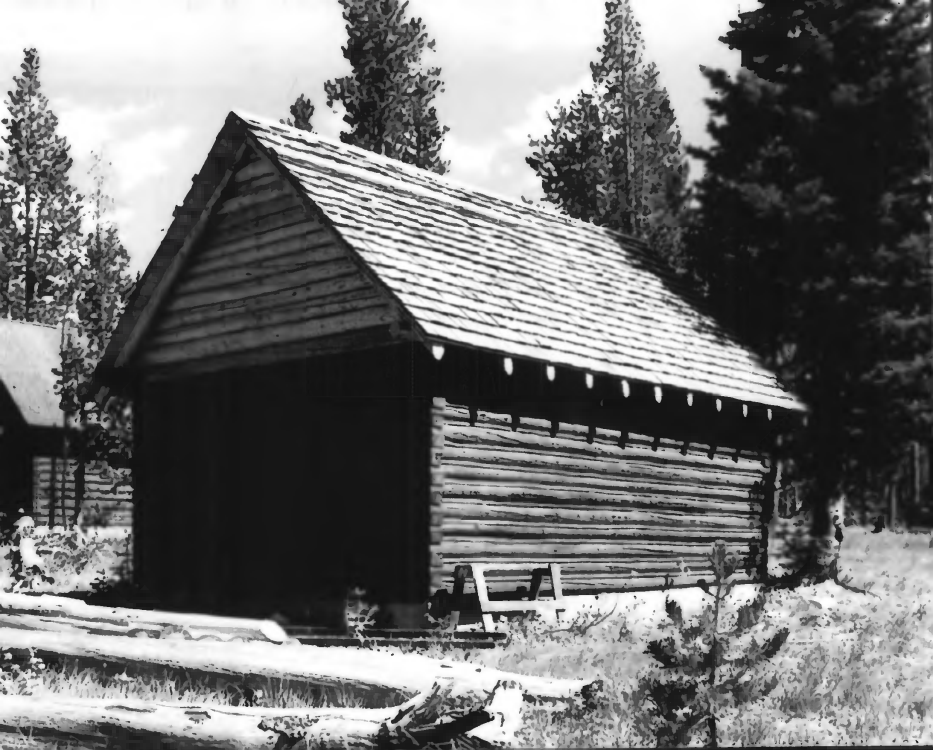
Garage, views from NW. Following repairs.

Replacement materials are unpainted.  
J. McDonald, 8/14/86
