UNITED STATES DEPARTMENT OF THE INTERIOR  
NATIONAL PARK SERVICENATIONAL REGISTER OF HISTORIC PLACES  
INVENTORY -- NOMINATION FORM

Challis Brewery Historic District

Klug Brewery

CHALLIS, IDAHO

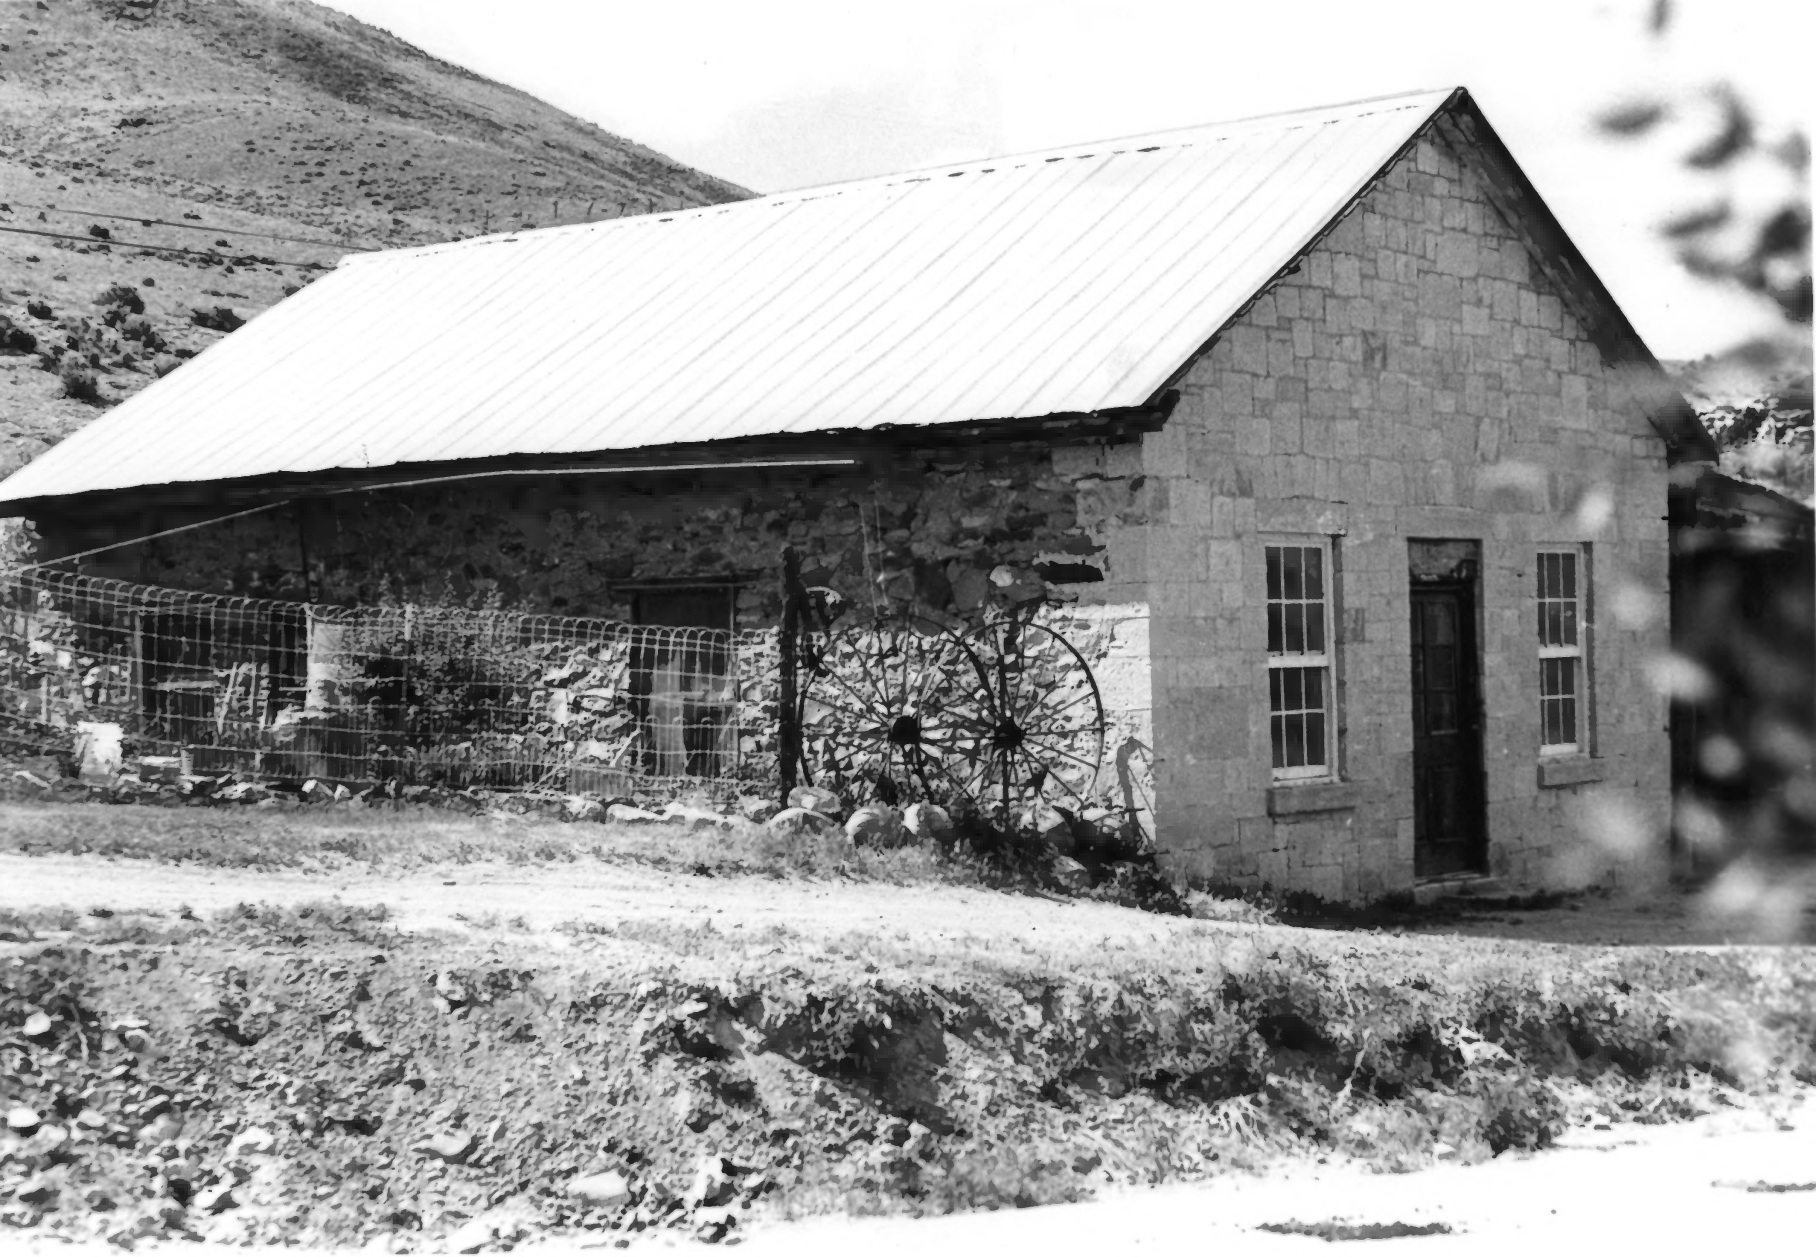
Photograph #1 of 4

Challis Brewery Historic District  
(Site 1, Brewery)  
Challis Creek Road, Challis, Custer  
County, Idaho

View from southeast

The one-story brewery building is the largest of the structures, and is in good condition. It is 37' 6" long x 28' wide, constructed of local stone. The east-facing entry wall is made of hand-cut smooth-finished stone, laid in random-coursed ashlar. The other three walls are of uncoursed rubble.

The front door is centered under the gable, and is flanked by double-hung 6 x 6 sash windows, one on each side. The three openings are spanned by stone lintels, each set under a shallow segmental arch in stone which relieves the weight of the wall above. The space between these arches and the lintels is slight, and is filled with mortar. A clearly discernible keystone is visible in the arches above the left-hand window and the door, but the same function on the right hand window is carried out with two stones. The projecting square-cut stone window sills are monolithic. There are two additional windows in north and south walls.

The roof is gabled, running east and west. It is covered with sheet metal but was originally shingled.

The brewery building itself is a fine example of frontier stone commercial architecture. The craftsmanship on the random ashlar facade is especially noteworthy. The front half of the building is well finished on the inside since it doubled as saloon as well as brew house.

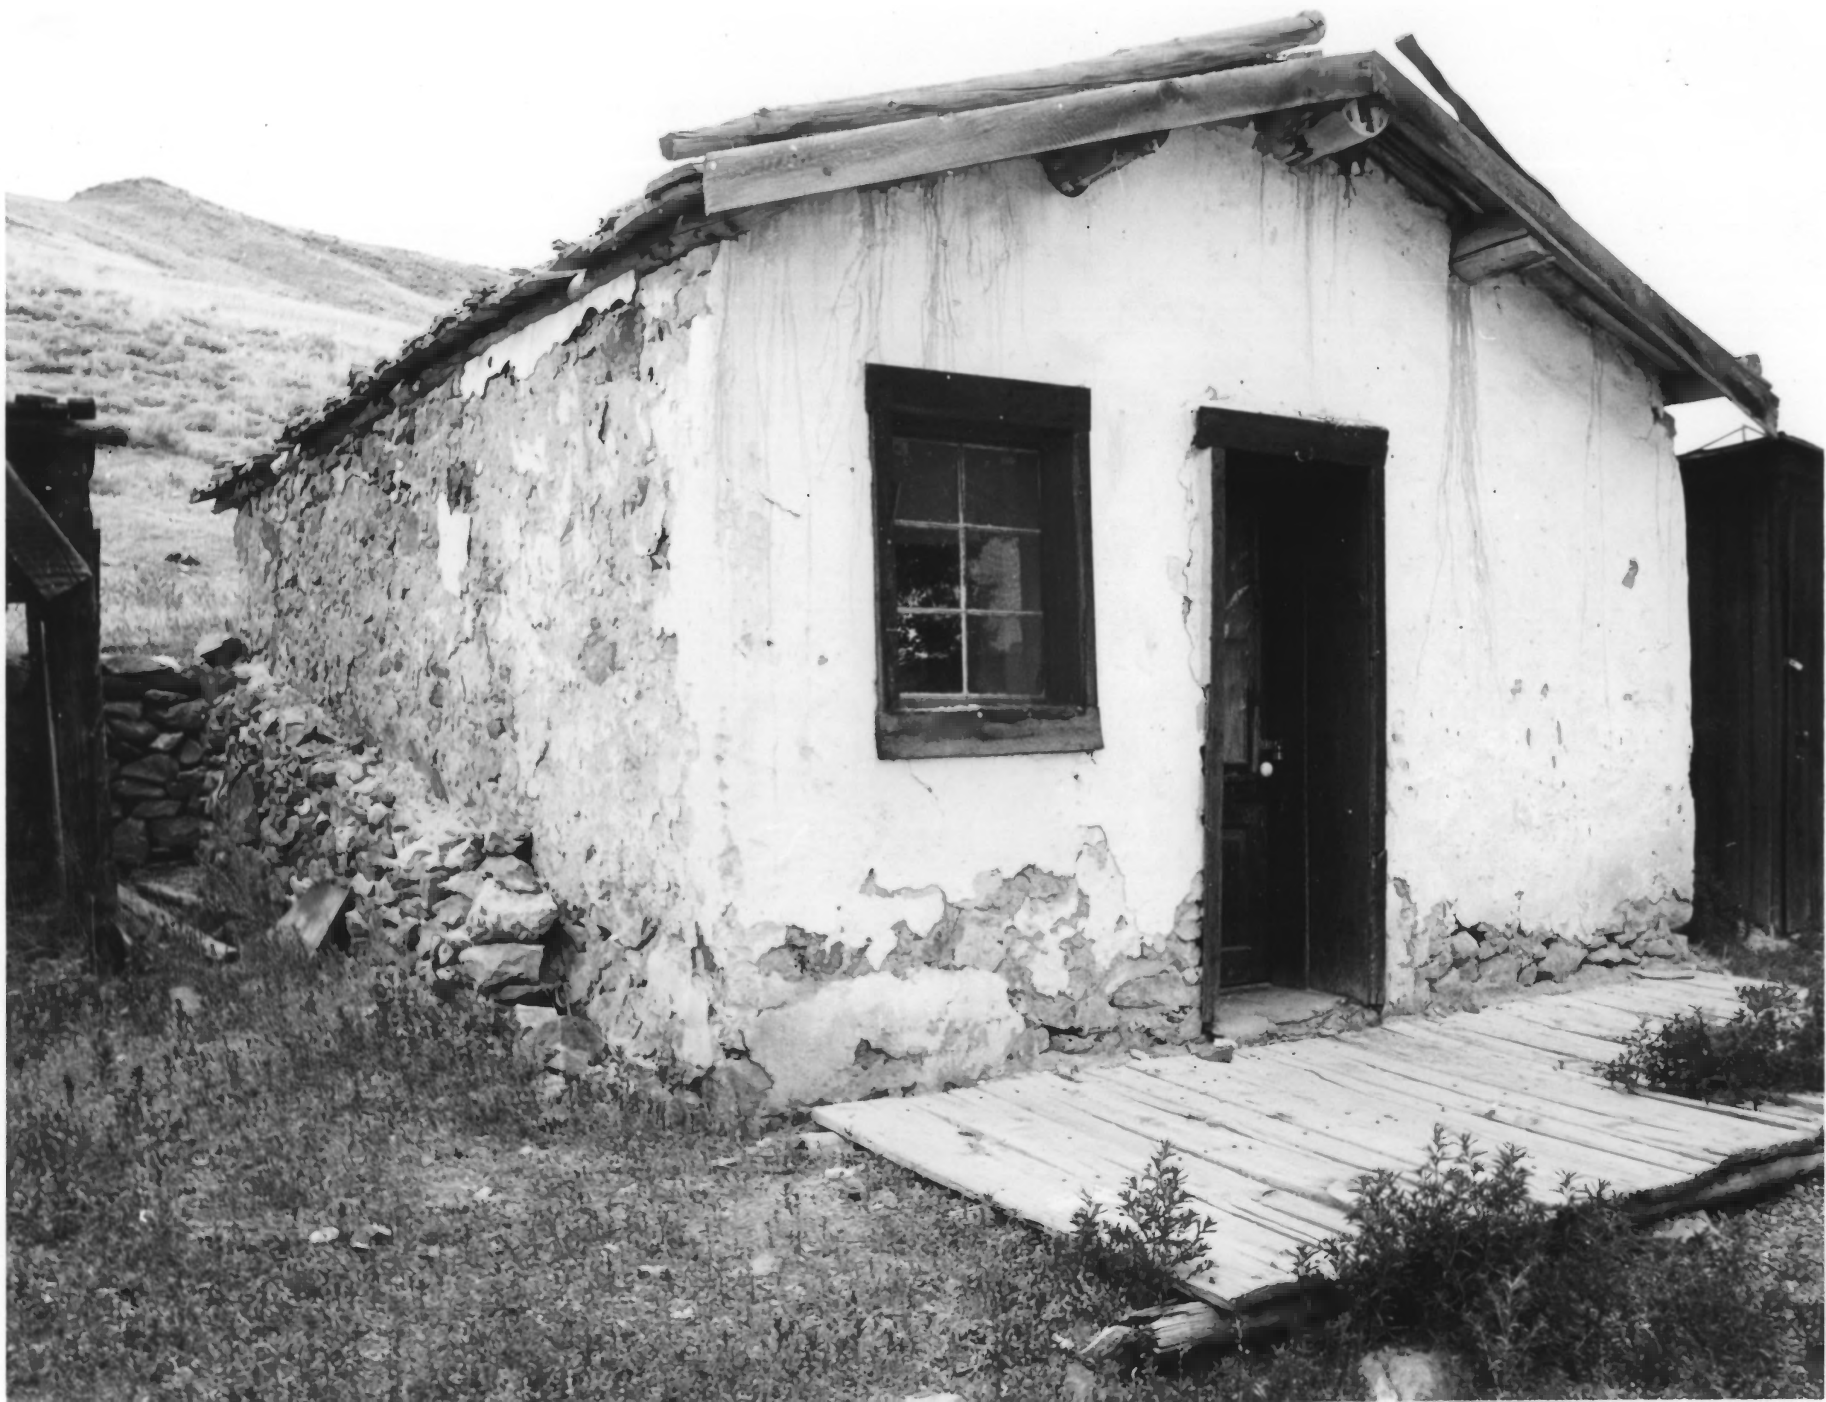
Photograph #2 of 4

Challis Brewery Historic District  
(site 4, Reynold's Adobe)  
Challis Creek Road, Challis, Custer  
County, Idaho

View from southeast

The two rubble structures to the south, originally dwellings for the brewers and their families, were literally held together with mud. Repeated plastering with mud, whitewashed on the outside, has built up an additional thickness of 4 to 6 inches on the rough stone beneath. This is severely weathered, but is intact enough for accurate restoration. The Don Ferguson rock-adobe "B" is the larger of the two. It has one small off-center six pane window in the east wall and a door on the north wall. The Henry Reynolds rock-adobe "A" has a centered door in the east wall flanked by one six-pane window on the left hand side. A window in the door supplies all additional light. Rubble retaining walls at the back of these two dwellings connect them and control erosion from the hillside to the rear. Several small wooden sheds of recent date complete the complex.

The low pitched roofs on these two dwellings are framed in lodgepole pine logs, running parallel to the ridgepole, and covered with planks. Earth for insulation was placed on top of the planks. Adobe "B" has a tin roof on top of original earth and plants. All of these structures are in fair condition and restorable, if work can be started within the next year or two.

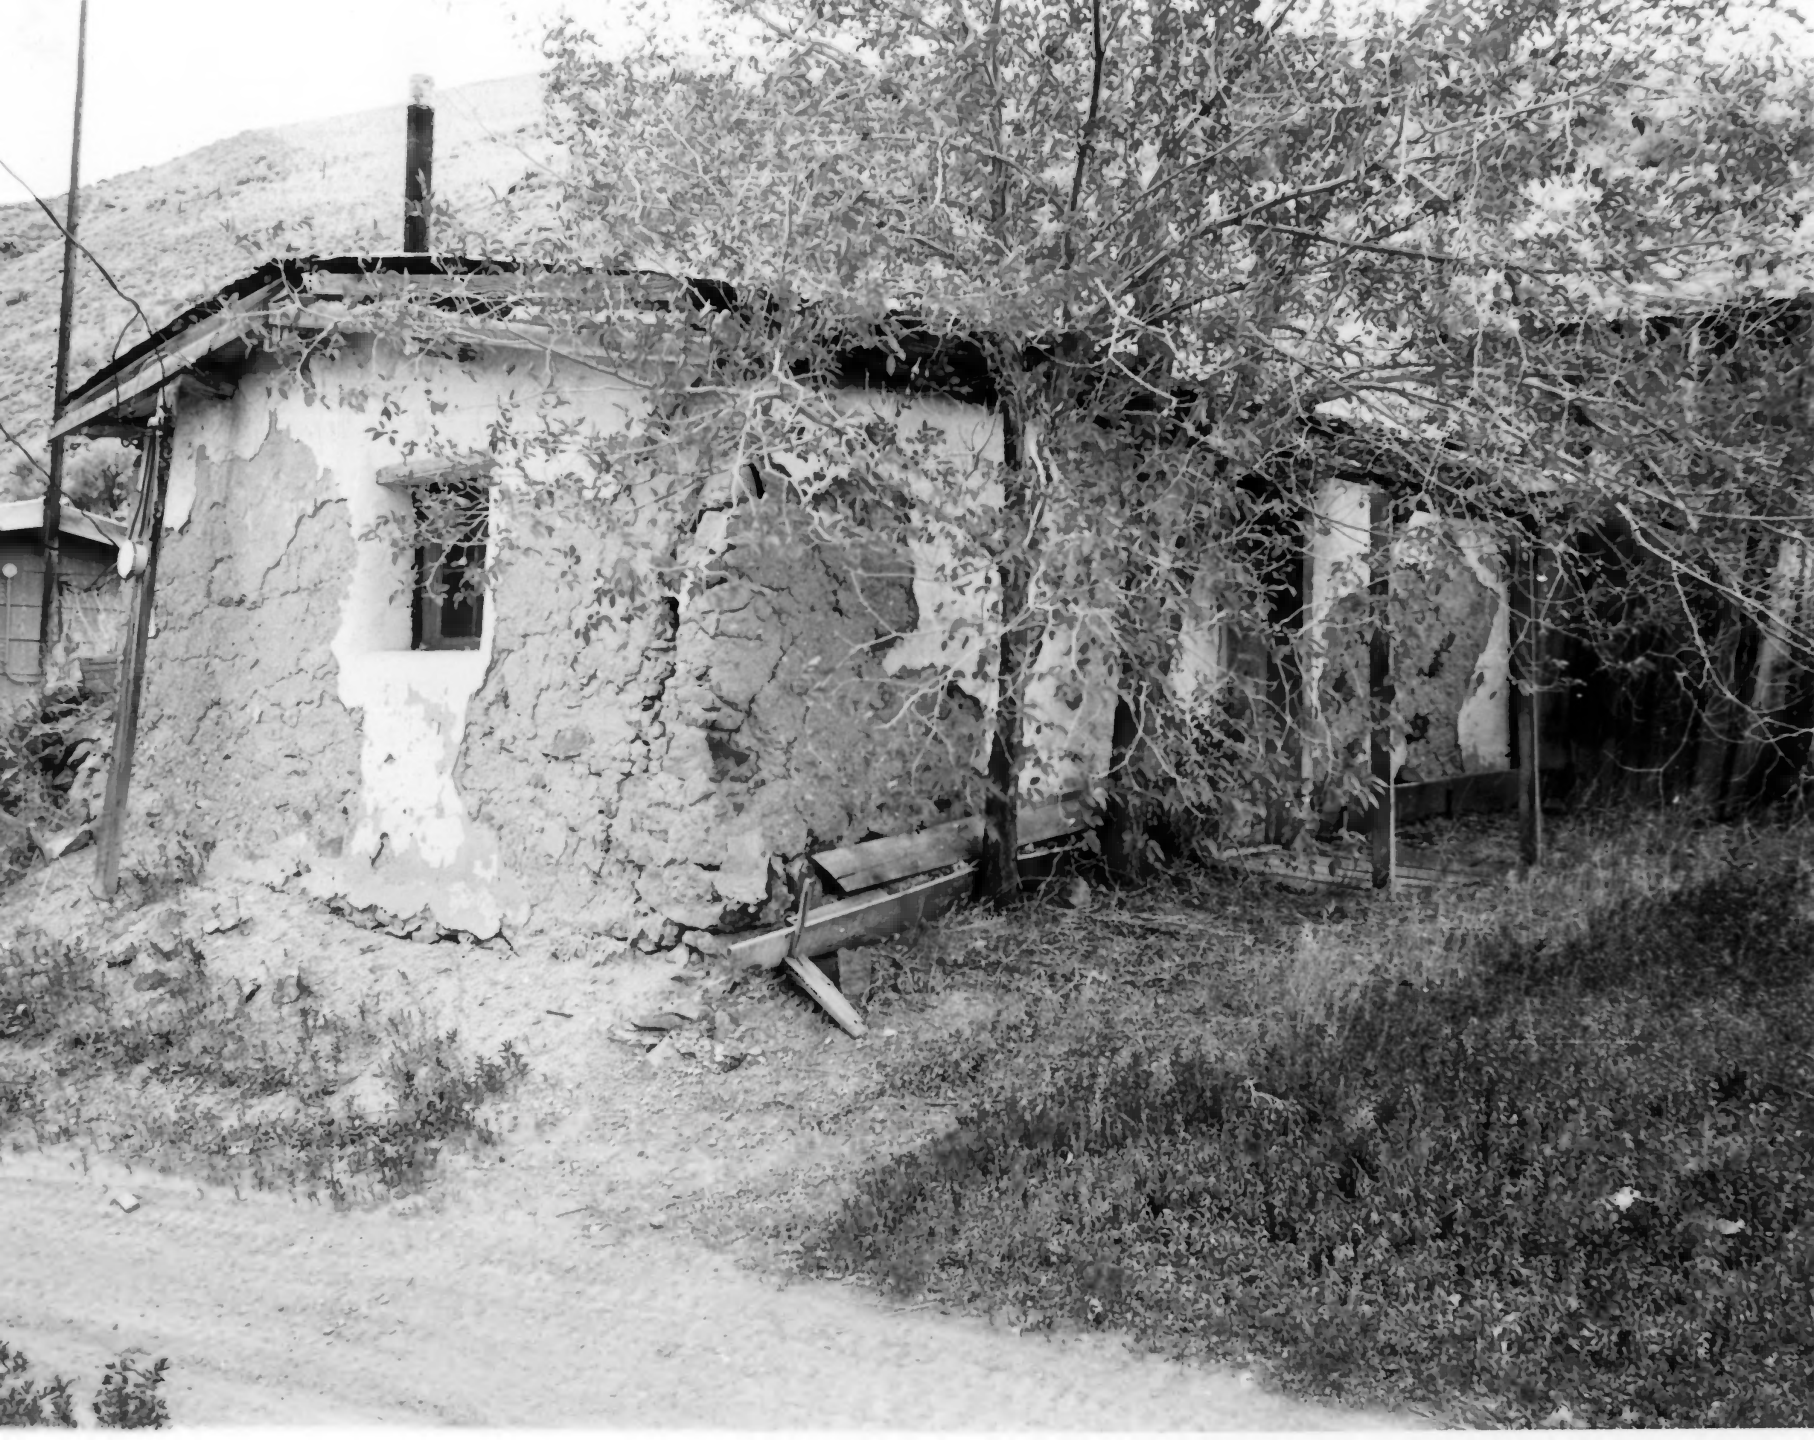
Photograph #3 of 4

Challis Brewery Historic District  
(site 7, Ferguson Adobe)  
Challis Creek Road, Challis, Custer  
County, Idaho

View from east

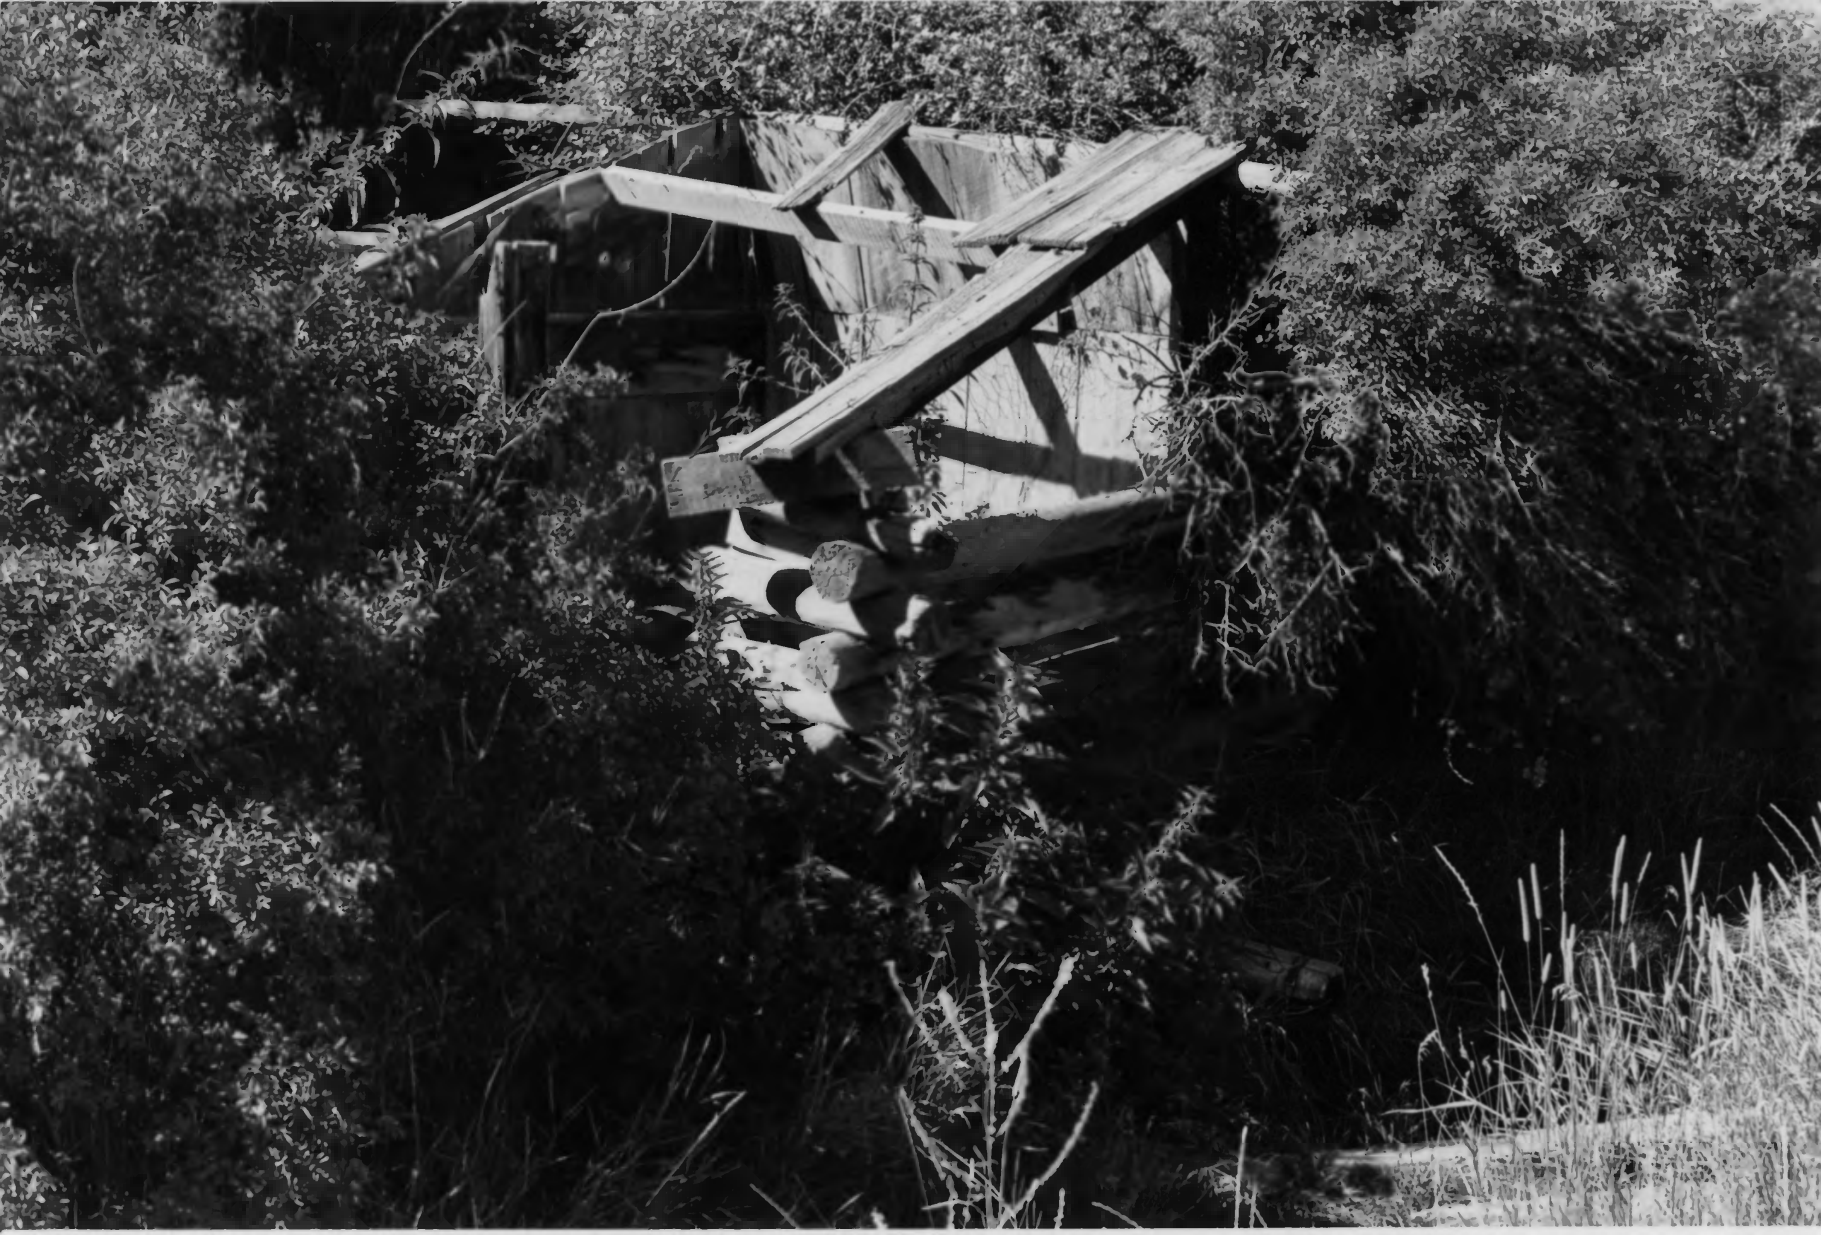
Photograph #4 of 4

Challis Brewery Historic District  
(site #9, springhouse)  
Challis Creek Road, Challis, Custer  
County, Idaho

View from southeast

The most southerly site in the district is Brewery Spring itself. The remains of a small springhouse sit over it. Although the roof is lost, the walls of saddle-notched poles remain. The greater height of the northern wall and the pitch of the rafter-poles show that the springhouse was a shed-roofed. Water flows steadily from a wooden pipe, formed from narrow staves bound by an iron strap, which emerges from the eastern base of the structure.
