United States Department of the Interior  
National Park ServiceNational Register of Historic Places  
Registration Form

historic name Edwards/Gillette Barnother names/site number Kellar Barn

street & number 3059 Rush Creek Road N/A not for publicationcity or town Cambridge N/A vicinitystate Idaho code ID county Washington code 087 zip code 83610

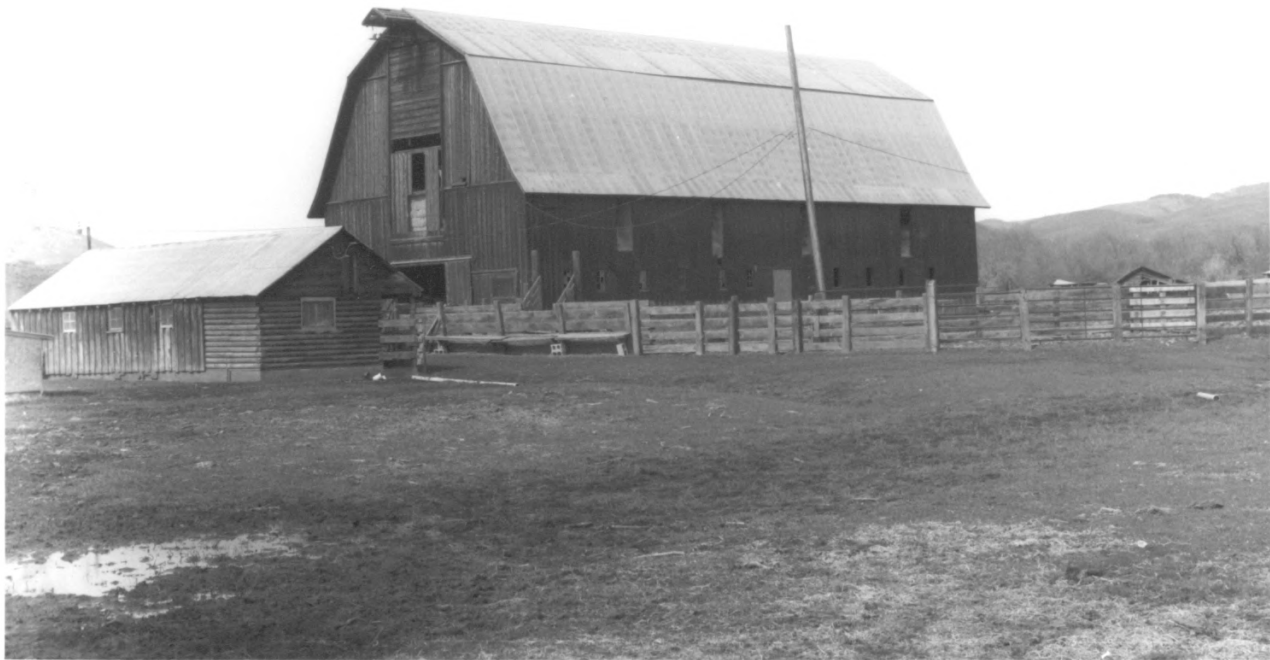
PHOTO 1 OF 5

VIEW LOOKING NW

The functionality of the barn is defined on the exterior by the location of openings. The south elevation features a large pair of sliding doors at the center. Two smaller, single sliding doors positioned to the left and right at the south ends of the stalls align with the track of the manure bucket at the interior. This allows for the waste to be moved out of the barn.

The upper level of the south elevation has a large, framed opening approximately sixteen feet wide by twenty-eight feet high capped with a small hay hood projecting from the peak of the roof. This opening, originally used for moving long hay into the barn, has been partially infilled at the top half with horizontal boards. The bottom half, partially enclosed with vertical boards, retains smaller openings for moving baled hay into the loft. The hay hood has lost most of its shingle roof and

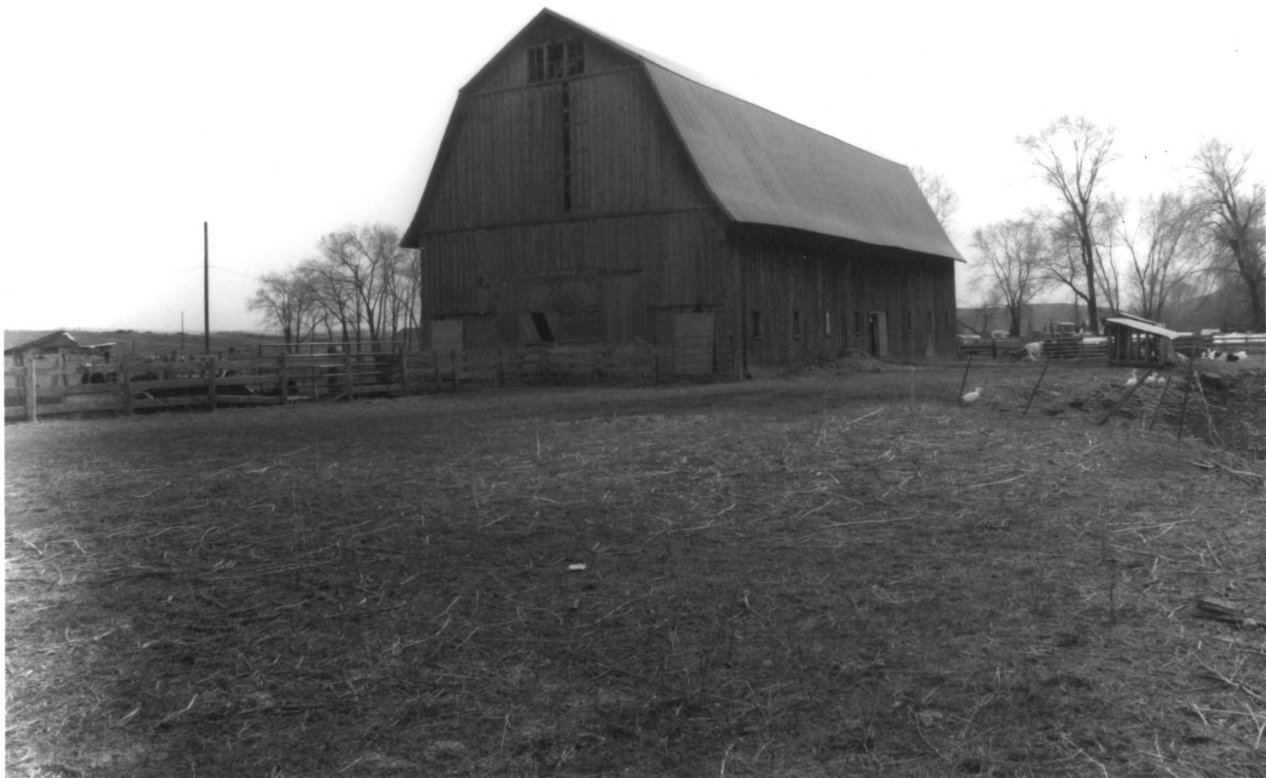
PHOTO 3 OF 5

VIEW LOOKING SE
