NOMINATION: Historic Resources of Challis (Partial Inventory: Architectural Properties)SITE NAME: Old Challis Historic District SITE # 1LOCATION: Block 36, Challis, IdahoOWNER'S NAME AND ADDRESS: See attached owners listQUADRANGLE AND SCALE: Challis 15 minute ACREAGE: less than oneVERBAL BOUNDARY DESCRIPTION: The Challis Historic District includes lots 1, 2, 3, and T-275 in block 36, Challis; see enclosed sketch map.UTM(S): 11/7,19,725/49,31,325DATE OR PERIOD: 1876-1890's EVALUATED LEVEL OF SIGNIFICANCE: localAREAS OF SIGNIFICANCE: architecture

NATIONAL REGISTER OF HISTORIC PLACES INVENTORY -- NOMINATION FORM

Old Challis Historic District, Site #1

OLD CHALLIS

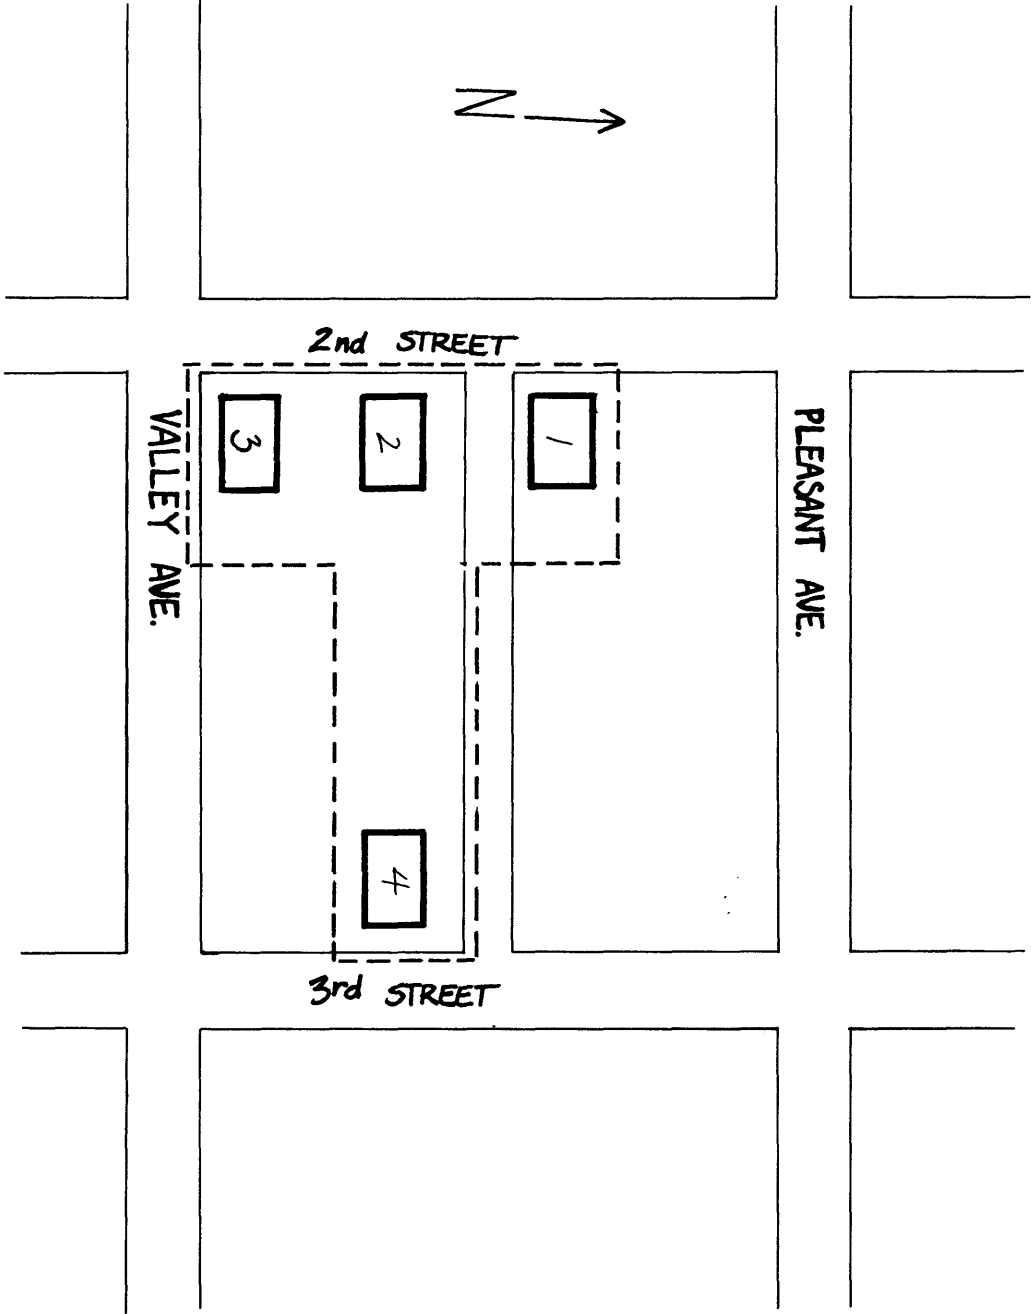
HISTORIC DISTRICT

NOT TO SCALE - 1980

DISTRICT BOUNDARY - - - - -

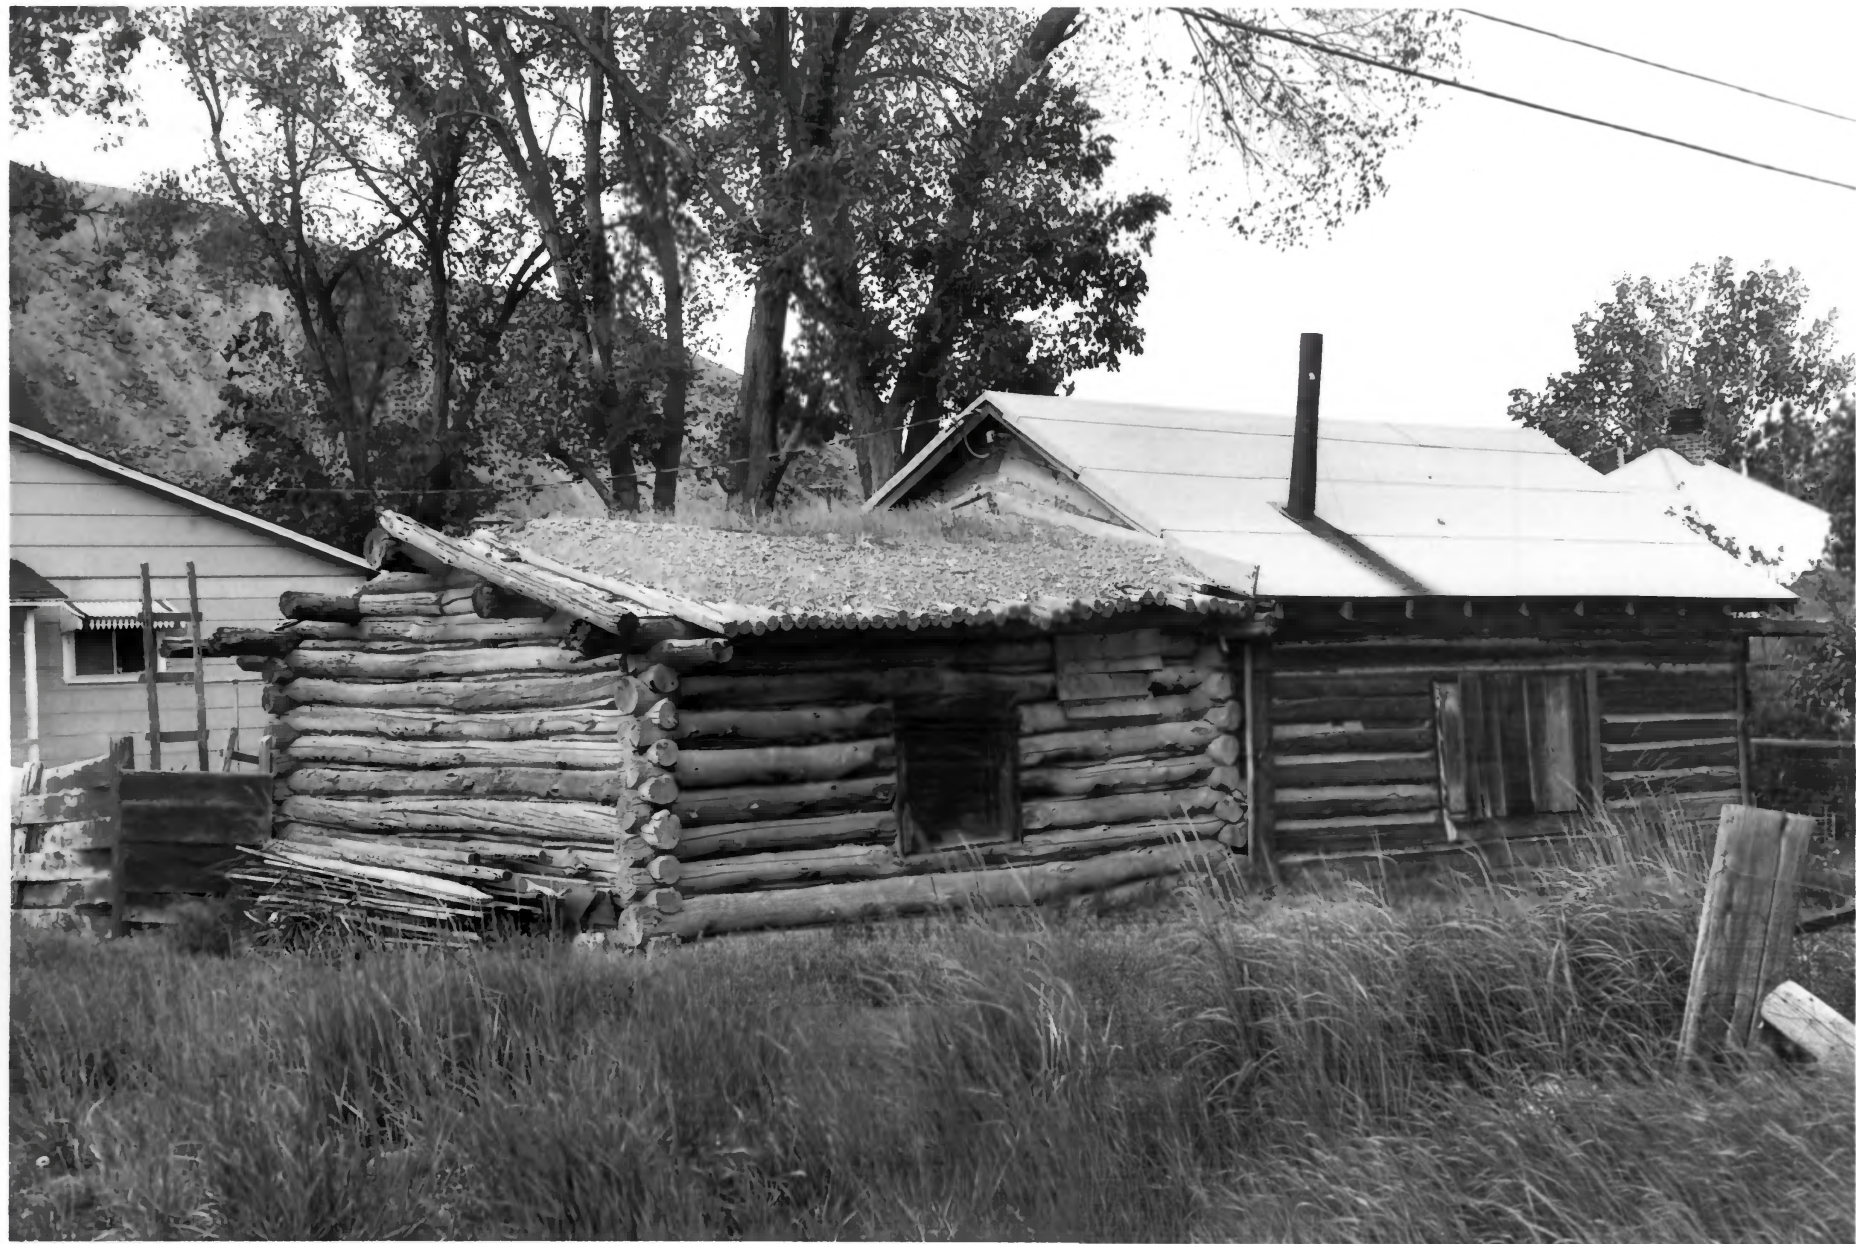
Photograph 1 of 4

Old Challis Historic District, Site #1
Log House I (building 1)
Second Street,
Challis, Custer, Idaho
Co.

View from Southwest

Inventory: (1) Log House I. This is a log house made up of two rectangular sections placed end to end. The eastern section is built of logs sawn to four-inch planks and joined with even-tiered square notching secured by nails. This section has a tarpaper-covered roof supported on exposed rafters. The western section of round, peeled logs has split-pole chinking and an exterior mud daub in the interstices between logs. The corner joints use a round notch cut in the log tops with the logs extending beyond the notching. A shallow dirt-covered roof is supported on log purlins. The building's two doors are in its north facade.

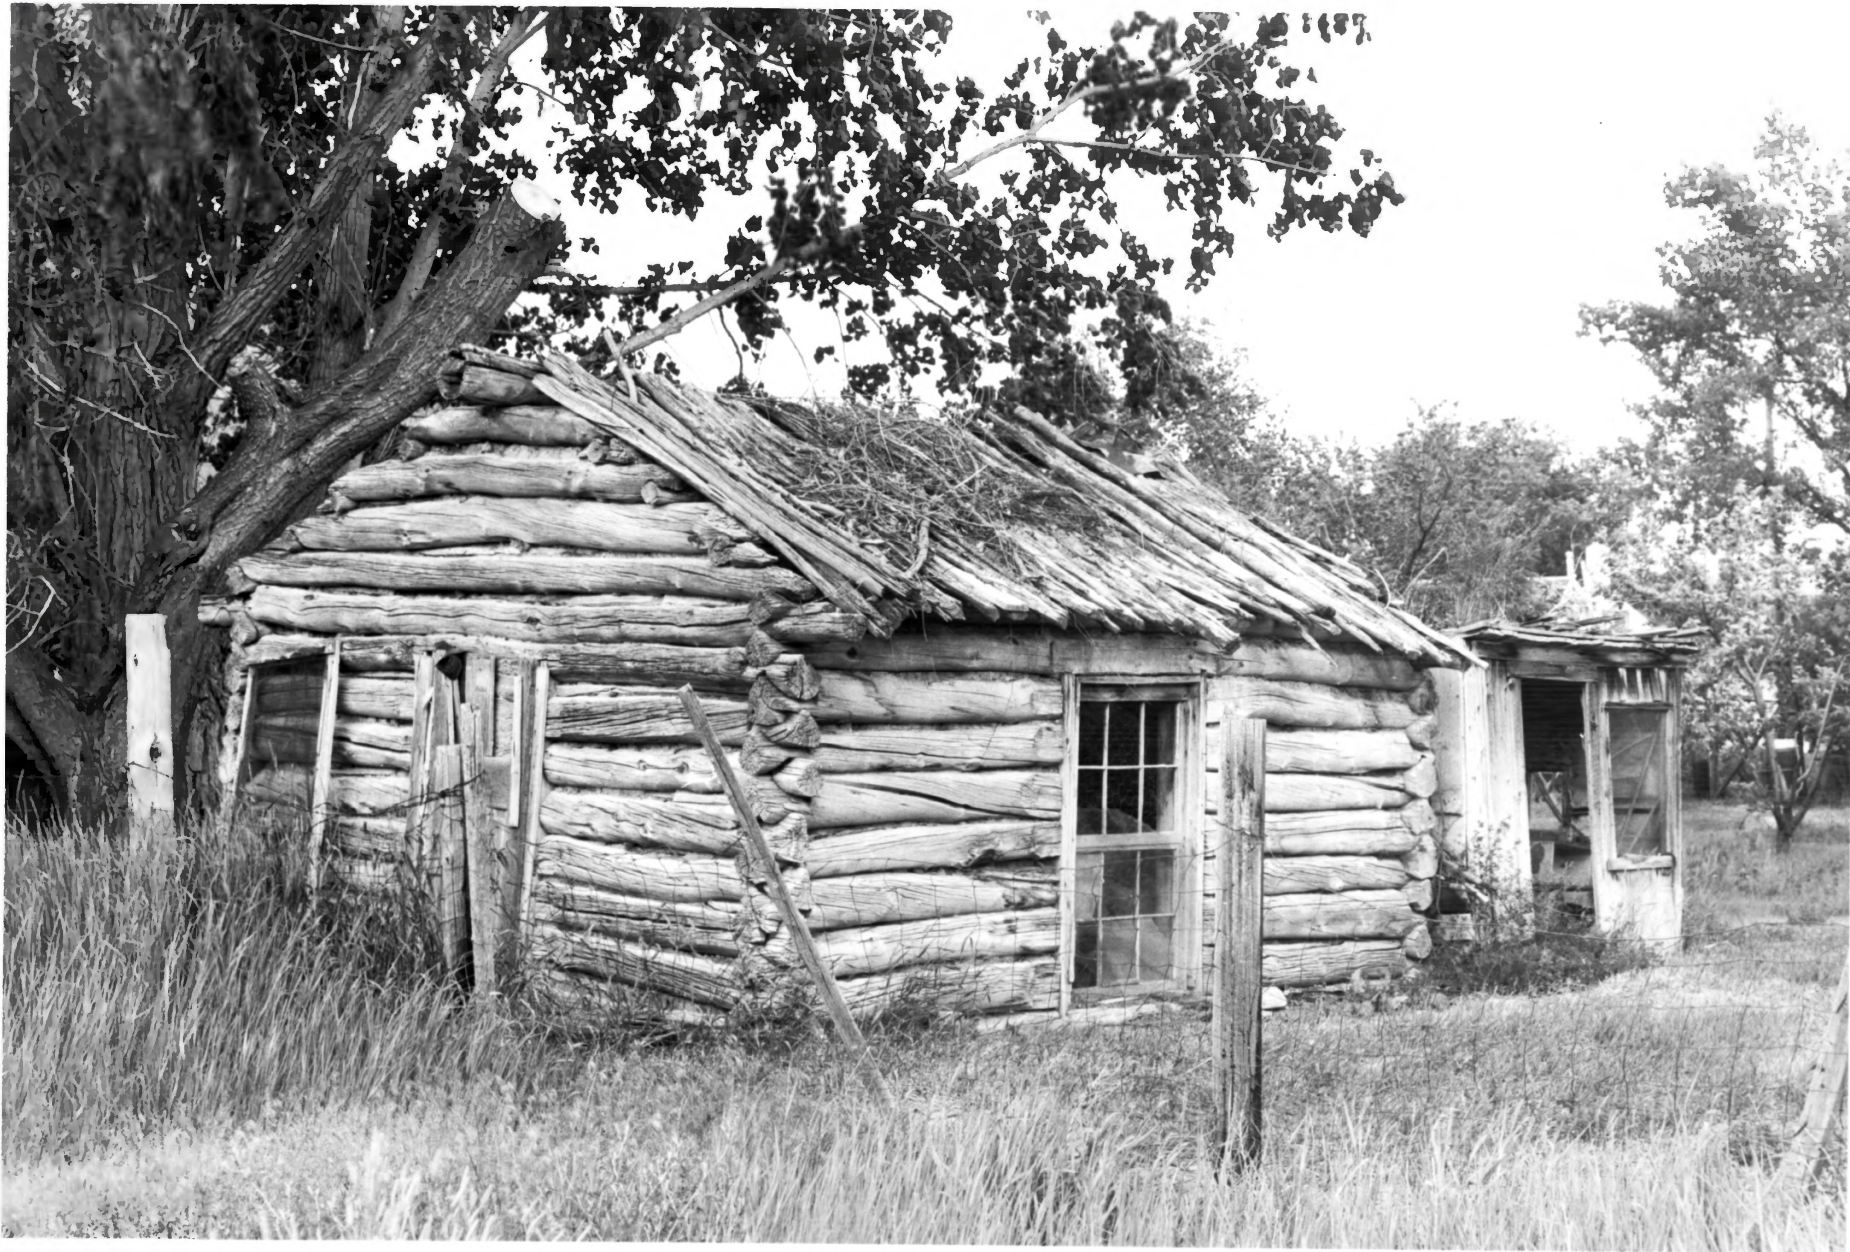
Photograph 2 of 4

Old Challis Historic District, Site #1
Log House II (building 2)
Second Street,
Challis, Custer, Idaho
CO.

View from Southwest

(2) Log House II. This round-log house has a westerly gable-front plan. Its peeled logs, joined with V-notching, extend slightly beyond the corners. Mud chinking and split-pole chinking fill the spaces between logs. A gable roof supported by log purlins is covered with poles. The house has one window--a six-over-six-light double-hung sash--in the south wall. The door is paneled. Attached to the eastern wall is a board-and-batten lean-to.

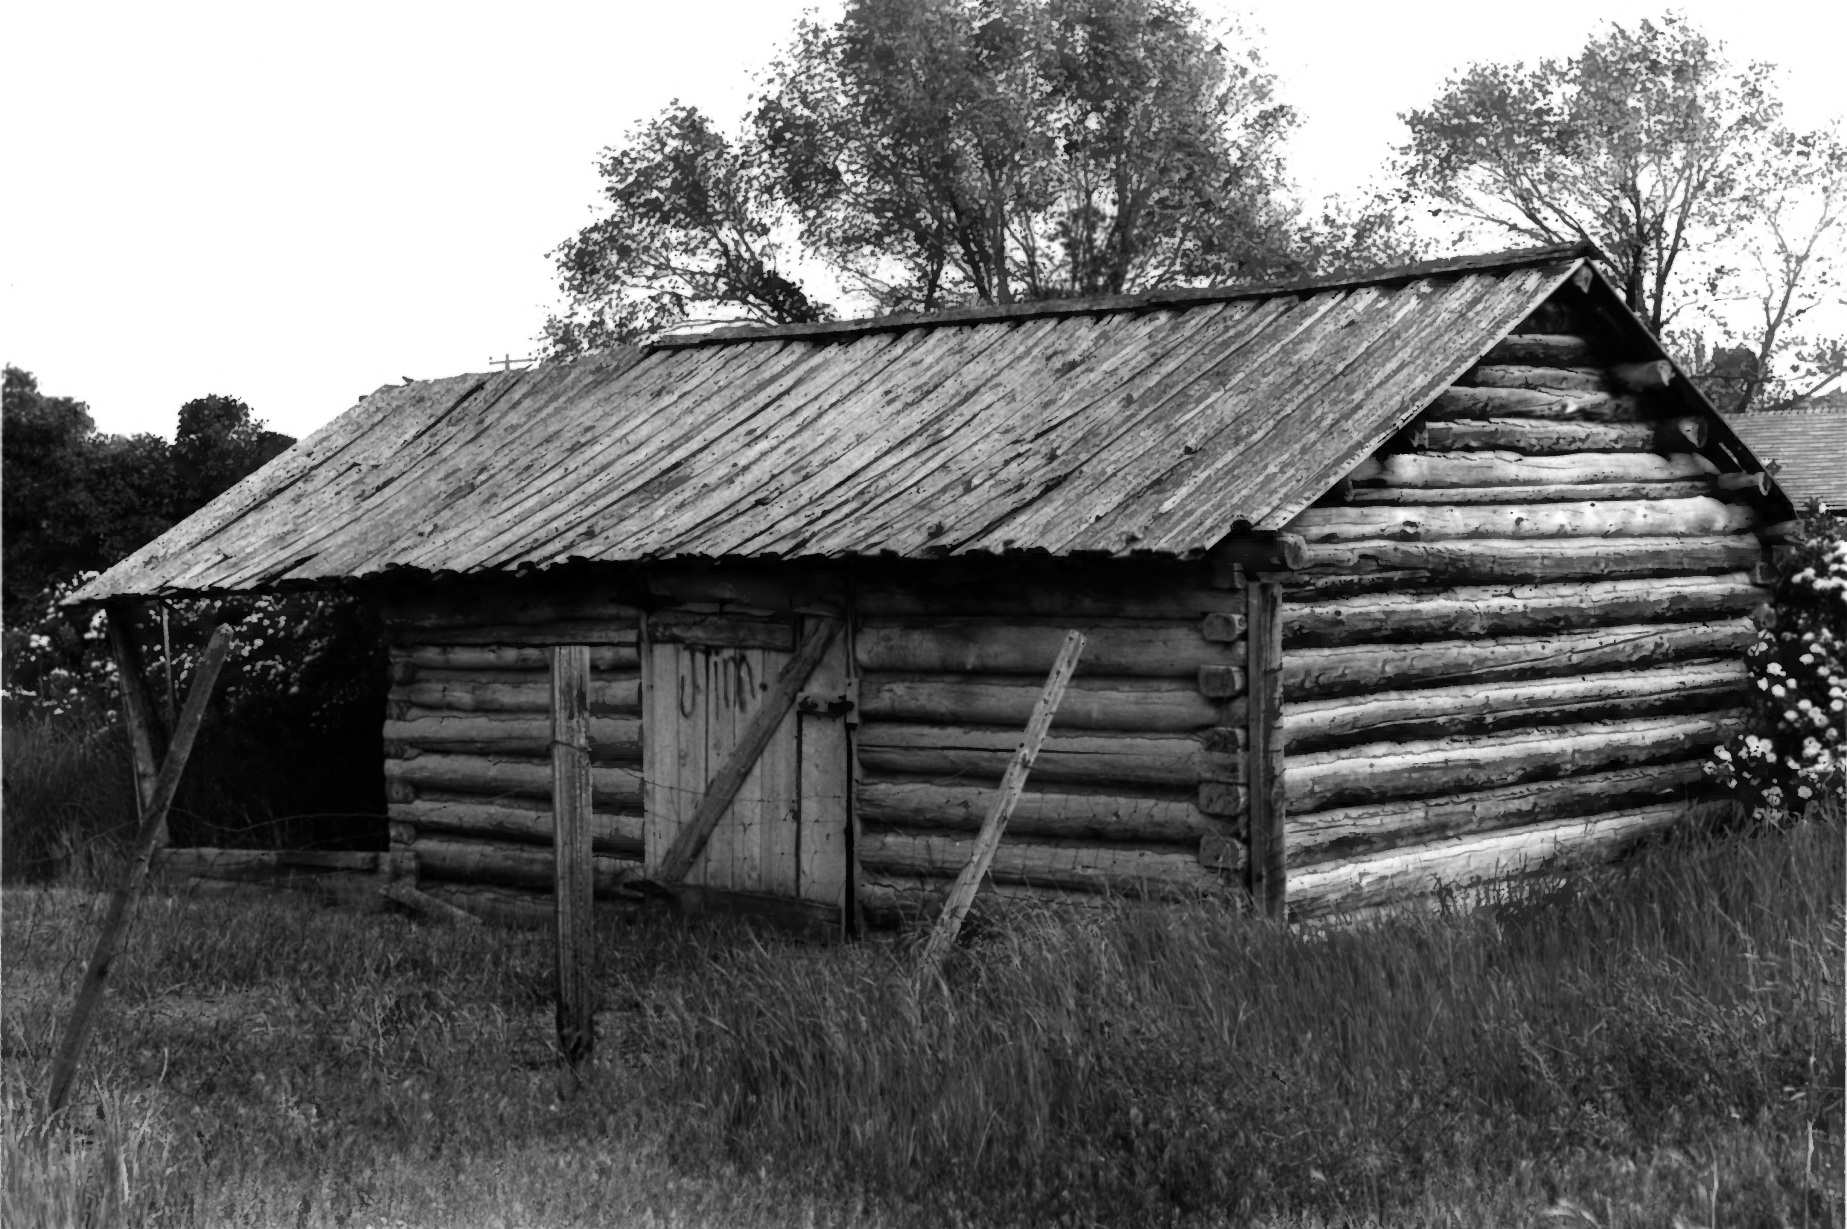
Photograph 3 of 4

Old Challis Historic District, Site #1
Log House III (building 3)
Second Street,
Challis, Custer, Idaho
CO,

View from Northwest

(3) Log House III. This round-log building with square notching has an east porch overhang of several feet, supported by the roof purlins and corner posts. The batten door is in the north wall. Full-length shingles terminate at the gable edge with a length of protective wooden flashing. The log interstices are filled with cement or lime mortar. The building stands on log sills.

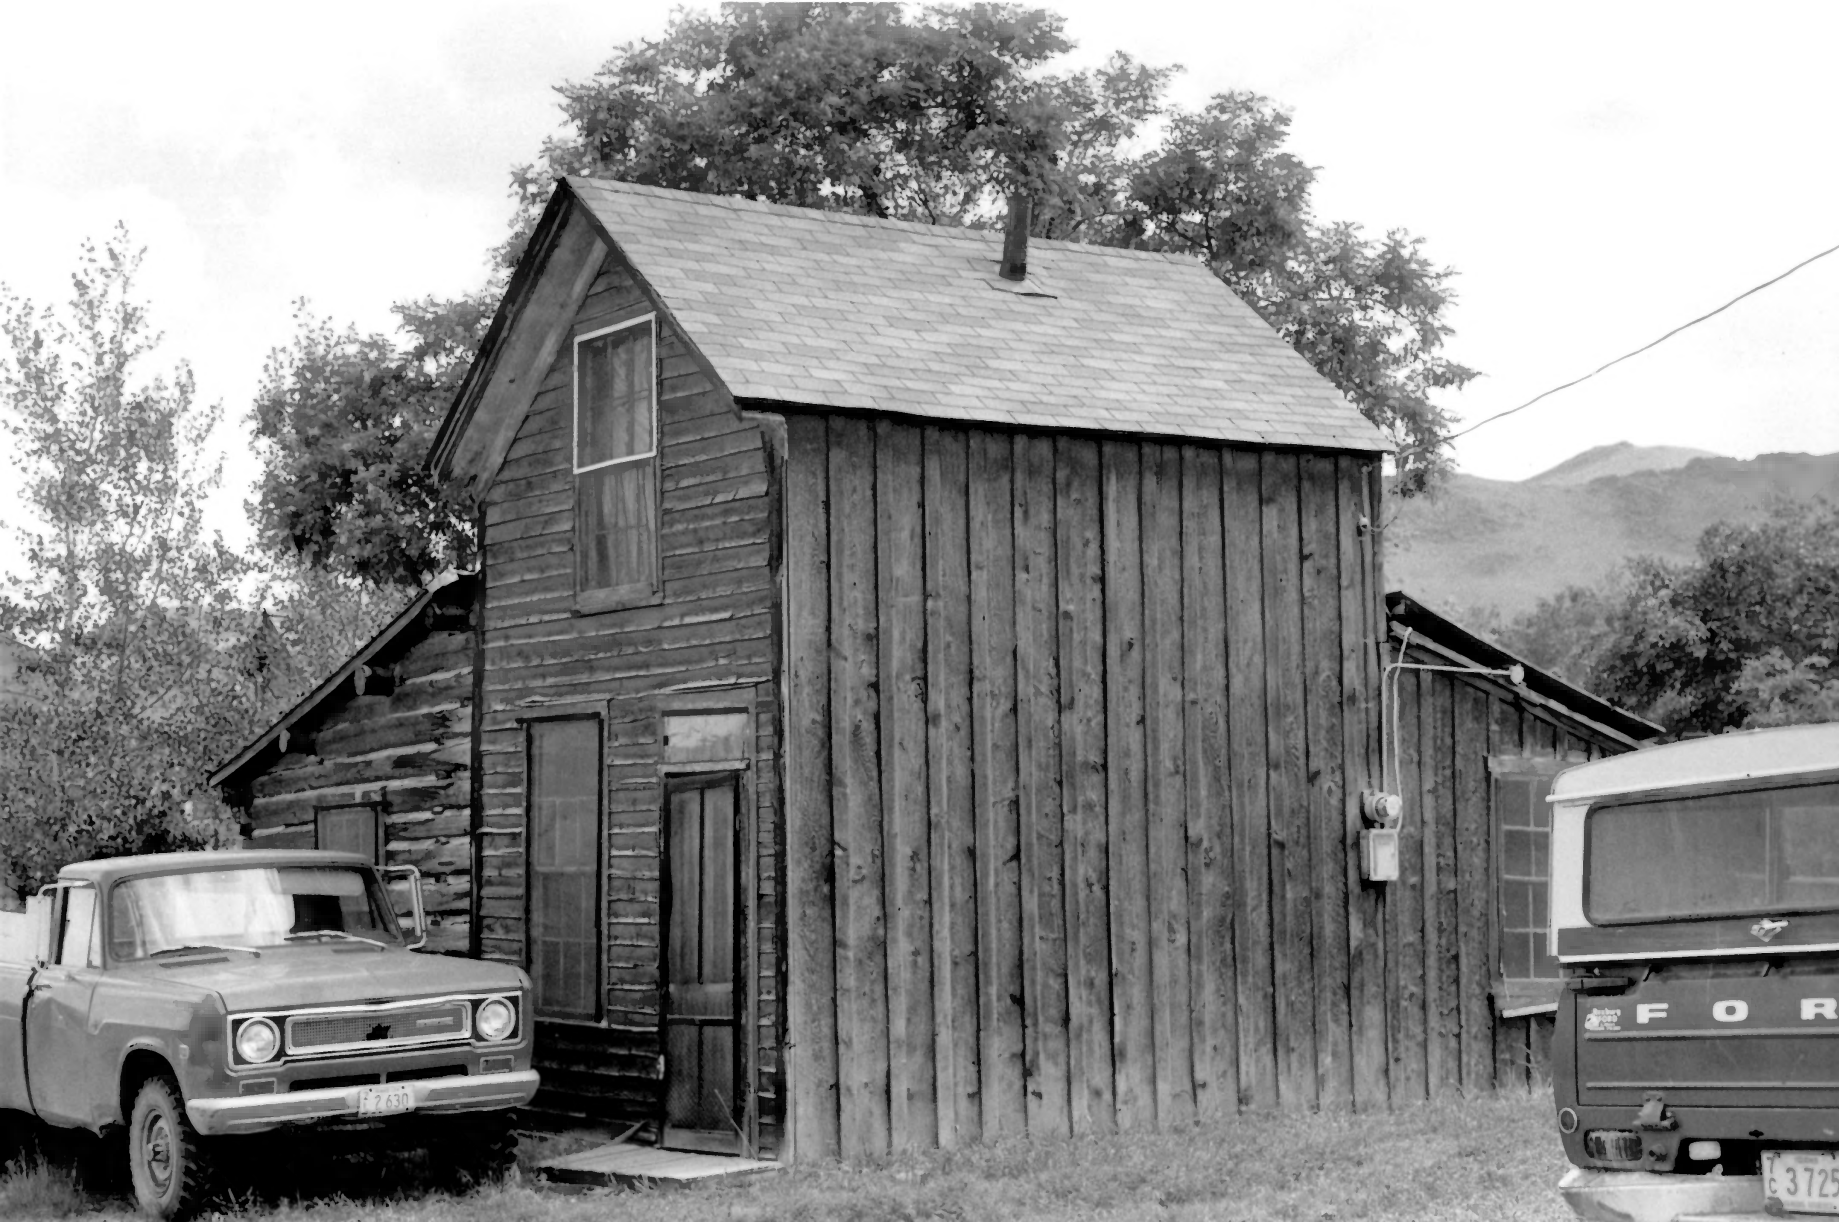
Photograph 4 of 4

Old Challis Historic District, Site #1
Frame and Log House (building 4)
Third Street,
Challis, Custer, Idaho
Co.

View from Northeast

(4) Frame and Log House. The two sections of this building--frame and log--join to form a gable-front house with a side lean-to. The gabled frame sections on the north combine board-and-batten construction and clapboard siding. The southerly log lean-to

has unpeeled round-log walls resting on log sills. Square notching, secured with an occasional large nail, joins the logs at their ends. The building's front and back paneled doors and six-over-six double-hung sash windows seem out of proportion to its modest size.
