National Register of Historic Places Registration Form

Historic name: Brose, Robert and Augusta, Ranch

Historic Agricultural Resources of Twin Falls County, Idaho: 1860 to 1970

City or town: Hansen State: Idaho County: Twin Falls

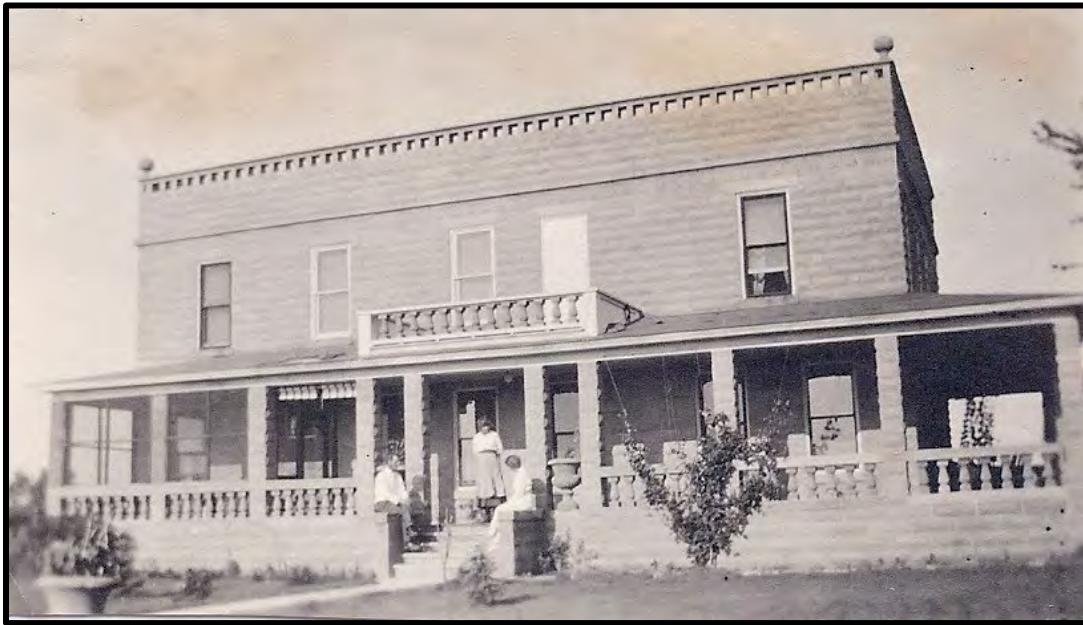
**Figure 15:** Brose House circa 1907. (Brose family Collection)

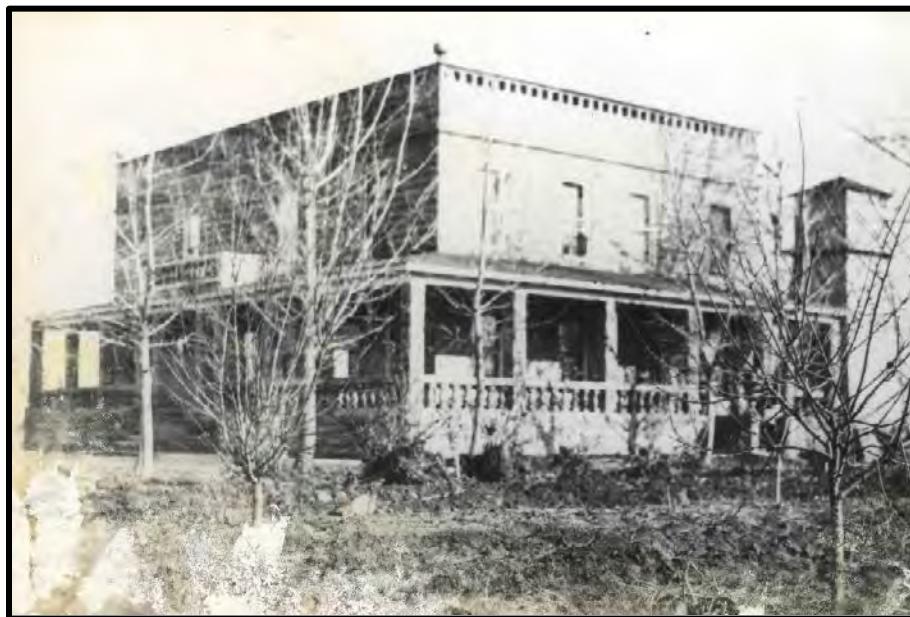
**Figure 16:** Brose house circa 1908. Water tank visible in the background.
(Twin Falls Public Library)

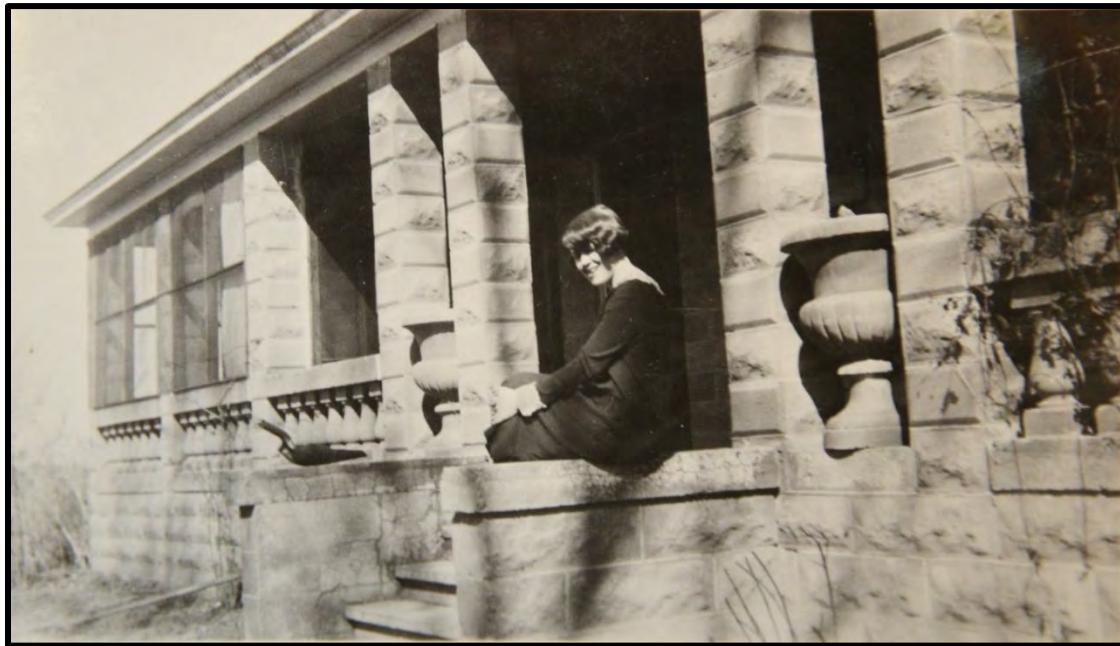
Figure 18: Unidentified woman on front porch. Circa 1910. Note concrete urns, porch, and screened porch. (Brose Family Collection).

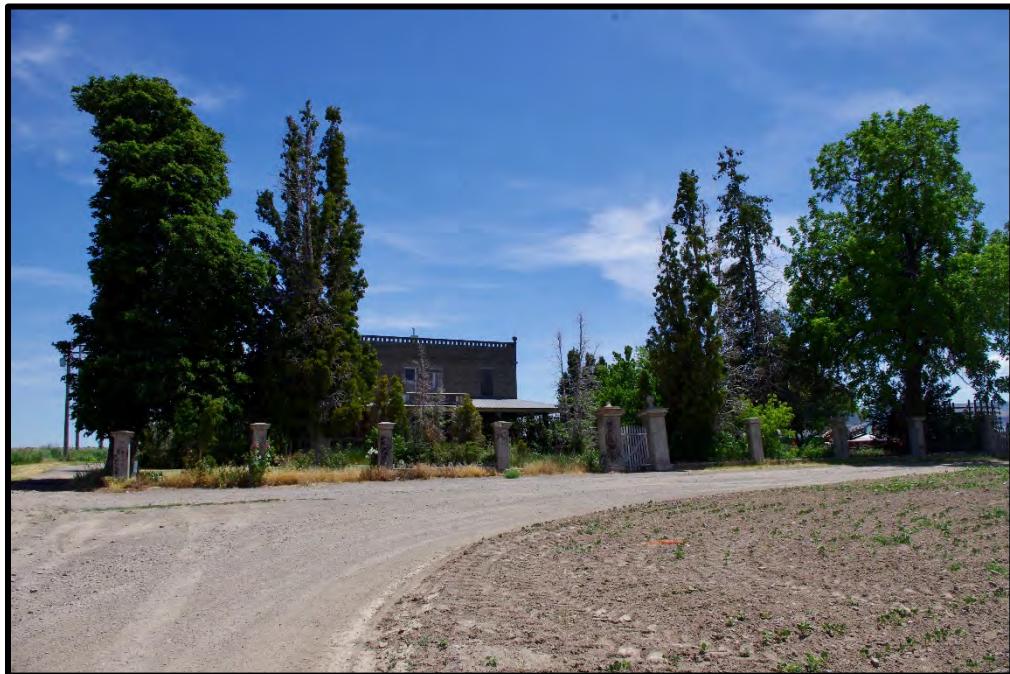
Photograph 2 of 101 Overview of house and grounds, façade, west elevation camera facing east.

Photo #2 (ID_Twin Falls County_Brose, Robert and Augusta, Ranch_002) Overview of house and grounds, façade, west elevation camera facing east

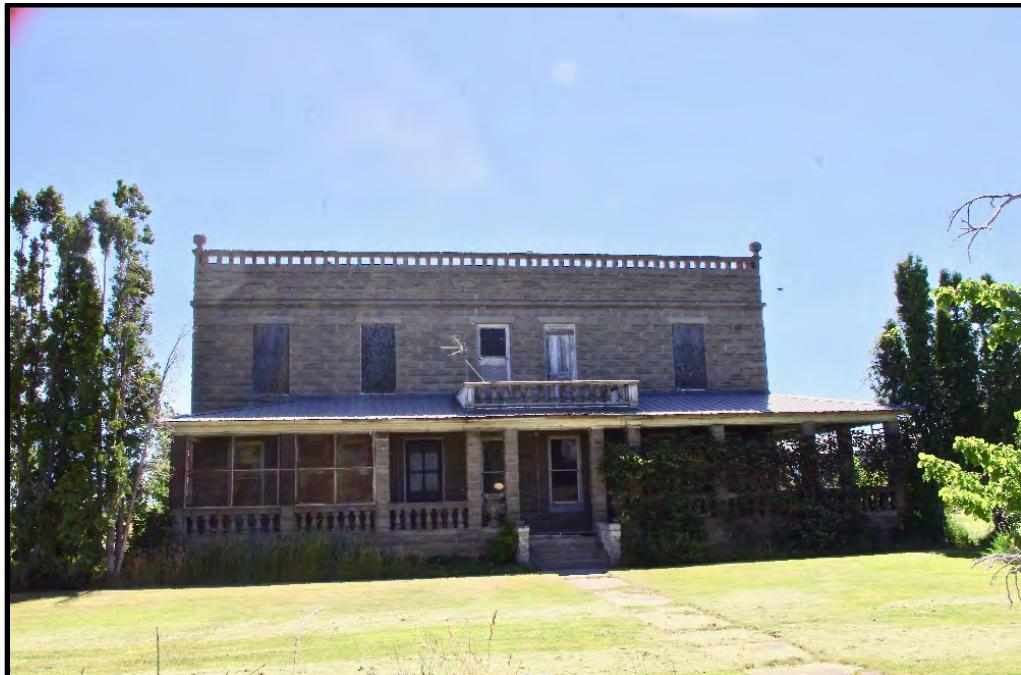
Photograph 4 of 101 Feature 1: House. West elevation, camera facing east.

The foundation is composed of bushhammer face concrete blocks below a cast concrete water table and rock face concrete block clad wall. The design of exterior walls includes lintel courses of concrete block molded to approximate a bushhammer face with a tooled edge at the top of the windows on both floors. The windows are mostly one-over-one, double-hung wood windows with solid concrete sills and architrave trim molding. Some of the original windows have been damaged and are now covered with boards. Above the lintels, molded blocks form a cavetto cornice over a decorative band of blocks cast with an ornamental wreath face. Above the second-floor windows, a balustraded parapet spans the entire top of the front and sides of the building with concrete orb finials at the southwest and northwest corners, accentuating the height of the building. The parapet wall is composed of four courses of rock-faced block below a decorative course of wreath-faced blocks surmounted by squat concrete block balusters capped by a rail of block formed as a cavetto molding. Paired interior chimneys punctuate the shallow slope of the standing seam metal shed roof, visually dividing the roofline into thirds.

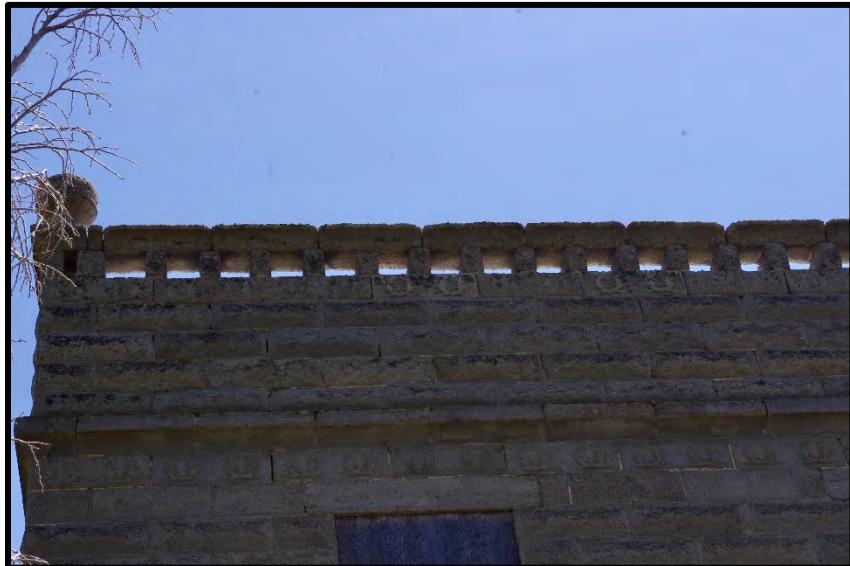
Photograph 5 of 101 Feature 1: House. Detail of parapet. Camera facing east.

Photo #5 (ID_Twin Falls County_Brose, Robert and Augusta, Ranch_005) Feature 1: House. Detail of parapet. Camera facing east.

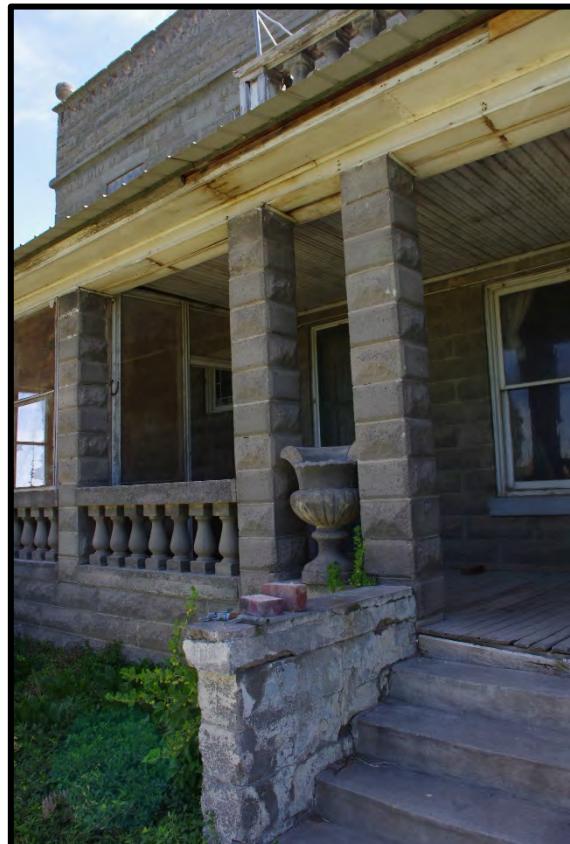
Photograph 6 of 101 Feature 1: House. Porch detail. Camera facing northeast.

Photo #6 (ID_Twin Falls County_Brose, Robert and Augusta, Ranch_006) Feature 1: House. Porch detail. Camera facing northeast.

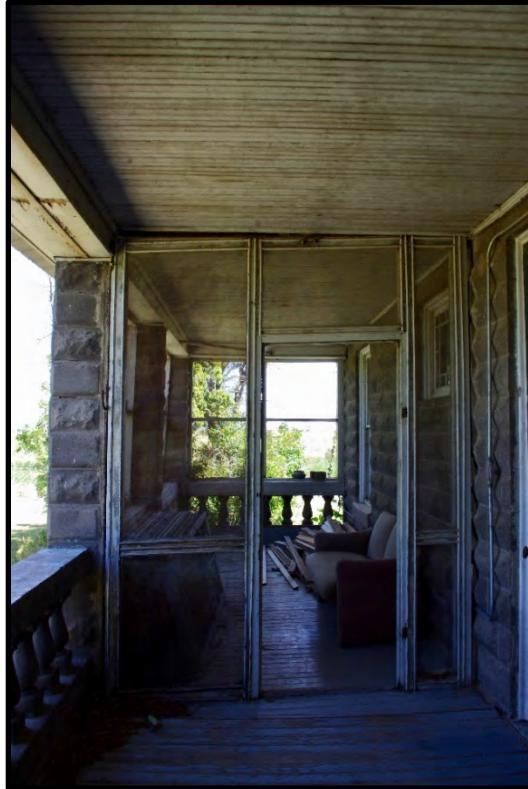
Photograph 7 of 101

Feature 1: House. West elevation showing screened porch,
camera facing north.

Photo #7 (ID_Twin Falls County_Brose, Robert and Augusta, Ranch_007) Feature 1: House. West elevation showing screened porch, camera facing north.

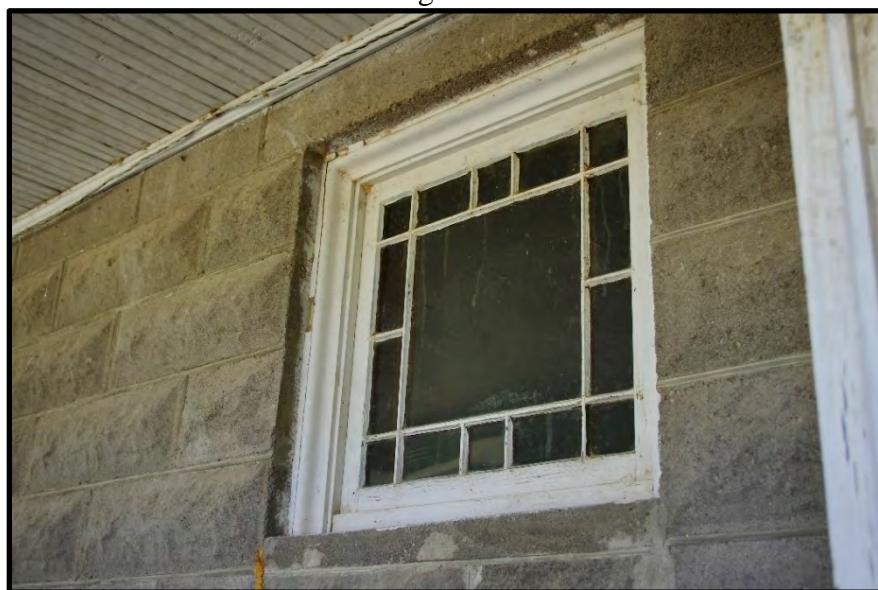
Photograph 8 of 101

Feature 1: House. West elevation, detail of fixed window, camera facing
northeast.

Photo #8 (ID_Twin Falls County_Brose, Robert and Augusta, Ranch_008) Feature 1: House. West elevation, detail of fixed window, camera facing northeast.

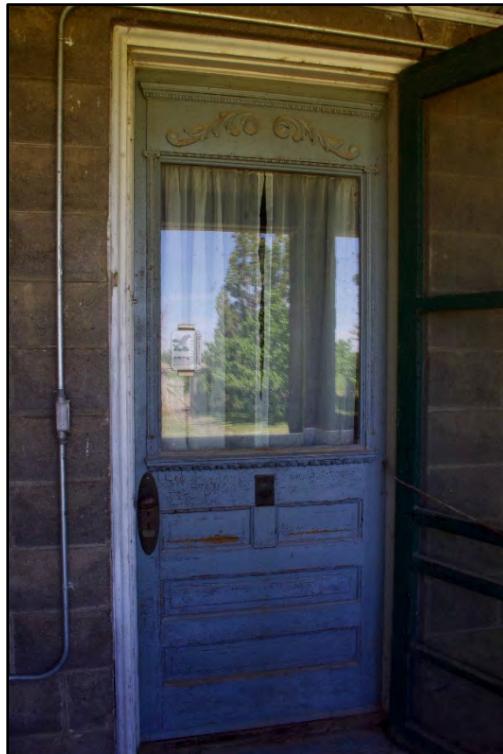
Photograph 9 of 101

Feature 1: House. West elevation, front door, camera facing east.

Photo #9 (ID_Twin Falls County_Brose, Robert and Augusta, Ranch_009) Feature 1: House. West elevation, front door, camera facing east.

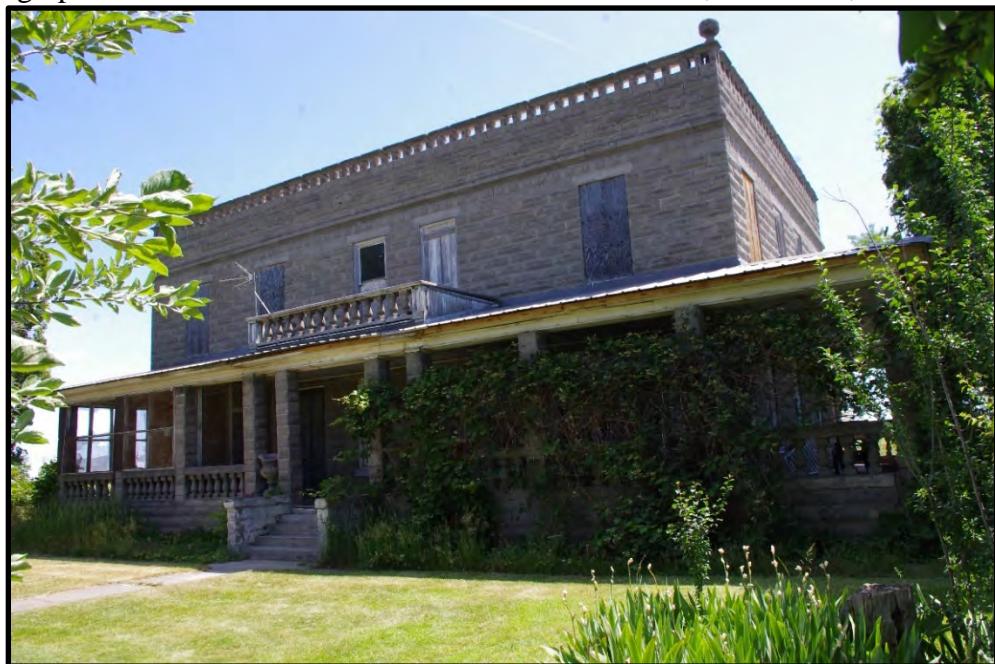
Photograph 10 of 101

Feature 1: House, view showing wrap-around porch. West elevation, camera facing northeast.

Photo #10 (ID_Twin Falls County_Brose, Robert and Augusta, Ranch_010) Feature 1: House, view showing wrap-around porch. West elevation, camera facing northeast.

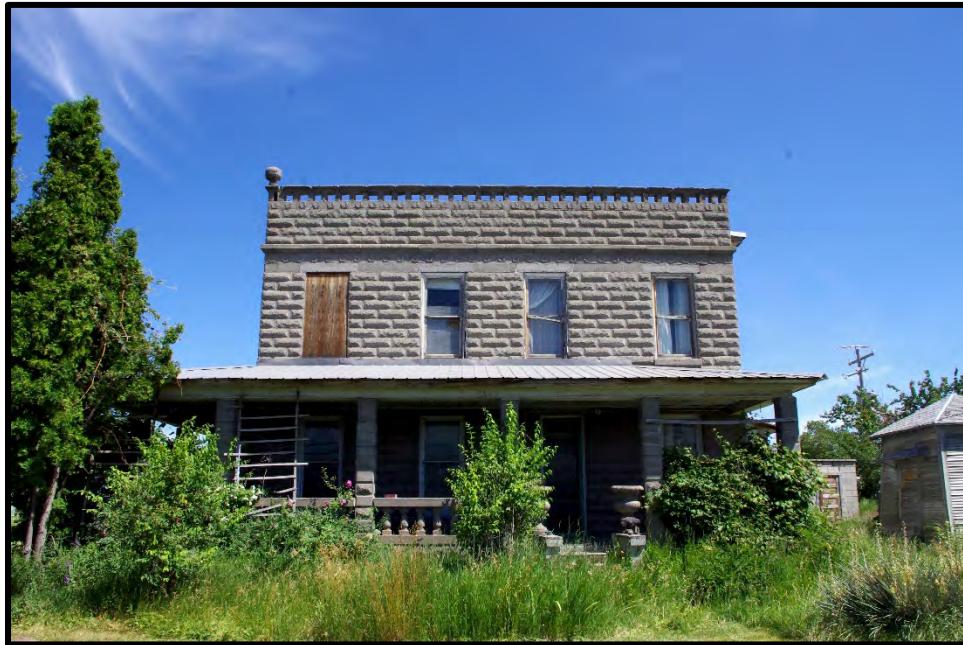
Photograph 11 of 101 Feature 1: House, south elevation. Camera facing north.

Photo #11 (ID_Twin Falls County_Brose, Robert and Augusta, Ranch_011) Feature 1: House, south elevation. Camera facing north.

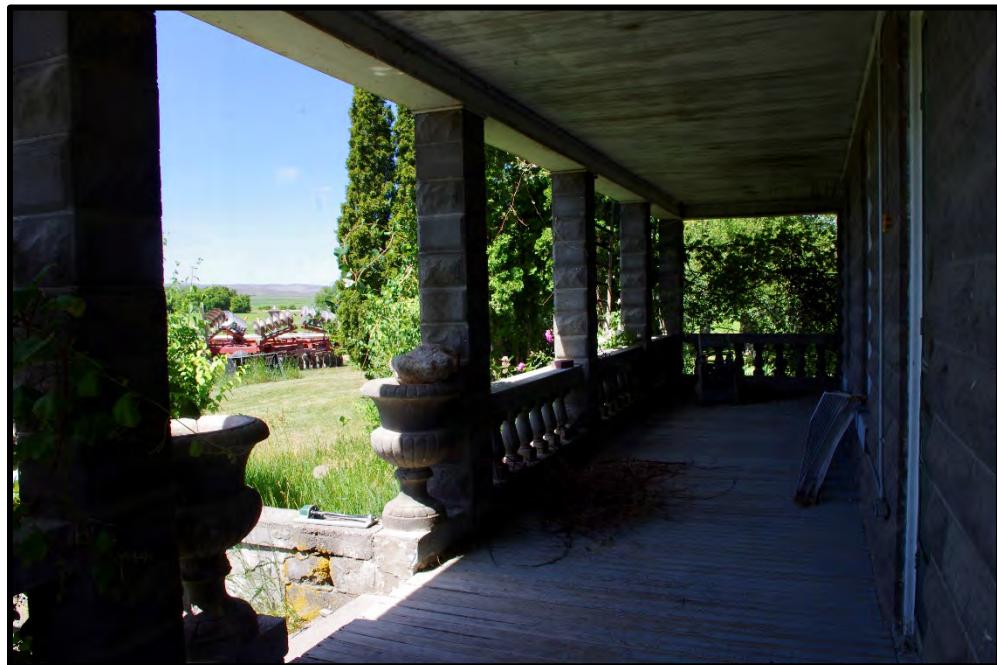
Photograph 12 of 101 Feature 1: House, south elevation, and side porch. Camera facing southwest.

Photo #12: (ID_Twin Falls County_Brose, Robert and Augusta, Ranch_012) Feature 1: House, south elevation and side porch. Camera facing north.

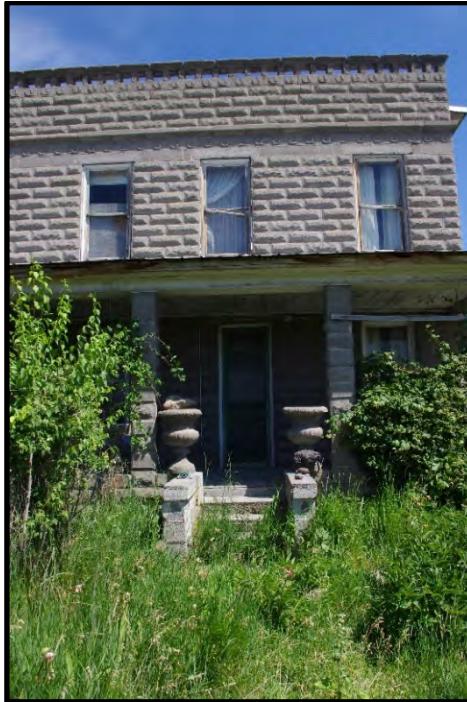
Photograph 13 of 101

Feature 1: House, side porch detail showing concrete urns and steps. South elevation, camera facing north.

Photo #13 (ID_Twin Falls County_Brose, Robert and Augusta, Ranch_013) Feature 1: House, Side porch detail showing concrete urns and steps. South elevation, camera facing north.

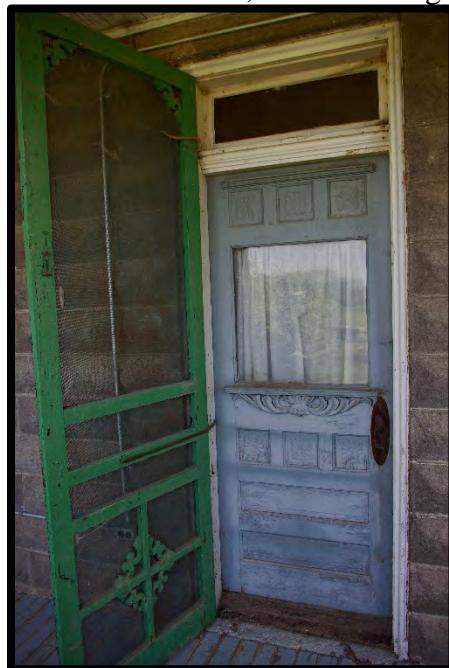
Photograph 14 of 101 Feature 1: House, side door. South elevation, camera facing north.

Photo #14 (ID_Twin Falls County_Brose, Robert and Augusta, Ranch_014) Feature 1: House, side elevation. South elevation, camera facing north.

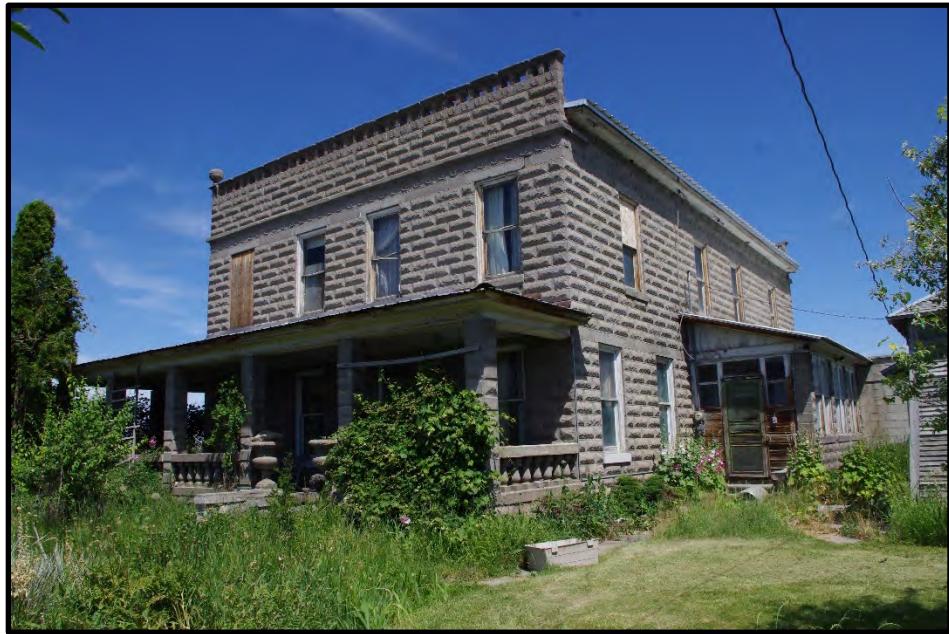
Photograph 15 of 101

Feature 1: House, south and east elevations, camera facing northwest.

Photo #15 (ID_Twin Falls County_Brose, Robert and Augusta, Ranch_015) Feature 1: House, south and east elevation, camera facing northwest.

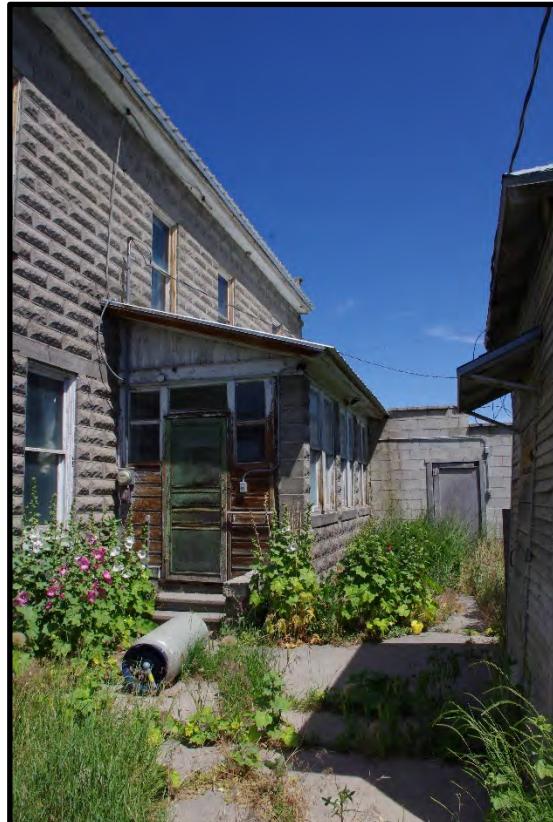
Photograph 16 of 101

Feature 1: House, back porch, and garage detail. East elevation, camera facing north.

Photo #16 (ID_Twin Falls County_Brose, Robert and Augusta, Ranch_016) Feature 1: House, back porch, and garage detail. East elevation, camera facing north.

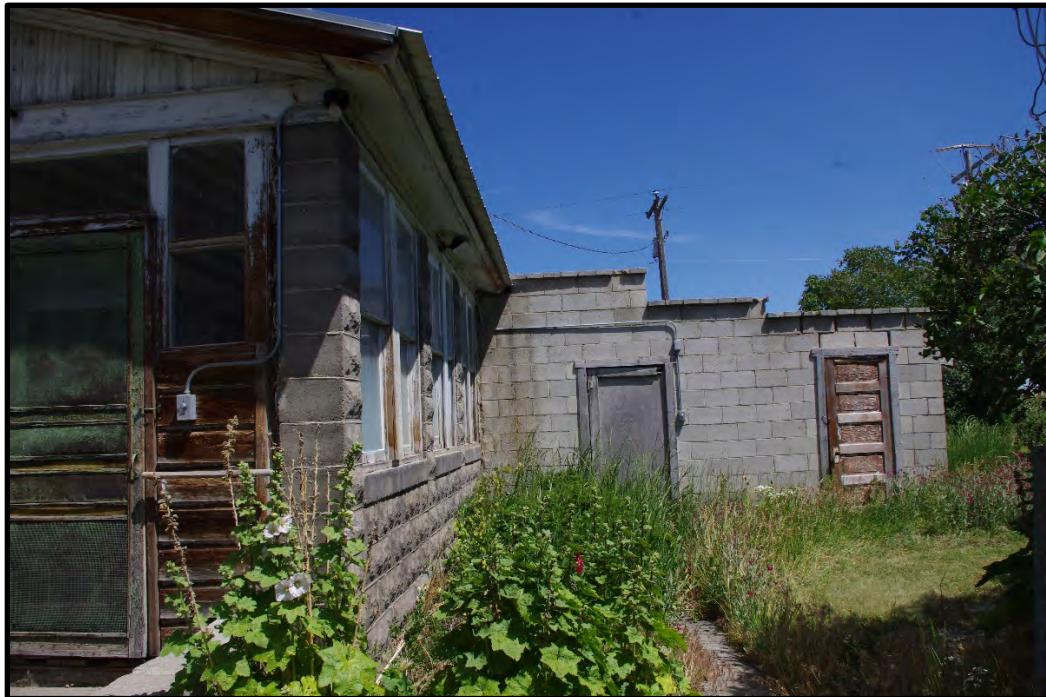
Photograph 17 of 101 Feature 1: House, east elevation, garage detail camera facing north.

Photo #17 (ID_Twin Falls County_Brose, Robert and Augusta, Ranch_017) Feature 1: House, east elevation, garage detail camera facing north.

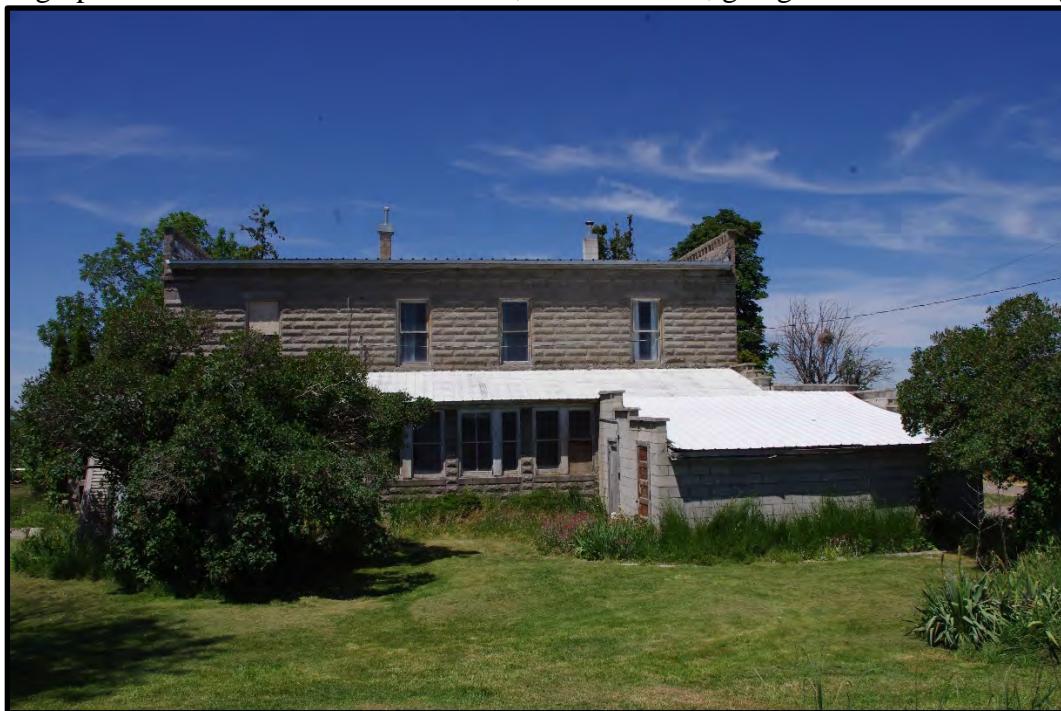
Photograph 18 of 101 Feature 1: House east elevation, camera facing west.

Photo #18 (ID_Twin Falls County_Brose, Robert and Augusta, Ranch_018) Feature 1: House east elevation, camera facing west.

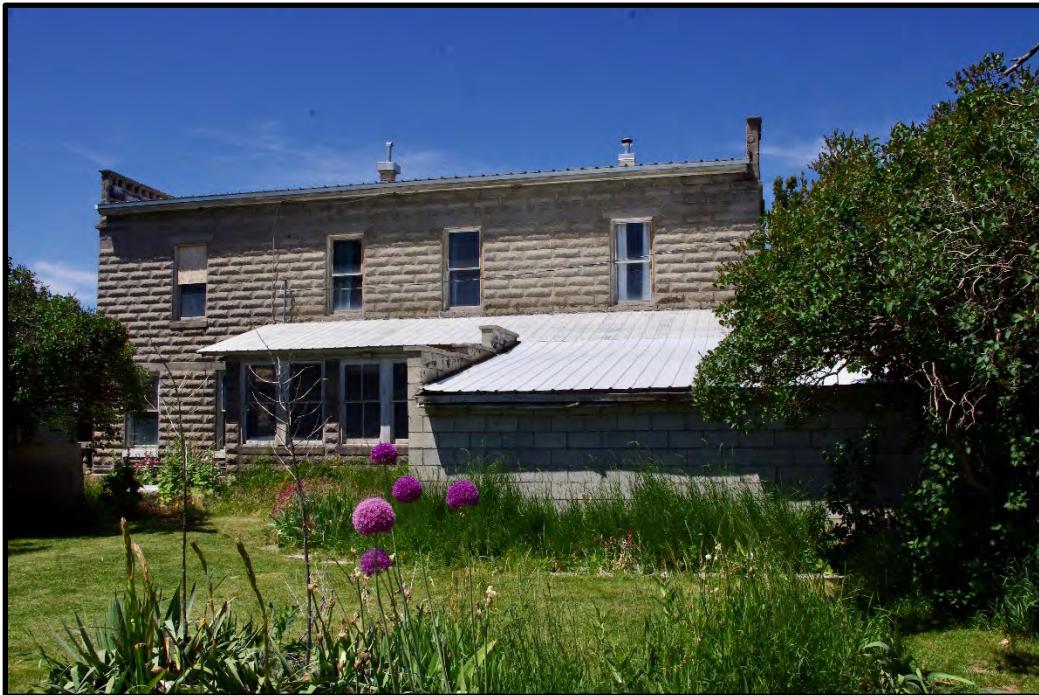
Photograph 19 of 101 Feature 1: House, east elevation, camera facing west.

Photo #19 (ID_Twin Falls County_Brose, Robert and Augusta, Ranch_0019) Feature 1: House, east elevation, camera facing west.

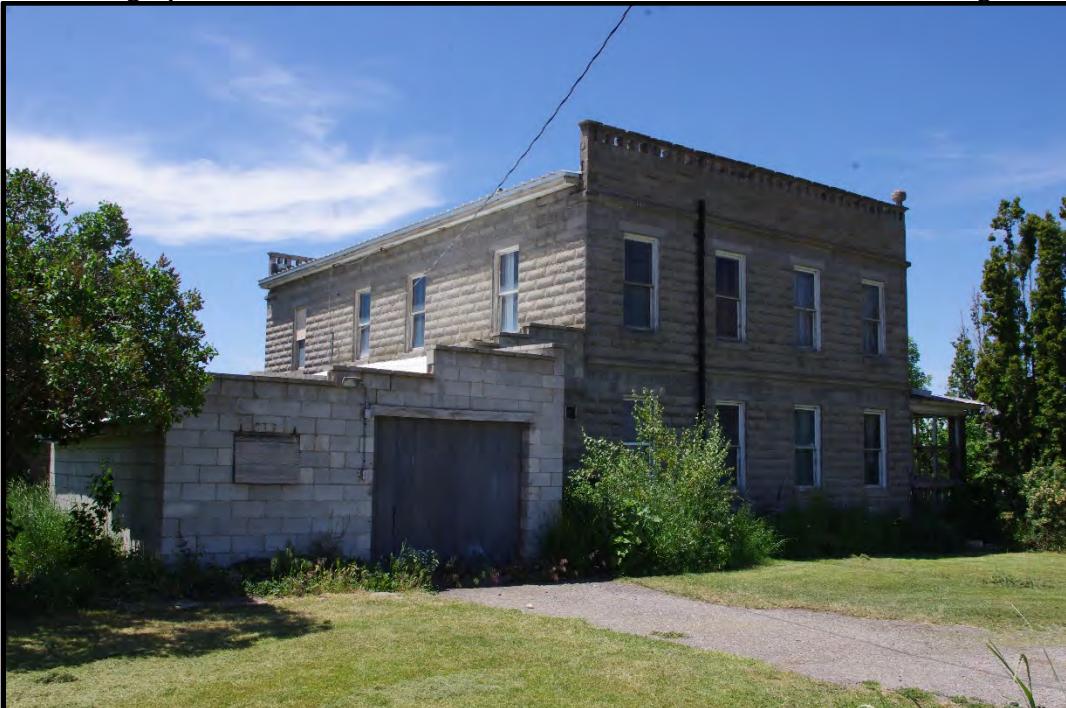
Photograph 20 of 101 Feature 1: House, north elevation, camera facing southwest.

Photo #20 (ID_Twin Falls County_Brose, Robert and Augusta, Ranch_020) Feature 1: House, north elevation, camera facing southwest.

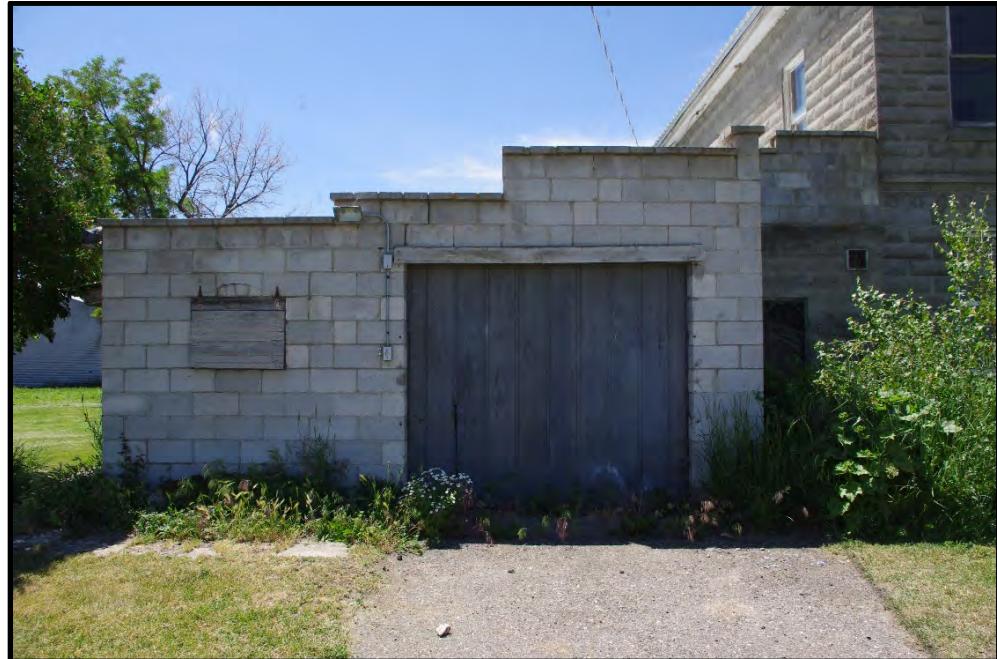
Photograph 21 of 101 Feature 1: House, garage detail, north elevation, camera facing south.

Photo #21 (ID_Twin Falls County_Brose, Robert and Augusta, Ranch_021) Feature 1: House, garage detail, north elevation, camera facing south.

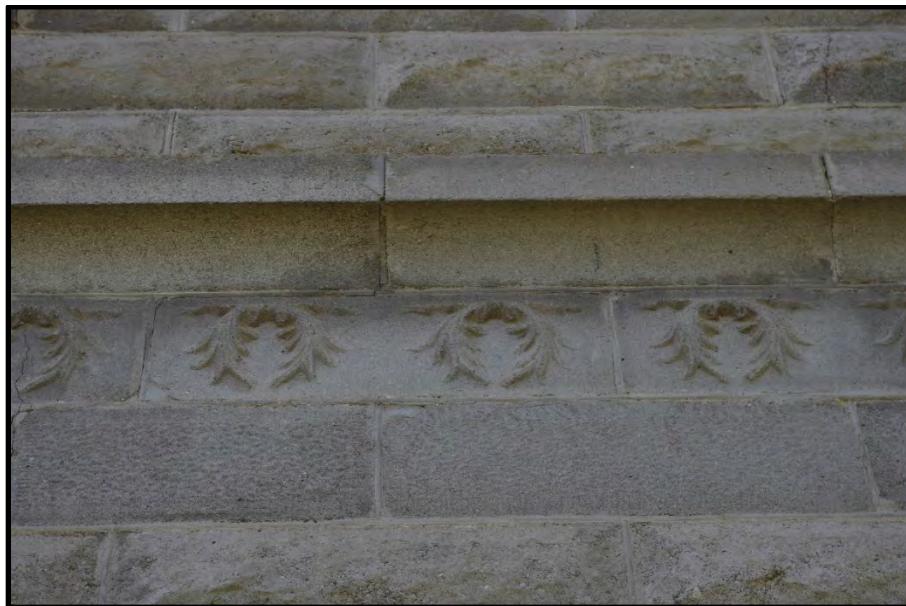
Photograph 24 of 101 Feature 1: House, wall detail, north elevation, showing decorative wreath courses.

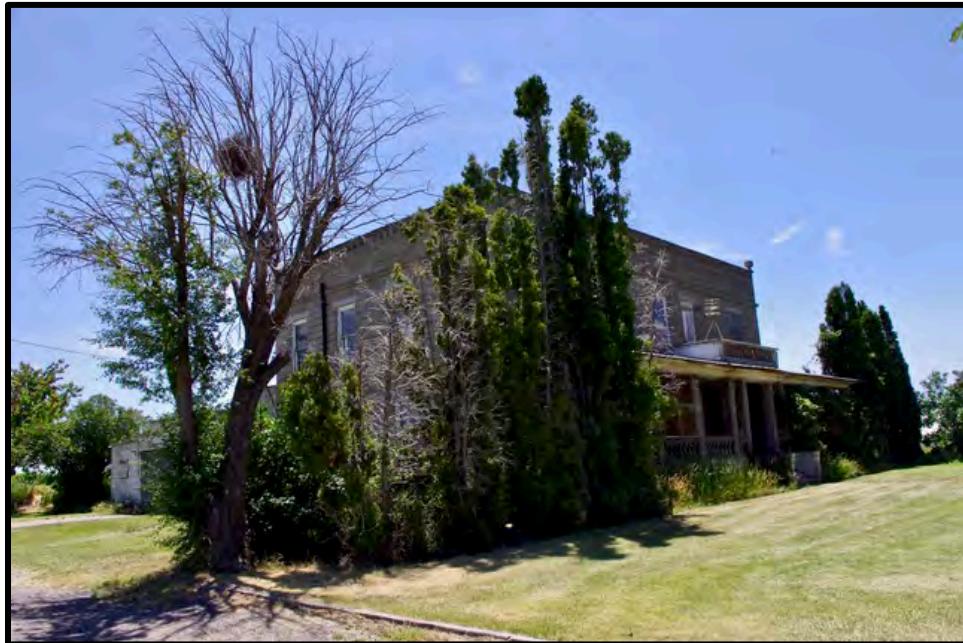
Photograph 25 of 101 Feature 1: House, north and west elevations. Camera facing southeast.

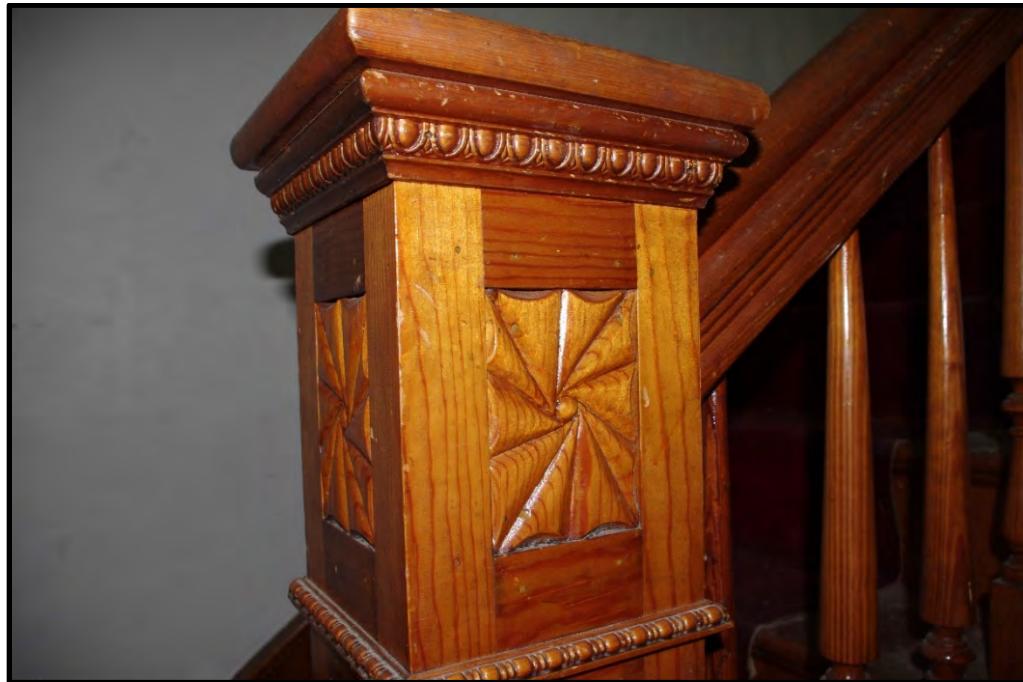
Photograph 27 of 101 Feature 1: House, entry hall, banister detail. Camera facing northeast.

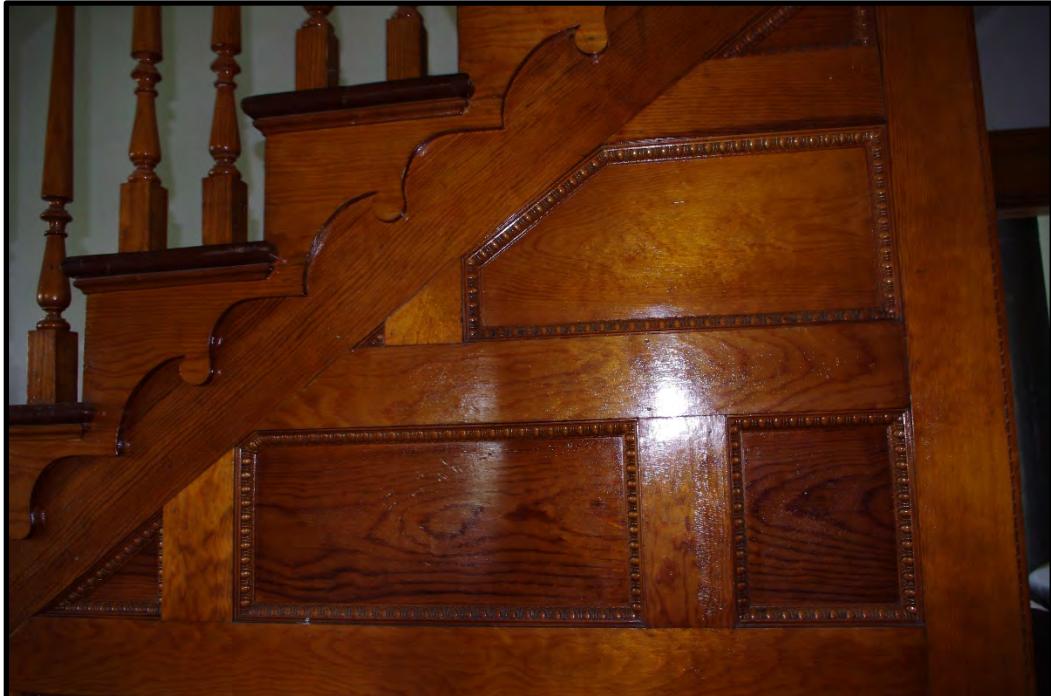
Photograph 28 of 101 Feature 1: House, entry hall. Stairs detail, camera facing northeast.

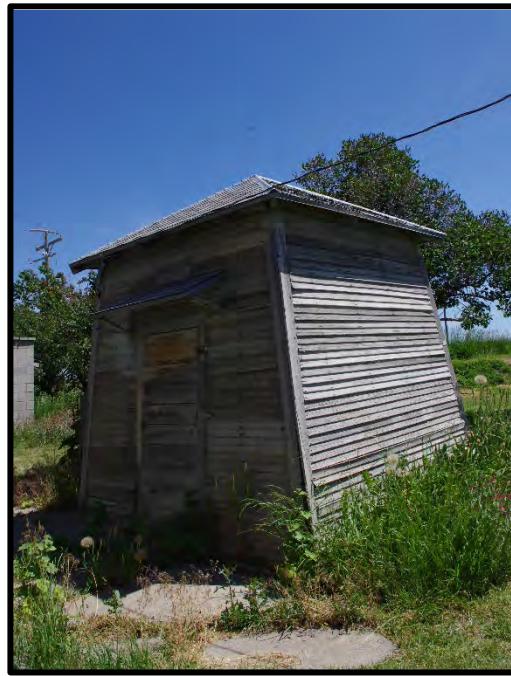
Photograph 53 of 101 Feature 2: Tank house. Camera facing northeast.

Photo #53 (ID_Twin Falls County_Brose, Robert and Augusta, Ranch_053) Feature 2: Tank house. Camera facing northeast.

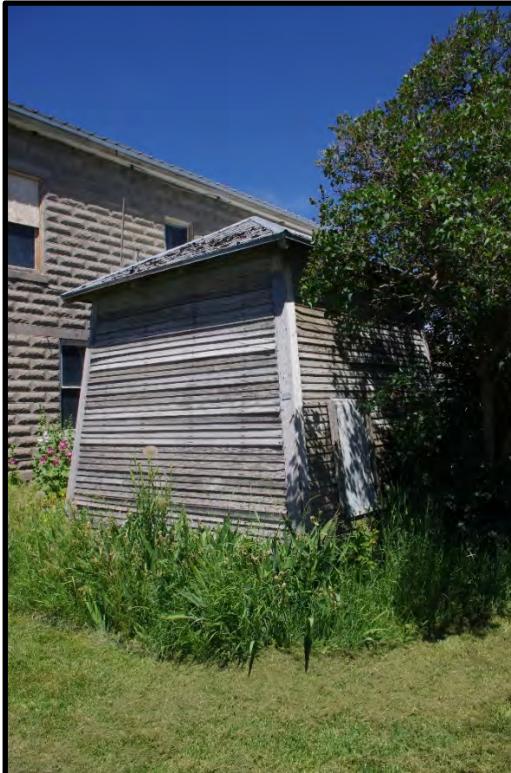
Photograph 54 of 101 Feature 2: Tank house, camera facing northwest.

Photo #54 (ID_Twin Falls County_Brose, Robert and Augusta, Ranch_054) Feature 2: Tank house, camera facing northwest.

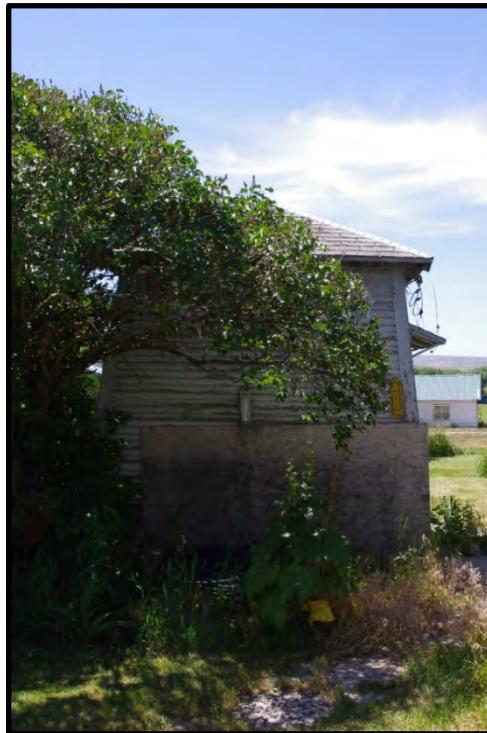
Photograph 55 of 101 Feature 2: Tank house, camera facing south.

Photo #55 (ID_Twin Falls County_Brose, Robert and Augusta, Ranch_055) Feature 2: Tank house, camera facing south.

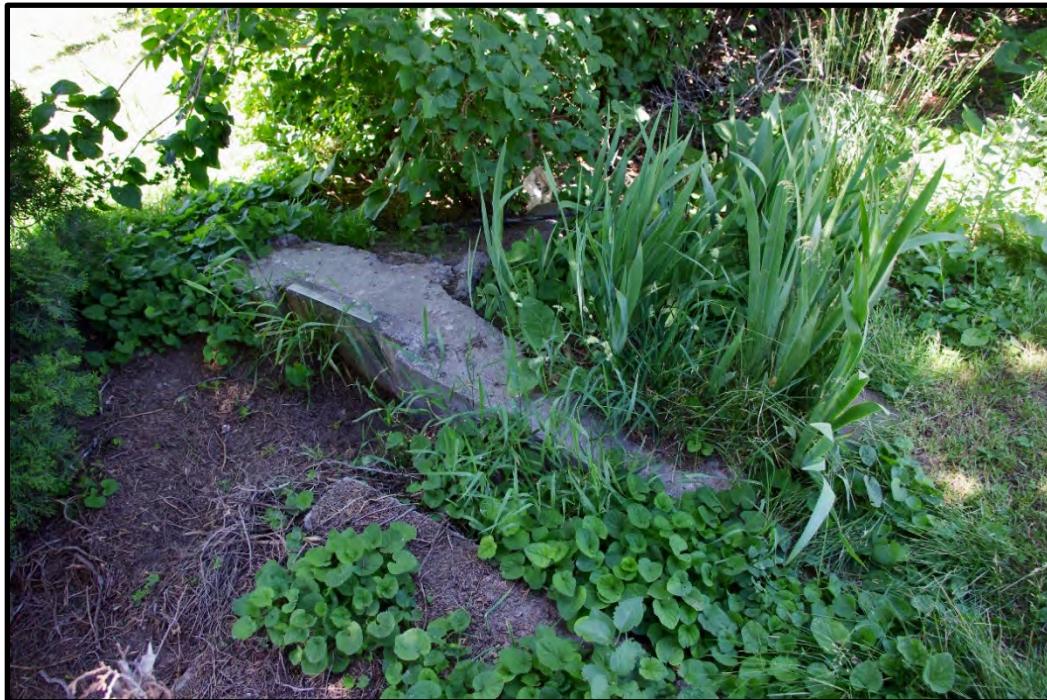
Photograph 56 of 101

Feature 3: Yard and landscaping. Detail, ditch.

Photo #56 (ID_Twin Falls County_Brose, Robert and Augusta, Ranch_056) Feature 3: Yard and landscaping. Detail ditch.

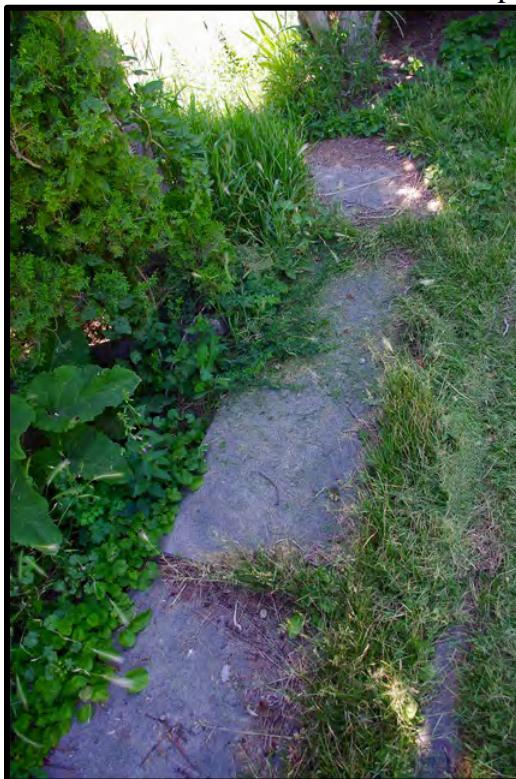
Photograph 57 of 101 Feature 3: Yard and landscaping. Path and ditch detail.

Photo #57 (ID_Twin Falls County_Brose, Robert and Augusta, Ranch_057) Feature 3: Yard and landscaping. Path and ditch detail.

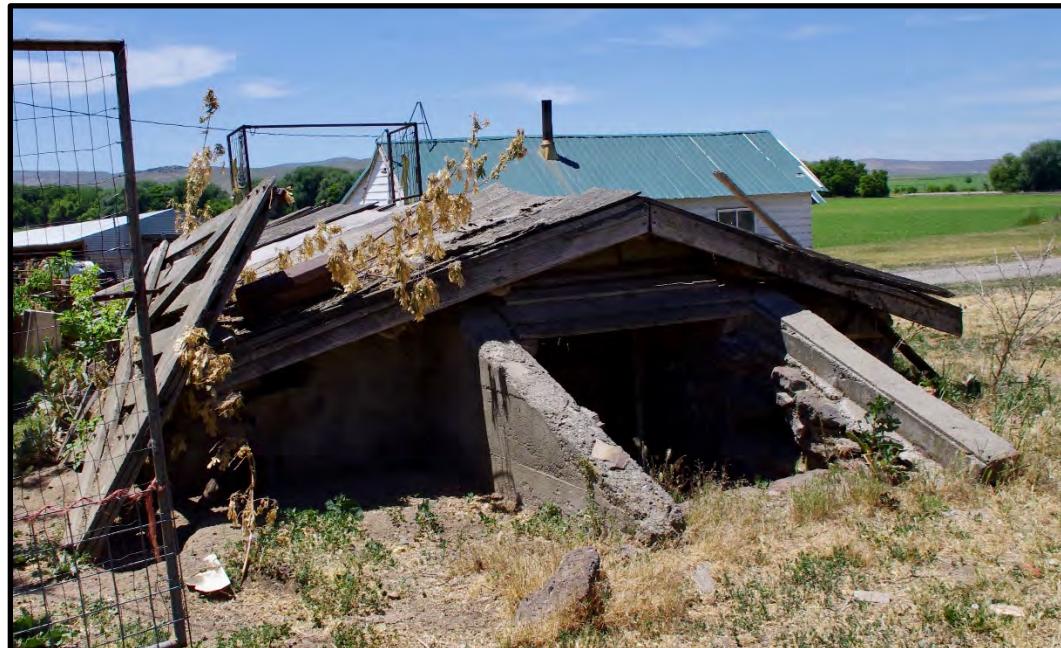
Photograph 59 of 101 Feature 4: Root cellar, camera facing southwest.

The root cellar is a rectangular dug-out rustic building located on the north side of the access road southeast of the house. The ridge line of the north-facing, front-gabled building is slightly skewed in a northeast/southwest alignment. The walls are constructed of dry-laid, uncoursed uncut rubble basalt (lava rock) with small rocks and chips acting as infill. The above ground portion of the exterior walls are covered with concrete stucco. The low-pitched roof construction consists of a single, centrally located log queen post truss supporting a log ridge board and log purlins overlaid with wood planks and topped with sheets of plywood. The open eaves with exposed rafters have a slight overhang; the slightly overhanging rakes are finished with wood plank rake boards.

The building is dilapidated with crumbling concrete mortar, weathered wood and joints, missing planks from the replacement roof, and neglect. The interior is empty, recently cleared of empty, forgotten bottles and jars of various materials littering the wood shelving and floor. While the root cellar is in disrepair, it retains integrity of location, design, setting, materials, feeling, and association.

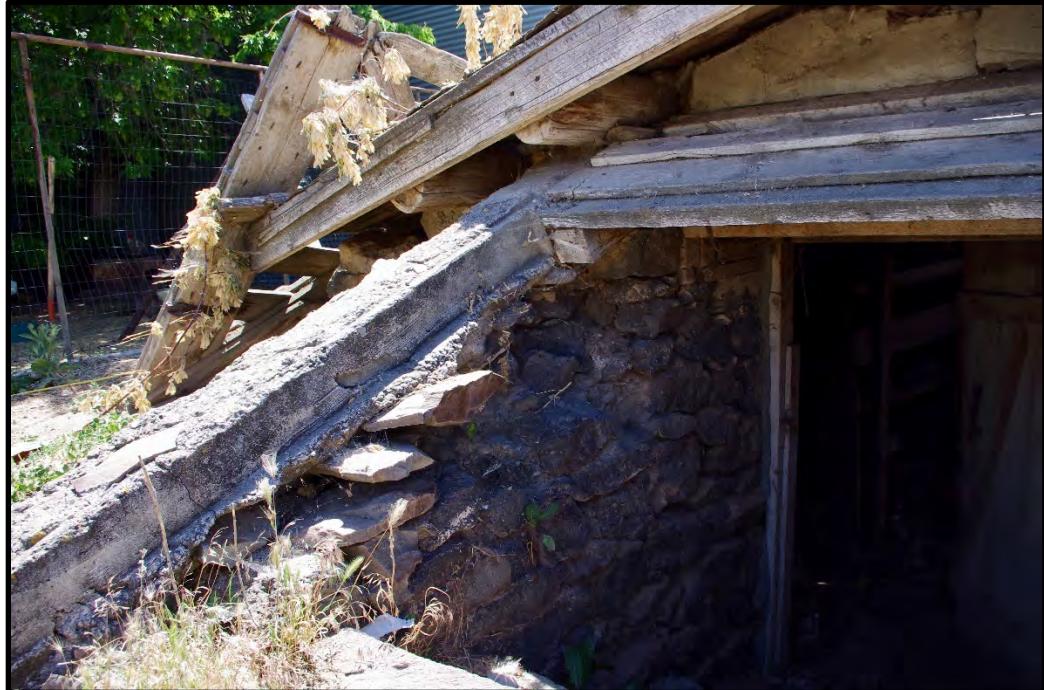
Photograph 60 of 101 Feature 4: Root cellar, camera facing southeast.

On the north front elevation, concrete steps with sloping wing walls lead down to a wood board and batten door and concrete floor. The wing walls are of the same material as the building walls and are stabilized with poured concrete on top of the walls. The east and west side elevations have no other features. The south rear elevation has a wood-framed, four-light wood casement window centered under the gable. The wood window casing provides a framework to stabilize the opening through the thick rubble wall with a remnant wooden crate board printed with the logo of the "Utah Cracker Factory" framing one side.

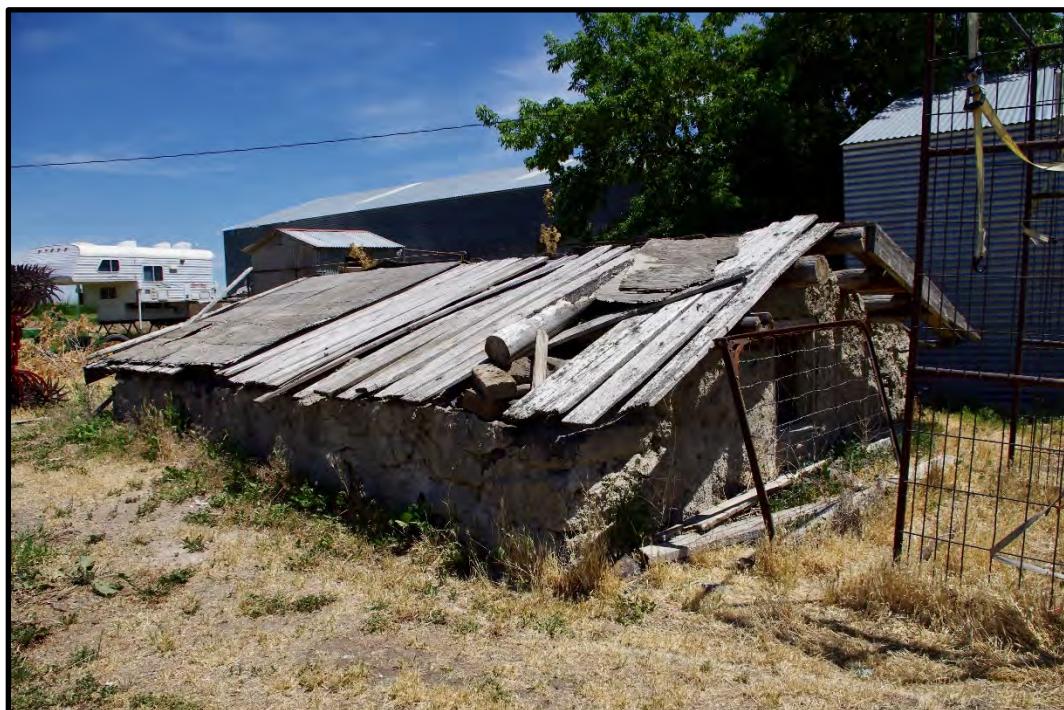
Photograph 61 of 101 Feature 4: Root Cellar. Camera facing northeast.

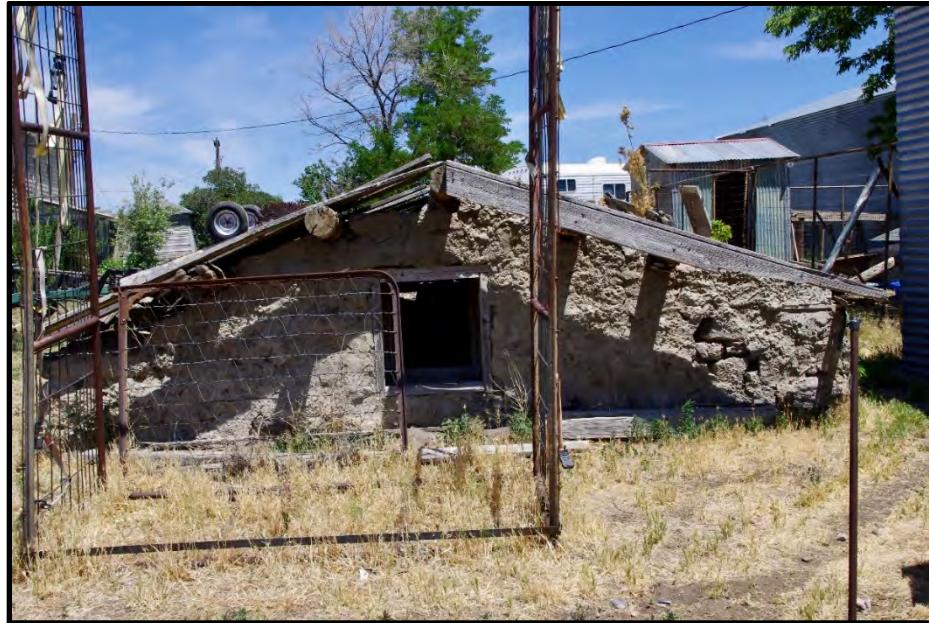
Photograph 62 of 101 Feature 4: Root cellar, camera facing north.

Photo #62 (ID_Twin Falls County_Brose, Robert and Augusta, Ranch_062) Feature 4: Root cellar, camera facing north.
