National Register of Historic Places Registration Form

Historic name: Brose, Robert and Augusta, Ranch

Historic Agricultural Resources of Twin Falls County, Idaho: 1860 to 1970

City or town: Hansen State: Idaho County: Twin Falls

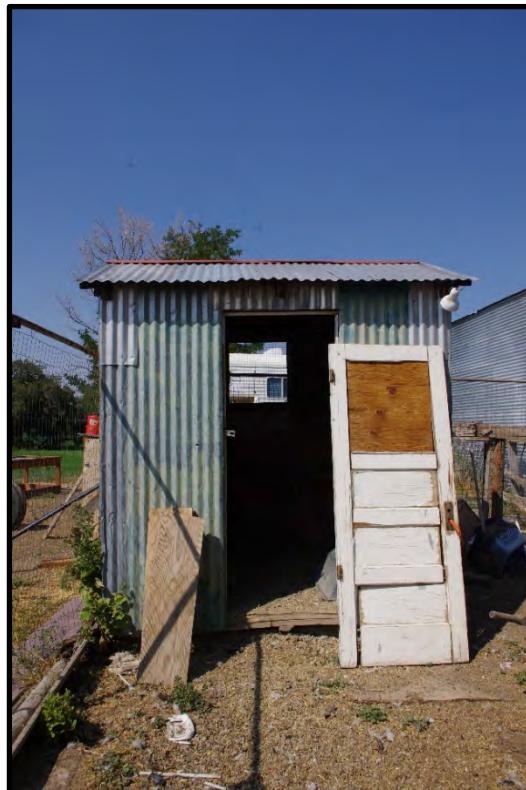
Photograph 63 of 101 Feature 5: Chicken coop, camera facing north.

Photo #63 (ID_Twin Falls County_Brose, Robert and Augusta, Ranch_063) Feature 5: Chicken coop, camera facing north.

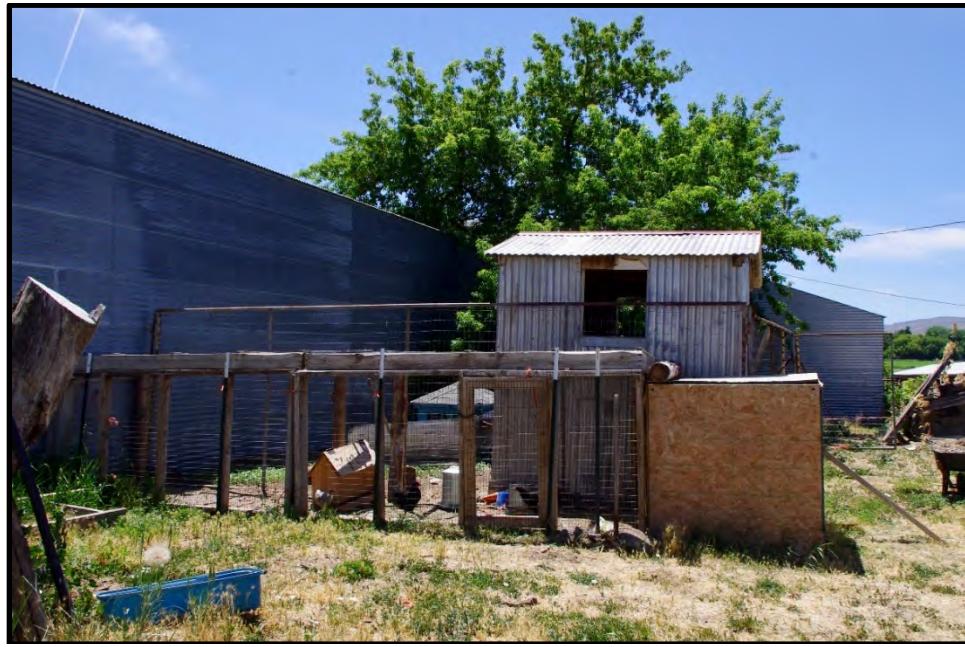
Photograph 64 of 101 Feature 5: Chicken coop, camera facing south.

Photo #64 (ID_Twin Falls County_Brose, Robert and Augusta, Ranch_064) Feature 5: Chicken coop, camera facing south.

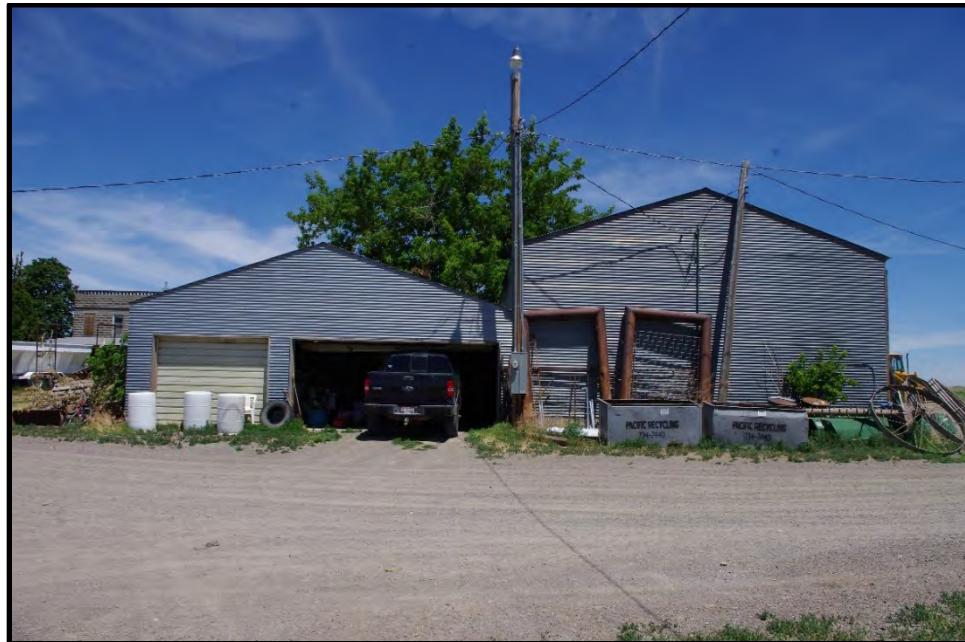
Photograph 65 of 101 Feature 6: Garage, camera facing north.

The garage is a simple, rectangular outbuilding that is east of the root cellar and adjacent to the equipment shed. The south-facing, front-gabled frame structure rests on a concrete slab foundation and has corrugated metal clad walls with no fenestration. The front (south) elevation has two roll-up, fiberglass garage doors, a single car door on the west and double car door on the east. The east wall is built directly against the rear (west) wall of the equipment shed. The roof is clad in corrugated metal sheets with sections of corrugated fiberglass panels to provide natural light. Although this building is within the period of significance, it lacks integrity of materials, workmanship, and feeling and does not contribute to the historic integrity of the district.

Photo #65 (ID_Twin Falls County_Brose, Robert and Augusta, Ranch_065) Feature 6: Garage, camera facing north.

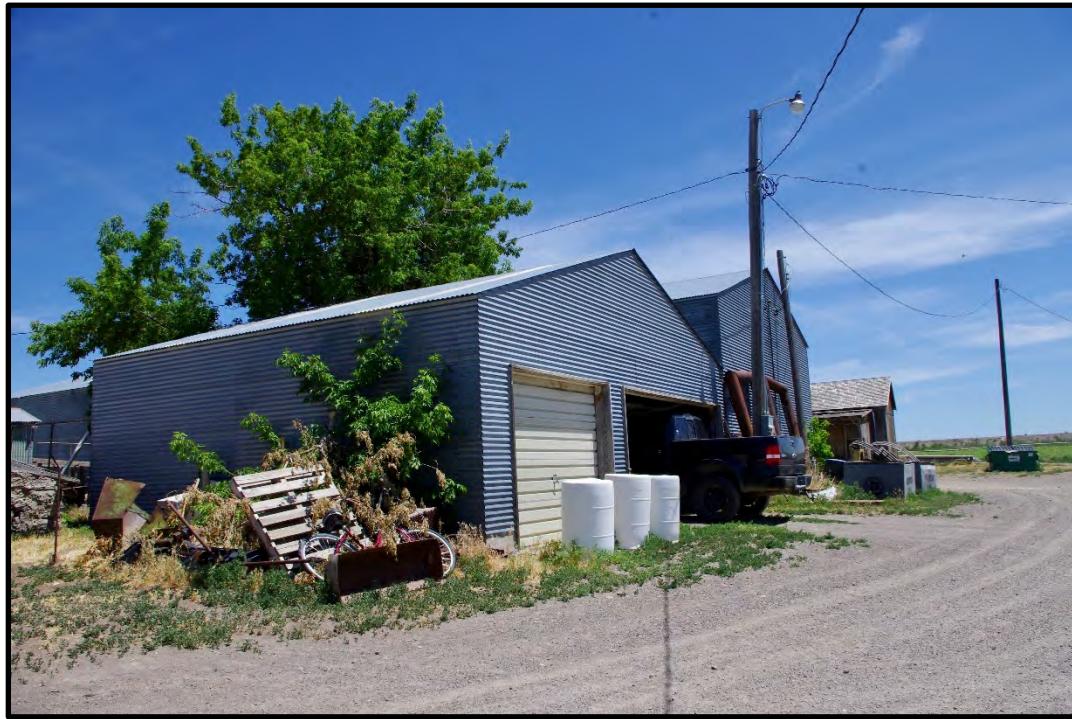
Photograph 66 of 101 Feature 6: Garage, camera facing northeast.

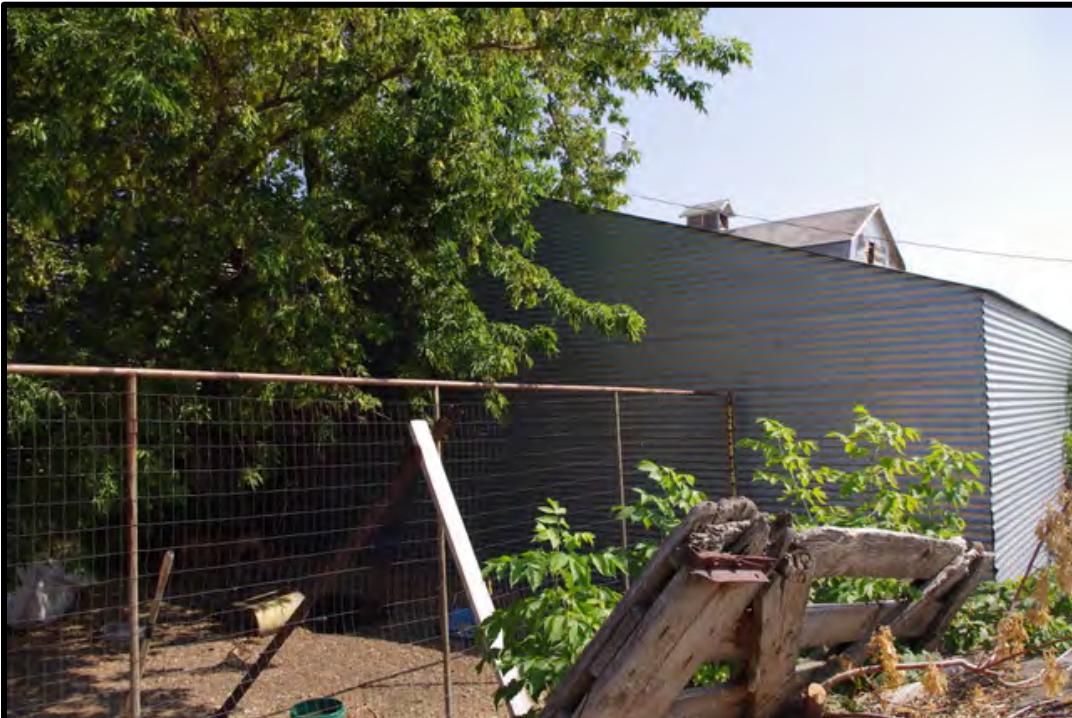
Photograph 67 of 101 Feature 6: Garage, camera facing south.

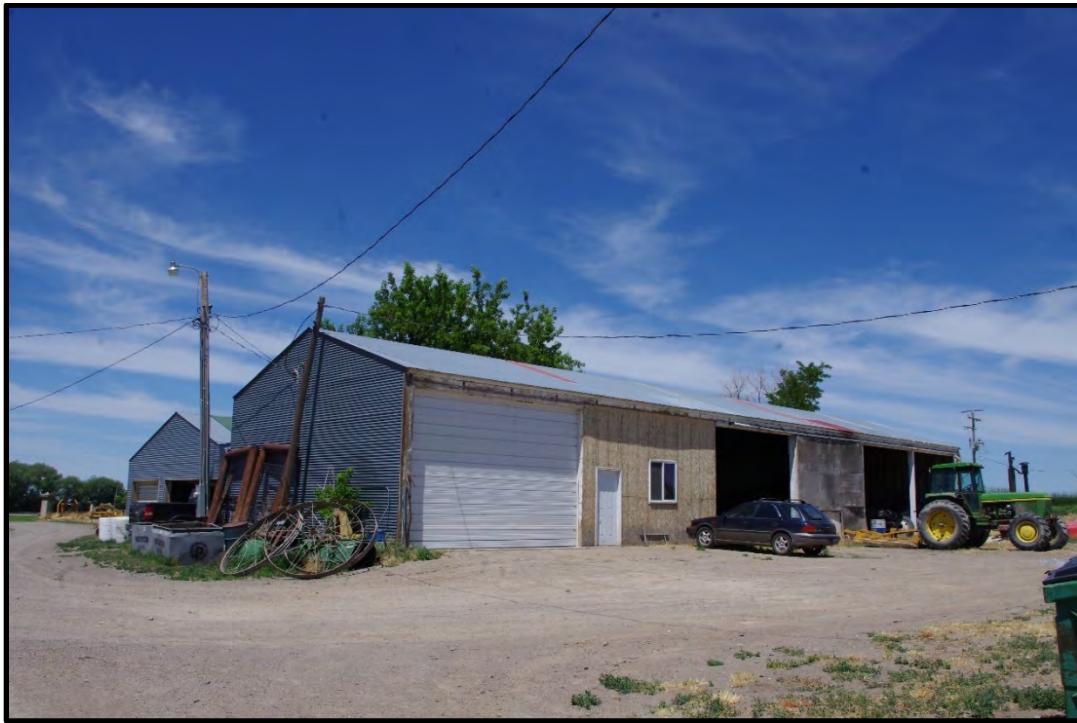
Photograph 68 of 101 Feature 7: Equipment shed, camera facing northwest.

Photo #68 (ID_Twin Falls County_Brose, Robert and Augusta, Ranch_068) Feature 7: Equipment shed, camera facing northwest.

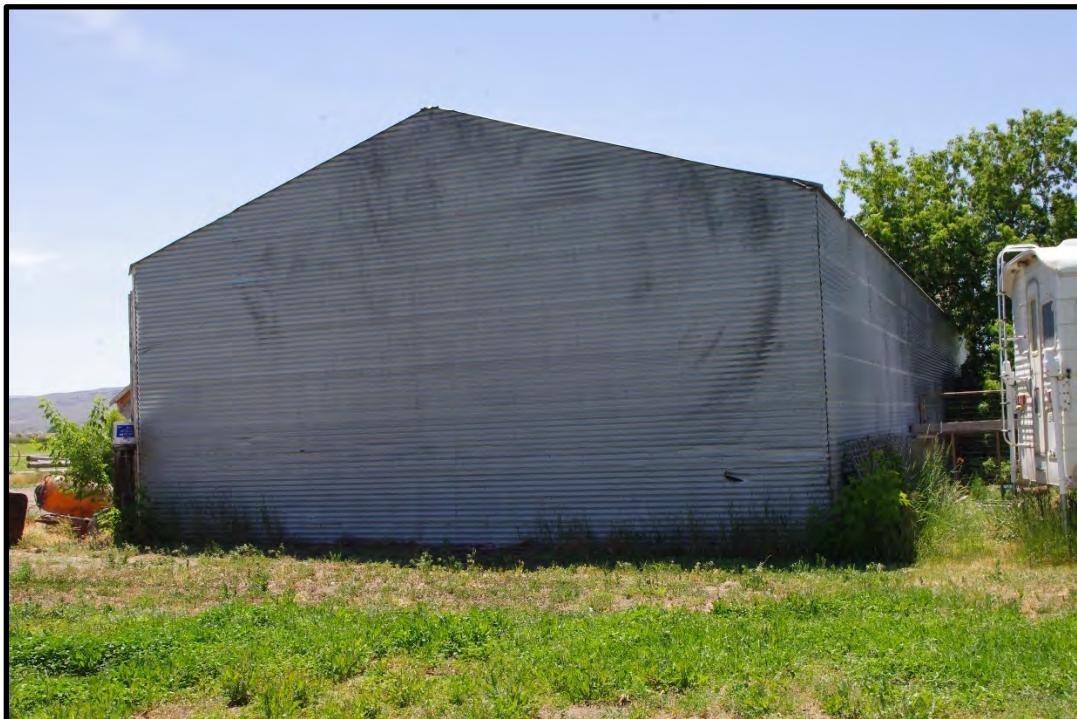
Photograph 69 of 101 Feature 7: Equipment shed, camera facing southwest.

Photo #69 (ID_Twin Falls County_Brose, Robert and Augusta, Ranch_068) Feature 7: 7: Equipment shed, camera facing southwest.

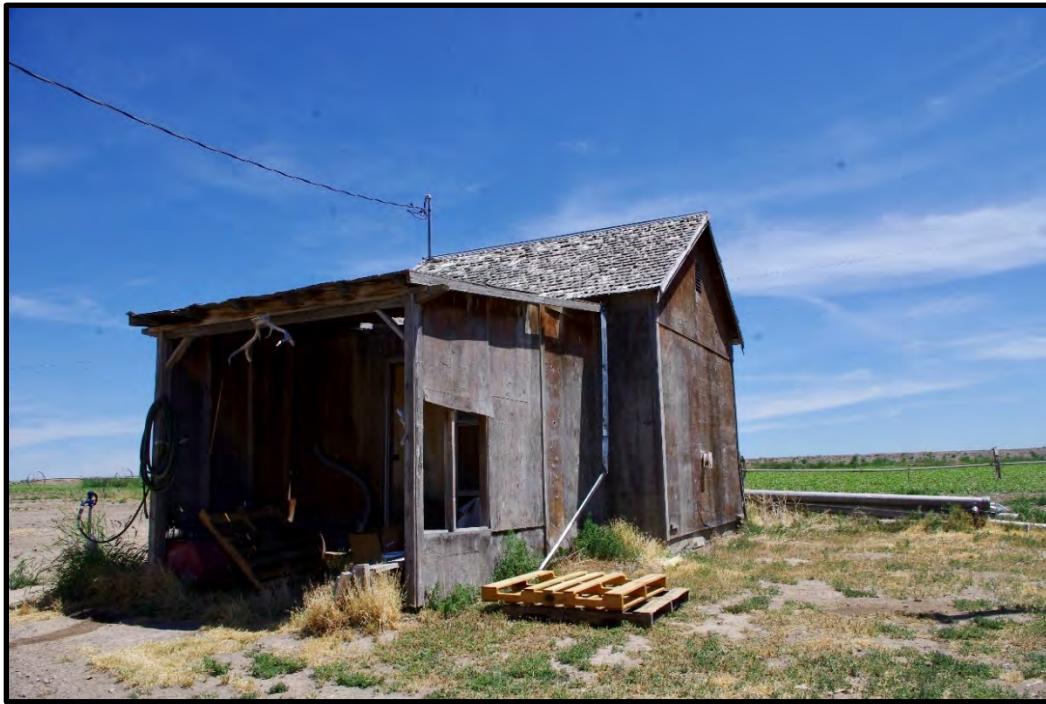
Photograph 70 of 101 Feature 8: Bunkhouse, camera facing northeast.

The bunkhouse is a side-gabled, single-story, wood framed building located to the east of the equipment shed at the back of the site. The walls are clad in plywood boards. It is built on a concrete foundation with a rectangular footprint. The west-facing front elevation has a dropped shed roof porch covering an enclosed interior space and open front space with walled sides. A concrete step leads up to a metal, glazed screen door and wood door on the front elevation; there is no fenestration. The south side elevation has a metal vent in the gable. The east rear elevation has a double-sash wood window that has

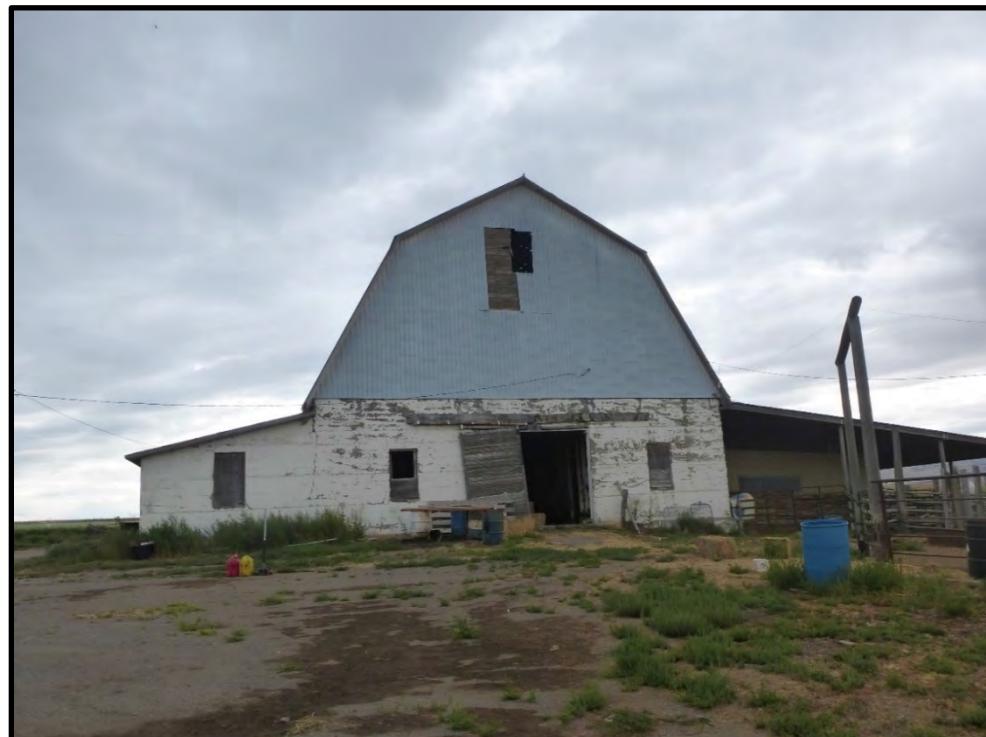
Photograph 79 of 101 Feature 11: Barn, West elevation. Camera facing east.

The primary, west-facing elevation has four bays consisting of a centrally located passage framed with two windows evenly spaced on either side of the door and a third window located in the concrete wall under the dropped shed roof. The wood framed windows are boarded up with the glazing partially or completely missing. The one remaining large sliding barn door is clad in wood clapboard siding and hanging off its rail and partially resting on the ground. There is a simple, unglazed opening centered high under the gable peak for ventilation. Two additional unglazed openings are set symmetrically lower in the gambrel end but are covered with the corrugated metal siding and only visible from the loft inside. Portions of the metal siding are missing in the upper story leaving the internal wood framing exposed. The historic photo of the barn around the time of its completion (Figure 25) shows the original features on the façade: unpainted concrete walls, wood clapboard wall treatment in the upper story, the six-over-six double-hung window, and double sliding barn doors for the central passage entry.

Wear and modifications to the barn are evident in the painted concrete walls, missing and replacement roofing, largely boarded up fenestration, and missing or broken doors. Wood siding under the gambrel roof has been replaced with metal siding. Although the integrity of materials and workmanship is compromised, the barn's original shape and massing dominate the view, and it retains integrity of location, design, setting, feeling, and association.

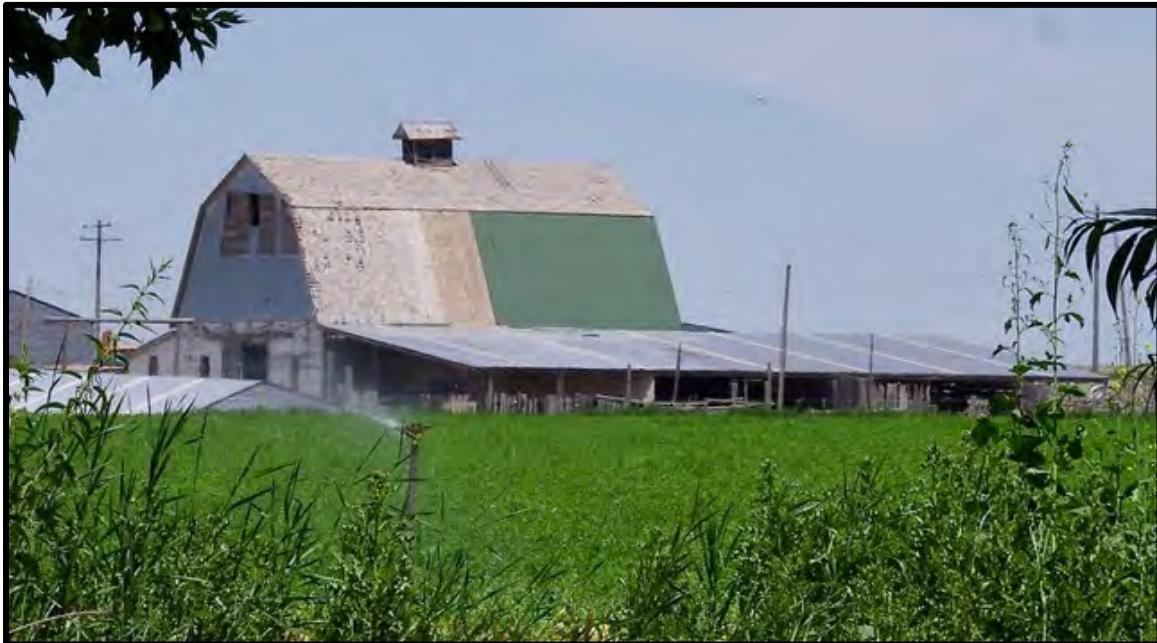
Photograph 80 of 101 Feature 11: Barn. West and south elevations. Camera facing northeast.

Photo #80 (ID_Twin Falls County_Brose, Robert and Augusta, Ranch_080) Feature 11: Barn. West and south elevations. Camera facing northeast.

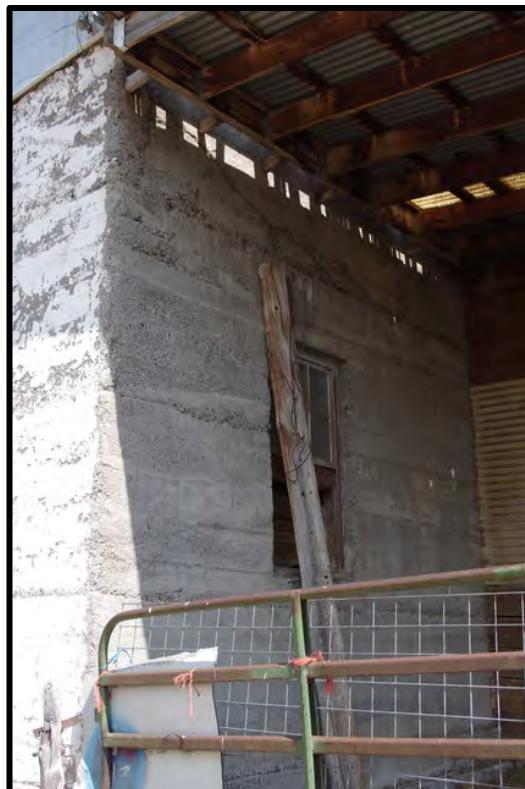
Photograph 81 of 101 Feature 11: Barn. South elevation detail. Camera facing northeast.

[Photo #81](#) (ID_Twin Falls County_Brose, Robert and Augusta, Ranch_081) Feature 11: Barn. South elevation detail. Camera facing northeast.

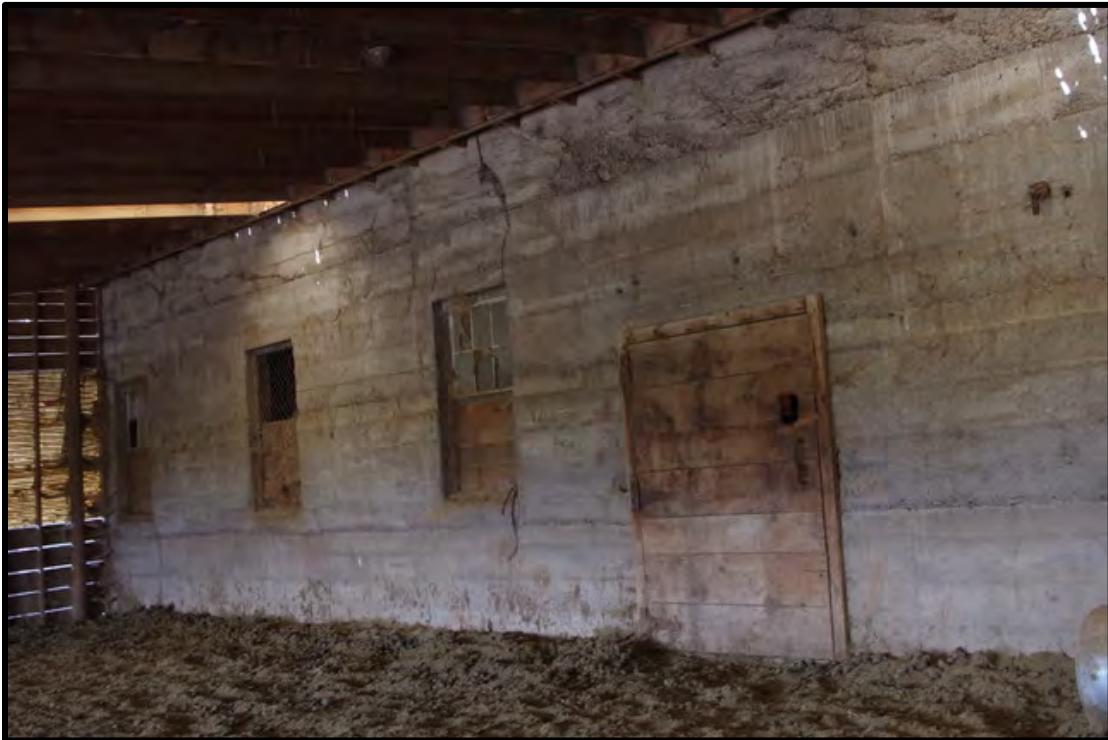
Photograph 82 of 101 Feature 11: Barn. South elevation. Camera facing northwest.

[Photo #82](#) (ID_Twin Falls County_Brose, Robert and Augusta, Ranch_082) Feature 11: Barn. South elevation. Camera facing northwest.

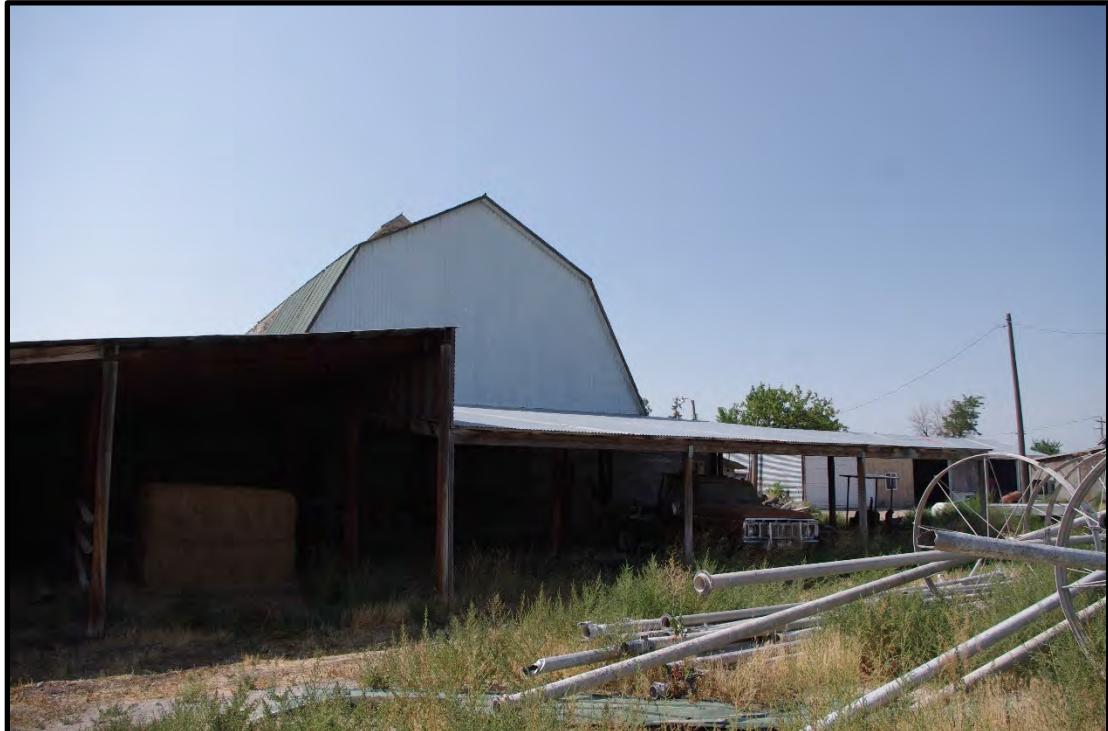
Photograph 83 of 101 Feature 11: Barn, camera facing northwest.

[Photo #83](#) (ID_Twin Falls County_Brose, Robert and Augusta, Ranch_083) Feature 11: Barn, camera facing northwest.

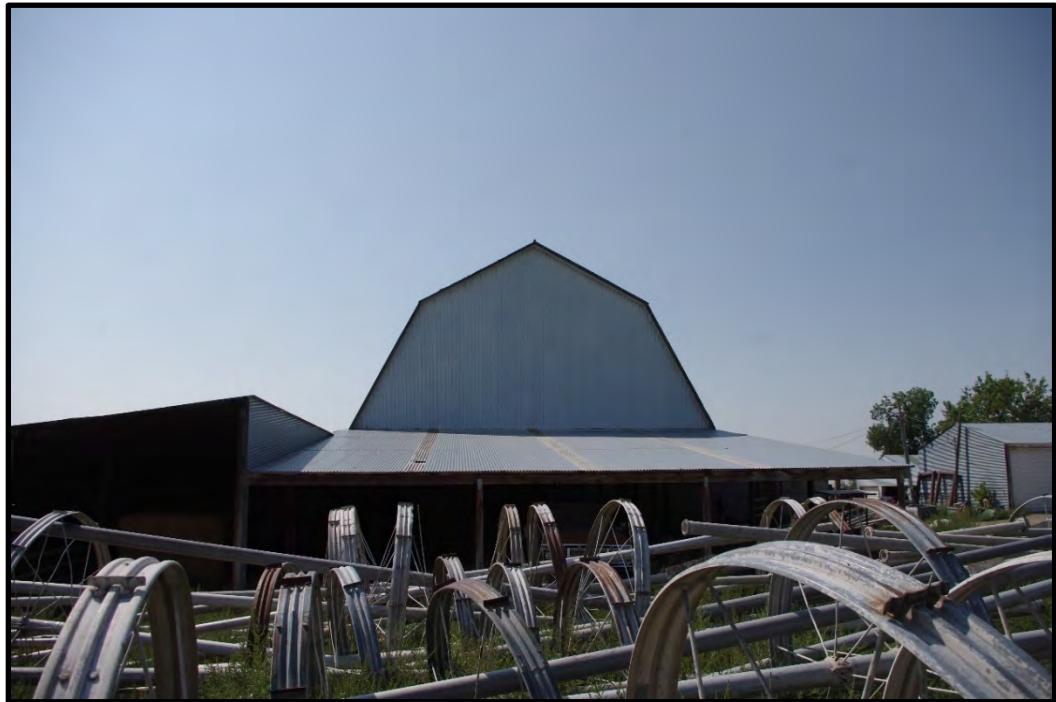
Photograph 84 of 101

Feature 11: Barn, camera facing west.

[Photo #84](#) (ID_Twin Falls County_Brose, Robert and Augusta, Ranch_084) Feature 11: Barn, camera facing west.

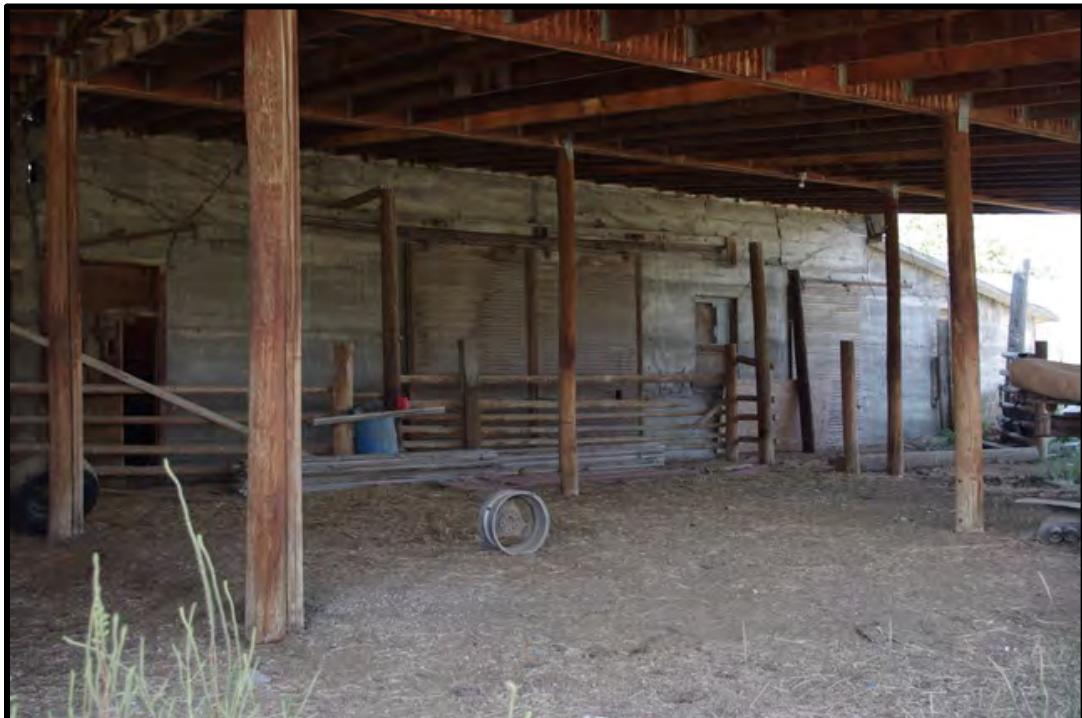
Photograph 85 of 101 Feature 11: Barn, east elevation. Camera facing northwest.

The rear (east) gambrel wall has five bays under the shed roof and no open fenestration in the upper story (two simple rectangular openings are evident from inside the loft). There is a side-hinged wood plank door, a centrally located double sliding wood clapboard clad barn doors, a boarded up window with broken glazing, a human-sized sliding wood clapboard clad barn door and boarded up rectangular opening.

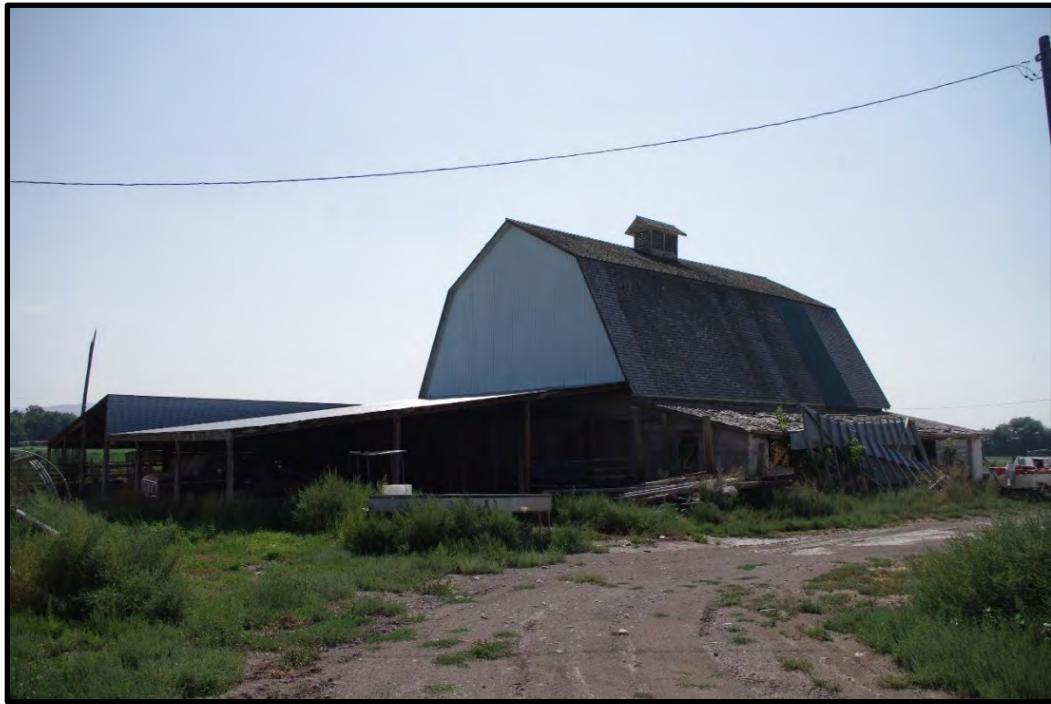
Photograph 86 of 101 Feature 11: Barn, east and north elevations. Camera facing southwest.

[Photo #86](#) (ID_Twin Falls County_Brose, Robert and Augusta, Ranch_086) Feature 11: Barn, east and north elevations. Camera facing southwest.

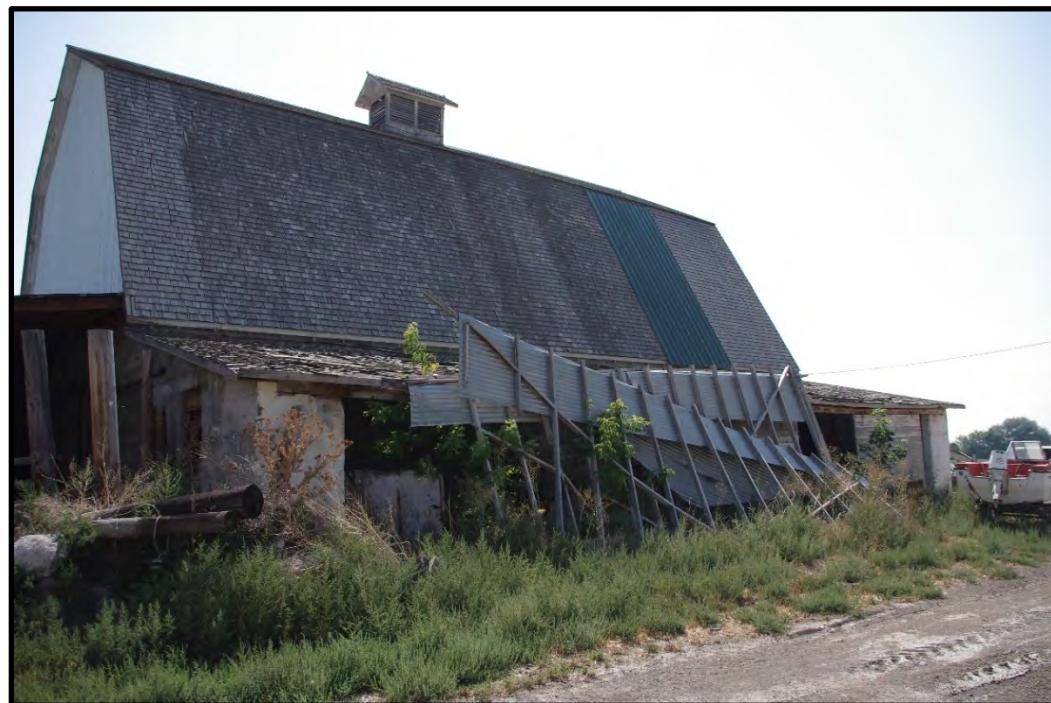
Photograph 87 of 101 Feature 11: Barn, north elevation. Camera facing southwest.

The various roofs have open eaves with rake and fascia boards and are covered with a combination of materials. The gambrel roof and dropped shed roof on the north elevation are mainly covered with wood shingles, which are wearing thin and going missing in several places. The lower gambrel pitch on both sides has sections patched with green standing seam metal sheets. The other two shed roofs are later additions covered with corrugated metal and fiberglass sheeting. The foundation varies to fit the needs of the space with a poured concrete foundation augmented by steel and timber posts set in concrete footings. The barn has a concrete slab foundation in the central passage inside the door as well as in select stalls in the west bay of the north side shed attachment and dirt floor in the remaining spaces. According to former owner Dennis Butler, two murals on the interior were painted by local artist Oral Shobe in the 1960s.

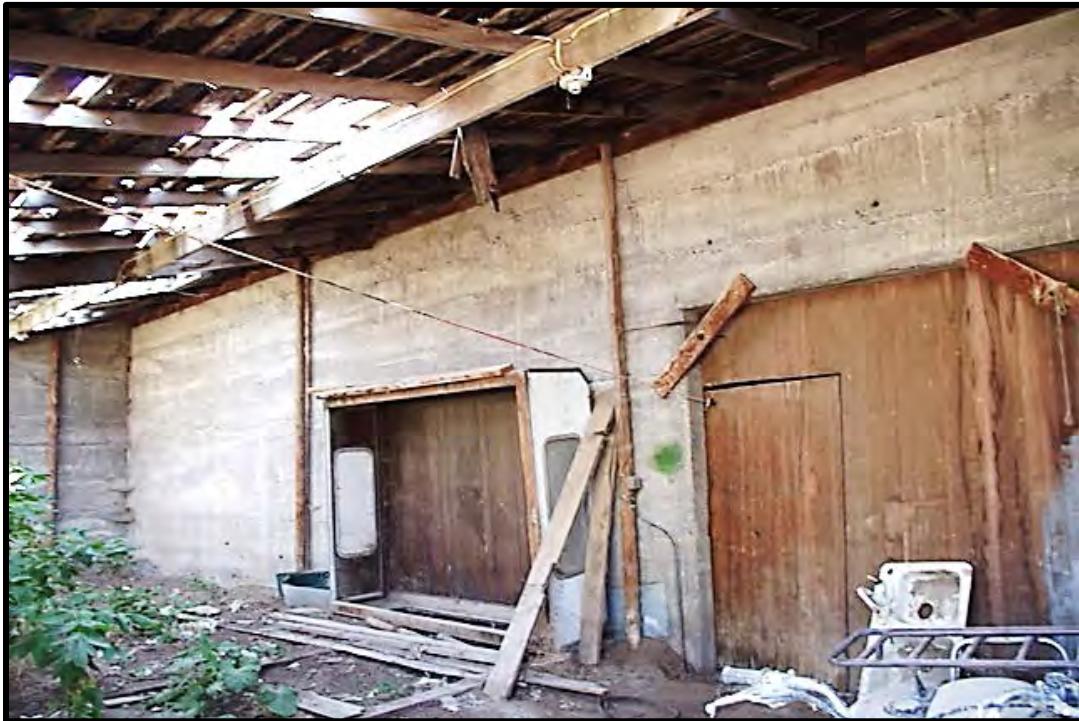
Photograph 88 of 101 Feature 11: Barn, north elevation detail. Camera facing southeast.

[Photo #88](#) (ID_Twin Falls County_Brose, Robert and Augusta, Ranch_088) Feature 11: Barn, north elevation detail. Camera facing southeast.

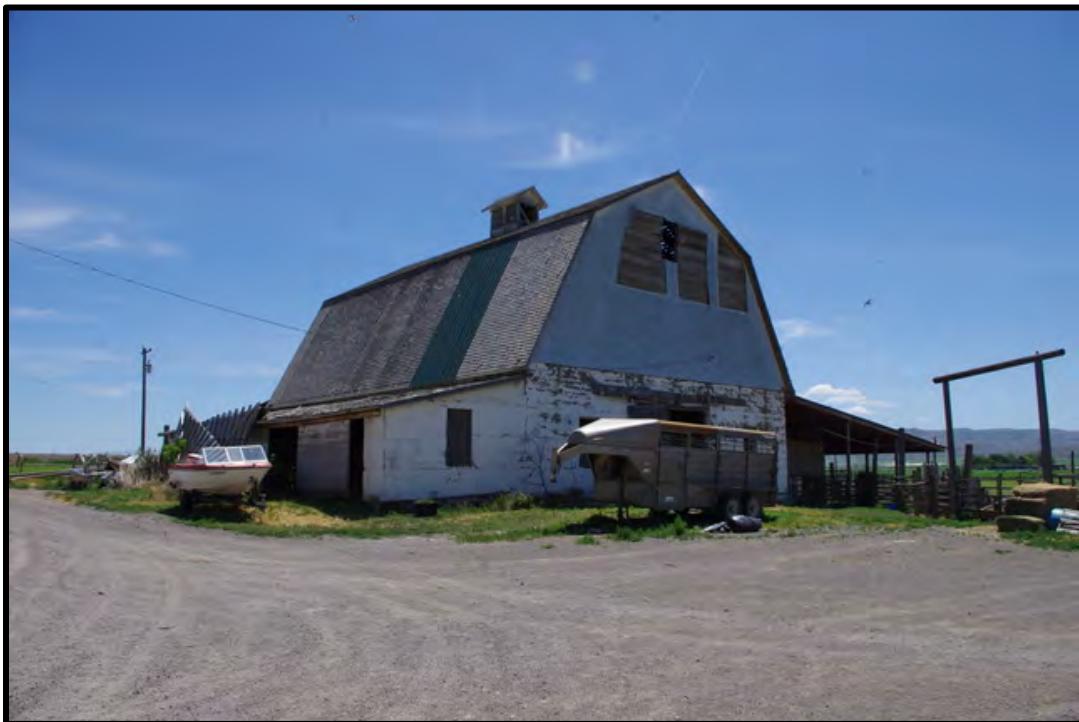
Photograph 89 of 101 Feature 11: Barn, north and west elevations. Camera facing southeast.

[Photo #89](#) (ID_Twin Falls County_Brose, Robert and Augusta, Ranch_089) Feature 11: Barn, north and west elevations. Camera facing southeast.

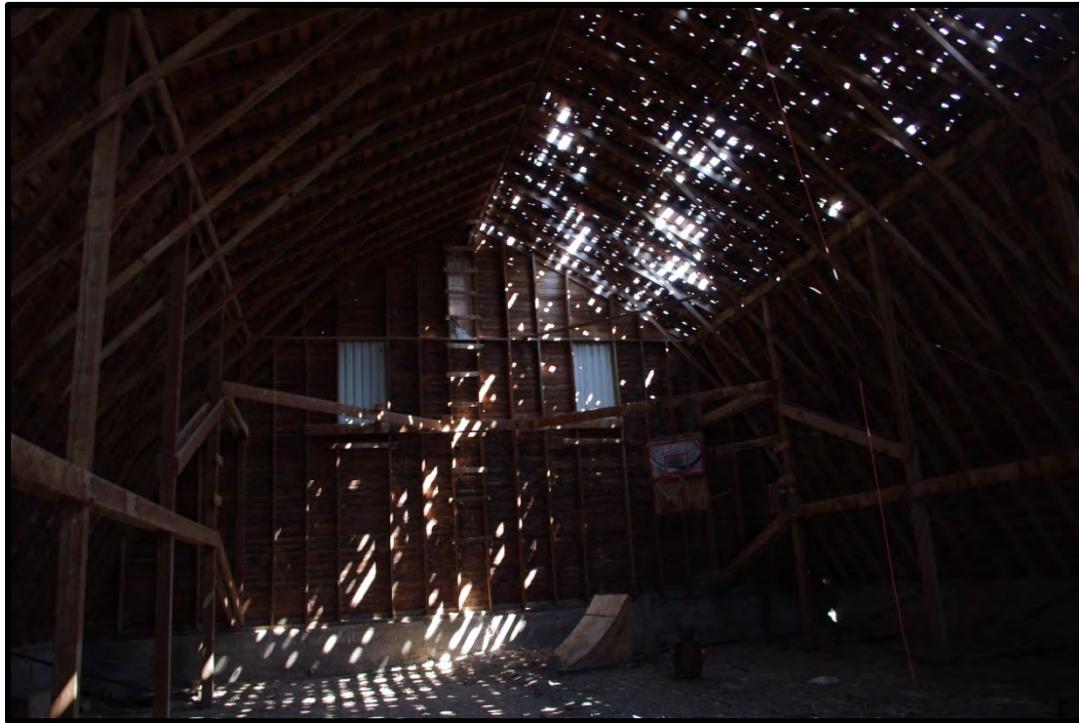
Photograph 90 of 101 Feature 11: Barn Interior, camera facing east.

[Photo #90](#) (ID_Twin Falls County_Brose, Robert and Augusta, Ranch_090) Feature 11: Barn interior, camera facing east.

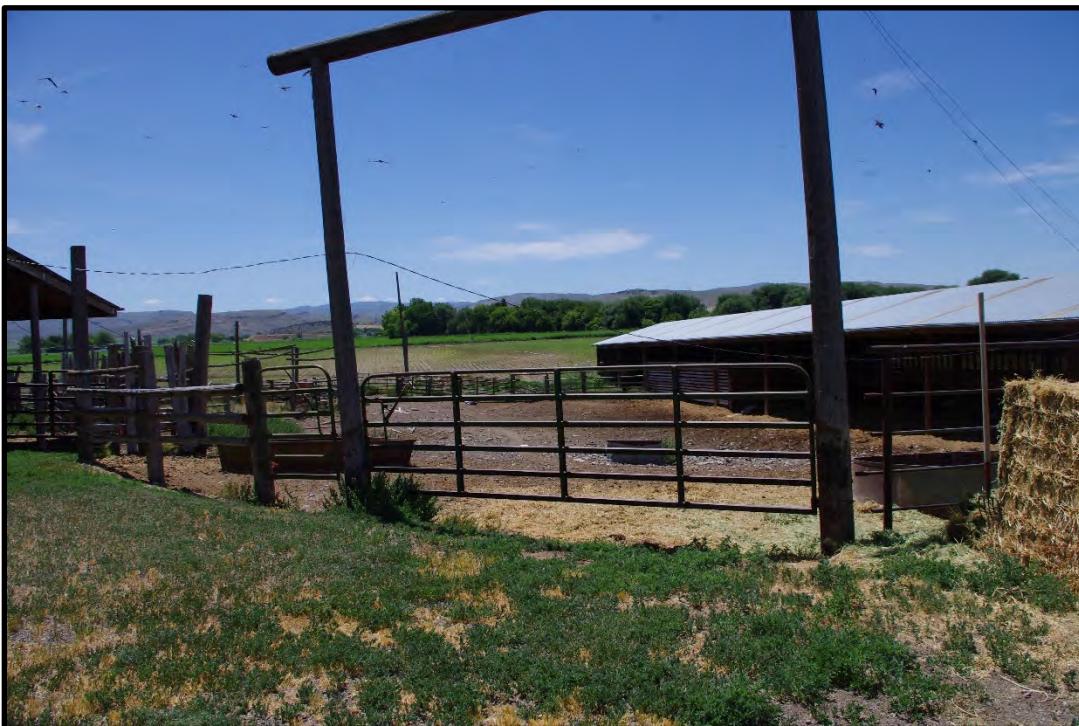
Photograph 91 of 101 Feature 12: Corrals, Camera facing south.

The materials have been replaced over time, but the corral retains its integrity of location, design, setting, feeling, and association. While the exact configuration and fence path may vary, as the metal sections can be moved when needed to access or limit animal movement, the integrity of the corral is intact.

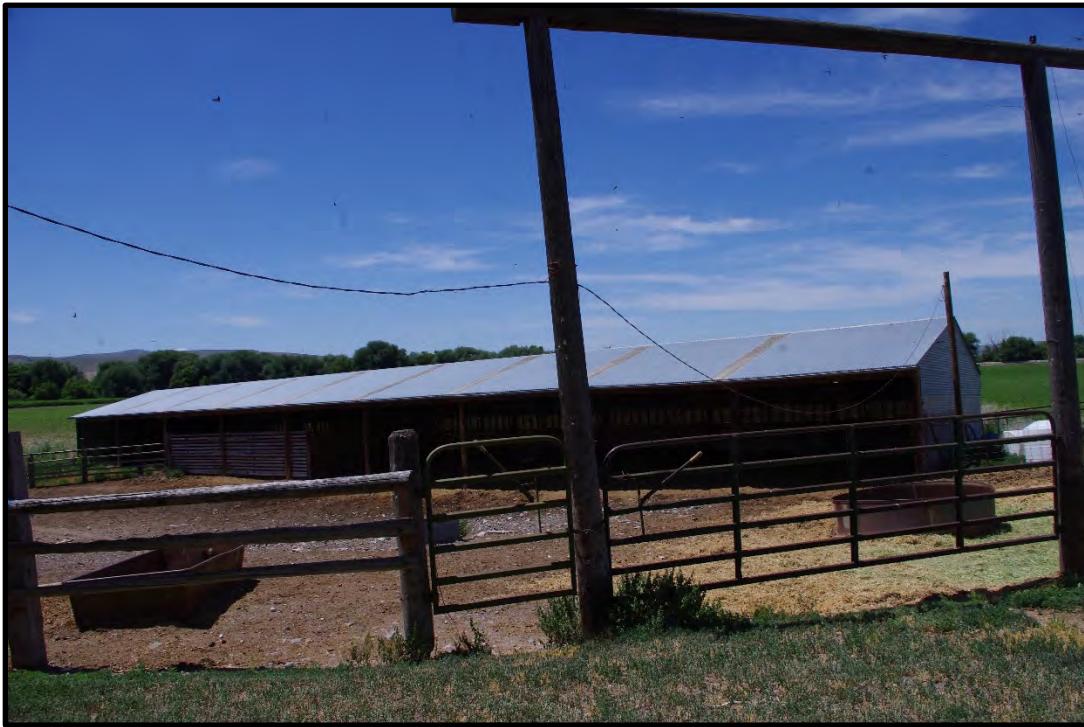
Photograph 92 of 101 Feature 12: Corrals, camera facing southwest looking toward. Feature 13: animal shed.

[Photo #92](#) (ID_Twin Falls County_Brose, Robert and Augusta, Ranch_092) Feature 12: Corrals, camera facing southwest looking toward Feature 13: animal shed.

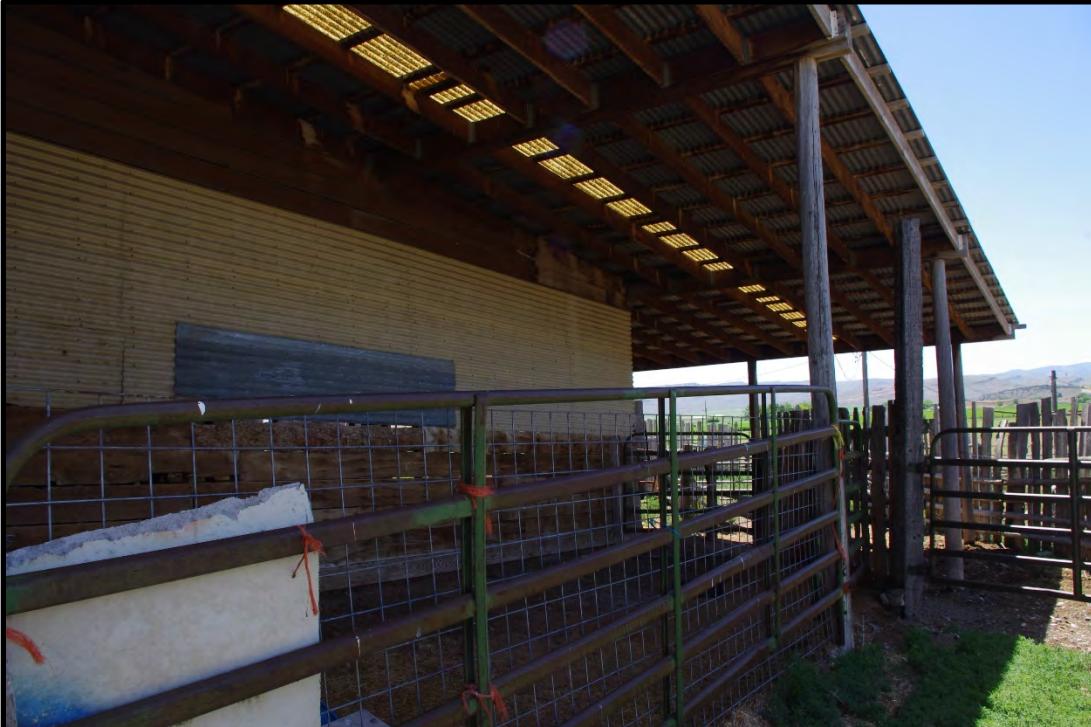
Photograph 93 of 101 Feature 12: Corrals, detail camera facing south.

[Photo #93](#) (ID_Twin Falls County_Brose, Robert and Augusta, Ranch_093) Feature 12: Corrals, detail camera facing south.
