Indian Mountain Fire Lookout
Name of Property

Adams County, Idaho
County and State

National Register of Historic Places Registration Form

historic name Indian Mountain Fire Lookout
other names/site number Mica Mountain Fire Lookout, 10AM270 (SITS), PY-616 (agency)

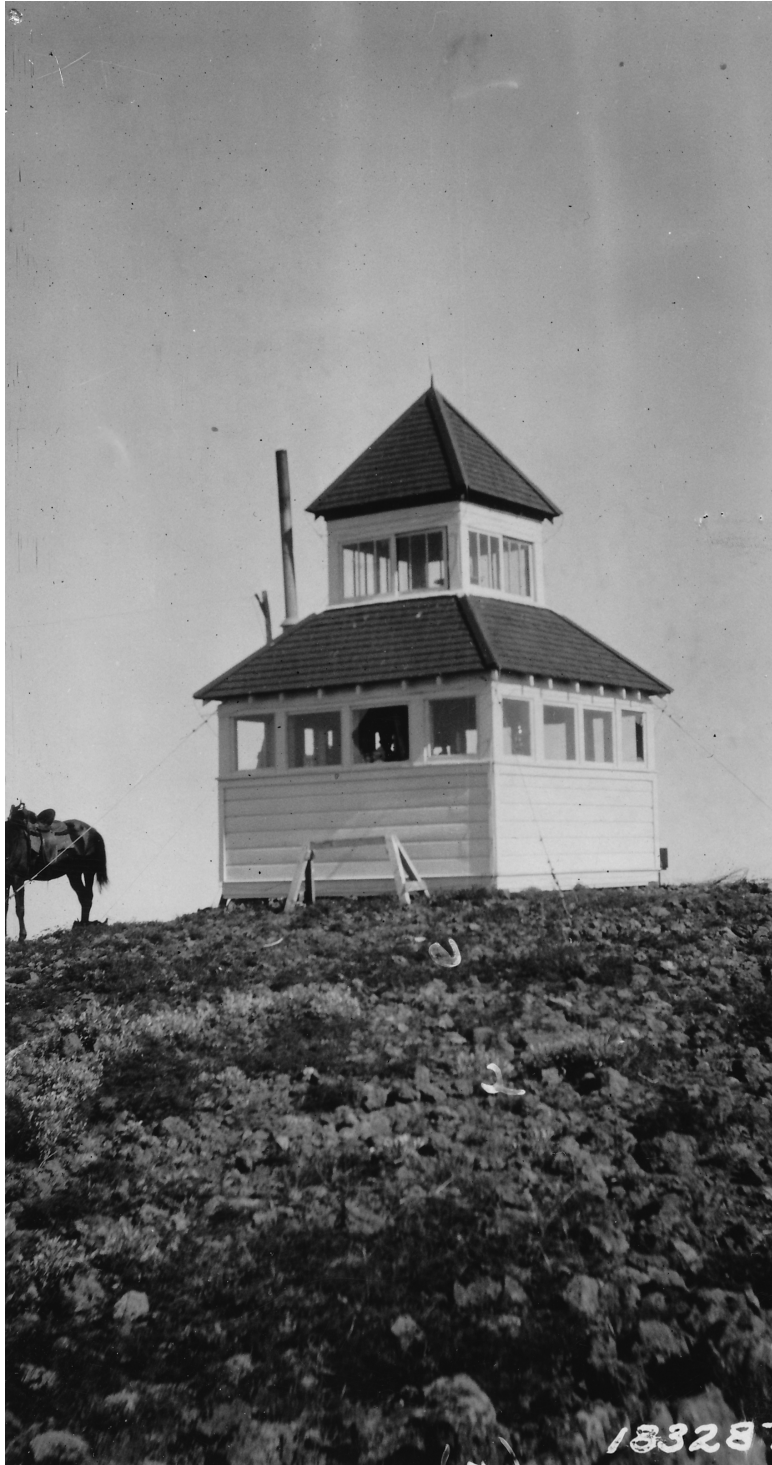
Figure 4. First permanent lookout building (not extant), facing northwest; 1923 by unknown photographer.

The use of fire lookouts began in the northwestern United States during the late nineteenth century when timber companies started utilizing lookouts as tools to protect valuable trees from wildland fire. From a well-placed vantage point, a firewatcher could pinpoint a fire, and have it extinguished before it had a chance to grow. Recognizing the need to manage and protect public lands, Congress established the Forest Service under the United States Department of Agriculture (USDA) in 1905 to provide quality water and timber for the nation's benefit. The agency was driven by a mission to conserve and manage resources for public use and sought to protect timber and watersheds through fire suppression. The Forest Service began using fire lookouts in the early twentieth century. These early lookout facilities were known as "rag camps" and generally consisted of a wooden tent platform and a stand for the firefinder. Indian Mountain has been continually used by the Forest Service as a lookout point since 1910, with the first permanent structure built on the site in 1922. (See Figure 4)

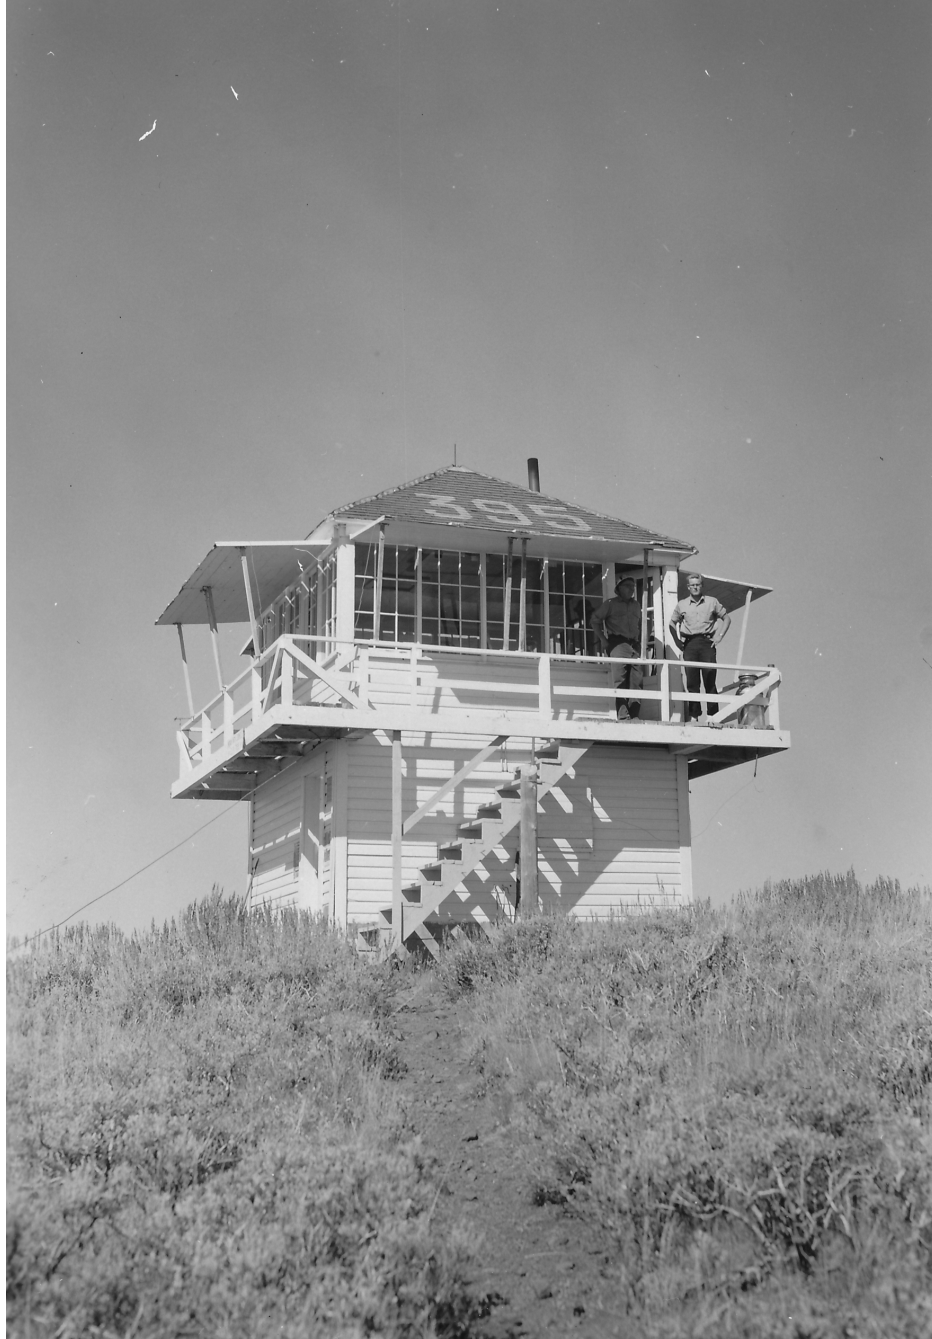
Figure 5. Indian Mountain Fire Lookout, 1956 by unknown photographer.

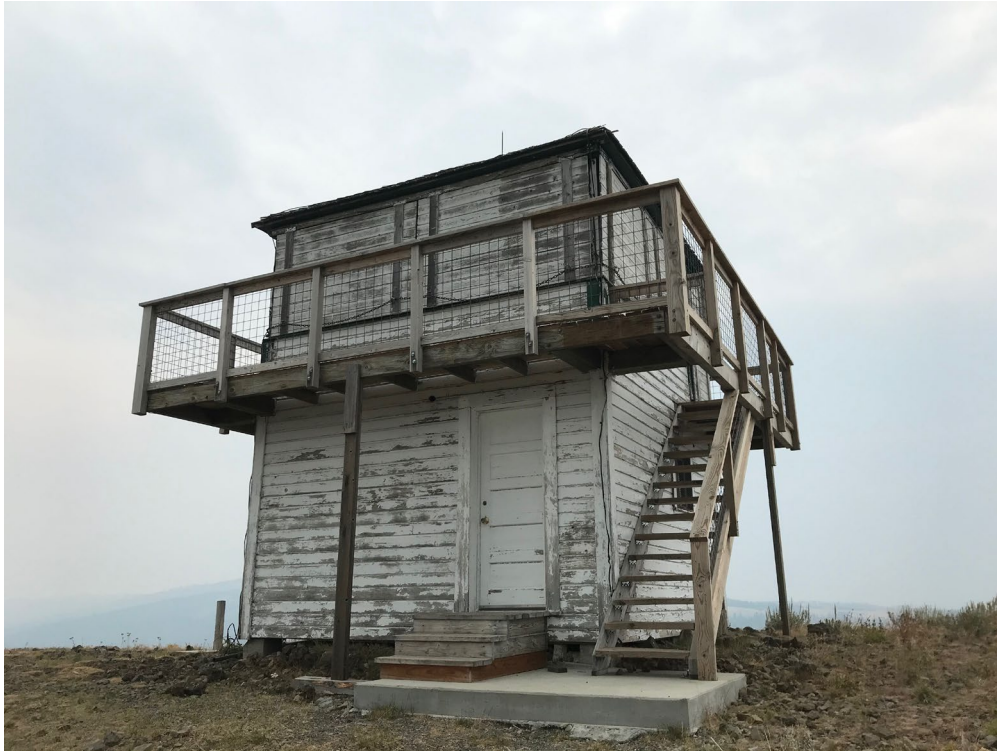
Photo #1. Lookout building. Facing northeast at the south and west elevations.

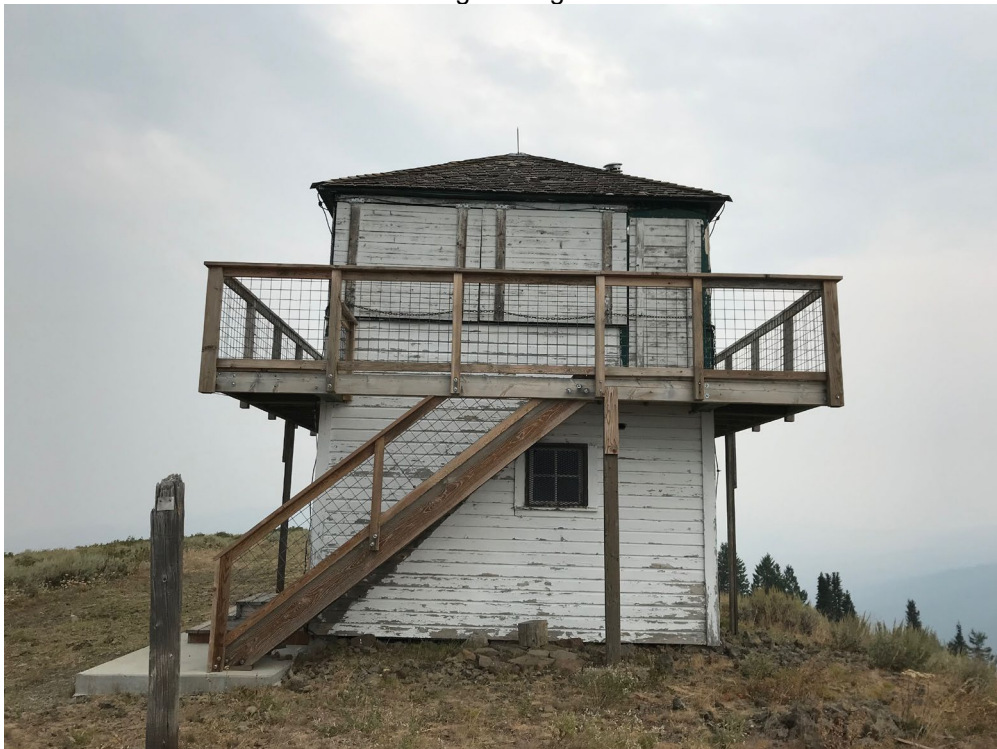
Photo #2. Lookout building. Facing north at south elevation.

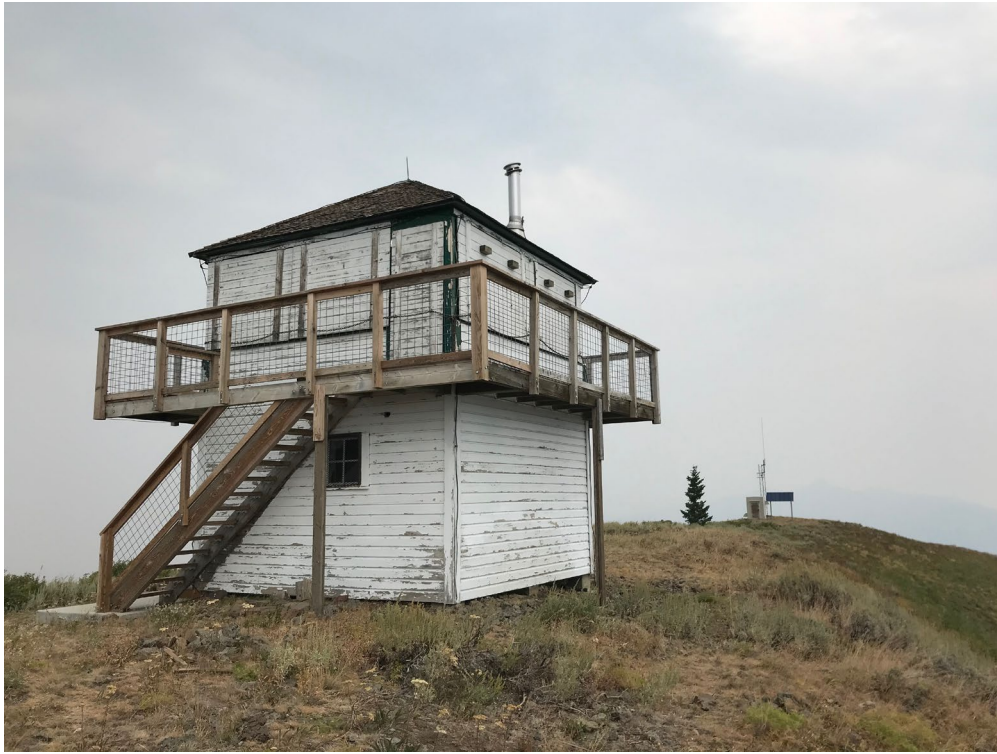
Photo #3. Lookout building. Facing northwest at the south and east elevations

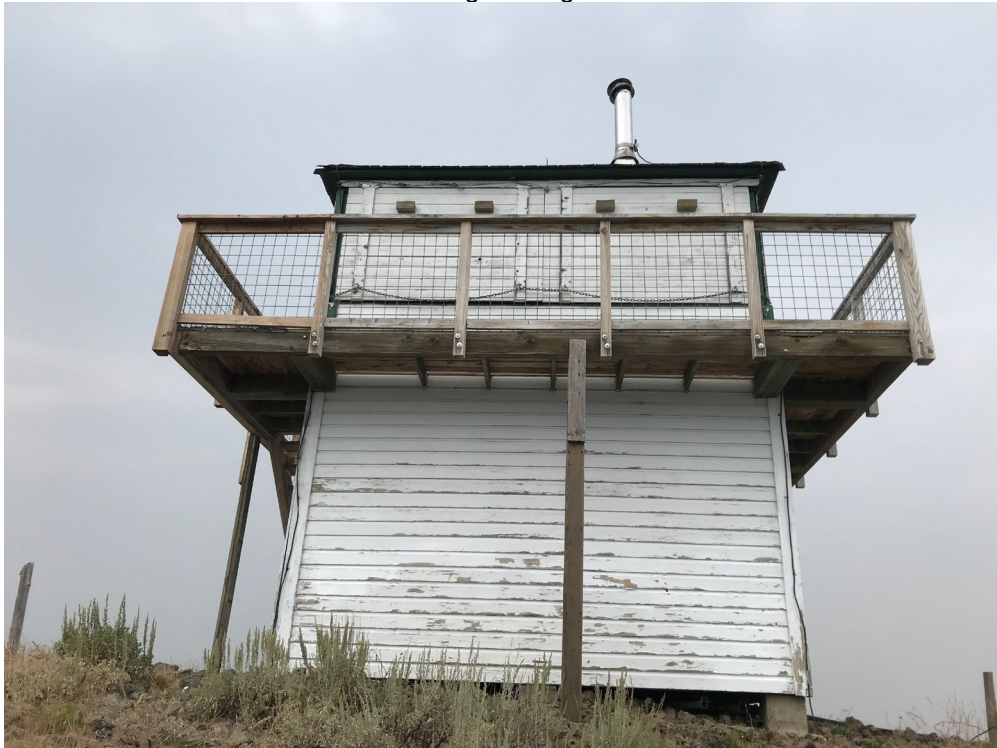
Photo #4. Lookout building. Facing east at west elevation.

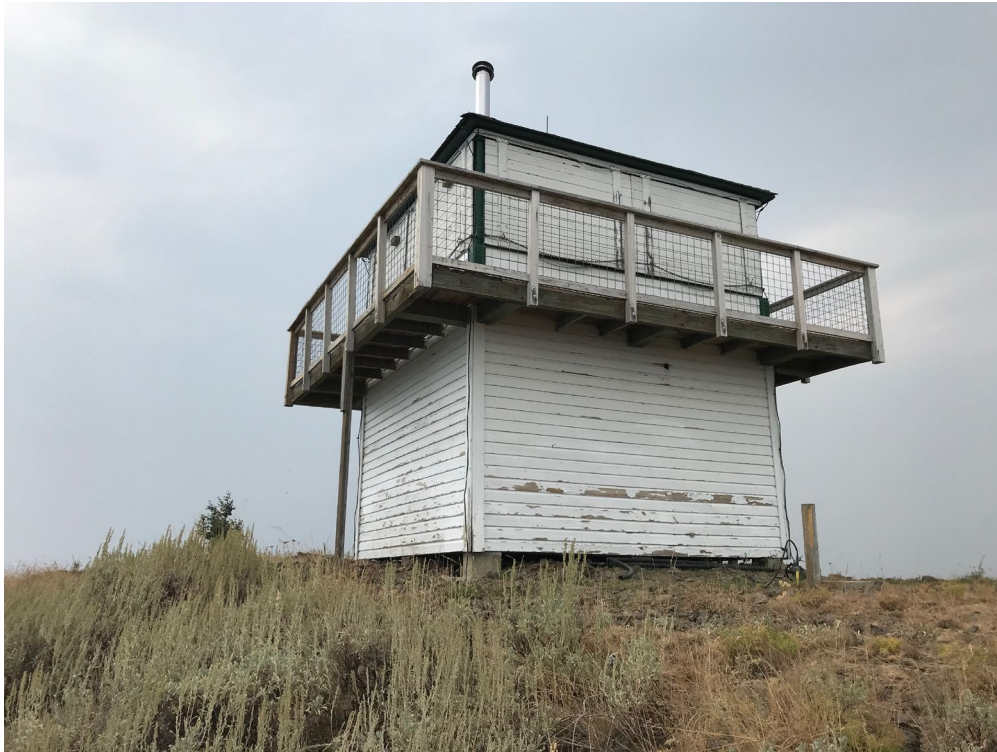
Photo #5. Lookout building. Facing southeast at west and north elevations.

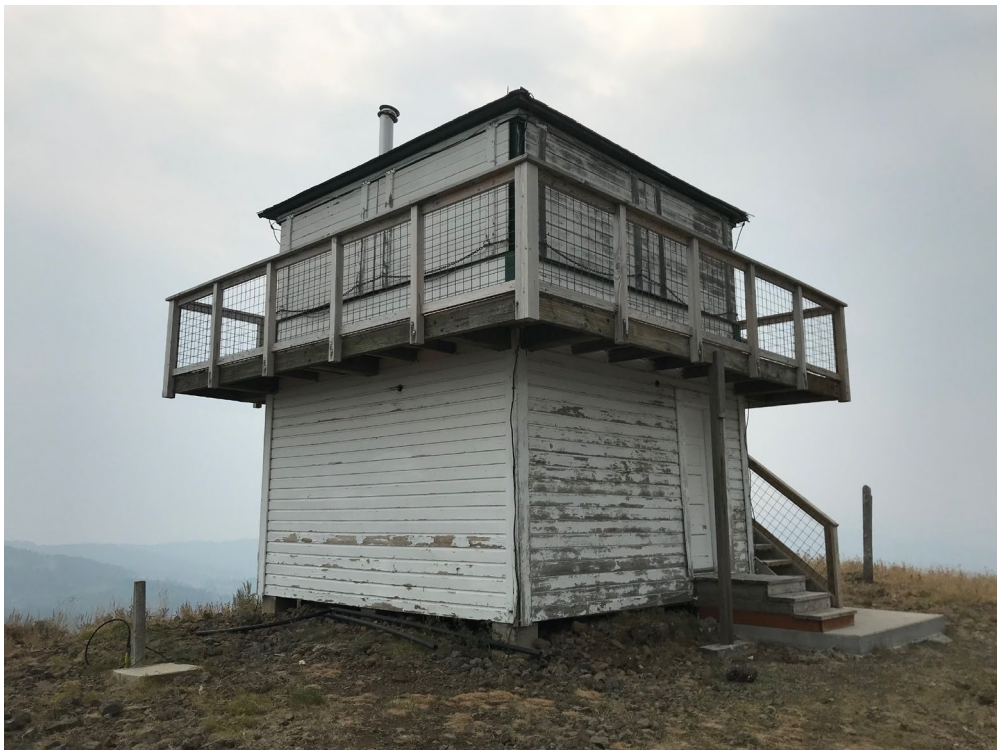
Photo #6. Lookout building. Facing southwest at north and east elevations.

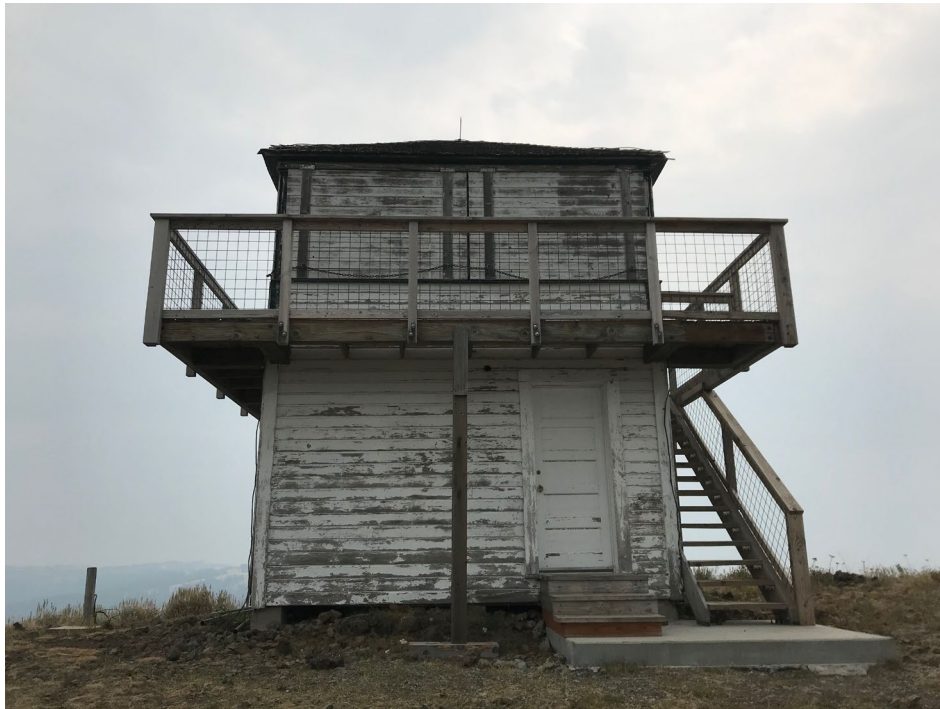
Photo #7. Lookout building. Facing west at east elevation.

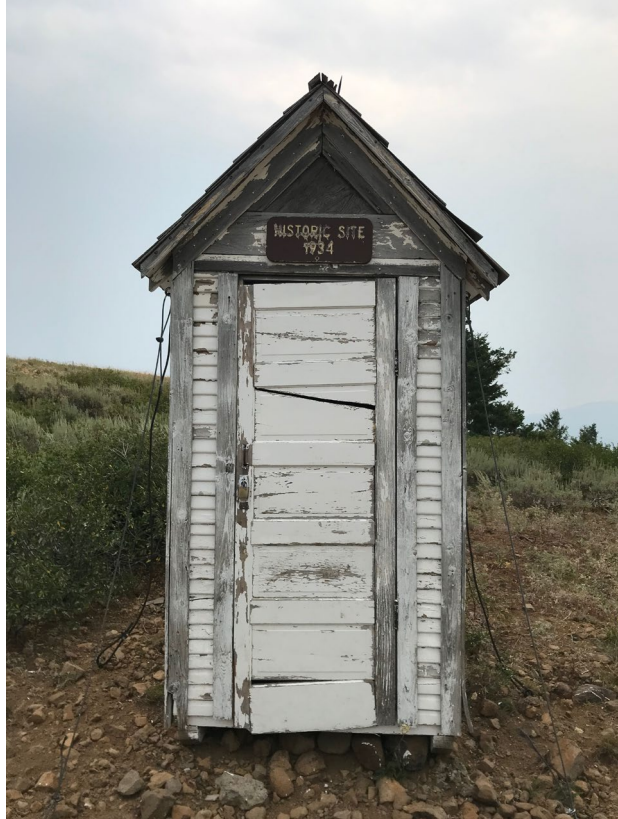
Photo #9. Historic outhouse. Facing northwest at east and south elevations. Lookout in background.

The old latrine, currently used as a storage shed, is a historic and contributing outbuilding. It was constructed in 1928 at the Bear Guard Station from a standard Forest Service plan that the Intermountain Region adopted in 1933 as R4 Plan 70. The latrine is located 30 yards SW of the lookout and was moved to the Indian Mountain Fire Lookout site in 1999 after the original Plan 70 latrine burned down two years earlier. Moving latrines is a historically common practice of the Forest Service as they were constructed to be mobile and frequently moved around within an administrative site or to other locations. The contributing wood frame outbuilding measures 3'-4" wide x 4'-1" deep x 8'-4" tall at the peak. It has pier block anchors, original wood novelty siding with a waterfall profile, a wood shingle front-gabled roof, and the original 5-panel wood door. Other features include plain corner boards, small round vent holes on the side and rear elevations, screened gable ends, and exposed rafter tails. It is painted white following the Forest Service scheme for the location. The interior bench seat has been removed and a lightning protection has been installed.

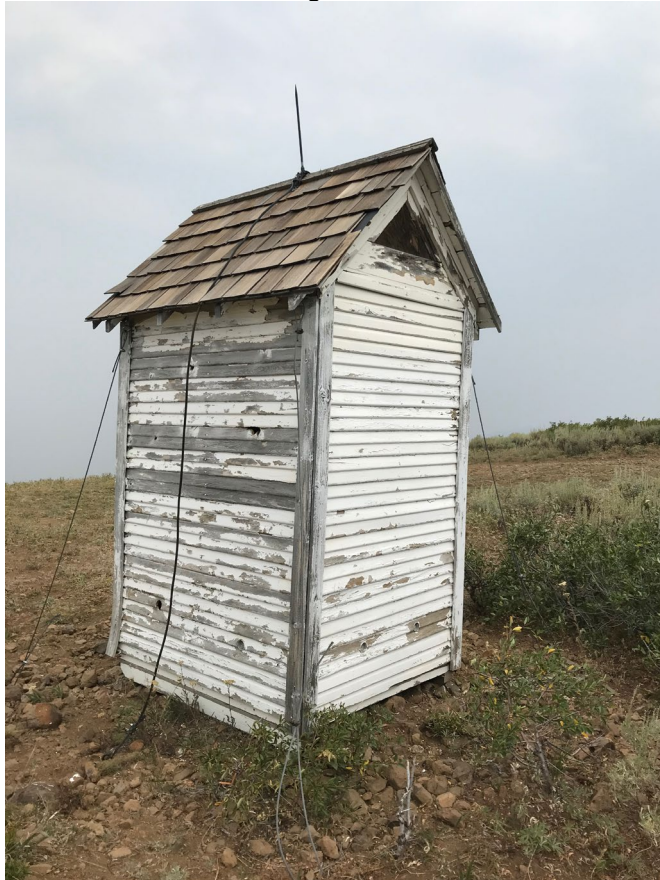
Photo #10. Historic outhouse. Facing southeast at west and north elevations.

- Photo #10 (ID_AdamsCounty_IndianMtnLookout_0010)
Historic outhouse. Facing southeast at west and north elevations. By Richa Wilson
- Photo #11 (ID_AdamsCounty_IndianMtnLookout_0011)
Historic outhouse. Facing south at north elevation. By Richa Wilson

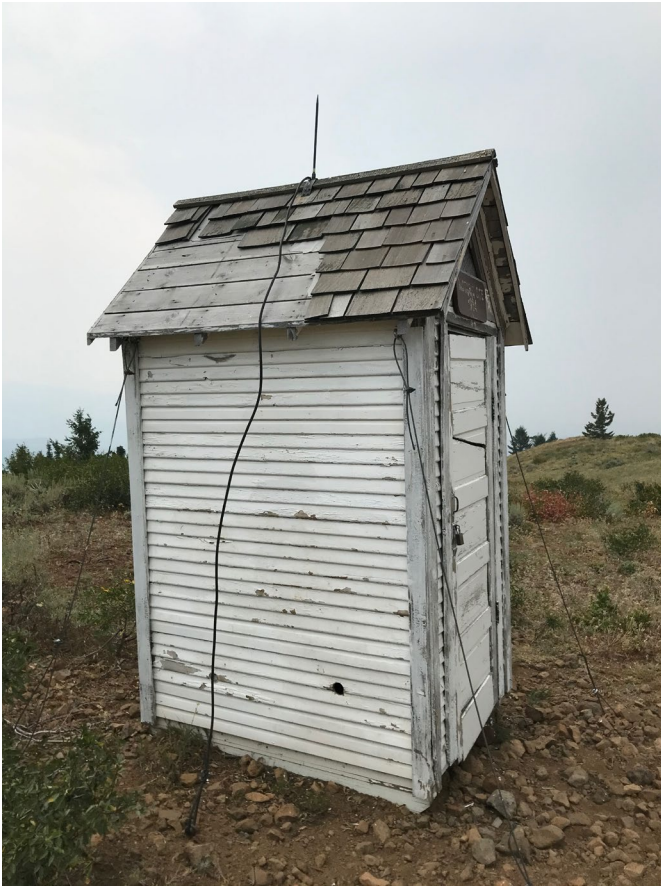
Photo #11. Historic outhouse. Facing south at north elevation.

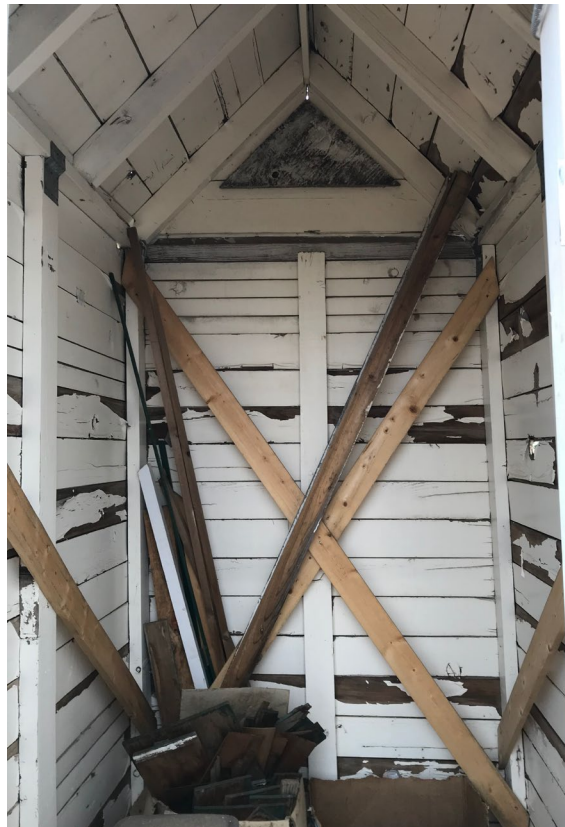
Photo #12. Historic outhouse. Interior. Facing west at east elevation.

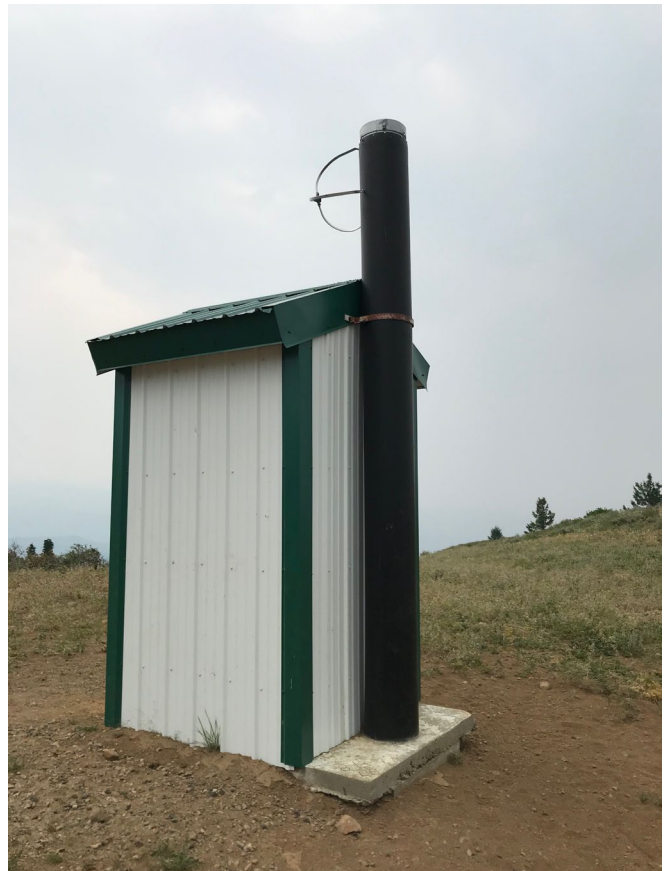
Photo #15. Modern latrine. Concrete slab inscribed 8-13-97 LB.

The modern latrine was constructed in 1997 and is classified as a noncontributing outbuilding. It measures 4'-8" wide x 4'-10" deep and approximately 8' tall with a large round vent pipe on its rear elevation. All indications suggest it was a standard plywood-clad Forest Service Sweet-Smelling Toilet (SST). In 2015, the latrine was covered in metal siding and a standing seam metal roof. It sits on a concrete slab inscribed with the date of 8-13-97. The slab was reinforced with bentonite, also in 2015.

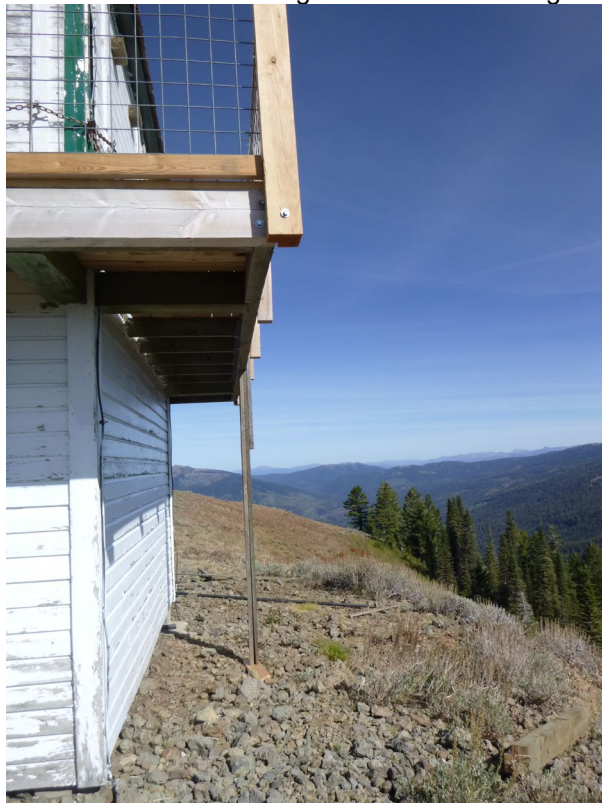
Photo #19. Rebuilt concrete step landing and steps leading to storage room. Facing northwest.

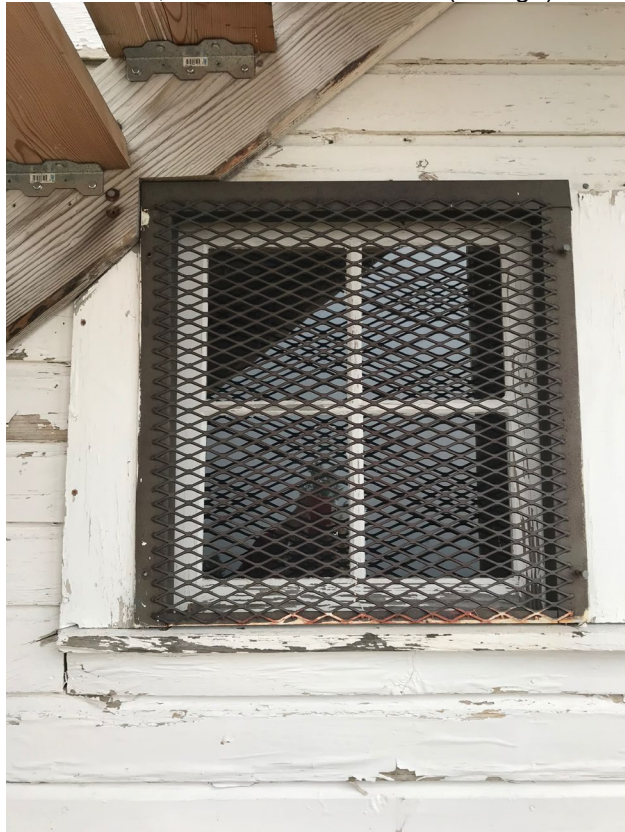
Photo #20. Historic Lookout. Window, one room substructure (storage) Facing north. South elevation.

Photo #20 (ID_AdamsCounty_IndianMtnLookout_0020)
Historic Lookout. Window, one room substructure (storage) Facing north. South elevation. By Richa Wilson

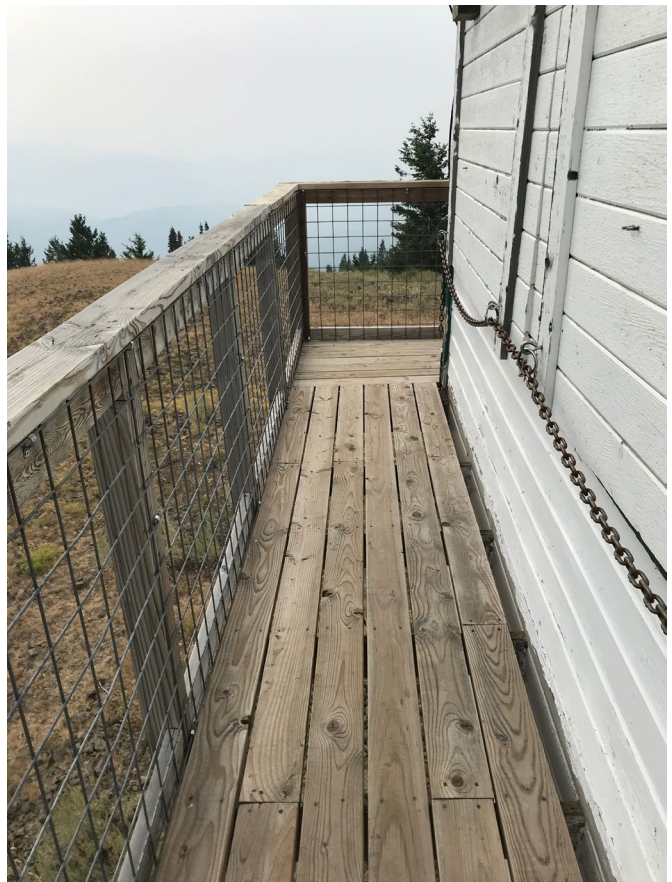
Photo #25. Lightning harness (detail). Northeast corner. Facing southwest.

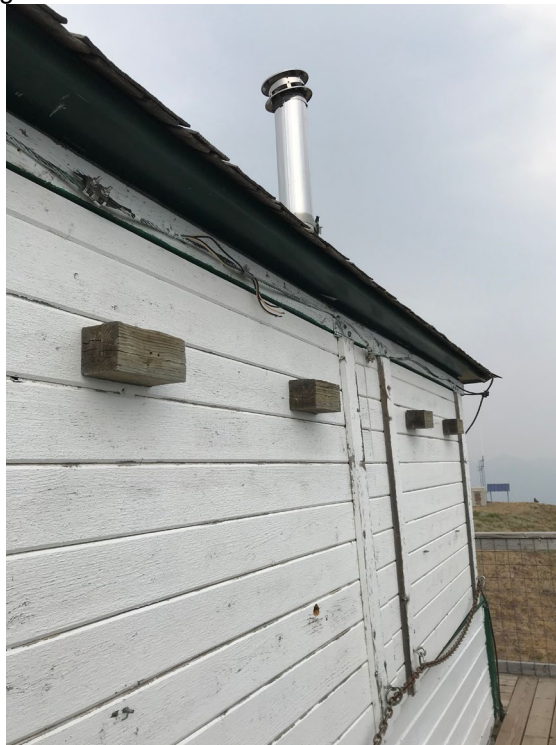
Photo #26. Lightning harness and facade detail. East elevation. Facing north northwest.

Photo #26 (ID_AdamsCounty_IndianMtnLookout_0026)
Lightning harness and facade detail. East elevation. Facing north northwest. By Richa Wilson

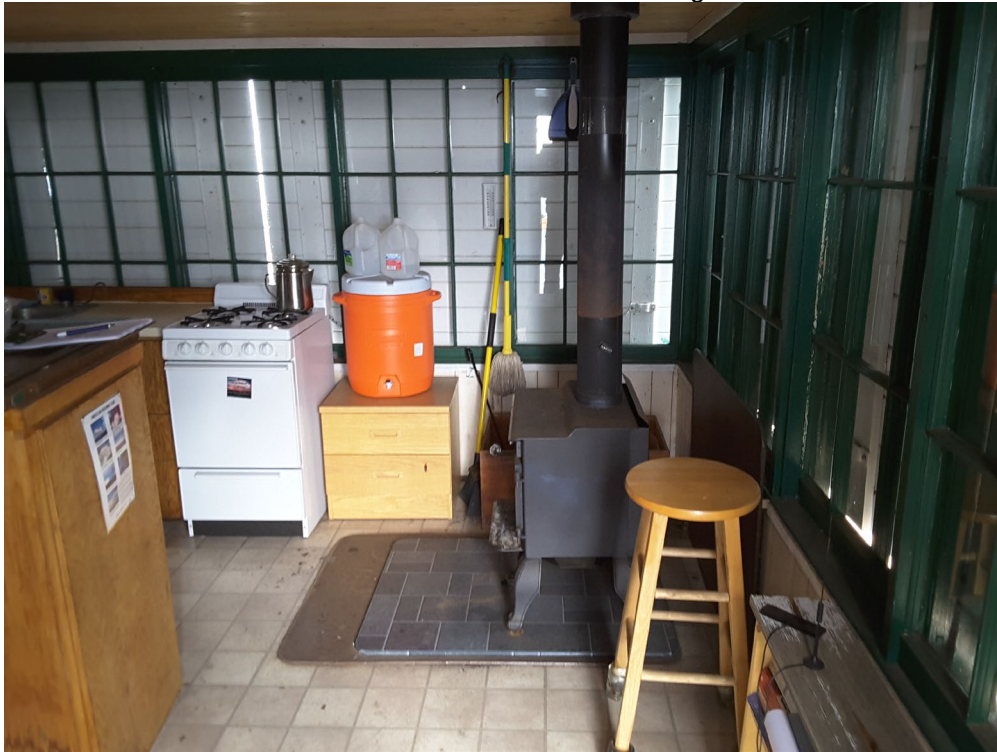
Photo #28. Lookout cab interior with alidade. Facing northeast.

The cab's interior retains its character-defining features. The most significant is the original alidade, also known as a firefinder. By triangulating a cross shot on a smoke with other lookouts, the alidade is the primary instrument used to accurately locate and properly record the locations of fires. The alidade is mounted on a built-in plywood stand in the cab's center. An attic access panel punctuates the ceiling, which is made of tongue-and-groove pine boards with a V-groove profile and a varnished finish. A wood panel mounted to the ceiling swings downward on hinges for easy storage and viewing of maps. Other furnishings include a wood-burning stove made of cast iron, which is not the original, a wooden box for storing firewood, a desk, a small dresser, a single bed with a trundle, and a propane cooking range. A chair with glass insulators at the bottom of its legs protects the lookout person from lightning. Despite the addition of vinyl flooring, wood wall paneling below the large windows, and plywood cabinets with a plastic laminate countertop and a stainless-steel sink, the interior retains historic integrity. Electric two-way radios replaced the original (1935) crank telephone, that connected to the Weiser and Payette National Forests' telephone systems via the former Mill Creek Ranger Station, east over the West Mountains to Long Valley and the town of Cascade, Idaho.

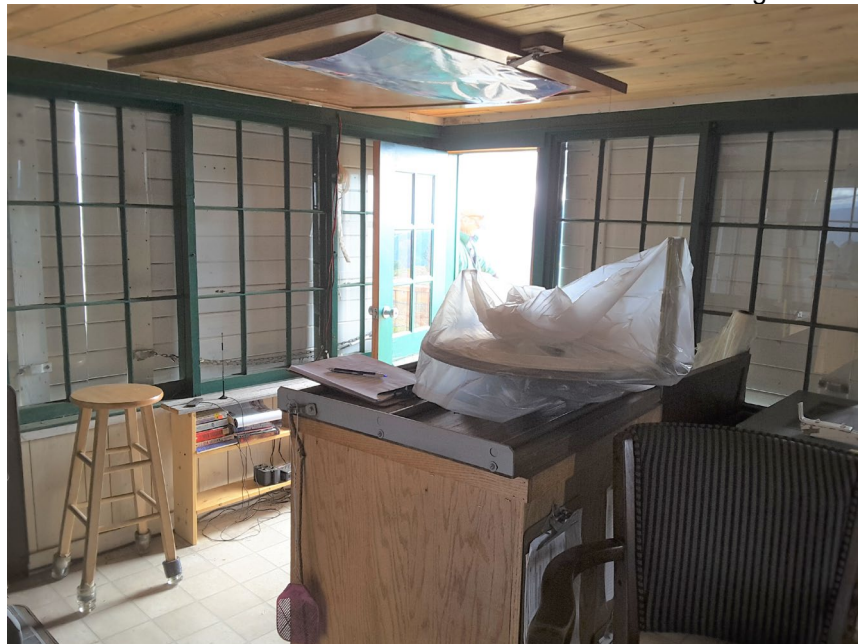
Photo #32. Lookout cab interior. Alidade and entrance door. Facing southwest.

Photo #32 (ID_AdamsCounty_IndianMtnLookout_0032)
Lookout cab interior. Alidade and entrance door. Facing southwest. By Samuel Thompson

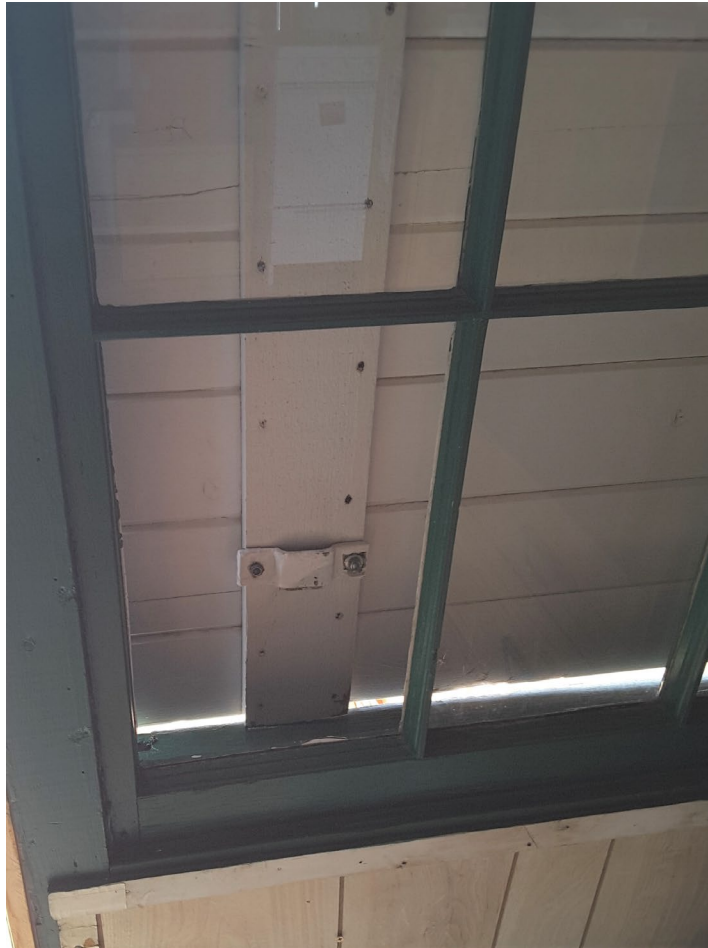
Photo #33. Lookout cab interior. Window and shutter detail. Facing west.

Photo #33 (ID_AdamsCounty_IndianMtnLookout_0033)
Lookout cab interior. Window and shutter detail. Facing west. By Samuel Thompson

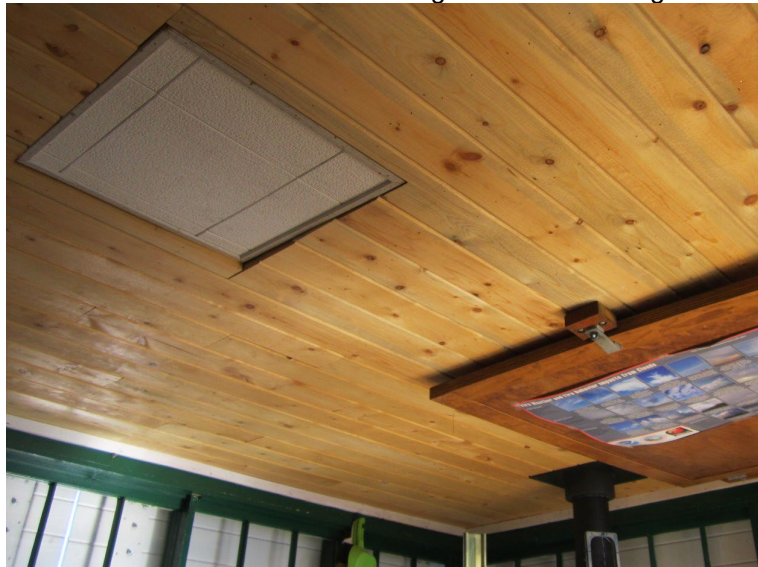
Photo #34. Lookout cab interior. Ceiling and hatch. Facing southeast.

Photo #34 (ID_AdamsCounty_IndianMtnLookout_0034)
Lookout cab interior. Ceiling and hatch. Facing southeast. By Gayle Dixon

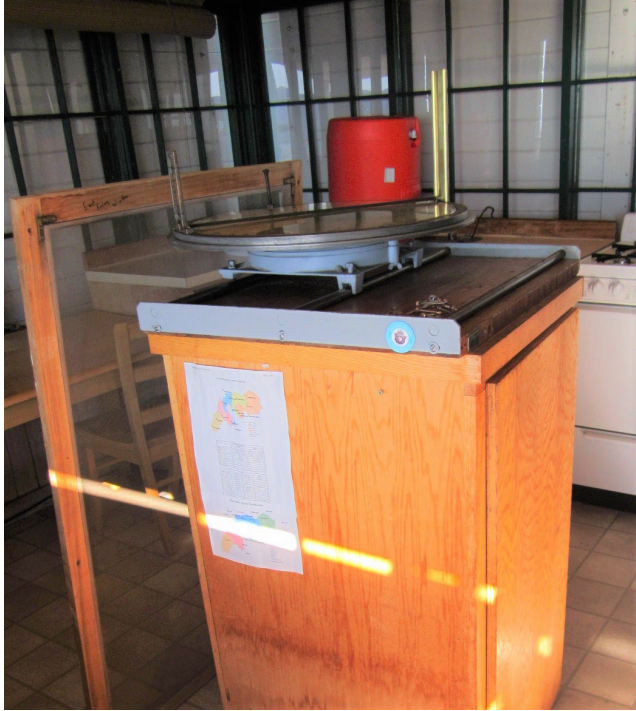
Photo #35. Lookout cab interior. Alidade detail. Facing northeast.

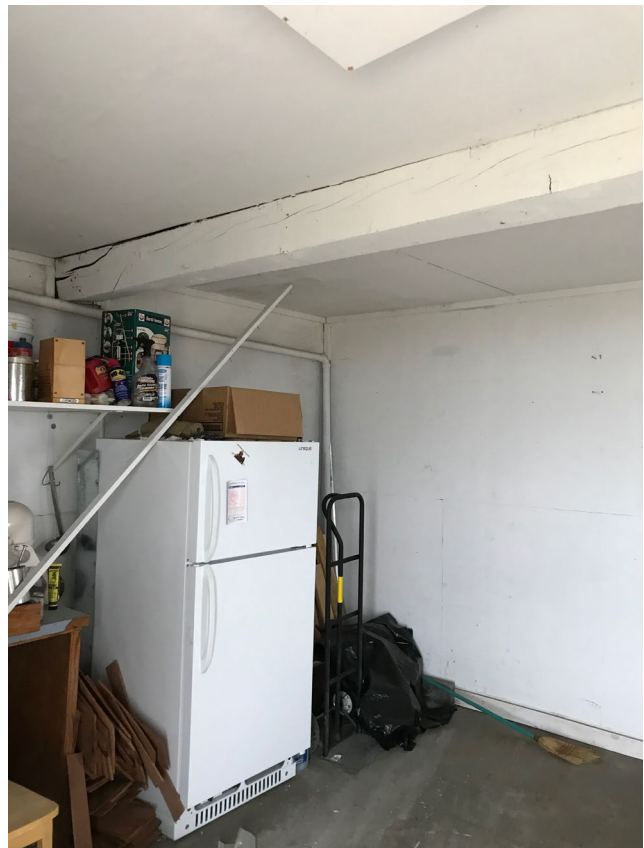
Photo #36. Lookout storage room interior showing original support beam. Facing northeast.

The building has an above-ground, one-room substructure that sits on a foundation of timber sills supported by poured concrete piers and basalt bedrock. It serves as a storage area and supports the lookout cab above. The south façade has a 4-pane wood hopper window, placed off center, that is protected with welded wire mesh added at an unknown date. An off-center, 5-panel wood door on the west provides access to the storage room's interior, which has an unfinished concrete floor. Painted plywood, likely an addition, covers the walls and ceiling. A plywood base cabinet with a plastic laminate countertop and a refrigerator are not original but they do not detract from the room's historic character.

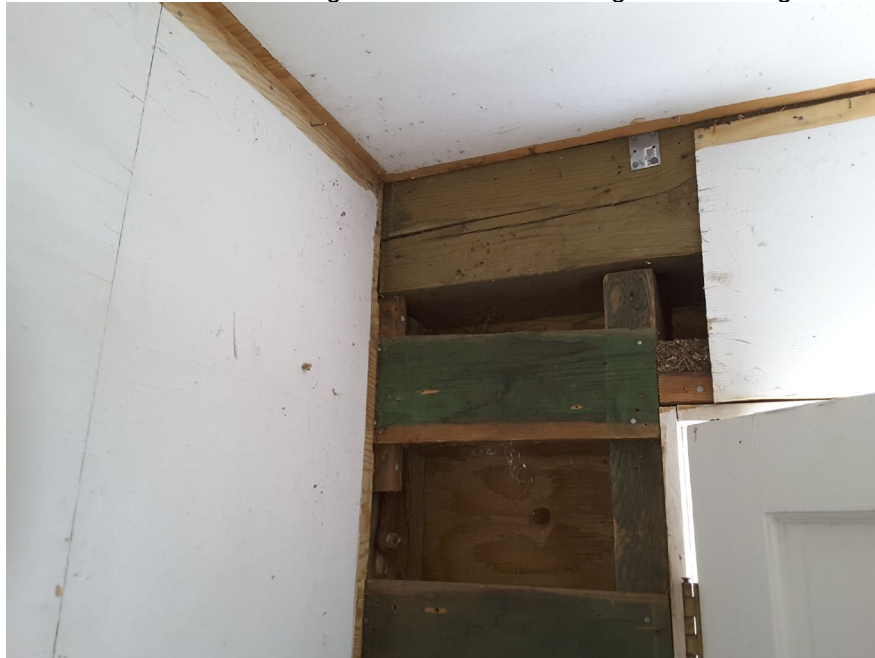
Photo #41. Lookout storage room interior. Framing detail. Facing west.

Photo #41 (ID_AdamsCounty_IndianMtnLookout_0041)
Lookout storage room interior. Framing detail. Facing west. By Samuel Thompson

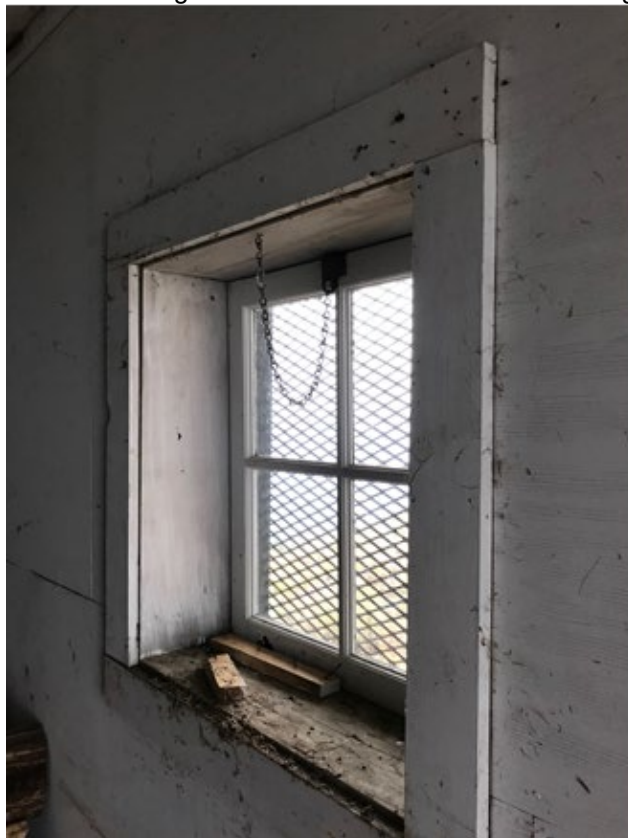
Photo #42. Lookout storage room interior. Window detail. Facing southeast.

Photo #42 (ID_AdamsCounty_IndianMtnLookout_0042)
Lookout storage room interior. Window detail. Facing southeast. By Richa Wilson

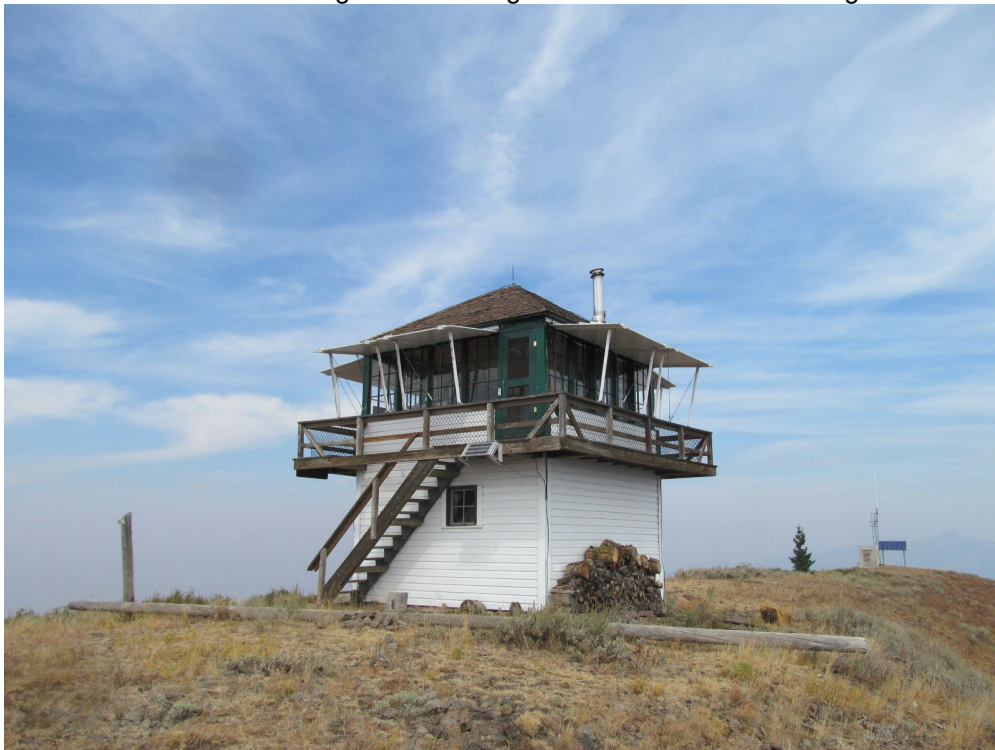
Photo #48. Lookout building. Before railing and stair restoration. Facing northwest.

Photo #48 (ID_AdamsCounty_IndianMtnLookout_0048)
Lookout building. Before railing and stair restoration. Facing northwest. By Samuel Thompson in 2015

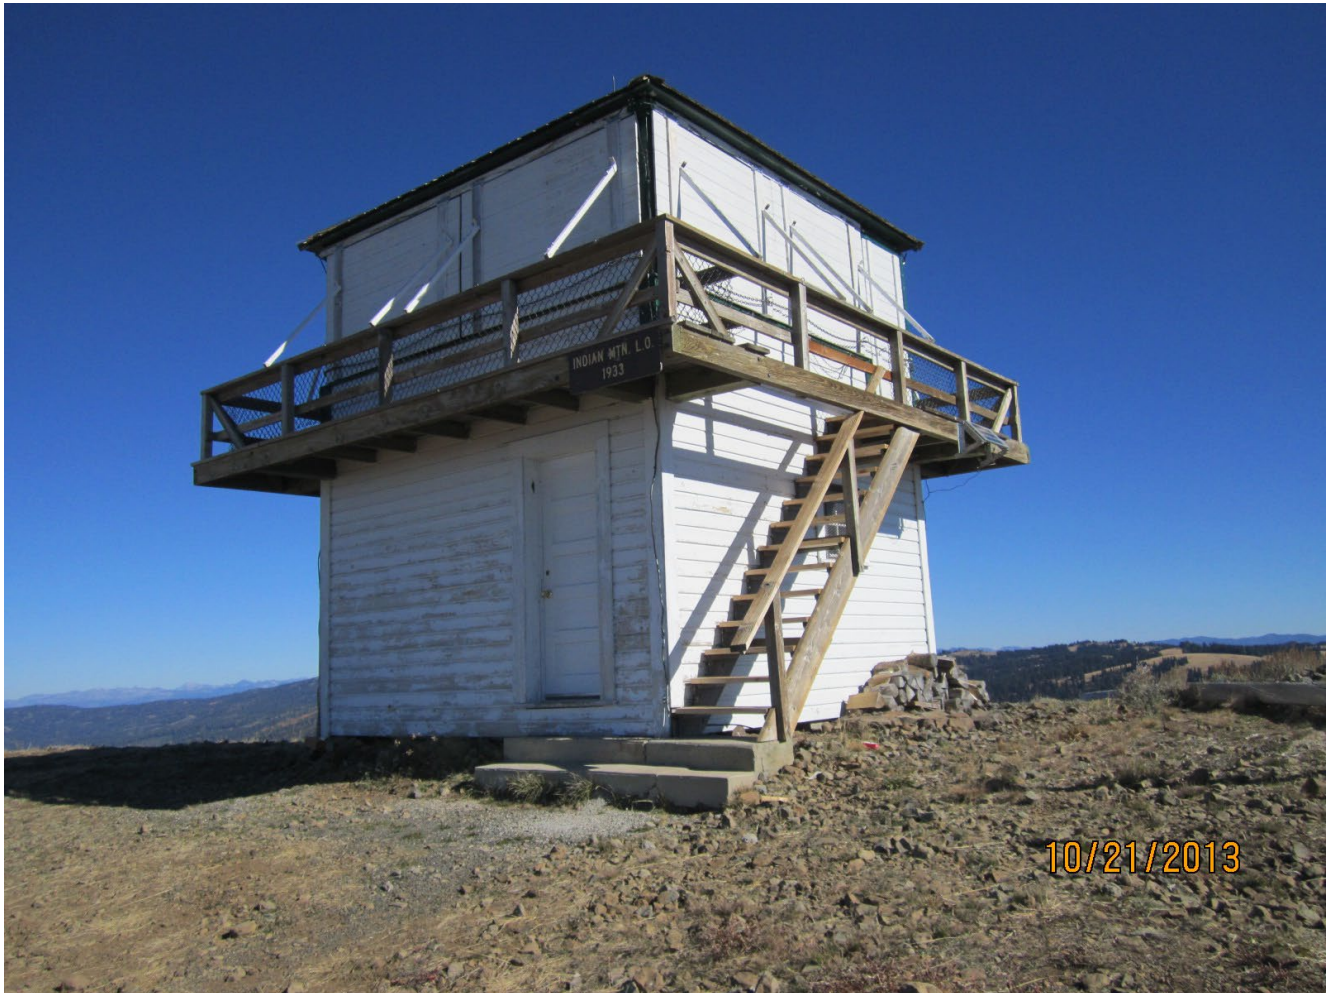
Photo #49. Lookout building. Before railing and stair restoration. Facing northeast.

Photo #49 (ID_AdamsCounty_IndianMtnLookout_0049)
Lookout building. Before railing and stair restoration. Facing northeast. By Gayle Dixon
