NATIONAL REGISTER OF HISTORIC PLACES INVENTORY - NOMINATION FORM

COMMON:
Leesburg

RESULTS OF THE 1982 INVENTORY

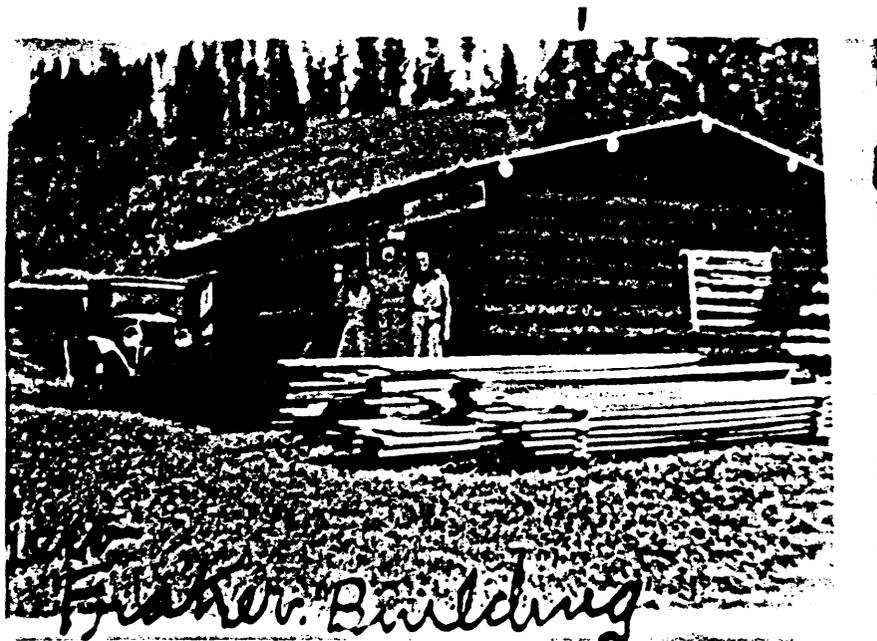
Fig. 9. Photograph of Feature 10 during construction in the mid-1930's.
(Lemhi County Historical Museum, Salmon.)

Feature 10 is a four room, saddle-notched log structure (Fig. 9). It was built in 1937 by Mike and Maude Fraker who used it as a boarding house and post office (Paul Fitzgerald and Marjorie Sims). The building is presently being used by the Napias Mining Company as a cookhouse and boarding house. Feature 10 is in good condition due both to its comparatively recent construction and to fairly continuous maintenance.

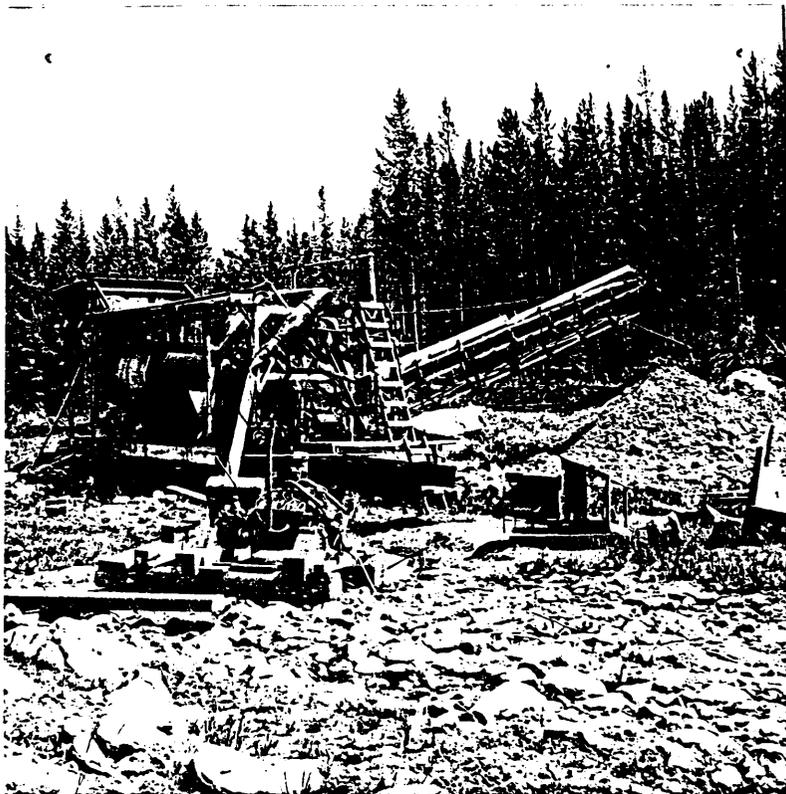
Fig. 14. Historic photograph of the Feature 75 washing plant. (Minerals Office, Salmon National Forest Supervisor's Office, Salmon.)

Feature 75 is the remains of a placer gold washing plant that dates to about 1955 (Fig. 14). Artifacts at the feature which is now covered with willows include the heavy, timbered foundation for the plant, a hopper, some parts of the conveyer, and some metal pipe and troughs. The operation was apparently short-lived because there are only a few piles of tailings at the feature.

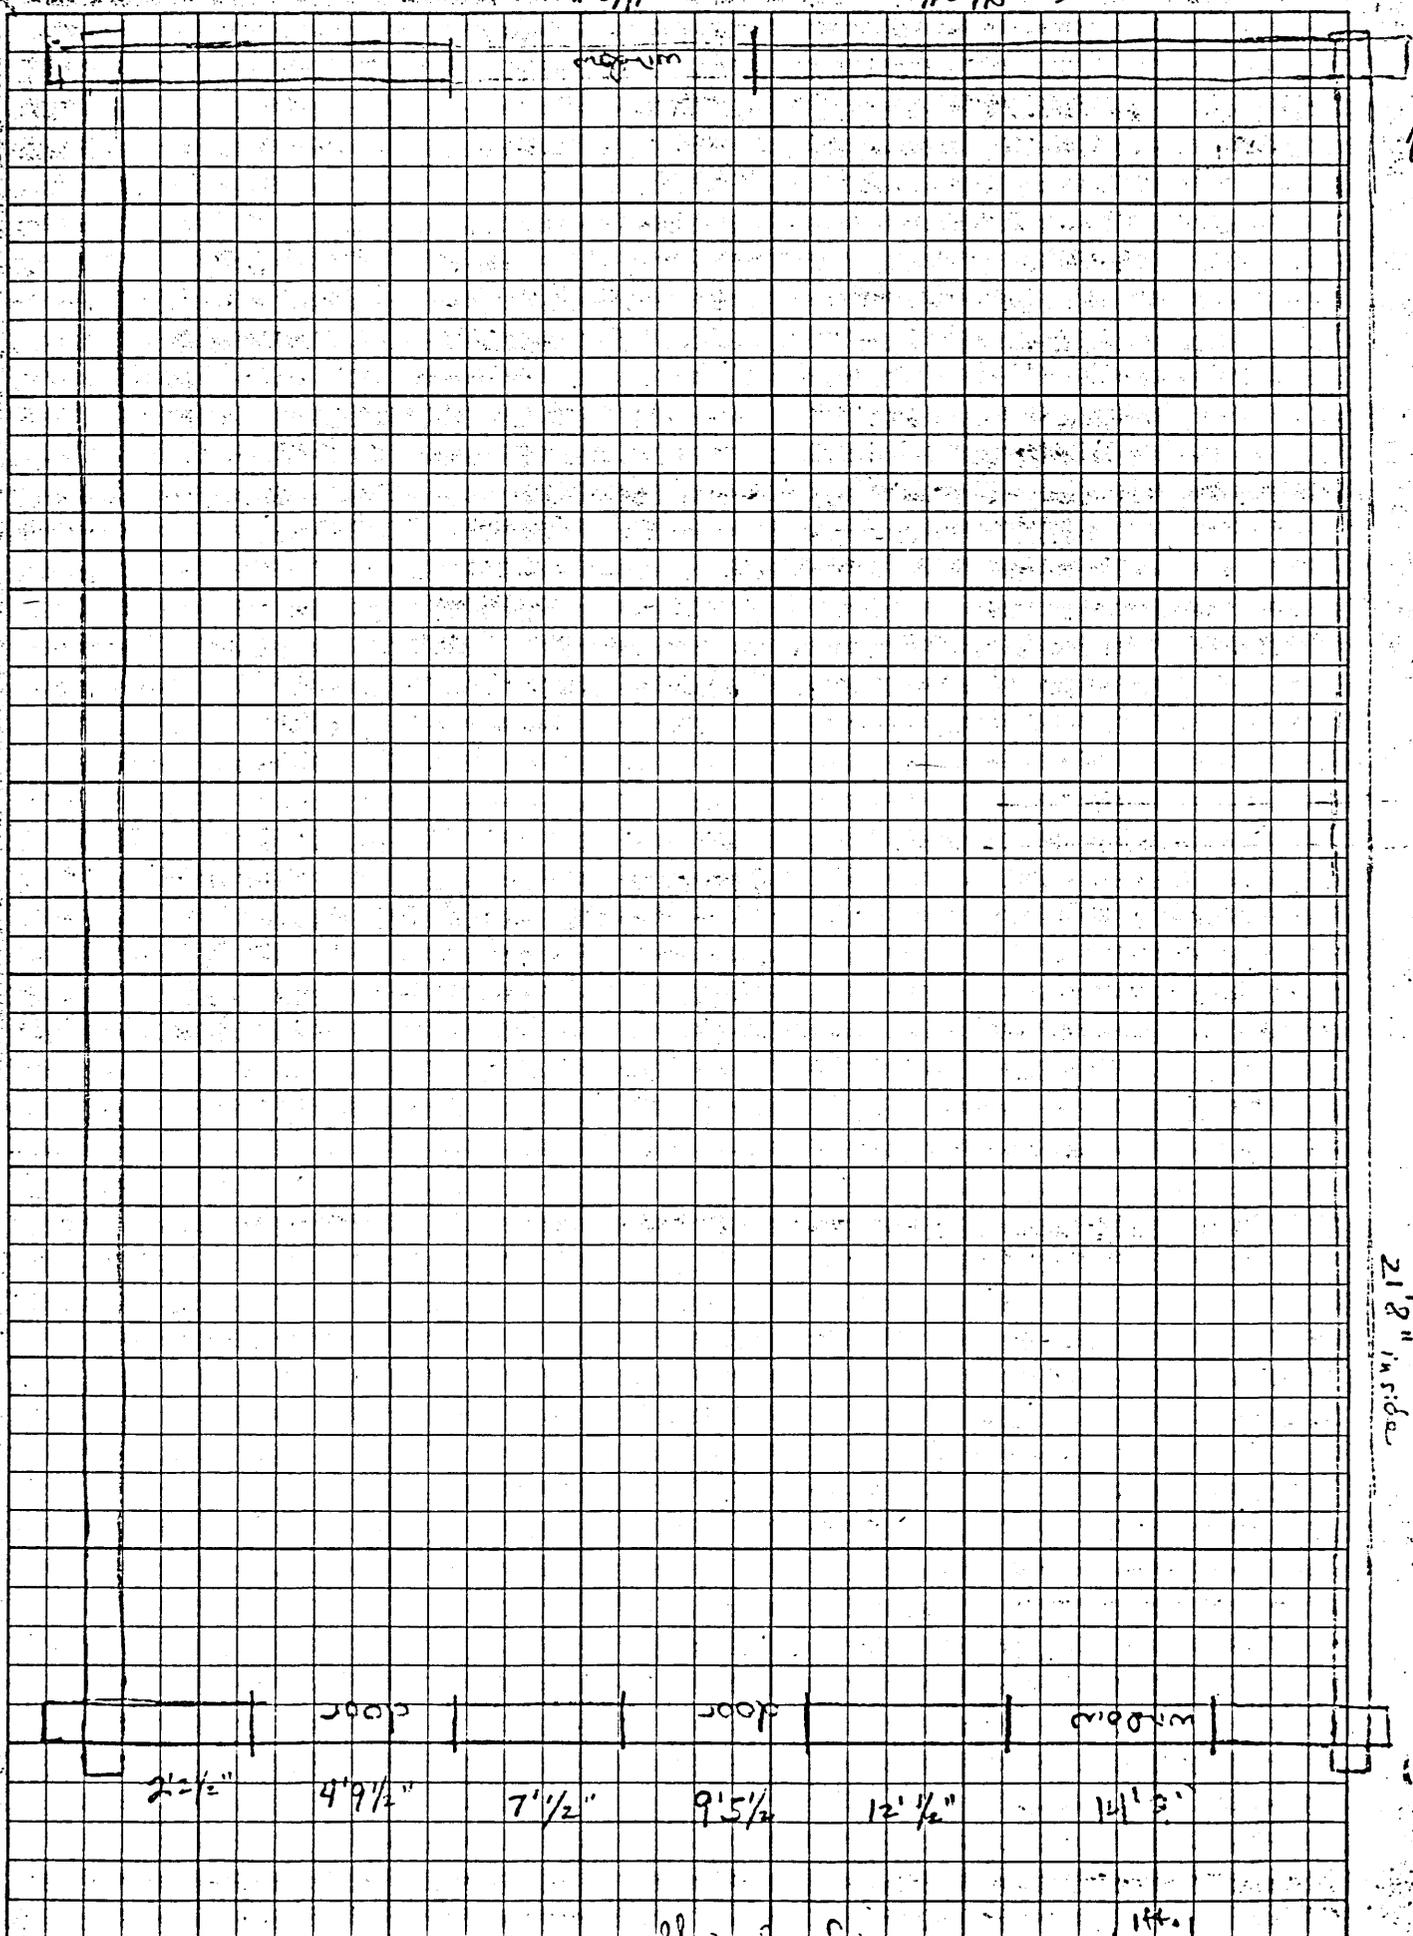
Structure 3
profile of south wall

Feature 3 is a single room, saddle-notched structure that was reportedly used by Monte Colwell as his office when he drove the stage from Salmon (Marjorie Sims). It was apparently constructed in the nineteenth century as the cut nails in the jams evidence. It is in fair condition; the west wall leans toward Feature 2 and the roof has collapsed.

Buildings in a poor state of repair or in ruins would not be repaired under the proposed stabilization program. Those buildings needing minor repairs to the walls or a new roof would have priority in the program. The buildings that would most benefit from a stabilization program are Feature 3 (roof), Feature 9 (roof and foundation along the north side),

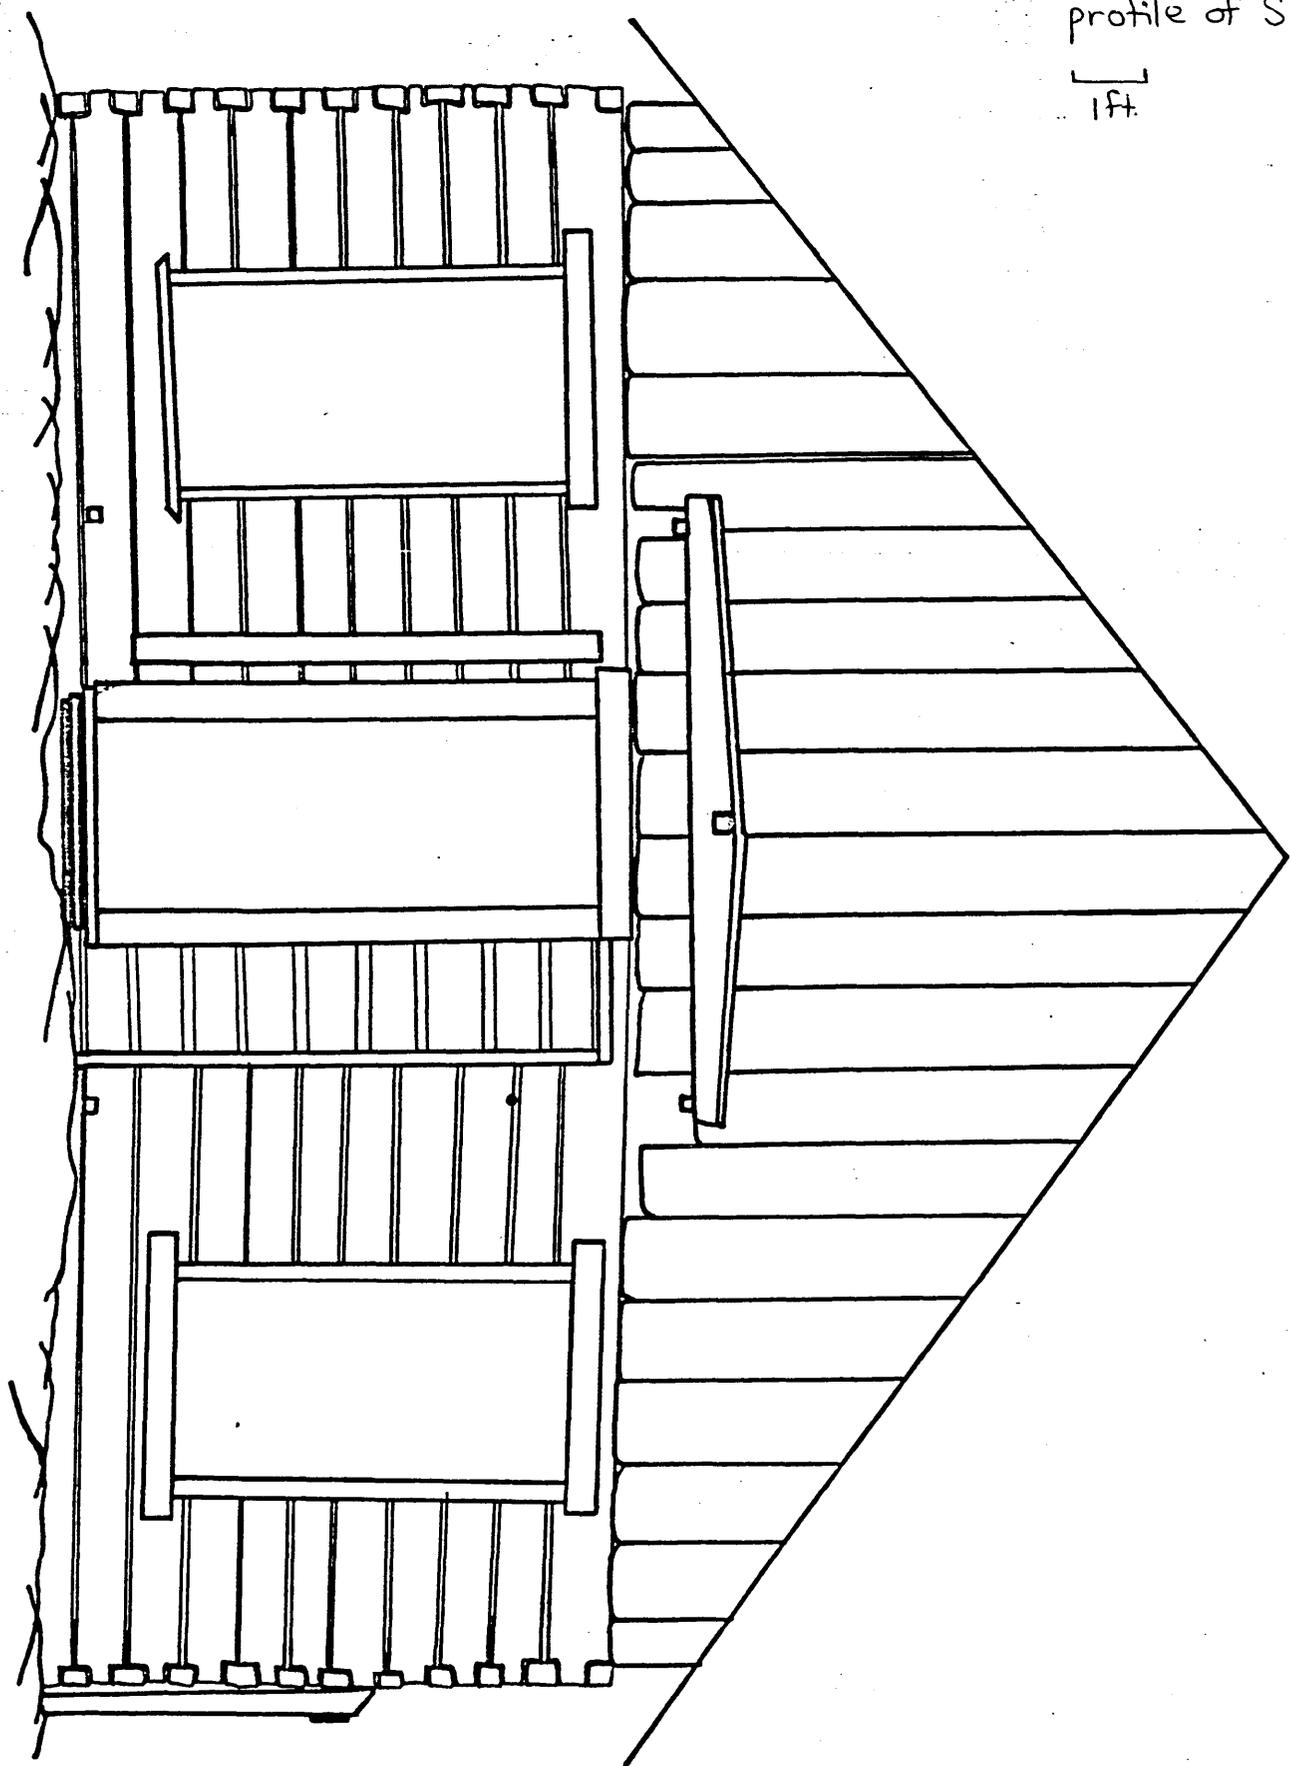
SL-86
Structure 9
profile of S wall

The building is in fairly good condition, but about 40% of the roof shingles are missing, the west wall is bowed in, and there is some settling along the north wall.

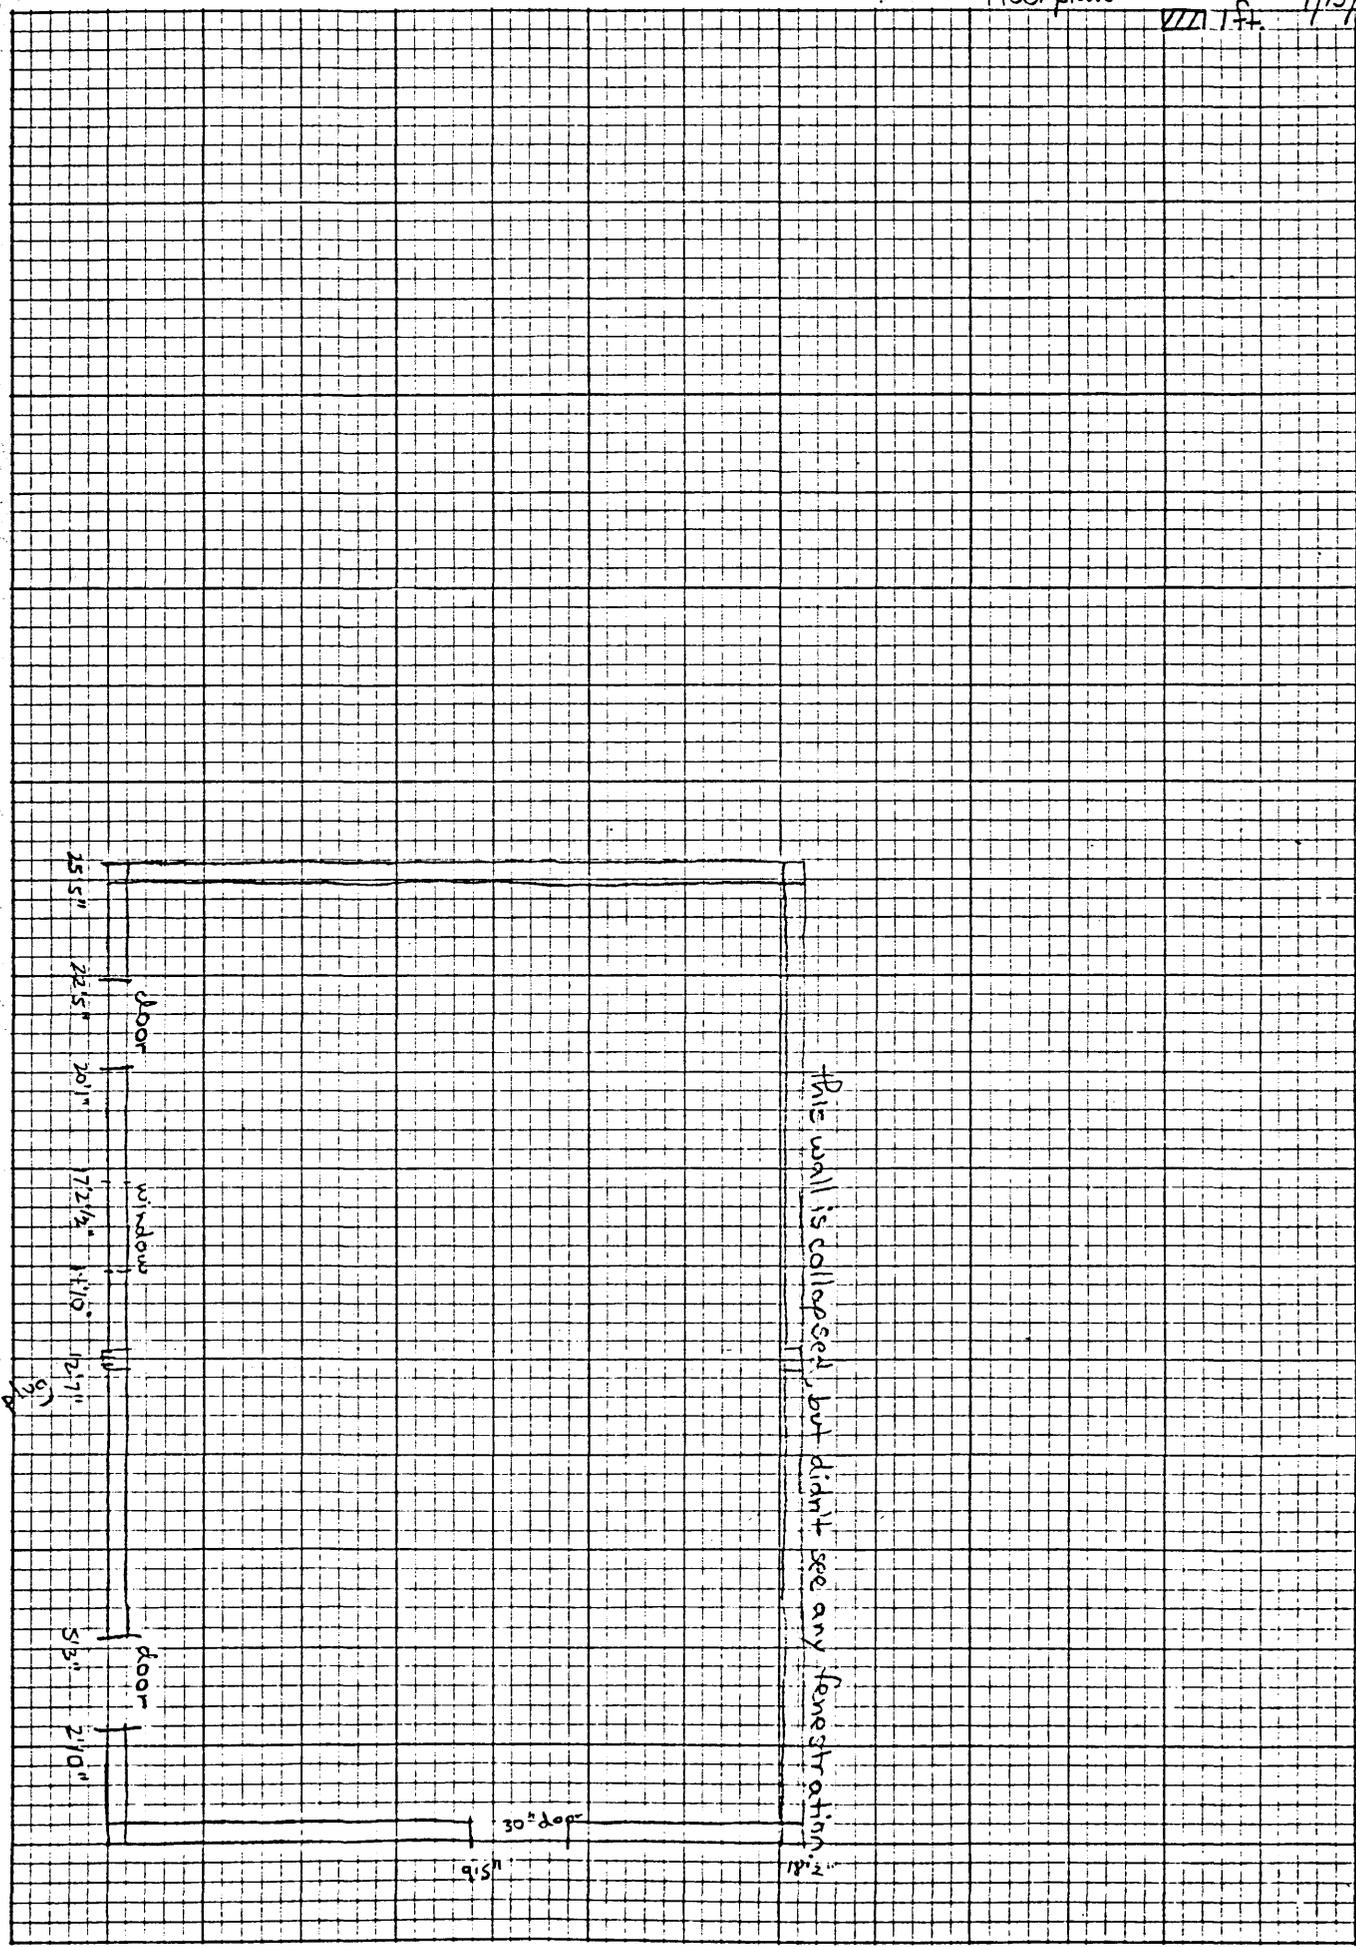
Structure 15
floorplan
7/15/82

Summary (1-2 sentences about function, form, condition): This house is in a terrible state with the roof and east wall collapsed, the whole thing leaning to the east, and a spring running through the middle of it. It is a square-notch log structure.

Identify defects to both primary (walls, roof) and secondary (porch, doors, windows) as slight, minor, major, critical, ruin. Specify deterioration. This feature is a mess. The roof is almost completely collapsed; the walls are falling or have fallen. There is green water standing on the floor rotting the wood. Napias Mining Co. dug a ditch right in front of the building and the dirt next to and underneath F-15 is slumping, further weakening the structure.

This wall is collapsed, but didn't see any fenestration.

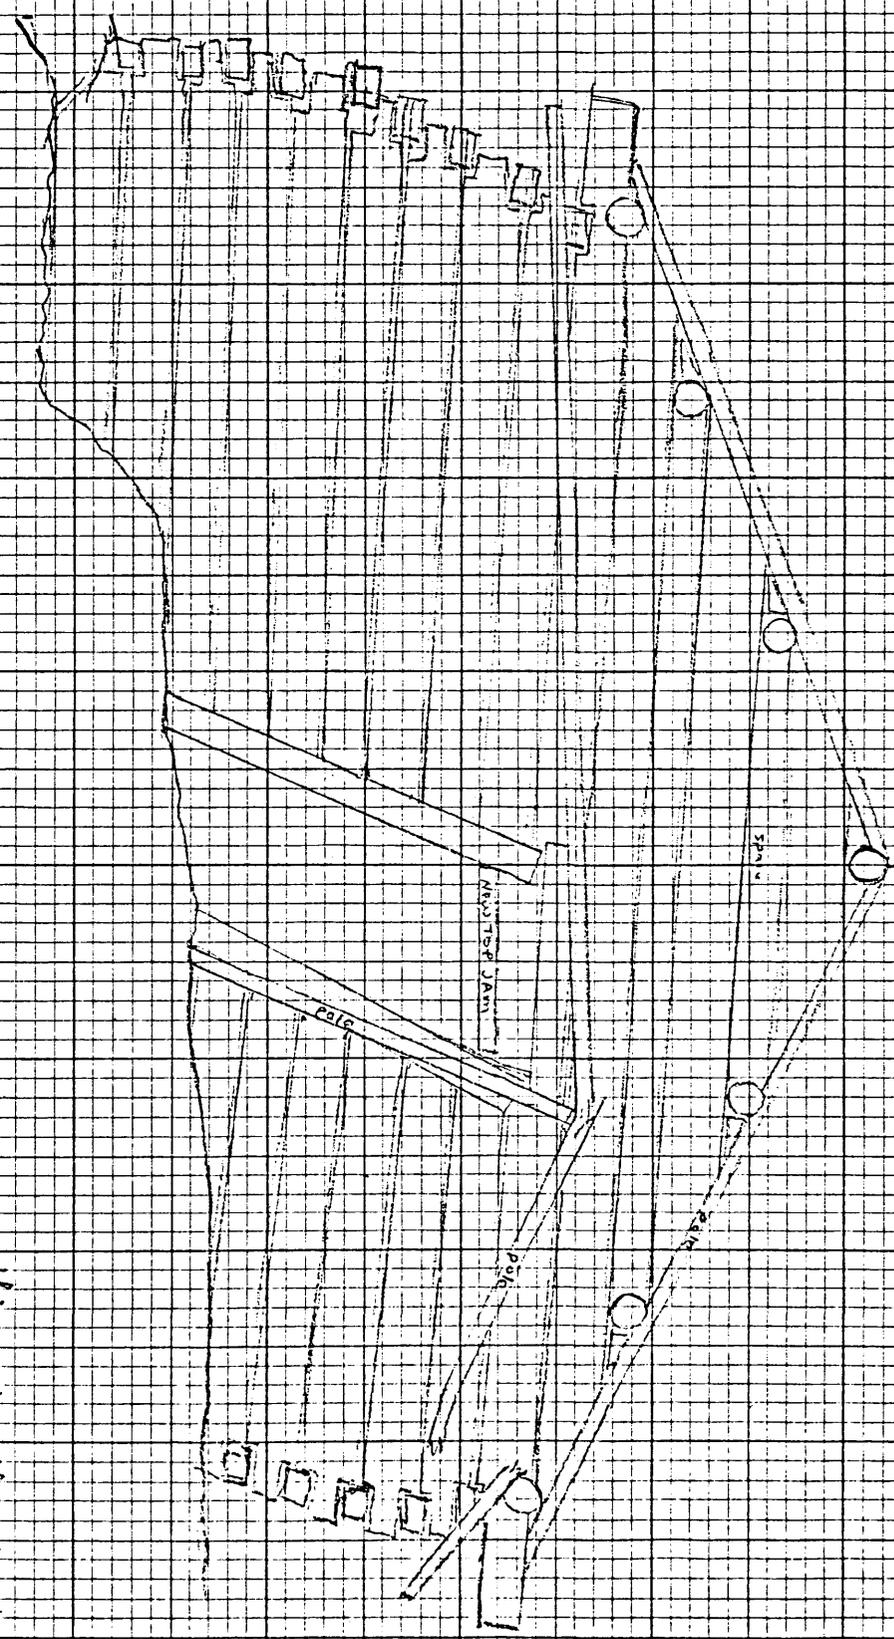
Structure 15
profile of south wall
7/10/82 11111 1ft.

this makes the structure
look better than it really is.
refer to photograph for true

state of affairs.

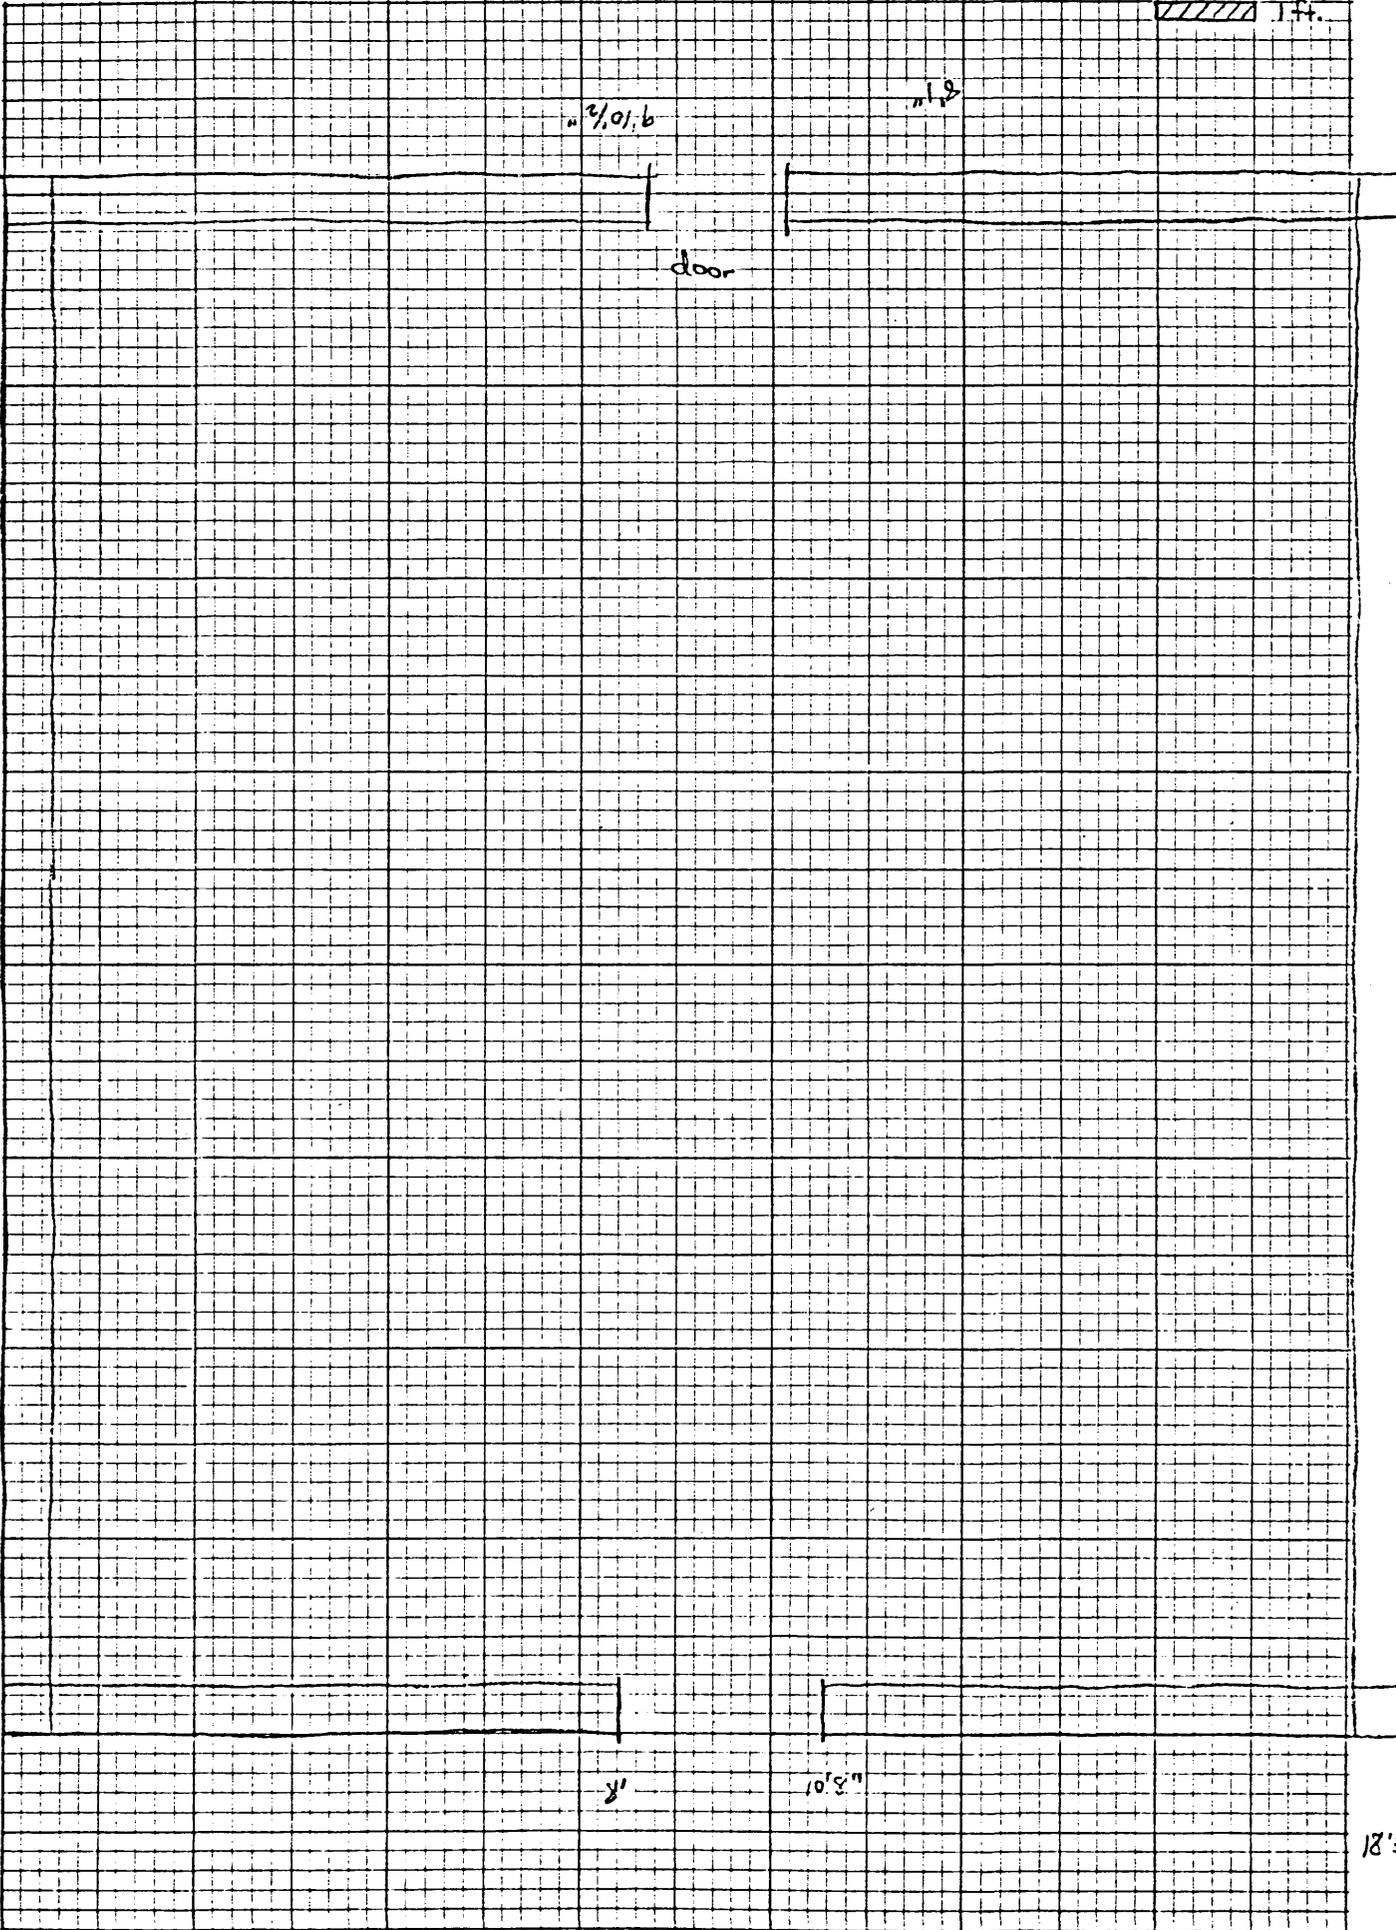
Structure 16
floor plan 7/15/82

Summary (1-2 sentences about function, form, condition): This is a partially collapsed log structure that Alice Mahoney used as a springhouse. It has 2 doors but no windows. The building is in poor condition. It presently stands in the meadow just above the water table.

Identify defects to both primary (walls, roof) and secondary (porch, doors, windows) as slight, minor, major, critical, ruin. Specify deterioration. The roof has collapsed and the walls are partially collapsed. Bottom logs are rapidly deteriorating because of the high water table. The fire that charred some of the interior logs doesn't appear to have done much damage. The doors are gone.

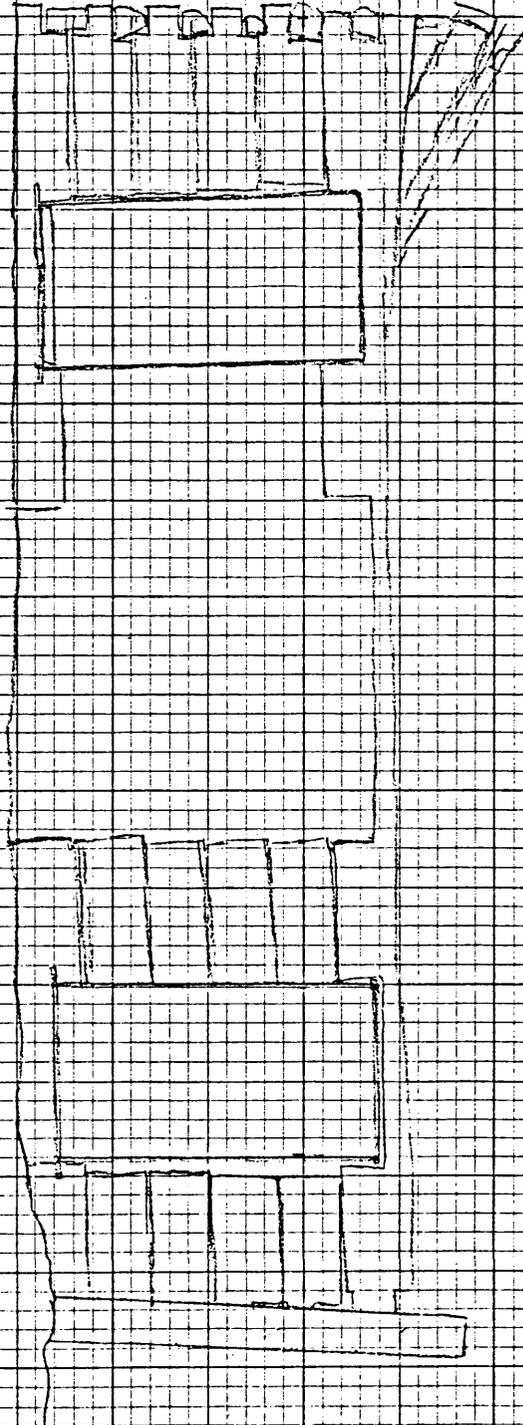
Structure 18
profile of north wall 7/20/82

Summary (1-2 sentences about function, form, condition): F-18 is a log and board structure w/square notched corners. It consists of 2 rooms, the south room apparently an addition. The roof and more than half of the wall logs have collapsed. The feature was the bunkhouse part of Alice Mahoney's hotel during about the first third of the 20th century.

Identify defects to both primary (walls, roof) and secondary (porch, doors, windows) as slight, minor, major, critical, ruin. Specify deterioration. Roof totally collapsed, walls in second room 0-3 logs high, walls in front room faring better w/most of N and E walls still standing. Only 1 window frame remains intact..

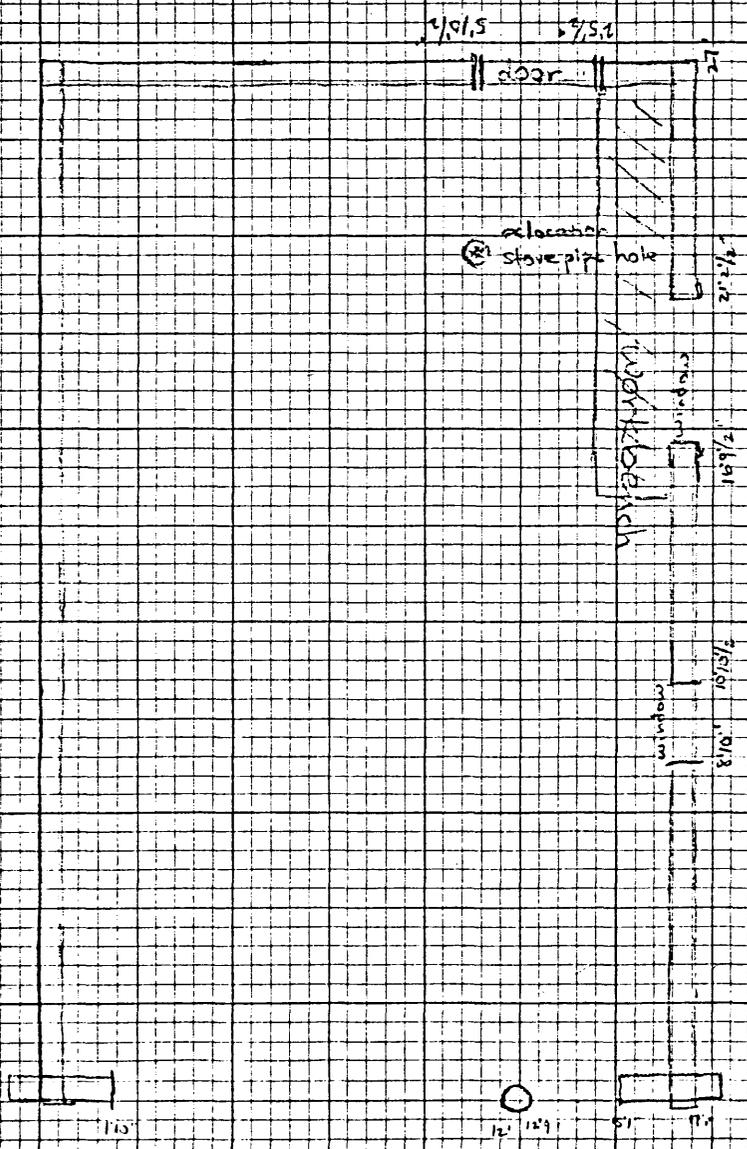
structure du
floor plan du 7/20/82
1/16" = 1 ft.

Summary (1-2 sentences about function, form, condition): Structure 20 is a workshop that used to be the butcher shop. It is in fairly good condition but, when the west wall collapses as it threatens to do any time now, the building will rapidly deteriorate.

Identify defects to both primary (walls, roof) and secondary (porch, doors, windows) as slight, minor, major, critical, ruin. Specify deterioration. The west wall is threatening to collapse, despite someone's effort to save it by bracing logs up against it on the outside. Other walls are in pretty good condition. The floor is a mess, maybe 1/4 of the floor planks remain. The roof is in good condition compared to those on most of the other buildings in Leesburg. One window minus glass is all that remains of the doors and windows.

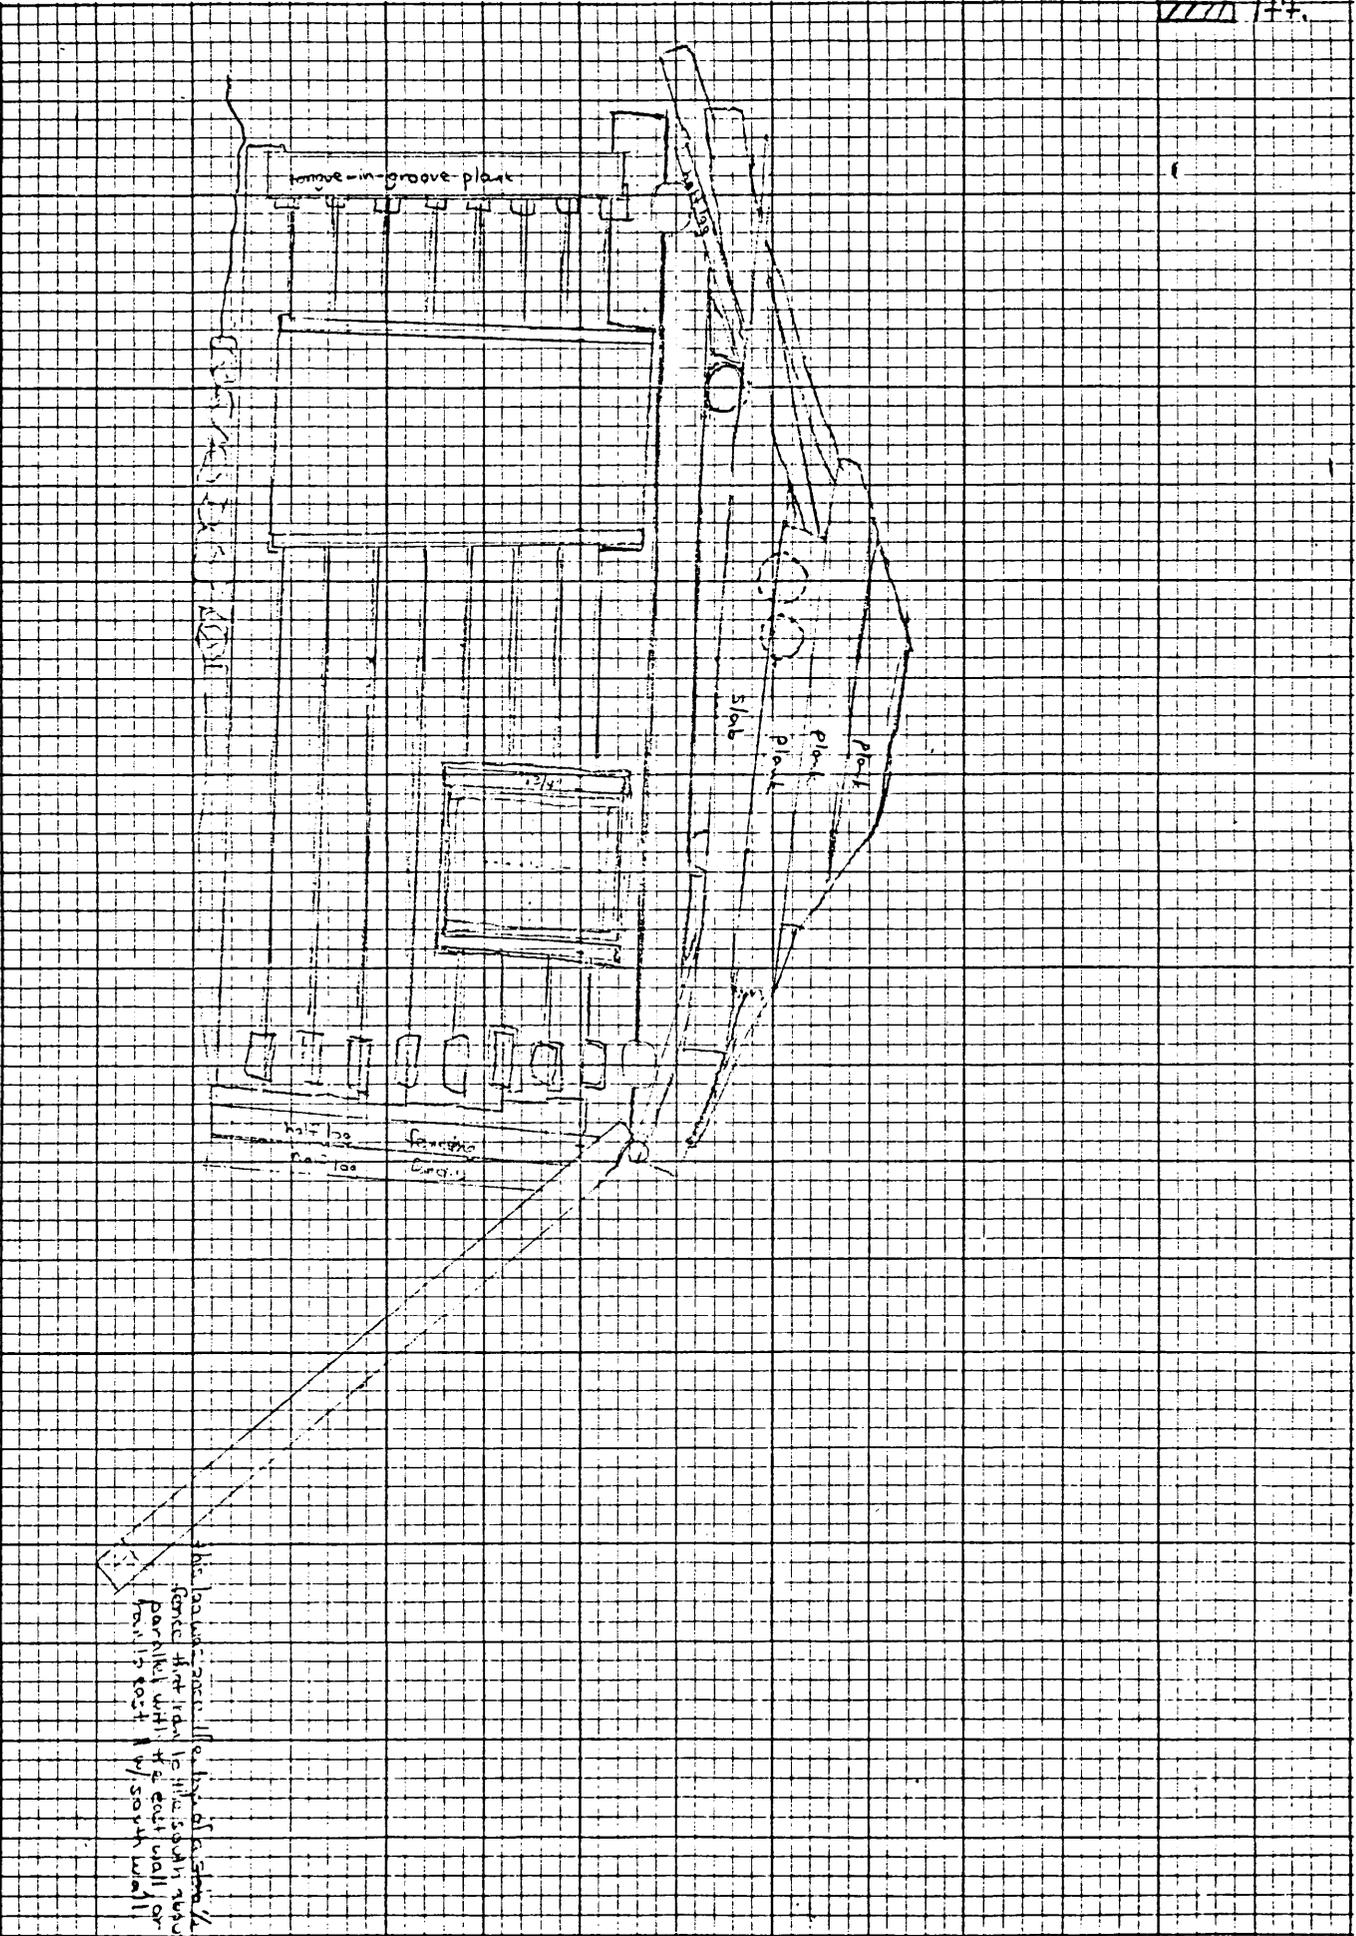
Structure 21
profile of south wall 7/22/8

Summary (1-2 sentences about function, form, condition): This structure was a chicken house that was later converted to a small horse or cow barn (I think). It is in very good condition. It is built of logs square notched at the corners.

Identify defects to both primary (walls, roof) and secondary (porch, doors, windows) as slight, minor, major, critical, ruin. Specify deterioration. The top layer of the roof is deteriorating. The rest of the roof and the walls are in very good condition. The floor is a mess, it is rotting and torn up by someone or something.

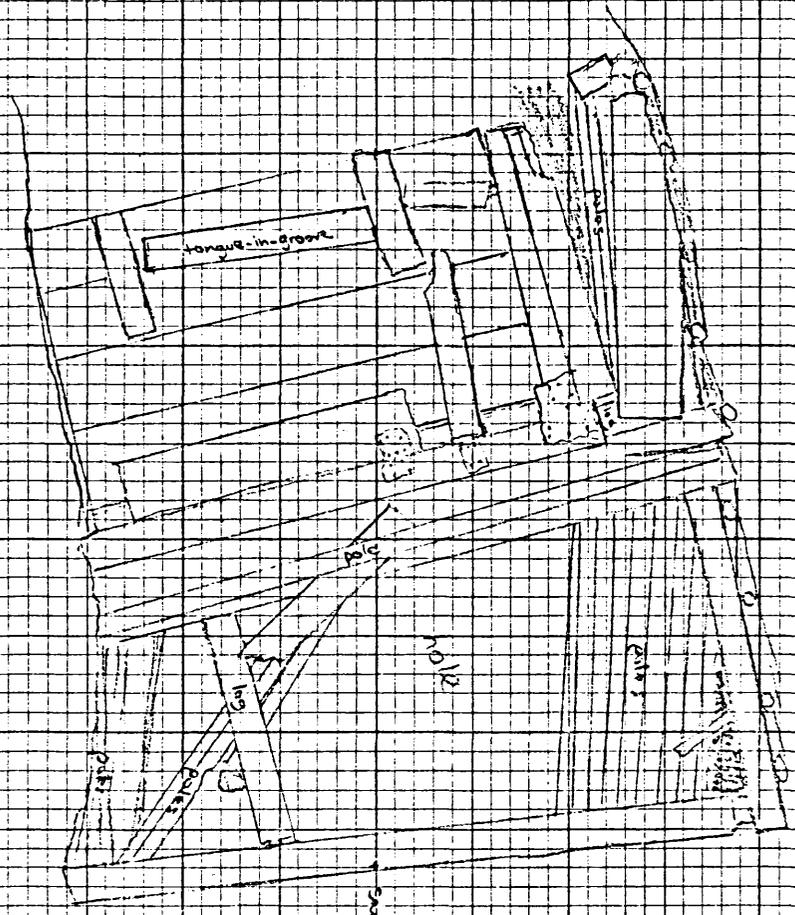
Structure 23
profile of N side 7/22/32

Summary (1-2 sentences about function, form, condition): This was a horse barn made of logs. The logs are steeple notched. The barn had a hay loft. The roof has collapsed and the east wall is partially collapsed and at a precarious tilt.
