INVENTORY SHEET FOR GROUP NOMINATIONS: IDAHO STATE HISTORICAL SOCIETY, BOISE, IDAHO

✓ NOMINATION: (Lava Rock Structures in South Central Idaho TR)

✓ SITE NAME: Keating, Clarence, House

SITE NUMBER: 47

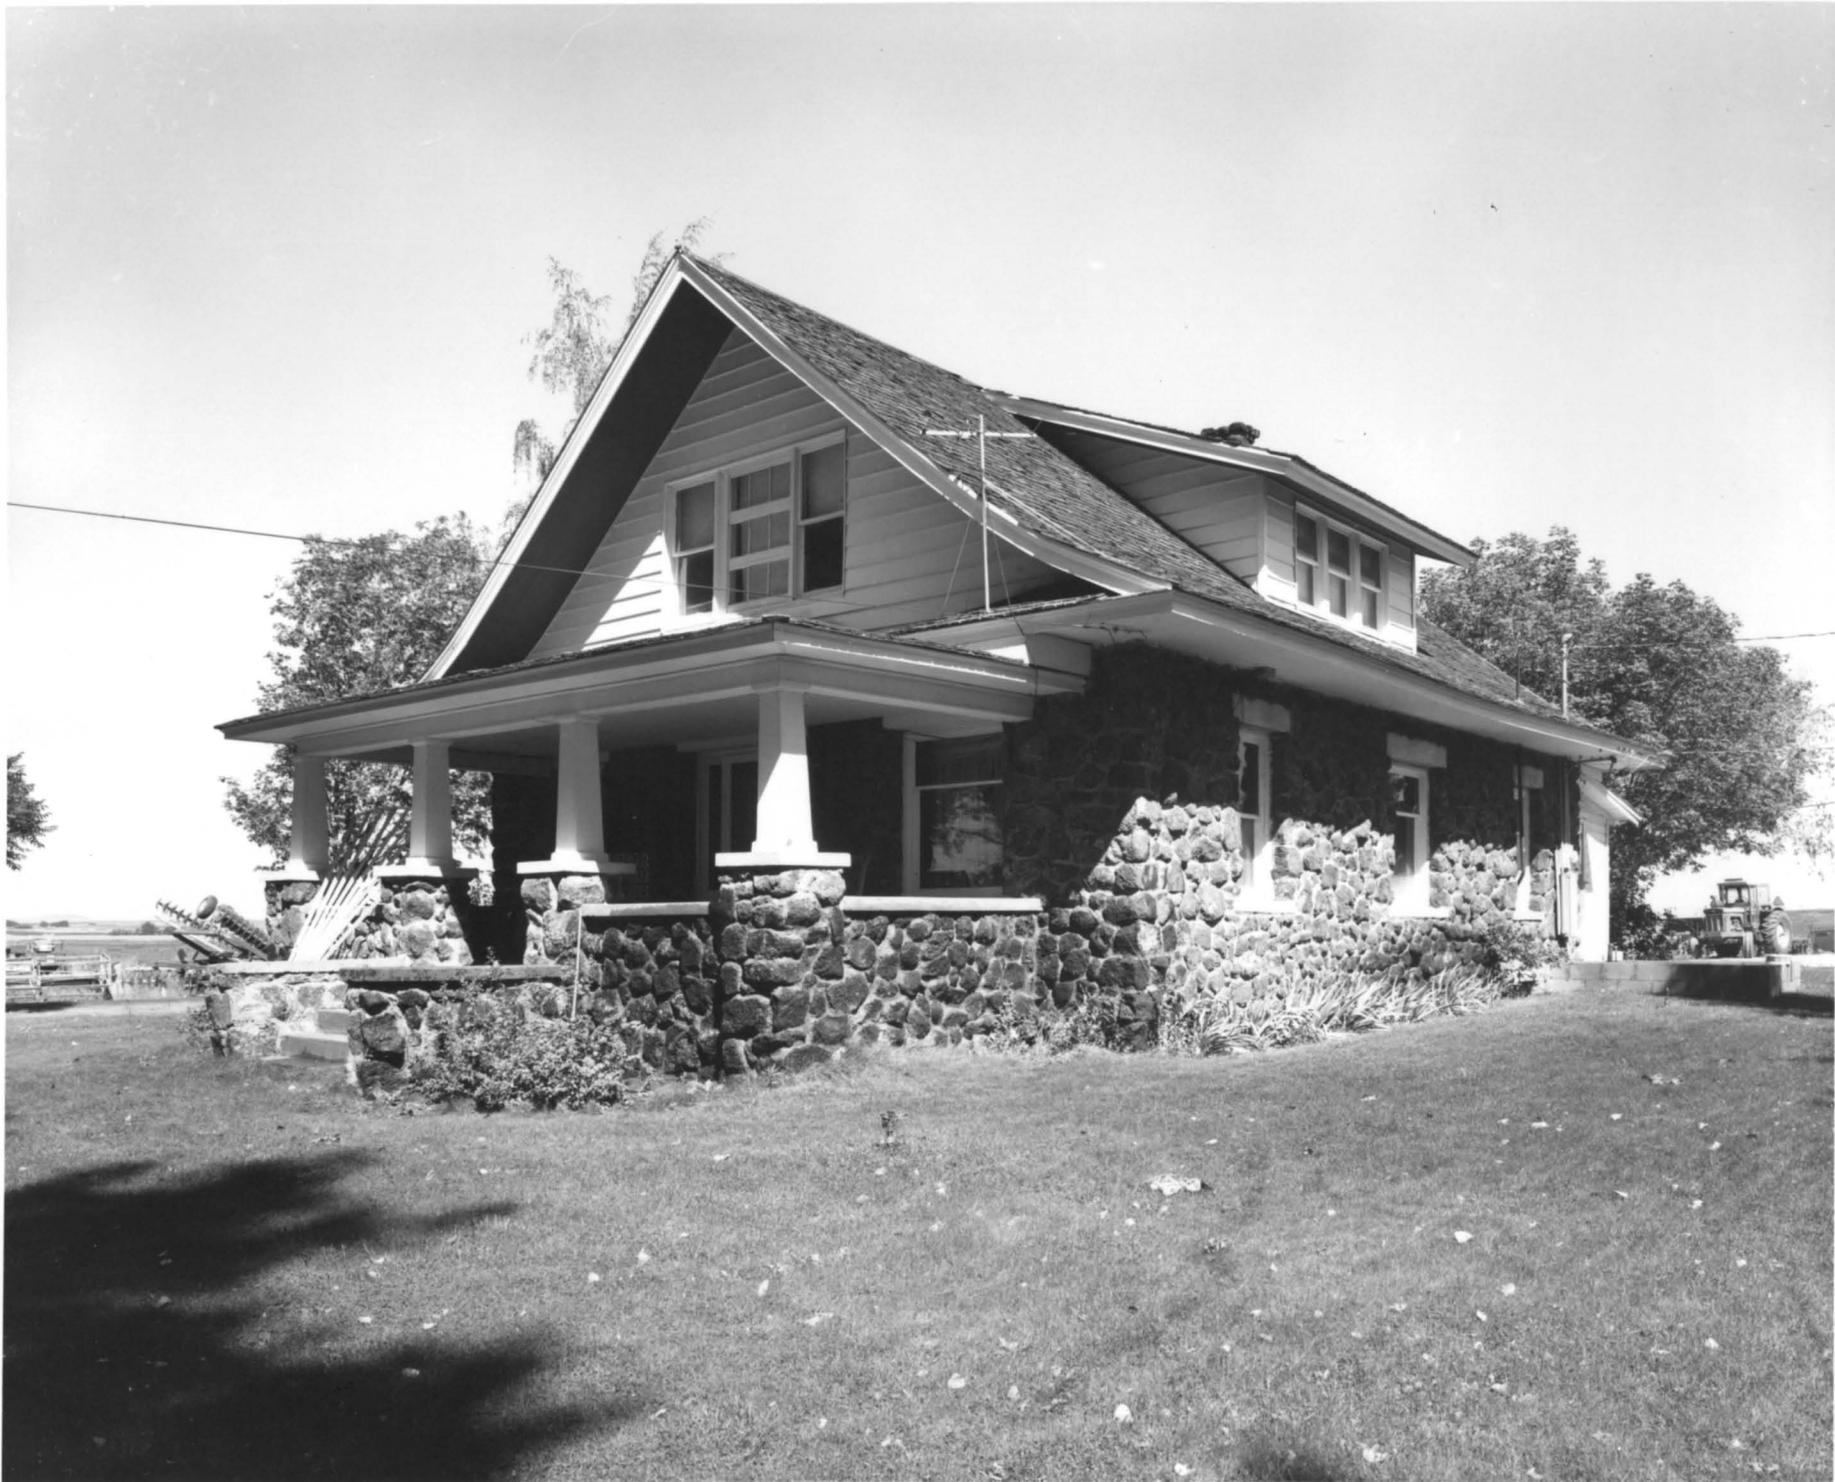
Photograph one of one

Lava Rock Structures in South Central Idaho  
Keating, Clarence, House, site 47

View from southwest
