INVENTORY SHEET FOR GROUP NOMINATIONS: IDAHO STATE HISTORICAL SOCIETY, BOISE, IDAHO

NOMINATION: (Lava Rock Structures in South Central Idaho TR)

SITE NAME: American Legion Hall

SITE NUMBER: 87

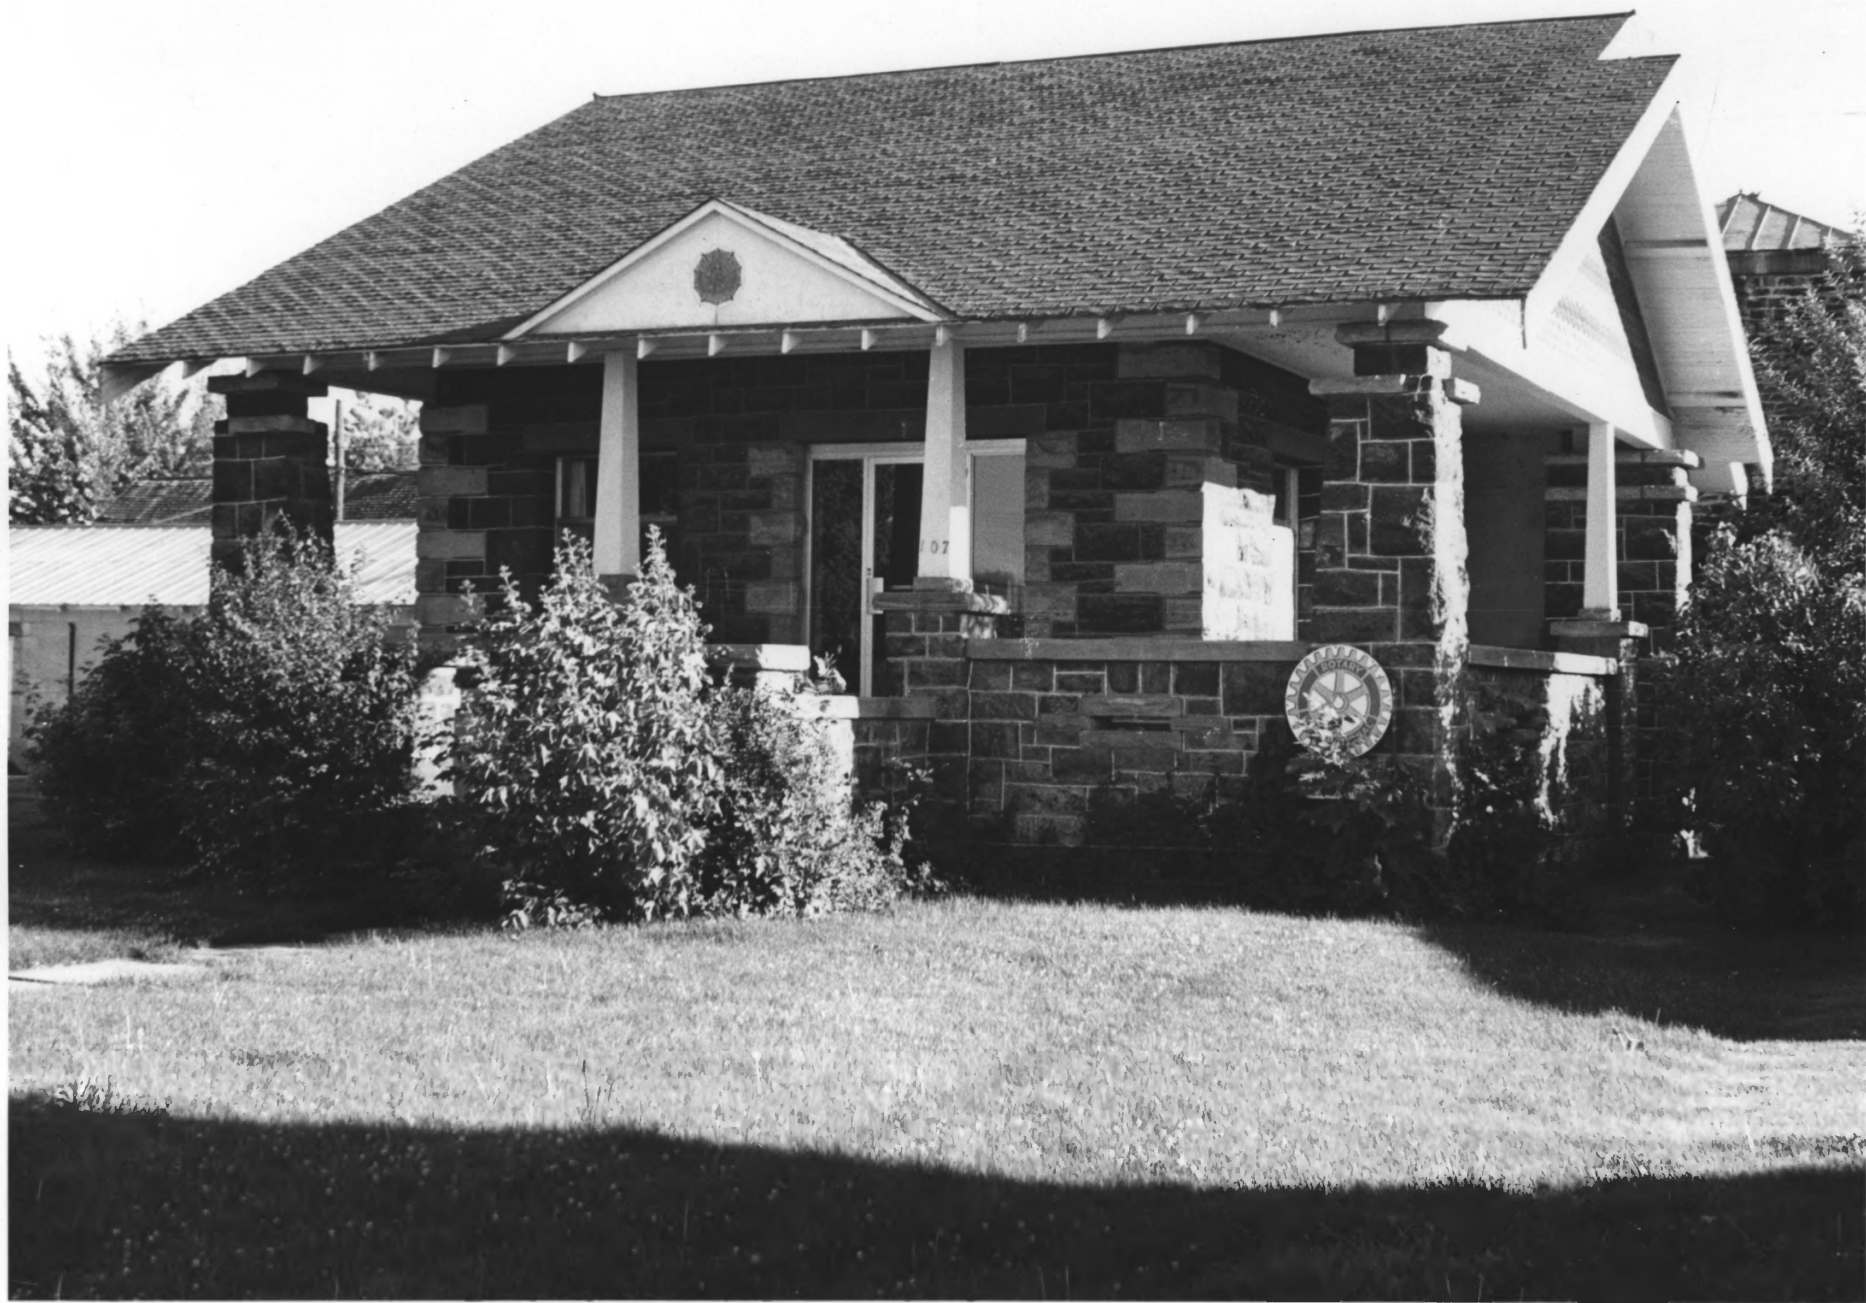
Photograph one of one

Lava Rock Structures in South Central Idaho  
American Legion Hall, site 87

View from north

The tall one-story American Legion Hall is approximately 44 by 36 feet. It has a basement and a gable roof with wide exposed eaves and plain bargeboards. The roofing material is dark green diamond-patterned composition shingles. Decorative shingles on the gables above the one-story stone walls have been painted red and green in wide courses. A gabled overdoor intersects the roof line above the centered entrance to the porch. A small round American Legion symbol is centered in its gable. The approximately eight-foot-wide porch is inset under the roof and wraps around the right corner as an outset porch across approximately two-thirds of the right wall. A third gable is above the side porch. The left side of its gable roof is continuous with the main roof, extending about three feet beyond the main roof. There are slightly battered stone columns outset from the high porch walls on each corner of the facade, with a narrower inset section about one foot tall at their top. There are piers raised about one foot above the porch walls on each side of the centered porch entrance and at the right corner of the side porch. Tapered, square, wooden columns are on each pier. Sandstone is used for coping on the porch columns and outline water outlets at the porch floor. A concrete stoop with high stone walls and piers like those on the porch extends from the porch. The porch and stoop walls have narrow, slightly outset, concrete coping. There are sandstone quoins on each corner of the building and at the sides of the front door. This door has plain side lights. The window to the left of the door has a sandstone lintel and sill. Some of the windows on the side walls have sandstone

lintels and sills, while some have concrete lintels and sills. All of the windows are one-over-one double-hung sash. There are concrete steps leading down to an inset basement door at the right of the side porch. There is a concrete basin outside each of the basement windows. There is a plain wooden molding at the top of the walls and at the bottom of the side porch gable. The moldings and porch columns have been painted white. The broken coursed masonry of dressed stones has narrow nearly flush joints tooled to produce a beaded line that has been painted white. There is a concrete block addition approximately ten-by-fourteen feet with a shed roof offset to the right of the rear wall, which shelters the original rear entrance. A modern metal-framed door has been installed in the original front door opening.
