INVENTORY SHEET FOR GROUP NOMINATIONS: IDAHO STATE HISTORICAL SOCIETY, BOISE, IDAHO

✓ NOMINATION: (Lava Rock Structures in South Central Idaho ^{TR})
✓ SITE NAME: Berriochoa, Ignacio, Farm SITE NUMBER: 67
✓ LOCATION: ~~Approximately five miles northwest~~ ^{nw} of Dietrich, ~~Idaho~~ ^{vic.}
OWNER'S NAME AND ADDRESS: Payneco, Inc.
Box 299
Shoshone, ID 83352

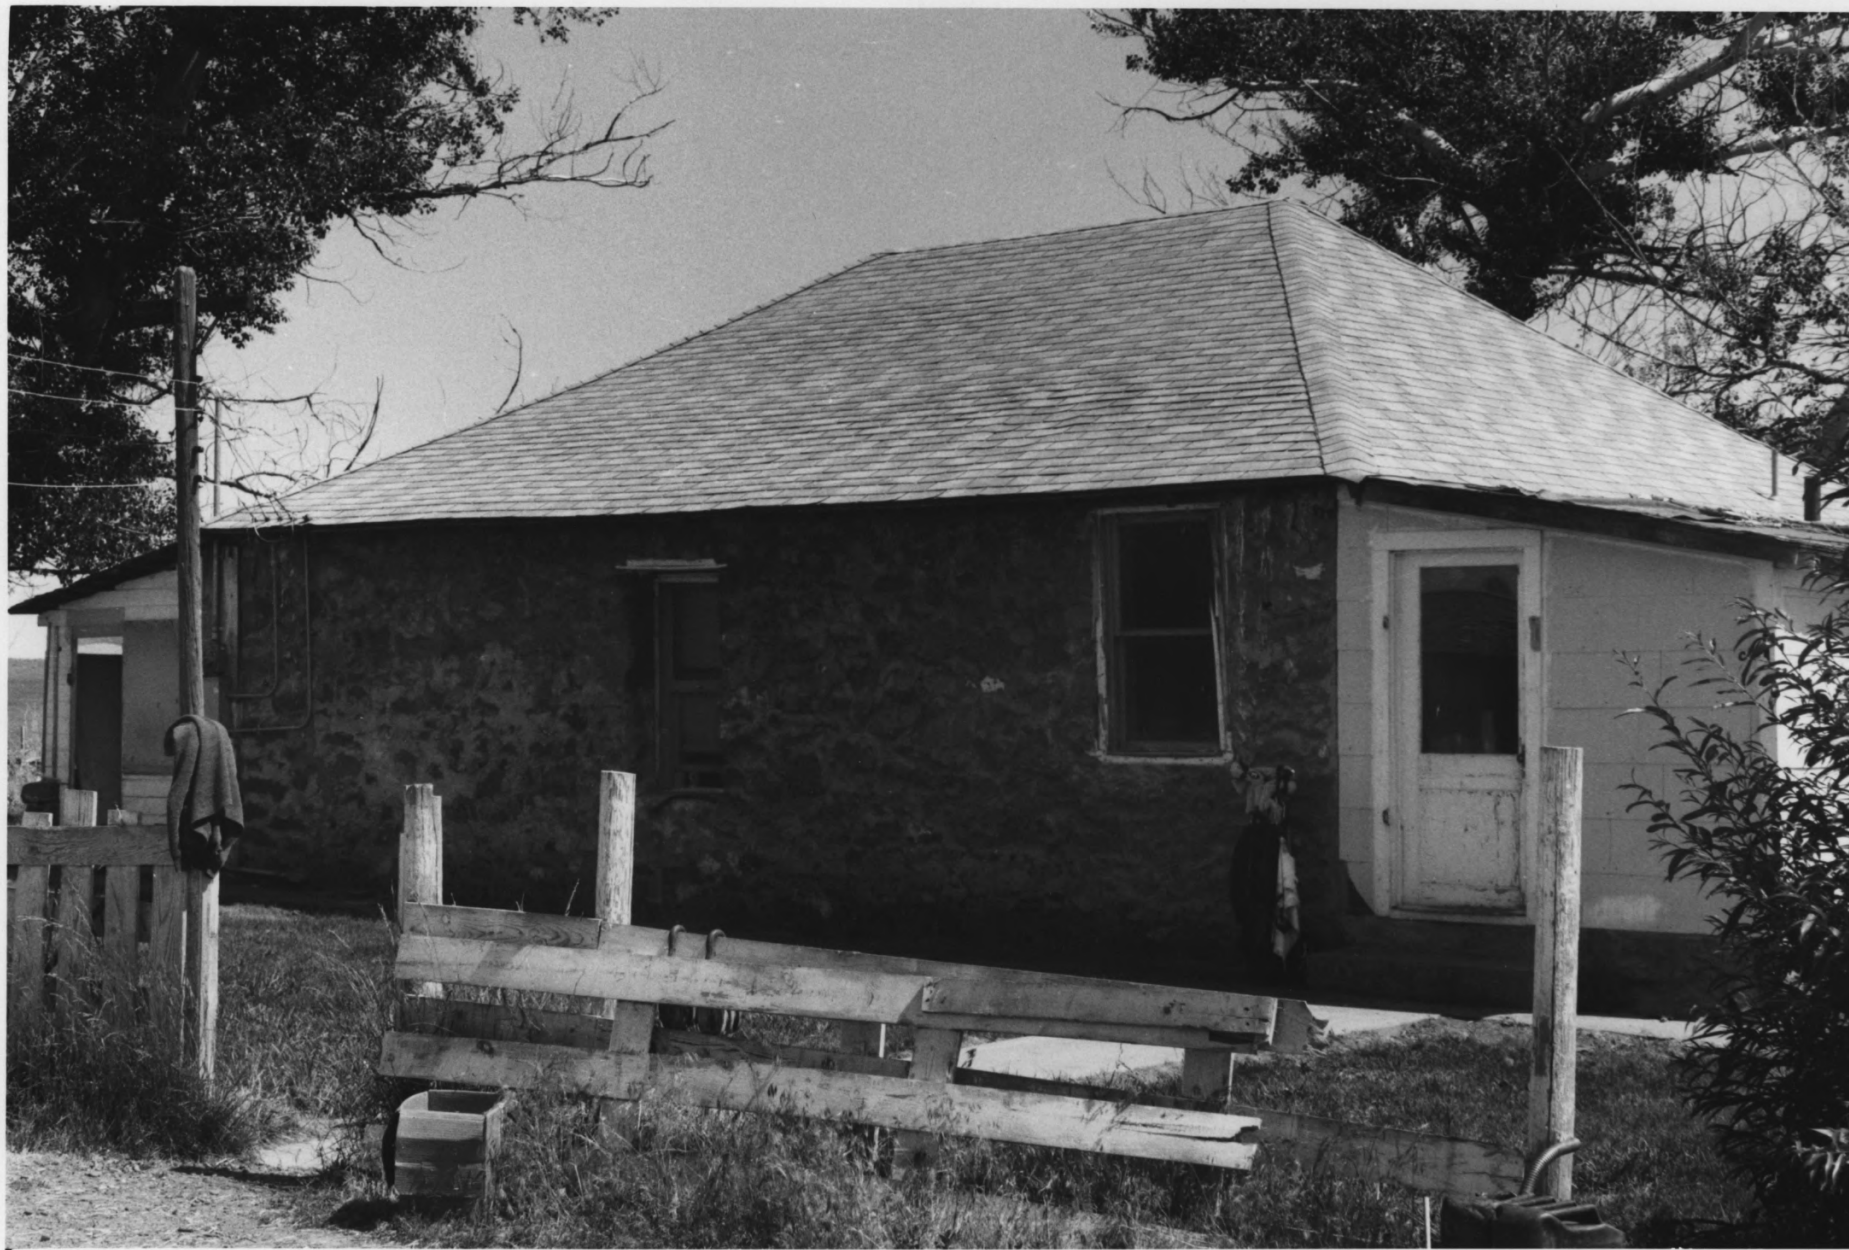
Photograph one of two

Lava Rock Structures in South Central Idaho
Berriochoa, Ignacio, Farm, site 67 (house)

View from northwest

House: The approximately 26-by-36-foot one-story, hip-roofed house has been extended on each end. A porch approximately eight feet wide is across the front, the narrow dimension of the house. A full frame addition about nine feet wide is across the rear, making the house almost 50 feet long. Shingled, shed roofs, beginning just below the narrow eaves of the shingled main roof, shelter the porch and the addition. The space above the stone porch walls have been enclosed with wooden framed windows, plywood, and other materials. The rubble walls have sand-colored mortar in their medium-width untooled joints. Double-hung windows are set almost at the outside of the walls. They have wooden lintels. The stone outside the window is covered with mortar.

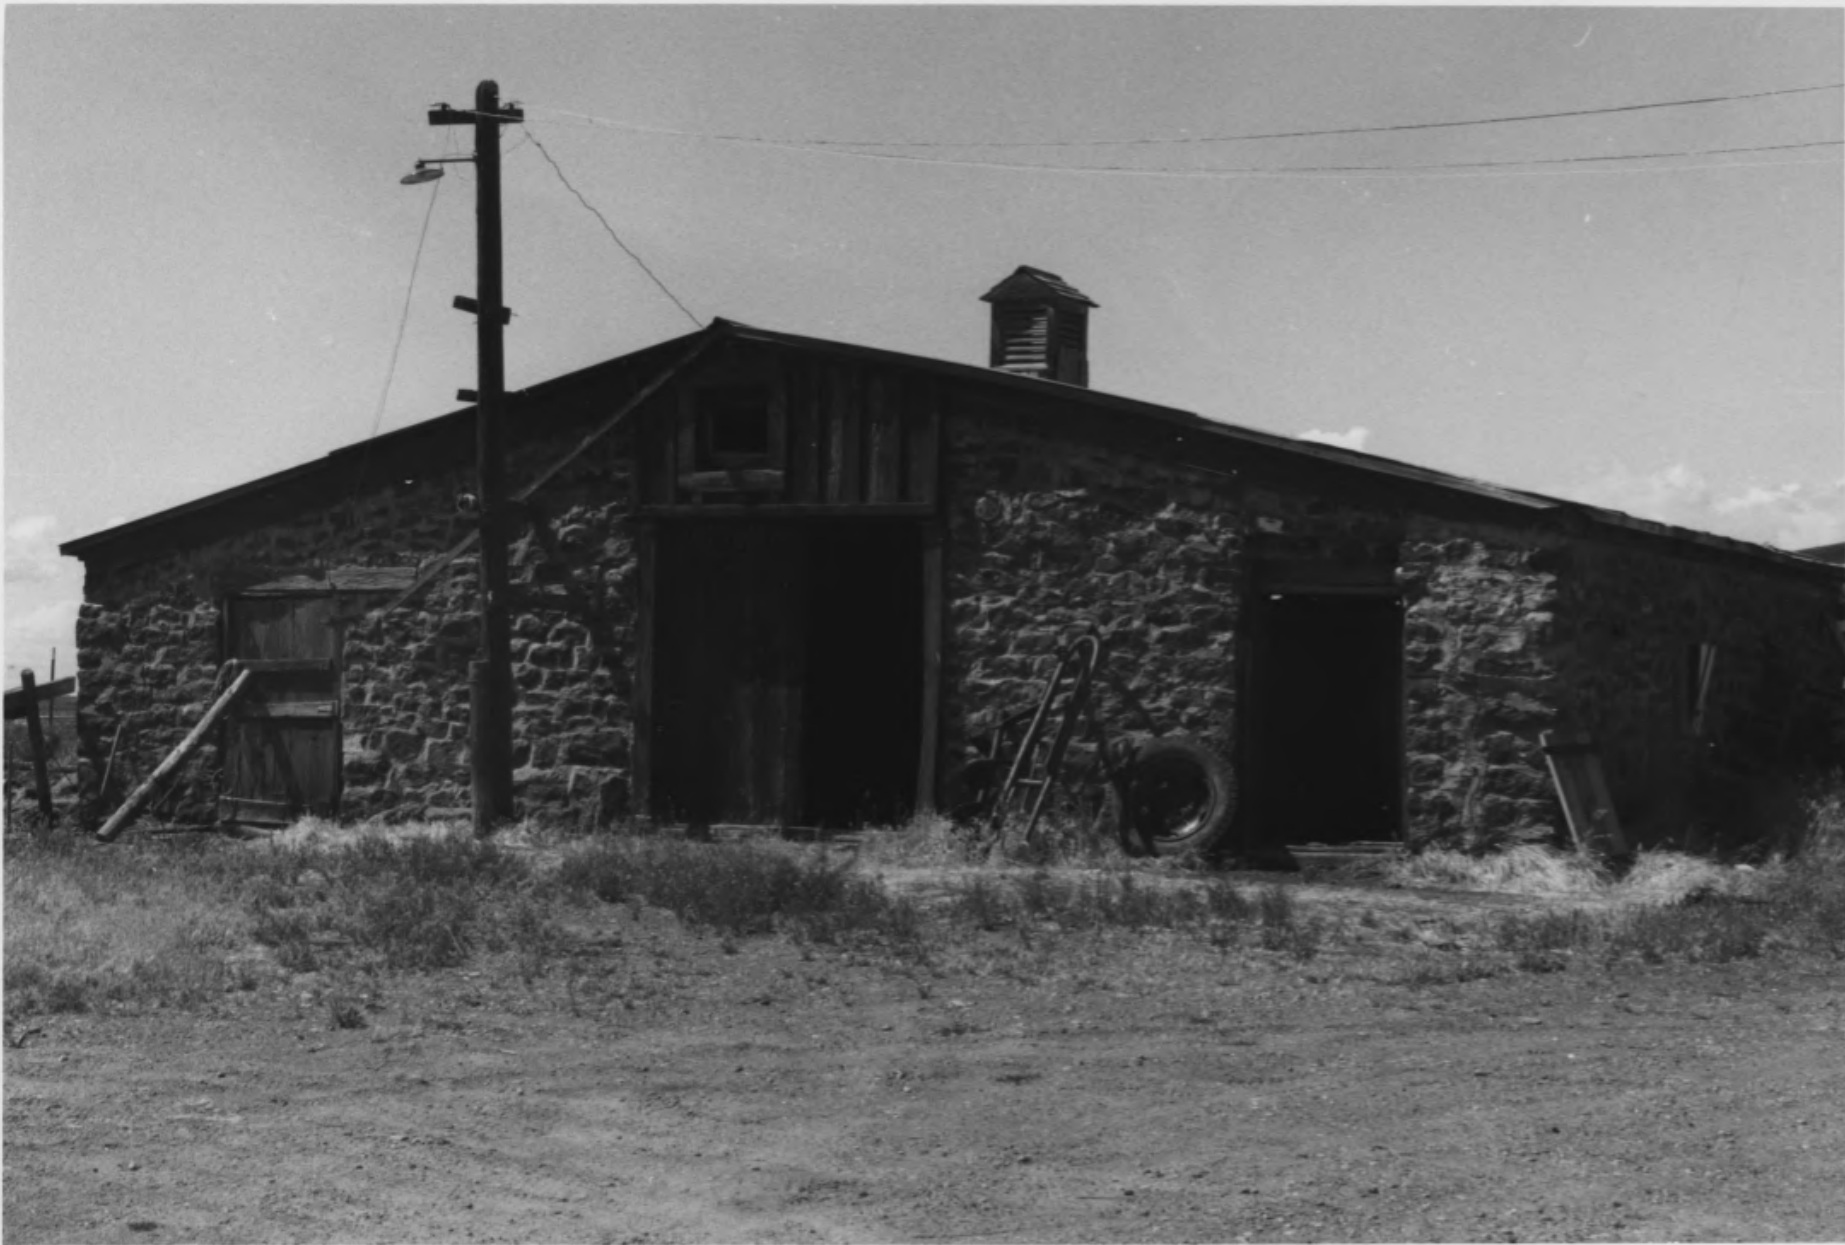
Photograph two of two

Lava Rock Structures in South Central Idaho
Berriochoa, Ignacio, Farm, site 67 (barn)

View from southeast

Barn: The approximately 30-foot-square barn has a shallow, uneven, shingled gable roof with narrow eaves. A small, square, wooden gable-roofed cupola is centered on the roofline. A double wooden door is offset slightly to the right on the gable facade. The space above the double door is board and batten. A small square window is below the peak of the gables. The coursed rubble walls have untooled, sand-colored mortar in the joints. A wooden plank used as a molding is at the top of each wall just below the eaves. A single wooden door is placed to the left of the facade and a slightly wider single is at the left. None of the details of the facade are symmetrically placed.
