## INVENTORY SHEET FOR GROUP NOMINATIONS: IDAHO STATE HISTORICAL SOCIETY, BOISE, IDAHO

NOMINATION: Historic Resources of Paris (Partial Inventory: Architecture)SITE NAME: Browning Block SITE # 74LOCATION: Southwest corner Main and Center, <sup>St.</sup> Paris, IdahoOWNER'S NAME AND ADDRESS: James Hawkes, Paris, Idaho, 83261QUADRANGLE AND SCALE: Paris, 7.5 minute ACREAGE: less than oneVERBAL BOUNDARY DESCRIPTION: Nomination includes the Browning Block and property on which it stands: fraction lots 9 and 10, block 17, Paris Townsite.UTM(S): 12/4, 66, 950/46, 74, 800DATE OR PERIOD: 1905, 1917 EVALUATED LEVEL OF SIGNIFICANCE: LocalAREAS OF SIGNIFICANCE: architecture, commerce

Browning Block, site #74

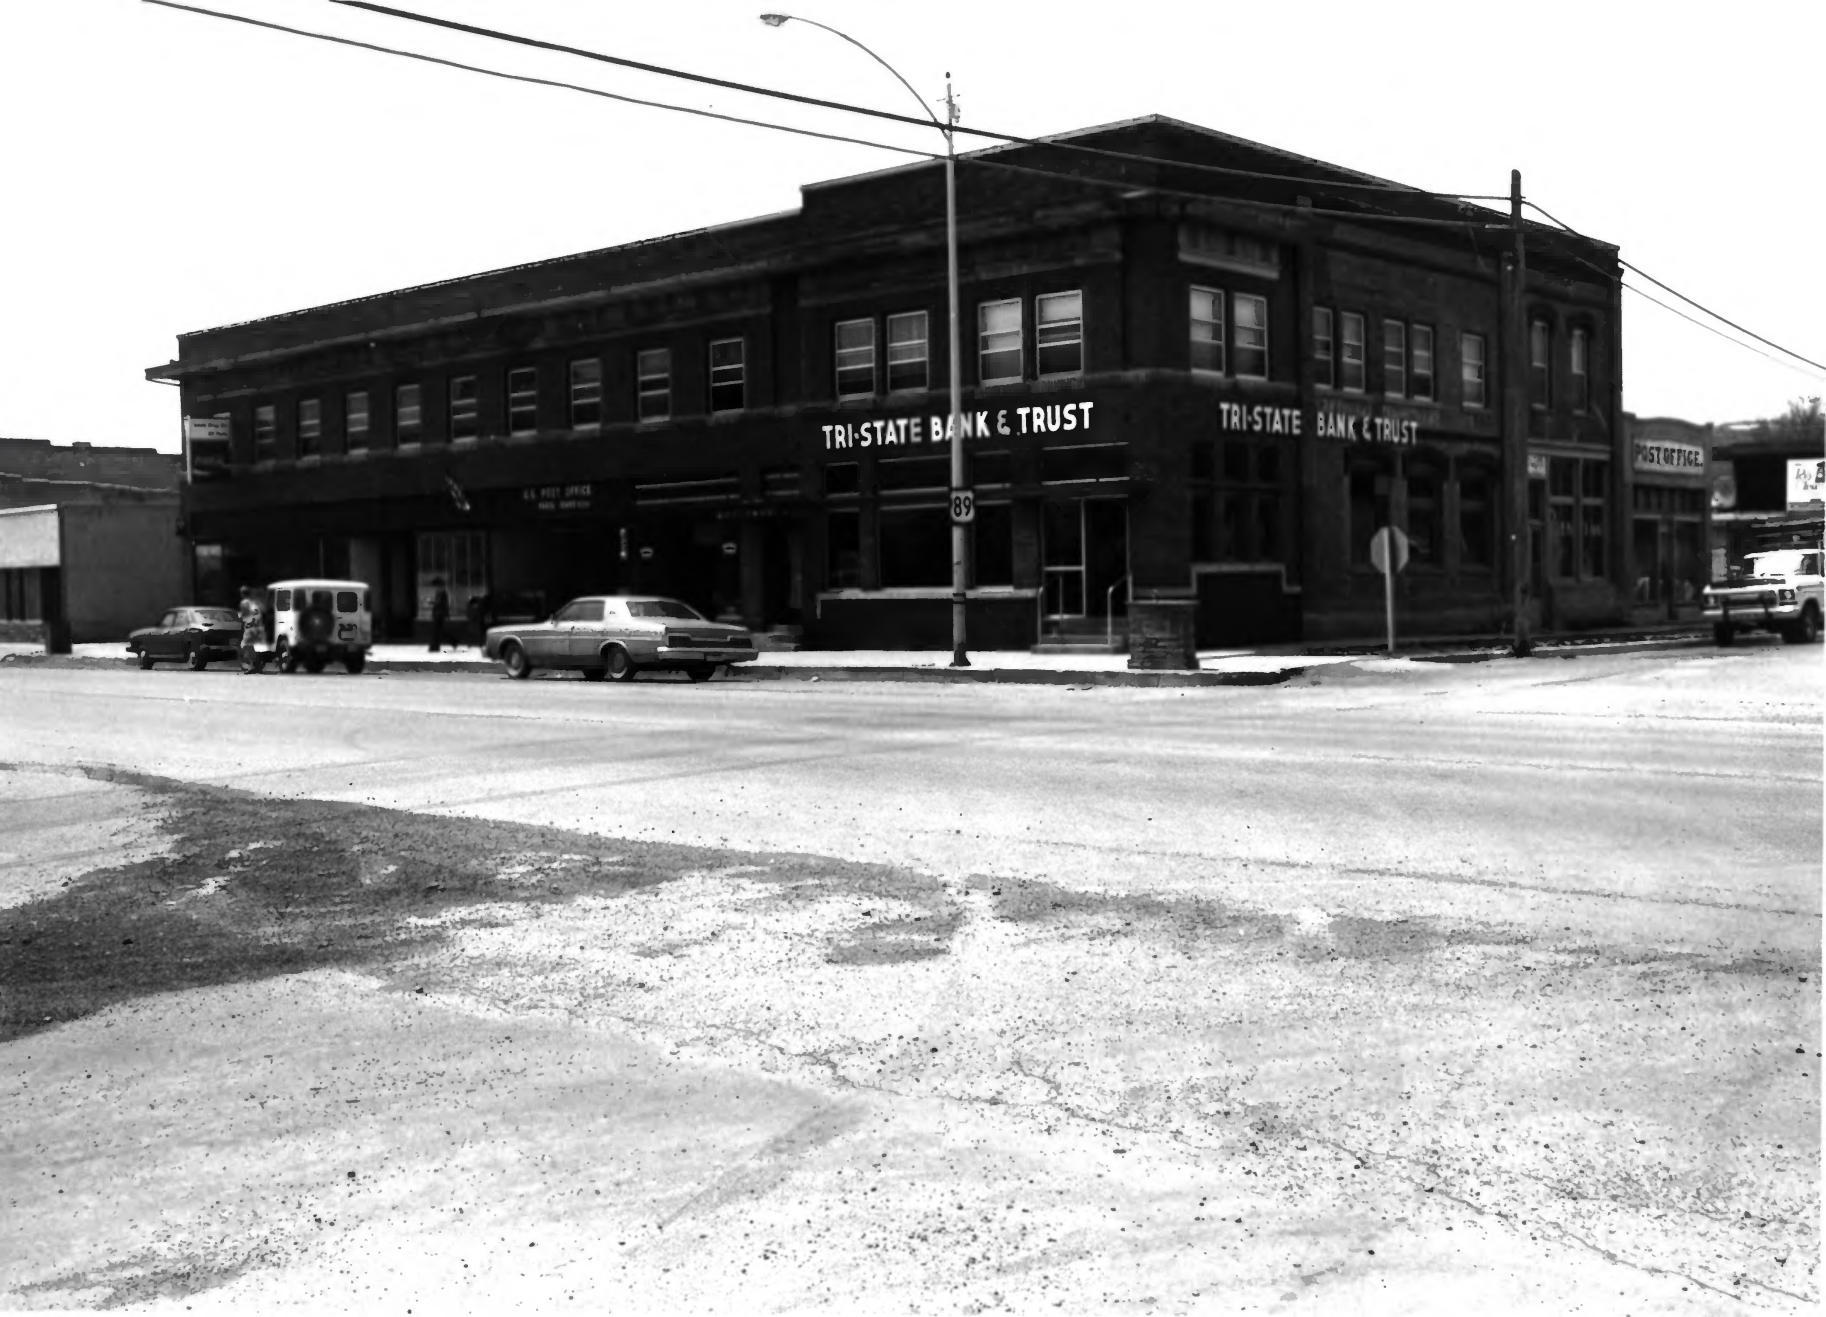
Photograph 1 of 1

The Browning Block is a two-story ell-shaped brick commercial structure, with a lateral block measuring about ninety-five feet along Main Street and an ell extending about seventy feet back along Center. Viewing the building from northern or oblique angles it is evident that an older structure, its segmentally-arched north elevation now facing Center Street, has been absorbed into the present building. The parapet of the earlier building has been built up and made continuous with that of the newer structure, which has been extended forward some dozen feet toward the corner. This composite corner section contains the local bank and is the most prominent part of the building. The structure continues under a lower parapet approximately seventy feet to the south. This section contains a row of first floor shopfronts and second-story office space.

The fabric of the Main Street facade is red-brown brick. A galvanized iron cornice and frieze of bars and discs, below the parapet and above the second story windows, runs the width of the building and back to the earlier structure on Center. The windows are in two pairs on the bank section of the facade. They are evenly spaced and ten in number above the shopfronts. The windows are little elaborated; they are square-headed, capped with triple and framed with double outset header courses. A slightly projecting course of end-set bricks runs immediately under the window line. Between this and the shopfronts is a broad unelaborated band of brick masonry.

View from northeast
