## INVENTORY SHEET FOR GROUP NOMINATIONS: IDAHO STATE HISTORICAL SOCIETY, BOISE, IDAHO

NOMINATION: Historic Resources of Challis (Partial Inventory: Architectural Properties)SITE NAME: Thomas Chivers House SITE # 10LOCATION: Challis Creek Road, Challis, IdahoOWNER'S NAME AND ADDRESS: Charles and Sylvia Pfeiffer, Box 642, Challis, IdahoQUADRANGLE AND SCALE: Challis 15 minute ACREAGE: less than oneVERBAL BOUNDARY DESCRIPTION: The nomination includes the Thomas Chivers House and the property on which it stands, T-847.UTM(S): 11/7,20,100/49,31,750DATE OR PERIOD: ca. 1910-12 EVALUATED LEVEL OF SIGNIFICANCE: localAREAS OF SIGNIFICANCE: architecture  
good condition unaltered original site

Thomas Chivers house, Site #10  
Challis Creek Road,  
Challis, Custer, Idaho

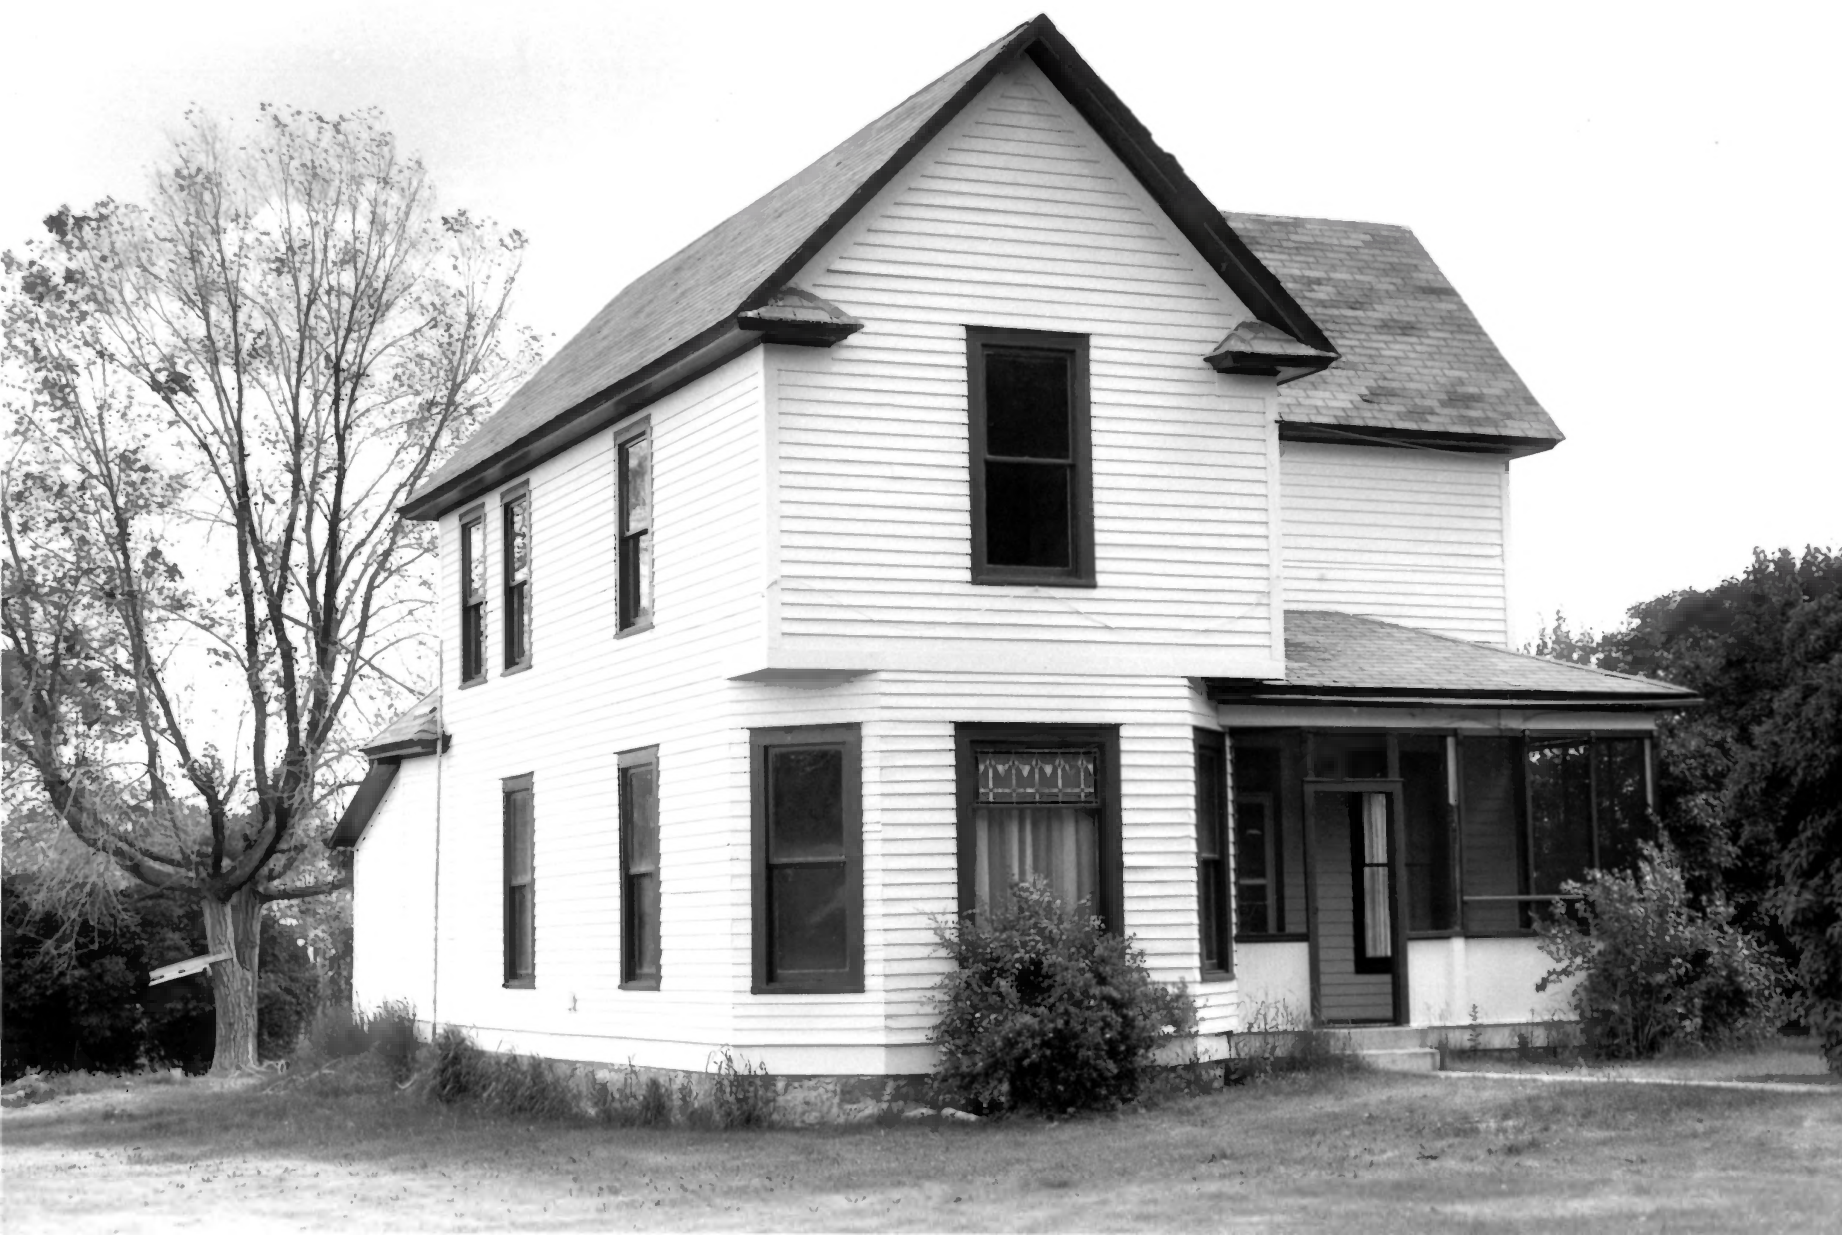
Photograph 1 of 1

Located on the northern edge of residential Challis, the Thomas Chivers House is a plain but large--for Challis--expression of the Queen Anne style with American colonial revival influences. The two-story cross gables have one-story extensions in the hipped front porch and a hipped addition that wraps around the rear of the building. The front door into the lateral gable has a large oval light; the front window of the forward bay, a stained glass light. The eaves and eave returns are enclosed and have a molded edge. The window heads are thinly molded. A surprising feature of the house is the rough-cut clapboards, which are painted buff with brown trim. The house has a mortared rock foundation.

View from Northwest
