NATIONAL REGISTER OF HISTORIC PLACES  
REGISTRATION FORM

historic name Fenn Ranger Station

city, town Kooskia / /vicinity

The Fenn Ranger Station, constructed by the Civilian Conservation Corps during the years 1937-1940, is the administrative complex out of which the Selway Ranger District of the Nez Perce National Forest is managed.

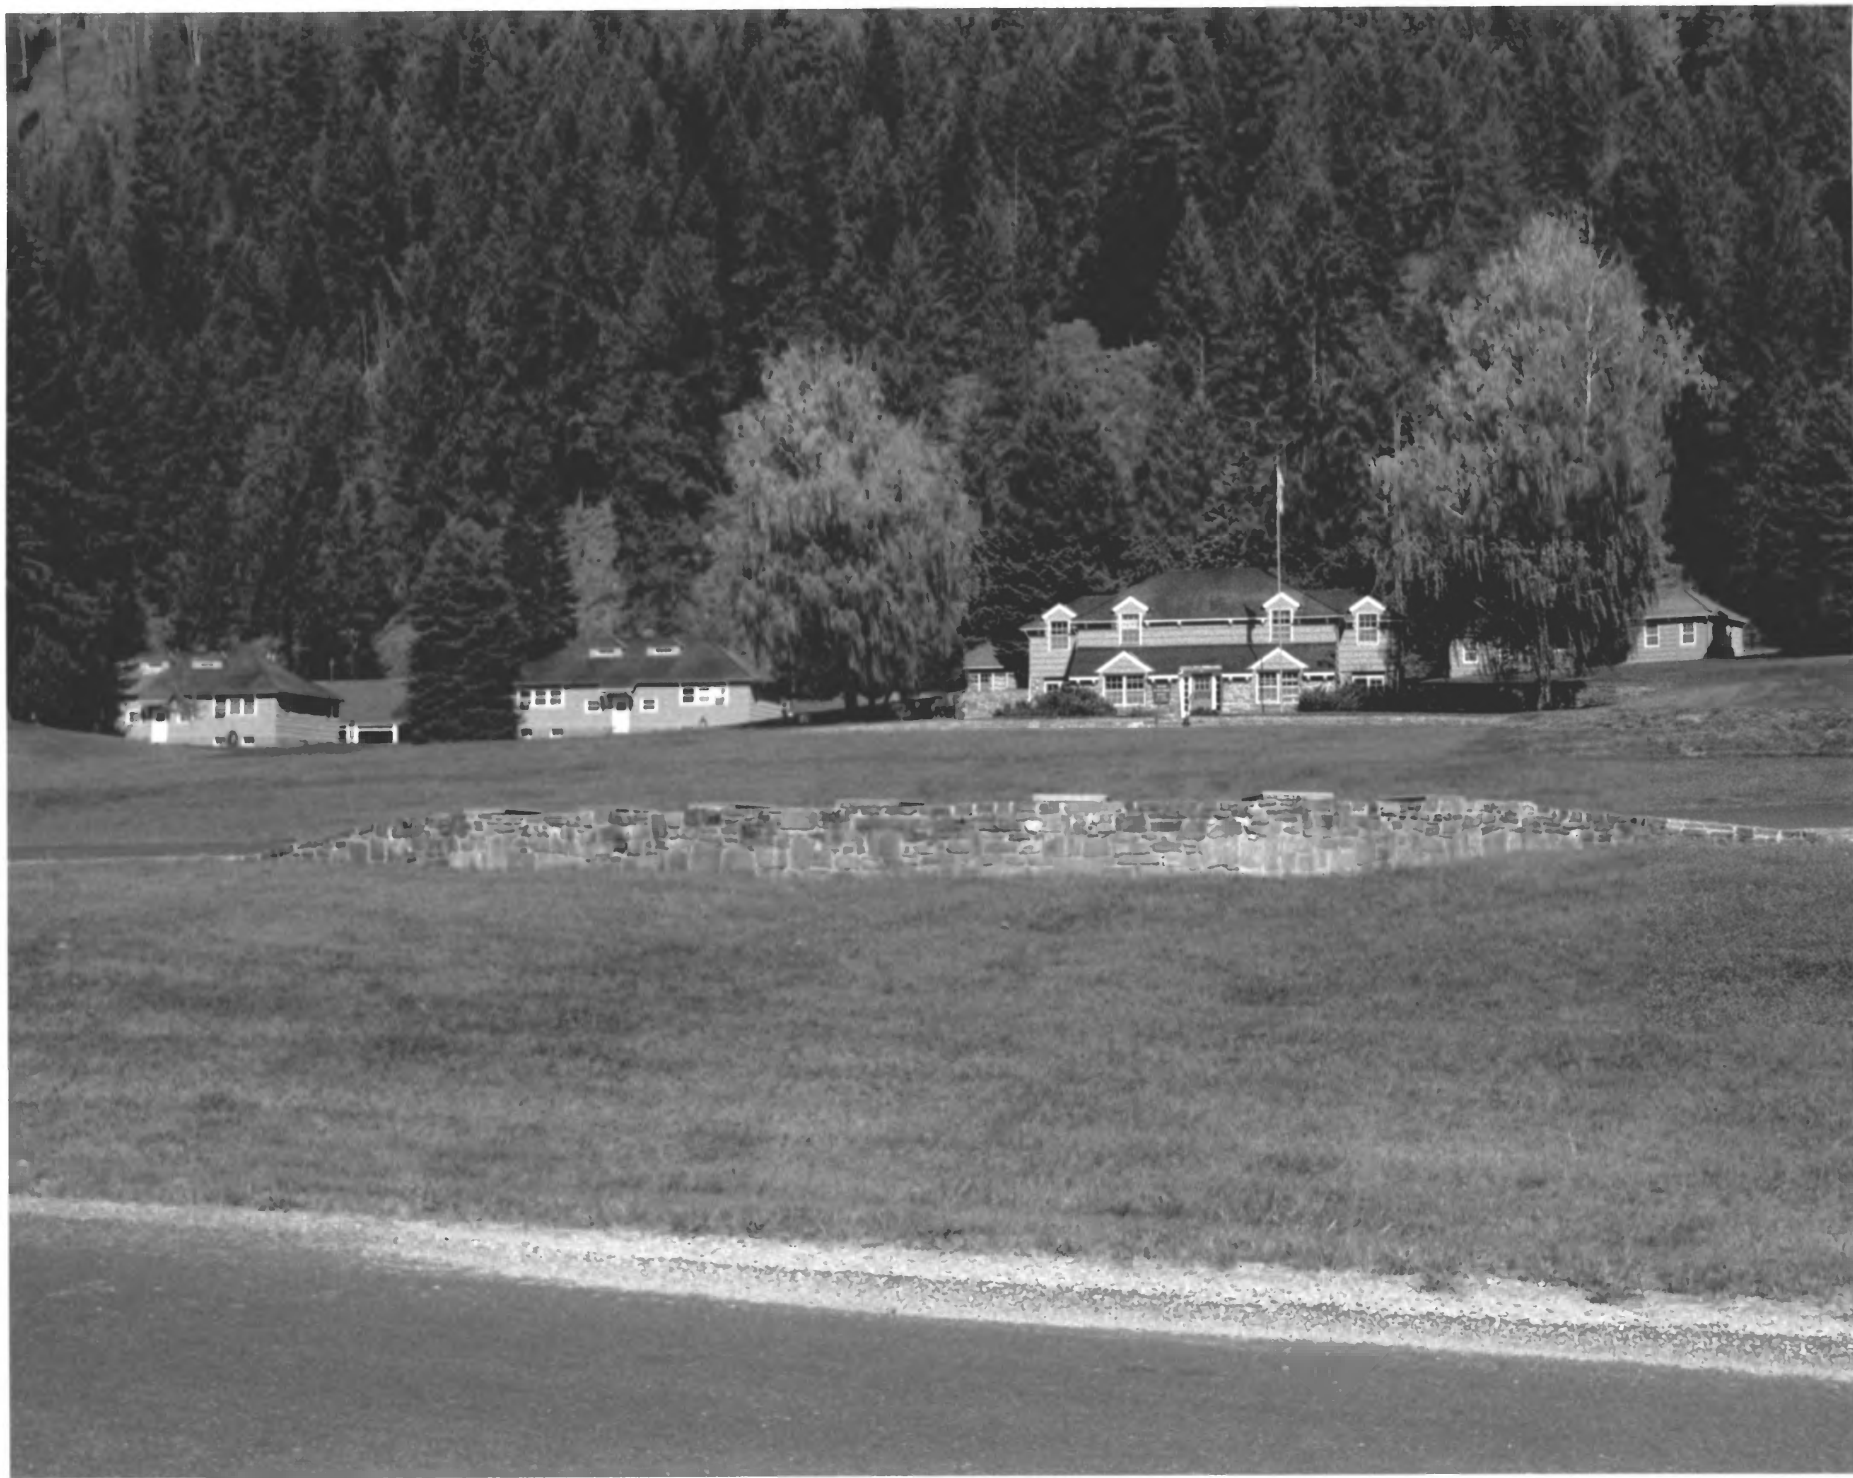
- 1) Fenn Ranger Station
- 2) Idaho
- 3) James Heid
- 4) June, 1989
- 5) Nez Perce NF, Supervisor's Office
- 6) Buildings #2, #3, #5, #6  
facing northeast
