National Register of Historic Places Registration Form

Historic name: Fort Russell Neighborhood Historic District (Boundary Increase and Additional Documentation)

Street & number: Roughly bounded by Jefferson Street on the west, East D Street on the north, Hayes Street on the east, and East Third Street on the south

City or town: Moscow State: ID County: Latah

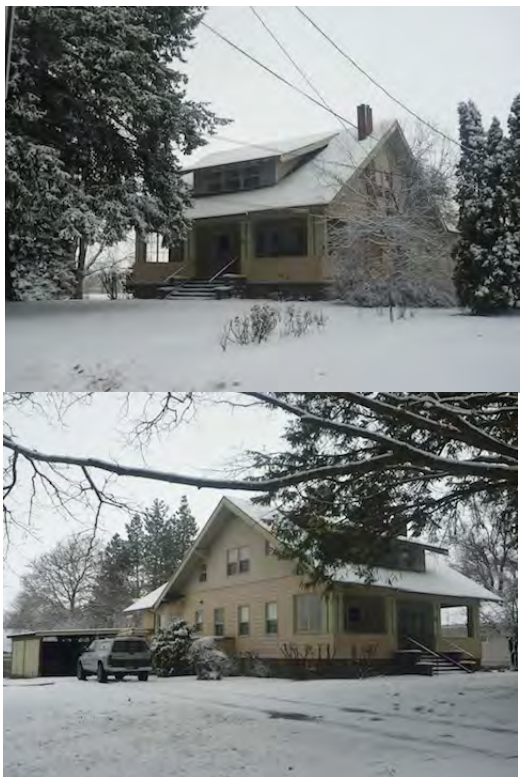
<p>Site 1 is a one-and-one-half story Bungalow with side gables and a shed-roofed dormer at the façade. On the porch to the west of the off-center door is a large picture window with fourteen-light upper over the large pane; to the east is a similar three-part window with small panes above large panes. The exterior wall on the porch retains the original narrow wood clapboards. The remainder of the exterior walls are covered in narrow and wide vinyl or metal replacement siding. The shed-roofed dormer features three, fifteen-over-one, double-hung windows, exposed rafter tails and wide bargeboards with birds-mouth notched ends. An exterior brick chimney is found at the east elevation. Other features include: twenty-over-one, double-hung windows, wide boxed eaves, knee-brackets, exposed rafter tails, a bay window at the rear of the west elevation, and a rusticated concrete block foundation. A modern, shed-roof carport on a concrete slab foundation is next to the house.</p>

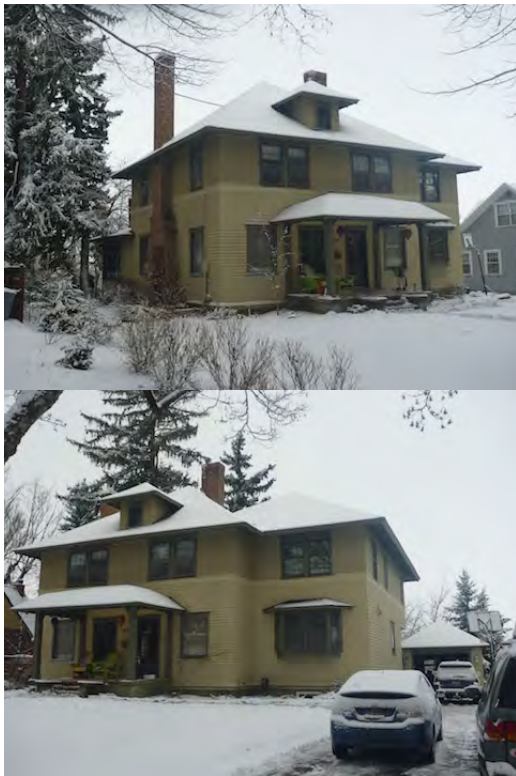
Survey Site Data	Site Photographs	Site Details
<p>Site #: 3</p> <p>407 North Polk Street</p> <p>Owner: Steffen Werner</p> <p>1909</p> <p>Previous District Status: C, 38</p> <p>DoE: C</p> <p>Garage: Historic</p> <p>DoE: C</p>

<p>This is a two-story, foursquare plan, Prairie style residence with a modern two-story addition attached along the north elevation. The central entry porch features a hip roof with exposed rafter tails, wide eaves, large square posts, and pilasters. At the second story of the façade are two sets of six-over-one paired windows. The first floor is sheathed in clapboards with a slight flare, while wood shingles cover the second story. A hip-roof dormer with a single small window is centered above the façade. Simple Craftsman-style trim surround the door and windows. Roofs are hipped with wide, open eaves and exposed rafter tails. A brick, shouldered chimney is located at the south elevation, and another small chimney pierces the main roof. At the rear is an enclosed porch. The addition features a hip-roof bay window at the first floor and a pair of six-over-one windows at the second story, an integral porch at the rear entrance, and materials that mimic the original. A small single-car garage is behind the dwelling. It is a historic single bay detached garage with a hip roof. The original nomination states that this is “another Butterfield house” (Wright, 10).</p>

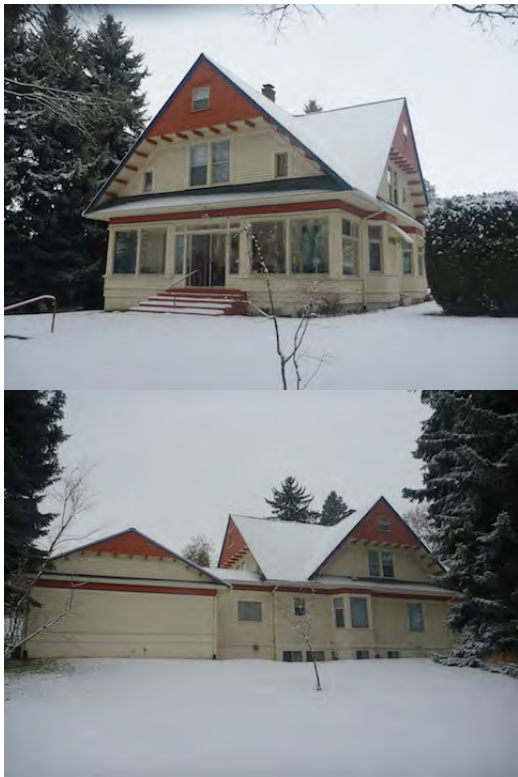
Survey Site Data	Site Photographs	Site Details
<p>Site #: 4</p> <p>420 North Polk Street</p> <p>Owner: Ronald Meldrum</p> <p>1906</p> <p>Previous District Status: C, 40</p> <p>DoE: C</p> <p>Garage: Historic</p> <p>DoE: C</p> <p>Garage: Modern</p> <p>DoE: NC</p>

<p>This is the Harvey R. Smith House. It is a square, one-and-one-half story dwelling. Dominating each elevation is a broad gable with an enclosed, shingled triangular section in the peak that projects beyond the wall plane. Exposed false-beams line the frieze bands in the gable ends. The façade features a full-width porch filled in with glazing in the openings between the Tuscan columns and a sliding-glass door with sidelights and transoms. The house is clad in wood clapboards and the roof is covered in composition shingles. Several of the windows are one-over-one, double-hung, wood sash. Three bay windows are found on this dwelling: one at the north elevation and two along the south side. Doors and windows feature simple classical wood trim and a wide frieze band highlights the boxed-in eaves. Numerous windows line the basement level and all appear to be vinyl. A historic single bay detached garage features a front facing gable. A brick chimney pierces the roof. An enclosed breezeway leads to a modern, two-car garage on the northeast corner. The garage has been constructed to mimic the style and materials of the main house.</p>

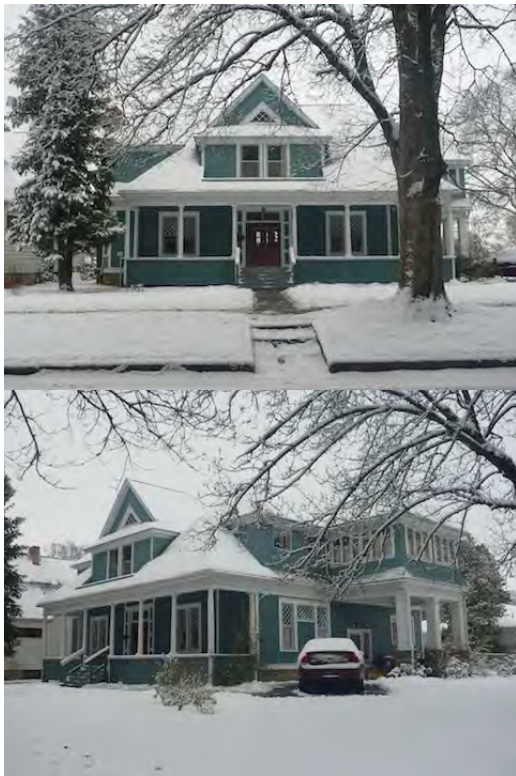
<p>The Emanuel Kaufmann House is a one-and-one-half story Queen Anne with classical elements. It has an irregular plan that was created by alterations in 1909. A large, shingled dormer on the façade features a pair of double-hung windows with a triangular window with small diamond panes. A full-width porch spans the façade. The main entry contains a set of doors with beveled-glass. Decorative wood trim flanks the doors and the transom above. At the north and the south elevations are large, shingled, hip-roof dormers with aluminum slider windows. Also found at the north elevation is a shingled, sleeping porch above a porte-cochere supported atop three large square columns on coursed ashlar-faced concrete-block piers.. The water table of the sleeping porch flares. A steeply pitched hip roof covers the rear porch on the west elevation. At the south elevation, eave brackets can be seen below the large dormer. Drop siding envelopes the house, while lap siding sheaths the porch surround and wood shingles wrap both the dormers and the sleeping porch. A variety of windows can be found on the residence, including: historic wood-sash, multi-diamond pane-over-single pane, double-hung, diamond pane fixed, one-over-one double-hung, and fixed picture. The dwelling features a wide fascia, corner boards and classical wood trim around doors and windows. Coursed ashlar, concrete block, and rubble foundations can be found. All roofs are covered in composition shingles. An arch-top canvas storage shed is also present.</p>

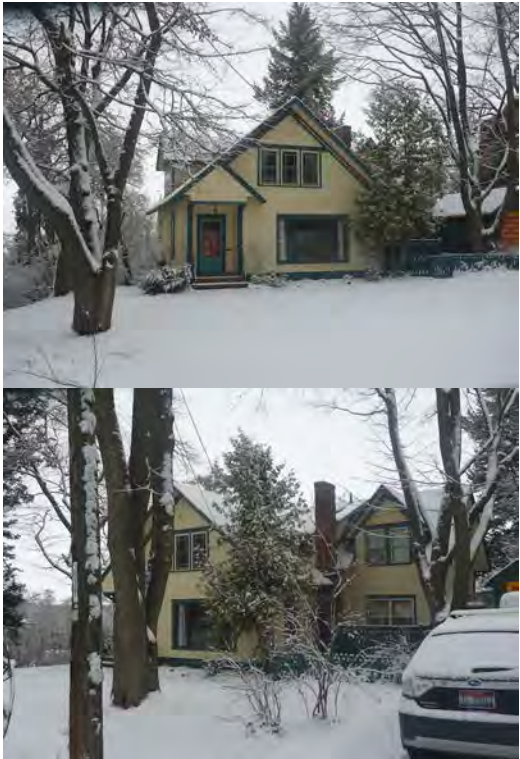
<p>This residence is a one-and-one-half story, cross-gabled, frame dwelling oriented towards the south. The eastern portion of the house, the cross gable, is a later addition. The main floor of the façade features a front-gabled porch roof that is tied into the main roof and supported by brackets over the entry door, and a wide window with a large central pane bracketed by multiple-pane sidelights. The double outside brick chimney is shouldered. A pair of windows is found at the main floor of the wing. The front-gable end is graced with a ribbon of three windows and machine-cut cedar shingles in the peak. A wall dormer pierces the south side of the roof of the crossing gable and features a pair of double-hung windows. There is a large dormer at the west elevation with a pair of double-hung windows. The east end features a pair of windows with cedar shingles in the peak. The roof has wide boxed eaves and is sheathed in composition shingles. The exterior walls are covered in narrow lapped wood siding. Most of the windows are wood. The foundation is concrete block.</p>

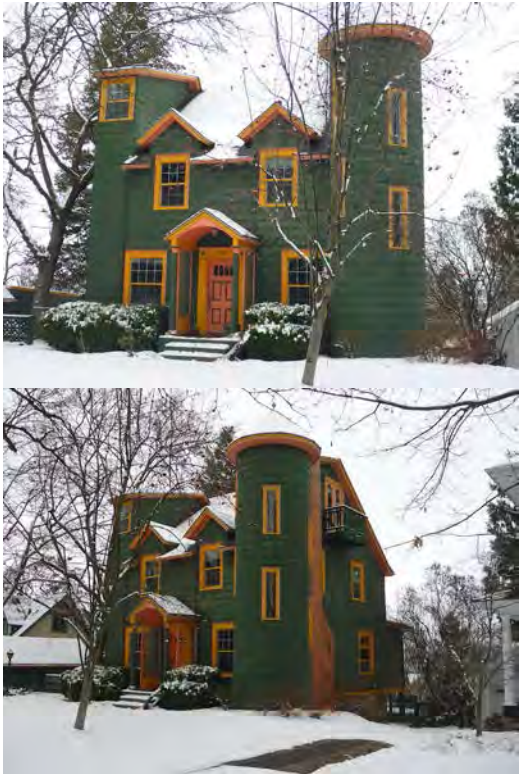
<p>This residence is a three story, altered, frame dwelling oriented towards the south. A single story, one-car garage sits to the west of the residence. The façade features a centered entry door covered by a front-gabled porch roof with an arched ceiling atop full-height columns, and two gabled wall dormers. Windows flank the entry door at the main floor. A three-story tower with six windows and a conical roof is found at the façade's eastern corner and a narrow third-story addition is found at the south end of the west elevation. A secondary entry door and numerous windows pierce the west elevation. The eastern elevation includes windows, a pair of French doors with a Juliet balcony and a tall shouldered outside brick chimney. The roof is covered in composition shingles, the walls are sheathed in cedar shingles and the foundation is concrete block. Most of the windows are replacements. There is a historic single bay detached garage featuring a front facing gable roof. It is wood shingle sided.</p>

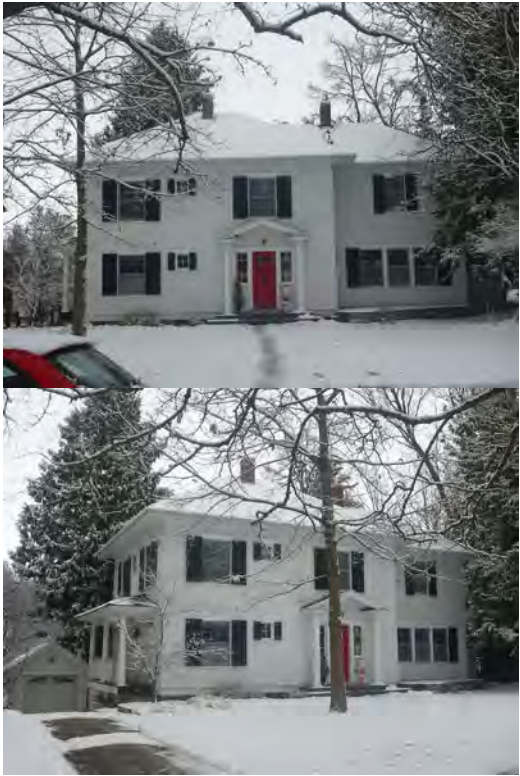
Survey Site Data	Site Photographs	Site Details
<p>Site #: 10</p> <p>514 East C Street</p> <p>1913</p> <p>Previous District Status: n/a</p> <p>DoE: C</p> <p>Garage: Historic</p> <p>DoE: C</p>

<p>This is a two-story, Neocolonial frame dwelling that is oriented towards the south. A single-story, one-car garage sits northwest of the residence. The original portion of the residence is a square plan with an offset main entrance door under an open pediment porch roof set atop fluted modified Doric columns. The entry door is wood panel with an arch top window in the upper portion, and is flanked by eight-light sidelights. There is a narrow side- entry porch on the west elevation with a hipped porch roof supported on fluted modified Doric columns and simple balustrade. The dwelling exhibits a wide fascia board and classical window and door trim. The roofs are hipped and clad in composition shingles, and the exterior walls are sheathed in narrow clapboards. The windows are vinyl. The eastern portion of the dwelling is a later addition. The house sits on a concrete foundation. Two brick chimneys pierce the roof.</p>

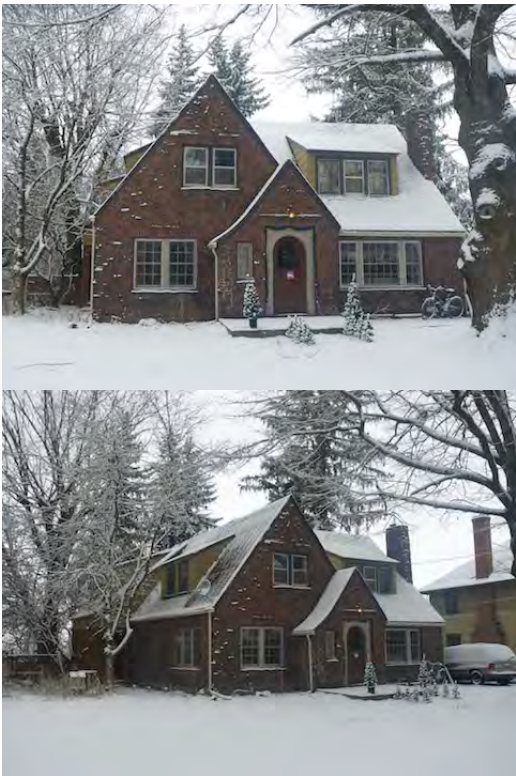
<p>This is a one-and-one-half story, cross-gabled Tudor in the “storybook” style. The façade exhibits a front gable and a smaller entry gable with a flared eave line. The entry has an arched wood door with two horizontal panels and six-light glazing. A painted wood surround with faux rustication surrounds the entry, topped by a soldier course brick lintel. To the left of the entry door is a narrow six-light window. Wood-sash windows remain. In the large shed-roof dormer is a triplet of original six-over-six windows. A smaller shed-roof dormer is found on the south elevation and exhibits two, six-over-six, double-hung, wood-sash windows. The first story is clad in clinker-brick veneer laid in an irregular, random, undulating tapestry-style bond, while the dormers and the crossing gable end are covered in wood shingles. A large clinker brick chimney with the same bond and an inset, arched niche is found on the north. At the southwest rear of the residence is a one-and-one-half story addition with a shed-roof dormer and rear entry. The addition features both stucco and shingle cladding.</p>

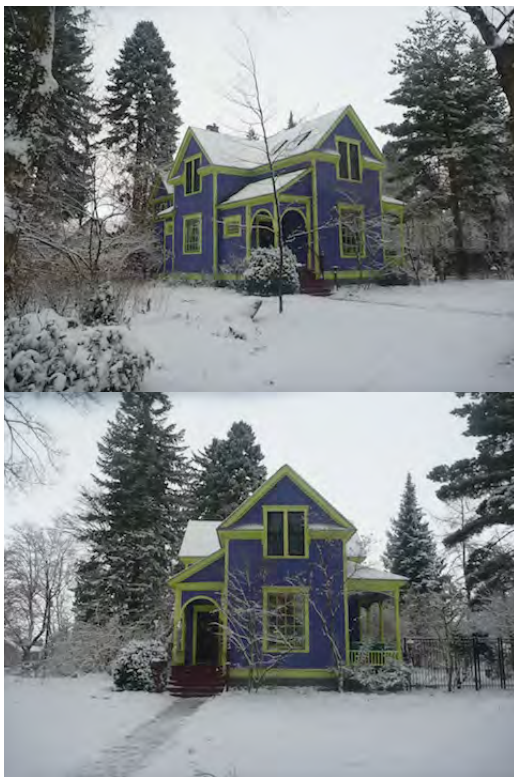
Survey Site Data	Site Photographs	Site Details
<p>Site #: 13</p> <p>604 East C Street</p> <p>Owner: Jayne Eliza Mahle</p> <p>1900</p> <p>Previous District Status: C, 49</p> <p>DoE: C</p> <p>Garage: Modern</p> <p>DoE: NC</p>

<p>This is a one-and-one-half story Queen Anne dwelling oriented to the south. The steeply pitched roof is cross gabled and sheathed in composition shingles. The residence features a T-shaped plan with a two-story rear addition. The roof is pierced by a brick, double-flue chimney and modern skylights. The main cross gables have full-height windows through the gable ends, breaking the cornice. In the gable ends are diamond and fish scale shingles and large scroll-cut brackets supporting the cornice break. Wood drop siding covers the exterior and simple trimmed capitals top the corner boards. The original portion of the residence has a parged stone foundation while the porch at the east elevation and the addition sit on concrete blocks. At the southwest corner of the façade, a pair of round arches grace the shed- roofed main entrance springing from a single turned post to matching pilasters. At the southeast corner, a porch within the ell of the crossing gable covers a secondary entrance. Many of the original windows are present at the first floor, however the second story and the addition feature replacement windows. There is a modernized detached single bay garage with a front facing gable.</p>

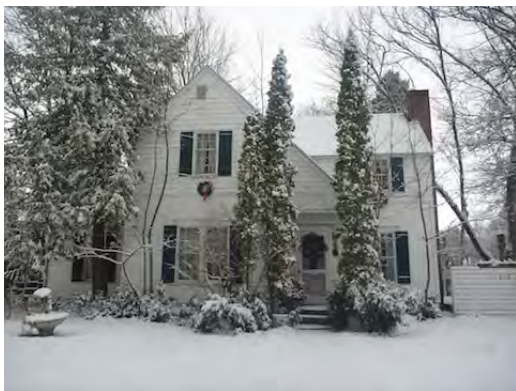
Survey Site Data	Site Photographs	Site Details
<p>Site #: 14</p> <p>616 East C Street</p> <p>Owner: Mary Blanton</p> <p>ca. 1900</p> <p>Previous District Status: NC (compatible), 47</p> <p>DoE: C</p> <p>Carport: Modern</p> <p>DoE: NC</p>

<p>This is a ca. 1900 dwelling updated with simplified Tudor detailing. The façade has a dominant front gable with varied eave-line heights and two side-gabled wings: a single story to the west, and a two-story to the east, with a large, brick, single-shouldered chimney. The roof has minimal eaves. The first floor exterior walls are covered in lap siding with corner boards while shingles cover the second story. The windows are double-hung, wood sash. At the second story they are six-over-nine and six-over-six, and nine-over-nine on the lower level. Shutters flank the windows on the façade. The main entrance features a shallow crown supported on simple pilasters framing the glazed wood panel. The foundation is concrete block and a large contemporary multi-level deck can be found at the rear.</p>

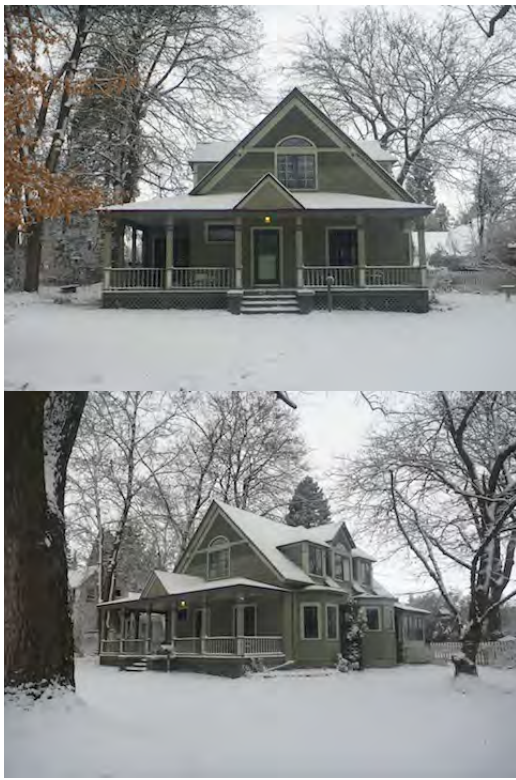
<p>Site #: 15</p> <p>622 East C Street</p> <p>Owner: Steven McGeehan</p> <p>1910</p> <p>Previous District Status: NC (compatible), 46</p> <p>DoE: C</p> <p>Garage: Historic</p> <p>DoE: C</p>

<p>This is an altered, front-gable Queen Anne-styled residence. The dwelling features nonhistoric gabled dormers with modern windows and arch-top windows in the gable ends on both the west and east elevations, centered between hip-roofed dormers. A variety of patterned shingles decorate all the gable ends. The house is clad in cedar shingles. A full-width porch wraps around the façade and extends along the west elevation. It features a front-gabled peak with a sunburst decoration centered over the front entry door atop the hip roof, and original French secondary entry doors from the porch at the west elevation. The square porch posts exhibit wood trim and small corner brackets. Two bays are found at the east elevation; the bay nearest the front is historic, while the northernmost bay is contemporary and features new windows, a poured concrete foundation, and boxed eaves under a low hip roof.</p>

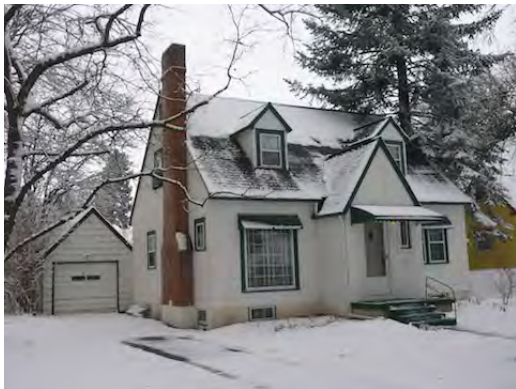
Survey Site Data	Site Photographs	Site Details
<p>Site #: 16</p> <p>630 East C Street</p> <p>Owner: David Lee Rauk</p> <p>1936</p> <p>Previous District Status: NC (compatible), 45</p> <p>DoE: C</p> <p>Garage: Historic</p> <p>DoE: C</p>

<p>This is a one-and-one-half-story side-gabled dwelling with an enclosed entry centered on the façade and two gabled dormers above. The entry is painted brick and has a small inset niche above the doorway. The entry also features a metal awning above. East of the door is a narrow, three-light wood window. Around both the door and window are brick surrounds set in rowlock courses for the sills and lintels, and header courses along the sides. The roof features narrow eaves, and vinyl replacement windows are found throughout. On the west is an exterior, shouldered brick chimney with a diamond pattern. Asbestos shingles cover the dwelling and the foundation is concrete. At the northwest corner of the site is a one-story, gable roof, single-car garage with a pull-up door, and wood shingles.</p>

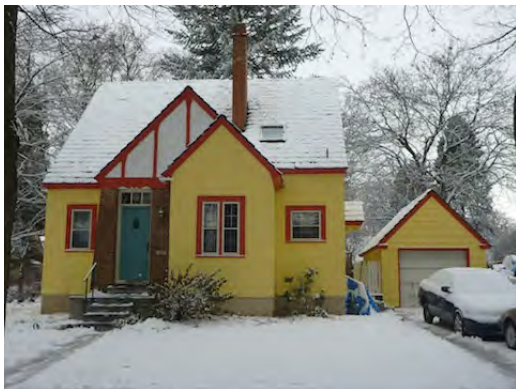
<p>Site #: 17</p> <p>405 North Howard Street</p> <p>Owner: James Elliott Johnson</p> <p>1936</p> <p>Previous District Status: NC (compatible), 44</p> <p>DoE: C</p> <p>Garage: Historic</p> <p>DoE: C</p>

<p>This is a one-and-one-half story, side-gabled dwelling with smaller front- and rear-facing gabled extensions. The entry gable has half-timbering and a scroll-cut fascia above the doorway. It is faced with brick veneer flanking the entry door. The entry contains a wood plank door with original hardware and a three-light transom above. An additional gable projects from the façade, with a centered pair of vinyl windows and wide wood trim. The side gable ends exhibit small cornice returns. At the north elevation the side entry door is covered with a gabled-porch roof set on knee brackets. The house is clad in asbestos shingles and the foundation is concrete. The roof is covered with wood shakes and features a tall chimney and modern skylight. A small single-car garage covered in wood shingles is also at the site. It has a front-facing gable roof with small cornice returns. It is covered in wood shingles.</p>

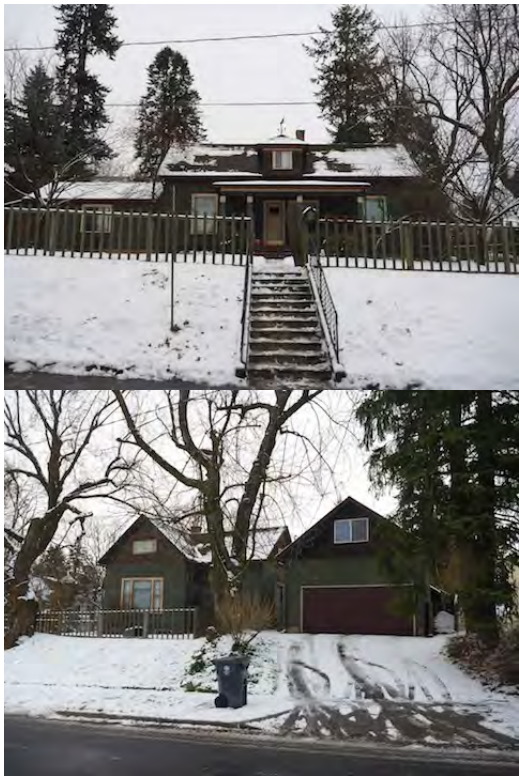
Survey Site Data	Site Photographs	Site Details
<p>Site #: 18 503 East C Street Owner: Gary Reed ca. 1890 Previous District Status: C, 32 DoE: C</p> <p>Garage: Compatible Modern DoE: C</p>

<p>This is a one-and-one-half story, side-gabled dwelling with a gable-roof extension to the rear and a single-story addition on the east side. The residence is oriented towards the north facing East C Street. The façade features a partial-width, central porch with a low hipped-roof supported by square columns atop shingled solid railings. The entry door is a painted wood Craftsman-style ledged door with glazing. The façade also features wood-sash, fixed pane windows on either side of the porch. A single, hip-roof dormer is centered above the porch at the roof. It contains an aluminum sliding window and wood-shingles. The east addition has a small shed roof on its east elevation, a wide horizontal sliding window at the façade, and a metal stovepipe. The roof is composition shingle, the exterior walls are clad in narrow wood clapboards, and a brick chimney exits the roof at the ridge. Also at this site is a modern one-and-one-half story, gable-front, two-car garage that is oriented towards North Van Buren Street. It features a roll-up garage door, an aluminum slider window, and narrow wood siding below with shingles above.</p>

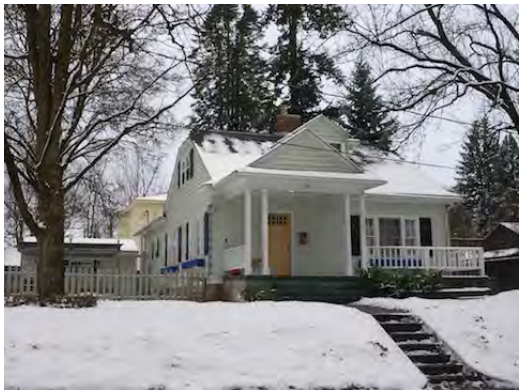
Survey Site Data	Site Photographs	Site Details
<p>Site #: 19</p> <p>511 East C Street</p> <p>Owner: Tara Waynant</p> <p>1920</p> <p>Previous District Status: C, 33</p> <p>DoE: C</p> <p>Garage: Historic</p> <p>DoE: C</p>

<p>This is a one-and-one-half story dwelling with a side-facing clipped-gable roof with front and rear crossing gables and a single dormer. The house has a front-facing gable entry porch with wood clapboards in the gable end, and a small pent roof atop paired square columns. The entry contains a paneled wood door with ten-light glazing. An eight-over-one, wood-sash window flanked by four-over-ones is to the west of the entry. A gable-front dormer with boxed eaves, cornice returns and a pair of vinyl windows is centered at the façade. All the windows except at the dormer have decorative shutters. The foundation is concrete and the roof is composition shingled with cornice returns and boxed eaves. Facing east to the alley is a small one-story, gable-roof, single-car garage with a metal pull-up door.</p>

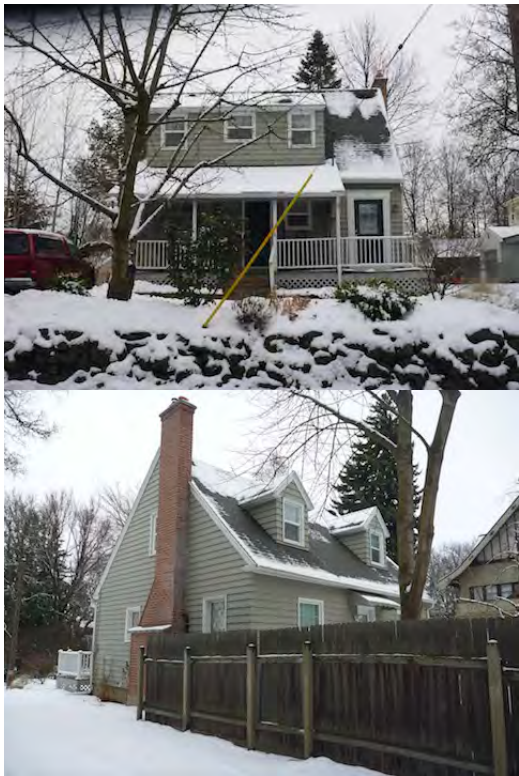
Survey Site Data	Site Photographs	Site Details
<p>Site #: 20 517 East C Street Owner: Nancy Soo Hoo 1937 Previous District Status: NC (compatible), 34 DoE: C</p> <p>Garage: Modern DoE: NC</p>

<p>This is a one-and-one-half story, steeply pitched, side-gabled dwelling with a large shed-roof dormer at the façade. The dwelling is oriented towards the north facing East C Street. The façade features a partial-width porch with a shed roof atop 4x4 posts with a simple wood railing. An entry door is sited between a vinyl window and a projecting square bay with a wood-sash, eight-light horizontal window. The main entry door sits on the porch to the west of the covered area; it is a modern fiberglass panel door. The door surround has fluted pilasters supporting an entablature. Above the porch roof and nearly as wide, is a shed-roof dormer with three vinyl double-hung windows. A pair of gabled dormers with vinyl windows graces the roof at the rear elevation above a rear entry door. At the west elevation a pair of original, leaded, diamond-pane windows flank the chimney, which is a tall, brick, double-flue, chimney with a full-width buttress, a single shoulder and a ledge. The foundation is concrete, the roof is composition shingle, and the siding is wide, wood lap siding. The gable ends have cornice returns and the residence has minimal eaves. Most of the windows have been replaced with vinyl sashes. A modern, small, gable-roof shed with open eaves, composition shingled roof and vertical sheet paneling is to the rear at the alley.</p>

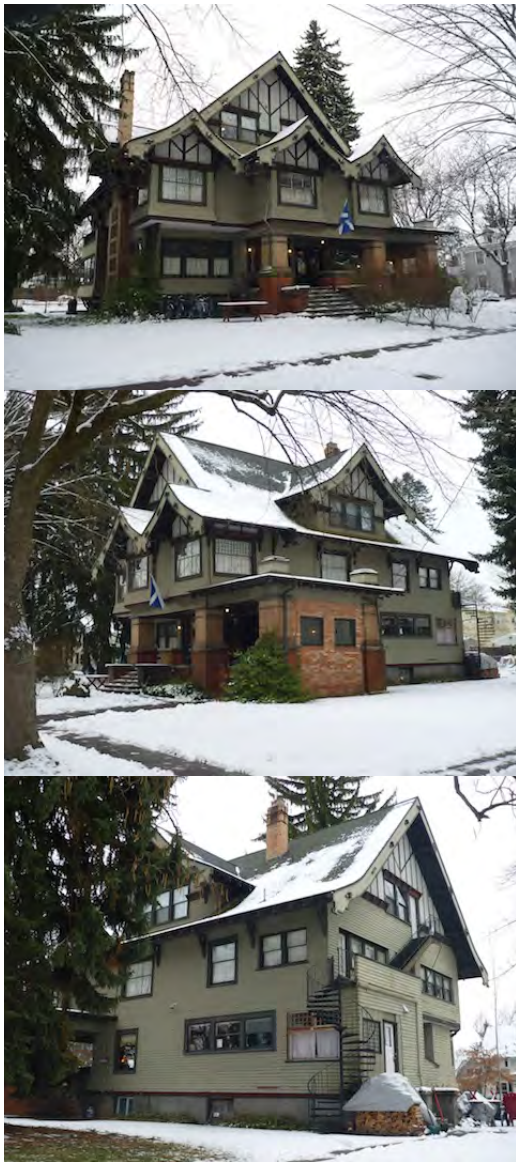
Survey Site Data	Site Photographs	Site Details
<p>Site #: 21</p> <p>325 North Polk Street</p> <p>Owner: Evan Wilson</p> <p>1911</p> <p>Previous District Status: C, 35</p> <p>DoE: C</p> <p>Garage: Modern</p> <p>DoE: NC</p>

<p>The Mark P. Miller House, also known as the Gingerbread house or the House of Seven Gables, is a large, two-and-one-half-story, eclectic Craftsman mansion with Swiss Chalet style detailing. It has a front-facing gable roof, large dormers over both side elevations, and three staggered gable-roof projections on the second level of the façade. A partial-width porch on the façade features supports of blonde and red brick piers with cast stone caps. The wood entry door has an inset panel and beveled glazing, and is flanked by a pair of beveled glass sidelights. Door hardware is original. At both sides of the entry is a band of triplet wood-sash, double-hung windows with stained-glass uppers over a large single pane. The gables have half-timbering and detailed bargeboards. A porte-cochere rests on supports that match the porch and extend up over the roof, which is hipped with a nearly flat pitch. It has open eaves with ornately sawn rafter tails. The space between the piers at the north elevation has been filled in with brick and two square windows with small lights. At the south elevation, four wood-sash, double-hung windows are set in a cantilevered square bay window with flared water table topped by a balconet, west of a tall, blonde brick, shouldered chimney with inset and projecting details of darker brick and a crenelated top. A forty-eight-over-one window is found east of the chimney; a second window of this size can be found on the dormer over the porch. A second blonde brick chimney with similar detailing exits the roof near the ridge of the rear gable. Other details include deep, open bracketed eaves with detailed rafter tails, and ornate scroll-sawn knee braces and brackets. The house is clad in wood drop siding that flares above the foundation. All windows are original except a few at the basement. Entry doors have been installed into window openings at both the second and third floors on the rear, and a spiral staircase, balcony and straight-run stair have been installed on the back. A small gable roof shed with painted OSB walls, half-timbering, open eaves, and rafter tails is also found at the site.</p>

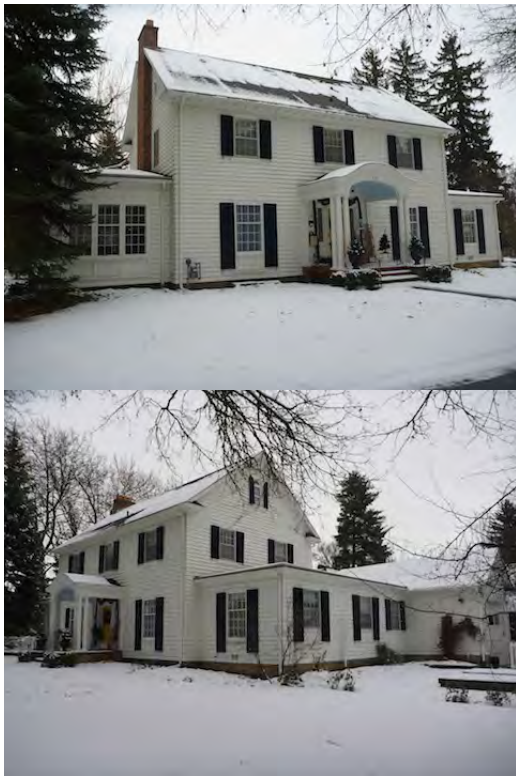
Survey Site Data	Site Photographs	Site Details
<p>Site #: 22</p> <p>328 North Polk Street</p> <p>Owner: John Ingram</p> <p>1927</p> <p>Previous District Status: C, 50</p> <p>DoE: C</p> <p>Garage: Historic</p> <p>DoE: C</p> <p>Shed: Modern Compatible</p> <p>DoE: C</p>

<p>This is a two-and-one-half story, side-gabled Colonial Revival dwelling, facing North Polk. It has a symmetrical façade and flat-roofed, one-story side wings. The main entry has a projecting portico with curved ceiling atop tripled Tuscan columns at the front corners, and square pilasters at the house. The entry is flanked with leaded glass sidelights and has a leaded glass fanlight above. Windows in the dwelling are multi-light, double-hung, wood-sashes with shutters; some with horizontal panels below the windows. At the north end the wing is filled with wood-sash windows. A brick triple-flue chimney is also on the north flanked by a pair of triangular windows. The wing on the south has numerous windows of varying sizes. An attached single-car garage with a front gable, cornice returns and a triangular louvered vent in the peak is found extending off the south wing facing the alley. At the rear is a hooded rear entry door with large brackets and two hip-roof dormers each with a pair of windows and modillions under the eaves. The foundation is concrete, and the siding is wide wood clapboard. Cornice returns are found at the gable ends and modillions are under the eaves. Also found at this site is a small, square shed with wood clapboards, corner boards, a hip roof with a windowed cupola, and wood plank, segmental arch-top, swing out double-doors.</p>

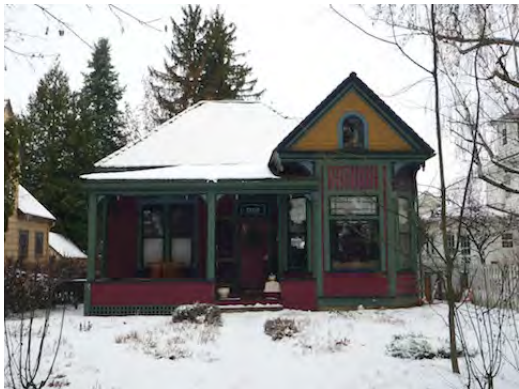
Survey Site Data	Site Photographs	Site Details
<p>Site #: 23 605 East C Street Owner: Steffen Werner ca. 1900 Previous District Status: C, 51 DoE: C</p> <p>Garage: Historic DoE: C</p>

<p>This is a one-and-one-half story Queen Anne dwelling, oriented north facing East C Street. It has a truncated hip roof with lower front-, rear- and side-facing gables and a partial-width porch. The porch has a low-pitched hip roof atop square wood posts with curved sunburst brackets and pendant drops at the simple cornice. The posts rest on a clapboard apron. Double-hung, wood-sash windows with elaborate surrounds remain extant. The front gable features chamfered corners with curved sunburst brackets and pendant drops. The central window has an upper narrow horizontal pane surrounded by multiple lights over a large, fixed single pane. Above the windows are textured panels over the wood siding. In the gable end are fish scale and square imbrication surrounding a stained glass, multi-light, arched window. The side and rear gables exhibit similar features to the front. The roof is covered in wood shingles and the walls are clad in wood lap siding. A nonhistoric, one-and-one-half-story, two-car garage with a louvered cupola and weathervane is found at the alley.</p>

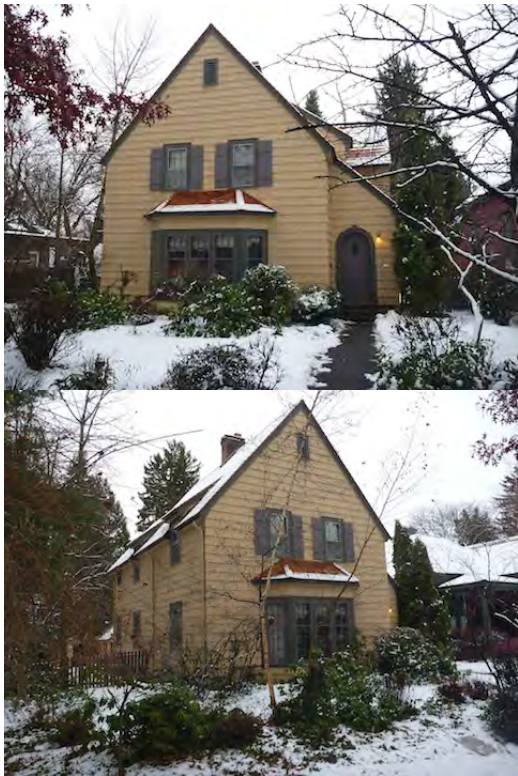
Survey Site Data	Site Photographs	Site Details
<p>Site #: 24</p> <p>615 East C Street</p> <p>Owner: Ethan Jones</p> <p>1931</p> <p>Previous District Status: NC (compatible), 48 and 52 (duplicated in the original nomination)</p> <p>DoE: C</p> <p>Garage: Historic</p> <p>DoE: C</p>

<p>This is a tall, two-story, Tudor-inspired dwelling, oriented north facing East C Street. It features a dominant front-facing gable and a small, single-story crossing gable on the west. The main entry is stepped-back under a continuation of the steeply pitched main roof. The entry is arched and has a wood surround with a keystone. In the front-facing gable is a wide, five-window bay with a cedar shingle hipped roof. The windows are tall, fifteen-light casements. Above the bay are two six-over-six, wood-sash windows with wood surrounds and shutters. At the east elevation are two wall dormers with shallow shed roofs. On the west, a shed-roof dormer with a small, four-light, wood-sash window sits atop the roof that shelters the entry. To the south of the dormer is a lower crossing gable with an oculus window with wood surround and a keystone that is located just over a nine-light, wood-sash window. The rear elevation features a lower rear-facing gable with a large wood-sash fanlight window over a pair of eight-light, wood-sash casement windows. The exterior is clad in wood shingles with a wide reveal and the roof is covered in cedar shingles. At the rear of the site at the alley is a one-car garage. It has a modern roll-up door, shingled walls, a wood shingle roof, and a tall brick chimney.</p>

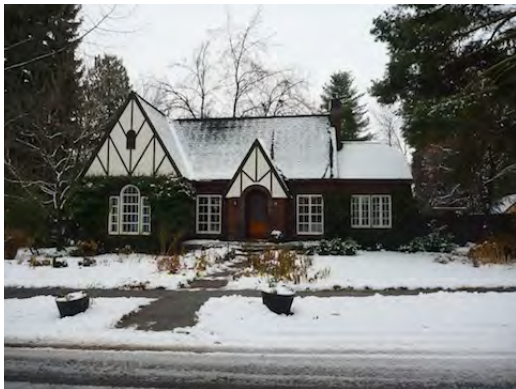
Survey Site Data	Site Photographs	Site Details
<p>Site #: 25</p> <p>621 East C Street</p> <p>Owner: Thomson McClure Family Trust</p> <p>1927</p> <p>Previous District Status: NC (compatible), 53</p> <p>DoE: C</p> <p>Garage: Historic</p> <p>DoE: C</p>

<p>This is a brick-veneered Tudor style dwelling with a steeply pitched, cross-gabled roof with a smaller front-facing entry gable and a shorter clipped-gable wing to the west. The arched entry has half-timbering in the gable and a projecting brick, double rowlock course arch-top header; the dark brick continues down both sides of the doorway. Semi-circular steps with brick trim and an iron handrail lead to the entry. The dominant front-facing gable has half-timbering and a triplet window with a central, arched, twenty-light window flanked by eight-light windows. The shorter clipped-gable wing features eight-light, wood-sash windows with storms and half-timbering detailing. The walls are clad in a red-tone brick veneer with a darker brick rowlock course as the window surrounds. The eaves are minimal. Piercing the roof is a large, brick, double-flue chimney. A shed-roof, covered patio area with skylights and brick knee-walls are to the rear, along with a gable-roof, two-car garage with half-timbering, brick veneer, and rowlock course brick window surrounds.</p>

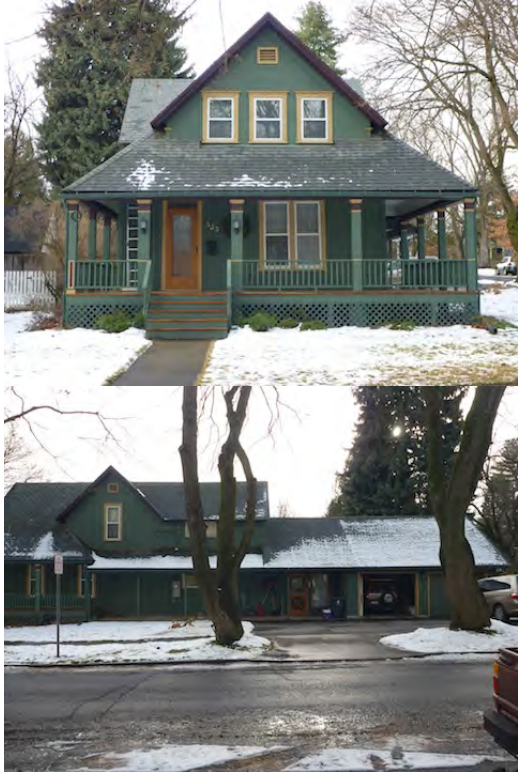
<p>Site 26 is located on the southwest corner of Howard and C Streets. It is a one-and-one-half story, cross-gabled, frame dwelling with a full-width porch spanning the façade and wrapping around both front corners. A full-height addition has been added to the rear, and a two-car garage with an additional rear entry door is found on the far rear. The original dwelling is covered in clapboard siding, while the additions exhibit vertical board siding. The porch is supported by square posts with crown molding at the top; crown molding can also be found above the windows, which contain vinyl sashes. Corner boards with crown molding and a transom above the main entry are also found on the dwelling. Though the large addition is visible along the north elevation due to the dwelling's location on a corner lot, it is to the rear, is the same or lower in height as the original portion, and is compatible in scale and material, thereby allowing the property to retain its ability to communicate as an early twentieth-century dwelling compatible with others in this area.</p>

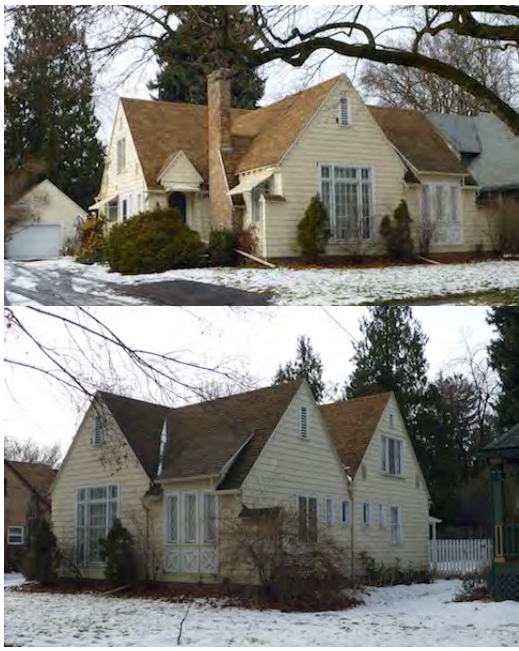
Survey Site Data	Site Photographs	Site Details
<p>Site #: 27</p> <p>321 North Howard Street</p> <p>Owner: Rosine Boyce-Derricott</p> <p>1928</p> <p>Previous District Status: NC (compatible), 55</p> <p>DoE: C</p> <p>Garage: Historic</p> <p>DoE: C</p>

<p>This is a cross-gabled, 1930s-era dwelling facing east toward Howard between B and C Streets. It features wood shingle siding, large, multi-light, wood-sash windows, and an exterior brick chimney with one shoulder. The main entry has a small gable roof over it and a metal awning above. A small shed roof pops up on the façade elevation, over three windows with diamond-shaped divisions in the glass. A side entry, with metal awning, is found on the south elevation. From the north elevation, another gable roof is visible at the rear, creating an M-shape roofline on that side. A gable-roof, frame, single-car garage is slightly southwest of the dwelling.</p>

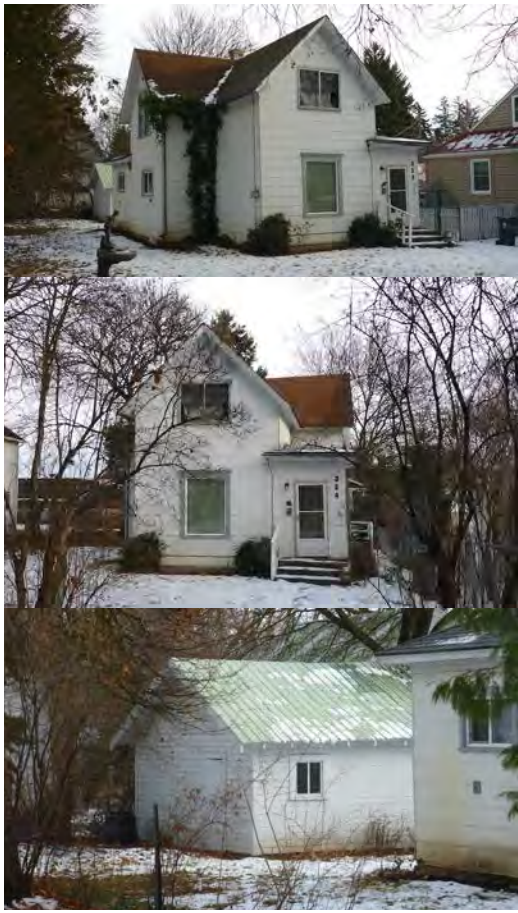
<p>Site 28 is located on the southeast corner of Howard and C Streets. It is a two-story, T-plan, cross-gabled, frame dwelling with a single-story enclosed porch on the rear. The dwelling also exhibits a small, single-story, enclosed entry porch on the southwest corner. It is covered in asbestos siding, and features nonhistoric metal windows with simple wood trims and crown molding above. A brick chimney pierces the roof near the rear of the dwelling. A small, gable-roof, frame garage is found at the rear of the property. It features weatherboard siding, corner boards, visible rafter tails, and nonhistoric V-groove metal roofing. Despite nonhistoric materials, the dwelling retains the overall character of a late nineteenth-century dwelling.</p>

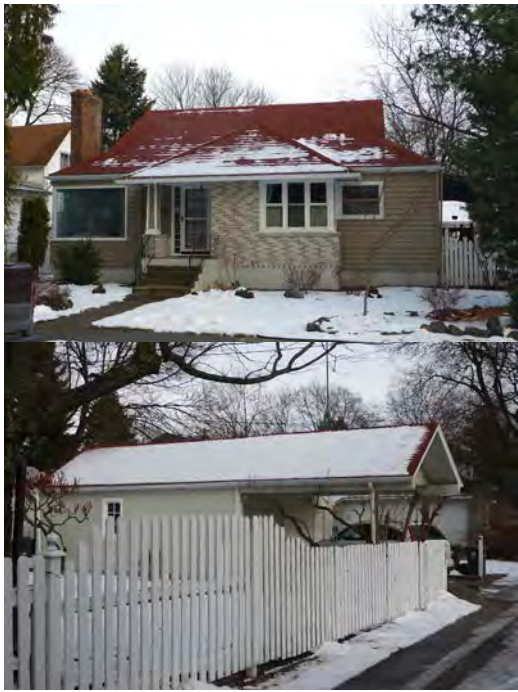
Survey Site Data	Site Photographs	Site Details
<p>Site #: 29</p> <p>322 North Howard Street</p> <p>Owner: Johana Doyle</p> <p>1946</p> <p>Previous District Status: n/a</p> <p>DoE: NC</p> <p>Carport: Historic</p> <p>DoE: NC</p>

<p>Site 29 is oriented toward the west on Howard Street, between B and C Streets. It is a single-story, gable-on-hip roof, minimal traditional dwelling. It features a partially enclosed, hip-roof extension centered on the front, which houses a recessed entryway. The entry contains a multi-light door with sidelights. The front extension has been covered in a brick veneer, while the rest of the dwelling is covered in vinyl siding. The windows are vinyl. An exterior brick chimney is found on the north elevation. A small shed roof is found on the south side, providing shelter over a patio. The south side gable end exhibits windows. A small, single-car, frame garage is found at the rear of the property. The roof extends far forward or south, providing cover over a carport. The garage is covered in weatherboard, with multi-light, wood-sash windows.</p>

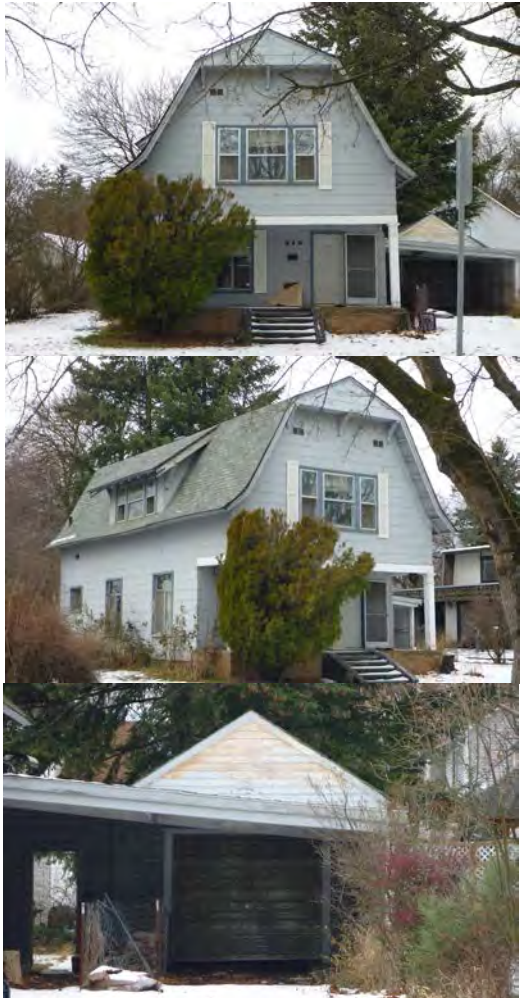
<p>Site 30 is located on the southwest corner of C and Monroe Streets. It is a one-and-one-half-story, frame, gambrel-roof dwelling with a full-width front porch sheltered beneath an overhang of the upper level. The porch is supported by full-height, square posts on a brick porch foundation. Shed-roof dormers are found above both the north and south side elevations. The dwelling is covered in asbestos shingles, and exhibits rafter tails on the dormers, and brackets on the façade elevation. The windows contain aluminum replacement windows some flanked with shutters. A gable-roof, frame, one-car garage is located at the rear corner of the dwelling. It is covered in weatherboard siding, and features a shed-roof carport in front of it, which is also connected to the house.</p>

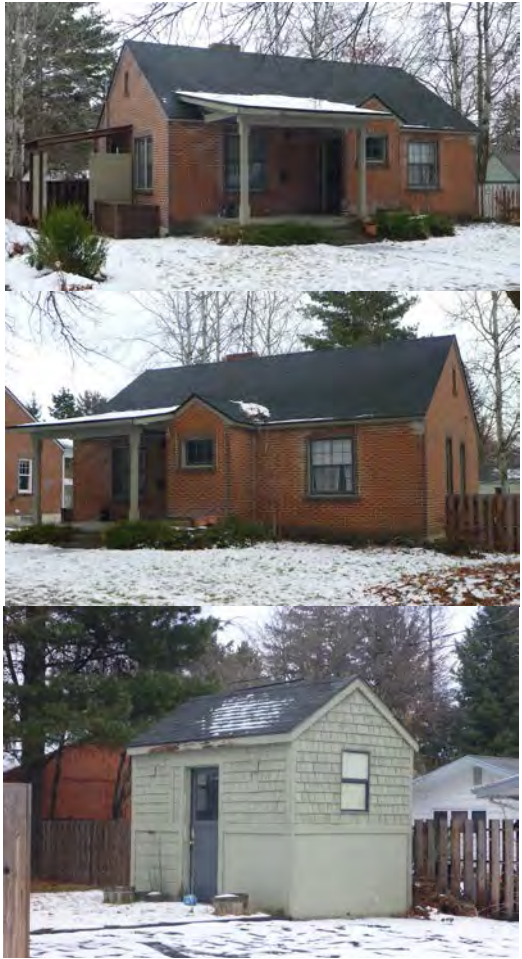
<p>Site 33 faces west toward Monroe, south of C Street. It is a side-gabled, brick veneered, single-story, minimal traditional dwelling. It features a small, gable-roof, enclosed entryway extending forward on the façade, and a shed-roof porch supported by square posts. It also features eight-over-eight and six-over-one, double-hung, wood-sash windows, and a small, fixed, six-light, wood-sash window on the enclosed entryway. Roofs are composition shingle. Brick sills and lintels are also found on this dwelling. A side entry on the north elevation is sheltered by a small shed-roof porch. A small, side-gabled frame shed is also found on the property. It features weatherboard and wood shingle siding, and a single-light, wood entry door.</p>

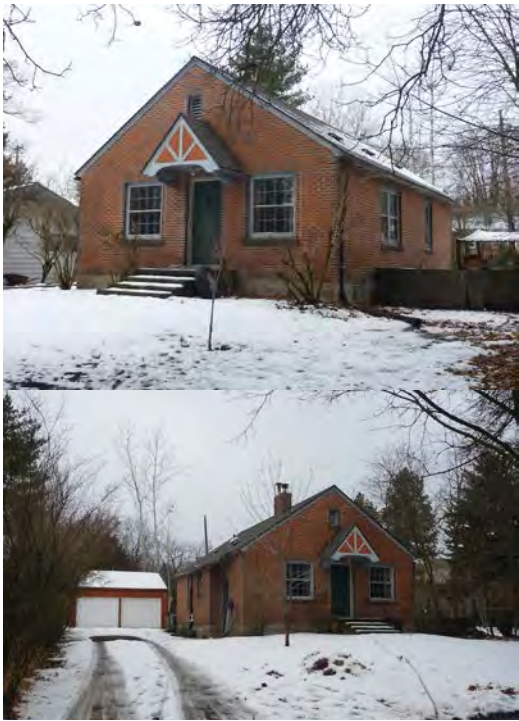
Survey Site Data	Site Photographs	Site Details
<p>Site #: 34</p> <p>323 North Lincoln Street</p> <p>Owner: Stephen LeCuyer</p> <p>1938</p> <p>Previous District Status: n/a</p> <p>DoE: C</p> <p>Garage: Modern</p> <p>DoE: NC</p>

<p>Site 34 is located on the southwest corner of Lincoln and C Streets. It is a symmetrical, three-bay (w/d/w), single-story, gable-oriented, dwelling with a brick veneer exterior. It features brick sills and brick soldier courses over the windows and entry doorway. The entryway also has a small, gabled porch roof above, with half-timbering detail. The dwelling features eight-over-eight, double-hung, wood-sash windows, and a small square bay extension on the south elevation. A brick chimney pierces the center of the roofline. The roof is composition shingle. A frame, side-gable roof, two-car garage is found at the rear of the property. It exhibits vertical board siding and overhead garage doors.</p>

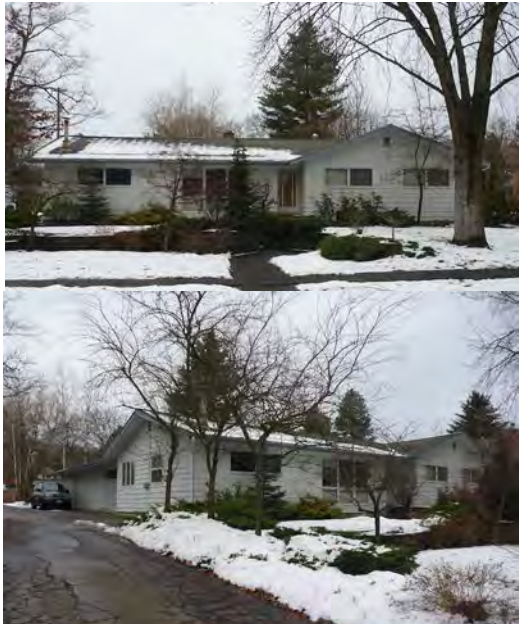
<p>Site #: 35</p> <p>317 North Lincoln Street</p> <p>Owner: Daniel Mullin</p> <p>1959</p> <p>Previous District Status: n/a</p> <p>DoE: NC</p> <p>Garage: Modern</p> <p>DoE: NC</p>

<p>Site 35 faces east toward Lincoln, south of C Street. This is a cross-gabled, single-story, Ranch house. It features an off-centered entry recessed behind the primary wall plane. It is covered in wide, composition board siding and the roofing is composition shingle. A large two-car garage has been attached to the rear of the dwelling, accessible via a breezeway from the house.</p>

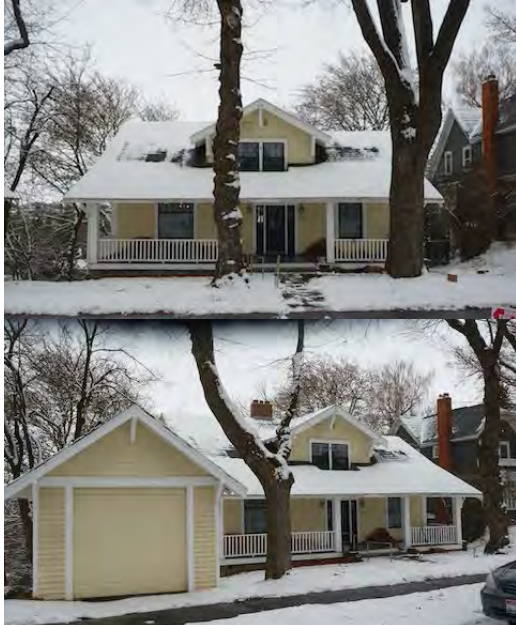
Survey Site Data	Site Photographs	Site Details
<p>Site #: 37</p> <p>404 East B Street</p> <p>Owner: Fredric Herbold</p> <p>1912</p> <p>Previous District Status: C, 23</p> <p>DoE: C</p> <p>Garage: Historic</p> <p>DoE: C</p>

<p>Site 37 is on the northeast corner of B and Adams Streets. It is a one-and-one-half-story, three-bay (w/d/w), frame dwelling. A full-width porch spans the façade, with square posts supporting an extension of the primary roof. An inset, gable-roof dormer is centered above the façade. Nine-over-one, six-over-one, and ten-over-one, wood-sash windows are found. The main entry is flanked by sidelights. The house also features visible rafter tails, large brackets, a small square bay on the west elevation, and a full-width porch on the rear. It is set on a concrete foundation with a basement and is covered in clapboard siding – though the dormer and gable ends have been stuccoed. A front-gabled single-car garage is extant.</p>

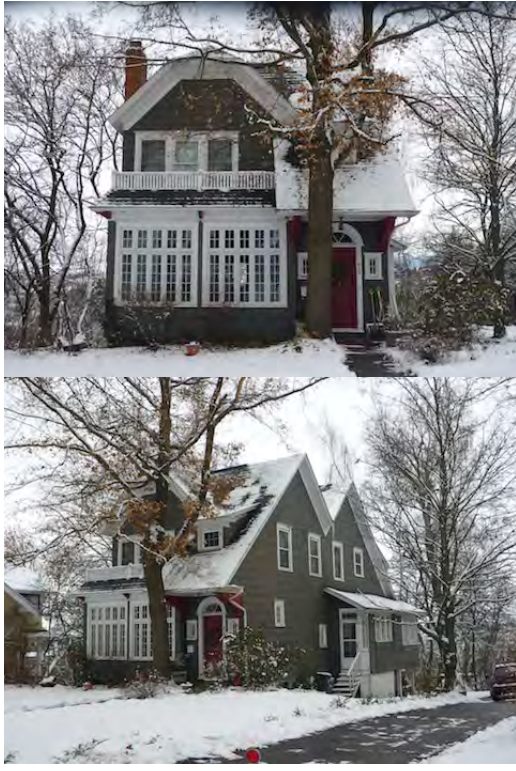
<p>The William Kaufmann Housefaces south on B Street east of Adams. It is a two-story, asymmetrical frame dwelling, with a forward facing, jerkinhead roof on the south elevation, a single gable roof on the west elevation, and two gable rooflines on the east elevation, giving the appearance of the letter M. The main entry is sheltered beneath an extension of the primary roofline on the southeast corner, which is supported by two large brackets. A three-light fanlight is above the door and two small windows are on each side. A sun porch is west of the entry, and has two sections with five, multi-light, wood-sash windows and transoms on the façade and a two window section around on the west side. A small balcony is found above. The sun porch has a slight roof overhang, with small brackets beneath. An enclosed porch is found on the east. The building is covered in wood shingle siding and retains wood windows.</p>
