National Register of Historic Places Registration Form

Historic name: Fort Russell Neighborhood Historic District (Boundary Increase and Additional Documentation)

Street & number: Roughly bounded by Jefferson Street on the west, East D Street on the north, Hayes Street on the east, and East Third Street on the south

City or town: Moscow State: ID County: Latah

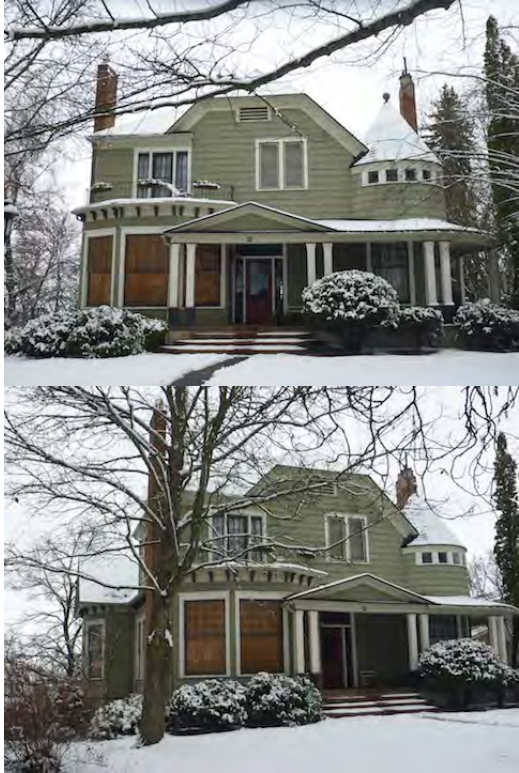
<p>The Dr. Gritman House faces south toward B Street, west of VanBuren. It is an asymmetrical, two-story, frame dwelling with a turret on the southeast corner and an open porch curving around the southeast corner. The dwelling features hipped, gabled, jerkinhead, and conical rooflines and has two, exterior brick chimneys on the east and west sides. The house has large, sixteen-over-one, wood-sash windows, and a multi-light wood door with sidelights that leads to a small second level balcony. A pair of vinyl windows is found above the main entry, while small, square windows surround the turret. The porch is supported by wood posts with a small gable above the entry, which contains a single-light door, multi-light transom, and narrow, multi-light sidelights. Scrolled brackets can be found in several locations where slight overhangs shelter the first story windows. The house is covered in wood shingles, and features a single-story portion at the rear.</p>

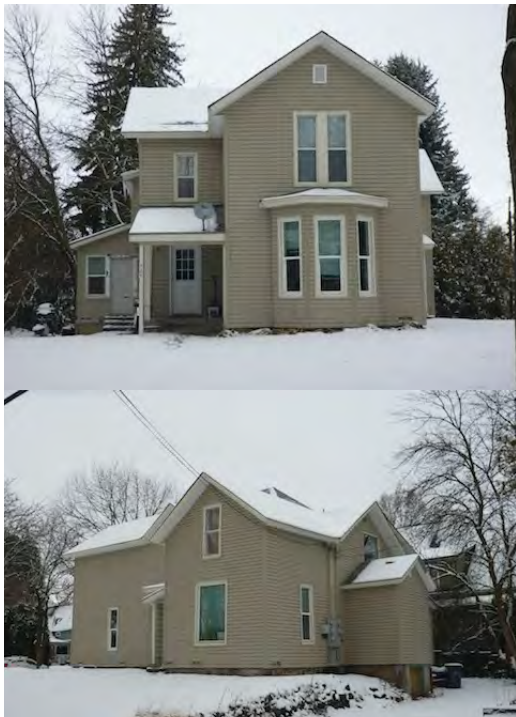
Survey Site Data	Site Photographs	Site Details
<p>Site #: 40 424 East B Street Owner: Bensen Family Trust 1888 Previous District Status: C, 27 DoE: C</p>

<p>The R. H. Barton House is located on the northwest corner of B and VanBuren Streets. It is a two-story, cross-gabled, L-plan, frame dwelling with a slightly shorter, two-story, cross-gabled addition on the rear. Though it appears the original dwelling is an L-plan, the rear addition creates an overall footprint of a T-plan. The original main entry is beneath a shed-roof porch on the south or façade elevation. Two more entries, also facing south are at the west and east ends of the rear addition. An enclosed, gable-roof extension is centered on the rear. A three-sided bay is centered on the forward extension of the original portion, with another on the east elevation. The house is covered in vinyl siding and has vinyl windows and replacement doors. The dwelling is set back within a large corner lot and rests on stone.</p>

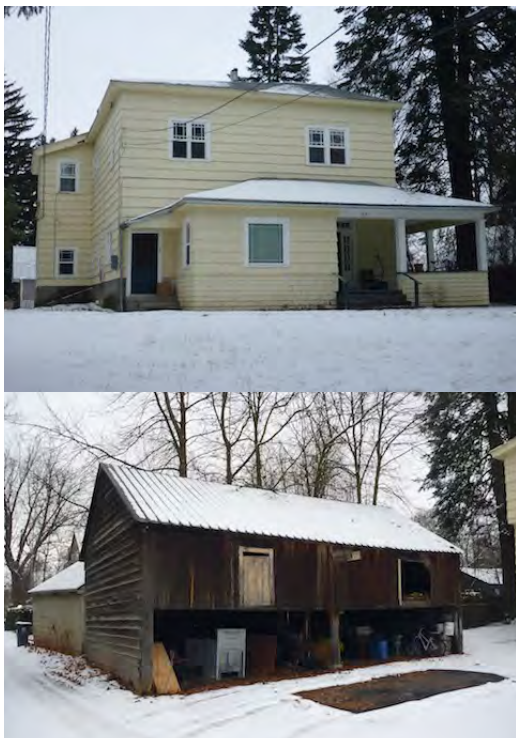
<p>Site #: 41 310 North VanBuren Street Owner: 310 North Van Buren LLC 1888 Previous District Status: C, 31 DoE: C Barn: Historic DoE: C</p>

<p>The original nomination identifies this as the Colonel Frank H. Barton House,. It is a two-story, multi-residence unit, with original full-height projections on the north and south sides and northeast corner. A hip-roof porch wraps around the southwest corner and was present by 1928; it appears to have been originally constructed partially enclosed as it currently appears. The deeply inset entry door is a wood paneled door with an oval window, eight-light sidelights, and a nine-light transom. The porch roof is set on square posts atop an apron wall. The exterior is clad in wood shingles. All of the windows have been replaced with vinyl sashes. At the southeast corner of the site is a side-gable, partially enclosed, raised barn built between 1904 and 1928. It features roughhewn wood clapboards and a metal roof.</p>

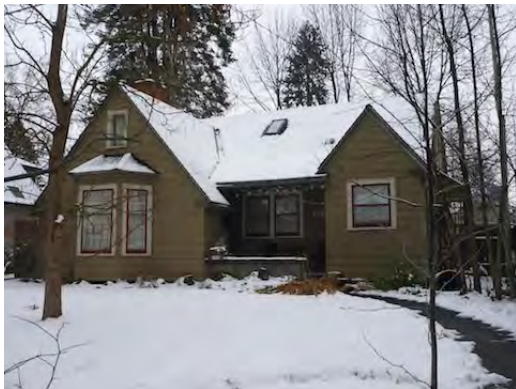
Survey Site Data	Site Photographs	Site Details
<p>Site #: 44</p> <p>518 East B Street</p> <p>Owner: Kimberly Dahl</p> <p>1933</p> <p>Previous District Status: NC (compatible), 71</p> <p>DoE: C</p> <p>Garage: Historic</p> <p>DoE: C</p>

<p>This is a single-story, cross-gable frame dwelling, oriented south towards East B. It features two front-facing gables of differing sizes and an inset entry porch under a deep eave. The porch also features a low, brick knee wall. Both forward gables have cornice returns, while the larger west end gable has a small, vertical wood window above a three-sided bay window. A side entry with a wood frame French door is found on the east, with a shed roof above. A large brick, double-flue chimney is located at the west end. The residence is clad in wood shingles, and two skylights are found on the roof. At the northeast corner of the property at the alley is a gable roof garage covered in wood shingles and featuring wide wood trim, narrow eaves and a metal single-car roll-up garage door.</p>

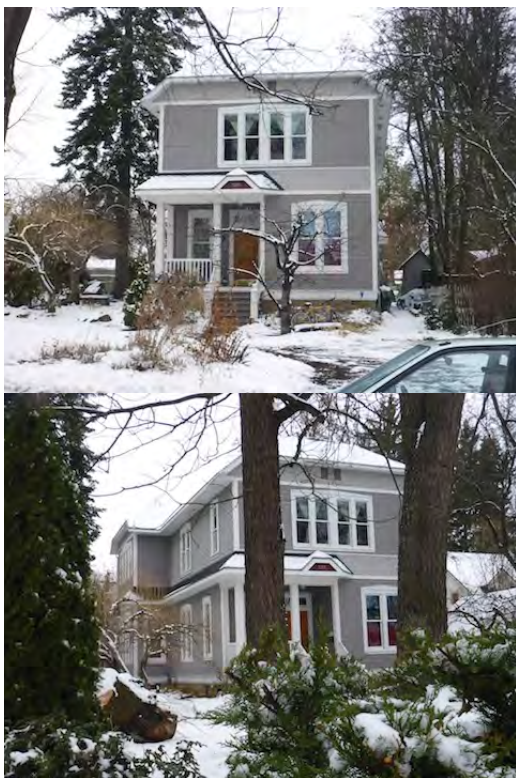
<p>The residence at Site 45 is a two-story dwelling oriented south to East B Street, and was moved here from 514 East First Street (Otness, 79). This is a tall, rectangular, clipped gable dwelling with a wide, clipped-crossing-gable and a two-story veranda at the rear. A partial-width porch with square columns and pilasters is found on the façade. All the trim and detailing mimics the Queen Anne style, but are created with modern materials. Vinyl windows are found throughout. The dwelling is clad in composite lap siding with a band of fish scale shingles between the floors. Roofing is composition shingle and the foundation is concrete. At the northwest edge of the site is a gable front garage with wood siding, metal roofing, open eaves, exposed rafter tails, a sheet of metal roofing as a siding repair, and a modern door. Northeast of the dwelling is a historic, gable-roof shed with wood siding and a wood shingle roof.</p>

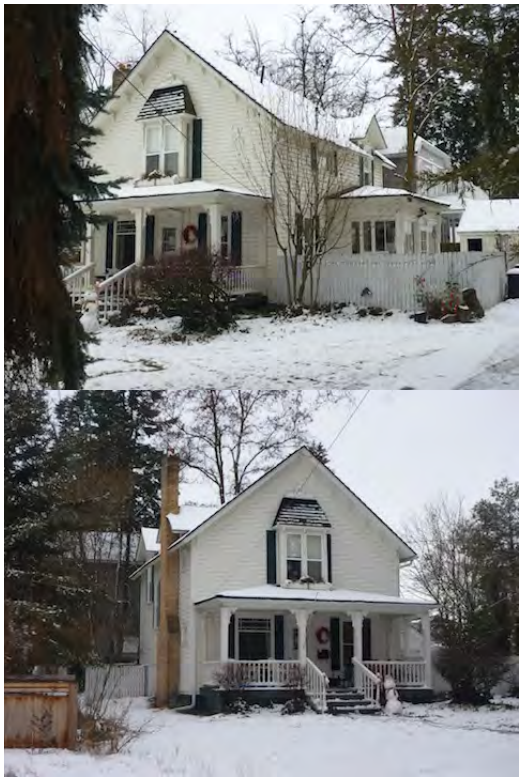
<p>This is a one-and-one-half story, gable-oriented, rectangular plan, Italianate-styled dwelling with a single-story addition on the north. Two gable-roof wall dormers are found on the south side and one is found on the north side. A full-width porch with a low-pitched hipped roof atop square posts and pilasters with elaborate scroll-sawn brackets and turned wood balusters spans the façade. Windows have shutters and simple wood surrounds; some wood-sash windows remain. Above the porch roof is a projecting square bay with a pair of vinyl windows, brackets, corner finials, and shutters, with a small, Mansard roof capped with a dated shield. On the north is a hip-roof sunroom addition with details that mimic the residence, with multiple wood-sash windows and a single French door. On the south is a blonde brick, double-shouldered exterior chimney that rises through one of the dormers. The dwelling is clad in wood drop siding with corner boards, and has a wide fascia with brackets lining the gable ends and narrow eaves. The roof is covered in wood shingles, and the foundation is stone. At the northwest corner of the site is an L-plan, single-car garage covered in drop siding, with a modern overhead door.</p>

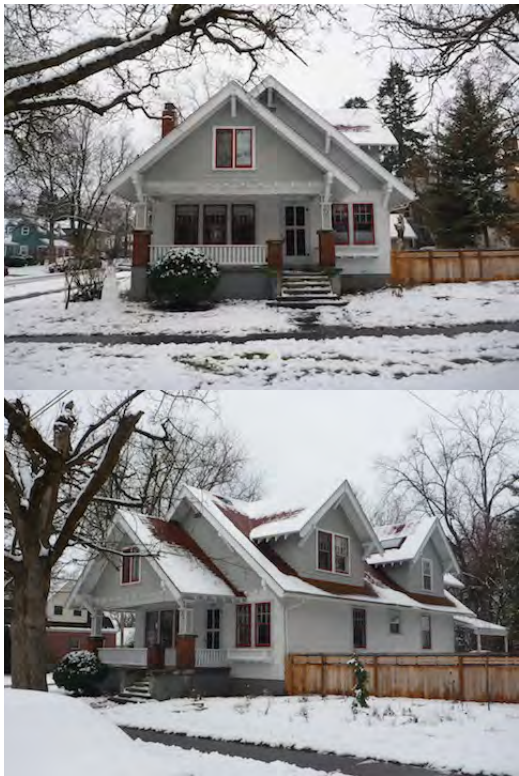
<p>This dwelling, oriented east, is a one-and-one-half story, front-gabled Craftsman Bungalow. The façade features a full-width porch under the main roof atop square wood posts with trim detailing resting on capped, brick piers. The entry is off-centered with a glazed wood panel entry door. Both original eight-over-one, double-hung, wood-sash windows and some vinyl replacement windows are found on the dwelling. The gables have heavy knee braces, exposed rafter tails, wide eaves, exposed beam ends, and wide bargeboards. At the north elevation is a pair of steeply pitched gabled dormers. On the south elevation is a single dormer and a large, single-shouldered brick, outside chimney. The rear features a gable-roof, screened sleeping porch that extends out from the second level creating a covered breezeway below. At the southwest corner is a small square addition with a hip roof, a glass-block window, several wood-sash windows, and a brick knee-wall. The dwelling is sheathed in a narrow lap siding while the dormers and gable ends are shingled. At the northwest corner of the site is a gable-front, two-car garage with glazed wood panel sliding doors. The garage features lap siding with wood shingles and knee braces in the gable end, and a pent roof at the opening set atop heavy knee braces with exposed rafter tails.</p>

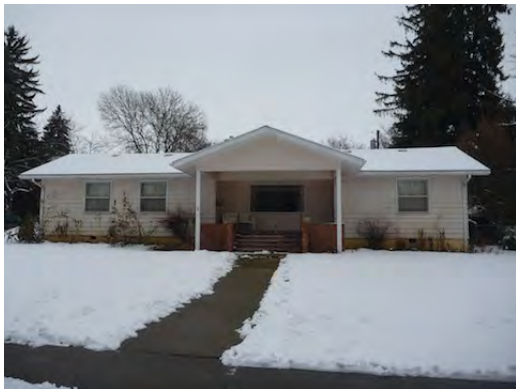
Survey Site Data	Site Photographs	Site Details
<p>Site #: 48</p> <p>604 East B Street & 304 North Polk Street</p> <p>Owner: Nathan Palmer</p> <p>1963</p> <p>Previous District Status: NC (intrusion), 67</p> <p>DoE: NC</p> <p>Garage: Modern</p> <p>DoE: NC</p>

<p>Site 48 is a single-story, mid-twentieth-century duplex. The dwelling was originally U-shaped, but now has an infill addition at the rear. The south-facing facade on East B Street has a gable-roof porch, set atop 4x4 wood posts. Centered in the porch is a wood-frame picture window. The entry door is set in the east wall of the porch. The west elevation has an inset entry porch under the main gable roof. A wood-sash picture window is also found on the west side. Windows throughout the dwelling are wood-sash, some with metal awnings. A low brick planter runs at the foundation. Attached at the flat-roofed breezeway to the north is a side-gabled, three-car garage facing North Polk Street. The garage features three roll-up garage doors.</p>

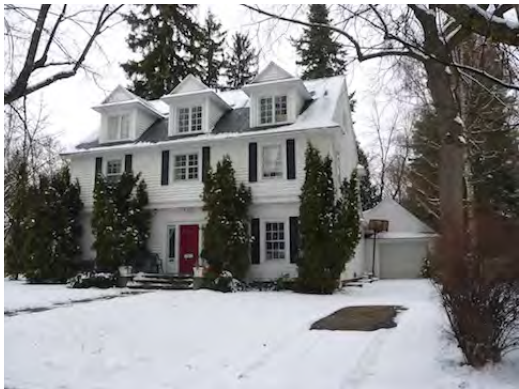
Survey Site Data	Site Photographs	Site Details
<p>Site #: 49</p> <p>610 East B Street</p> <p>Owner: Jan Boll</p> <p>1925</p> <p>Previous District Status: NC (compatible), 66 DoE: C</p> <p>Garage: Historic DoE: C</p>

<p>This is a two-and-one-half-story Colonial Revival dwelling facing south toward East B Street. It has a symmetrical, three-bay (w/wdw/w), side-gabled façade with an overhanging second story and three gable-roof dormers. A shed roof, one-story side wing is to the west and an attached garage to the east. The main entry has a wood, inset panel door with leaded glass sidelights and wide wood trim. Wood-sash, double-hung windows, many with shutters, are found throughout. The dormers contain eight-light casement windows. The west side wing's shed roof appears to be a later addition over the original flat roof. Also on the west side is a tall, brick, double-flue chimney flanked by a pair of triangular wood-sash windows. On the east, the attic level has a fanlight window. The gable ends feature cornice returns, and the dwelling is covered in vinyl. A small, shed-roof enclosed back porch connects the residence to the garage, which has a pent roof over the opening, a modern metal door, wide wood siding, and a shed roof addition on its west elevation.</p>

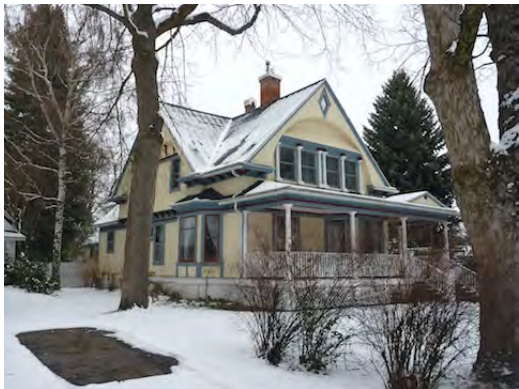
Survey Site Data	Site Photographs	Site Details
<p>Site #: 50 622 East B Street Owner: Janice Boughton 1904 Previous District Status: C, 65 DoE: C</p> <p>Garage: Historic DoE: C</p>

<p>The Wellington Ely House is a one-and-one-half story cross-gabled dwelling, oriented south facing East B Street. Dominating three of the elevations are broad, open gables that overhang with a flare at the junction, with the first level supported by scroll-sawn brackets. Each of the gable ends exhibit unique features, including varying shingle patterns, varying windows, some with columns between, arched insets, false timbering, and a projecting cornice detail with brackets. The gable on the façade features a diamond-shaped window in its peak. Below the gable on the façade is a full-width, hip-roof porch with a small gable highlighting the offset entry. Within the porch is a bay window with three, one-over-one, wood-sash windows, and a simple, painted wood panel entry door with glazing. Below the gable on the east are an arched, wood-sash window and a bay window with a hip roof and three one-over-one, wood-sash windows. On the west is another bay window similar to the east side. The main level is clad in wood drop siding, the foundation is brick and the roof is covered in composition shingles. The original garage is to the rear, and features an early addition, creating an L-shaped footprint. It is covered in wood clapboards. The garage features a pair of carriage doors, corner boards, wide fascia detail, cornice returns, wood sash windows, and a narrow wood panel door on the west.</p>

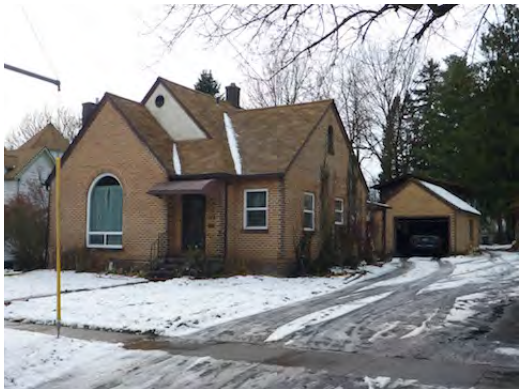
Survey Site Data	Site Photographs	Site Details
<p>Site #: 51</p> <p>315 North Howard Street</p> <p>Owner: Richard Hart</p> <p>1935</p> <p>Previous District Status: NC (compatible), 56</p> <p>DoE: C</p> <p>Garage: Historic</p> <p>DoE: C</p>

<p>Site 51 faces east toward Howard,north of B Street. It is a one-and-one-half-story, cross-gabled, brick dwelling. An arched window is centered on the forward extending gable, while the main entry, sheltered by a metal awning, is recessed slightly behind. A small arched window is also found on the north elevation, while a large arched opening, containing sliding glass doors, is found on the south. A gable-roof addition, similar in scale to the original dwelling, is found at its southwest corner. It features brick cladding on the side facing the street, while the rest is covered in vinyl. Vinyl windows are found throughout. The original, gable-roof, brick, single-car garage is found behind the dwelling, with a two-story, frame addition on its rear. Because the addition on the dwelling is setback from the façade, it does not detract from the historical integrity of this property.</p>

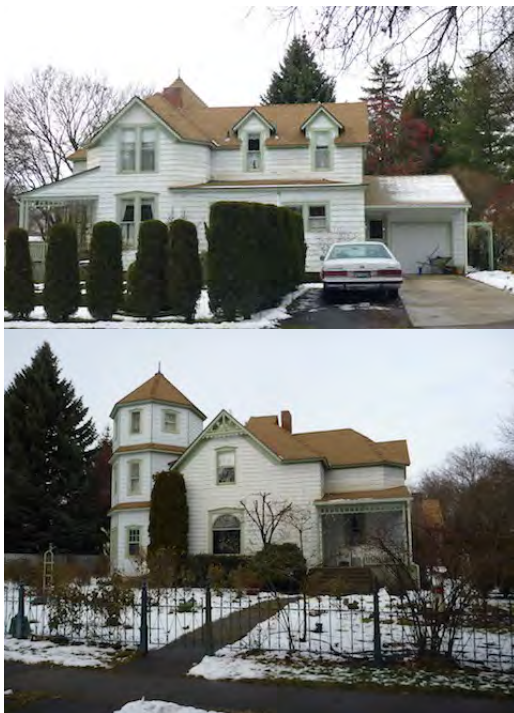
Survey Site Data	Site Photographs	Site Details
<p>Site #: 52</p> <p>634 East B Street</p> <p>Owner: Dick Sanchez</p> <p>1895</p> <p>Previous District Status: NC (compatible), 57</p> <p>DoE: C</p> <p>Garage: Modern</p> <p>DoE: NC</p>

<p>Site 52 is on the northwest corner of Howard and B Streets. It is two-story, asymmetrical dwelling with a three-story, polygonal tower at the southwest corner. According to <i>A Great Good Country</i>, the tower was added during the early 1980s (Otness, 90). Those same owners added the millwork on the porch and the aluminum siding. According to that text, the stained-glass, arched window on the south elevation was salvaged from the Ursuline Convent building. A slight gable-roof extension, with two gabled wall dormers, is found on the rear of the dwelling. A single-story, hip-roof portion is found on the east wall of the rear extension. One-over-one, six-over-one, and eight-over-one, wood-sash windows can be found on the dwelling. A small, single-car garage is also attached to the far rear of the house. According to a neighbor, the iron fencing surrounding the yard was also salvaged.</p>

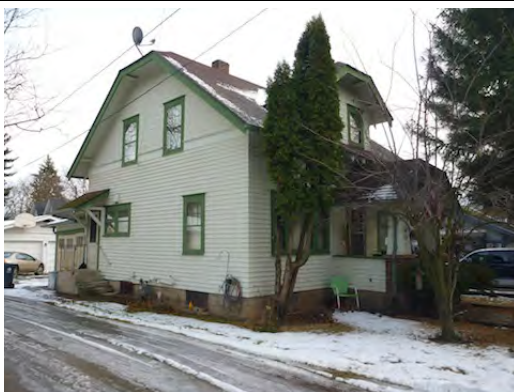
<p>Site #: 53</p> <p>320 North Howard Street</p> <p>Owner: Paul Hedler Trustees</p> <p>1924</p> <p>Previous District Status: C, 58</p> <p>DoE: C</p> <p>Garage: Historic</p> <p>DoE: C</p> <p>Garage: Modern</p> <p>DoE: NC</p>

<p>This is a one-and-one-half-story, three-bay (www/d/w), frame Bungalow. It features clapboard siding on the lower level and wood shingles above, a jerkinhead roof over the main house as well as over a dormer above the façade and over the central entry porch on the façade. The entry is supported by flared columns on brick piers. The house is set on a concrete basement foundation. The windows on the dwelling retain six-over-one, double-hung, wood-sash windows. An early garage is attached to the rear of the dwelling, retaining multi-light, paneled, wood doors. At the rear of the property, is a nonhistoric, gable-roof, frame, two-car garage.</p>

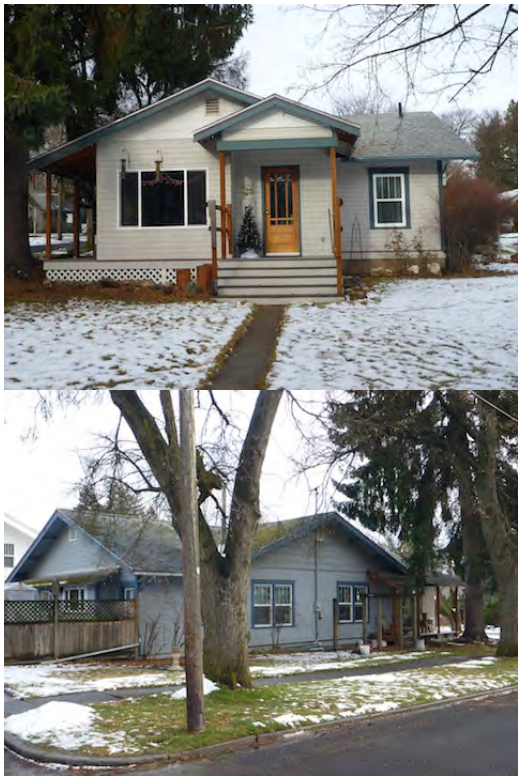
<p>Site 54 faces south on the northeast corner of Howard and B Streets. It is a single-story, cross-gabled, frame Bungalow with a nonhistoric, gable-roof addition extending on the façade. The main entry porch, featuring a gable roof above, is also found on the façade. A small deck is located on the west side of the front addition, and a small, shed-roof, enclosed porch is found on the rear. The dwelling is set on a concrete foundation, and the original portion is covered in clapboard siding with shingles in the gable ends, while the addition is covered in horizontal boards. The windows are vinyl throughout. A frame, gable-roof garage is found at the rear. It features clapboard siding, brackets, and multi-light doors. The façade addition has altered the building's original appearance, and has compromised its ability to read as a Bungalow.</p>

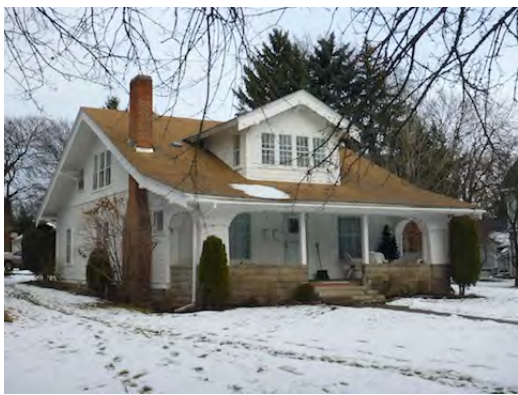
<p>Site #: 55 708 East B Street Owner: Richard Hoeft 1910 Previous District Status: C, 60 DoE: C Garage: Historic DoE: NC Shed: Historic DoE: NC</p>

<p>This dwelling is a one-and-one-half-story, three-bay (w/d/w), side-gable, Bungalow with a full-width porch spanning the façade. The porch is sheltered beneath an extended overhang of the primary roof, supported by square posts with curved brackets. The porch and dwelling are set on rusticated concrete blocks. A large gable-roof dormer extends above the façade. The dwelling is covered in drop wood siding, with wood shingles covering the dormer and side, gable ends. Multi-light, wood-sash windows remain. A shouldered, brick chimney is found on the west elevation. A small, square bay topped with a shed roof exhibiting rafter tails is found on the east side. A small, frame, gable-roof garage is located at the rear of the property.</p>

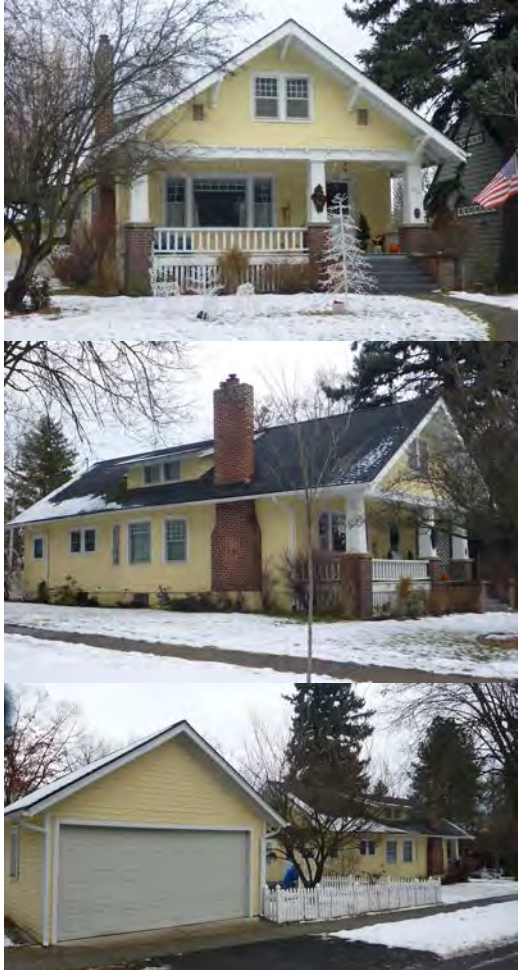
<p>Site 57 is located on the northeast corner of B and Monroe Streets, oriented south. It is a one-and-one-half-story, two-bay (www/d), gable-oriented Bungalow, with a full-width porch spanning the façade. The porch is recessed beneath the upper level, and is supported by flared posts on brick piers. Shed-roof dormers pierce the roof over the east and west elevations. A shouldered, exterior brick chimney is found on the west elevation, along with a three-sided bay window on the first level. The dwelling exhibits visible rafter tails, brackets, and bargeboards with birds-mouth elaborated ends. The house is covered in asbestos siding and retains multi-light, wood-sash windows. A small, gable-roof overhang shelters a rear entry. A large, frame, nonhistoric, two-car garage covered in horizontal boards is located behind the house.</p>

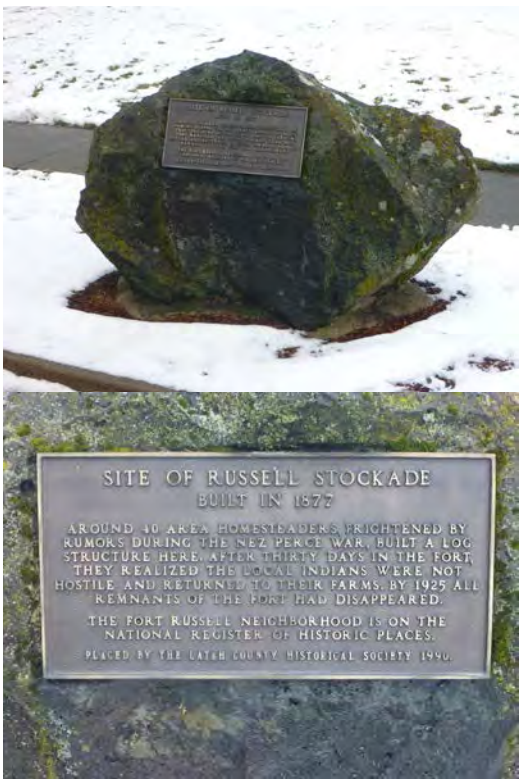
Survey Site Data	Site Photographs	Site Details
<p>Site #: 58</p> <p>East B Street, between North Monroe and North Lincoln Streets</p> <p>Owner: City of Moscow</p> <p>1990</p> <p>Previous District Status: n/a</p> <p>DoE: NC</p>

<p>Site 58 is located on East B Street, between Monroe and Lincoln. It is situated in front of 810 East B Street. This is a boulder, set in the grass strip between the sidewalk and the street in this location. It features a marker on it that reads “Site of Russell Stockade, Built in 1877. Around 40 area homesteaders, frightened by rumors during the Nez Perce War, built a log structure here. After thirty days in the fort, they realized the local Indians were not hostile and returned to their farms. By 1925 all remnants of the fort had disappeared. The Fort Russell neighborhood is on the National Register of Historic Places. Placed by the Latah County Historical Society 1990.” Though the marker itself dates at less than 50 years of age, it is marking a spot that is much older, and which carries with it great historical significance for the area and most notably for this neighborhood and district that bears its name.</p>

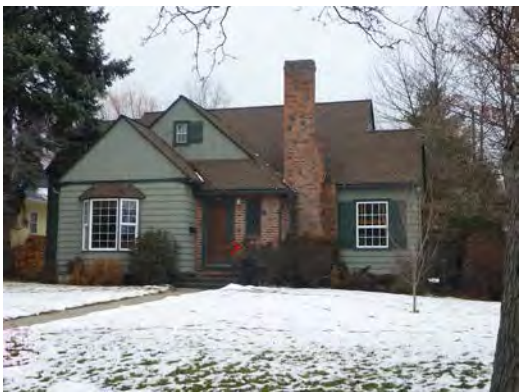
<p>Site #: 59</p> <p>810 East B Street</p> <p>Owner: Sanford Eigenbrode</p> <p>1935</p> <p>Previous District Status: n/a</p> <p>DoE: C</p> <p>Garage: Historic</p> <p>DoE: C</p>

<p>Site 59 faces south toward B Street, and is a single-story, asymmetrical, cross-gabled, frame. It features two forward extending gables on the façade, and a small gabled extension on the east side. A small, full-height addition is found on the west side. The house is clad in horizontal boards, with vertical boards within the gables. The windows are vinyl, though a leaded-glass window with a diamond pattern is found next to the main entry in an area clad in brick. A single-shouldered, exterior brick chimney is also found next to the entry. Some windows feature wood shutters.</p>

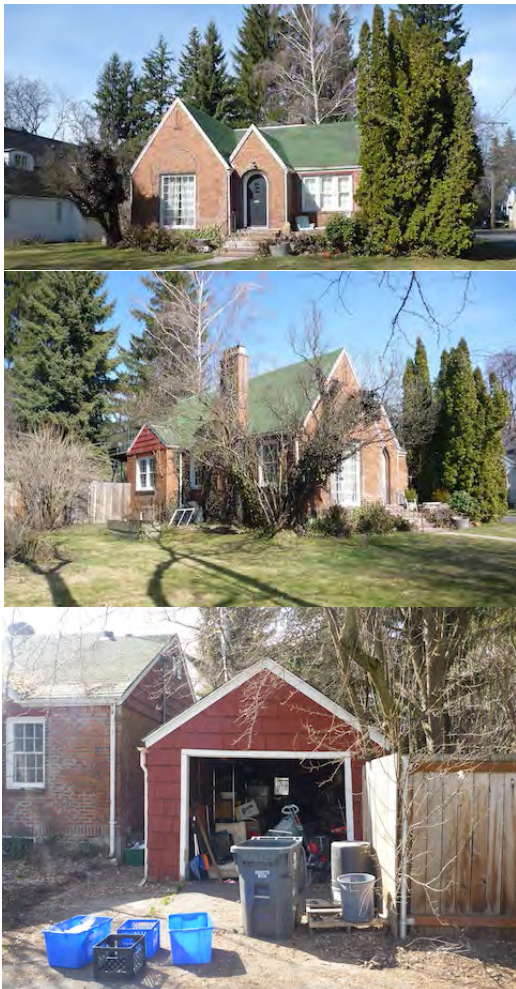
<p>This is a one-and-one-half-story, cross-gable roof, brick, English Cottage-style residence with an attached garage on the northeast corner. A large, thirty-light, wood-sash window is found below a large brick arch on a forward-facing extension on the south elevation. Next to this gable is an enclosed, gable-roof porch with an arched wooden door set slightly back within a brick arch. A triple window containing three, four-over-four, double-hung, wood-sash windows is found on the façade elevation of the side-gabled section. A small, single-story, gable-roof, square bay is found on the west elevation. The gable roof on the east and rear elevations and the gable over the bay on the west are all filled with wood shingles. A wide, exterior brick chimney is also found on the west elevation. Multi-light, double-hung, wood-sash windows are found throughout the remainder of the dwelling. A soldier course of bricks is found along the cornice line as well as just above the concrete foundation. An original gable-roof, single-car garage is attached by a hyphen at the northeast corner of the house. It is covered in wood shingles.</p>

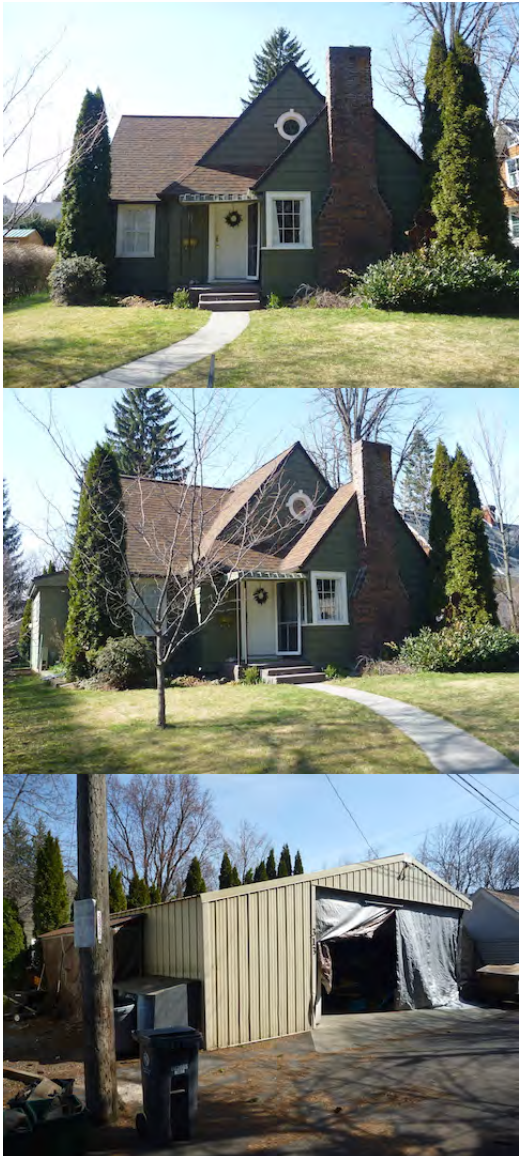
<p>This is a one-and-one-half-story, cross-gabled, frame dwelling. It features a full-height, gable-on-hip extension with a slightly smaller, gable-roof extension on its façade elevation. The main entry on the façade is sheltered by a small, nonhistoric, metal awning. An exterior, brick, shouldered chimney is found on the forward most extension on the façade, while a small, wood-sash oculus window is found on the forward wall of the larger, forward extension. The dwelling is covered in wood shingles and contains multi-light, double-hung, wood-sash windows and replacement vinyl windows. A small, single-story addition has been added to the southwest side of the house. A large, nonhistoric, metal garage and workshop is set rear of the dwelling.</p>

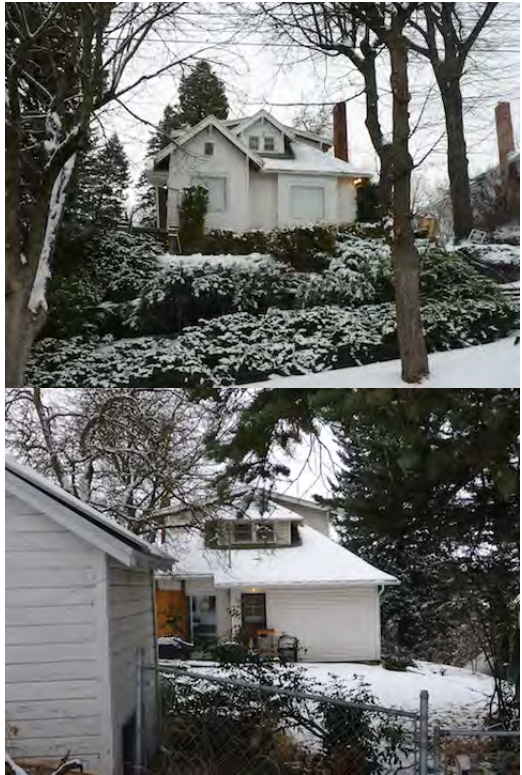
<p>Site 66, located on Jefferson, north of A Street, is a one-and-one-half-story, hip roof dwelling, with a gable-roof extension on the façade or west elevation. A small square bay is also found on the façade, and dormers are found above both the façade and rear elevations – gable-roofed on the façade, and hip-roofed on the rear. Large, shed-roof dormers rise above both the south and north elevations. The dwelling is covered in vinyl siding, and exhibits multi-light, wood-sash windows and aluminum windows, with an aluminum sliding door on the rear. An exterior brick chimney rises on the south elevation. The dwelling also exhibits wood brackets and bargeboards with decorative notched ends. A small, concrete, gable-roof garage is found at street level just south of the dwelling. A small shed roof shelters the wooden garage door, and is supported by curved brackets. A small, frame, gable-roof shed covered in clapboard siding is located at the rear of the property.</p>

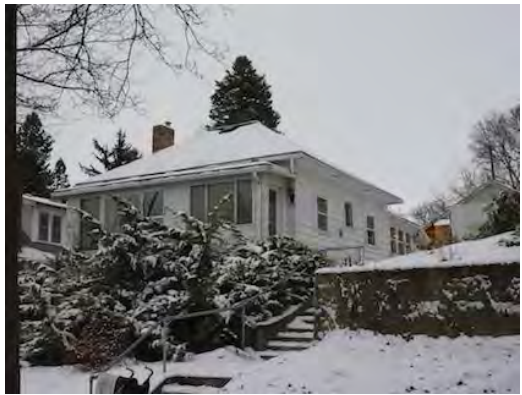
<p>Site #: 67</p> <p>226 North Jefferson Street</p> <p>Owner: 226 N Jefferson LLC</p> <p>1915</p> <p>Previous District Status: C, 13</p> <p>DoE: C</p> <p>Garage: Historic</p> <p>DoE: C</p>

<p>Site 67 faces west toward Jefferson, north of A Street. It is a single-story, frame dwelling with a truncated hip roof, and a single-story, enclosed porch on both the façade and rear elevations. The dwelling is covered in wood shingle siding, with simple wood window surrounds around replacement, vinyl windows. At the rear of the property is a large, frame, gable-roof vehicular garage with two entry bays – one containing sliding doors, and the other with hinged doors. The garage is covered in clapboard and retains wood doors.</p>

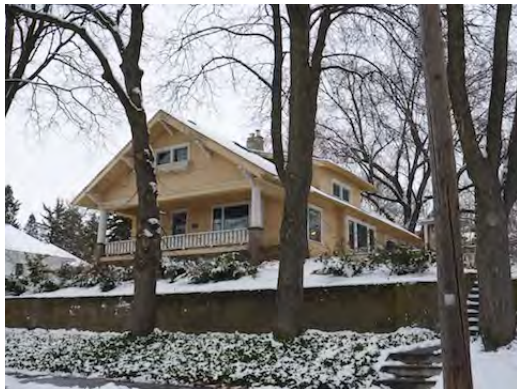
Survey Site Data	Site Photographs	Site Details
<p>Site #: 68</p> <p>220 North Jefferson Street</p> <p>Owner: Brian Thie</p> <p>1907</p> <p>Previous District Status: C, 12</p> <p>DoE: C</p> <p>Garage: Historic</p> <p>DoE: C</p>

<p>Site 68 faces west onto Jefferson Street north of A Street. It is a one-and-one-half-story, three-bay (w/d/www), gable-oriented, frame Bungalow. A full-width porch spans the façade, sheltered by an extension of the upper story, supported by Tuscan columns set on stone block piers. A wooden balustrade spans the porch. A multi-light, wood door is centered on the façade. Large brackets support the wide eaves. The dwelling is clad in clapboard on the main level and wood shingles on the upper level. Multi-light, wood-sash windows can be found on the house. A shed roof dormer is located on the south elevation above a square bay that extends from the main level. A shed-roof, enclosed porch spans the entire rear elevation. A large, gable roof, frame, vehicular garage, with one, single-car garage door is found to the rear of the property.</p>

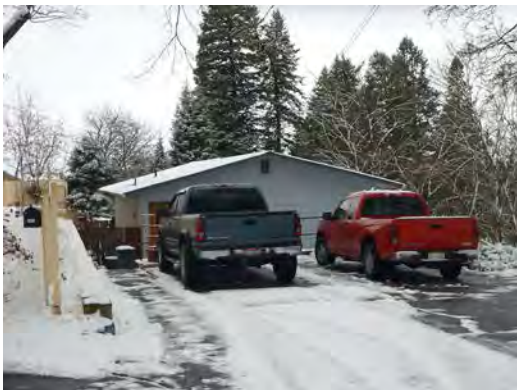
<p>Site #: 69</p> <p>223-225 North Adams Street</p> <p>Owner: Michael Jennings</p> <p>1971</p> <p>Previous District Status: n/a</p> <p>DoE: NC</p>

<p>Site 69 faces east toward the intersection of Adams and B Streets. It is a nonhistoric, single-story, gable-roof, frame duplex dwelling covered in horizontal boards, with vertical boards filling the gable end. Only a single entry door is visible on the east elevation. No windows or entries are found on the south elevation. Private property access and the severely sloping property line prohibited access to photograph remaining elevations.</p>

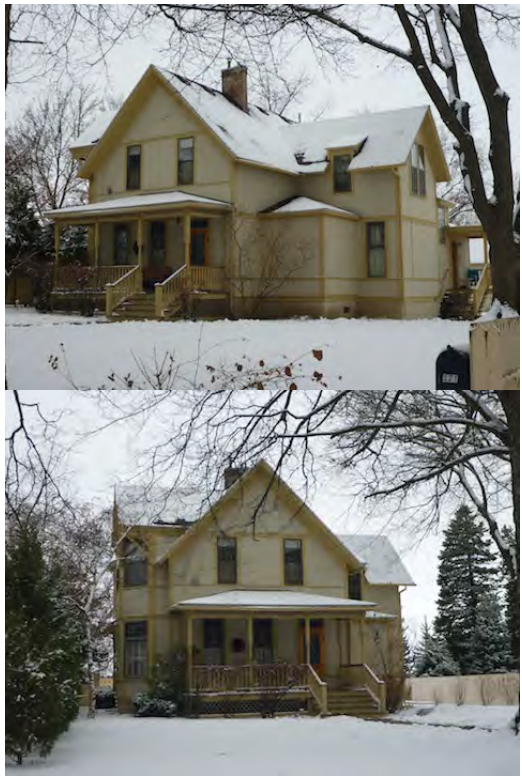
<p>The old Henry Dernham House faces east toward the intersection of Adams and B Streets. It is a two-story, cross-gabled, frame Queen Anne Victorian, with a slightly shorter, gable-roof extension on the north elevation and a single-story addition or enclosed porch behind the extension on the rear. A single-story, hip-roof enclosure is found in the ell between the forward gable and the north extension. The façade features a forward-facing gable roof, and a single-story, hip-roof porch with turned posts. The south side elevation features a full-height, three-sided bay with a gable roof supported by brackets, and a three-sided bay with a hip roof. An entry, beneath a shed-roof porch with turned posts and decorative brackets is found at the rear of the south elevation. The rear of the house is covered in vinyl or aluminum. Some one-over-one, wood-sash windows with small stained-glass lights can be found on the house. On the façade and side elevations, the house is covered in clapboard siding on the lower level, with both fish scale and diamond shingle imbrication above. A nonhistoric, gable-roof, single-car garage is located at the rear of the lot.</p>

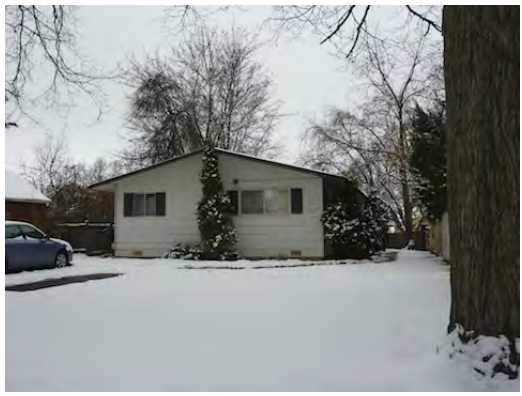
<p>Site #: 71</p> <p>215-217 North Adams Street</p> <p>Owner: David Potter OR/</p> <p>1970</p> <p>Previous District Status: NC (intrusion), 21</p> <p>DoE: NC</p>

<p>Site 71 is a nonhistoric residence, facing east on Adams south of B Street. It is a single-story, gable-roof, frame, duplex dwelling with entries on the north and south sides. The building exhibits a combination of vinyl and aluminum windows, nonhistoric shutters, and aluminum or composite siding.</p>

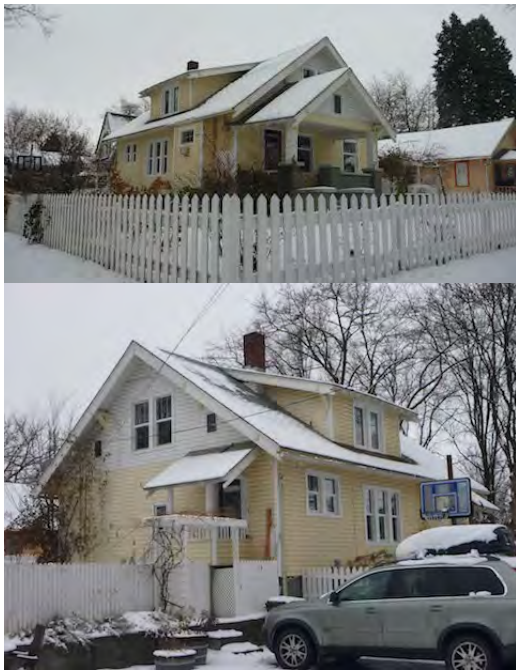
Survey Site Data	Site Photographs	Site Details
<p>Site #: 72</p> <p>222 North Adams Street</p> <p>Owner: Tanja Rankin</p> <p>1917</p> <p>Previous District Status: C, 20</p> <p>DoE: C</p>

<p>Site 72 faces west on the southwest corner of Adams and B Streets. It is a one-and-one-half-story, frame, gable-oriented Bungalow with a gable-roof porch on the façade elevation. The porch is supported by square posts set on raked brick, which has been painted and partially covered with mortar or another material. The dwelling exhibits rafter tails and brackets. The walls are covered in vinyl siding and all the windows are vinyl replacements. Shed-roof dormers are found above both the north and south side elevations, and a shed-roof porch is found on the rear. A small, square bay extends on the north elevation.</p>
<p>Site #: 73</p> <p>216 North Adams Street</p> <p>Owner: Garth Blanchard</p> <p>1917</p> <p>Previous District Status: C, 19</p> <p>DoE: C</p> <p>Garage: Historic</p> <p>DoE: C</p>

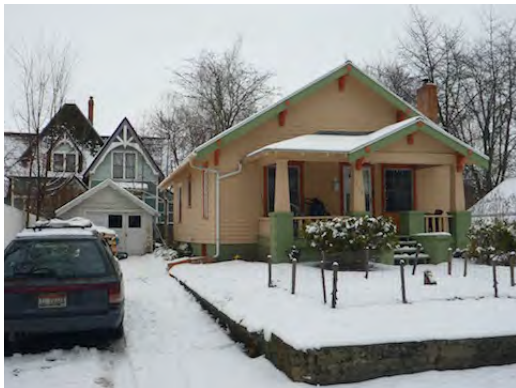
<p>Site 73 faces west toward Adams south of B Street. It is a single-story, gable-oriented, three-bay (w/d/w), Bungalow with a gable-roof porch supported by flared posts set on concrete bases. It exhibits clapboard siding, wood window and door surrounds with crown molding above, wood-sash windows, and an exterior brick chimney on the south elevation. The house is set on a concrete foundation, with non-egress basement windows. A frame, gable roof, single vehicle garage is located to the rear. It is covered in clapboard siding, and features three paneled wood doors.</p>

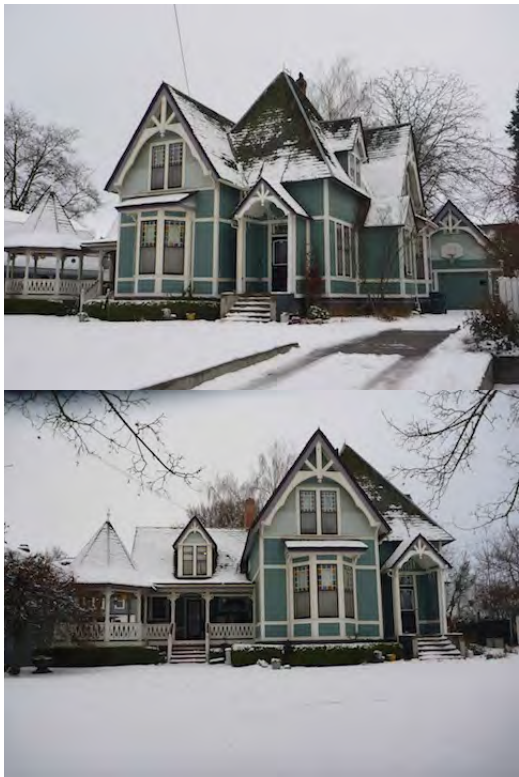
<p>According to <i>A Great Good Country</i>, this dwelling originally faced Adams Street and its property took up the entire block (Otness, 84). It is a one-and-one-half-story, frame dwelling exhibiting Queen Anne elements. It features a steeply pitched hip roof, with gable-roof extensions toward the north and west. Shed roofs cover three-sided bays on the north and west sides. There is a gable-roof entry porch on the north side, and an enclosed, gable roof extension on the west. A gable-roof dormer is found on the west side. A slightly shorter, one-and-one-half-story, gable-roof section is found on the east side. It features a gable-roof dormer, a highly decorated porch across its full width, and a round deck off the northeast corner with a conical roof and finial. A narrow brick chimney extends from the original hip-roof portion of the house, while two more brick chimneys are found between the original rear elevation and east addition. The house is covered in clapboard, with fish scale imbrication within the gable ends. Heavy brackets and one-over-one, wood-sash windows with small stained glass lights around the edges also remain. A gable-roof, two-car garage exhibiting similar materials to the dwelling is found at the southwest corner.</p>

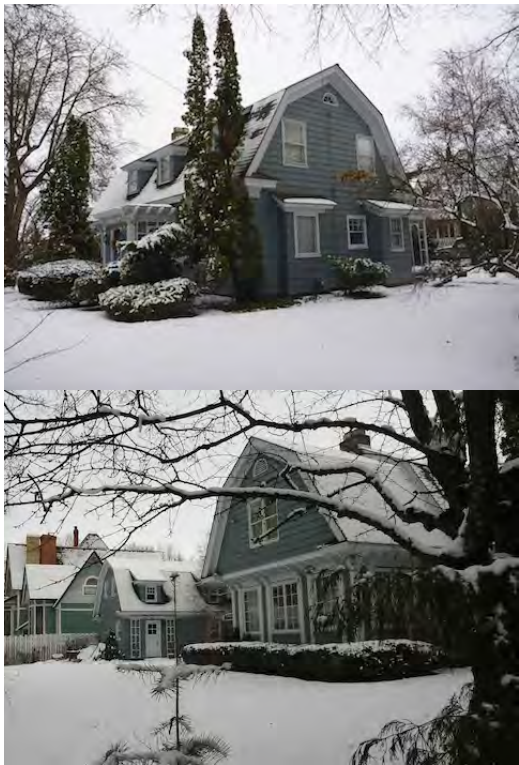
Survey Site Data	Site Photographs	Site Details
<p>Site #: 75</p> <p>215 North VanBuren Street</p> <p>Owner: Gregory Moller</p> <p>1917</p> <p>Previous District Status: C, 28</p> <p>DoE: C</p> <p>Garage: Historic</p> <p>DoE: C</p>

<p>Site 75 sits on the southwest corner of VanBuren and B Streets. It is a one-and-one-half-story, gambrel-roof, Dutch Colonial Revival dwelling. A flat roof, enclosed porch extends from the façade, while a full-height addition constructed to match the original dwelling extends on the south side. The addition exhibits rafter tails beneath the overhang of the upper level. The dwelling is covered in wood shingles, and exhibits six-over-one, eight-light, and twelve-light, wood-sash windows. Some windows on the main level of the façade are flanked with wood shutters with an incised cross design. Three shed-roof dormers are found above the façade elevation. Two shed roof, square bays extend from the main level on the north elevation and a wood-sash, half-moon window is found on the north side in the attic level. A brick chimney pierces the roof. A one-and-one-half-story, frame, gambrel-roof, vehicular garage is found behind the house. It features six paneled, wooden hinged doors with four-light windows, six-over-one wood-sash windows, shed-roof dormers, and a paneled pedestrian door.</p>

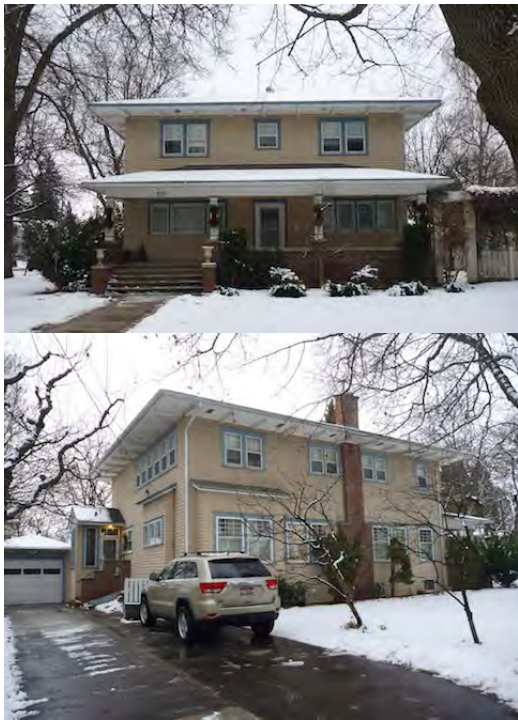
Survey Site Data	Site Photographs	Site Details
<p>Site #: 76</p> <p>220 North VanBuren Street</p> <p>Owner: William Woolston</p> <p>1912</p> <p>Previous District Status: C, 29</p> <p>DoE: C</p> <p>Garage: Historic</p> <p>DoE: C</p>

<p>The Homer David House is a large, two-story, Prairie-style dwelling oriented west facing North VanBuren. The house features a low-pitched, hip roof with deep, boxed eaves with modillions, and a full-width hipped-roof porch spanning the façade. The porch roof is supported by square posts atop brick piers with concrete caps. A concrete-capped brick wall surrounds the porch. South of the door is a ribbon of four, wood-sash casement windows each with four lights above a single, larger pane. Double-hung and casement, wood-sash windows are found throughout. At the north elevation, a tall, shouldered, brick, chimney pierces the eave to rise above the roof. Both the north and east elevations feature square bay windows with a shallow shed roof. A ribbon of six, wood-sash, double-hung, nine-over-one windows is found on the second level on the dwelling's rear. Also on the rear is a gable-roof, enclosed porch with a French door with a three-light transom. The roof is composition shingle and the walls are clad in narrow lap siding. At the southeast corner is a small, single-car garage with a hip roof, wood lap siding, an overhead door, and wide wood trims.</p>

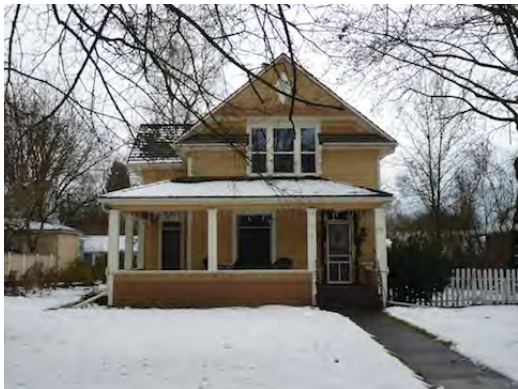
Survey Site Data	Site Photographs	Site Details
<p>Site #: 77</p> <p>210 North VanBuren Street</p> <p>Owner: Robert Hieronymus</p> <p>ca. 1900</p> <p>Previous District Status: C, 90</p> <p>DoE: C</p> <p>Garage: Modern</p> <p>DoE: NC</p>

<p>Site 77 is a one-and-one-half-story Queen Anne with a cross-gabled roof, oriented west facing North VanBuren. The façade features a dominant front-facing gable exhibiting scalloped, square and diamond shingles. A three-part window breaks the pent roof, which is supported on large elaborate scroll-sawn brackets. The hip-roof porch wraps around the northwest corner, atop square posts set on an apron with decorative shingle cladding. The off-centered entry door is a wood panel door with beveled glazing and a transom. Around the corner is a secondary entry with similar features. The north-facing gable exhibits similar features as the front. Both wood-sash and vinyl windows are found on the dwelling. The residence features wood lap siding, corner boards, a wood shake roof, narrow boxed eaves, and a classical wood door and window surrounds. A tall, painted brick chimney pierces the roof. At the rear of the site is a gable roof, double-car garage. It has a low-pitched roof, composite lap siding, a wide roll-up garage door, and an attached shed-roof greenhouse.</p>

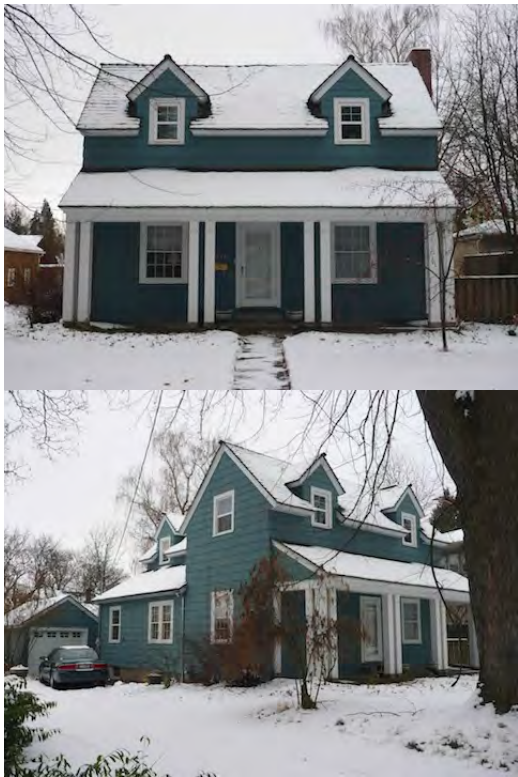
<p>The residence at Site 78 is a one-and-one-half story, side-gable roof I-house with two wall dormers on the façade and additions at the rear. The dwelling is oriented north facing East B Street. The symmetrical, three-bay (w/d/w) façade features a full-width shed roof porch atop square columns that are paired in the center and tripled at the corners. The entry door is wood with inset panels. Double-hung, eight-over-eight, wood-sash windows and wood surrounds remain, though vinyl windows are found on the east elevation and in the two dormers. The west elevation features a brick, shouldered, double-flue, chimney. A one-and-one-half-story, gable-roof ell addition is found on the rear, and features a single-story shed-roof extension spanning the east side. The house sits on a concrete foundation, the walls are clad in machine-cut wood shingles, and the roof is covered in wood shakes. At the rear of the site is a single-car garage with a gable roof, shake roofing, wood shingle siding, and a fiberglass door.</p>

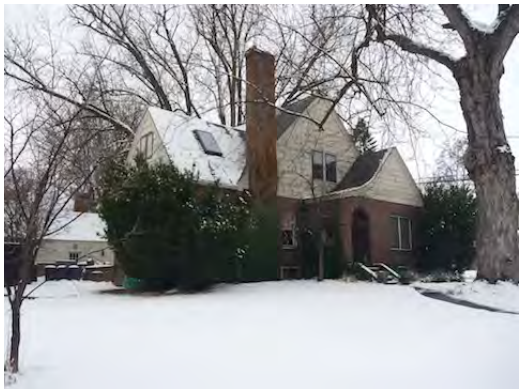
Survey Site Data	Site Photographs	Site Details
<p>Site #: 80</p> <p>221 North Polk Street</p> <p>Owner: David Lien</p> <p>1932</p> <p>Previous District Status: NC (compatible), 75</p> <p>DoE: C</p> <p>Garage: Historic</p> <p>DoE: C</p>

<p>This is a one-and-one-half-story, cross-gabled dwelling with brick veneer at the first level and shingles above. The façade, facing east, features a dominant front gable and another smaller, front-facing gable that contains a porch, inset through an arched entryway. The front door is wood panel with a soldier-course brick header and rowlock course bricks at either side. North of the entry is a pair of six-over-one, wood-sash windows with rowlock course brick surrounds. Rowlock bricks also run around the dwelling as a water table. A tall, double-flue, single-shouldered brick chimney is also found at the façade. A modern skylight pierces the roof over the façade. Eaves are minimal, and both double-hung and casement, wood-sash windows remain. A shingle-clad dormer is found over the north elevation. The rear elevation features an additional entry, and an oriel window with multiple diamond panes and a hip roof atop a pair of scroll-cut bracket. The residence has a basement. Behind the dwelling is a wide, two-car garage with a doublewide, fiberglass roll-up door, wood shingle and wide lap siding, and minimal eaves.</p>

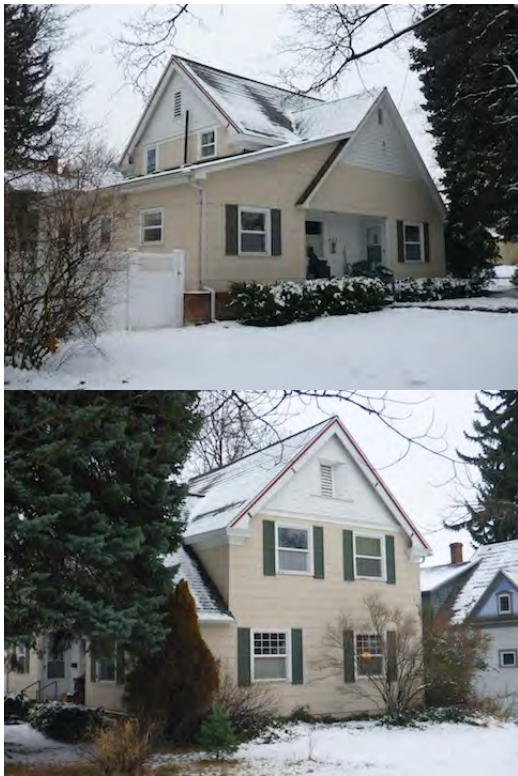
Survey Site Data	Site Photographs	Site Details
<p>Site #: 82</p> <p>605 East B Street</p> <p>Owner: Thomas Hipple</p> <p>ca. 1900</p> <p>Previous District Status: NC (compatible), 77</p> <p>DoE: NC</p> <p>Garage: Modern</p> <p>DoE: NC</p>

<p>Site 82 is a one-and-one-half-story, side-gable dwelling with a single-story enclosed entry and a shed-roof addition on the east. The dwelling, oriented north toward East B Street, originally faced North Polk as indicated by Sanborn maps. The entry is inset under the front-facing gable with entry doors in both the east and west walls, and a large picture window facing north. The entry porch is clad in vertical sheet paneling, the body of the residence is clad in wide asbestos shingles, and the gables are covered in painted wood shingles. The east and west side gables exhibit patterned shingles, a slight flare at the window header, and feature altered bargeboards and classical cornice returns. Windows are vinyl. The foundation is concrete and the roofing is composition shingles. At the rear of the site sits a gable front, two-car garage with two fiberglass roll-up doors, wide asbestos shingle siding, and a composition shingle roof.</p>

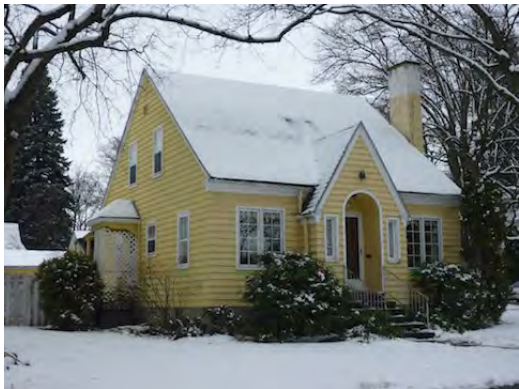
Survey Site Data	Site Photographs	Site Details
<p>Site #: 84</p> <p>217 North Howard Street</p> <p>Owner: Richard Nielsen</p> <p>1940</p> <p>Previous District Status: NC (compatible), 64</p> <p>DoE: C</p> <p>Garage: Historic</p> <p>DoE: C</p>

<p>Site 84 is a symmetrical, one-and-one-half story, side-gable roof dwelling. It has a steeply pitched front-facing gable with an arched doorway flanked by a pair of vertical four-light wood-sash windows with simple wood surrounds. The enclosed porch features a wide trimmed fascia and small cornice returns. On both sides of the entry are paired, eight-light, wood casement windows. A tall, double-flue, parged and painted brick chimney graces the north elevation. Double-hung, wood-sash windows are found on the side and rear. At the south elevation is a porch hood with scroll-sawn brackets. The exterior is clad in lap siding. On the rear elevation a hyphen leads to the small, attached, one-car garage that has a wide fascia, cornice returns, and a metal tilt-up garage door. At the southwest corner of the site is a shed with lap siding, wood windows, wood barn-style sliding doors, and a shed roof.</p>
