National Register of Historic Places Registration Form

Historic name: Fort Russell Neighborhood Historic District (Boundary Increase and Additional Documentation)

Street & number: Roughly bounded by Jefferson Street on the west, East D Street on the north, Hayes Street on the east, and East Third Street on the south

City or town: Moscow State: ID County: Latah

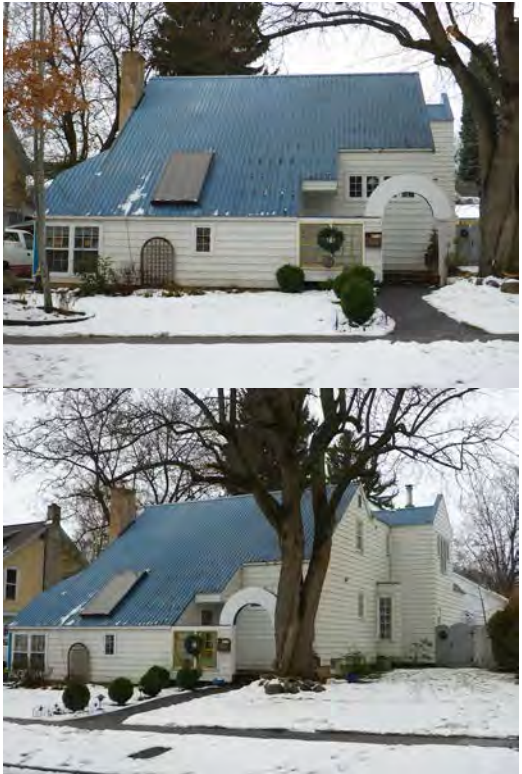
<p>Site 85 faces east toward Howard Street, south of East B Street. It is an altered, one-and-one-half-story, side-gable roof frame dwelling. This was originally a rectangular dwelling, with a small extension at the southwest corner. The small extension remains, though a multi-part addition has been added along the façade beneath an extension of the primary roof, creating a large overall roof plane. A large skylight is found on the roof in this addition. The wall plane of the addition continues north until it reaches an opening with an arch over it, leading to the main entry. A small wall with a narrow vertical window in it extends on the north elevation. A chimney on the south has been parged. A large, two-story addition is also found on the rear. The building is clad in vinyl or aluminum siding, and the roof is covered in metal. The windows are vinyl throughout. A large, nonhistoric, two-car garage is found to the rear.</p>

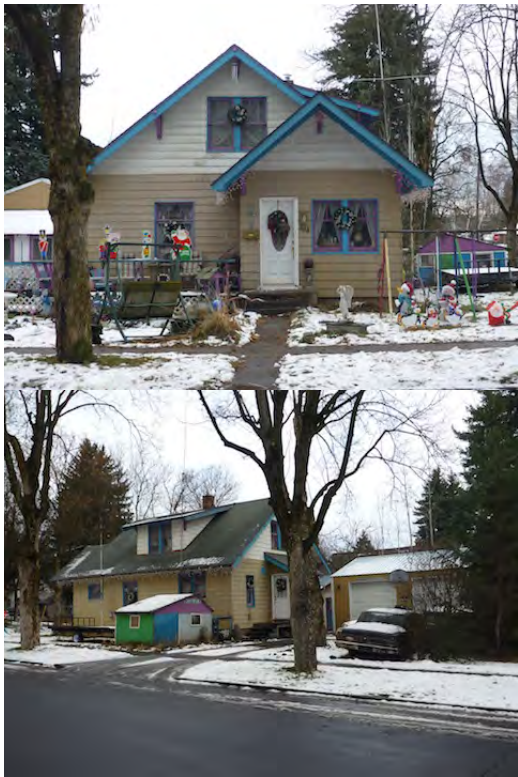
<p>This is a one-and-one-half-story, gable-oriented, frame Bungalow with an enclosed, gable-roof porch on the façade elevation. It features three-over-one and two-over-one, wood-sash windows, brackets and rafter tails and is covered in aluminum siding. A shed-roof dormer, with brackets, rafter tails, and original windows, is found over the west elevation. An enclosed, shed-roof porch is centered on the rear. It rests on a concrete basement foundation, and has three-part, wood-sash windows. A large, gable roof, metal, two-car garage is at the southeast, rear corner of the property. It features a shed-roof, plywood and frame extension on its north side. The original, smaller, single-car garage remains at the northeast corner of the property. It exhibits clapboard siding, and wood shingles within the gable as well as brackets, and a two-part, hinged wooden door. A small, frame and plywood, children's playhouse is located west of the house.</p>

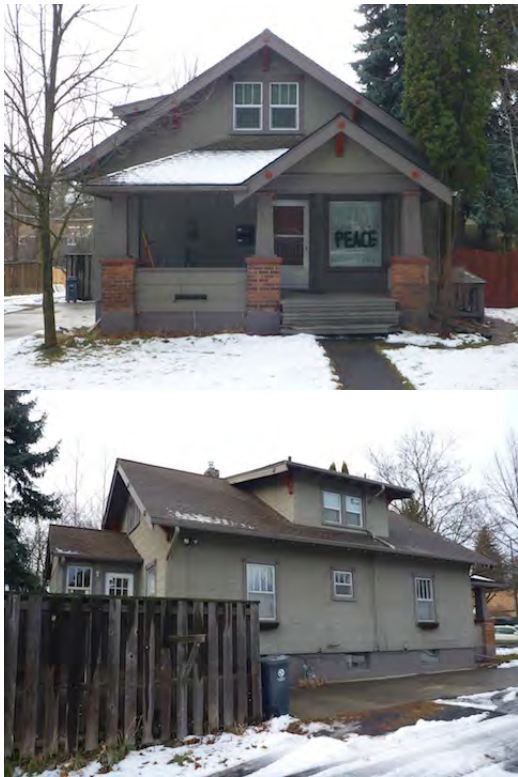
<p>Site 87 faces north toward B Street, east of Howard. It is a one-and-one-half-story, gable-oriented, frame Bungalow, with a hip-roof porch spanning the façade. A gable roof extends up from the porch over the primary entry. The porch is supported by flared posts, set on brick piers. The house is set on a concrete foundation and is covered in asbestos siding – though the wall inside the front porch is covered in vertical siding. Visible rafter tails and brackets are also found on the dwelling. Four-over-one, double-hung, wood-sash windows remain on the dwelling and are surrounded with simple wood trim featuring square wooden ornamental pieces at the top corners. A large metal sash window is found at the front porch. A shed-roof dormer is found over the east elevation, while a square bay topped by a gable roof is found on the west side. An enclosed, gable-roof porch is found on the rear.</p>

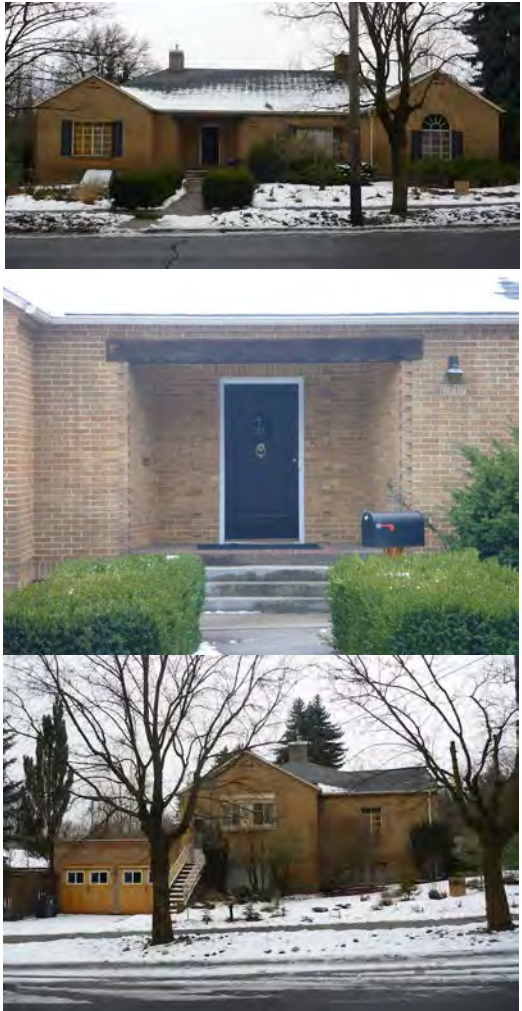
Survey Site Data	Site Photographs	Site Details
<p>Site #: 88</p> <p>717 East B Street</p> <p>Owner: Stephen Katz</p> <p>1937</p> <p>Previous District Status: n/a</p> <p>DoE: C</p> <p>Garage: Modern</p> <p>DoE: NC</p>

<p>Site 88 is on the southwest corner of Monroe and B Streets. It is a single-story, very early Ranch dwelling with a brick veneer exterior. It features a hip roof, with gable-roof sections extending forward at both corners on the façade, rear on the southwest corner, and out to the east on the southeast corner. Multi-light, steel windows remain, some flanked by shutters. The gable extension on the northwest corner features a metal-sash, fanlight window above the main window. The windows feature brick sills, and soldier course brick lintels above. The primary entry is recessed from the primary wall plane, off-centered on the façade elevation. A large wood header is found above the entryway to the porch. Two brick chimneys pierce the roof, one at each end of the main, hipped roofline. A small, bow window is found in the gabled extension on the east elevation, next to a side entry accessible via a set of brick stairs. The dwelling features an integrated back deck, surrounded by a brick awning. The deck sits on top of two, single-car garages that exhibit wooden doors. A portion of the deck area is recessed from the rear wall plane, while a portion of it is sheltered by a mid-century, metal awning.</p>

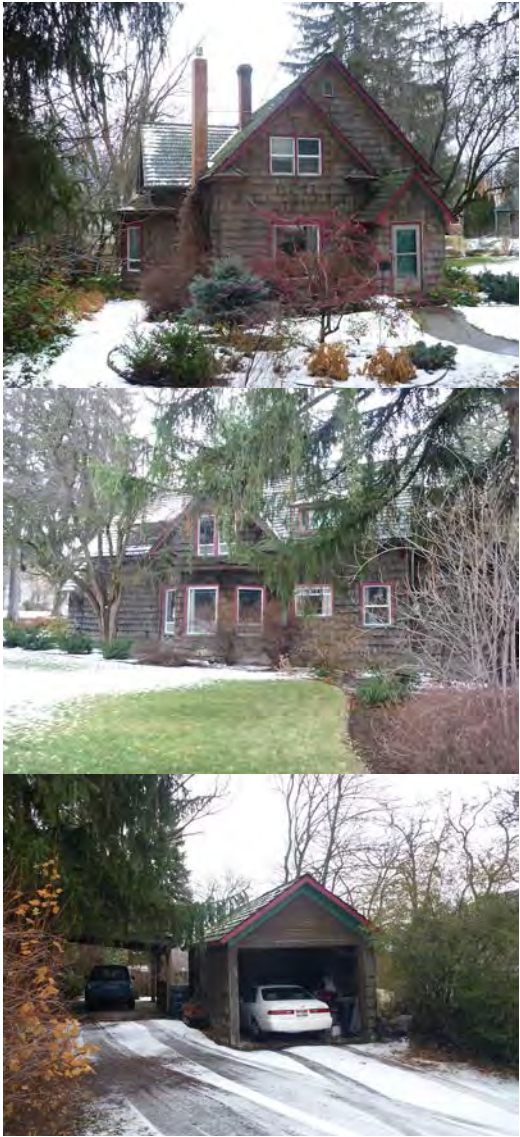
Survey Site Data	Site Photographs	Site Details
<p>Site #: 89</p> <p>801 East B Street</p> <p>Owner: James Gary Williams</p> <p>ca. 1900</p> <p>Previous District Status: n/a</p> <p>DoE: C</p> <p>Garage: Historic</p> <p>DoE: C</p>

<p>The photographs show a one-and-one-half-story house with a cross-gabled roof and wood shake siding. The front view shows a single-story porch on the northwest corner and three-sided bays on the east and west sides. The side view shows the exterior brick stack and the older brick chimney. The garage view shows a small, gable-roof, frame, single-car garage located behind the house.</p>	<p>Site 89 is located on the southeast corner of Monroe and B Streets. This is a one-and-one-half-story, frame, cross-gabled dwelling covered in wood shake. A single-story, gable-roof, enclosed entry porch is found on the northwest corner, and single-story, three-sided bays are found on both the east and west side elevations. An exterior brick stack is found on the east, while an older brick chimney pierces the roof over the dwelling. Vinyl windows and cornice returns are also found on the house. The original house on this site predated the 1904 Sanborn map, though the current house has a different footprint. The older brick chimney indicates this may be a remodel, as opposed to a new dwelling. A small, gable-roof, frame, single-car garage is located behind the house.</p>

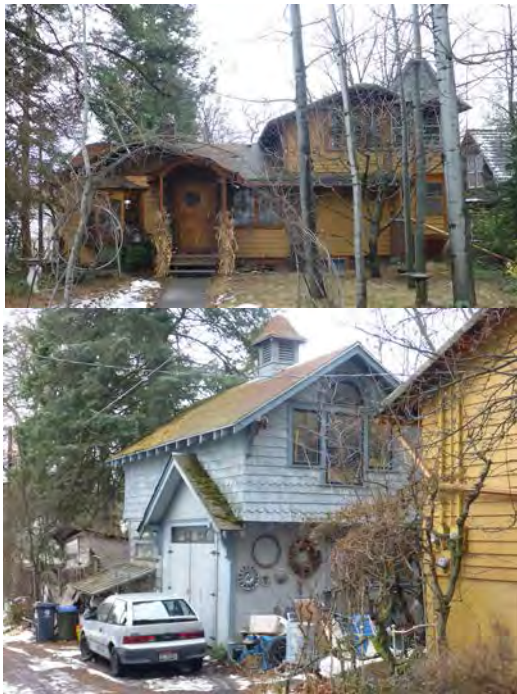
Survey Site Data	Site Photographs	Site Details
<p>Site #: 90</p> <p>809 East B Street</p> <p>Owner: Roberta Radavich</p> <p>1950</p> <p>Previous District Status: n/a</p> <p>DoE: NC</p> <p>Garage: Modern</p> <p>DoE: NC</p>

<p>Site 90 faces north toward B Street, east of Monroe. It is a single-story, side-gable dwelling, with a two-story addition on the northwest corner. The addition features a turret extending up from its corner. Originally a small, rectangular, single-story dwelling with a small porch at the northeast corner, this house has been altered and now exhibits a storybook cottage style with roof shingles that wrap around the fascia. The porch has a small, clipped-gable extension on the front exhibiting a sunburst motif within it. A new, gable-roof entry porch has been added beside it and a bay window added below it. A two-story, gable-roof outbuilding is found behind the dwelling, exhibiting weatherboard siding, square and scalloped shingles on the second level, and a cupola on the roof. It also features wood-sash windows, and an entry with hinged doors and a small gable roof line over it.</p>

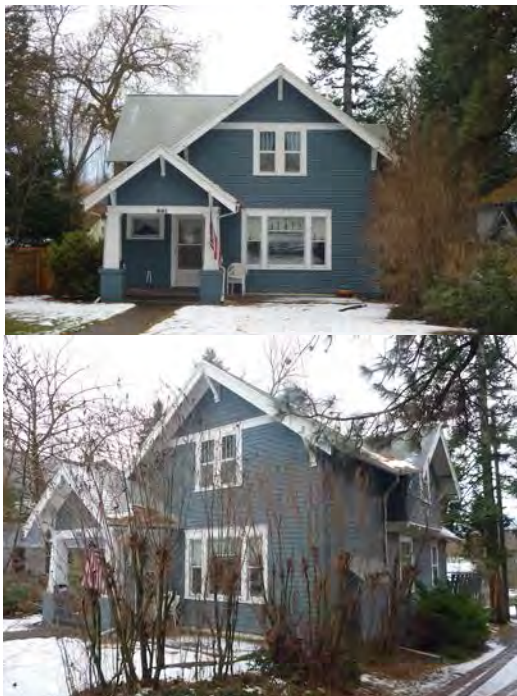
<p>Site #: 91</p> <p>821 East B Street</p> <p>Owner: Arvo Smith et al Life Estate</p> <p>ca. 1900</p> <p>Previous District Status: n/a</p> <p>DoE: C</p> <p>Garage: Modern</p> <p>DoE: NC</p>

<p>Site 91 faces north toward B, west of Lincoln. It is a two-story, cross-gabled, frame dwelling exhibiting elements common to some Bungalows of the era. It features large brackets, heavy wood window surrounds, and flared wood posts supporting a single-story, gable-roof porch off-centered on the façade. The house is covered in weatherboard, with shingles in the highest gable end. One-over-one, and four-over-one, wood-sash windows remain. A gable-roof, square, oriel window is found on the west elevation with extensions of the support rafters visible below. A single-story extension or enclosed porch is found on the rear, and is original to the dwelling. It exhibits rafter tails, which are also found on a small shed-roof awning over a side entry door on the west side.</p>

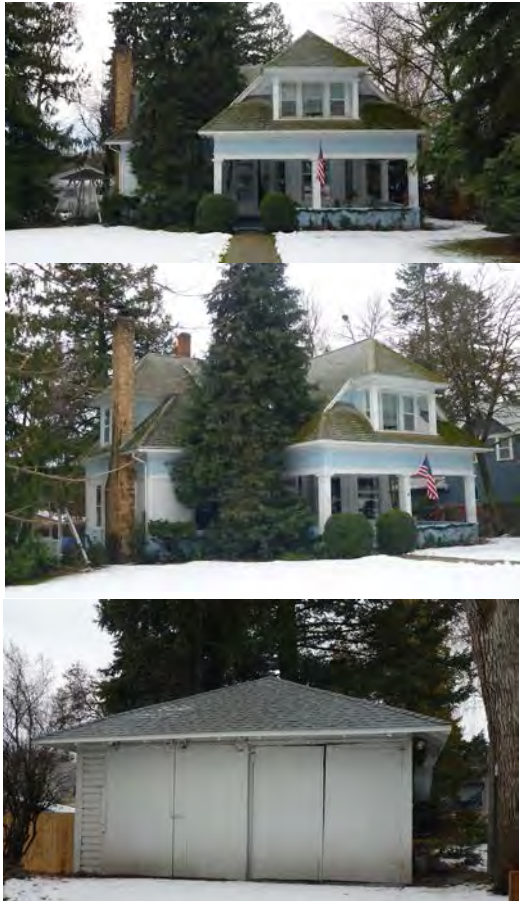
<p>Site 92 is located on the southwest corner of B and Lincoln Streets. It is a one-and-one-half-story, L-shape, frame dwelling with hip-roof dormers over all four elevations. A recessed, L-shape porch is found around the northwest corner, and is supported by square posts with decorative molding around the top, that are set on an apron covered in wood siding. The house features horizontal boards, weatherboard, and both square and sawtooth shingle imbrication. The corners of the dormers exhibit square corner posts with the same decorative molding as the porch. Wood-sash windows remain, as does a transom above the main entry. A single-shouldered, exterior, brick chimney is found on the east elevation, while another brick stack pierces the roof at the rear of the house. A small, single-story, shed roof, enclosed porch is found on the rear. A large, hip-roof, frame garage is found behind the dwelling. It features drop-wood siding, and horizontal sliding wood doors.</p>

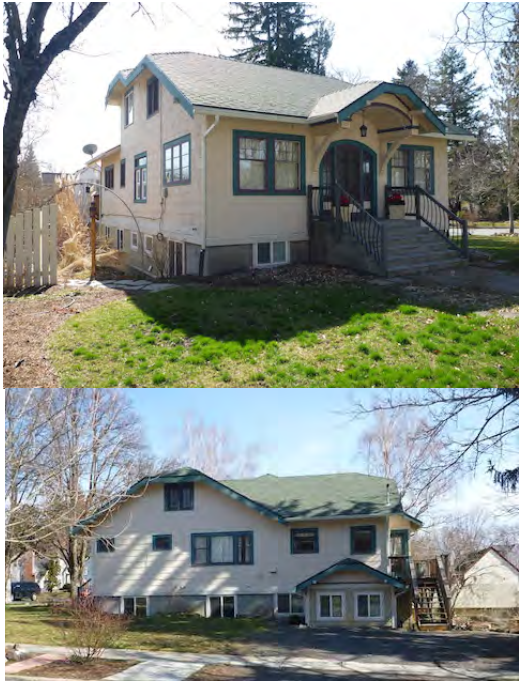
Survey Site Data	Site Photographs	Site Details
<p>Site #: 93</p> <p>901 East B Street</p> <p>Owner: Jeffrey Sowle</p> <p>1926</p> <p>Previous District Status: n/a</p> <p>DoE: C</p>

<p>This is a one-and-one-half-story Bungalow with a cross-gabled, jerkinhead roof. The dwelling has a small, clipped-gable porch centered on the façade with an arched ceiling over the entry and large brackets supporting the porch roof. The main entry is segmentally arched and contains a paneled wood door flanked by multi-light sidelights. The house has a second-story addition that extends the roofline upward on the east elevation. A small, clipped-gable addition is also found on the basement level on the west elevation. Paired, eight-over-one, double-hung, wood-sash windows flank the entry on the façade elevation. Both original, wood-sash windows and nonhistoric vinyl windows are found throughout the remainder of the dwelling. The house is set on a poured-concrete basement foundation, which is partially covered in nonhistoric siding on the east elevation. The dwelling itself is covered in asbestos shingles and retains some straight braces beneath the eaves. An exterior, wooden staircase and porch is found on the rear providing access to an enclosed, rear porch.</p>

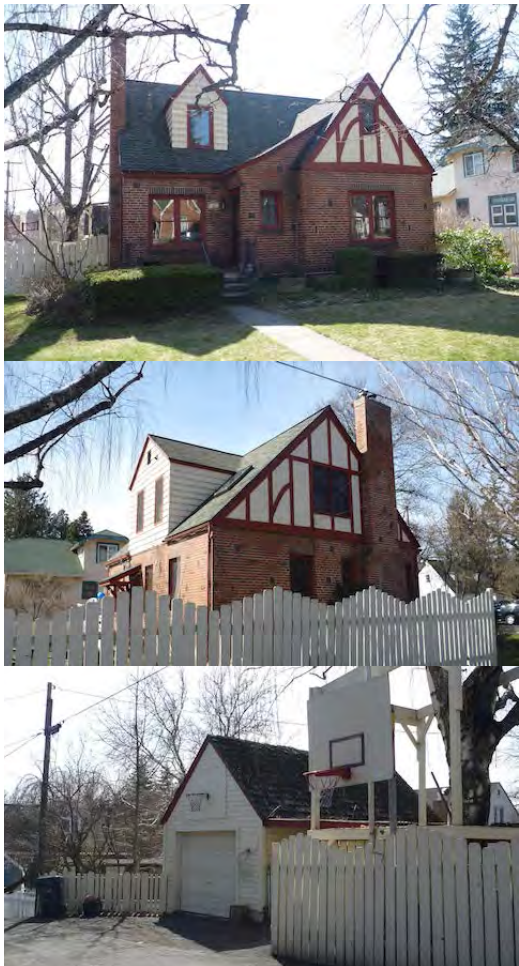
<p>Site 94 faces north toward B Street east of Lincoln. It is a one-and-one-half-story, cross-gable roof, Tudor-revival style dwelling. It features an enclosed porch in the crux between the crossed gables on the façade elevation beneath a shed-roof swooping down from the forward-facing gable. A gable-roof dormer is found above the façade elevation and a large, gable-roof wall dormer is centered on the rear. It features a clinker brick exterior, though the dormers are covered in aluminum siding and the forward and side gable ends are covered in half-timbering and stucco detail. A large, shouldered, exterior, brick chimney is found on the east elevation. Multi-light, double-hung, wood-sash windows remain on the dwelling. They feature brick sills and soldier-course brick lintels. A skylight has been added over the west side of the forward-facing gable. A small, shed-roof overhang supported by brackets shelters an entry on the rear elevation. A small, single-car, gable-roof garage is located at the rear of the property. It is covered in drop-wood siding with wood shingle roof sheathing and a nonhistoric overhead door.</p>

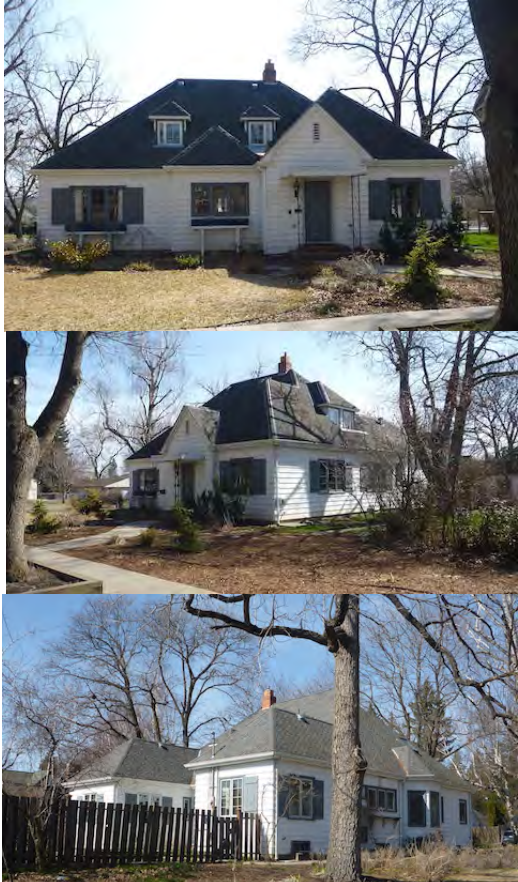
Survey Site Data	Site Photographs	Site Details
<p>Site #: 95 925 East B Street Owner: Kevin Murphy 1934 Previous District Status: n/a DoE: C</p> <p>Garage: Historic DoE: C</p>

<p>The photographs show a white, one-and-one-half-story house with a dark roof. The front view shows a central entrance with a small porch and a bay window to the right. The side view shows the profile of the house with a dormer. The rear view shows a two-car garage and a flat-roofed canopy over the main entrance.</p>	<p>Site 95 is an asymmetrical, one-and-one-half-story frame dwelling. It features a hip roof over the central portion, and a small, single-story, hip-roof, bay window extending on the façade elevation directly east of a larger, hip-roof extension on the northwest corner. An enclosed, gable-roof porch is situated on the east side of this extension. Two small, hip-roof dormers are found above the façade elevation, while a slightly larger one is located over the west elevation. A three-sided bay window is found on the east elevation, and two single-story, hip-roof additions have been added onto the rear creating a U-shaped courtyard. The house is covered in aluminum siding and contains both multi-light, wood-sash windows and vinyl windows. Many of the windows are flanked by nonhistoric shutters. A brick chimney pierces the center of the roof. A flat-roof canopy with scrolled metal posts shelters the main entry. A hip-roof, two-car garage also covered in aluminum siding is found to the rear of the dwelling.</p>

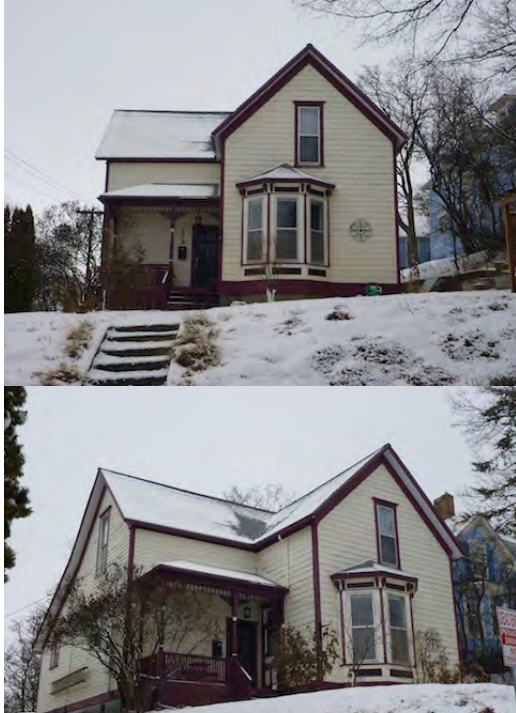
Survey Site Data	Site Photographs	Site Details
<p>Site #: 96</p> <p>216 East A Street</p> <p>Owner: Roger Lew</p> <p>ca. 1900</p> <p>Previous District Status: C, 9</p> <p>DoE: C</p>

<p>Site 96 faces south toward A street, west of Jefferson. It is one-and-one-half-story, frame, gable-roof, L-shape dwelling that appears to date to the late 1800s. A single-story, shed-roof addition has been added to the rear. A hip roof porch shelters the entry on the southwest side of the house, while a three-sided bay extends, off-centered from the forward extension. A paneled, wood door with a single window and transom above, as well as a multi-light, wood door, are both found on the porch. Decorative brackets and turned post detailing are found on the bay. Wide, drop wood siding covers the dwelling.</p>
<p>Site #: 97</p> <p>203 North Jefferson Street</p> <p>Owner: Helen Belt</p> <p>1906</p> <p>Previous District Status: C, 10</p> <p>DoE: C</p> <p>Garage: Historic</p> <p>DoE: C</p>

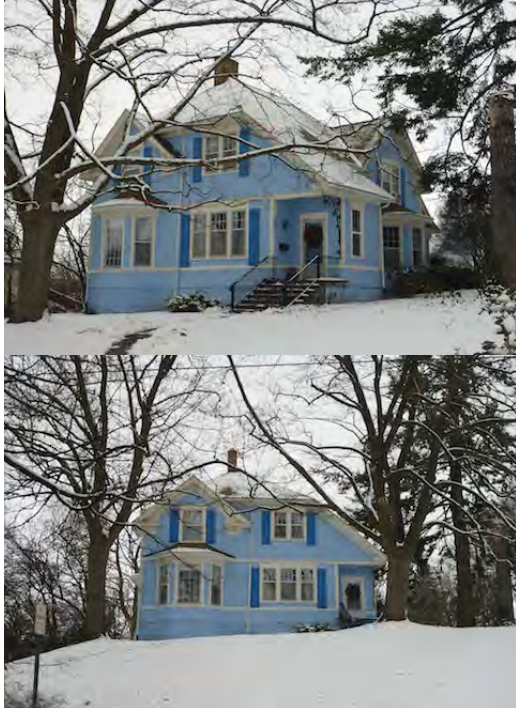
<p>Site 97 faces south on the northwest corner of Jefferson and A. This is a two-story, asymmetrical, frame dwelling. It features a central hip roof, with gable-roof extensions on the rear, northeast corner, and façade elevations. Three-sided bays are found on the west, south, and east elevations. The main entry is recessed on the southeast corner. The dwelling exhibits cornice returns, crown molding above the windows, and wood shingle siding. Nonhistoric shutters flank the windows, which are vinyl sash. Three wall dormers extend up on the west elevation. A large, gable, frame, two-car garage is found at the rear.</p>

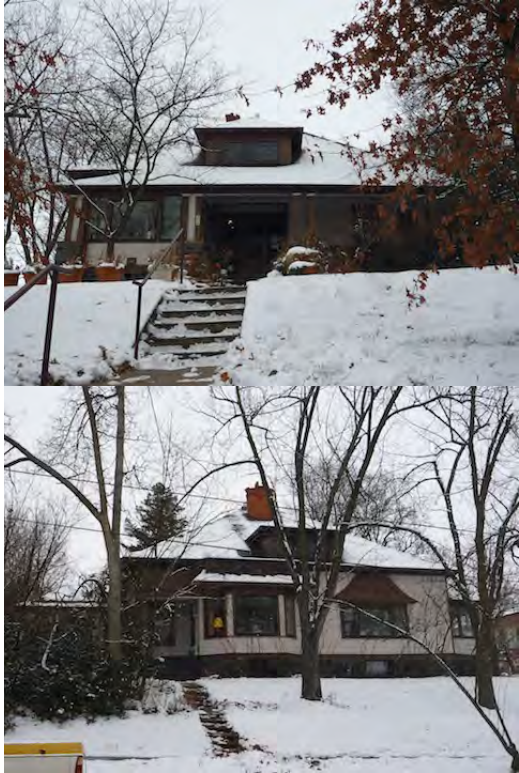
Survey Site Data	Site Photographs	Site Details
<p>Site #: 98 304 East A Street Owner: Linda Blackwelder Pall 1907 Previous District Status: C, 11 DoE: C</p>

<p>Site 98 is on the northeast corner of A and Jefferson Streets. It is a one-and-one-half-story, frame Bungalow characterized by a broad and low form. It features a single-light, wood entry door with leaded-glass sidelights, accessed within a large porch that spans nearly the width of the façade. The porch is supported by paired, square posts. The west end of the porch is an enclosed sun porch with wood-sash windows. A hip-roof dormer is centered above the façade and contains leaded-glass windows and visible rafter tails. The west elevation has a matching dormer above. The west side also has a three-sided bay and a three-part window. A single-story enclosed porch is found at the rear, while a portion of the east elevation extends a full one-and-one-half-story and is topped by a jerkinhead roof, which is slightly flared. The dwelling is set on a mortared, stone foundation pierced by small basement windows. A brick chimney pierces the roof over the west elevation.</p>

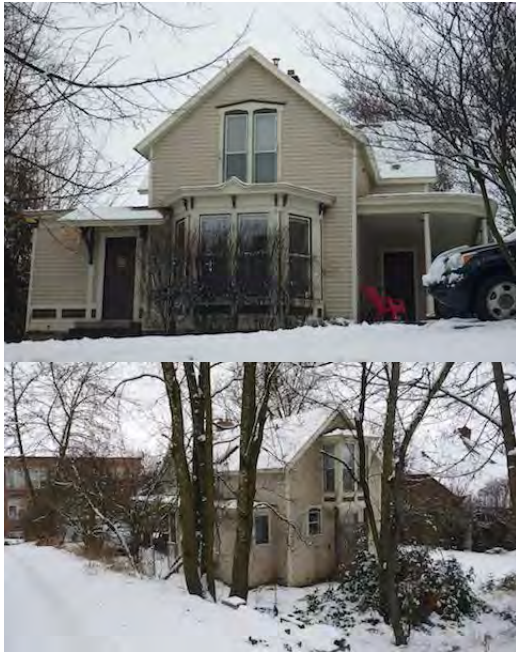
Survey Site Data	Site Photographs	Site Details
<p>Site #: 99 310 East A Street Owner: Seeley 2009 Family Trust 1893 Previous District Status: C, 15 DoE: C</p>

<p>Site 99 faces south toward A Street, east of Jefferson. It is a two-story, cross-gabled, Italianate dwelling with a curved porch atop Tuscan columns on the southeast corner, a small shed-roof porch over an entry in a single-story extension on the west end of the façade, and a three-sided bay centered on the façade, which features brackets and a small peak above the windows and recessed panels below. On the far rear of the building, an oriel window is found on the second story, which exhibits similar recessed panels below the windows as the bay on the front. The rear portion and single-story extension at the southwest corner appear to be additions. The house contains vinyl windows and has been covered in vinyl siding, though characteristics of the original Italianate design and original ornamentation remain.</p>

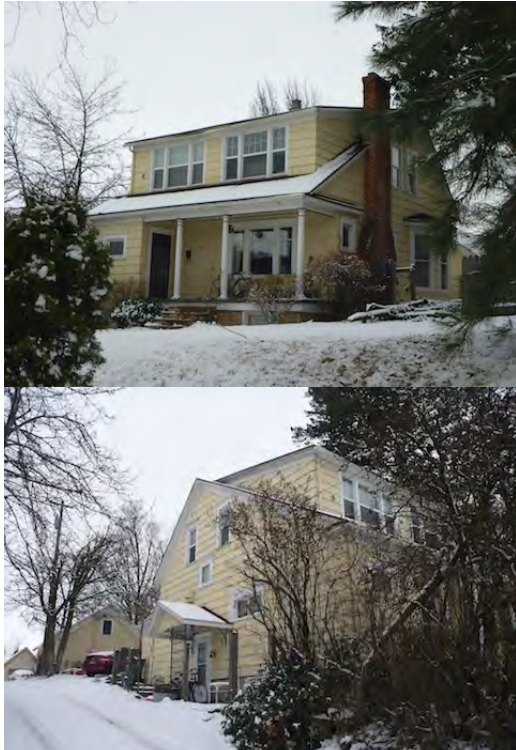
<p>Site #: 100 320 East A Street Owner: Justin Bonner 1912 Previous District Status: NC (compatible), 16 DoE: C Garage: Historic DoE: C</p>

<p>Site 100 faces south toward A Street, west of Adams. It is a one-and-one-half-story, frame dwelling. A nearly full-width porch spans the façade, with round posts supporting an overhang of the primary roof; an enclosed entry is found at the west end of the porch. A large shed-roof dormer spans nearly the width of the house above the façade. A three-sided bay is located on the east side, while an entry to the daylight basement is found on the west. The house has a combination of wood and vinyl windows, and is set on a concrete foundation. It is covered in wood shingle siding and has an exterior, shouldered, brick chimney on the east side. A large, frame, gable-roof garage or outbuilding is located to the rear. It is covered in clapboard siding and exhibits multi-light, wood-sash windows.</p>

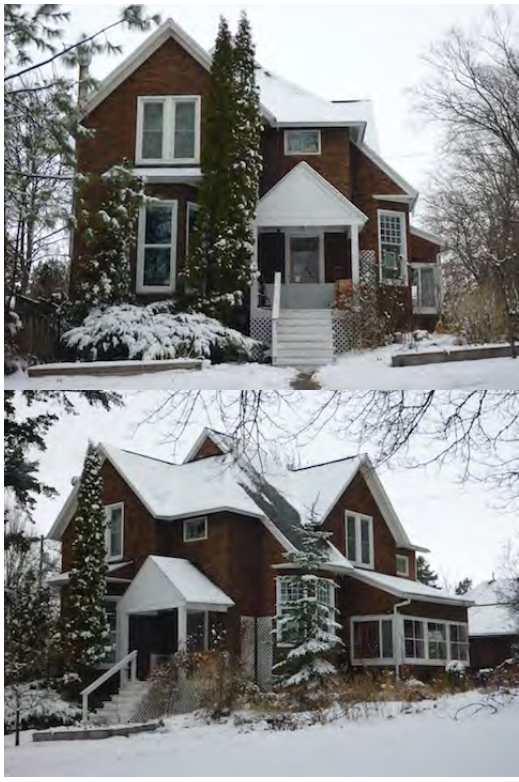
Survey Site Data	Site Photographs	Site Details
<p>Site #: 101 326 East A Street Owner: Cynthia Magnuson 1881 Previous District Status: C, 17 DoE: C</p> <p>Garage: Compatible DoE: C</p>

<p>The Henry Baker House, 1884, is on the northwest corner of Adams and A Streets. It is a two-story, cross-gabled dwelling with a gable-on-hip roof at the highest point. It exhibits brick veneer cladding, and a combination of multi-light or single-light, wood-sash windows and aluminum windows. A gable-roof porch covers the entry on the south elevation, and a three-sided, single-story bay beneath an extension of the primary roof extends from the southeast corner. Another three-sided bay beneath a small shed roof is on the façade. A slightly shorter, one-and-one-half-story, gable-roof extension is found on the rear, and a single-story, hip-roof addition is found on the east. The rear extension has a shed-roof dormer with horizontal board siding over its east elevation. A rear entry is sheltered by a hip roof with brackets. A nonhistoric, single-car garage, set on concrete with horizontal board siding is to the rear.</p>

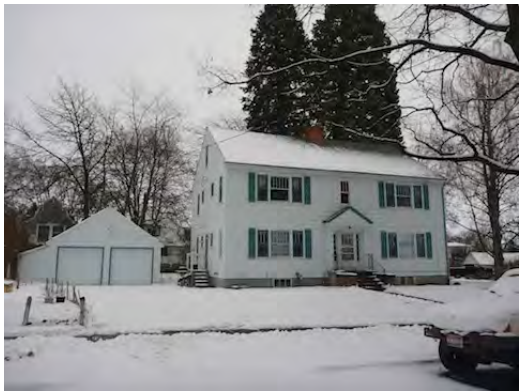
<p>Site #: 102 204 North Adams Street Owner: 204 North Adams LLC 1936 Previous District Status: NC (compatible), 18 DoE: C</p> <p>Garage: Historic DoE: C</p>

<p>Site 102 is located on the northeast corner of Adams and A Street. It is a large, two-and-one-half-story, symmetrical, three-bay (www/wdw/www), side-gable, frame dwelling on a concrete, basement foundation. The building features three-over-one, six-over-one and one-over-one, wood-sash windows, some flanked by nonhistoric shutters. It is covered in wood shingles, and has a brick entry porch and small gable roof over the porch. The building has a three-light, wood door with multi-light sidelights. A brick chimney pierces the center of the roofline. Secondary entries are found on the north and east elevations. A frame, gable-roof, two-car garage is located northeast of the dwelling. It features wood shingle siding, and a small, shed-roof addition on the north.</p>

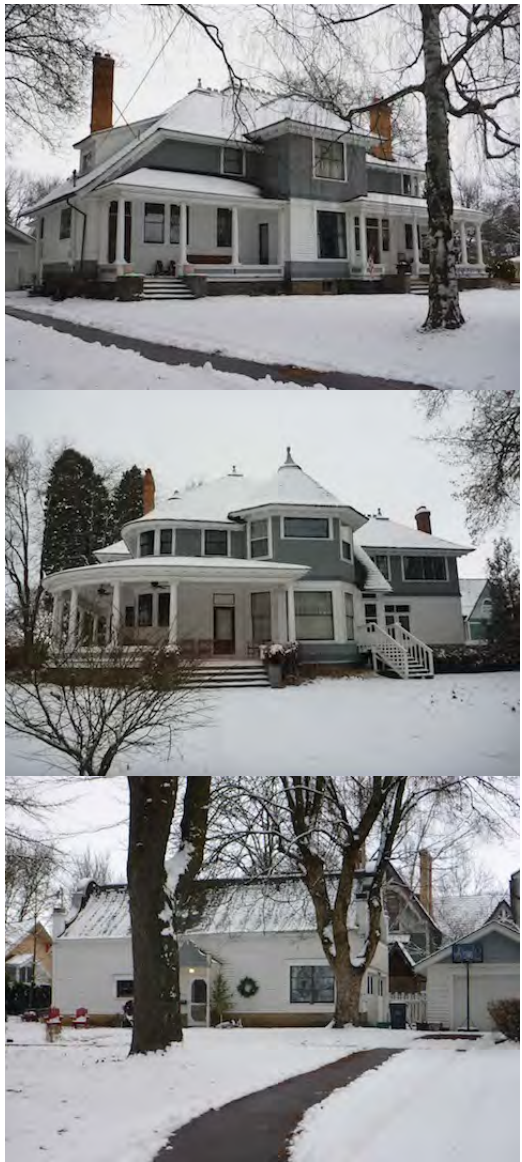
<p>The Jerome J. Day House features a main dwelling, a carriage house, and a modern garage. The dwelling is a large, asymmetrical, Queen Anne with a full-height, square bay on the south elevation, a rounded southeast corner, and a full-height, three-sided bay with a turreted roof on the east elevation. A shorter, two-story portion is found on the rear and houses a separate apartment. The main level is covered in clapboard, while the upper levels exhibit diamond shingle imbrication – some of which is also below the windows on the bays. One-over-one, wood-sash windows remain; some of which exhibit ornate beveled glass. Scrolled brackets are found beneath the eaves on the upper levels as well as the curved porch, which is supported by Ionic columns. Iron finials and cresting top the rooflines. The main entry on the south elevation contains a single-light, wood door with sidelights and a transom. Two more entries are found within the hip-roof porch at the southwest corner. A small, shed-roof dormer is located above the west side. Two large, brick chimneys pierce the roof. A frame, gable-roof, carriage house is found in the northwest corner of the property. It has a bell-curved roofline, and Spanish-inspired parapets on the north, east and west sides as well as over the main entry porch centered on the south elevation. Multi-light wood-sash windows, and clapboard siding remain. A small, circular window is found above two entry doors on the east elevation. The entries contain multi-light wood doors. A small, nonhistoric, gable-roof, garage is found northwest of the dwelling. It is covered in horizontal board siding with fish scale shingles above. There is a historic carriage house with a gable roof, bell curve parapets and single bay garage.</p>

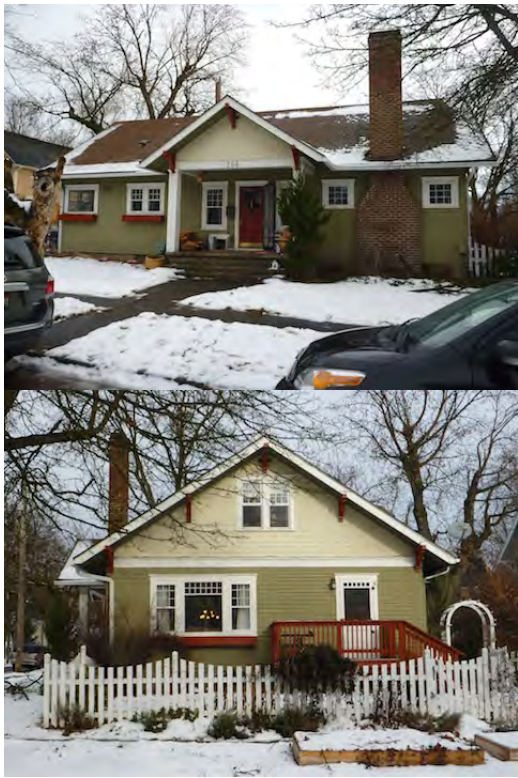
<p>Site 104 is a one-and-one-half-story, rectangular, side-gable roof Bungalow with a front-gabled entry porch. The dwelling, oriented west facing North VanBuren, features wood shingles in the peaks of the gables and open eaves supported on knee braces. The porch roof rests on square wood posts. The door and windows exhibit wood surrounds. South of the entry is a brick, shouldered, exterior chimney flanked by two small, high-nine-light, wood-sash windows. Varying patterns of multi-light, wood-sash windows are found throughout. A side entry door with wood deck, stairs and railing is found on the south. The roof is composition shingle, the walls are clad in wood lap siding, and the foundation is concrete. A single-car garage is located at the northeast corner of the site. It features a gable-front roof with composition shingles, wood clapboard siding, a metal panel roll-up door, and knee braces.</p>

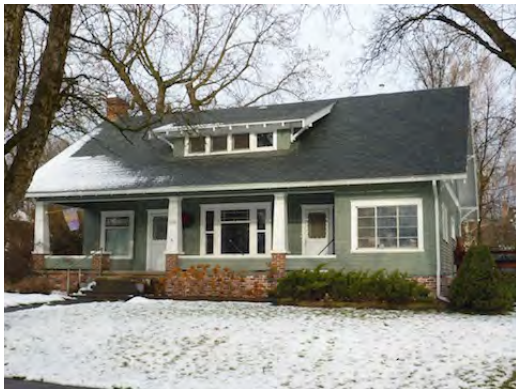
Survey Site Data	Site Photographs	Site Details
<p>Site #: 105</p> <p>506 East A Street</p> <p>Owner: Michael Gaffney</p> <p>1889</p> <p>Previous District Status: C, 88</p> <p>DoE: C</p> <p>Garage: Historic</p> <p>DoE: C</p>

<p>This is a one-and-one-half-story, side-gabled, Bungalow with a shed-roof dormer over the façade. A partial-width porch is recessed from the façade. It has battered wood posts set on brick piers. Two wood panel entry doors with glazing are found on the porch, with a triplet window between. The central sash has small colored-glass lights around a horizontal pane; similar colored glass is found in a window to the west. Fixed and double-hung, wood-sash windows are found throughout. Faux brick covers the foundation, and the house is clad in narrow wood lap siding. The gable ends and dormer feature wide cornice trim, open eaves, knee braces, wood shingles, visible rafter tails, and bargeboards. A brick chimney rises through the eave on the west side. To the rear is a gable-roof, two-car garage with open eaves, exposed rafter tails, knee braces, narrow wood lap siding, wood shingles, and a metal garage door.</p>

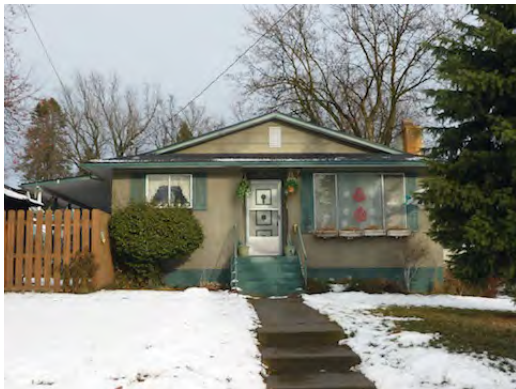
<p>Site #: 106</p> <p>522 East A Street</p> <p>Owner: Gregory Blanchard</p> <p>1973</p> <p>Previous District Status: NC (intrusion), 84</p> <p>DoE: NC</p> <p>Garage: Modern</p> <p>DoE: NC</p>

<p>Site 106 is a small, Ranch house, oriented south facing East A Street. It is a front-facing gable-on-hip roof dwelling, with a rectangular plan. The façade features a central entry inset under the main roof. Aluminum-sash windows are found on the dwelling. Siding is T1-11 sheet paneling. The foundation is concrete. The gable peak is filled with horizontal board siding and a louvered attic vent. A light stone, double-flue, chimney is found at the east elevation. At the northwest corner of the site along the alley is a two-car garage. It features a gable-on-hip roof, metal panel roll-up door, and T1-11 paneling.</p>

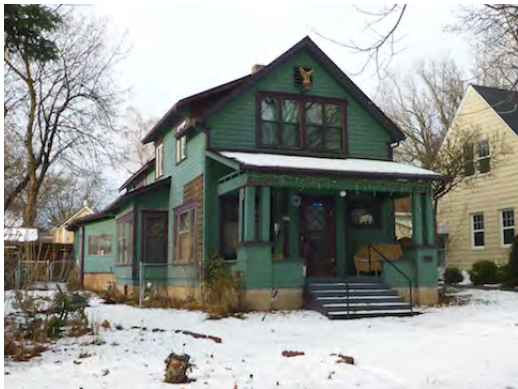
Survey Site Data	Site Photographs	Site Details
<p>Site #: 107</p> <p>211 North Polk Street</p> <p>Owner: Frank Rodriguez</p> <p>ca. 1900</p> <p>Previous District Status: C, 79</p> <p>DoE: C</p> <p>Garage: Modern</p> <p>DoE: NC</p>

<p>This is a gable-oriented frame dwelling with a full-width front porch and a shed-roof wall-dormer on the south side. The porch features a shed roof atop tripled square posts, and clapboard covered piers and apron. The entry door is set in a square projecting bay with a wood panel door with diamond glazing and a classical wood surround. Wood-sash windows, some with diamond-shaped leaded glass above, and aluminum windows are found on the dwelling. On the south side, a square bay with shed roof set with six windows is found beneath the wide, shed-roof wall dormer. A brick chimney pierces the roof near the ridge, while a shorter brick chimney is found to the west. The foundation is concrete, and the wall sheathing is clapboard. Located to the rear is a modern, two-car garage with faux log siding, a projecting front-gable roof, and a metal garage door.</p>

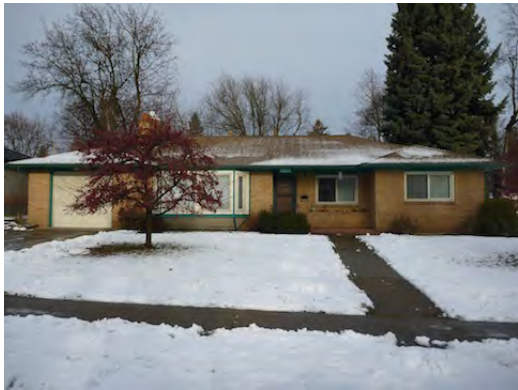
<p>Site #: 108</p> <p>528 East A Street</p> <p>Owner: James Papineau</p> <p>1951</p> <p>Previous District Status: NC (intrusion), 85</p> <p>DoE: NC</p>

<p>This is a wide, low Ranch style dwelling that is oriented south, facing East A Street. It features raked-brick veneered exterior walls, a low-pitched hip-roof with projecting hip roof extensions at each corner, and a low, raked-brick, inside chimney. A single-car garage with a roll-up metal door is located at the west end of the façade. A wide, four-window, bay is next to the garage. Rowlock course raked brick creates the window sills. The roof is composition shingle, and the foundation and stoop are concrete. All windows are vinyl. Located northeast of the house is a small gable-front shed. It features wood drop siding, corner boards, composition shingle roof, and two vinyl windows.</p>

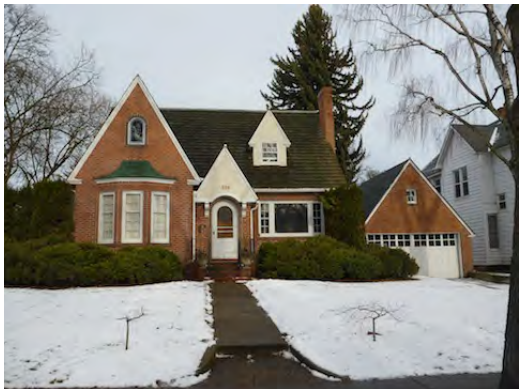
Survey Site Data	Site Photographs	Site Details
<p>Site #: 109</p> <p>604 East A Street</p> <p>Owner: Asaph Cousins</p> <p>1936</p> <p>Previous District Status: C, 80</p> <p>DoE: C</p> <p>Garage: Historic</p> <p>DoE: C</p>

<p>Site 109 is a one-and-one-half-story, cross-gabled, masonry dwelling with a steeply pitched gable roof and steep gables over the forward projection, the enclosed porch, and the dormer above the façade. It features an arched doorway within the entry porch, multi-light wood-sash windows, and a picture window flanked by multi-light windows. A small arched window with brick surround is found above a three-sided bay on the forward -gabled projection, and an exterior chimney is found on the east elevation. The walls of the dormer and the peak of the entry gable are stuccoed. Scrolled brackets support the overhanging gable at the entry. Soldier course brick lintels and sills are found on many of the windows. A shed roof dormer is found above the rear elevation. A shed roof shelters a patio at the back of the house. A two-car, gable-roof garage with similar detailing is directly east.</p>

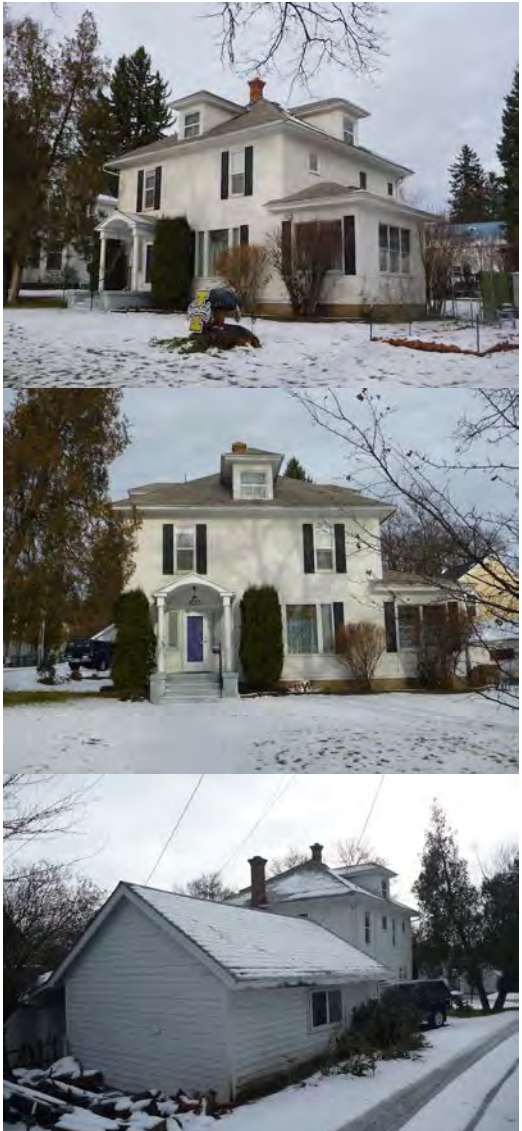
<p>The photographs show Site 111 from three different angles. The top photo is a front-facing view of a two-story house with a white facade, dark shutters, and a small porch. The middle photo is a side view of the same house, showing the porch and the side of the house. The bottom photo shows a single-story garage with a white facade and a gabled roof, situated next to the main house.</p>	<p>Site 111 is oriented south toward East A Street. This is a two-and-one-half-story American Foursquare set on a parged foundation. It features a hip roof, with hip-roof dormers over the east, west, and façade elevations. A single-story, hip-roof addition is found on the east elevation, and a small, gabled porch with a barrel-vaulted ceiling and supported by Tuscan columns is off-centered on the façade. A shed-roof overhang shelters a rear door. A brick chimney pierces the center of the roof, while an exterior brick chimney is found on the rear. The dwelling is covered in asbestos tiles, and features vinyl windows, some flanked by nonhistoric shutters. A gable-roof, single-car garage is found to the rear. It features a metal overhead door, corner boards, and wide horizontal board siding.</p>

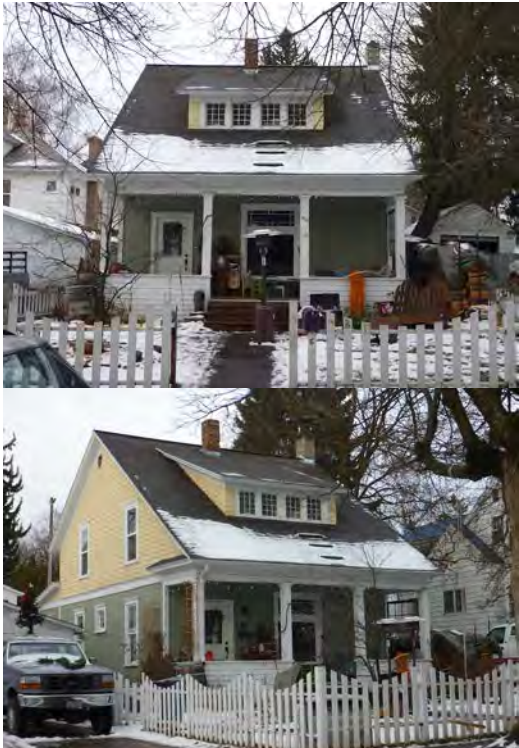
Survey Site Data	Site Photographs	Site Details
<p>Site #: 112</p> <p>209 North Howard Street</p> <p>Owner: Erik Perryman</p> <p>1910</p> <p>Previous District Status: n/a</p> <p>DoE: C</p>

<p>This is a one-and-one-half-story, early-twentieth-century, side-gable roof Bungalow. It features a full-width porch recessed beneath the main roof, and a shed-roof dormer above the façade. The porch is supported by square posts, resting on a shingled knee-wall. Wood-sash windows remain throughout, some with numerous small divided lights, some double-hung sash, and some with small divisions in the upper portion. All of the windows, except those in the dormer, exhibit simple wood surrounds with crown molding above. A chimney on the north elevation has been replaced with a concrete-block stack. A brick stack pierces the roof over the façade. A single-story, enclosed porch spans the rear. The dwelling is covered in wood shingles, while the cornice line over the porch runs along both side elevations visually dividing the upper and lower levels.</p>

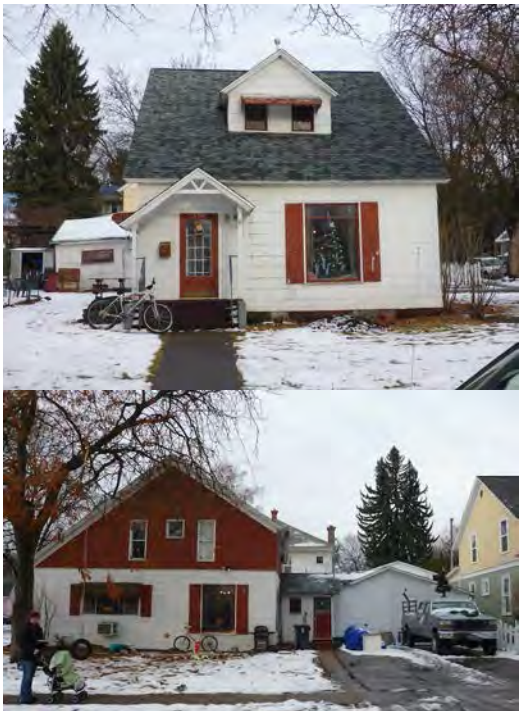
<p>Site #: 113</p> <p>650 East A Street</p> <p>Owner: Adam Raines</p> <p>ca. 1900</p> <p>Previous District Status: n/a</p> <p>DoE: NC</p> <p>Garage: Historic</p> <p>DoE: NC</p>

<p>Site 113 is located on the northwest corner of Howard and East A. It is a one-and-one-half-story, side-gable roof, frame, simple Bungalow. A small, gable-roof dormer is centered above the façade, while a small, gable-roof overhang shelters the off-centered entry on the façade. An original, full-width porch is no longer extant. The dwelling retains wood-sash windows, some of which are large, single windows with bands of small lights across the top. Two multi-light, metal-sash windows are found on the west elevation. Some windows are flanked with nonhistoric shutters, and some exhibit metal awnings. An enclosed rear porch is found on the northwest corner, leading to an attached garage. The dwelling is covered in asbestos shingles, with wood cladding remaining on half of the attached garage.</p>

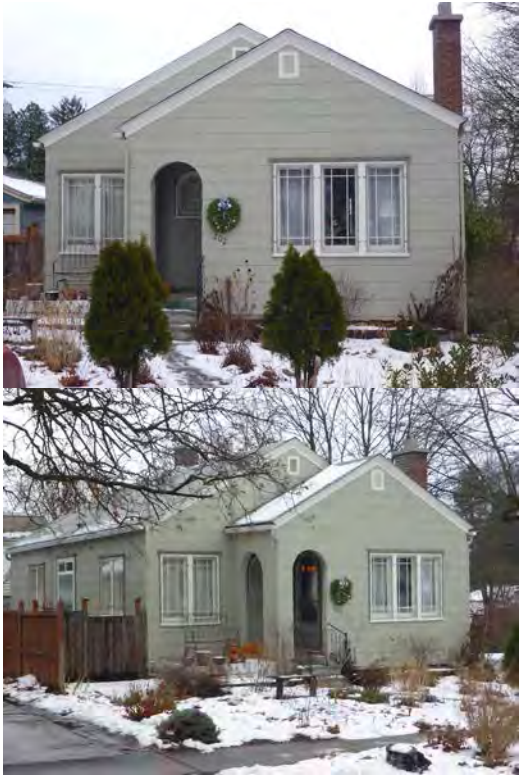
<p>Site 116 faces west on the northeast corner of Howard and A. It is a small, single story, frame Bungalow. A gable roof extension, slightly lower than the main roofline, extends on the façade, housing the recessed main entry. A small, gable-roof, square bay is also found on the south side in addition to an exterior brick chimney, flanked by two small windows. Another brick stack extends from the center of the roof. Single, paired, and three-part, wood-sash windows with typical Bungalow divisions in the glass remain on the house. They feature minimal surrounds, with small crown molding above. The house rests on a concrete foundation, and has been covered in asbestos siding. Arched entries on two sides of the porch lead to the main door, also arched. A small, arched, multi-light wood window is found within the porch. Basement windows are also found on the house.</p>

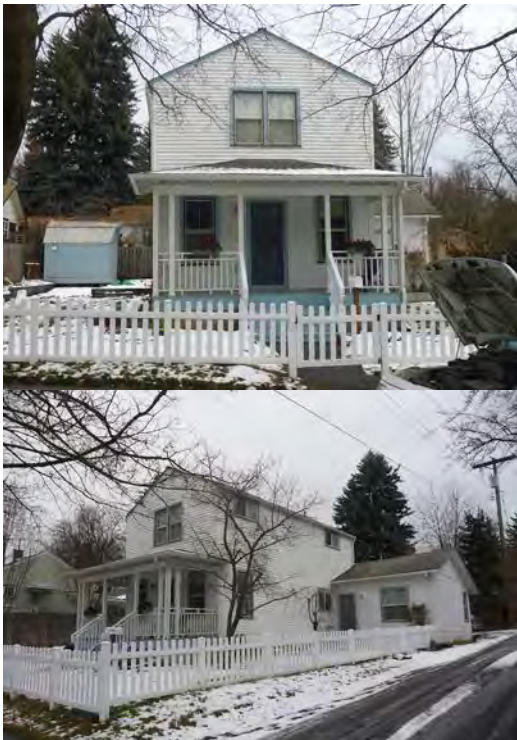
Survey Site Data	Site Photographs	Site Details
<p>Site #: 117</p> <p>708 East A Street</p> <p>Owner: Elizabeth Cassel</p> <p>ca. 1900</p> <p>Previous District Status: n/a</p> <p>DoE: C</p>

<p>Site 117 faces south toward A Street, east of Howard. It is a narrow, two-story, gable-oriented, frame dwelling. It features a single-story, gable-roof extension on the northeast corner, and a small, single-story, gable-roof portion built of rusticated concrete blocks on the far rear. According to the Sanborn maps, both these sections were original to the dwelling. A single-story, hip-roof porch spans the width of the façade, and exhibits small wood support posts and visible rafter tails. The dwelling is covered in vinyl siding, and features vinyl windows. The extension on the northeast corner is covered in asbestos shingles and features a separate entry. A small, gambrel roof, prefabricated shed is found at the rear.</p>

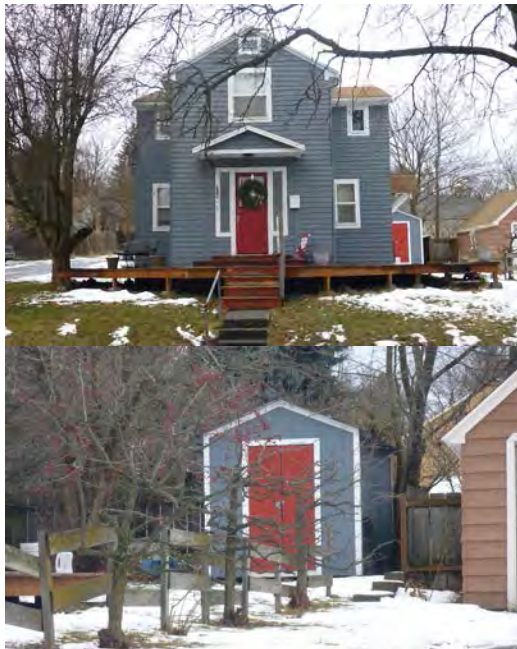
<p>Site #: 118</p> <p>716 East A Street</p> <p>Owner: James Tunca</p> <p>1939</p> <p>Previous District Status: n/a</p> <p>DoE: NC</p>

<p>Site 118 faces south toward A Street, west of Monroe. This is a two-story, T-shape, frame dwelling with a small, gable roof awning over the front entry, and another supported by brackets over a side door on the east elevation. A wooden deck surrounds the façade and front corners. A small, prefabricated shed is also associated with the site. According to historical Sanborn maps, the dwelling in this location was a square, single-story house with a small porch centered on the facade facing A Street. It appears the current dwelling is a replacement or modification of the original house.</p>

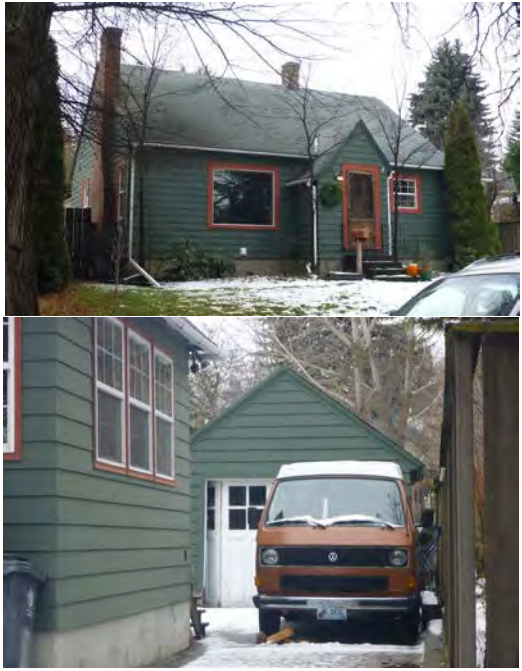
Survey Site Data	Site Photographs	Site Details
<p>Site #: 119</p> <p>209 North Monroe Street</p> <p>Owner: James Randal Morasch</p> <p>1938</p> <p>Previous District Status: n/a</p> <p>DoE: C</p> <p>Garage: Historic</p> <p>DoE: C</p>

<p>Site 119 is oriented toward the east on Monroe Street, north of A Street. It is a side-gabled, single-story, frame, English Cottage style dwelling. It features horizontal board siding, and vinyl windows with simple wood surrounds. Typical of the style, it features an enclosed entry porch, with an asymmetrical, swooping roofline. The main entry contains a door with an arched detail in it, behind a wooden screen door. A small, single-story, hip-roof extension is found on the north elevation. An exterior, shouldered brick chimney is located on the south elevation, while another brick stack pierces the roof toward the north end of the house. A small, frame, gable roof, single-car garage is located northwest of the dwelling.</p>
