National Register of Historic Places Registration Form

Historic name: Fort Russell Neighborhood Historic District (Boundary Increase and Additional Documentation)

Street & number: Roughly bounded by Jefferson Street on the west, East D Street on the north, Hayes Street on the east, and East Third Street on the south

City or town: Moscow State: ID County: Latah

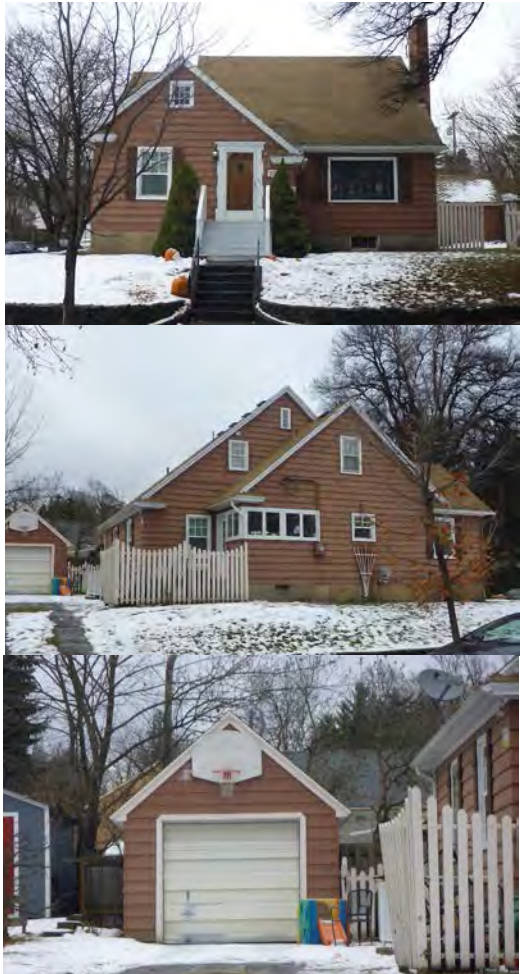
Survey Site Data	Site Photographs	Site Details
<p>Site #: 120</p> <p>205 North Monroe Street</p> <p>Owner: Jennifer Johnson Leung</p> <p>1938</p> <p>Previous District Status: n/a</p> <p>DoE: C</p> <p>Garage: Historic</p> <p>DoE: C</p>

<p>The photographs show a one-and-one-half-story house with a gable roof and a forward-facing gable extension on the southeast corner. The house has wide wood siding, vinyl windows, and a brick chimney on the north side. A small, frame, gable roof, single-car garage is located at the rear.</p>	<p>Site 120 is located on the northwest corner of Monroe and A Streets. It is a one-and-one-half-story, gable-roof, frame dwelling with a forward-facing, gable-roof extension on the southeast corner and a gable-roof portion, slightly shorter than the main roofline, on the south elevation. The dwelling is covered in wide wood boards or a composite siding, and features vinyl windows – some with nonhistoric, wood shutters. Three-light, wood-sash basement windows can be seen within the concrete foundation level. An exterior brick chimney, with one shoulder, is found on the north side. The main entry features a wood surround decorated with quoins and crown molding. Cornice returns are also found on the dwelling. A small, frame, gable roof, single-car garage is found to the rear.</p>

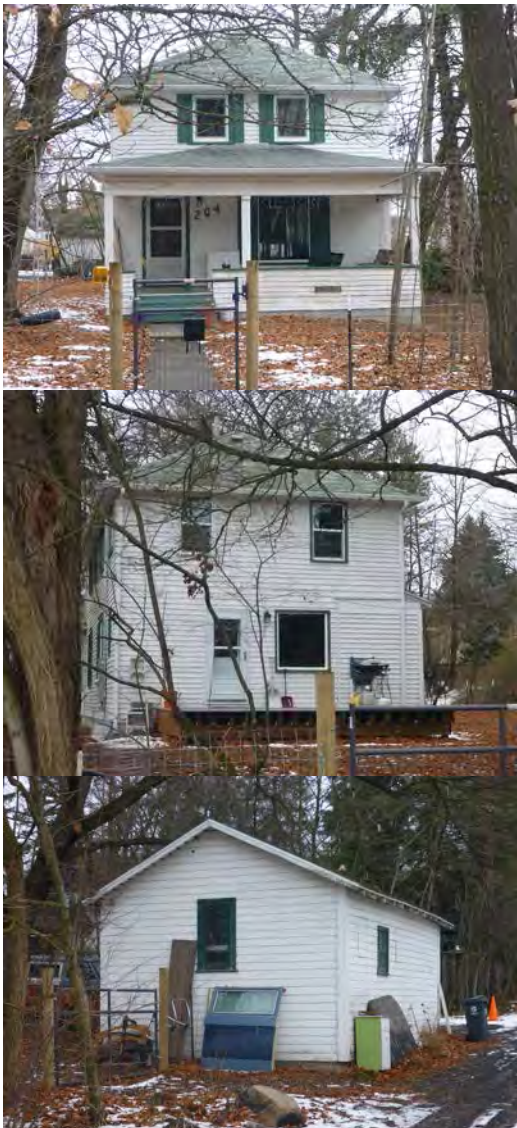
Survey Site Data	Site Photographs	Site Details
<p>Site #: 121</p> <p>204 North Monroe Street</p> <p>Owner: David White</p> <p>1910</p> <p>Previous District Status: n/a</p> <p>DoE: C</p> <p>Garage: Historic</p> <p>DoE: C</p>

<p>The photographs show a two-story white house with a green roof and shutters. The front view shows a porch with square posts. The side view shows the house's profile. The rear view shows a small gable-roofed garage with horizontal siding and a blue door.</p>	<p>Site 121 is located on the northeast corner of A and Monroe Streets. It is a two-story, hip roof, two-bay (d/w), frame dwelling with a full-width, hip-roof front entry porch. It features weatherboard siding and vinyl windows. The front porch is set on square posts. Nonhistoric wood shutters flank the windows, some of which exhibit crown molding above. A small, gable roof, frame garage is found to the rear. The garage appears to date to the 1930s or 1940s, and features horizontal board siding, visible rafter tails, and simple wood window surrounds. This house is set on a large, heavily wooded lot.</p>

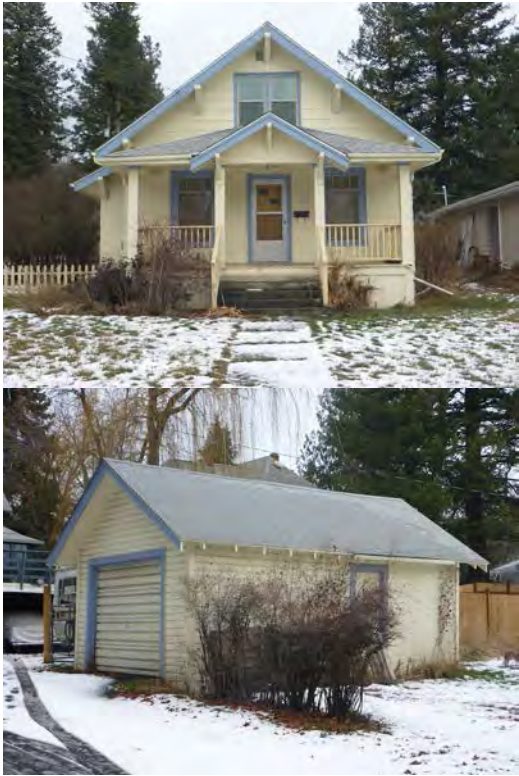
<p>Site 122 faces south toward A Street, west of Lincoln. It is a one-and-one-half-story, gable-oriented, frame Bungalow. It features a gable-on-hip front porch spanning the façade, and a shed roof extension on the west elevation following the dwelling's original footprint. The house is covered in composite or hardboard siding, and retains large brackets. Wood windows remain, some with wood storms. They exhibit simple wood surrounds. The house is set on a parged foundation. A gable-roof, single-car garage is found to the rear. It features both horizontal boards, and drop-wood siding, as well as visible rafter tails, and a nonhistoric, overhead door.</p>
<p>Site #: 123 207 North Lincoln Street Owner: Luke Sheneman 1949 Previous District Status: n/a DoE: NC</p> <p>Garage: Historic DoE: NC</p>

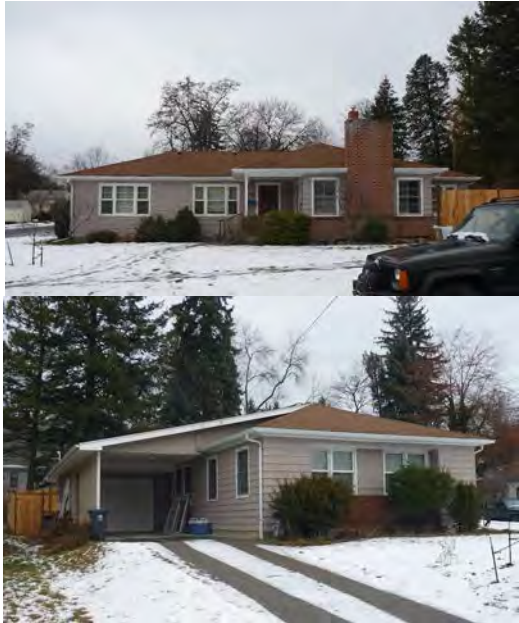
<p>Site 123 is on the northwest corner of Lincoln and A Streets, facing east. It is a single-story, cross-hip-roof dwelling. A front porch is recessed beneath the corner of a hip roof extension on the façade elevation. The house is covered in wood or composite siding, with brick covering the lower portion of the forward extension, which also features a wide, exterior brick chimney. The windows are vinyl. Two paired windows are found recessed from the primary wall plane on the south elevation; the bottom portion of this wall is also clad in brick. A single-car garage is attached to the rear of the dwelling, and is accessible through a carport covered by a shed roof extension added over the dwelling's original roof.</p>

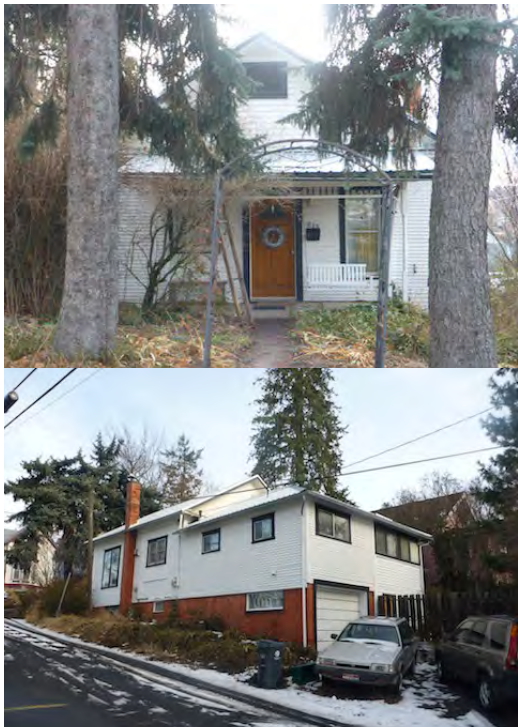
Survey Site Data	Site Photographs	Site Details
<p>Site #: 124 215 East A Street Owner: Hilary Lane ca. 1900 Previous District Status: C, 8 DoE: C</p>

<p>Site 124 is a one-and-one-half-story, gable-oriented, simple Bungalow with a partial-width front porch and a hip-roof addition on the rear as large in size as the main dwelling, which was added between the 1904 and 1928. The southeast corner is L-shaped, wrapping around the rear addition, which extends at the southwest, rear corner. A single-car, basement level garage is found on the southwest corner. The main dwelling and rear addition are set on brick foundations and are covered in clapboards, while the L-shaped section on the southeast corner exhibits a basement level covered in a slightly wider wood siding. Wood-sash windows and metal windows are found on the dwelling. The main entry porch features a shed roof with turned posts at the corners, and large, arched braces. A straight, exterior brick chimney is found on the west elevation.</p>

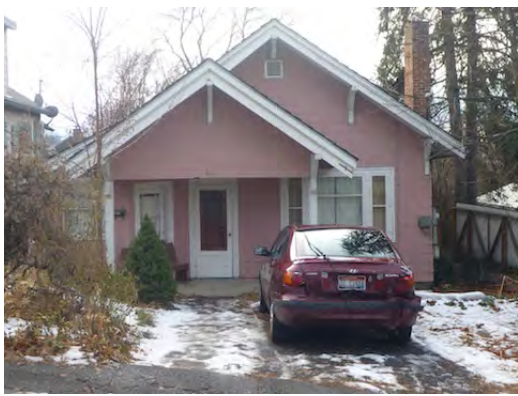
<p>Site #: 125 221 East A Street Owner: Bryan Broocks 1910 Previous District Status: C, 7 DoE: C</p>

<p>This is a single-story, gable-oriented, frame dwelling. It features a gable-roof entry porch off-centered on the façade, which has an enclosed gable over the porch. A small, shed-roof addition is found on the northeast corner. The dwelling features multi-light, wood-sash windows and an exterior brick chimney on the west elevation. Brackets are found on the gable ends, and the exterior walls are covered in asbestos shingles. The roof is covered in wood shingles.</p>

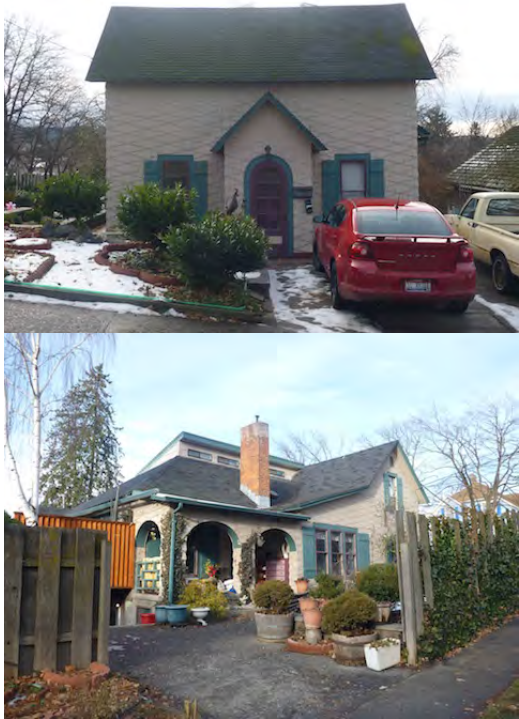
Survey Site Data	Site Photographs	Site Details
<p>Site #: 126 225-227 East A Street Owner: Larry Martin ca. 1900 Previous District Status: C, 6 DoE: C</p>

<p>This is a one-and-one-half-story, side gable, frame dwelling with a single-story, shed-roof extension across the rear and an original ell extending to the rear. The rear extension has been added onto along its east side with a shed roof, open porch accessible via two large, arched openings. The rear ell also has a second-story addition appearing as a dormer on the north side, creating a row of clerestory windows visible on the east side. A single-story, gable-roof, enclosed entry porch has been added on the façade. The dwelling features nonhistoric shutters, an arched doorway in the front porch, one-over-one, wood-sash windows as well as nonhistoric windows contained in the addition, and a brick chimney piercing the roof over the porch addition on the rear. The dwelling is covered in unique, multi-sized wood shingles creating a geometric pattern on its outside walls. A nonhistoric, shed-roof outbuilding is situated rear of the dwelling.</p>

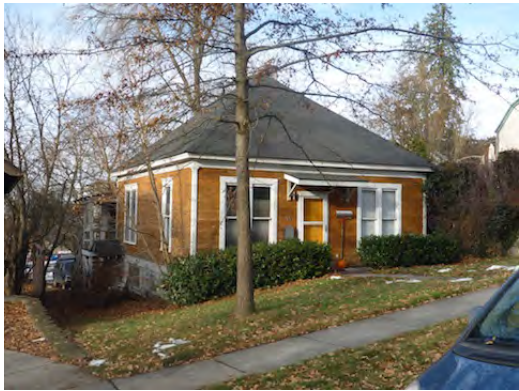
<p>Site #: 127 113 North Jefferson Street Owner: Phillip Mead 1912 Previous District Status: C, 4 DoE: C</p>

<p>This is a single-story, three-bay (ww/d/ww), hip-roof dwelling, oriented east on North Jefferson Street. It has a small, shed roof awning over the main entry, and an original, partial-width, enclosed porch on the rear. The dwelling contains one-over-one, double-hung, wood-sash windows with simple wood surrounds – some with crown molding, narrow wood siding, corner boards with simple capitals, and a simple wood cornice. The foundation level is covered in wider, lap siding. A small, brick chimney pierces the roof near the central ridgeline.</p>

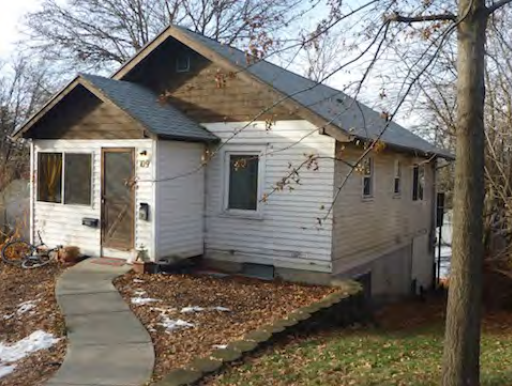
Survey Site Data	Site Photographs	Site Details
<p>Site #: 128</p> <p>109 North Jefferson Street</p> <p>Owner: Andrea Masom</p> <p>1920</p> <p>Previous District Status: n/a (within original district boundaries, but not included in inventory)</p> <p>DoE: NC</p>

<p>This is a single-story, gable-oriented, frame dwelling with an enclosed, gable-roof porch off-centered on the façade elevation and a small, gable-roof bay on the south elevation. Originally, this dwelling featured a full-width porch across the façade and an extension to the north creating an L-shaped footprint; neither feature remains today. The residence is covered in clapboard siding, with shingles filling the peaks of the gables. It rests on a concrete or parged basement foundation, covered with some vinyl siding at the west end. A rear deck is found on the west.</p>

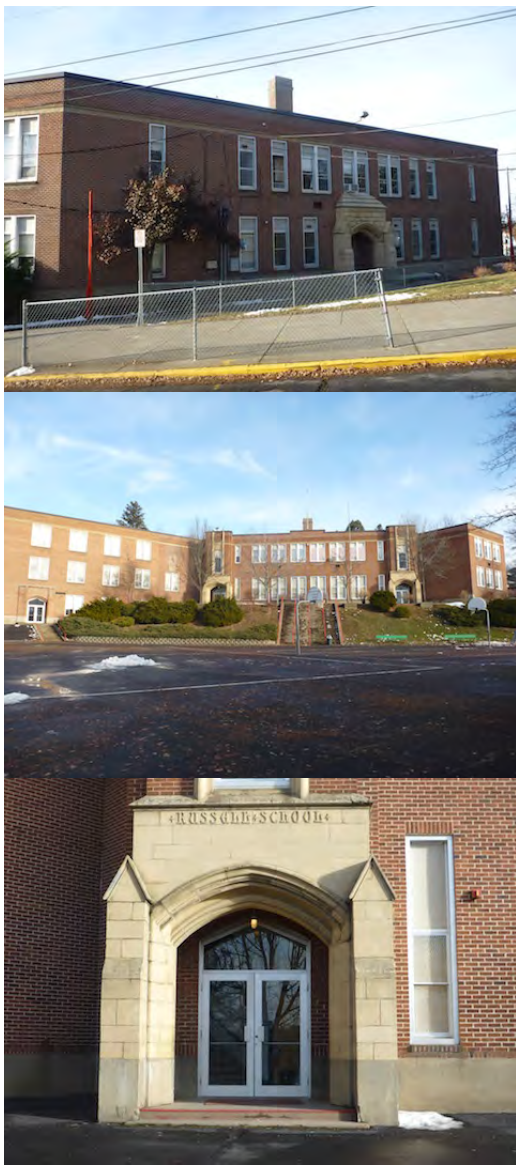
<p>This is the John Russell Elementary School, or the Russell School. The original portion of the building is a rectangular central block, flanked by small wings. The building is situated diagonally crossing the northeast corner at the corner of Adams and A Street. A rectangular wing was added at the west end of the building parallel to A Street between 1928 and 1962. The building features a raked brick veneer, and a poured-concrete foundation. It exhibits elements of the Collegiate Gothic style, including cast stone surrounds around the entries, with pilasters exhibiting peaked stones at the top, and Gothic arches over both the cast stone and brick entries. The building has soldier course brick lintels and sills. A soldier course of blonde bricks runs above the second-story windows. The windows throughout have been replaced with metal sashes, with the top of the window openings being filled in. The addition exhibits features similar to the original, except that the veneer is laid in a six-row common bond. The building's doors have been replaced with metal frame doors, retaining the peaked transom windows. A large, brick chimney extends over the center of the roof in the center of the original building. The roofline is capped in metal. A nonhistoric, single-story, prefabricated portable building is located west of the building. Two doors on the east side are accessible via a wooden stairway and ramp.</p>

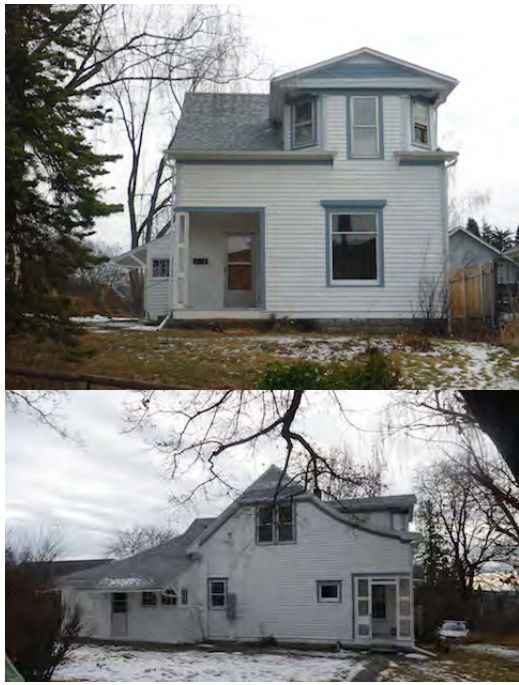
Survey Site Data	Site Photographs	Site Details
<p>Site #: 130</p> <p>403 East A Street</p> <p>Owner: Merritt Decker</p> <p>ca. 1900</p> <p>Previous District Status: NC (compatible), 93</p> <p>DoE: C</p> <p>Garage: Historic</p> <p>DoE: C</p>

<p>Site 130 is oriented west on the southeast corner of A and Adams Streets. It is a one-and-one-half-story, side-gable, frame dwelling. It features a prominent gable roof bay with chamfered corners that was added later at the southwest corner. A porch recessed beneath an extension of the main roof on the northwest corner and a large hip-roof addition on the rear behind the original rear porch were both added during the same period. A shed roof extension shelters a rear entry on the south side. Wood-sash windows covered with are found on the dwelling. The residence is covered in clapboard siding and features fish scale and square shingles in the peaks of the gables, as well as pilasters on the gabled bay. An early twentieth-century, frame, gable-roof, single-car garage is behind the dwelling.</p>

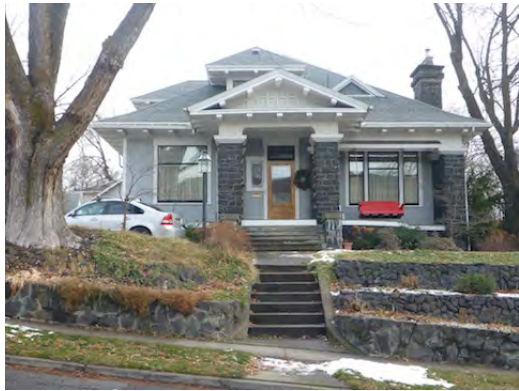
<p>Site #: 131</p> <p>120 North Adams Street</p> <p>Owner: Patricia Ann Bowen</p> <p>1908</p> <p>Previous District Status: C, 94</p> <p>DoE: C</p> <p>Garage: Historic</p> <p>DoE: C</p>

<p>This is a one-and-one-half-story, hip-roof Bungalow. It features an open entry porch centered on the façade, supported by basalt rock piers supporting a pedimented roof filled with lattice-like detailing and modillions above. The porch extends along the east end of the façade, with a basalt pier at the east end. The main entry contains a single-light, wood door with a transom, and a small stained-glass window next to the door. Stone pilasters flank the entry. A hip-roof dormer and small triangular window are found above the façade. One-over-one, double-hung, wood-sash windows remain throughout. A large basalt stone chimney extends on the south elevation. The dwelling is covered in narrow, clapboard siding and exhibits modillions throughout. Another hip-roof dormer and additional chimney are found above the north elevation. A frame, gable-roof, two-car garage is found at the northeast corner.</p>

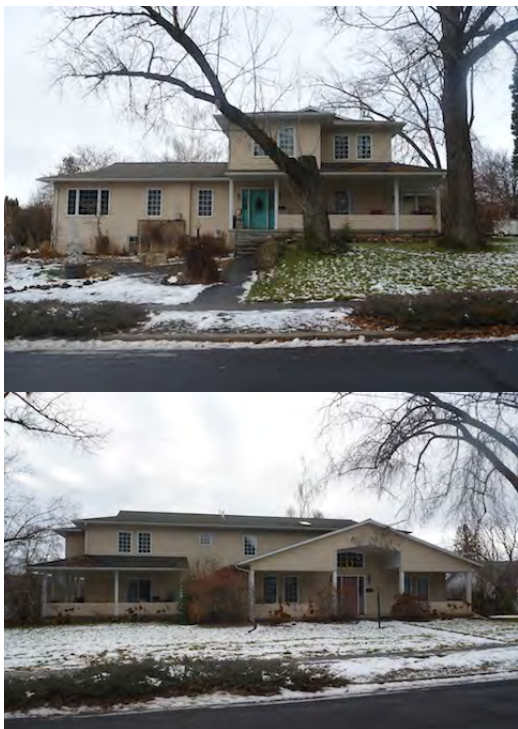
Survey Site Data	Site Photographs	Site Details
Site #: 132 133 North VanBuren Street & 415 East A Street Owner: Robert Shepard 1994 Previous District Status: NC (compatible), 92 DoE: NC Garage: Historic DoE: C

Site 32 is located on the southwest corner of A and VanBuren Streets. It is an asymmetrical, eclectic, multi-unit, multi-height dwelling with a number of separate sections and additions. A single-story, gable-on-hip roof section extends to the south, a long, two-story, gable-on-hip section runs east-west along the north side and a single-story section with a broad gable roof is found on the northwest side. A single-story porch wraps around the northeast corner. The house exhibits all modern materials. A gable-roof outbuilding or garage is found west of the dwelling. It is covered in vertical metal panels and wide, horizontal wood boards.

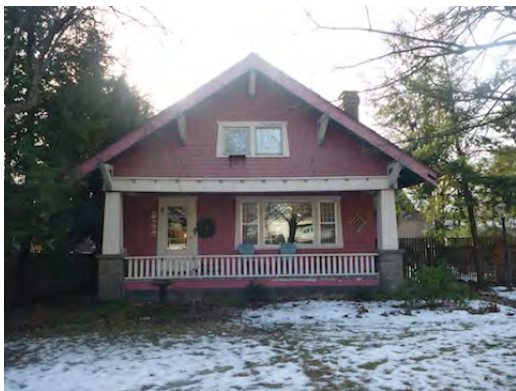
Survey Site Data	Site Photographs	Site Details
<p>Site #: 134</p> <p>515 East A Street</p> <p>Owner: Richard Gomulkiewicz</p> <p>1911</p> <p>Previous District Status: C, 87</p> <p>DoE: C</p> <p>Garage: Historic</p> <p>DoE: C</p>

<p>Site 134 faces north toward A Street, east of Van Buren. It is a one-and-one-half-story, gable-oriented Bungalow. It features a full-width porch recessed beneath the upper level. The porch is set on flared posts at the corners, on top of stone piers. The porch and dwelling foundation are stone blocks. The door and window trims are flared. The dwelling exhibits weatherboard siding, rafter tails, wood shingles in the gable end, large brackets, and multi-light, wood-sash windows. The bargeboards have notched ends. An exterior brick chimney extends up at the northwest corner near a shed-roof dormer over the west elevation. An addition is found on the rear, southwest corner. The addition is set back from the street, is subordinate to the original dwelling, and is largely blocked by vegetation. A nonhistoric, frame, gable-roof playhouse elevated up from the ground is found in the yard.</p>

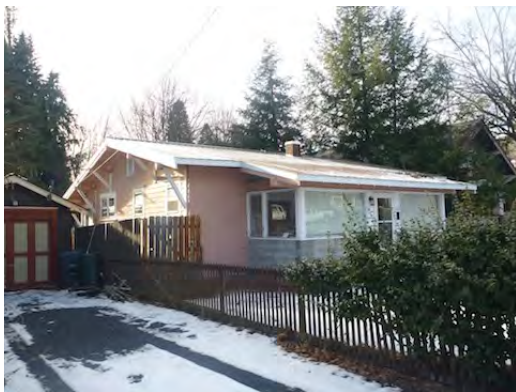
<p>Site #: 135</p> <p>517 East A Street</p> <p>Owner: Properties & Development, Inc.</p> <p>1913</p> <p>Previous District Status: NC (intrusion), 86</p> <p>DoE: NC</p>

<p>Site 35 is a dwelling located near the corner of A and Van Buren Streets and is a small, square plan, single-story, side-gabled, frame house. It has an enclosed porch spanning nearly the full-width of the façade, which is covered by a shed-roof extension of the main roofline. The front porch features concrete block below, and wood-framed windows above. The house is covered in wood shingles, and retains wood-sash windows. A brick chimney pierces the center of the roof. Large brackets are found on the side elevations.</p>

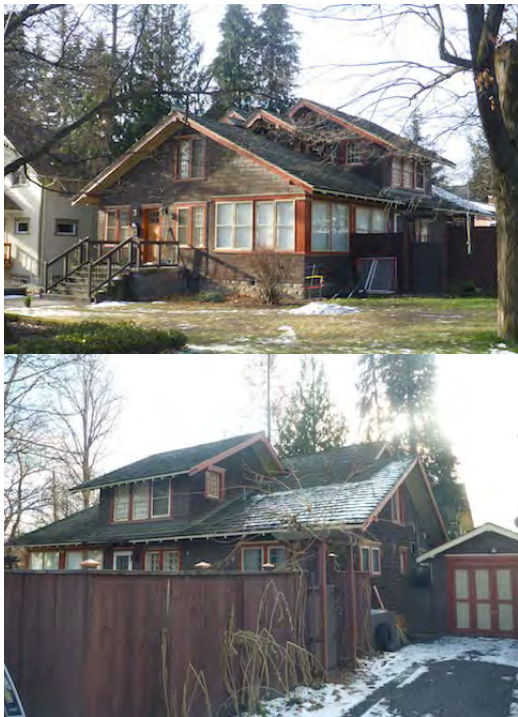
Survey Site Data	Site Photographs	Site Details
<p>Site #: 136</p> <p>121 North Polk Street</p> <p>Owner: John Sullivan</p> <p>1914</p> <p>Previous District Status: C, 83</p> <p>DoE: C</p> <p>Garage: Historic</p> <p>DoE: C</p>

<p>Site 136 is set on the southwest corner of A and Polk facing east. It is a one-and-one-half-story, gable-roof Bungalow with several additional gable-roof dormers extending up from the roof. It is set on a foundation of rusticated concrete blocks, and features wood shingle siding, visible rafter tails, and notched bargeboards. Multi-light, wood-sash windows remain – exhibiting very small, square divisions in the glass. A small porch at the front entry no longer remains; the entry is now accessible via a larger staircase with no shelter overhead. An exterior, shouldered, brick chimney is found on the south elevation extending up along the front corner of one of the roof extensions. The original, small, gable-roof, frame garage is found behind the dwelling. It features shingle siding and original, multi-section wood doors.</p>

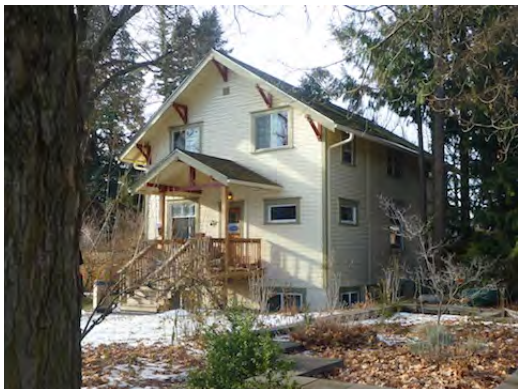
<p>Site #: 137</p> <p>115 North Polk Street</p> <p>Owner: Andriette Pieron</p> <p>1915</p> <p>Previous District Status: C, 112</p> <p>DoE: C</p> <p>Garage: Historic</p> <p>DoE: C</p>

<p>Site 137 faces east toward Polk Street, south of A Street. It is a two-story, gable-oriented, frame dwelling with a small, gable-roof porch centered on the façade. The dwelling retains drop wood siding, large brackets, and simple wood window trims with crown molding. Basement level windows have been added, and the foundation has either been redone or parged. A basement entryway has been added on the south elevation. A nearly full-width, enclosed rear porch remains, though an upper level deck has been added over it. A small, gable-roof, frame outbuilding with materials similar to the main house is found in the southwest corner of the property.</p>

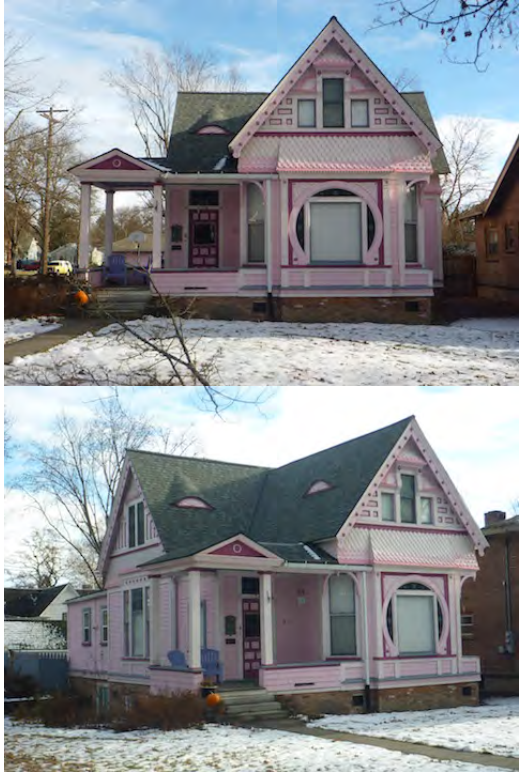
<p>This is a cross-gabled, one-and-one-half-story, Queen Anne dwelling. It exhibits an asymmetrical form, extensive ornamentation including diamond-shaped and scalloped imbrication, recessed panels, and rosettes. The forward gable features chamfered corners with brackets above, and a semi-circular window trim with small stained-glass windows filling in the curves. Four eyebrow dormers with sunburst designs are found on the house. A porch at the northwest corner has square posts, a shingled apron, and a small gable-roof over the entry stairs. A hip-roof, enclosed porch wraps around the rear, northeast corner. The dwelling is clad in weatherboard, and features both vinyl and wood-sash windows. A three-part window is found on the gable extension on the north elevation. The house rests on a brick foundation, with a daylight basement visible on the north elevation. A small, original, hip-roof, frame, single-car garage is found at the rear of the property. It features drop-wood siding and hinged wooden doors. A prefabricated, gambrel-roof shed sits up against the back wall.</p>

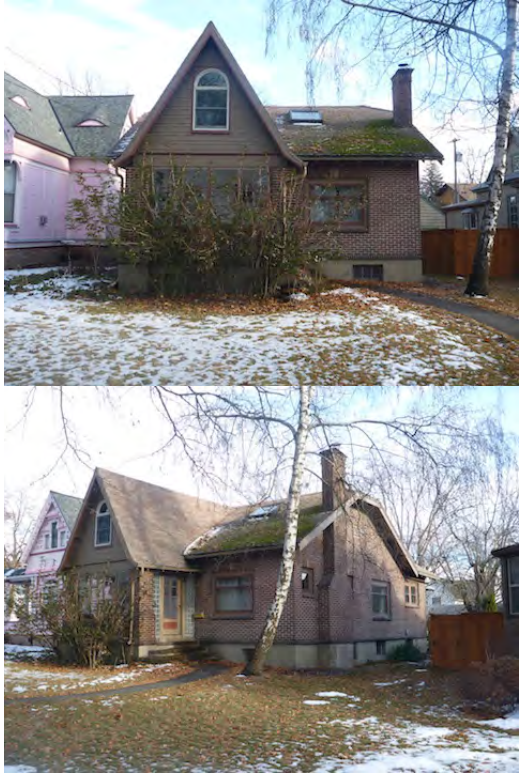
<p>This is a one-and-one-half-story, Bungalow exhibiting a brick exterior. A large, gable-roof, enclosed entry porch extends from the north end of the façade and features brick posts at the corners, with multi-light, wood-sash windows on the north and east elevations. A multi-light, wood entry door is found on the south side of the porch, flanked by glass-block sidelights. The dwelling is set on a concrete or parged foundation with a brick water table above. Wood-sash windows remain and exhibit brick sills and jack arches with keystones. The forward facing gable is covered in wood shingles, with both scalloped and saw-tooth imbrication around an arched vinyl window. The roof over the main dwelling exhibits clipped gables. An exterior, shouldered brick chimney is found on the south elevation, and a partial-width, enclosed, hip-roof porch is off-centered on the rear. A gable-roof, frame, single-car garage is at the rear of the property. It features wood shingles, multi-light, wood-sash windows, visible rafter tails, and paneled wooden doors.</p>

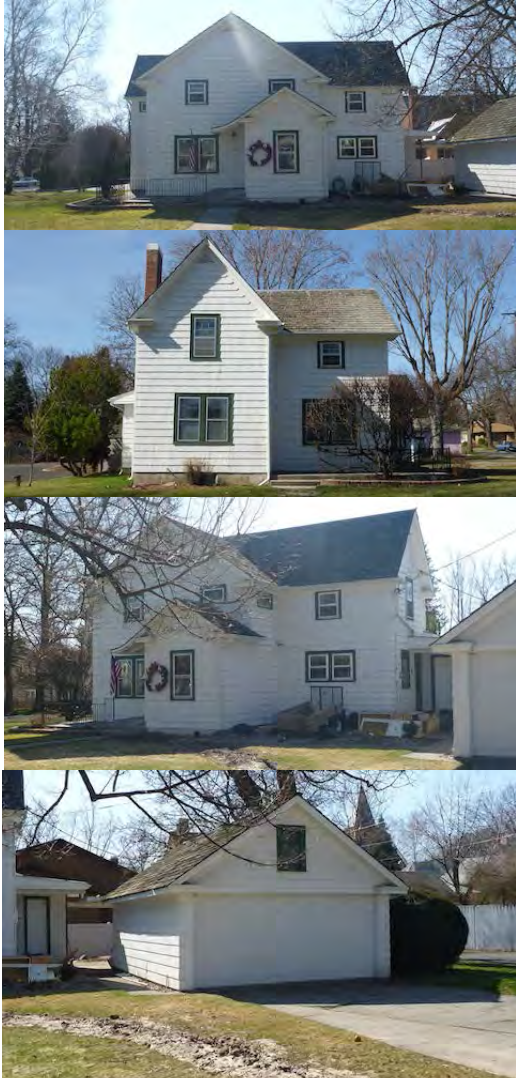
Survey Site Data	Site Photographs	Site Details
<p>Site #: 141</p> <p>621 East A Street</p> <p>Owner: Catholic Church</p> <p>ca. 1900</p> <p>Previous District Status: n/a</p> <p>DoE: C</p> <p>Garage: Historic</p> <p>DoE: C</p>

<p>This is a two-story, cross-gable dwelling. A front-gable section featuring paired window with six-over-six-light, double-hung, wood sash windows projects from the side-gable section near its east elevation. It features a wide cornice and cornice returns with a small, triangular vent at the top. A concrete deck with a partially enclosed metal railing spans the width of the façade of the side-gable portion of the dwelling and wraps around to a one-story, gable-roof projection on its east elevation. It features cornice returns on the gable end and an elongated, slightly curved roof overhang sheltering the main entry. Individual and paired windows with multi-light, double-hung, wood sashes are found throughout. A one-story, partially enclosed shed-roof porch addition is found on the west side. A concrete and brick chimney pierces the roof slope of the east elevation of the front-gable portion of the dwelling. The roof is sheathed in wood shingles and features wide overhang and cornice returns on the gable ends. The exterior walls of the dwelling are clad in wood shingles and the house rests on a poured concrete foundation. A one-bay, gable-oriented garage featuring a wood shake roof with a wide cornice and cornice returns is found just to the rear of the dwelling.</p>

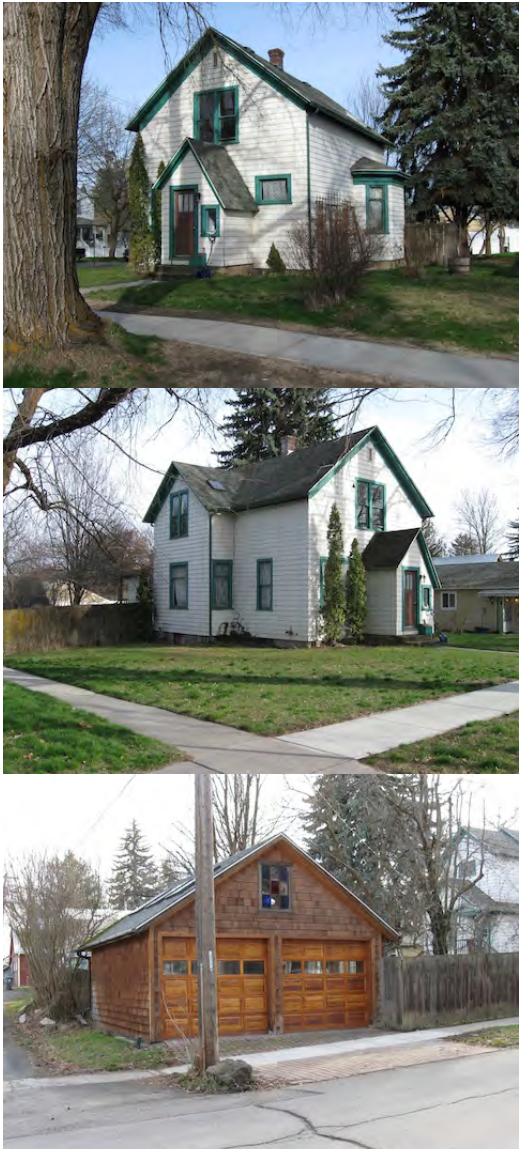
<p>This is a, one-and-one-half story, cross-gable dwelling with an overall rectangular plan that is oriented west facing North Howard Street. The façade features a pair of one-over-one, double-hung, wood-sash windows in the gable end above an asymmetrical, Tudor style entry vestibule that has varied eave heights. A Bungalow style wood door and a small, low window is found within the porch, which replaces an original porch in this same location. The crossing gable on the north elevation contains original wood-sash windows and a skylight. The south elevation features a three-sided bay window with wood-sash windows. Also found at this site, is a contemporary, gable front, two-car garage that faces north. The garage features stained wood shingle siding, composition shingle roof, skylights, a multi-paned colored glass window in the peak and two wood roll-up garage doors.</p>

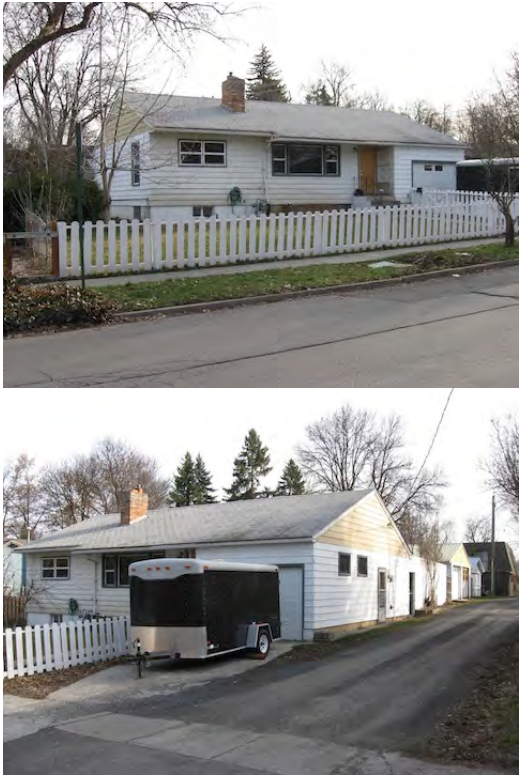
Survey Site Data	Site Photographs	Site Details
<p>Site #: 145 717 East A Street Owner: Ethan Atwood 1956 Previous District Status: n/a DoE: NC</p> <p>Garage: Modern DoE: NC</p>

<p>Site 145 is a one-story, side gable, early Ranch style dwelling with a basement and an L-shaped plan. The asymmetrical façade features an off-center entry containing a solid-core, flush, wood door. East of the door is a wide, triple window and a paired set of windows. To the west of the door is a single-car garage that projects slightly from the plane of the house. A brick chimney pierces the north slope of the roof. The west façade features two, small, high windows and a secondary entry door in the garage wall. To the rear is a flat-roofed addition. The building is wrapped in aluminum siding, and both vinyl and metal windows are found on the dwelling. The roofing is composition shingle and the foundation is concrete. At the alley to the rear of the dwelling is a front gable, two-car garage with metal roofing, metal siding, one metal roll-up door, and one wood roll-up door with glazing.</p>

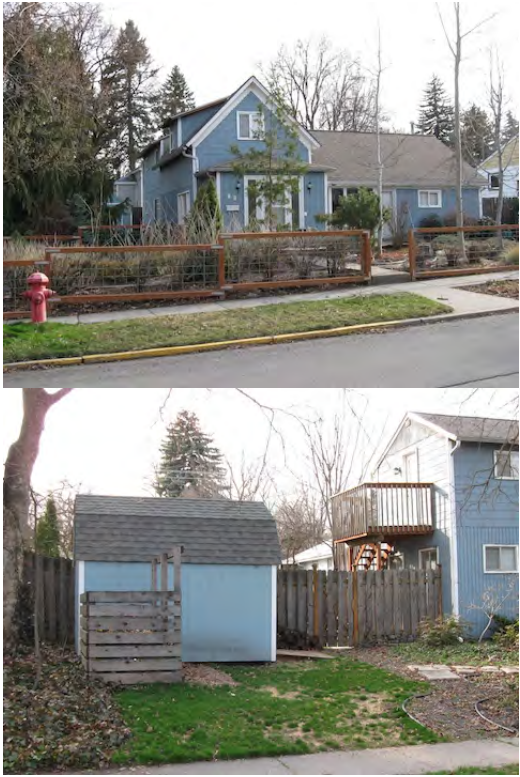
Survey Site Data	Site Photographs	Site Details
<p>Site #: 146 723 East A Street Owner: Tyler Wright Kee ca. 1900 Previous District Status: n/a DoE: NC</p>

<p>Site 146 is an altered, one-and-one-half story, gable-front-and-wing dwelling with a two story addition at the rear. The residence is located on the southwest corner of East A Street and North Monroe Street, facing north towards East A Street. The façade features an enclosed, filled-in entry porch under a hip roof on the front facing gable, with a fiberglass entry door with sunburst glazing and sidelights. A slider window is in the peak of the gable. Modern windows and a fiberglass door are located in the elongated and widened wing to the west. The east elevation features a shed-roof dormer with off-center slider window and the two-story addition at the rear of the gable. At the south elevation a second-story wood deck highlights the rear of the addition covered in both horizontal and vertical sheet siding. Roof is composition shingle. Also on this site is a small, gambrel-roofed, pre-fabricated shed with T1-11 siding and composition shingle roof.</p>

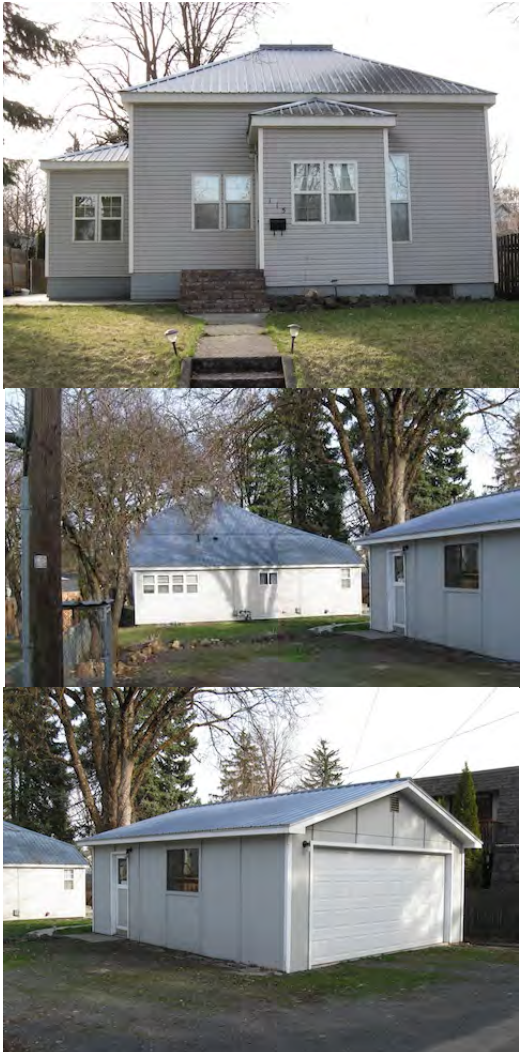
Survey Site Data	Site Photographs	Site Details
<p>Site #: 147</p> <p>115 North Monroe Street</p> <p>Owner: Evan Holmes</p> <p>ca. 1900</p> <p>Previous District Status: n/a</p> <p>DoE: NC</p> <p>Garage: Modern</p> <p>DoE: NC</p>

<p>Site 147 is an altered, single-story, truncated-hip roof dwelling oriented east facing North Monroe Street. The façade features a central, enclosed entry vestibule under a hipped roof with the entry door in the south facing wall and a pair of windows in the east-facing wall. A pair of windows is located south of the entry and a single window to the north. The projection at the south elevation is hip roofed and features a pair of windows. At the rear of the house is an historic, full-width, shed-roofed extension that exhibits a number of windows. The house has been wrapped in vinyl siding, the roof is metal and all the windows are vinyl replacements. At the alley is a contemporary, two-car, gable front garage. It features plywood sheet-and-batten siding, a metal roof, metal slider windows, glazed, wood entry door, and a composite, roll-up garage door.</p>

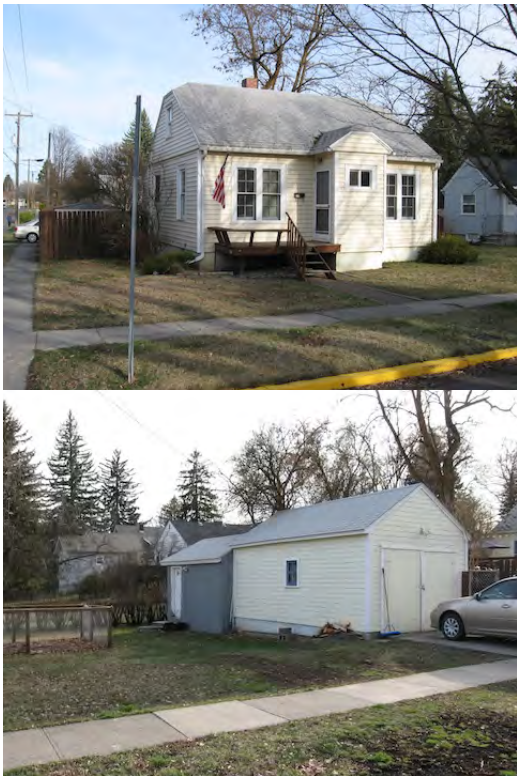
<p>This is a one-and-one-half-story, clipped-gable, cottage on the southeast corner of East A and North Monroe Streets. The façade features an enclosed, front-facing, clipped gable entry with the entry door in the north facing wall and a slider window in the west-facing wall. A wood deck is located north of the entry door. Paired windows flank the entry. Small windows are found in the peaks of the gable ends. At the east elevation is a contemporary wood deck and a shed-roof projection containing a sliding-glass door. A brick, interior chimney is found on the east slope of the roof. The building has vinyl siding, vinyl windows, composition shingle roof, and a concrete foundation. Also at this site is a gable-front, one-story garage with a pair of plywood swing-out doors, wood-sash windows, wood drop siding, and composition shingle roof. A small, metal-sided, gable-roof addition is found at the rear of the garage.</p>

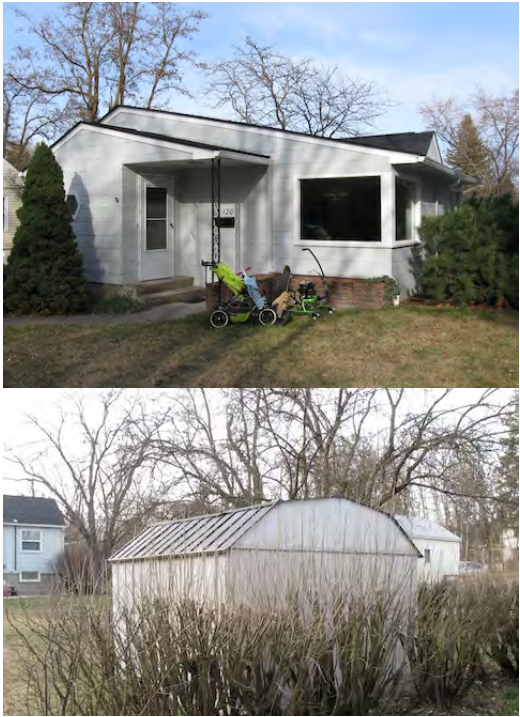
Survey Site Data	Site Photographs	Site Details
<p>Site #: 149</p> <p>120 North Monroe Street</p> <p>Owner: Jacquelyn Rigg</p> <p>ca. 1940</p> <p>Previous District Status: n/a</p> <p>DoE: NC</p>

<p>This is an altered, single-story, cross-gable dwelling, oriented west facing North Monroe Street. The façade features a secondary front gable with the roofline elongated to the south to shelter the entry door. A small, hexagonal window is nearly centered on the west-facing wall of the entry. In the main gable, which is also elongated towards the south, is a large corner window and one smaller window. A gable-front hood shelters a side entry door at the north elevation. The siding is wide composite clapboards, the roof composition shingle and the foundation is concrete block. At the rear of this site is a gambrel-roof, prefabricated metal shed.</p>

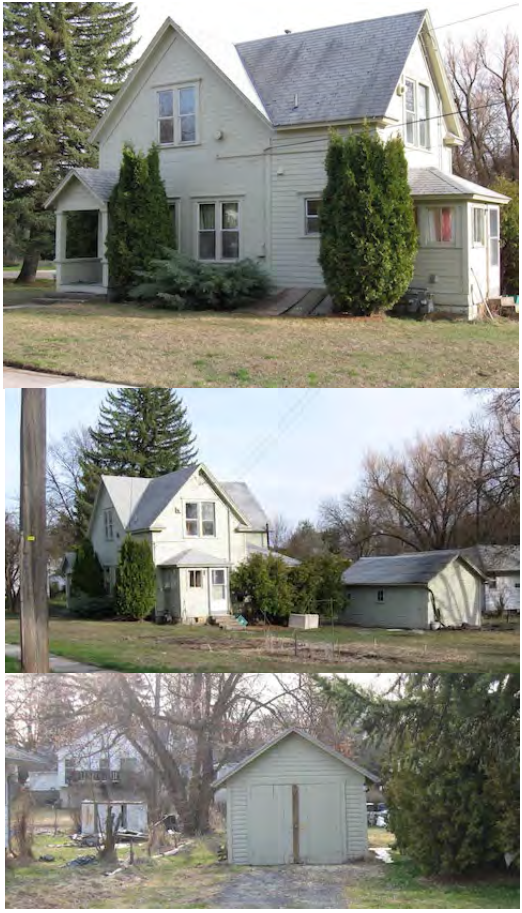
<p>This is a one-and-one-half story, cross-gabled, Vernacular dwelling oriented north facing East A Street. The façade features a gable-front entry porch supported by square, trimmed posts on closed porch rails with a single-glazed, horizontal panel, wood door. To the west of the entry are two pairs of windows, and a single window. Window surrounds are classical wood trim. In the gable peak is a pair of windows. The west elevation features an off-center, hip-roofed rear porch wrapped in wood-sash windows. A pair of windows and cornice returns are found in the rear gable end above the rear porch. At the east elevation is another gable-roof porch flanked by windows. The walls of the dwelling are clad in wood drop siding, most of the windows are metal sash, the roof is composition shingle, and the foundation is rusticated concrete block. Also on this site, is a one-story, gable-front, single-car garage. It features wood drop siding, wood-sash windows, felt roofing, a nonhistoric entry door, and wood plank, swing-out garage doors.</p>

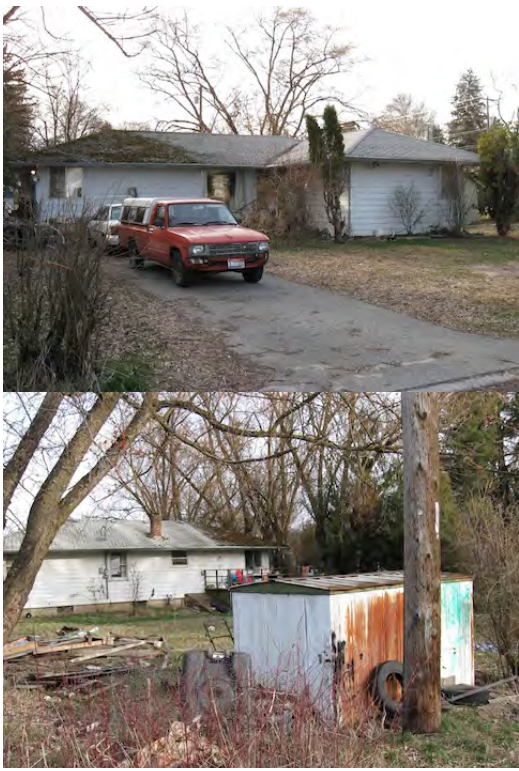
<p>This is a one-story, L-shape, hip-roof Ranch style dwelling oriented towards the east facing North Lincoln Street. The integral garage has been closed in and converted to living space. The façade features an inset entry under the main roof in the forward extension, and both a large picture window and a slider window in the south-facing wall. A small window is found at the northeast corner of the house. Three windows line the north elevation and a raised wood deck wraps the southwest corner at the rear of the dwelling. A brick, interior chimney pierces the roof on the west slope. One double-hung window is on the west elevation. The windows are a combination of vinyl and metal sash, the siding is aluminum, the roof is composition shingle, and the foundation is concrete. Also at this site is a gable-roof, pre-fabricated, metal shed.</p>

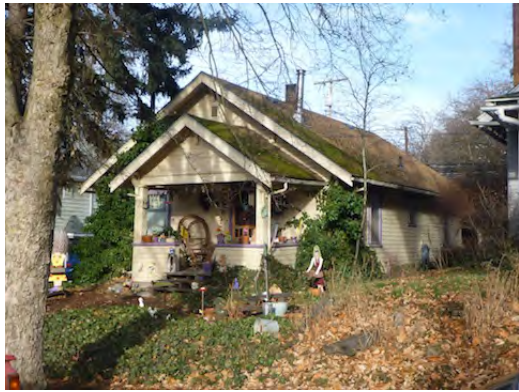
<p>Site #: 153</p> <p>216 East First Street</p> <p>Owner: Carol Shultzman-Hill</p> <p>1915</p> <p>Previous District Status: C, 1</p> <p>DoE: C</p> <p>Garage: Historic</p> <p>DoE: C</p>

<p>This is a single-story, frame, gable-oriented Bungalow facing south toward First Street. An open, gable-roof porch is off-centered on the façade, supported by square posts set on a clapboard-covered apron. An enclosed porch, is found on the northwest corner with multi-light, fixed, windows. The dwelling is covered in clapboards, and exhibits brackets supporting the gables. Wood-sash windows remain throughout. A brick chimney pierces the center of the roof, while a metal stovepipe exits the roof above the east elevation. An gable-roof, frame garage is located behind the dwelling. It is clad in wood boards, has a single entry on the south side flanked by small windows, and a vehicular entry on the west side with a two-part, hinged, wooden door.</p>

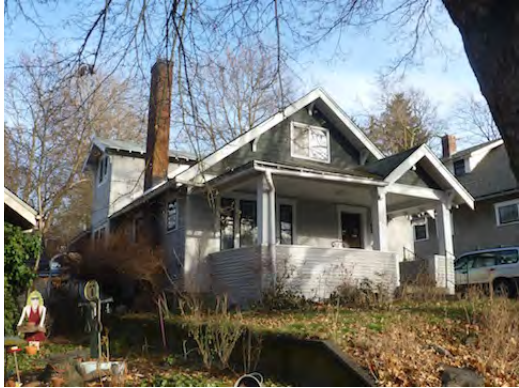
Survey Site Data	Site Photographs	Site Details
<p>Site #: 154</p> <p>220 East First Street</p> <p>Owner: Lucas Roy Hugie</p> <p>1915</p> <p>Previous District Status: C, 2</p> <p>DoE: C</p> <p>Garage: Historic</p> <p>DoE: C</p>

<p>Site 154 is located mid-block, facing south toward First Street west of Jefferson. It is a one-and-one-half-story, gable-oriented Bungalow with a nearly full-width front porch across the façade and a full-height, gable-roof wall dormer centered on the west elevation. The main entry porch exhibits a hip roof with a gable over the main entryway. The house is covered in clapboards, with shingles filling the gable ends. One-over-one, double-hung, wood-sash windows remain. A three-part window is found on the façade with a large single-light window flanked by one-over-one sashes. A brick chimney extends up on the west elevation. The main porch has square posts with brackets beneath the gable roof. The posts sit on a clapboarded apron wall. An original, frame, gable-roof, single-car garage is found at the northeast corner of the site featuring materials and characteristics similar to the dwelling, and contains a three-part, hinged, glazed, paneled wood door.</p>

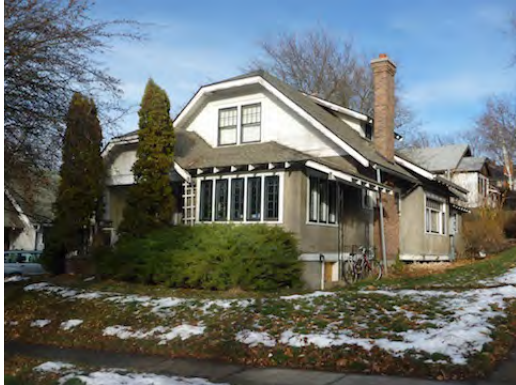
Survey Site Data	Site Photographs	Site Details
<p>Site #: 155</p> <p>103 North Jefferson Street & 226 East 1st Street</p> <p>Owner: Stephen Cooke</p> <p>1916</p> <p>Previous District Status: C, 3</p> <p>DoE: C</p> <p>Garage: Historic</p> <p>DoE: C</p>

<p>This is a one-and-one-half-story, Bungalow with a front-facing, clipped-gable roof over the main dwelling, a clipped gable of the entry porch on the southwest corner, and a hip roof over a enclosed porch at the southeast corner. A square bay under a shed roof, which pops up from the main roofline is centered on the east side, beneath a small shed roof dormer above. A similar dormer is found on the opposite side. A full-width, hip-roof, enclosed porch spans the rear, and a single-car garage with a clipped gable roof is attached at the dwelling's northwest corner. The dwelling is covered in aggregate, while the gable ends and dormers are clad in wood shingles. Multi-light, wood-sash windows, some fixed and some double-hung, are found on the dwelling. An exterior, shouldered, brick chimney is found on the east side. The dwelling also exhibits visible rafter tails and a basement entry on the southeast corner. An additional small brick chimney pierces the roof over the west elevation.</p>

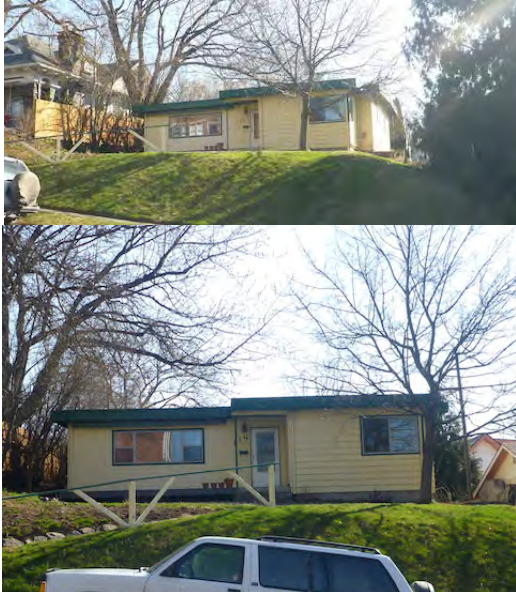
<p>Site #: 156</p> <p>114 North Adams Street</p> <p>Owner: Jonathan Lyle Gallup</p> <p>1958</p> <p>Previous District Status: n/a</p> <p>DoE: NC</p>

<p>This is a small, single-story, Contemporary Style dwelling. The dwelling features a very low-pitched roof, horizontal emphasis, large windows, a combination of horizontal and vertical cladding, and heavy, overhanging eaves. A small, rectangular bay extends from the south elevation. It features replacement windows, but retains an original, mid-century front door with three stepped windows. It rests on a poured-concrete foundation, and features an uncovered entry porch spanning the west portion of the façade. The main entry is sheltered by a small extension of the primary roof. A shed-roof outbuilding covered in lattice is found behind the dwelling.</p>

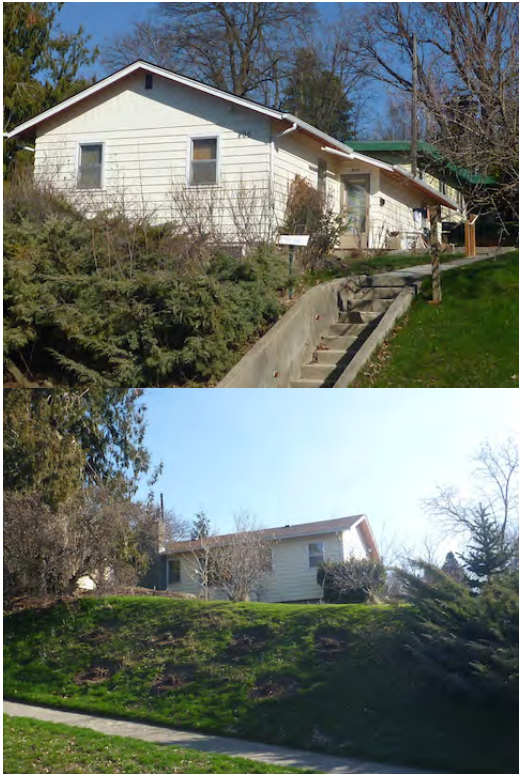
<p>Site 157 is a single-story, gable-roof, contemporary dwelling constructed in place of a ca. 1900 dwelling originally on this site. It exhibits wide, horizontal board siding with paneling within the gable ends appearing as vertical boards. An enclosed porch is found on the east elevation, beneath an extension of the primary roof. A large, exterior, concrete-block chimney is found on the west side. A small, shed-roof outbuilding is behind the dwelling.</p>

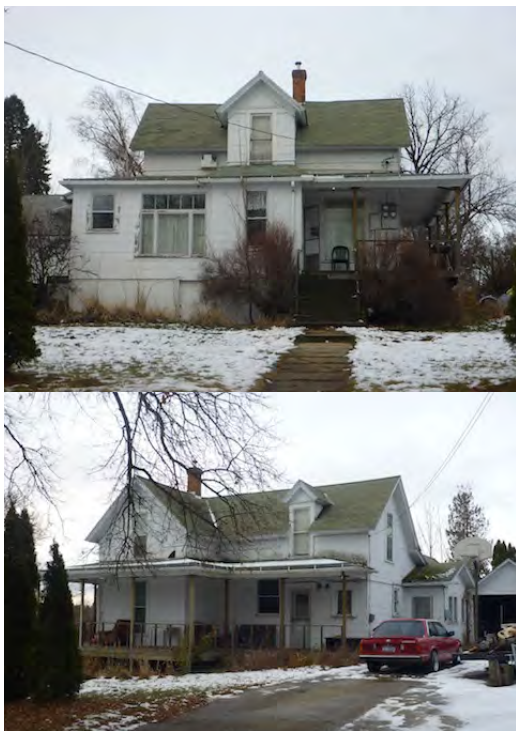
Survey Site Data	Site Photographs	Site Details
<p>Site #: 158</p> <p>426 East First Street</p> <p>Owner: Roger Crozier</p> <p>1890</p> <p>Previous District Status: NC (compatible), 95</p> <p>DoE: C</p> <p>Garage: Historic</p> <p>DoE: C</p>

<p>This is a one-and-one-half-story, T-plan, frame dwelling. It features a full-height rear ell, two, single-story extensions to the west, and a porch that wraps around the southeast corner and extends up the east side. A full-height, gable-roof addition centered on the façade and a single-story addition on the southwest corner of the main block were added by 1928. A narrow, gable roof wall dormer is found over an entry on the east side of the rear ell, and a brick chimney extends above the roofline of the main block of the dwelling. A gable-roof, enclosed porch is found on the rear. The dwelling retains wood-sash windows, and has been covered in asbestos siding. The foundation is concrete block. A small, gable-roof, frame, single car garage constructed by 1928 is located directly northwest of the dwelling.</p>

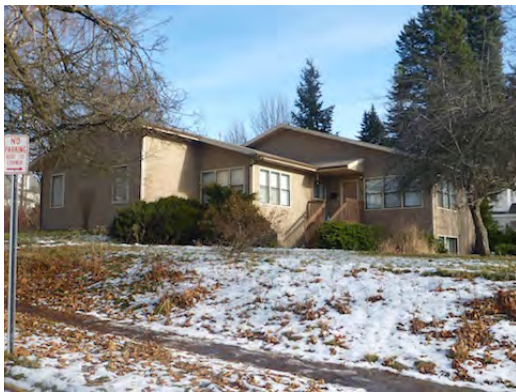
<p>Site #: 159</p> <p>106 North VanBuren Street</p> <p>Owner: James Tangen-Foster</p> <p>1986</p> <p>Previous District Status: C, 113</p> <p>DoE: NC</p>

<p>Site 159 is located on the northeast corner of First and VanBuren Streets and contains a dwelling (Site #159) and a barn (Site #160). This is a contemporary dwelling, which has replaced the 1890 Frank A. David House. It features multiple gable-roof sections and is set on a basement foundation.</p>
