National Register of Historic Places Registration Form

Historic name: Fort Russell Neighborhood Historic District (Boundary Increase and Additional Documentation)

Street & number: Roughly bounded by Jefferson Street on the west, East D Street on the north, Hayes Street on the east, and East Third Street on the south

City or town: Moscow State: ID County: Latah

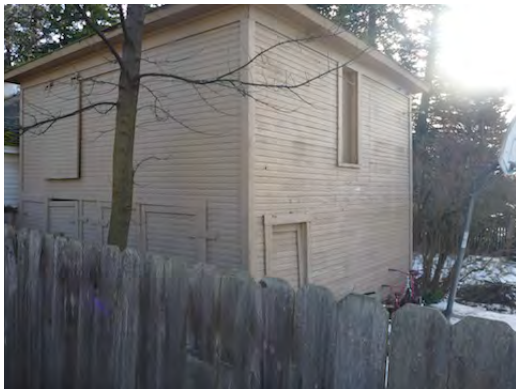
Survey Site Data	Site Photographs	Site Details
<p>Site #: 160</p> <p>106 North VanBuren Street</p> <p>Owner: James Tangen-Foster</p> <p>ca. 1900</p> <p>Previous District Status: n/a</p> <p>DoE: C</p> <p>Garage: Historic</p> <p>DoE: C</p>

<p>Site 160 is located on the northeast corner of First and VanBuren Streets and contains a dwelling (Site #159) and a barn (Site #160). Site 160 is the original two-story, hip-roof barn though the original dwelling is no longer extant. It features a square footprint, and several wooden entry doors on both the lower and upper levels. A wooden door on an overhead sliding track is found on the north elevation over paired, hinged doors. The building is covered in drop wood siding and retains wood corner boards and cornice with small crown molding detail. Though the dwelling no longer remains, the barn retains the historical character that makes it a part of the story of this district.</p>

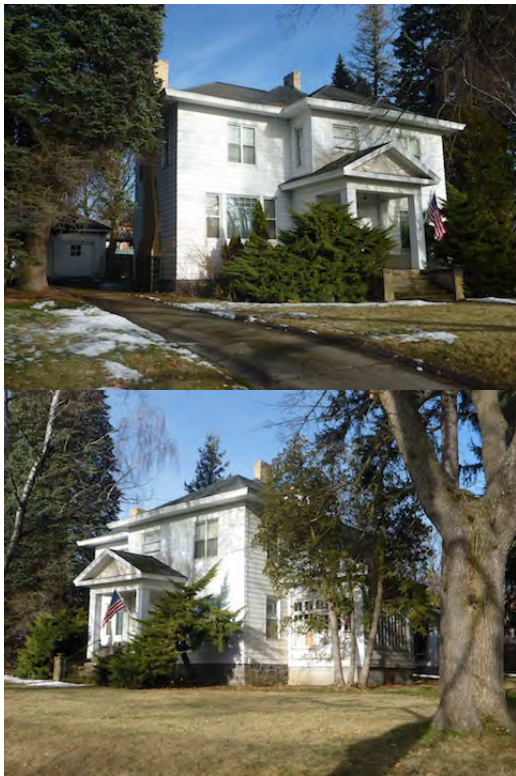
<p>Site 161 faces south toward East First, west of Polk Street. This is the W.L. Paine House, and is a large, asymmetrical, cross-hipped-roof, two-story, frame dwelling. It has a heavy, gable-roof entry porch supported by square posts with a starburst design in the gable end. The house is set on a stone block foundation. An exterior, blonde brick chimney is found on the west elevation and a blonde brick chimney pierces the roof. The house, has been covered in aluminum siding and the windows have been replaced with metal-sashes. A single-story sunroom is found on the east elevation. It is set on a concrete or parged foundation and has multi-light, wood-sash windows. A single-story addition with a gable roof and bay window is found on the rear northeast corner. A hip-roof, frame carriage house with a cupola, weatherboard siding, and sliding, paneled wood doors is found at the rear.</p>

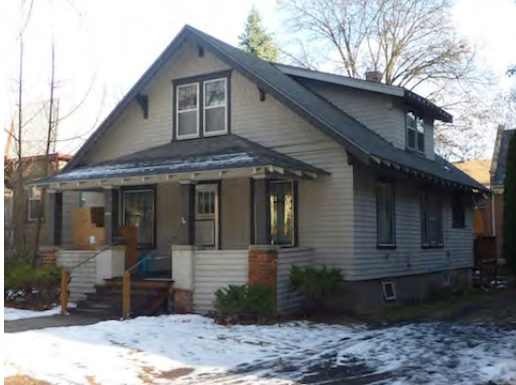
Survey Site Data	Site Photographs	Site Details
<p>Site #: 163</p> <p>110 North Polk Street</p> <p>Owner: Catholic Church</p> <p>ca. 1930</p> <p>Previous District Status: C, 109</p> <p>DoE: C</p> <p>Garage: Historic</p> <p>DoE: C</p>

<p>Site 163 is located just north of St. Mary's Catholic Church, facing west toward Polk Street. It is a three-bay (w/d/w), one-and-one-half-story, gable-oriented, frame Bungalow. It features a nearly full-width, hip-roof porch across the façade, supported by square posts with crown molding atop brick piers, the center two of which have been partially covered. The dwelling is clad in weatherboard with wood shingles in the gable end. Shed roof dormers are found above the north and south elevations. Brackets, visible rafter tails, and multi-light, wood-sash windows are extant. A small shed roof supported by brackets serves as the back porch. The house has a concrete basement foundation. A single-car garage with wide horizontal board siding, visible rafter tails, and four paneled wood doors is at the rear. .</p>

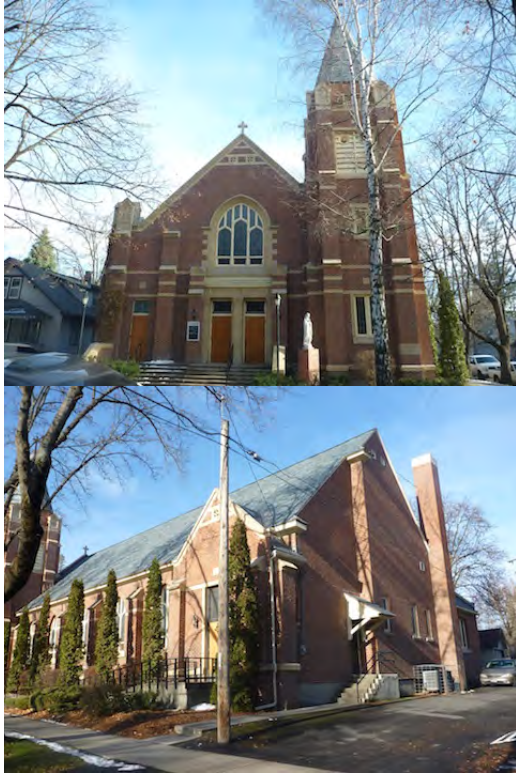
<p>Site 164 is St. Mary's Catholic Church, located on the northeast corner of First and Polk Streets. The building is L-shaped, with a large rectangular portion running east-west along First, a small extension at the northeast, rear corner, and a square tower at the southwest corner. It features a red brick exterior, slate or rubber tile roof, and stone detailing including sills, a water table, window trims, and cornice detailing. Additional stone detail is found on top of the buttresses and at the top of the pilasters on the tower. Further evidence of the building's Late Gothic Revival style includes pointed arched stained-glass windows and the restrained use of detail. A number of leaded-glass windows can also be found. The building also features hopper windows beneath the stained glass windows and cornice returns.</p>

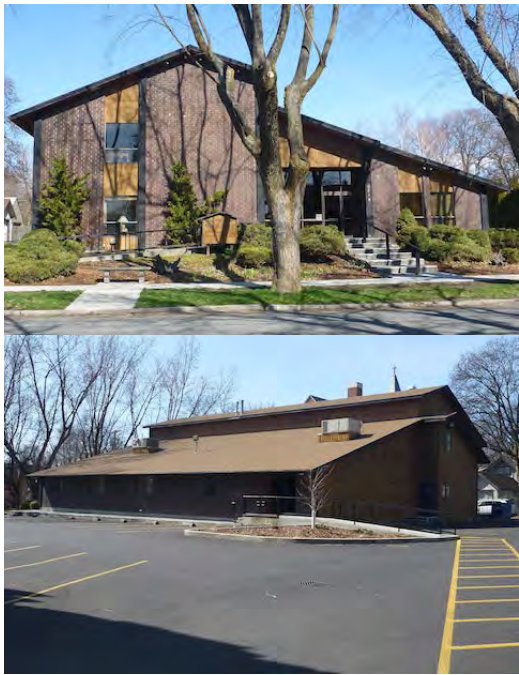
Survey Site Data	Site Photographs	Site Details
<p>Site #: 165</p> <p>618 East First Street</p> <p>Owner: Catholic Church</p> <p>Contemporary</p> <p>Previous District Status: n/a</p> <p>DoE: NC</p>

<p>Site 165, oriented to the south, is a large, multilevel, brick structure known as St. Mary's Family Center. This shed style, contemporary building has a large, two-story, asymmetrical front-facing gable section on the façade with a lower, elongated, shed-roof section that spans the width of the east elevation of the building. It features a modern, double-leaf entry with full-light metal doors surrounded by a large, open, full glass entry section on the façade. Wide, full-height vertical sections with modern, metal-frame windows and wood paneling in between are featured on the facade, with vertical wood paneling and metal frame windows exhibited throughout the building. The roof of the building, featuring wide, angled overhangs, is sheathed in asphalt shingles.</p>

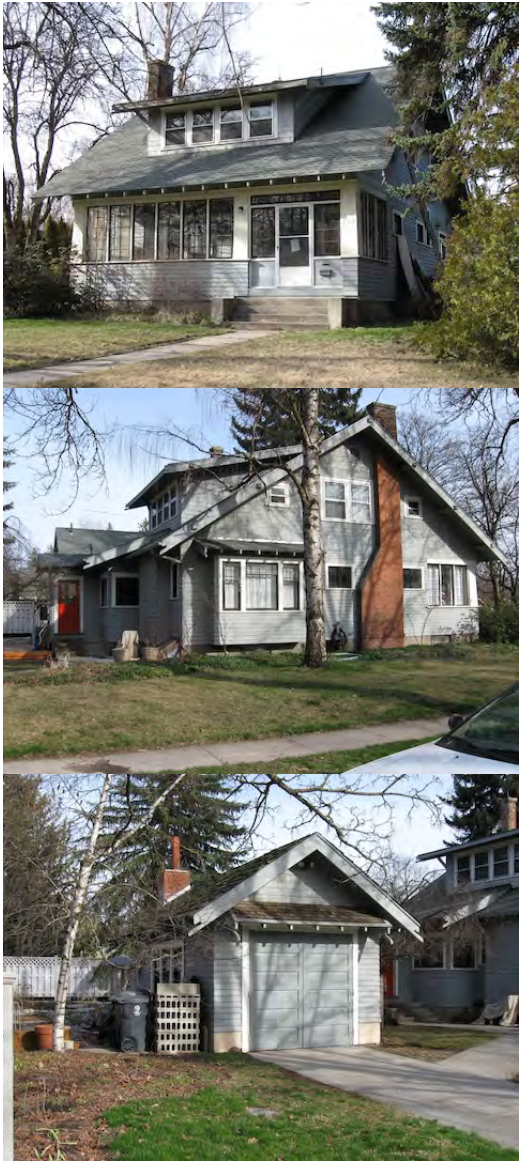
<p>This is a one-and-one-half story, side gable, Craftsman style dwelling that is oriented towards the south facing East First Street. The façade features a full-width, integral porch under the main roof. The porch is supported by tapered square columns atop an apron wall. The porch openings are filled with ten-light, wood-sash windows and an aluminum-frame storm door. The off-center entry door is a glazed, wood-ledged door and shares the porch with three, large windows. Shed-roof dormers are found over the north and south elevations each with a ribbon of four windows. The north elevation features a shed-roofed, square bay with three windows and a brick, outside chimney flanked by a pair of small, windows. The gable ends feature half-timbering with painted cedar shingles between. At the rear of the dwelling is a secondary entry door within a gabled projection. A single-flue, brick, chimney pierces the north slope of the roof. Details include elaborated barge boards, knee braces, deep eaves, and exposed rafter tails. Windows are original wood sash. The first-floor is clad in clapboards, and the dormers in cedar shingles, and the roofing is composition shingle. Also on this site is a gable front, single-car garage. It features a pent roof over the wooden, swing-out, garage doors. Wood clapboards cover the walls while wood shingles fill the gable ends. The garage exhibits exposed rafter tails, elaborated bargeboards, shingled roof and a brick chimney.</p>

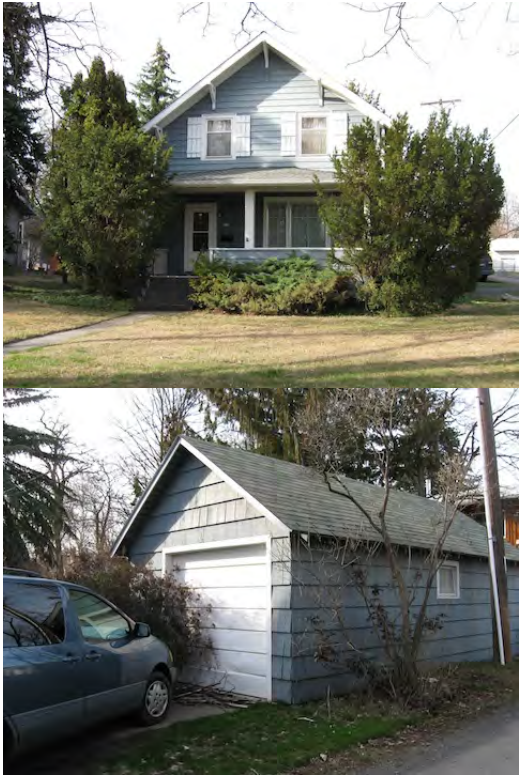
Survey Site Data	Site Photographs	Site Details
<p>Site #: 167</p> <p>718 East First Street</p> <p>Owner: Richard Penticoff</p> <p>ca. 1900</p> <p>Previous District Status: n/a</p> <p>DoE: C</p> <p>Garage: Historic</p> <p>DoE: C</p>

<p>This is a one-and-one-half story, front gable dwelling with an irregular plan that is oriented towards the south facing East First Street. The façade features a full-width, hip-roof porch atop square posts on a closed railing. The entry door is a glazed, ledged, wood door. An original wood-sash, triple window shares the wall with the entry. Above the porch is a pair of wood-sash windows with nonhistoric shutters. Knee braces support the eaves in the gable ends. A single, brick, interior chimney pierces the west slope of the roof. A small greenhouse has been added to the west elevation at the hip-roof addition. The walls are clad in aluminum siding and the roof is covered in composition shingles. The foundation is concrete. Also on this site at the alley is a one-story, front gable, single-car garage with walls sheathed in machine-cut shingles, a composition shingle roof, and a metal roll-up garage door.</p>

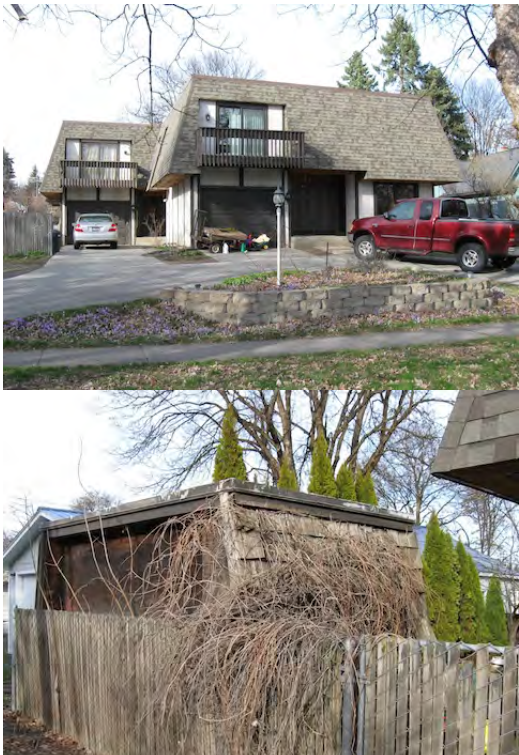
Survey Site Data	Site Photographs	Site Details
<p>Site #: 168</p> <p>720 East First Street</p> <p>Owner: Gayle Rogalski</p> <p>1971</p> <p>Previous District Status: n/a</p> <p>DoE: NC</p> <p>Carport: Modern</p> <p>DoE: NC</p>

<p>Site 168 is a two-story, contemporary, Neo-Mansard duplex that is oriented towards the south facing East First Street. The façade of each unit features double wood doors, a large picture window, a single-car, roll-up garage door, and a second story balcony with sliding-glass doors. Through-the-cornice windows are featured at the west and east elevations, and those at the east with small balconies. A small, Mansard roof shed is found at the rear of the site.</p>

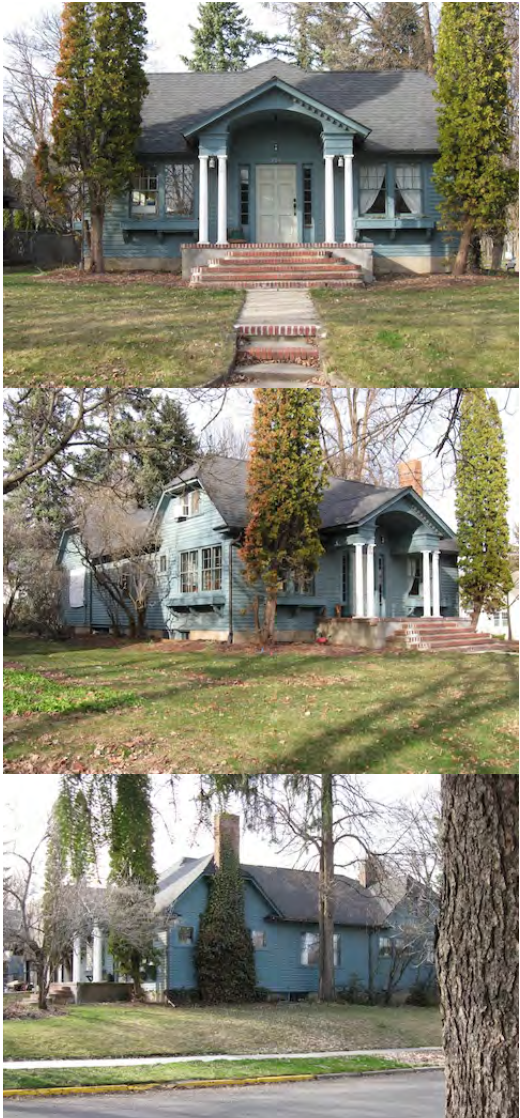
<p>The photographs show a light blue, one-and-a-half-story house with a dark roof. The front view shows a central entrance with a small porch supported by columns. The side view shows the H-shaped plan of the house. The rear view shows a chimney and a side gable.</p>	<p>Site 169 is a one-and-one-half story, clipped gable dwelling with on a basement foundation, located on the Northwest corner of North Monroe Street and East First Street, facing East First Street. The H-shaped plan is created by a pair of clipped, side gables connected by a slightly taller linear portion of the building. The façade features a Colonial Revival style, gable-roof entry with curved ceiling. The porch is set atop a wide entablature supported by paired, classical columns. Dentils detail the cornice. The wide, front entry door is paneled wood and is bracketed by five-light sidelights. Paired windows with window boxes flank the entry. At the west elevation are paired windows of varying sizes. At the east elevation is a tall double-flue, brick, exterior chimney that breaks the clipped eave. The chimney is flanked by small, square, six-light, wood-sash windows. A second chimney pierces the center of the ridge of the rear clipped side gable. The windows are all original wood-sash, and most are six-over-one, double-hung. The foundation is parged and the roof is composition shingle.</p>

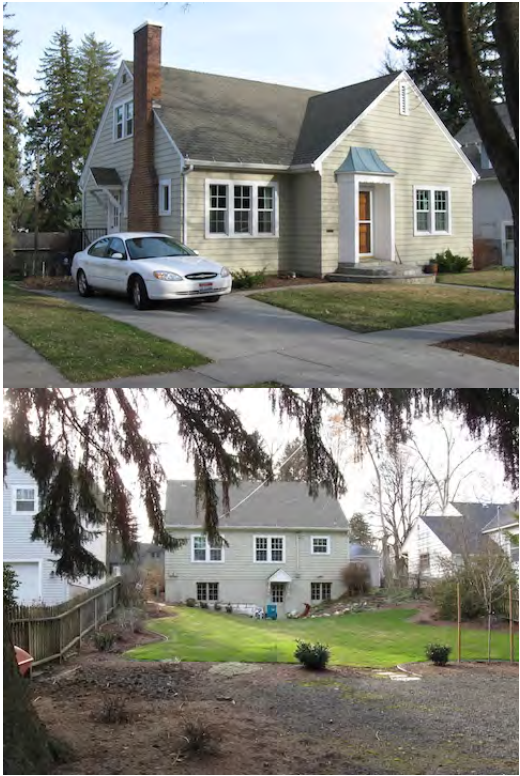
<p>This is a one-and-one-half story, cross-gable roof dwelling oriented towards the west facing North Monroe Street. The forward gable extension features an off-center entry door with a flared metal hood atop wood-trimmed side walls, a pair of windows, and a louvered vent in the peak. North of the entry is a triplet of windows. On the north elevation is a tall, double-flue, brick, outside chimney. A number of windows and a gable-front hood atop carved brackets sheltering the side entry door are also found on the north elevation. All the windows at the first and second levels are vinyl replacements, the siding is wide wood clapboards, and the roof is composition shingle. Original, wood-sash, casement windows and rear entry door are extant at the basement level at the east elevation. Sanborn maps indicate this dwelling retains its original footprint.</p>

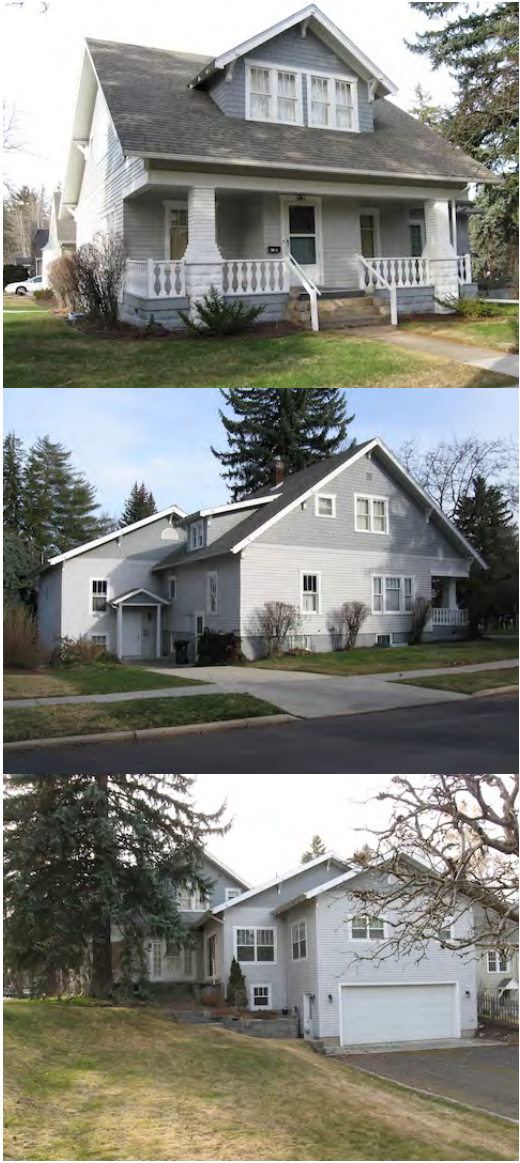
<p>This is a one-and-one-half story Craftsman Bungalow with an irregular plan. It is oriented towards the south facing East First Street. The façade features a full-width integral porch under the main roof, which is supported on two brick columns that taper at the bases and sit atop rusticated concrete-block piers. The porch features decorative wood balusters. An off-centered entry bay projects forward within the porch containing the entry door, which is flanked by large, five-over-one wood-sash windows. Centered above the front porch is a wide, front-gabled dormer with two pairs of three-over-one wood-sash windows, knee braces and exposed rafter tails. At the rear elevation, a shed-roof dormer with a pair of windows and a single-flue, brick, chimney are found on the north slope of the roof. An entry door and several windows are located at the first floor and a window is found at the basement level. Wood clapboards cover the first level and shingles clad the gable ends and the dormers. At the west elevation, a gable front roof on square posts shelters an entry door to the two-story addition that is attached to the original building's southeast portion. East of this addition is a two-story, gable-roof addition with living space above a two-car garage. The additions were constructed with materials that appear similar to the original. Roofs are composition shingle and foundations are concrete.</p>

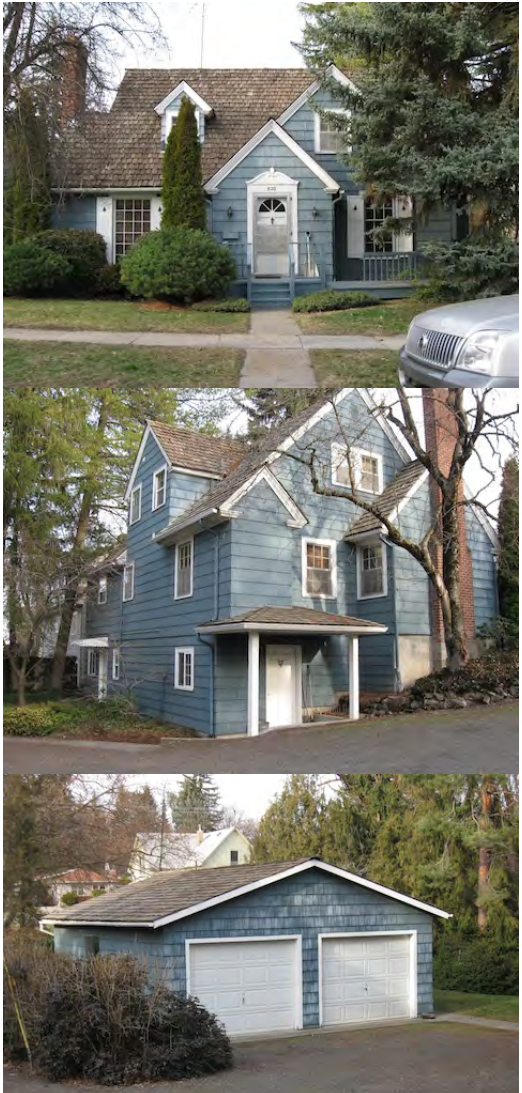
Survey Site Data	Site Photographs	Site Details
<p>Site #: 172</p> <p>820 East First Street</p> <p>Owner: George B Hatley Trust</p> <p>1932</p> <p>Previous District Status: n/a</p> <p>DoE: C</p> <p>Garage: Historic</p> <p>DoE: C</p>

<p>This is a one-and-one-half story, side-gable English Cottage with two front-facing gables on the façade. The larger forward gable features a six-over-six window in its peak above a tall six-over-nine window with shutters. Projecting from this gable is a lower, smaller entry gable with a central entry door with fanlight glazing and pedimented trim atop fluted pilasters. To the west of the entry is a large, twenty-four-light window with shutters and a small, shingled, gable-front dormer with a six-over-six window at the roof. A tall, brick, outside chimney is at the west elevation at a lower projecting side gable. Another small side gable punctuates this elevation above a hip-roofed secondary entry door. A rear-facing, gable-roof wall dormer is located at the north elevation. A rear entry door with a metal awning is at the walkout basement with three vinyl windows. Windows are wood sash except at the basement level. The exterior walls are covered in painted cedar shingles and the roof is sheathed in cedar shingles. The foundation is concrete and concrete block. Gable ends exhibit cornice returns. At the rear of the site is a gable-front, shingled, two-car garage with composition shingle roof and two metal roll-up doors.</p>

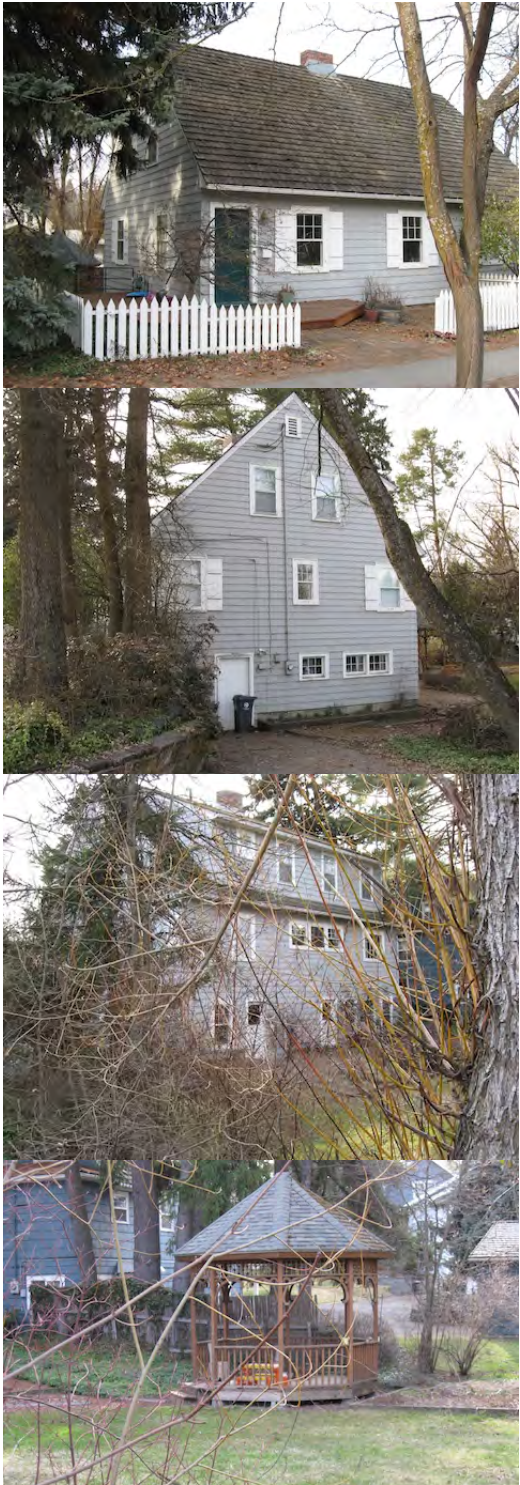
Survey Site Data	Site Photographs	Site Details
<p>Site #: 173</p> <p>824 East First Street</p> <p>Owner: Jeffrey Hicke</p> <p>1936</p> <p>Previous District Status: n/a</p> <p>DoE: C</p>

<p>This is a one-and-one-half story, side-gabled, Cape Cod styled dwelling with a square plan located on the northwest corner of East First and North Lincoln Streets. The façade features a low eave height over the entry door located at the west end of the façade, and three, six-over-one, double-hung, wood-sash, windows with and shutters. The entry door is an inset panel wood door with brass wicket. A central double-flue, brick, inside chimney pierces the ridge. The house is clad in painted cedar shingles. The west elevation features a pair of windows near the peak above a pair of windows at the first level. The east elevation features an entry door into the walkout basement and three small, six-light, wood-sash windows. At the first floor are three windows and a pair are located at the second floor. A small louvered vent is in the peak. At the north elevation a full-width, shed-roofed dormer is at the roof highlighted with four windows. Numerous windows and two entry doors to the basement also are located at this elevation. The roof is cedar shingled. At the rear of the site is an octagonal gazebo with composition shingle roof, wood railings and wood deck.</p>

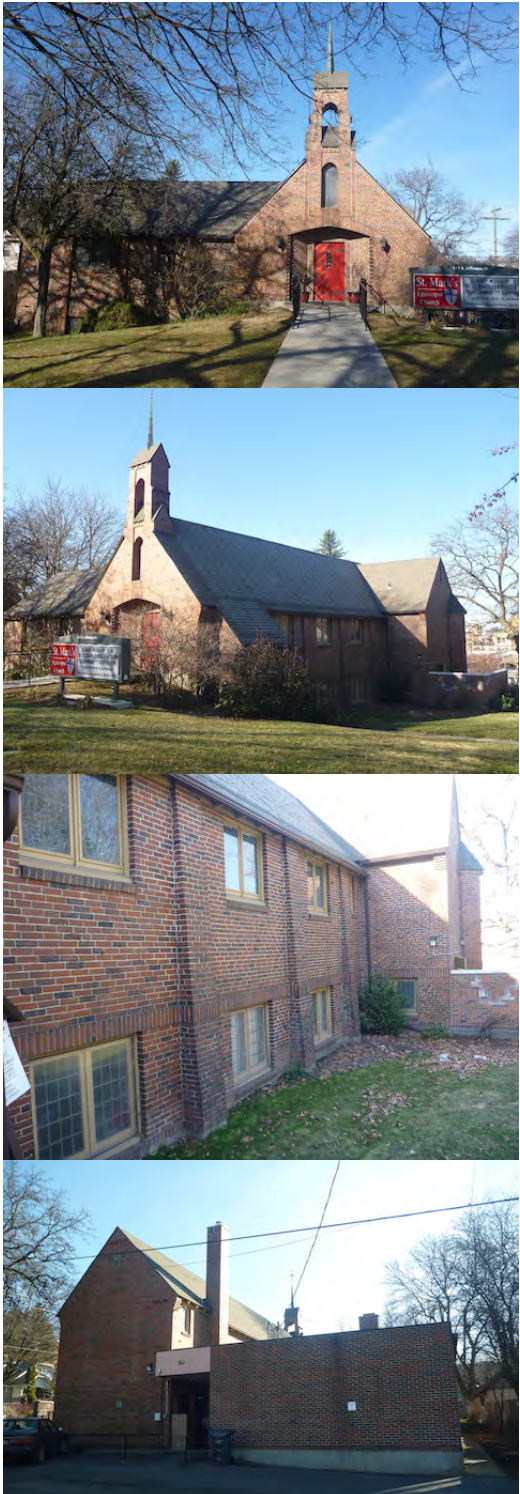
<p>St. Mark's Episcopal Church is located on the southwest corner of Jefferson and First. It is a single-story, brick, cruciform plan church set on a basement foundation. The main block has a gable roof, with a brick steeple extending up on the front elevation. A full-height, gable-roof extension is found toward the west end of the north elevation, and a small, shed-roof extension on the northeast corner. A gable-roof addition is found at the south elevation with a flat-roof extension on the rear. The building is of masonry construction, with a six-row, common bond brick exterior with a water table of soldier-course bricks. The main entry is recessed from the primary wall plane flanked by angled brick walls. The entry door is wood set in a chevron pattern, with a leaded-glass window. A Gothic-arched, stained-glass window is found above a Gothic arch detail above the entry. A copper steeple is found at the top. Stained-glass, wood-sash, casement windows are found around the main level, while 20-light, leaded-glass, wood-sash, casement windows are found on the basement level. The side elevations feature brick buttresses set nearly flush with the walls. A small, three-sided bay is found on the east end of the north side. Small rafter tails are also visible along the side elevations. A single-story, brick wall at the northwest corner creates an area for the Jane Dunham Fellowship Garden established in 2002.</p>

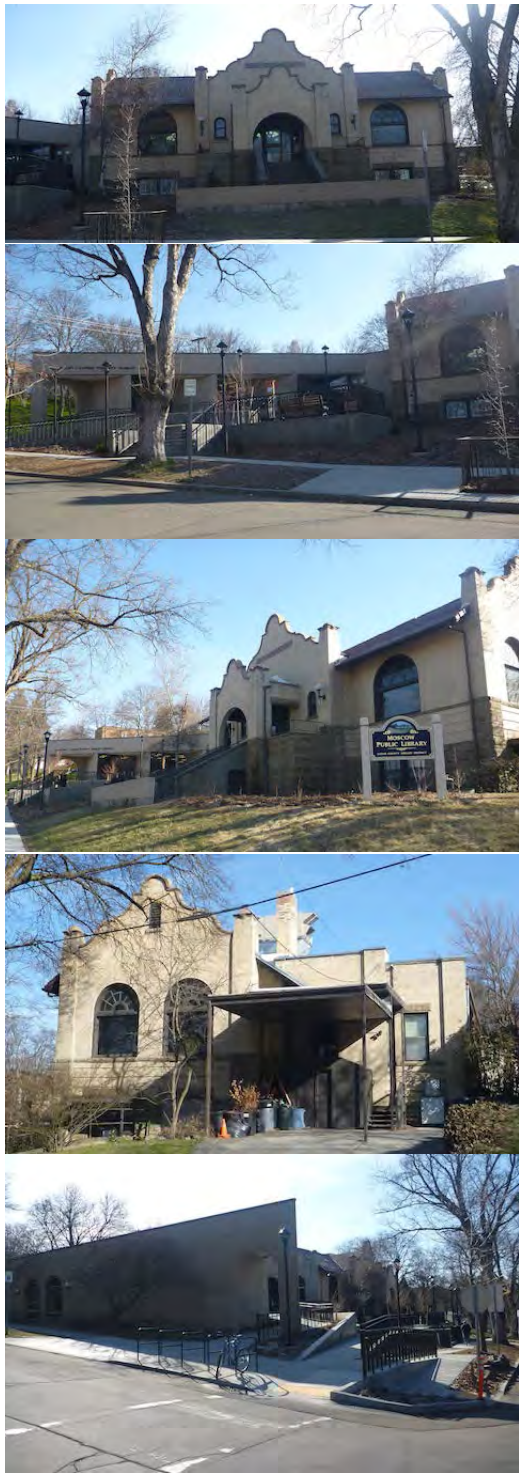
<p>Site 175 is the Moscow Branch for the Latah County Library District. The original portion of the building is a Mission style Carnegie Library. It is a side-gable roof, brick building with Mission style parapets on both sides as well as a parapet extending over the main entry centered on the façade. The entry is recessed behind a large, arched opening with an additional parapet. The entry contains a nonhistoric door but retains sidelights and transom windows. Two small, arched windows flank the entry porch while two very large single-light, wood-sash windows with fanlights above are found on each side of the façade. All of the arched windows exhibit large, soldier-course brick arches above. Two large windows are also found on the south elevation. The windows exhibit narrow stone sills, which continue around the building. Between the sills and the basement foundation, the bricks run in bands with a narrow band of recessed brick between. The roof is covered in tile. The building is set on a mortared, stone block foundation with paired, three-light, wood-sash windows in the basement level toward the north and paired, three-over-one, wood-sash windows toward the south. A basement entry with a flat porch roof is found on the south side. On the rear of the building is a small, flat-roof, brick addition constructed in the 1930s according to the previous survey form. The addition exhibits a similar light-colored brick as the original building, as well as stone sills and lintels at the windows. The rear of this addition is finished in red brick with four recessed portions with corbelling above and pilasters between. On the north side of the original building, is a large, single-story, flat-roof 1980s addition. It is</p>

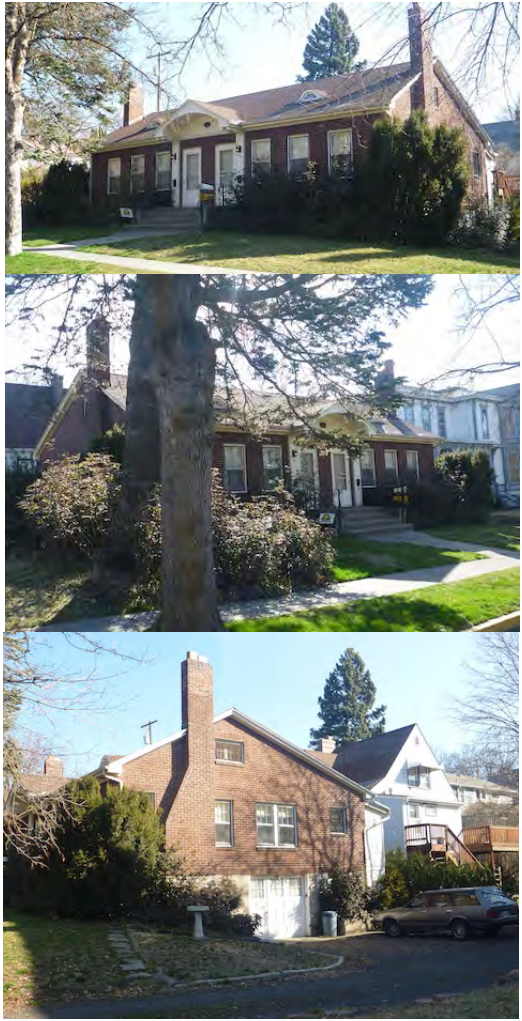
Survey Site Data	Site Photographs	Site Details
<p>Site #: 177</p> <p>104-106 South Adams Street</p> <p>Owner: John Smiley</p> <p>1928</p> <p>Previous District Status: n/a</p> <p>DoE: C</p>

<p>Site 177 is a single-story, side-gabled Bungalow duplex set on the southeast corner of Adams and First. The residence has brick veneer exterior walls. A cantilevered, gabled porch hood is centered on the façade elevation with straight braces and pilasters beneath each side. Two entry doors are sheltered by the hood. They retain paneled wood doors. Six-over-one, double-hung, wood-sash windows are found across the façade and south side elevation, while three-over-one, wood-sash windows are found on the both the north and south side elevations. Paired, six-light, wood-sash windows are found in the attic level on the gable ends and fanlight windows are found within two eyebrow dormers over the façade. Other than the dormers, all of the windows exhibit brick sills and lintels. A single-shouldered, exterior, brick chimney is located on each end of the dwelling. The dwelling is set on a poured-concrete foundation, which features a small garage on the south elevation where the grade slopes downward. The garage exhibits three hinged, paneled wooden doors with four-light windows. A narrow, shed-roof, frame addition is found on a portion of the rear elevation.</p>

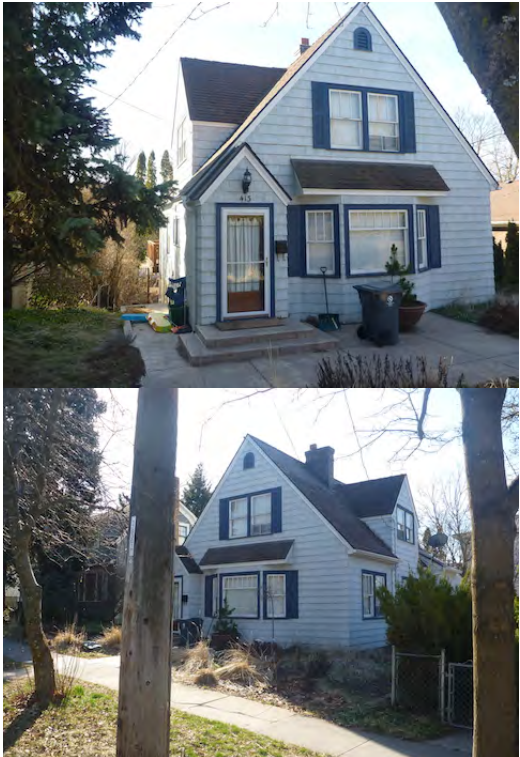
Survey Site Data	Site Photographs	Site Details
<p>Site #: 178</p> <p>413 East First Street</p> <p>Owner: Pine Country Homes LLC</p> <p>1930</p> <p>Previous District Status: n/a</p> <p>DoE: C</p>

<p>Site 178 is a one-and-one-half-story, gable-oriented frame dwelling with gable-roof wall dormers extending over both the east and west side elevations, an enclosed, gable-roof porch extending from the façade elevation, a covered shed-roof, three-sided bay on the lower level of the façade, and a small, single-story, shed-roof extension on the southwest corner. A brick chimney pierces the roof over the west side of the dwelling and a wooden deck is found on the rear. The house is set on a poured-concrete foundation and exhibits raked shingle siding. Three-over-one, double-hung, wood-sash windows are found on the dwelling, some flanked by shutters. The center window on the three-sided bay on the façade is a larger, seven-over-one, wood-sash window. The front entry retains a multi-light, wooden door and a small, arched vent is located within the peak of the gable on the façade.</p>

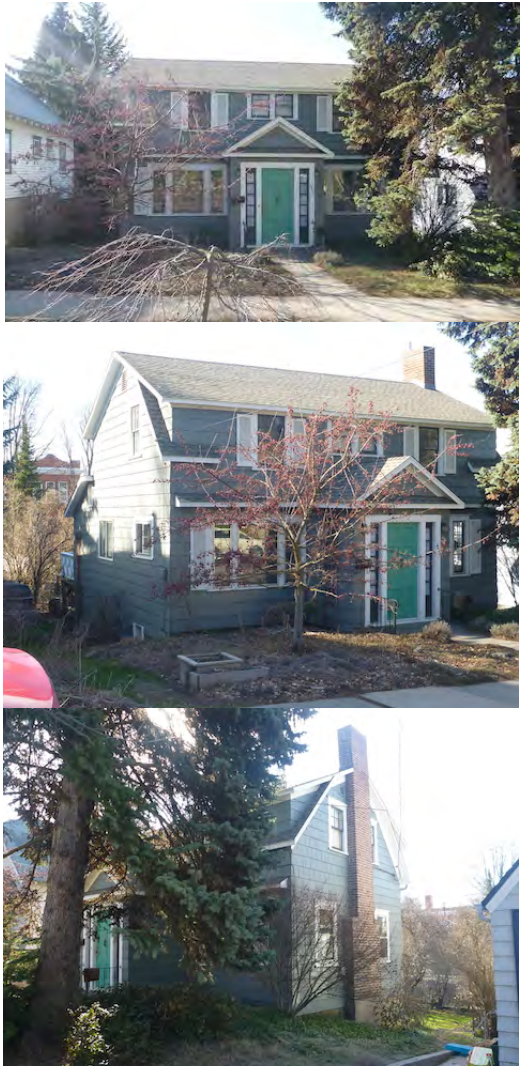
Survey Site Data	Site Photographs	Site Details
<p>Site #: 179</p> <p>415 East First Street</p> <p>Owner: James Robert Reece</p> <p>1926</p> <p>Previous District Status: n/a</p> <p>DoE: C</p>

<p>The top photograph shows a front view of a two-story house with a gambrel roof, a green front door, and a small porch. The middle photograph shows a side view of the same house, highlighting the side porch and the chimney. The bottom photograph shows the rear of the house, featuring a brick chimney and a wooden deck.</p>	<p>This is a one-and-one-half-story, gambrel-roof, frame dwelling. A nearly full-width wall dormer extends over both the façade and rear elevations, while a single-story, shed-roof enclosed porch or addition spans the entire rear in place of the original small, centered porch. A single-story, enclosed, gable-roof porch extends from the center of the façade. The front entry is flanked by five-light, wood-sash, sidelights. Six-over-one and four-over-one, double-hung, wood-sash windows remain on the dwelling, some of which are flanked by shutters. The windows all exhibit simple wood surrounds with crown molding. A small, pent roof extends across the façade above the first level windows, along the same horizontal line as the lower pent of the closed gable on the front entry porch. An exterior, shouldered brick chimney is centered on the west elevation and a wooden deck is found on the rear.</p>

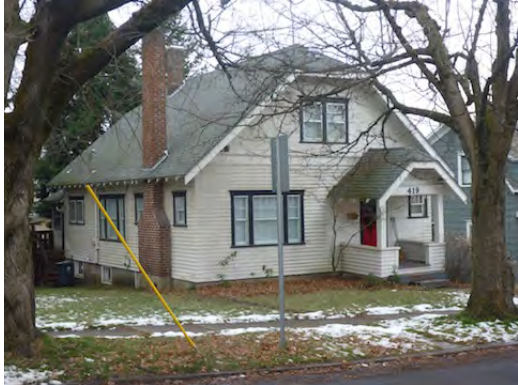
Survey Site Data	Site Photographs	Site Details
<p>Site #: 180</p> <p>419 East First Street</p> <p>Owner: Anne Lawrason Marshall</p> <p>1926</p> <p>Previous District Status: C, 97</p> <p>DoE: C</p>

<p>This is a one-and-one-half-story, gable-front Bungalow with a clipped-gable roof over the main dwelling as well as over the open porch, off-centered on the façade. It sits on a concrete basement foundation. The dwelling exhibits numerous multi-light, double-hung, wood-sash windows. The entry porch is set on square wood posts atop clapboard knee-walls. The dwelling is covered in clapboards, with shingles filling the gable ends. The windows exhibit simple wood surrounds with crown moldings. Rafter tails are found at the eaves, and a brick, shouldered chimney is located on the east elevation. A single-story, enclosed porch is also located toward the east end of the rear elevation.</p>
<p>Site #: 181</p> <p>103 South VanBuren Street</p> <p>Owner: John Sturgul</p> <p>1925</p> <p>Previous District Status: C, 96</p> <p>DoE: C</p>

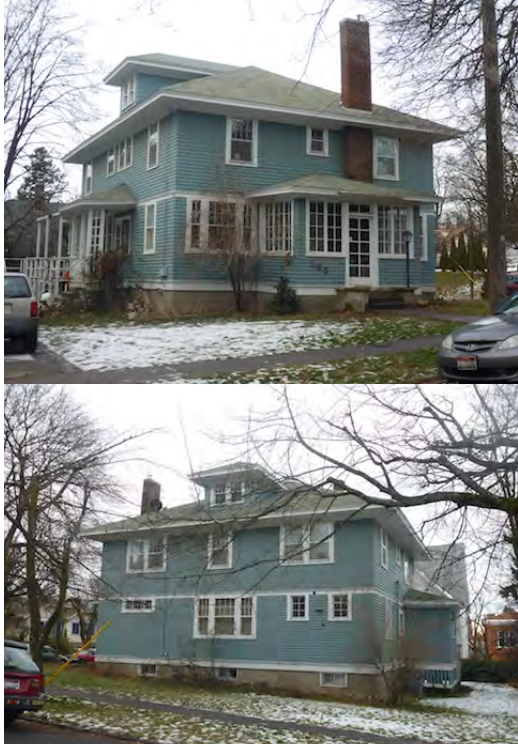
<p>Site 181 is oriented east on the southwest corner of First and VanBuren. It is a two-and-one-half-story, hip-roof, American Foursquare dwelling. It features an enclosed, hip-roof entry porch on the east, an open porch on the south side, and an enclosed rear porch. A small porch extends west from the south side porch. Hip-roof dormers are found above the north and south elevations, and an exterior brick chimney extends up piercing the roofline on the façade. Multi-light, double-hung, wood-sash windows remain throughout. The dwelling is covered in clapboards, and sits on a parged foundation. The dormers are covered in wood shingles. A simple wood trim piece with crown molding wraps around the house at the cornice line dividing the lower and upper levels. Similar trim is found above the foundation and over the upper level windows at the cornice.</p>

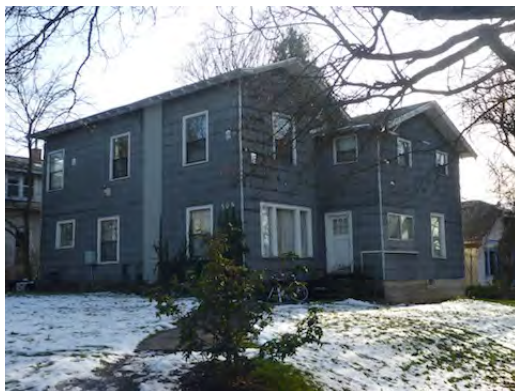
Survey Site Data	Site Photographs	Site Details
<p>Site #: 182</p> <p>505 East First Street</p> <p>106 South VanBuren Street</p> <p>Owner: First Van Buren LLC</p> <p>1904-28</p> <p>Previous District Status: NC (compatible), 101</p> <p>DoE: NC</p>

<p>Site 182 is located on the southeast corner of First and VanBuren Streets. It is a two-story, gable-roof, multi-family dwelling. A slightly shorter, gable-roof section is found at the west end, which contains a door on the entry. It is set on a rusticated concrete block foundation, and retains numerous curved brackets beneath the eaves. The building is covered in asbestos and has replacement windows.</p>
<p>Site #: 183</p> <p>509 East First Street</p> <p>1912</p> <p>Previous District Status: C, 102</p> <p>DoE: C</p> <p>Garage: Historic</p> <p>DoE: C</p>

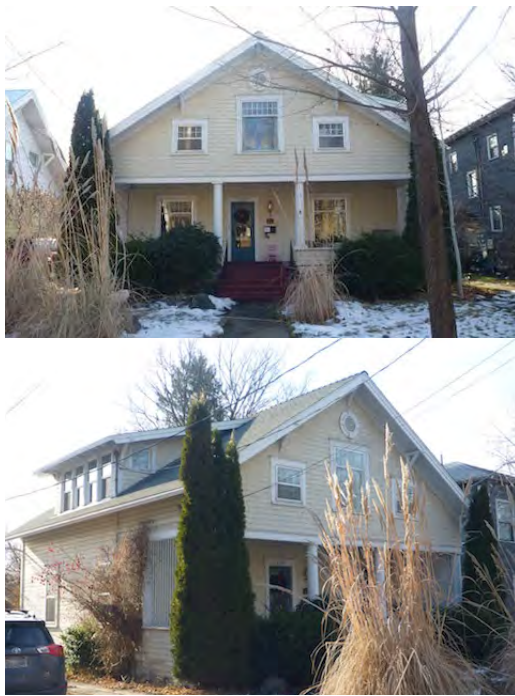
<p>Site 183 faces north toward First Street and is a one-and-one-half-story, gable-oriented Bungalow. The dwelling has a full-width porch recessed beneath the upper level, which is supported by Tuscan columns set on an apron covered in saw-tooth shingles. The lower level of the house is covered in wood drop siding, while the upper level gable end exhibits wood shingle siding. Multi-light, wood-sash windows remain. A round vent opening is found at the peak of the forward gable. Two large, shed-roof dormers are found on the house; one above each side elevation. Large brackets and visible rafter tails also remain. An original, single-car garage is found at the rear. It features a gable roof, wood drop siding, and an overhead garage door.</p>

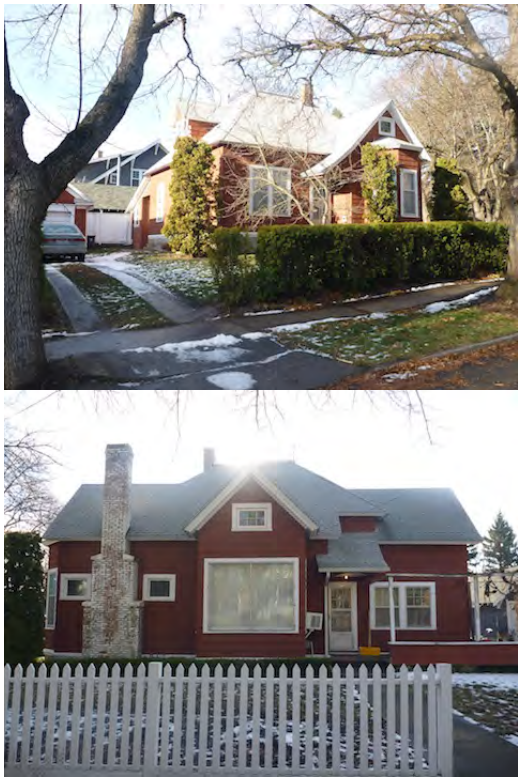
Survey Site Data	Site Photographs	Site Details
<p>Site #: 186</p> <p>103 South Polk Street</p> <p>Owner: Edwin Helmstetter</p> <p>1889</p> <p>Previous District Status: NC (compatible), 105</p> <p>DoE: C</p> <p>Garage: Historic</p> <p>DoE: C</p>

<p>This is a single-story, frame dwelling that was originally built as a traditional Queen Anne. The central block features a truncated hip roof with a mock widow's walk on the top. Gable-roof extensions are found on the north side, and northeast corners, and were original per Sanborn maps. A three-sided bay on the façade was also original. The roofline on the forward-facing gabled section has been extended down to provide shelter over the main entry.. A shed-roof, enclosed porch is found on the rear, southwest corner. An additional gable-roof addition is also found on the rear. A side door with a small, shed-roof extension of the rear addition roof line serves as a porch for the rear entry. The house is clad in raked cedar shingles and retains wood windows. An exterior brick chimney is found on the north elevation, while an additional brick stack pierces the roof near the widow's walk. A small, gable-roof, single-car garage is found to the rear. It exhibits cornice returns and drop wood siding.</p>

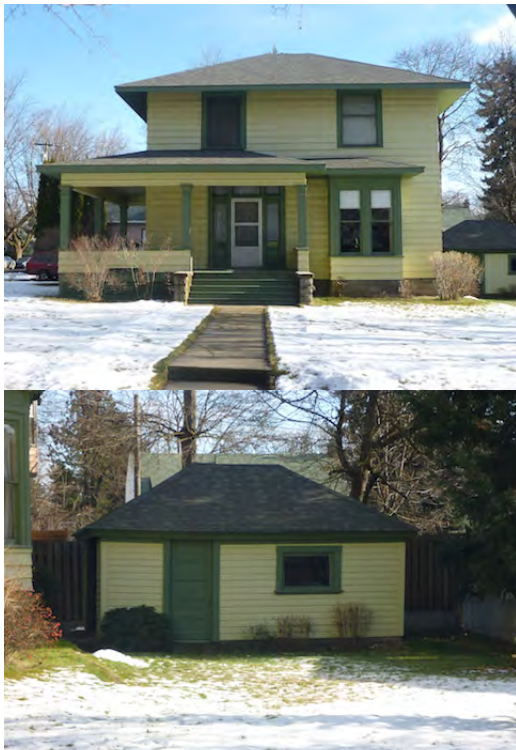
Survey Site Data	Site Photographs	Site Details
<p>Site #: 187</p> <p>106 South Polk Street</p> <p>Owner: Kay French</p> <p>ca. 1900</p> <p>Previous District Status: C, 106</p> <p>DoE: C</p> <p>Garage: Historic</p> <p>DoE: C</p>

<p>This is a two-story, frame dwelling and is a modest representation of an American Foursquare. It features a truncated hip roof, a single-story, hip-roof porch wrapping around the northwest corner, and a single-story, three-sided bay window on the façade elevation. The main entry contains a single-light, wood door with sidelights and transoms. One-over-one, double-hung, wood-sash windows remain. The house rests on a rusticated concrete block foundation and is clad in metal or composite siding. The porch sits on square wood posts with crown molding. A small, three-sided bay window is also found on the south elevation.. A small, original, frame garage is also associated with the site. It has a hip-roof, drop wood siding, a paneled wood entry door on the west, an overhead single-car garage door on the north, and wood sash windows.</p>

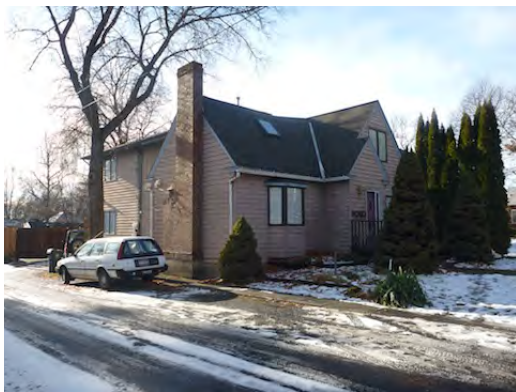
<p>Site #: 188</p> <p>611-613 East First Street</p> <p>Owner: Theresa Hanford</p> <p>1939</p> <p>Previous District Status: NC (compatible), 107</p> <p>DoE: NC</p>

<p>Site 188 faces north toward First Street, east of Polk Street. It is a one-and-one-half-story, cross-gabled residence with a large, gable-roofed, two-story addition on the rear. The façade exhibits a forward-facing gable, a small, single-story, enclosed, gable-roof entryway, and a nonhistoric, three-sided bay window. A single-shouldered, exterior, brick chimney is found on the east elevation. The house is covered in horizontal boards with replacement windows. Due to a number of modifications and additions, this house no longer represents its original period or characteristics.</p>

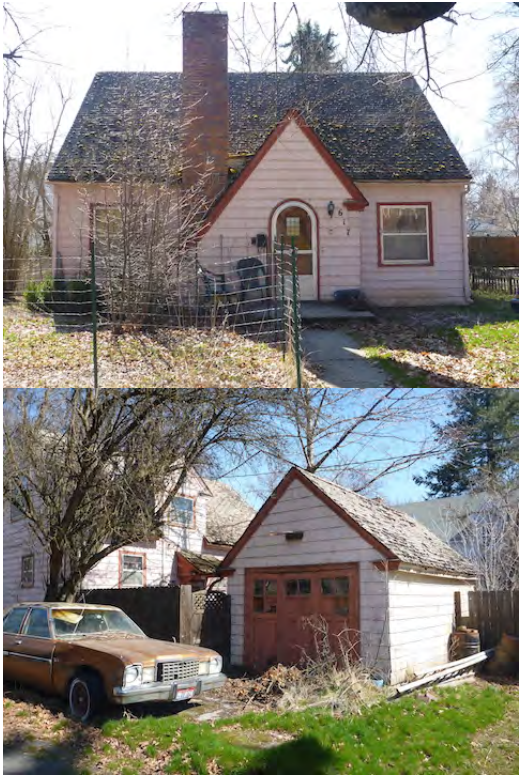
Survey Site Data	Site Photographs	Site Details
<p>Site #: 189</p> <p>617 East First Street</p> <p>Owner: Merle Butler</p> <p>1936</p> <p>Previous District Status: n/a</p> <p>DoE: C</p> <p>Garage: Historic</p> <p>DoE: C</p>

<p>This is a one-and-one-half-story, three-bay (w/d/w), side-gable, English cottage style dwelling. An exterior brick chimney and an asymmetrical, one-story, front-gabled enclosed porch with the main entry is centered on the façade of the dwelling. It features an arched wood door with a small, twelve-light opening. The brick chimney rises from the elongated, slightly curved, east roof slope of the porch. The roof of the projection features a wide cornice and cornice returns. The entry is flanked by ten-over-one-light, double-hung, wood sash windows. Similar windows with varying multi-light, wood sashes are exhibited throughout the dwelling. A gable-roof wall dormer and an entry sheltered by a shed-roof awning with brackets are found on the rear elevation. The roof is asphalt shingles and features cornice returns. The exterior is clad in wood shingles. The house rests on a concrete foundation. A gable-oriented, one-bay garage is found to the rear of the house, and features three, four-light, wood panel doors a wide cornice and cornice returns.</p>

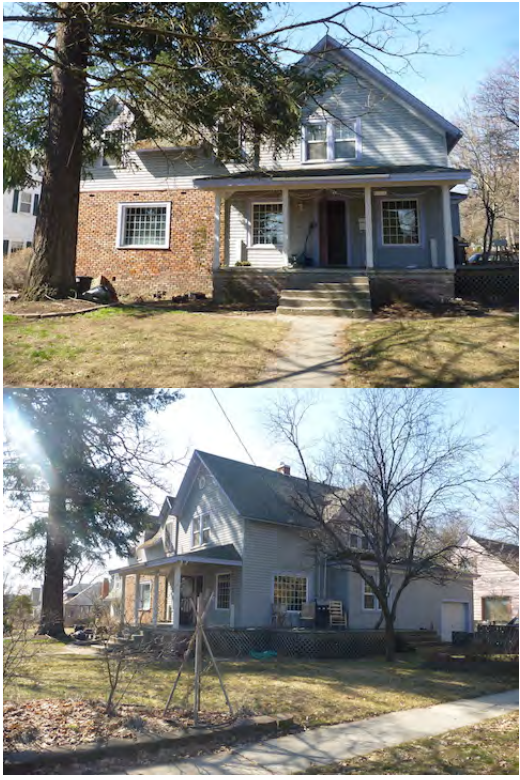
Survey Site Data	Site Photographs	Site Details
<p>Site #: 190</p> <p>103 South Howard Street</p> <p>Owner: Jack Colliflower</p> <p>ca. 1900</p> <p>Previous District Status: n/a</p> <p>DoE: NC</p> <p>Garage: Modern</p> <p>DoE: NC</p>

<p>Site 190 is a one-and-one-half-story, highly altered, multi-gable brick and frame dwelling, oriented to the north. A one-story, hip-roof porch spans partially across the facade. The porch shelters an entry with a multi-light wood door flanked by two large, twenty-five-light, nonhistoric windows. A portion of the façade exhibits a brick veneer on the lower level and features a large, multi-light picture window with two, gable-roof wall dormers above. Large, multi-light windows and paired, six-over-six-light windows are found throughout the dwelling. A nonhistoric wood deck and one-story, hip-roof addition featuring one garage bay spans the dwelling's west elevation. The roof of the dwelling is sheathed in asphalt shingles and the exterior walls are clad in vinyl. An interior brick chimney pierces the ridgeline of the front-gable section of the dwelling.</p>

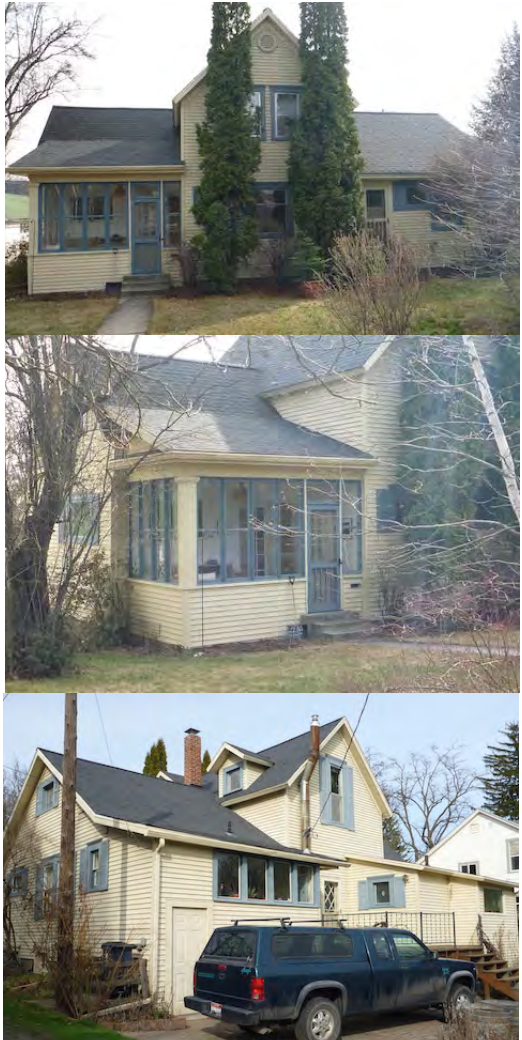
Survey Site Data	Site Photographs	Site Details
<p>Site #: 192</p> <p>717 East First Street</p> <p>Owner: Lynn Wolfe Murray</p> <p>1922</p> <p>Previous District Status: n/a</p> <p>DoE: C</p>

<p>This is a one-and-one-half-story, gable-front, central block with wing dwelling that is oriented towards the north facing East First Street. The façade features the central, front-facing gable that contains wood- and aluminum-sash windows and an octagonal louvered attic vent. The filled-in entry porch is also found on the façade at the east wing. Two gable-front dormers are located on the west slope of the gable roof. The porch features one-over-one, wood-sash windows and a glazed, wood-panel door with transom. A single, French-style entry door with sidelight and a horizontal wood-sash window give entry to the house. The side-gabled west wing features a secondary entry door, three windows at the façade and a number of windows at the west elevation. At the rear of the dwelling extending from both of the wings are shed-roof additions, each with an entry door and windows. The dwelling has vinyl siding, composition shingled roofs, and a concrete, basement foundation.</p>

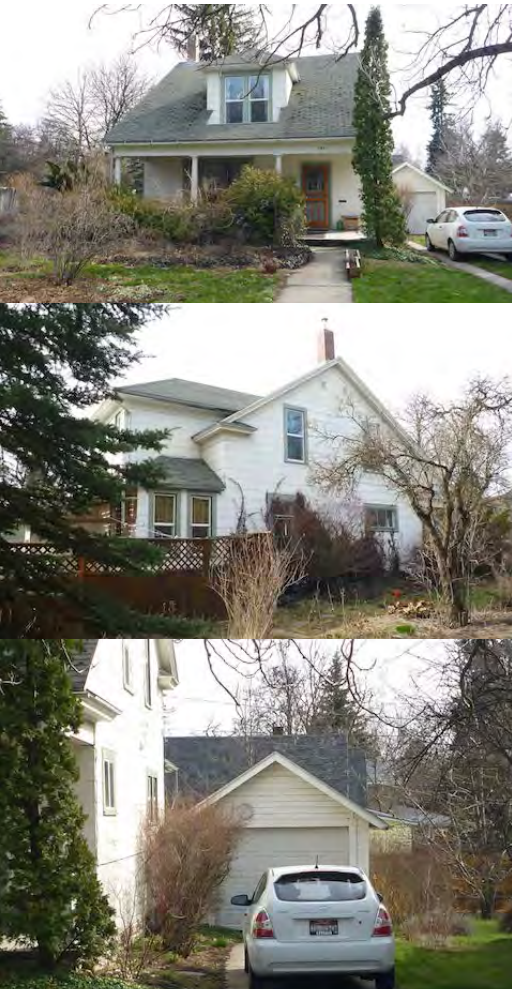
Survey Site Data	Site Photographs	Site Details
<p>Site #: 193</p> <p>721 East First Street</p> <p>Owner: Joseph De Angelis</p> <p>1911</p> <p>Previous District Status: n/a</p> <p>DoE: C</p> <p>Garage: Historic</p> <p>DoE: C</p>

<p>Site 193 is a one-and-one-half story, side-gable dwelling with a full-height, hip-roof addition on the rear. The dwelling is oriented towards the north facing East First Street. The façade features a full-width porch inset under the main roof, which sits atop Tuscan-style columns. The off-center entry door is glazed wood panel and shares the porch with a wood-sash, triplet window. Also at the façade is a central, hip-roofed, inset dormer with a pair of windows. A brick, interior chimney pierces the ridge above the east elevation. A shed-roofed patio and a small shed-roofed addition are found at the rear elevation. Windows are a mix of wood-sash and vinyl, and the siding is asbestos. The roof is clad in composition shingles and features cornice returns. The foundation is rusticated concrete block. Also on the site, to the rear of the residence is a gable front, one-story, single-car garage with wood clapboards and composition shingle roof. The garage has wood-sash windows and a metal roll-up door. A linear addition to the rear of the garage has a hip roof.</p>
