National Register of Historic Places Registration Form

Historic name: Fort Russell Neighborhood Historic District (Boundary Increase and Additional Documentation)

Street & number: Roughly bounded by Jefferson Street on the west, East D Street on the north, Hayes Street on the east, and East Third Street on the south

City or town: Moscow State: ID County: Latah

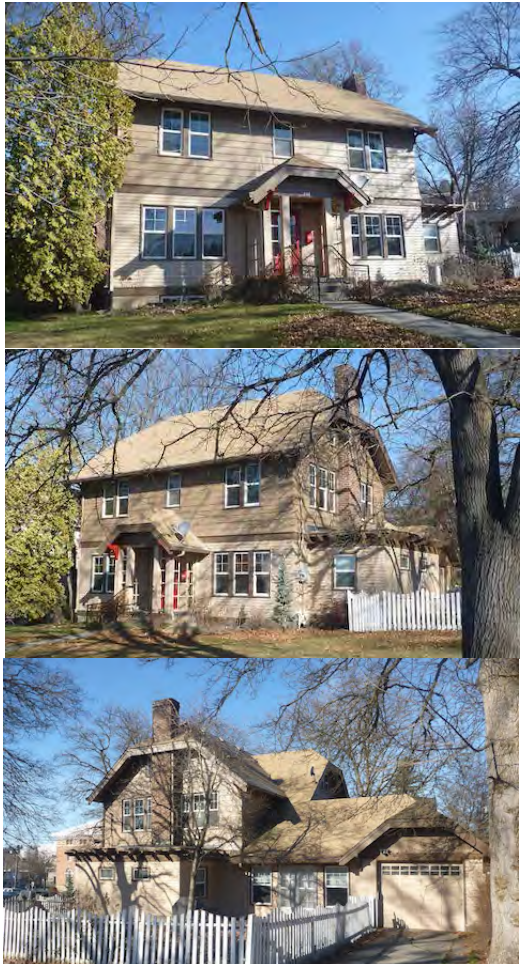
Survey Site Data	Site Photographs	Site Details
<p>Site #: 196</p> <p>226 East Second Street</p> <p>Owner: Church, Episcopal</p> <p>1904-28</p> <p>Previous District Status: n/a</p> <p>DoE: C</p> <p>Garage: Historic</p> <p>DoE: C</p>

<p>This is a two-story, clipped-gable-roof dwelling dating to the first quarter of the twentieth century. It has a single-story, flat-roof extension on the east elevation, and a full-height extension on the rear with a single-story extension behind it that leads to a small, attached, single-car garage on the far rear: all of these extensions are original to the dwelling. A single-story, clipped-gable roof porch is centered on the façade. It is supported by square, wood posts with small, spaced-out, horizontal, wood pieces spanning between them. The dwelling is clad in clapboards on the first level, and wood shingles on the upper level. The house sits on a concrete, basement foundation and also features visible rafter tails. An exterior brick chimney extends up on the east elevation between the main block and the flat-roof extension. All the windows are vinyl and the roof is composition shingle.</p>

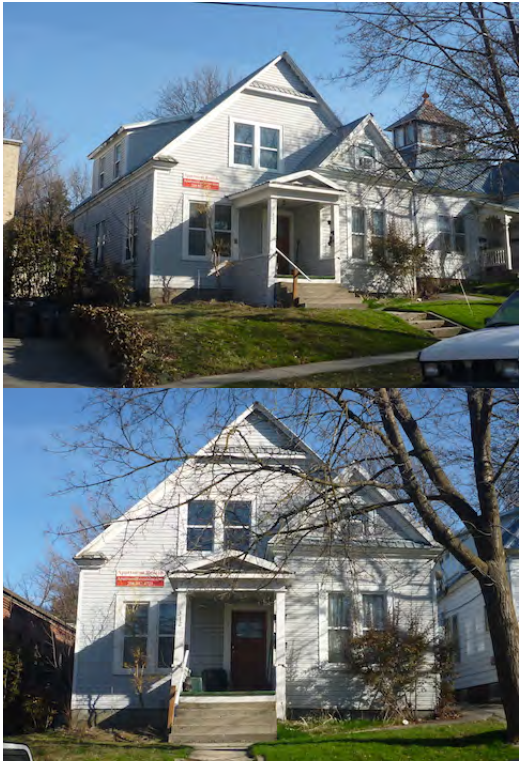
Survey Site Data	Site Photographs	Site Details
<p>Site #: 197</p> <p>312 East Second Street</p> <p>Owner: Idaho Apartment Rentals LLC</p> <p>ca. 1900</p> <p>Previous District Status: n/a</p> <p>DoE: C</p>

<p>This is a one-and-one-half-story, gable-oriented dwelling with a slightly smaller, closed-gable roof extension on the southeast corner. A small porch is centered on the façade and features a closed gable above. A shed-roof dormer is found over the west elevation. A single cornice return is found on the southwest corner on the façade elevation. The dwelling is covered in vinyl siding, contains vinyl windows, and V-groove metal roofing.</p>

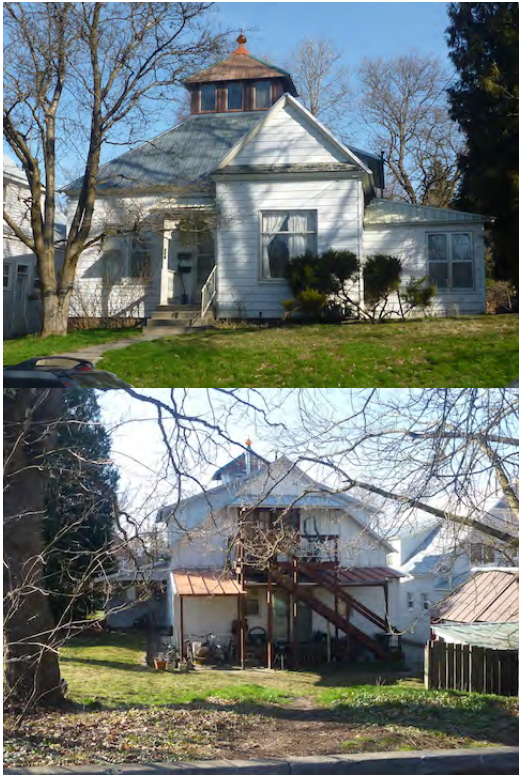
Survey Site Data	Site Photographs	Site Details
<p>Site #: 198</p> <p>314 East Second Street</p> <p>Owner: DR2 Rentals LLC</p> <p>ca. 1900</p> <p>Previous District Status: n/a</p> <p>DoE: NC</p>

<p>This is a one-and-one-half-story, truncated, hip-roof dwelling with a pyramidal-roof extension centered over the top. This early dwelling features a generally square footprint, with an original, forward-facing, gable-roof extension on the southeast corner. Originally a porch was centered on the rear, later, a larger, full-width addition was built around it. The rear addition currently features a second story with its own entry accessible via an exterior wooden staircase. A shed-roof porch spans the far rear. Two shed-roof dormers have also been added to the dwelling, one above each side elevation. A small, hip-roof, single-story addition has also been added on the east elevation. The dwelling is covered in aluminum siding. A wide porch at the southwest corner no longer remains –a small, shed-roof overhang shelters the entry. A small, gable-roof, metal shed is found at the rear of the property.</p>

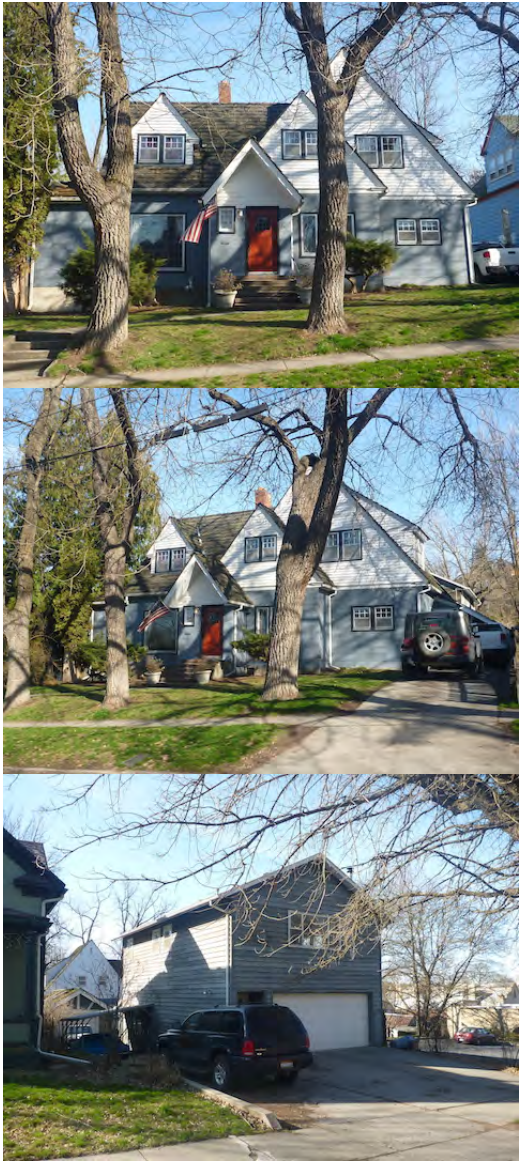
Survey Site Data	Site Photographs	Site Details
<p>Site #: 199</p> <p>320 East Second Street</p> <p>Owner: David McIlroy</p> <p>ca. 1900</p> <p>Previous District Status: n/a</p> <p>DoE: NC</p> <p>Garage: Modern</p> <p>DoE: NC</p>

<p>This is a one-and-one-half-story, asymmetrical, multi-height, frame dwelling. It features a side-gabled main block, a forward-facing, gable-roof entry porch, a forward-facing, gable-roof extension beside the porch, and a larger, forward-facing, gable-roof extension on the east end. A small, single-story, side-gabled addition is found on the west elevation, and a single-car garage has been added to the basement level on the rear, northeast corner where the grade is lower in the back yard. A gable-roof dormer is found above the façade elevation, while a low-pitched, shed-roof dormer is found above the east elevation. A small, shed-roof overhang supported by scrolled brackets shelters a side entry on the east elevation. The main level of the residence is covered in asbestos shingles, while the upper level gables are clad in weatherboard. The roof is covered in wood shingles. Most of the windows in the dwelling feature vinyl sash, however, some original windows remain on the lower level, façade elevation – some with diamond-shaped panes. The garage addition on the rear is constructed of rusticated concrete block. A large, two-story, gable-roof garage with a residential unit above is found at the far rear of this lot. It features a shed-roof carport on the east side, a two-car overhead door, horizontal board siding, vinyl windows, and a small, shed-roof overhang on the west side.</p>

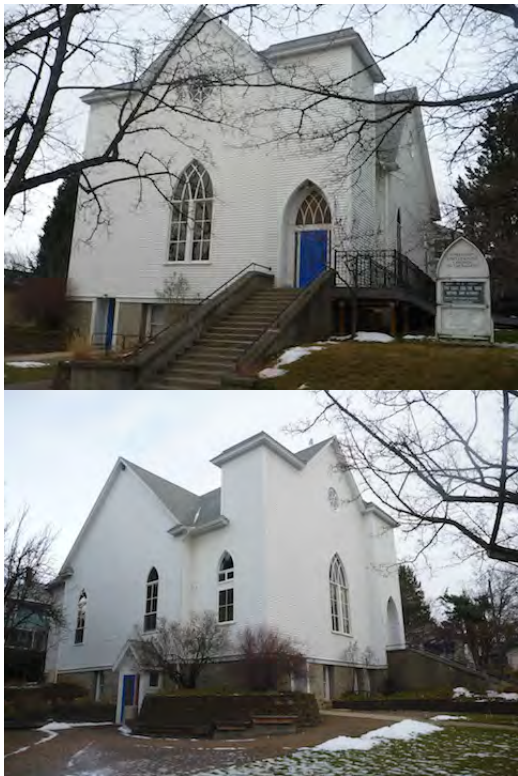
Survey Site Data	Site Photographs	Site Details
<p>Site #: 203</p> <p>420 East Second Street</p> <p>Owner: Church, Unitarian</p> <p>1905</p> <p>Previous District Status: C, 99</p> <p>DoE: C</p>

<p>This is the Unitarian Universality Church, situated on the northwest corner of East Second and VanBuren. It is a large, cross-gable roof frame building constructed as the Emmanuel Lutheran Church, replacing the earlier Swedish Lutheran Church on this site. It features a cross-roof plan, with full-height towers flanking the gable on both the southwest and southeast corners. The building contains Gothic-arched windows with paired, six-light, wood-sashes below and either single-light or tracery sashes above. Some windows contain vinyl replacement sashes. Original wood-sash, rose windows are found in the peak of the south and east gables. The building also exhibits small cornice returns. The main entry is recessed within a Gothic arch on the east end of the south elevation. Secondary entries are located on the northeast corner, and the basement level on the west side. The building is covered in vinyl siding and rests on a parged foundation. An ADA accessible ramp is found on the east elevation and an exterior brick chimney is centered on the north.</p>

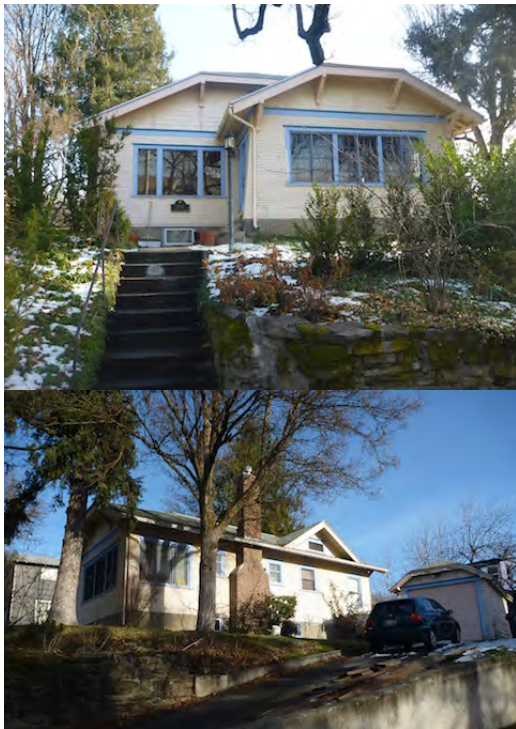
Survey Site Data	Site Photographs	Site Details
<p>Site #: 204</p> <p>110 South VanBuren Street</p> <p>Owner: Sandra Reineke</p> <p>1923</p> <p>Previous District Status: C, 100</p> <p>DoE: C</p> <p>Garage: Historic</p> <p>DoE: C</p>

<p>This is a one-and-one-half-story Bungalow with an L-shaped footprint. The dwelling features a jerkinhead roof on both the main block and the enclosed porch extension. The porch exhibits three twelve-light, wood-sash windows, while the main entry door exhibits fifteen lights and is flanked by multi-light sidelights. The lower portion of the porch walls flare. The dwelling is clad in weatherboard with wood shingles in the gable ends. Details include brackets, visible rafter tails, wood-sash windows, and wood trim with crown moldings. A gable-roof dormer and an exterior, shouldered, brick chimney are found on the south elevation. A one-car garage is found at the southeast corner of the house exhibiting details and materials similar to the house. A nonhistoric, shed-roof outbuilding and a plywood tree house are also found at this site.</p>

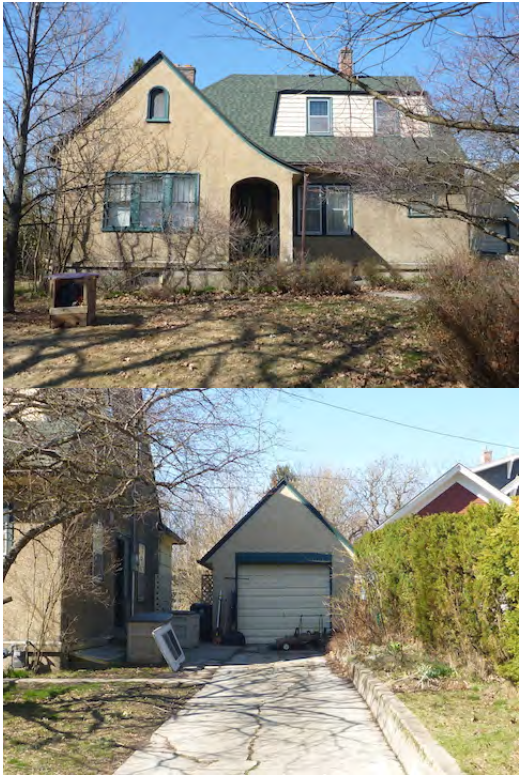
Survey Site Data	Site Photographs	Site Details
<p>Site #: 205</p> <p>115 South Polk Street</p> <p>Owner: Brian Johnson</p> <p>1928</p> <p>Previous District Status: n/a</p> <p>DoE: C</p> <p>Garage: Historic</p> <p>DoE: C</p>

<p>This is a one-and-one-half-story, four-bay, cross-gable, English cottage dwelling. It features a front-gable projecting from a truncated hip-roof section and a rear addition. The front-gable exhibits a curved east roof slope, which shelters a porch entry featuring an arch entryway and supported by a wide post with a metal railing. A set of three, four-over-one, double-hung, wood-sash windows are found south of the entry with a small arched window in the gable peak. Individual and paired wood-sash windows are exhibited throughout the dwelling. A dormer with two windows and horizontal board siding is found on the front roof slope. A one-story, rear addition clad in horizontal board siding spans the dwelling's rear elevation. Brick chimneys pierce both ridgelines of the house. The roof is asphalt shingles, the exterior walls are clad in aggregate and the foundation is concrete. A one-bay, gable-roof garage with a metal door and aggregate siding is found adjacent to the house.</p>

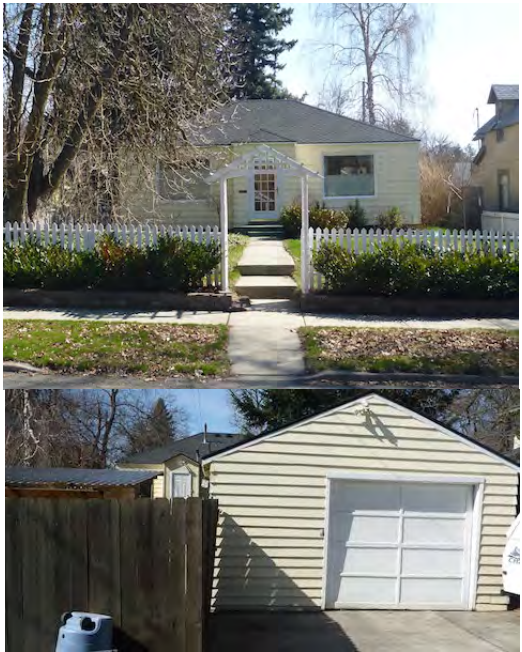
Survey Site Data	Site Photographs	Site Details
<p>Site #: 206</p> <p>114 South Polk Street</p> <p>Owner: Thomas Whitney</p> <p>1947</p> <p>Previous District Status: n/a</p> <p>DoE: NC</p> <p>Garage: Historic-not in period</p> <p>DoE: NC</p>

<p>Site 206, oriented the west, is a one-story, three-bay, hip-roof, Minimal Traditional dwelling. A small, enclosed, hip-roof entry porch is centered on the façade and features an entry with a nonhistoric, fifteen-light door. The small entry porch is flanked by two large picture windows. The roof of the dwelling is sheathed in asphalt shingles and the exterior walls are clad in horizontal board siding. The house rests on a concrete foundation. The one-bay, gable-roof garage is located just northeast of the house. It is similar in appearance and materials to the dwelling and is also clad in wide, horizontal boards.</p>

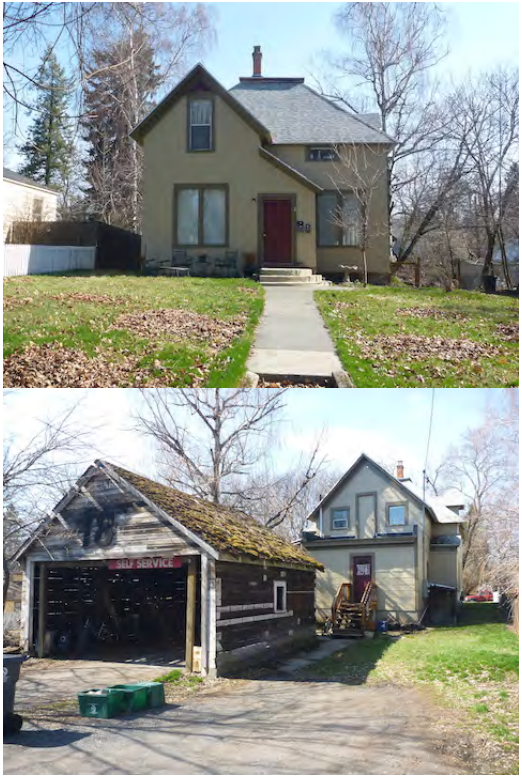
Survey Site Data	Site Photographs	Site Details
<p>Site #: 207</p> <p>120 South Polk Street</p> <p>Owner: Brenda Truelove</p> <p>1914</p> <p>Previous District Status: n/a</p> <p>DoE: C</p> <p>Garage: Historic</p> <p>DoE: C</p>

<p>This is a one-and-one-half-story, three-bay (w/d/w) dwelling that features a main, truncated-roof section with a front-facing, gable projection. A one-story, enclosed porch is found on the façade. A single-leaf entry with a simple surround and a large vertical, two-light window is featured on the façade. A similar, two-light window is found on the façade of the dwelling's pyramidal roof section. One-over-one windows and one-light windows are exhibited on the dwelling. Gable-roof dormers pierce the ridgeline of the dwelling's north and south roofs. A brick chimney rises from the, truncated hip roof. Multi-height additions span the rear of the dwelling. Two entries provide access on lower and upper levels of the rear additions. The house rests on a brick foundation while the rear additions rest on concrete. The roof of the dwelling is sheathed in asphalt shingles and the exterior walls are clad in asbestos siding.. A gable-roof, frame garage is found to the rear of the dwelling and exhibits exposed rafter tails, horizontal, wood board siding and rests on a concrete block foundation.</p>

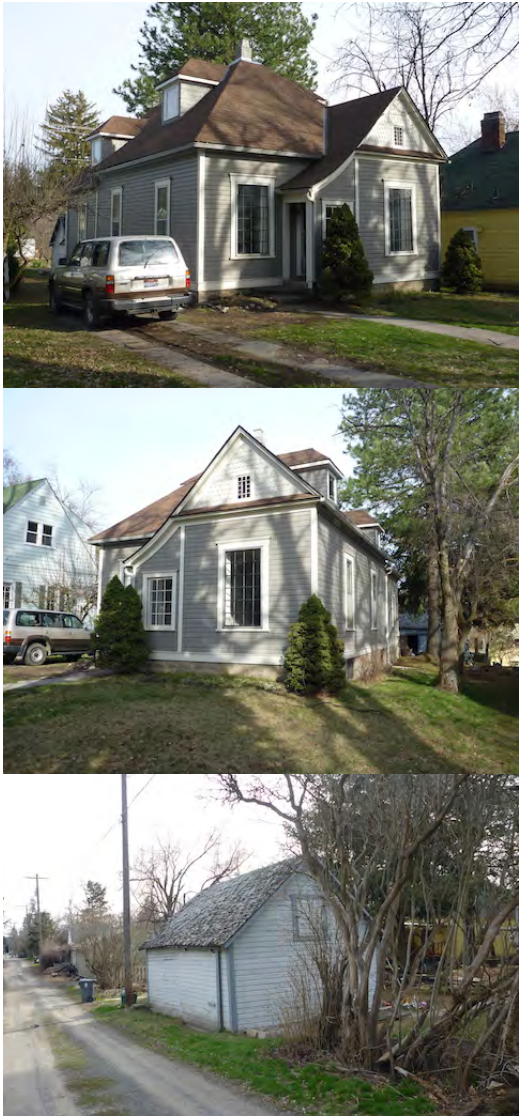
Survey Site Data	Site Photographs	Site Details
<p>Site #: 210</p> <p>104-108 South Howard Street</p> <p>Owner: Joel Penney</p> <p>1920</p> <p>Previous District Status: n/a</p> <p>DoE: C</p> <p>Garage: Historic</p> <p>DoE: C</p>

<p>Site 210 is a one-and-one-half story, hipped-roof Queen Anne style dwelling with a gable-roof projection on the façade. The façade features fish-scale, wood shingle imbrication and a colored, multi-light, wood-sash window in the closed, front-facing gable. Two large, twenty-four-light, wood-sash windows are located flanking the porch at the first level. The porch was altered to a Tudor-style roofline that creates an enclosed entry with a multi-light window in the exterior wall and shelters the entry door. The tall, main roof has four, hipped-roof dormers with fish scale shingles; two on the north slope and two on the south. Each dormer contains a single, vinyl window. A central chimney pierces the roof at the ridge. The foundation is rusticated concrete block, the walls are clad in wood drop siding and the roof is composition shingle. Windows are original with classical wood surrounds. Also on this site at the rear of the property is a side gabled, single-car garage. The garage features wood drop siding, composition shingle roof, a small attic access hatch, and a wood-sided sliding barn-style door. Though the façade of this dwelling has been altered with a Tudor porch, this change is now historic itself and did not diminish the dwelling's original form, style or most character-defining features.</p>

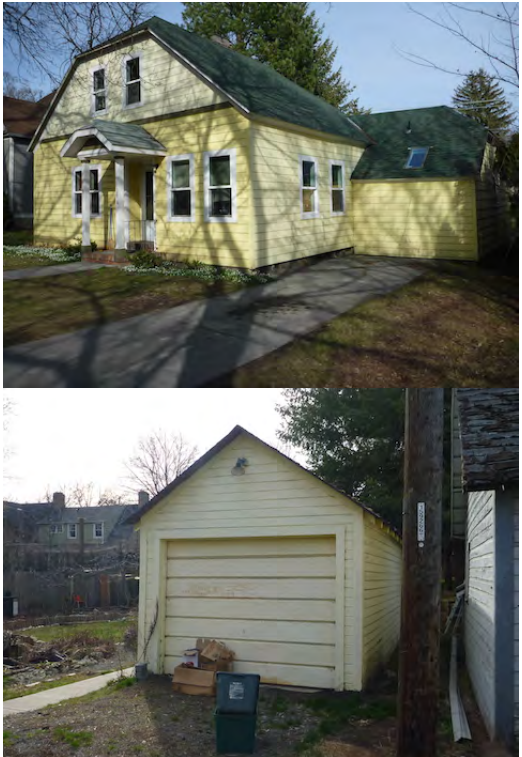
Survey Site Data	Site Photographs	Site Details
<p>Site #: 211</p> <p>114 South Howard Street</p> <p>Owner: James Wilson</p> <p>1923</p> <p>Previous District Status: n/a</p> <p>DoE: C</p> <p>Garage: Historic</p> <p>DoE: C</p>

<p>This is a one-and-one-half story, gable-oriented dwelling with a clipped-gable roof and a smaller, single-story, clipped-gable-roof addition. The façade features a clipped gable porch roof atop square posts sheltering an inset, wood panel entry door. Windows are vinyl replacements, siding is wide composite clapboard with machine-cut wood shingles in the gable ends, and a skylight is noted in the west-facing slope of the addition's roof. A hip-roof addition is found at the rear of the dwelling. A double flue brick inside chimney is located on the north slope of the main roof. Also at this site is a gable-front, single-car garage with wood, drop siding, exposed rafter tails, composition shingle roof, and a metal, roll-up garage door.</p>

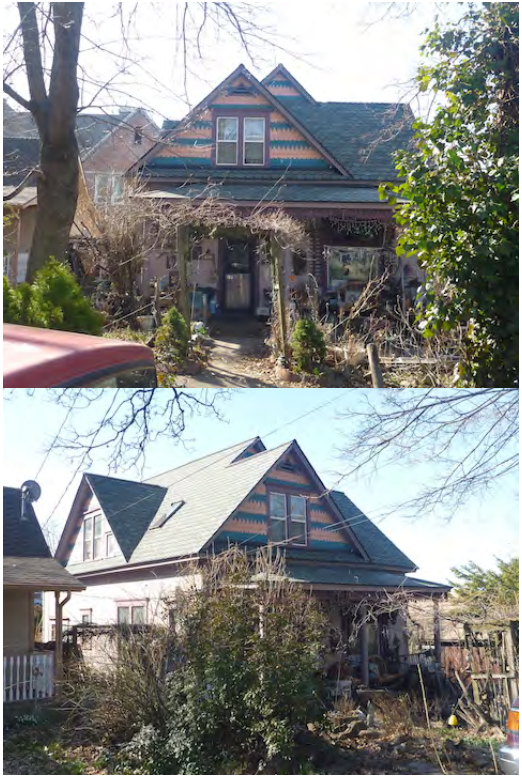
Survey Site Data	Site Photographs	Site Details
<p>Site #: 214</p> <p>315 East Second Street</p> <p>Owner: Ellyn Kerr</p> <p>1910</p> <p>Previous District Status: n/a</p> <p>DoE: C</p> <p>Garage: Historic</p> <p>DoE: C</p>

<p>Site 214 is a gable-oriented, one-and-one-half-story, Victorian. It features a large gable over the façade, a small, forward-facing, gable-roof peak above the main roofline, a side-facing, gable-roof extension on the northwest corner, and a gable-roof dormer over the east elevation. The gables are filled with scalloped and sawtooth shingles, while the main level clad in narrow clapboards. The windows on the house contain vinyl replacement sashes, but retain simple wood surrounds with crown molding; many of the windows are paired. A small, stained-glass transom is found above a large single-light window on the façade. The roof is sheathed in composition scalloped shingles resembling slate tile. A full-width porch spans the façade, while a partial-width, enclosed porch is found on the rear. The front porch is decorated with ornamentation. A small bay window extends on the west elevation. A small, gable-roof garage is found behind the house. It exhibits similar materials as the dwelling.</p>

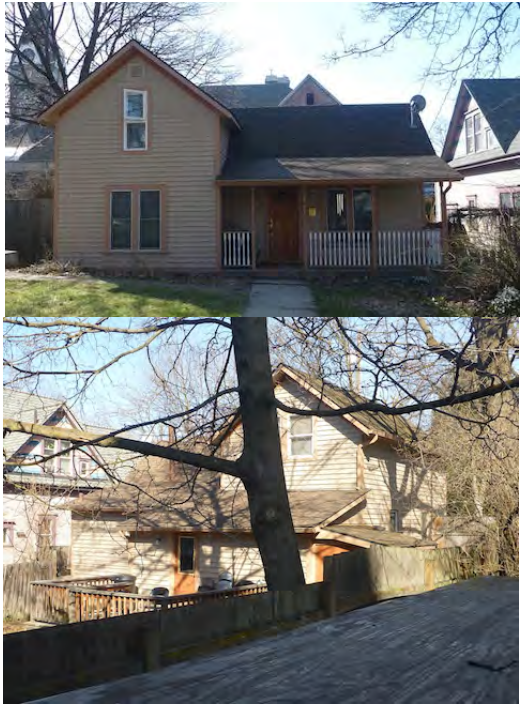
Survey Site Data	Site Photographs	Site Details
<p>Site #: 215</p> <p>319 East Second Street</p> <p>Owner: Matt Ruck</p> <p>ca. 1900</p> <p>Previous District Status: n/a</p> <p>DoE: C</p>

<p>This is an Upright and Wing house, with a one-and-one-half-story, forward-facing, gable-roof section on its east and a single-story, side-gabled section on its west side (creating a T-plan). A single-story porch beneath a shed-roof extension of the primary roof expands across the width of the single-story section. An original, enclosed section is found on the rear of the single-story section, while an additional enclosed porch has been added to the rear of the upright section. A small, shed-roof enclosure has also been added on the rear, southeast corner of the dwelling. The house is covered in clapboard siding with wood corner boards. The windows have been replaced with vinyl and a wooden deck has been added on the rear. The turned posts and balustrade on the front porch appear to be nonhistoric replacements.</p>

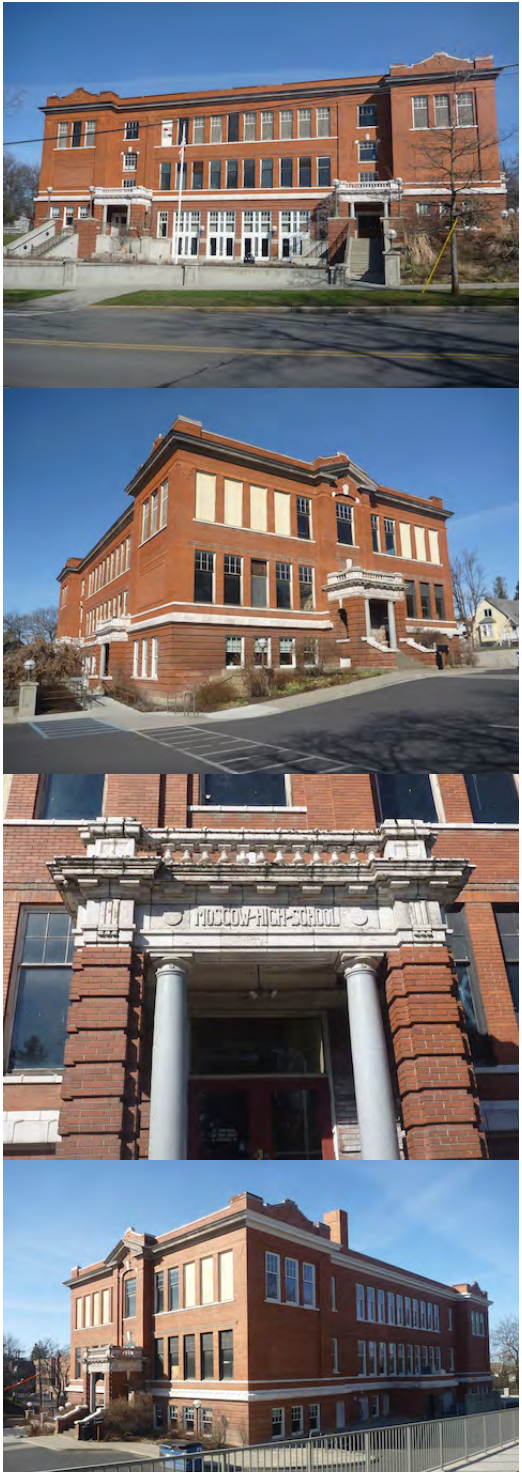
Survey Site Data	Site Photographs	Site Details
<p>Site #: 217</p> <p>410 East Third Street</p> <p>Owner: City of Moscow</p> <p>1912</p> <p>Previous District Status: n/a</p> <p>DoE: C</p> <p>Previously Listed to the NRHP: 5/5/1992</p>

<p>This is the old Moscow High School, built in 1912 designed by Spokane architect Clarence Hubbell, which was listed to the NRHP in 1992. It is a two-story building set on a raised basement foundation. It has an H-shape plan with gabled parapets on each of the four corner extensions and full-height entry porticos centered on the east and west sides. A flat-roof entry porch extends out from each of these sides, each with granite pillars, terrazzo flooring, and terra cotta ornamentation including a wide entablature and small balustrade surrounding the top. The entries are accessed by concrete stairs flanked by brick knee walls that are capped with terra cotta tiles. Two additional similar porches are found on the south side. A metal cornice and a terra cotta water table surround the building. On the basement elevation the brick runs in bands, with narrow recessed areas between. Soldier coursed bricks run above the windows, some of which retain wood-sashes though some have been replaced or are boarded over. The sides of the entry porches exhibit arched openings with terra cotta keystones. The terra cotta detailing exhibits a splattered decorative finish. Keystones are also found above segmentally-arched windows found above the entries. The building currently houses the 1912 Center, a community arts facility.</p>

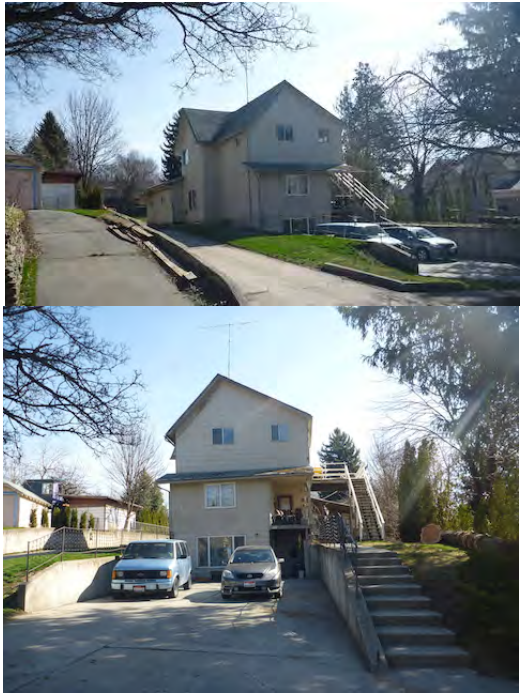
Survey Site Data	Site Photographs	Site Details
<p>Site #: 218</p> <p>122 South VanBuren Street</p> <p>Owner: Marietta Davis et al Trust</p> <p>ca. 1900</p> <p>Previous District Status: n/a</p> <p>DoE: NC</p>

<p>The Wylie A. Lauder house is a two-story, significantly altered, cross-gable dwelling, oriented to the west. The residence features an asymmetrical, two-story front-gable section projecting from a two-story, side-gable section with multi-level additions. A poured-concrete driveway flanked with concrete walls leads to a fully above ground basement entrance accessed by a lower-level, shed-roof addition that spans the width of the dwelling's front-gable section. This section features recessed porches with entries on the southeast corners and nonhistoric windows. Wood steps lead to a small wood deck with railings on the upper level of the dwelling's east elevation. One-story, shed-roof additions are also found on the east and rear elevations of the dwelling. The house features aluminum windows throughout and is clad in asbestos shingles and, vertical board siding. The roof is sheathed in asphalt shingles.</p>

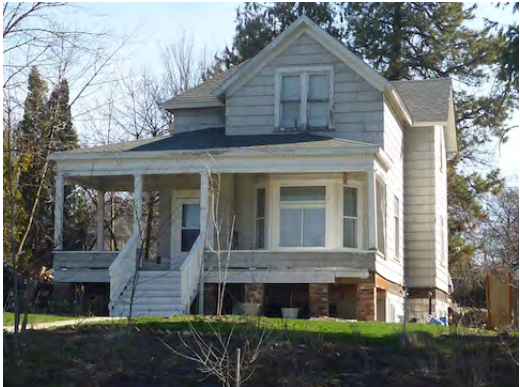
Survey Site Data	Site Photographs	Site Details
<p>Site #: 219</p> <p>204 South VanBuren Street</p> <p>Owner: Kjelda Berg</p> <p>1921</p> <p>Previous District Status: n/a</p> <p>DoE: C</p>

<p>This is a two-story, frame dwelling with a main, side-gable section with a front-gable section projecting from a pyramidal roof portion found on its south elevation. A two-story, front-gable section spans the width of the main side-gable block's rear elevation, with a hip-roof addition extending from its rear elevation. A one-story, hip-roof porch spans the façade of the dwelling. The porch rests on brick piers, is supported by square wood posts and features dentil molding. The main entry is located on the façade of the dwelling, with a bay window spanning the majority of the front-gable section under the porch. The house features one-over-one, wood-sash windows and is clad in asbestos shingles. The roof of is sheathed in asphalt shingles and the house rests on a foundation of rusticated blocks. A small, prefabricated, metal shed is situated at the rear of the lot.</p>

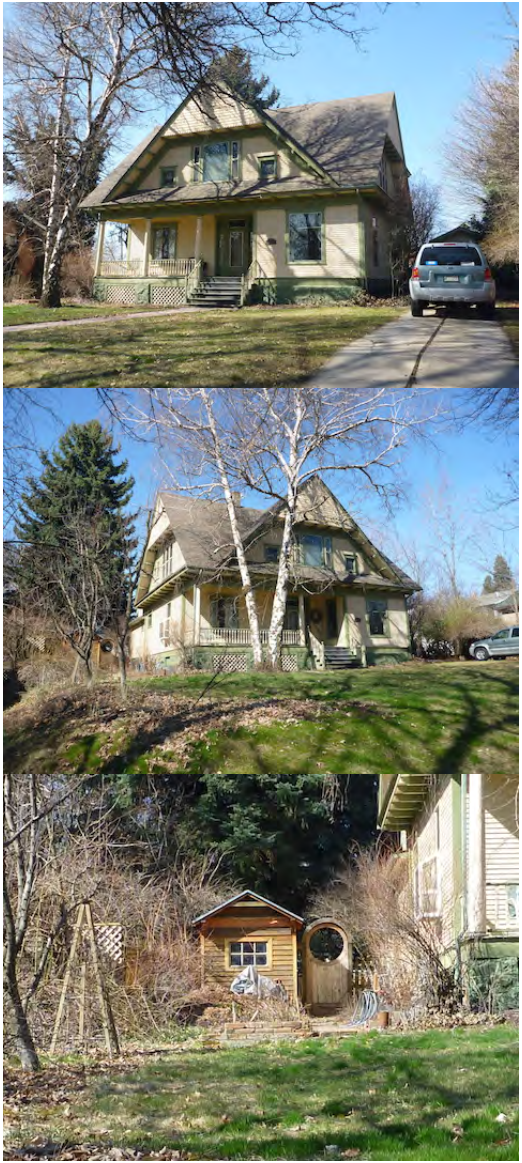
Survey Site Data	Site Photographs	Site Details
<p>Site #: 220</p> <p>123 South Polk Street</p> <p>Owner: Jay Hunter</p> <p>1902</p> <p>Previous District Status: n/a</p> <p>DoE: C</p> <p>Garage: Historic</p> <p>DoE: C</p>

<p>This is a one-and-one-half-story, three-bay, steeply pitched, cross-gable roof, frame dwelling. A large, central, front-facing gable spans the majority of the east roof slope on the façade of the dwelling. A triplet window is centered within the portion of the gable recessed from the wide eaves with decorative, straight braces. A smaller, square, diamond-pane leaded glass window is found on either side of the triplet window. These features are found in all of the gable ends of the dwelling. Large picture windows and a recessed porch span the central and south section of the dwelling's façade. The porch is supported by round posts. Narrow spindled railings enclose the porch. The main entry features a full-light door flanked by single-panel, full-light sidelights and a full-light transom above with a decorative door surround. All windows feature simple wood surrounds. The rear roof slope exhibits a smaller, gable-roof projection to compliment the façade. The roof of the dwelling is sheathed in asphalt shingles with exposed rafter tails below the wide eaves. The exterior walls are clad in weatherboard and the house rests on a stone foundation. A gable-oriented garage is located northwest of the dwelling and features a one-bay garage door entry and is clad in weatherboard siding. A small, gable-roof, wood outbuilding is found just south of the dwelling.</p>

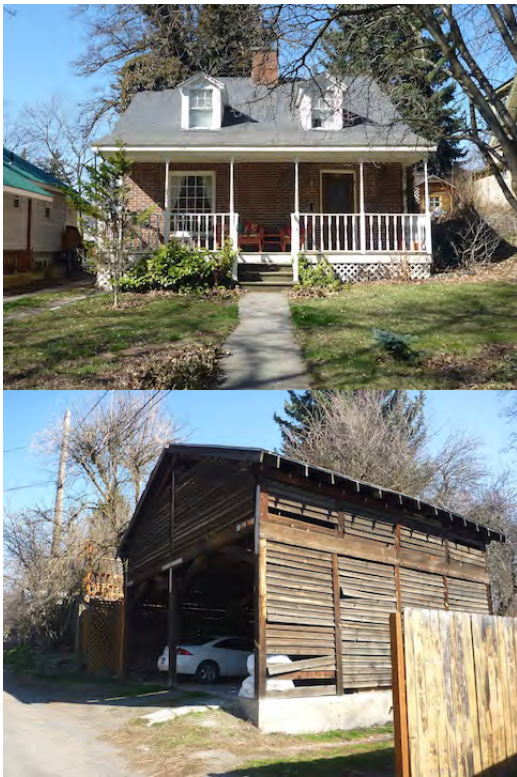
Survey Site Data	Site Photographs	Site Details
<p>Site #: 221</p> <p>203 South Polk Street</p> <p>Owner: Lindsey Pinson</p> <p>1917</p> <p>Previous District Status: n/a</p> <p>DoE: C</p> <p>Garage: Historic</p> <p>DoE: C</p>

<p>This is a one-and-one-half-story, two-bay, brick, Cape Cod dwelling. A shed-roof porch spans the width of the façade and is supported by spindle posts with spindle railings that rest on a raised wood deck. The façade features a large, twenty-five light picture window and the main entry door. A central brick chimney with a stone cap pierces the ridgeline of the dwelling, and two gable-dormers with six-over-one-light, double-hung, wood sash windows are found above the porch. Multi-light, double-hung, wood sash windows are exhibited throughout the dwelling and feature flat brick coursing and sills. The house rests on a partially raised, poured-concrete foundation that features fixed-light windows. The roof of the dwelling is sheathed in asphalt shingles. A horizontal board, wood post barn with exposed beams is located to the rear of the dwelling. The structure features a metal roof with exposed rafter tails that extend below the eaves and rests on a concrete block foundation.</p>

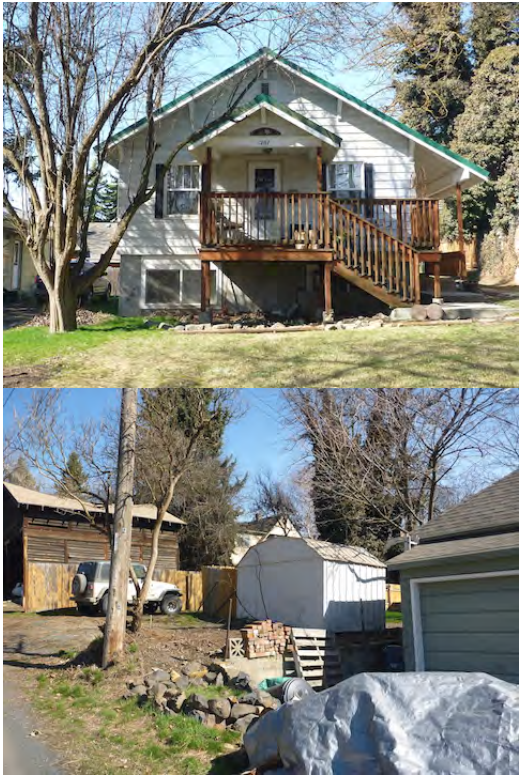
Survey Site Data	Site Photographs	Site Details
<p>Site #: 222</p> <p>207 South Polk Street</p> <p>Owner: Erika Frances Iiams</p> <p>1928</p> <p>Previous District Status: n/a</p> <p>DoE: NC</p> <p>Garage: Modern</p> <p>DoE: NC</p>

<p>This is a one-story, three-bay, front-gable dwelling that rests on a raised, poured-concrete basement. Wood steps ascend to a wood deck supported by square wood posts on concrete blocks with a wrap-around railing. The entry is sheltered by a front-gable roof with exposed rafter tails beneath the extended eaves. Vinyl windows flank the façade's central entry. The concrete basement exhibits large, aluminum windows. The dwelling's elongated north roof slope spans the width of the elevation and is supported by wood posts connected by a wood-post railing. The railing extends above a below-grade basement entry on the north elevation, accessed by descending concrete steps. The roof is sheathed in nonhistoric, V-groove metal panels with exposed rafter tails extending below the eaves and exhibit supporting brackets. A small, prefabricated, gambrel-roof shed is set rear of the dwelling.</p>

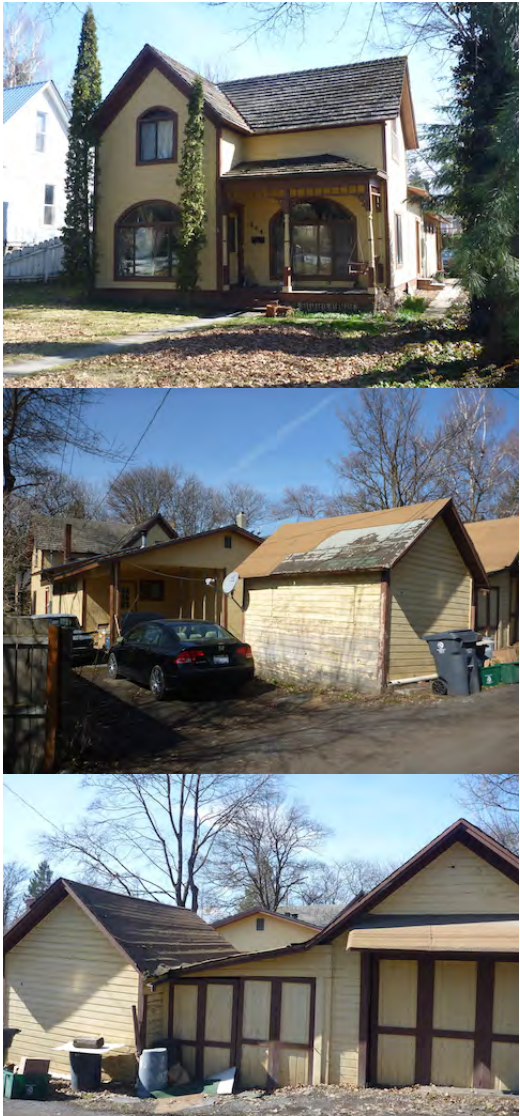
Survey Site Data	Site Photographs	Site Details
<p>Site #: 224</p> <p>204 South Polk Street</p> <p>Owner: Timothy Hull</p> <p>ca. 1900</p> <p>Previous District Status: n/a</p> <p>DoE: NC</p> <p>Garage: Historic</p> <p>DoE: C</p>

<p>This is a two-story, cross-gable, frame dwelling with several rear additions. The front-gable section features a large, three-light picture window with a arched transom on the first story, and a similar two-light window above. A hip-roof porch spans the façade of the side-gable portion of the dwelling and shelters an identical three-light, arched picture window. Large, vertical windows are found throughout the dwelling with simple wood surrounds. The porch is supported by decorative turned posts that rest on a wood deck. The roof of the porch is sheathed in wood shingles. The entry door is found on the front-gable section's south elevation. A large nonhistoric stone or stone veneer, chimney projects from the eave of the north elevation. The roof of the house is sheathed in wood shingles. The exterior walls are clad in weatherboard siding and the foundation is concrete. Multiple, one-story, gable-oriented additions extend to the rear of the dwelling with a recessed porch found within one of them. Three buildings (early barn and sheds now attached) combine to create a garage (two gable-roof sections connected by a shed-roof section) clad in weatherboard siding and vertical board door entry doors is found to the rear of the dwelling.</p>

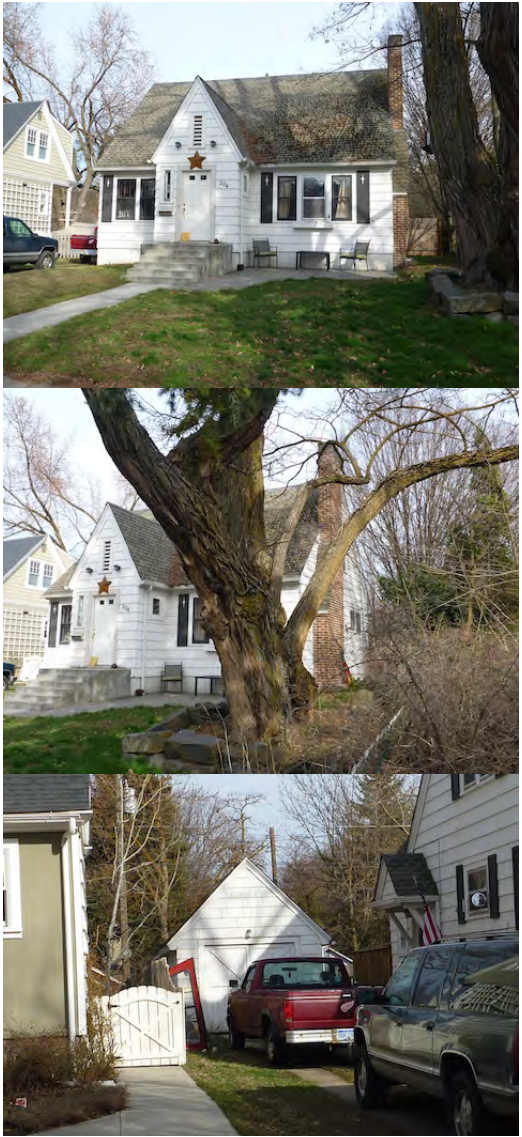
Survey Site Data	Site Photographs	Site Details
<p>Site #: 228</p> <p>204 South Howard Street</p> <p>Owner: Jeffrey Antkowiak</p> <p>1931</p> <p>Previous District Status: n/a</p> <p>DoE: C</p> <p>Garage: Historic</p> <p>DoE: C</p>

<p>This is a side-gabled, one-and-one-half story, Tudor style dwelling. The façade features an off-center, steeply-pitched, front-facing, gabled entry vestibule with a contemporary entry door, a narrow wood-sash window with a storm window, and a louvered vent in the peak. A triple window is to the south of the entry gable and a double window to the north. Windows are three-over-one, wood sashes with nonhistoric shutters. At the south elevation is a tall, double-flue, brick, exterior chimney. At the north elevation are a number of windows and a small, gable-front roof on knee braces over the side entry door. Walls are covered in cedar shingles, the roof is composition shingle and the foundation is concrete. Also on this site is a one-story, gable front, single-car garage that has been extended with a linear, slightly taller addition towards the east at the alley. The early part of the garage features shingled walls, wood swing-out garage doors and composition shingle roof. The addition is clad in T1-11 sheet siding and has a single-car composite roll-up garage door.</p>

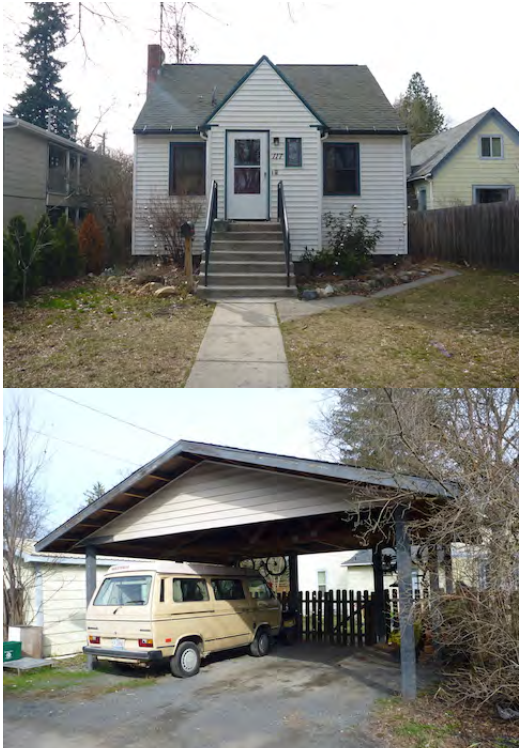
Survey Site Data	Site Photographs	Site Details
<p>Site #: 229</p> <p>117 South Monroe Street</p> <p>Owner: Dennis DeHart</p> <p>1937</p> <p>Previous District Status: n/a</p> <p>DoE: C</p> <p>Garage: Modern</p> <p>DoE: NC</p>

<p>This is a small, nearly symmetrical, side-gabled dwelling that is one-and-one-half stories with a rectangular plan and a basement. The façade features a projecting, front-gabled, entry vestibule that contains the entry door and two small narrow windows: one alongside the door, and the other in the south wall. The entry door is a glazed, wood panel door. The vestibule is flanked by a pair of six-over-one windows. A double-flue, brick, exterior chimney and a pair of windows grace the south elevation and a number of windows punctuate the north elevation. At the rear elevation is a one-and-one-half story, gabled extension with a rear entry door. Windows are wood sash, wall sheathing is vinyl, and the roof is composition shingle. At the rear of the site is a front-gabled, double carport. It is set atop square posts and has clapboards in the gable ends.</p>

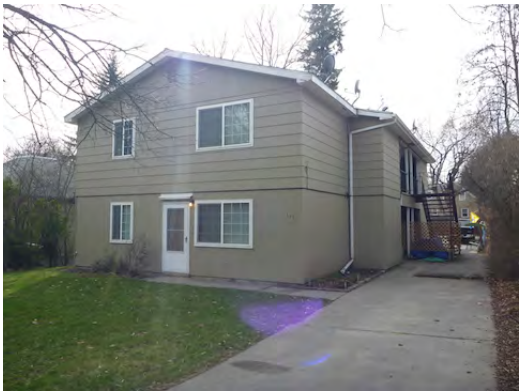
<p>Site #: 230</p> <p>123 South Monroe Street</p> <p>Owner: Brian Lande</p> <p>1968</p> <p>Previous District Status: n/a</p> <p>DoE: NC</p>

<p>This is a contemporary, two-story, front-gabled, multi-unit dwelling with a rectangular plan. The façade features an entry door with flashing above, flanked by vinyl slider windows at the first floor. The second story features a pair of windows. The gable ends and the first level are clad in T1-11 sheet siding, while the second story is sheathed in wide composite boards. At the north elevation is a two-story shed-roofed extension that houses entry doors accessed by a metal staircase, with storage below. Attached at the rear of the site, is a single story, hip roofed unit.</p>

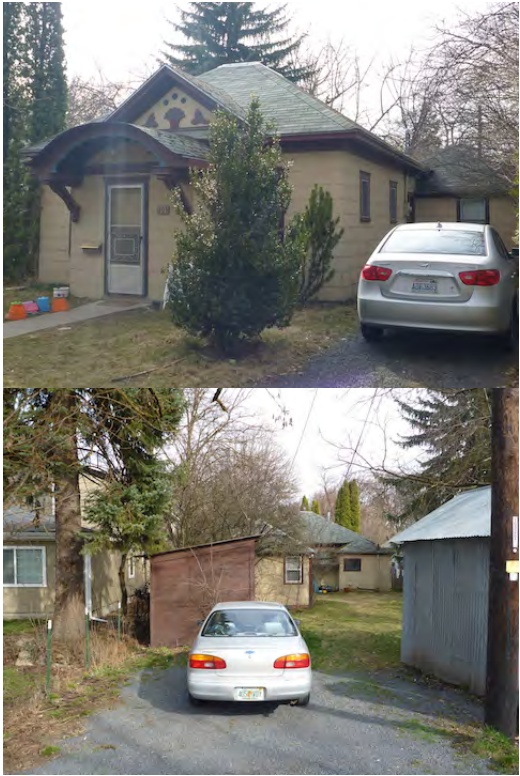
Survey Site Data	Site Photographs	Site Details
<p>Site #: 231</p> <p>203 South Monroe Street</p> <p>Owner: DRM Rentals LLC</p> <p>ca. 1900</p> <p>Previous District Status: n/a</p> <p>DoE: NC</p> <p>Garage: Modern</p> <p>DoE: NC</p> <p>Shed: Modern</p> <p>DoE: NC</p>

<p>This is a small, pyramidal-roofed dwelling with a square plan. The façade features a closed, front-facing gable with applied decorations in its tympanum that is centered above the entry. The enclosed entry porch projects out from the front of the house and is sheltered under an arched porch roof atop carved, bracketed knee-braces. The entry contains a solid-core flush door. A pair of dissimilar windows flanks the entry. Windows are a combination of wood, metal and vinyl sash. The walls are covered in asbestos shingles and the roof is composition shingled. A single-story, hip-roof addition is found off the northwest corner of the dwelling; the addition is visible from the façade elevation. At the rear of the site is a shed-roofed, wood frame shed. It features wood clapboards, a metal roof and a wide opening. Also at the rear of the site is a gable front, corrugated metal shed with a fiberglass entry door and a corrugated metal roof.</p>

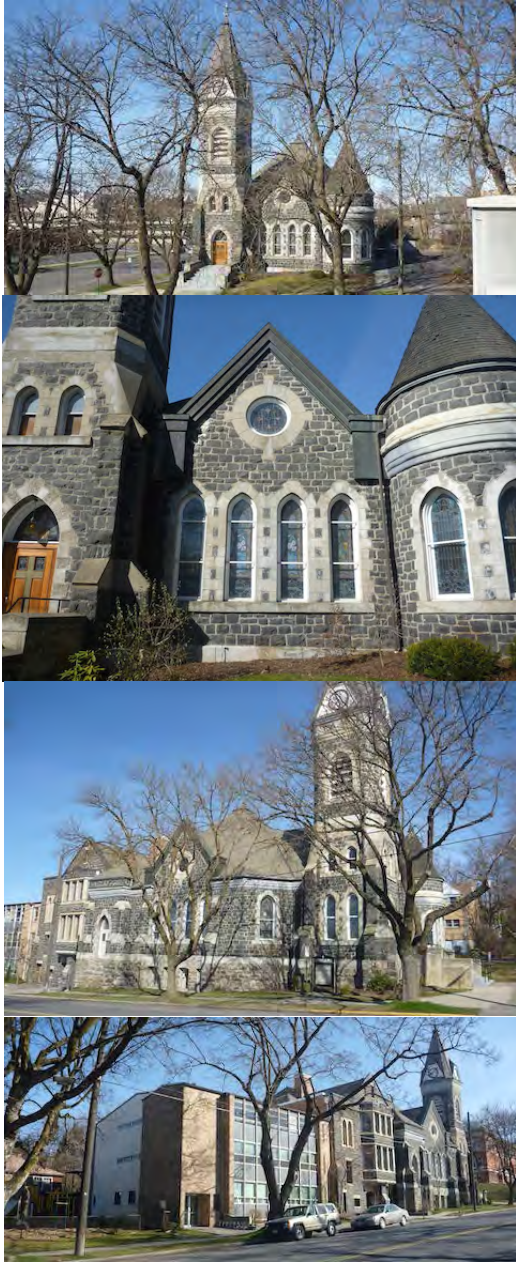
Survey Site Data	Site Photographs	Site Details
<p>Site #: 232</p> <p>322 East Third Street</p> <p>Owner: Methodist Church</p> <p>1904</p> <p>Previous District Status: n/a</p> <p>DoE: C</p> <p>Previously Listed to the NRHP: 10/5/1978</p> <p>Shed: Historic</p> <p>DoE: C</p>

<p>This is the Moscow First Methodist Church, listed individually to the NRHP in 1978. It is an asymmetrical Gothic Revival style church exhibiting a mortared stone exterior and concrete-over-brick surrounding the Gothic-arched windows, entries and oculus window found on the south elevation. The windows retain ornate stained-glass wood sashes. A rounded turret is found on the southeast corner, while a square clock tower rises from the southwest corner. The tower exhibits Gothic-arched vents and clocks on all four sides. An extension with a gable-roof parapet is found on the south side and buttressed pilasters are found throughout. A ca. 1950s addition, exhibiting red brick on the north elevation and stone similar to the original building on the south elevation, is found west of the original building. It is similar in appearance to the original building facing busy East Third Street. A windowed bay extends from the main and upper level of this addition on the south side above a recessed basement level entry. Some of the windows contain leaded-glass. Another addition is found on the far west of the building. It is mid-century modern in appearance, exhibiting a stone or faux stone veneer and ribbons of metal-sash windows with grey colored panels between. Its north wall is plain with small metal-sash windows. A small, gable-roof, frame shed is found at the northwest corner of the site, sheathed in clapboards with exposed rafter tails. Despite the additions, the original portion remains a highly intact, significant architectural example of its era.</p>

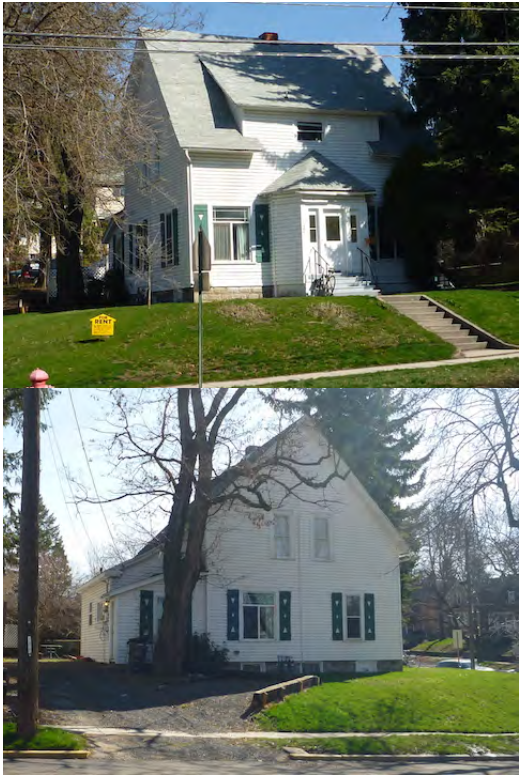
Survey Site Data	Site Photographs	Site Details
<p>Site #: 233</p> <p>504 East Third Street</p> <p>Owner: Five Star Equity Inc.</p> <p>1910</p> <p>Previous District Status: n/a</p> <p>DoE: NC</p>

<p>This is a two-and-one-half-story, three-bay, side-gable, frame dwelling. A central, enclosed one-story, pyramidal, entry porch is found on the façade. The porch features an entry with a wood panel door flanked by two-light sidelights. Windows featuring vertical, two-light panes with one horizontal pane above flank the porch. One-over-one, wood-sash windows are found throughout the dwelling. The lower-level windows exhibit decorative shutters. A large, wide, shed-roof wall dormer with a small, two-light window is above the entry porch. A one-story, shed-roof addition spans the width of the rear elevation while a double-deck with lattice and small, gable-roof side entry is found on the dwelling's east elevation. A central brick chimney pierces the ridgeline. The roof is sheathed in asphalt shingles and the exterior walls are clad in vinyl siding. The house rests on a rusticated block foundation.</p>

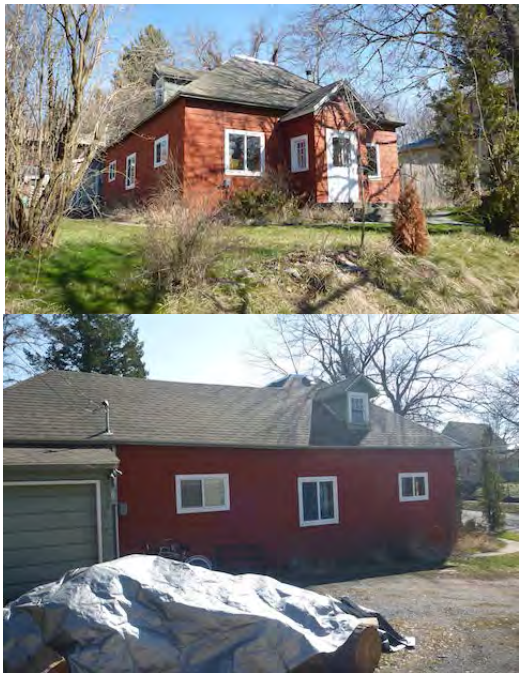
<p>Site #: 235</p> <p>520 East Third Street</p> <p>Owner: Sonja LaPaglia</p> <p>ca. 1900</p> <p>Previous District Status: n/a</p> <p>DoE: C</p>

<p>Site 235 is a one-and-one-half story, three-bay, truncated-roof dwelling with a rear addition. Concrete steps lead to an enclosed, gable-roof entry porch. A twelve-light, wood-sash window is found on either side elevation of the porch. A large picture window and fixed, vertical, two-pane window flank the entry. Two-light, sliding windows are exhibited throughout the dwelling. A small, gable-roof dormer with a six-over-one-light, wood-sash window pierces the dwelling's west roof slope. A nonhistoric, metal flue projects from the east roof slope of the dwelling. A shed-roof addition with a one-car garage is found on the east elevation at the rear of the house. The roof is sheathed in asphalt shingles, the walls are clad in wide, horizontal boards, and the house rests on a concrete foundation.</p>

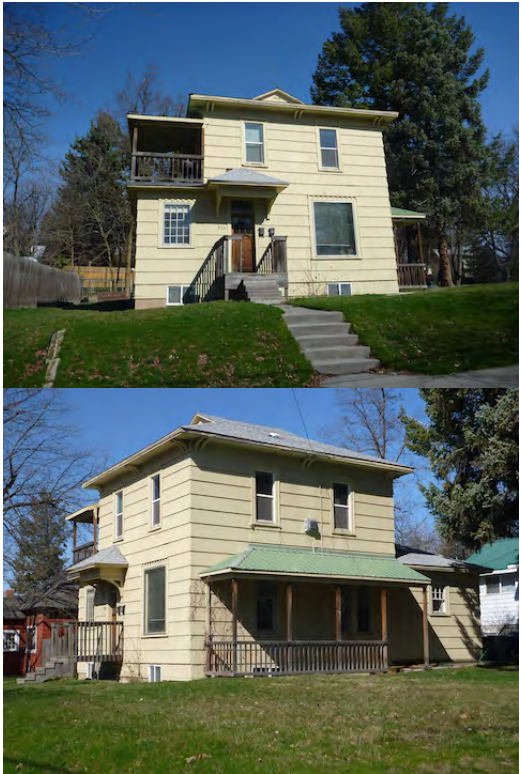
Survey Site Data	Site Photographs	Site Details
<p>Site #: 236</p> <p>528 East Third Street</p> <p>Owner: Randy Rauch</p> <p>1911</p> <p>Previous District Status: n/a</p> <p>DoE: NC</p>

<p>This is a two-story dwelling with additions. Off-centered on the façade, a hip-roof awning with brackets shelters an entry with a transom above. A fixed, twenty-light window and a larger picture window flank the main entry. A gable-roof extension projects from the truncated roof. The main block features a wide overhang supported by decorative, paired brackets. One-over-one windows are found on both levels of the dwelling, with six-over-one-light windows found on the house's lower level. The windows have simple wood surrounds with decorative dentils above. A one-story, hip-roof porch spans the width of the east elevation. The porch is supported by wood posts with a simple wood railing. The roof of the porch is V-groove metal panels. A small, shed-roof porch with wood posts and railing, is located above the one-story section on the west side. The porch roof is sheathed in metal. A one-story, gable-on-hip roof addition spans the width of the rear elevation. The roof of the house is sheathed in asphalt shingle, the exterior walls are clad in asbestos shingles and the foundation is concrete.</p>
