National Register of Historic Places Registration Form

Historic name: Fort Russell Neighborhood Historic District (Boundary Increase and Additional Documentation)

Street & number: Roughly bounded by Jefferson Street on the west, East D Street on the north, Hayes Street on the east, and East Third Street on the south

City or town: Moscow State: ID County: Latah

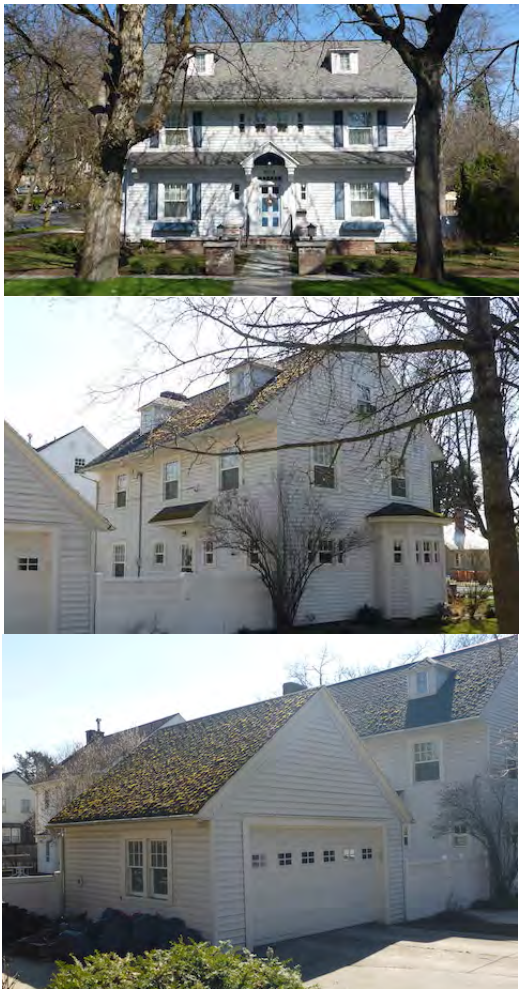
Survey Site Data	Site Photographs	Site Details
<p>Site #: 237</p> <p>604 East Third Street</p> <p>Owner: Douglas Adams</p> <p>1922</p> <p>Previous District Status: n/a</p> <p>DoE: C</p> <p>Garage: Historic</p> <p>DoE: C</p>

<p>Site 237 is a two-and-one-half-story, three-bay (w/d/w), side-gable, Colonial Revival dwelling. The stone and brick steps that lead to the main entry feature iron railings and are flanked with higher brick piers with concrete caps. Accentuated with a decorative gabled pediment, the central entryway features a wood panel door with two square lights at the top and a six-light transom above. The entryway is flanked by small, vertical, two-light windows. Two small, hip-roof dormers are centered on both the north and south roof slopes of the house. An enclosed bay projection with small vertical windows is found on the dwelling's west elevation, while an exterior brick chimney with stone accents pierces the ridgeline on the dwelling's east gable end and is flanked by half-fanlight windows. The roof of the dwelling is sheathed in asphalt shingles, the exterior walls are clad in vinyl and vinyl windows are found throughout. The house rests on a stone foundation. A gable-roof, vinyl clad garage featuring a large, six-light garage door and six-over-one-light, double-hung windows is found to the rear of the dwelling.</p>

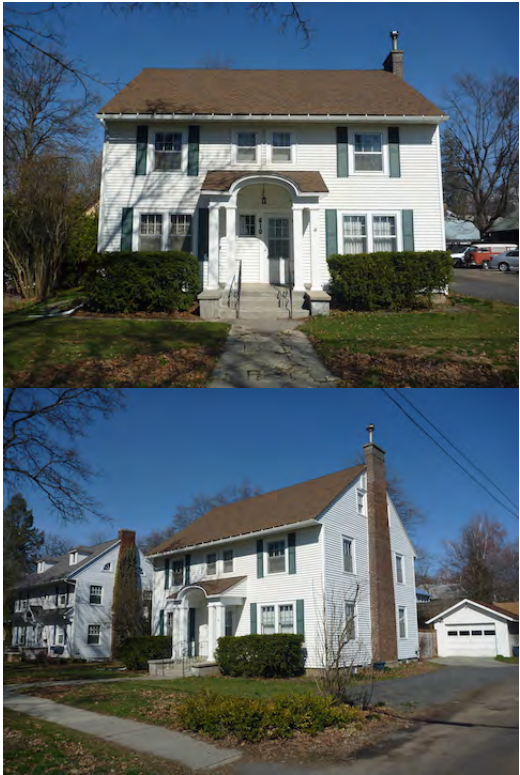
Survey Site Data	Site Photographs	Site Details
<p>Site #: 238</p> <p>610 East Third Street</p> <p>Owner: Kelly Harkins</p> <p>1926</p> <p>Previous District Status: n/a</p> <p>DoE: C</p> <p>Garage: Historic</p> <p>DoE: C</p>

<p>Site 238 is a two-and-one-half-story, side-gable dwelling. The shed-roof porch with a semi-elliptical hood is supported by paired square posts and shelters the main entry and a fixed, six-light window. The entry features a twelve-light, wood panel door. Paired, six-over-one light, wood-sash windows with fixed shutters flank the main entryway, with individual six-over-one-light windows with fixed shutters are found on the upper level. A set of smaller two, six-over-one-light windows are featured above the main entryway. Windows with six-over-one-lights are on the first and second stories and on both upper gable ends. An exterior brick chimney is on the east end. The roof is sheathed in asphalt shingles and the exterior walls are clad in vinyl. The house rests on a poured concrete foundation. A gable-oriented garage featuring a four-light, metal garage door is found just northeast of the dwelling. The structure has an asphalt shingle roof and is clad in vinyl siding.</p>

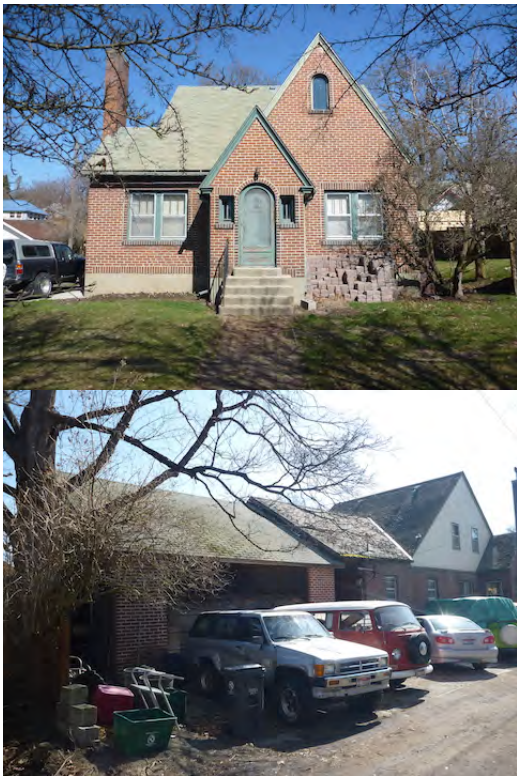
Survey Site Data	Site Photographs	Site Details
<p>Site #: 239</p> <p>616 East Third Street</p> <p>Owner: Roger Crozier</p> <p>1935</p> <p>Previous District Status: n/a</p> <p>DoE: C</p> <p>Garage: Historic</p> <p>DoE: C</p>

<p>This is a one-and-one-half-story, three-bay, English cottage brick dwelling. It features a steeply-pitched gable projection with a small, arch window at the peak and paired windows with brick lintels and sills found at the first level. A centered, one-story, front-gabled entry projects from the taller gable. An arch entry door framed with a brick surround and flanked by small, vertical two-light windows is featured on the façade. A simple cornice with returns decorates the front-facing gables. The windows contain vertical, three-over-one, double-hung wood sashes. Individual and paired windows are found throughout the dwelling. A one-story, gable-roof projection extends from the rear elevation of the dwelling. A brick, gable-roof garage addition extends from the rear gable. The roof of the house is sheathed in asphalt shingles. The upper gable ends are clad in aggregate. The house rests on a partially raised concrete basement.</p>

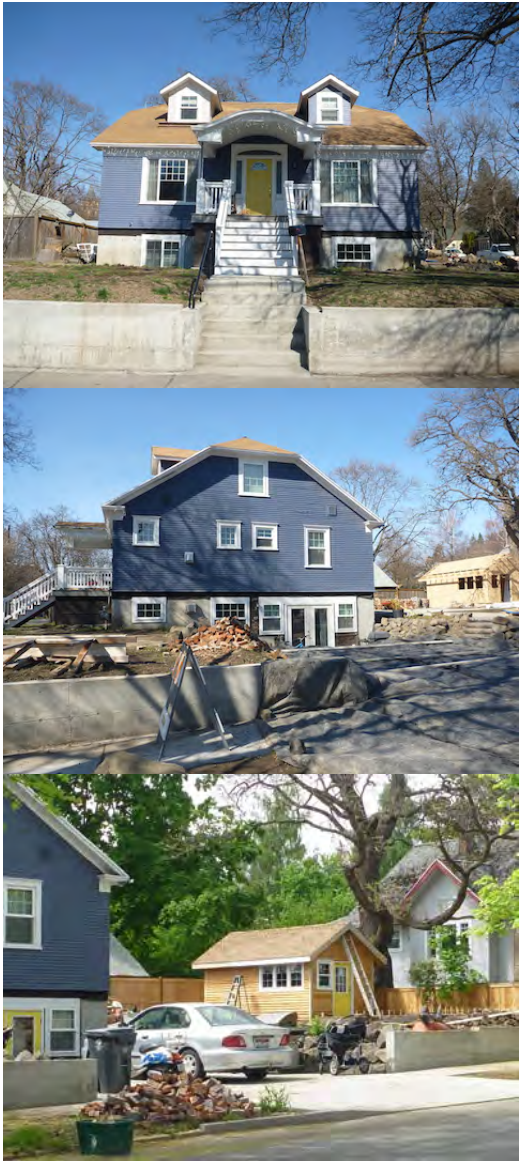
Survey Site Data	Site Photographs	Site Details
<p>Site #: 240</p> <p>620 East Third Street</p> <p>Owner: Timothy Van Den Broek</p> <p>1929</p> <p>Previous District Status: n/a</p> <p>DoE: C</p> <p>Garage: Modern</p> <p>DoE: NC</p>

<p>Site 240, is a one-and-one-half story, three-bay, clipped gable-roof bungalow. The dwelling rests on a partially raised concrete foundation accessed by a full walkout basement with a double entry on its east elevation. Centered on the façade is a curved roof porch supported by slender poles atop square posts enclosed with wood post railings. The entry is a modern door with sidelights and a fanlight. Modern, vinyl triplet windows are found on either side of the main entrance on the façade of the dwelling. Two gable-roof dormers with two-over-one windows set on the front roof slope of the dwelling. Various, modern windows are found throughout the house. The dwelling's rear elevation features a wide shed-roof dormer with a series of five windows on the north roof slope of the house. Wood steps and deck provide access to the rear elevation. The entry is sheltered by a shed roof supported by brackets. The roof of the dwelling is sheathed in asphalt shingles and features cornice returns. The exterior walls are clad in weatherboard siding. A newly constructed, gable-roof shed is found in close proximity to the dwelling. Per the property's owner, the dwelling was raised and given a new foundation due to structural issues with the original foundation. The original brick chimney on the east elevation was removed, and the bricks are being reused in the landscaping.</p>

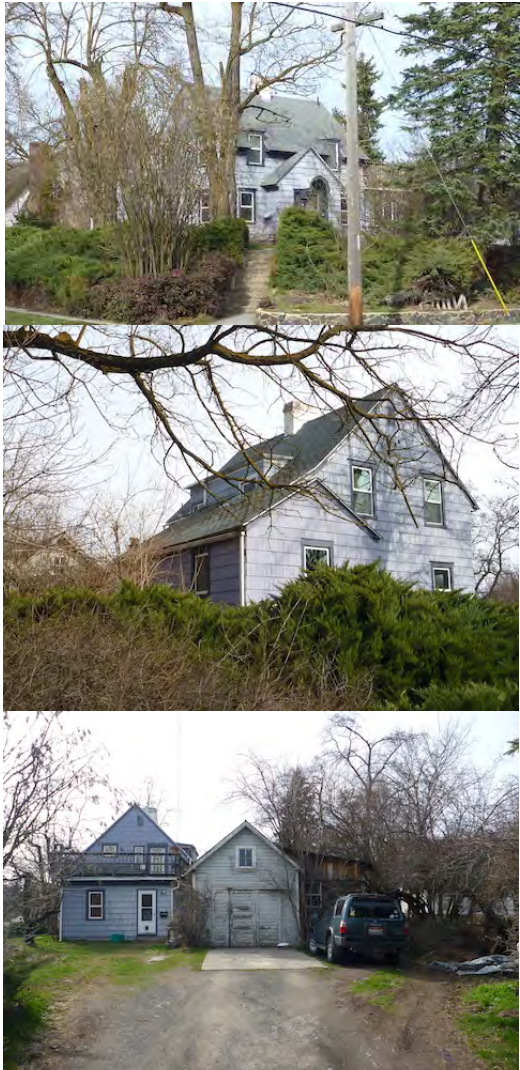
Survey Site Data	Site Photographs	Site Details
<p>Site #: 241</p> <p>704 East Third Street</p> <p>Owner: Mark Solomon</p> <p>1913</p> <p>Previous District Status: n/a</p> <p>DoE: C</p> <p>Garage: Historic</p> <p>DoE: C</p>

<p>Site 241 is a large, one-and-one-half story, side-gabled dwelling. The façade features a projecting, front-gabled entry vestibule with a round-arch hood on carved brackets upon classical pilasters. The wood-panel entry door has sidelights outside the pilasters and a fanlight above within the hood. The façade also features a pair of nearly flat, shed-roofed, through-the-cornice wall dormers and a double-flue, brick, inside chimney centered at the ridge. A flat-roofed wing at the east elevation is balustraded and functions as a roof deck. At the first level is a side entry door. A small, side-gabled, single-story addition extends from the west elevation and a shed-roof, two-window dormer is found on the roof slope at the rear of the dwelling. The eaves are minimal, the windows are vinyl, and the roof is composition shingle. The walls are clad in wide-reveal cedar shingle. Also at the site is a one-story, gable-front single-car garage. It features wood clapboards, wood-sash window, a composition-shingled roof, wood, swing-out doors, and a shed-roof addition at the north elevation.</p>

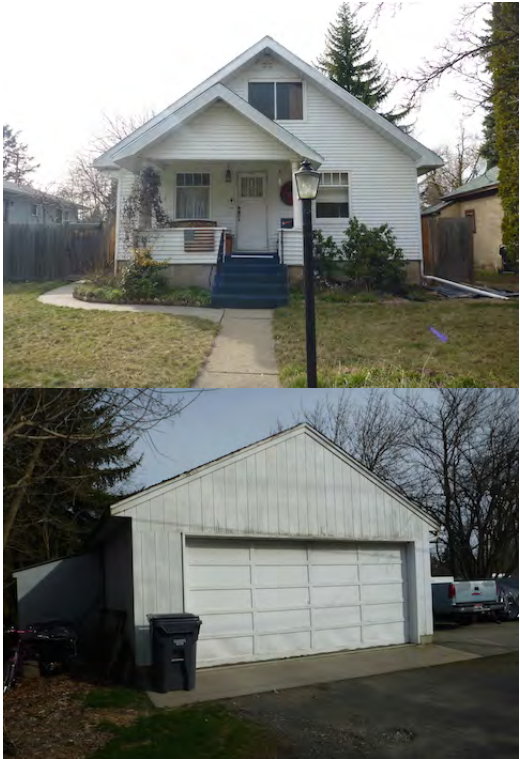
Survey Site Data	Site Photographs	Site Details
<p>Site #: 242</p> <p>207 South Monroe Street</p> <p>Owner: Art Moen</p> <p>1931</p> <p>Previous District Status: n/a</p> <p>DoE: C</p> <p>Garage: Modern</p> <p>DoE: NC</p>

<p>Site 242 is an altered, one-and-one-half-story, front-gabled Bungalow with a rectangular plan. The dwelling is oriented towards the east facing South Monroe Street and East City Park. The façade features a front facing, gable, entry porch roof that sits atop a pair of Tuscan style columns and a closed porch rail. The entry has a painted wood, ledged door with glazing that is flanked by four-over-one, wood-sash windows. In the gable peak, the fenestration has been altered to accept a large, horizontal-sliding window. At the south elevation is a square, projecting bay with a pair of four-over-one, wood-sash windows. The exterior walls, eaves and gable ends are covered vinyl siding. The foundation is concrete. Also on the site facing the alley, is a two-car garage with T1-11 sheet siding, composition shingle roof, and a composite roll-up garage door.</p>

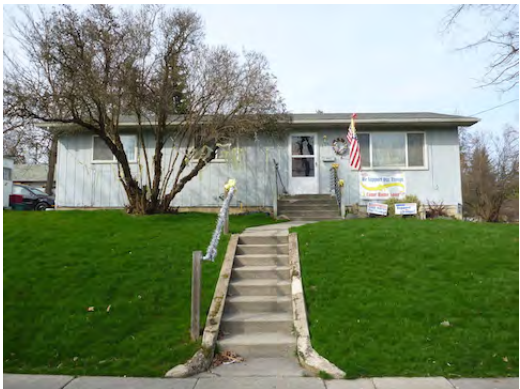
<p>Site #: 243</p> <p>726 East Third Street</p> <p>&</p> <p>213 South Monroe Street</p> <p>Owner: Wai Family Living Trust</p> <p>1968</p> <p>Previous District Status: n/a</p> <p>DoE: NC</p>

<p>Site 243 is a side-gabled, one-story dwelling, with a rectangular plan and a basement unit. The façade of the dwelling is asymmetrical and features an off-center entry door and three windows. The east elevation features the entry to the basement unit and windows, while the north elevation features windows and a sliding glass door. The walls are clad in T1-11 sheet siding and the roof is covered in composition shingle.</p>

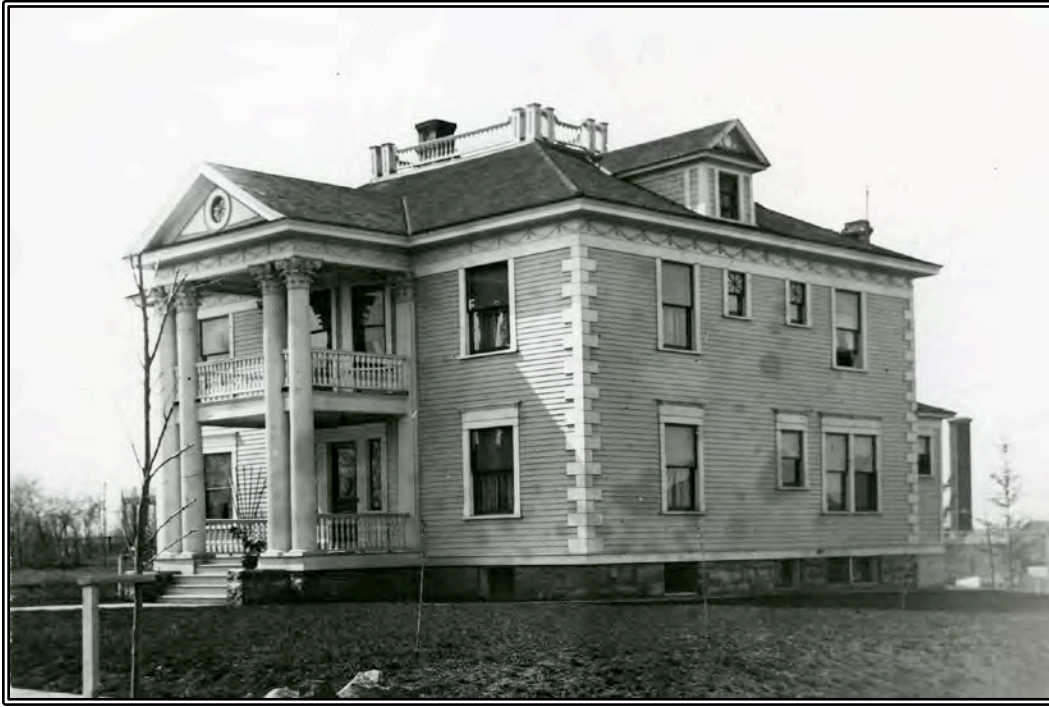
1: Site 12, Charles L. Butterfield House (LCHS)

- Charles L. Butterfield House (1902-03) (403 North Polk Street), a two-story, Neoclassical dwelling with a dominant entry porch with a classical pediment, fluted, full-height, Corinthian columns and pilasters, and an upper porch with a spindled balustrade. Dormers are found on the truncated hip roof on all elevations but the façade;

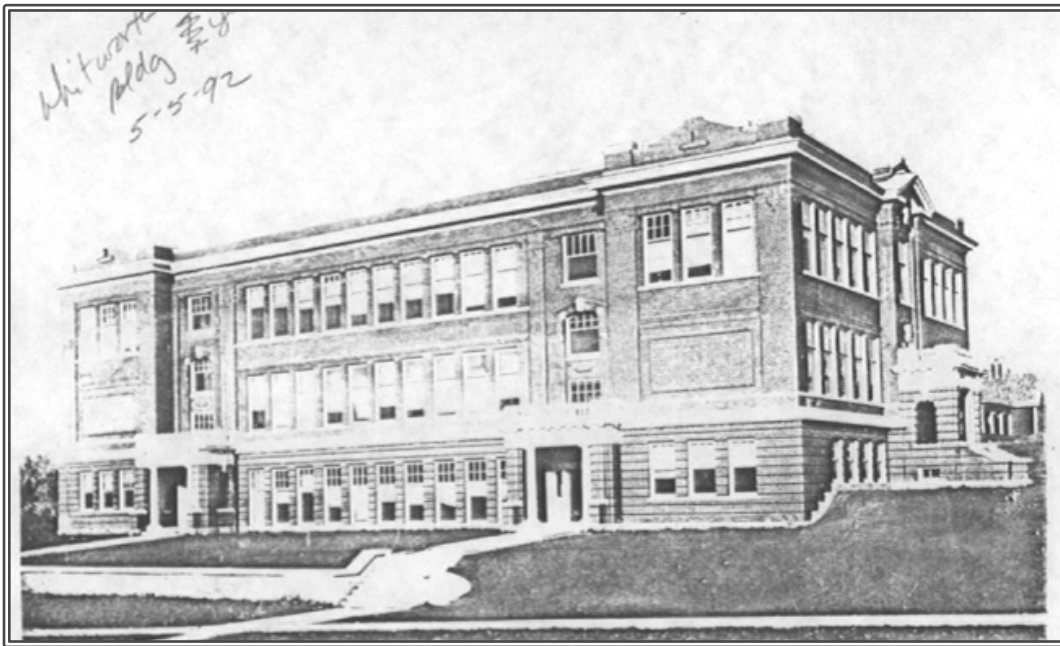
7: Site 217, old Moscow High School (LCHS)

- The old Moscow High School (1912) was designed by Spokane architect Clarence Hubbell in the Neoclassical style. It is a two-story building set on a raised basement foundation with an H-shape plan and with gabled parapets on each of the four corner extensions and full-height entry porticos centered on the east and west elevations. A flat-roof entry porch extends out from each of these elevations, each with granite pillars, terrazzo flooring, and elaborate terra cotta ornamentation including a wide entablature and small balustrade surrounding the top. This building is now known as the Whitworth Building and is listed individually in the NRHP.

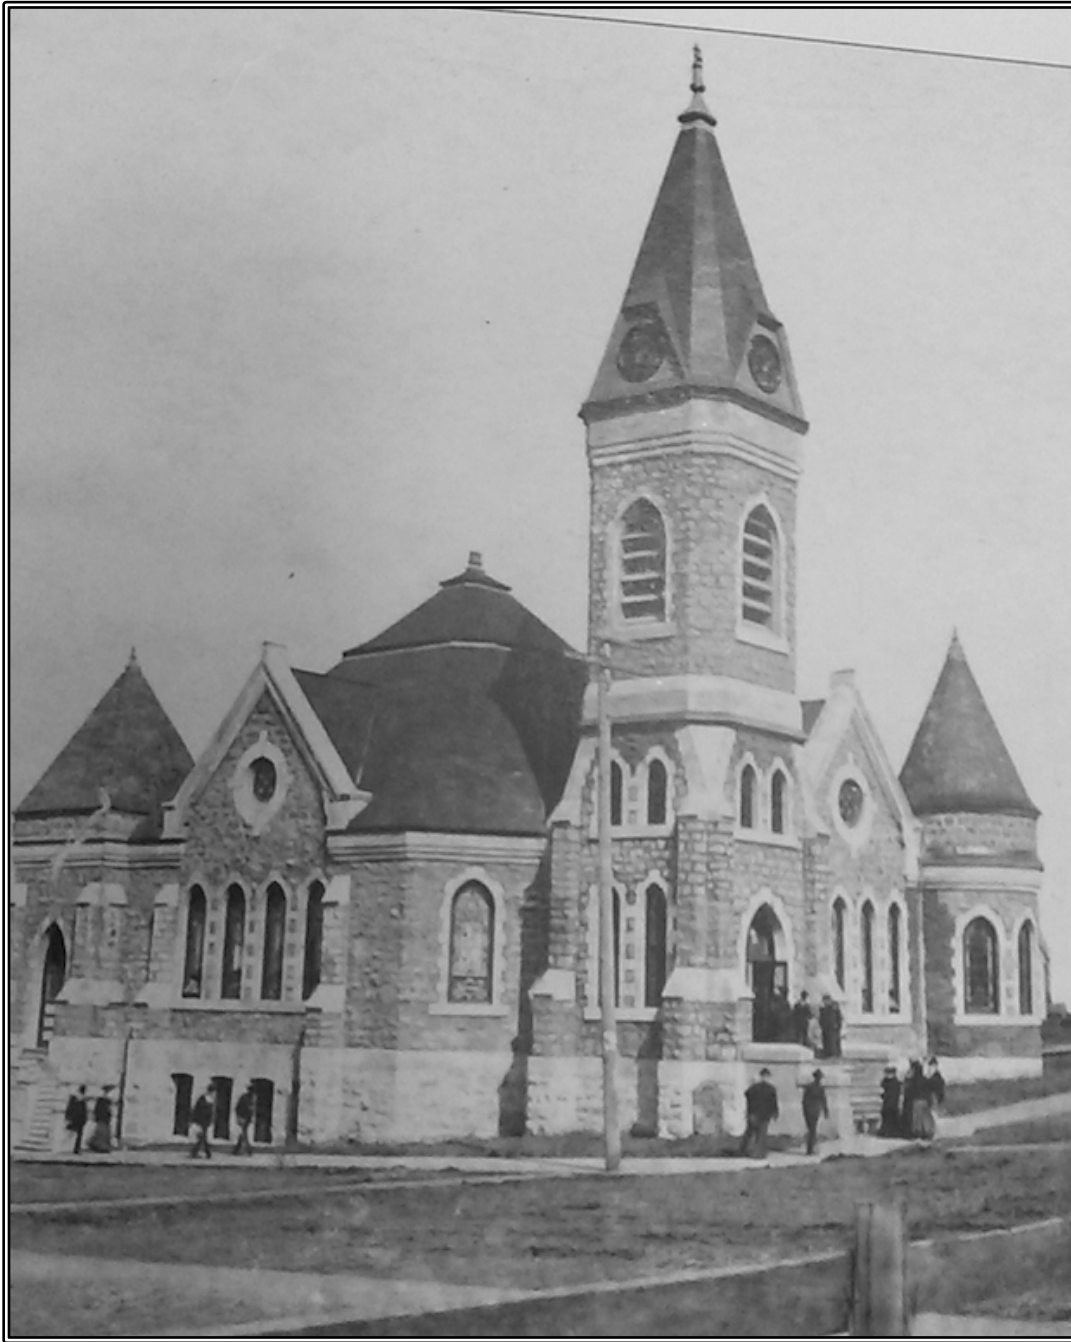
11: Methodist Church, Site 232 (Monroe, 2006: n.p.)

<p>This is the Moscow First Methodist Church, listed individually to the NRHP in 1978. It is an asymmetrical Gothic Revival style church exhibiting a mortared stone exterior and concrete-over-brick surrounding the Gothic-arched windows, entries and oculus window found on the south elevation. The windows retain ornate stained-glass wood sashes. A rounded turret is found on the southeast corner, while a square clock tower rises from the southwest corner. The tower exhibits Gothic-arched vents and clocks on all four sides. An extension with a gable-roof parapet is found on the south side and buttressed pilasters are found throughout. A ca. 1950s addition, exhibiting red brick on the north elevation and stone similar to the original building on the south elevation, is found west of the original building. It is similar in appearance to the original building facing busy East Third Street. A windowed bay extends from the main and upper level of this addition on the south side above a recessed basement level entry. Some of the windows contain leaded-glass. Another addition is found on the far west of the building. It is mid-century modern in appearance, exhibiting a stone or faux stone veneer and ribbons of metal-sash windows with grey colored panels between. Its north wall is plain with small metal-sash windows. A small, gable-roof, frame shed is found at the northwest corner of the site, sheathed in clapboards with exposed rafter tails. Despite the additions, the original portion remains a highly intact, significant architectural example of its era.</p>
