UNITED STATES DEPARTMENT OF THE INTERIOR  
NATIONAL PARK SERVICENATIONAL REGISTER OF HISTORIC PLACES  
INVENTORY -- NOMINATION FORM

HISTORIC Geertson, Lars, House

Herb Aldous House

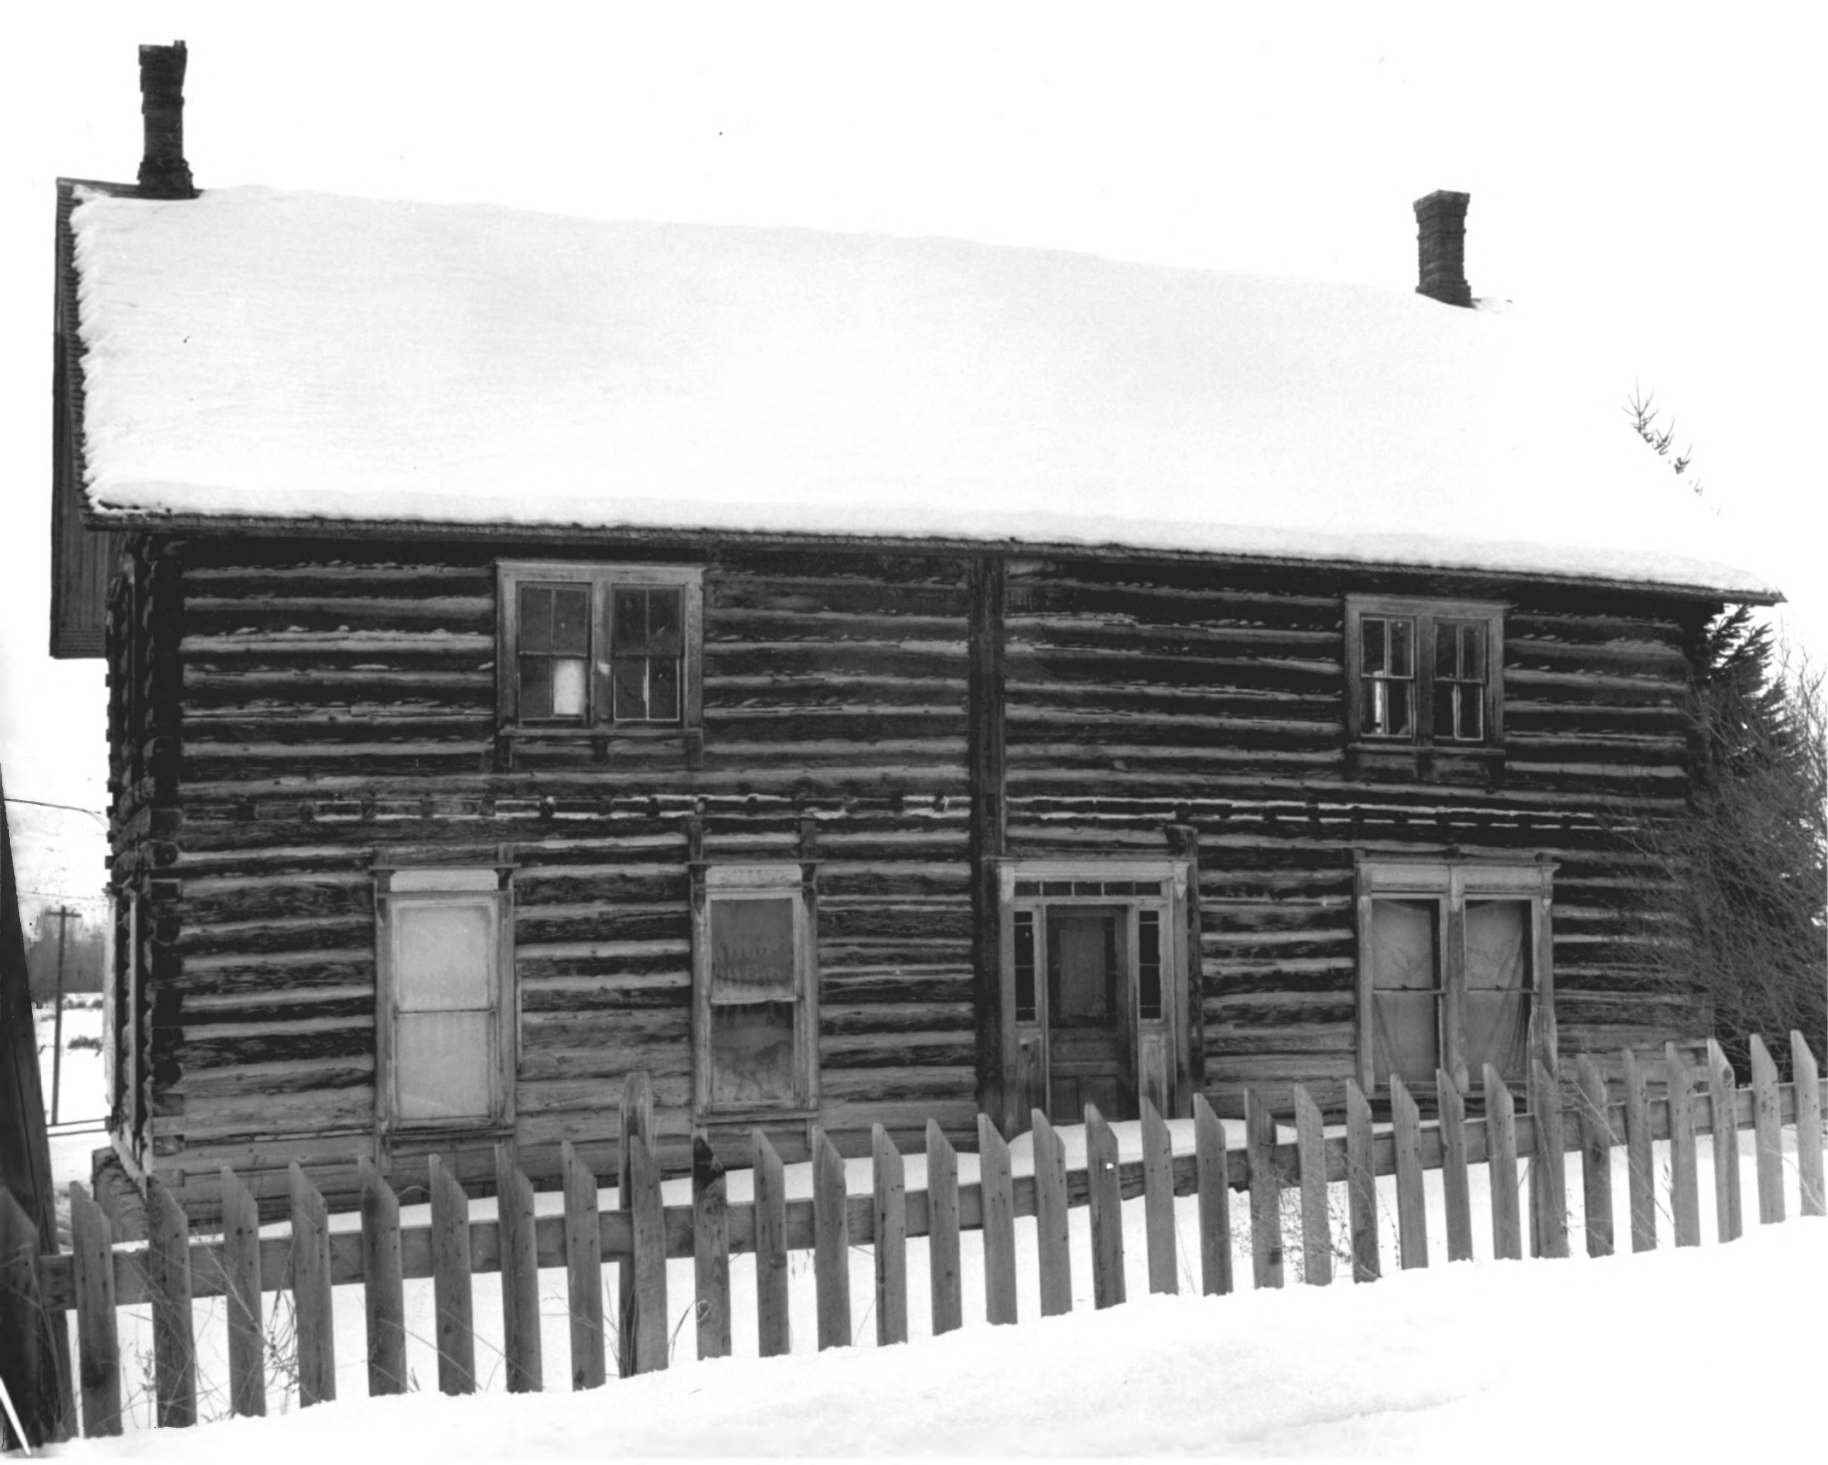
View from North  
1 of 3

Geertson, Lars, House  
Geertson Creek  
Vicinity of Salmon, Idaho  
Lemhi County, Idaho

The Geertson House is a two-story rectangular log structure with a one-and-one-half-story rear ell. It is constructed of hewn log timbers, one foot thick, joined at the corners with square notching and chinked between the logs. Log joists for the second story are framed into the front and back walls and run parallel to the gables. The gables are frame with horizontal siding, and the forty-five-degree gable roof is shingled. In 1940 a concrete foundation was added.

The four-bay facade of the house has a central door offset to the right with multipane side lights and a transom. The windows are one or two-over-two-light double-hung sash. Each gable in the front section has two pentagonal windows on either side of a brick chimney. The original three porches, and a commissary that served stagecoach customers on the Red Rock-Salmon City Line and local residents, have been removed. The present owner has added a small frame porch on the west side of the ell and a framed-in outside entrance to the wine cellar.

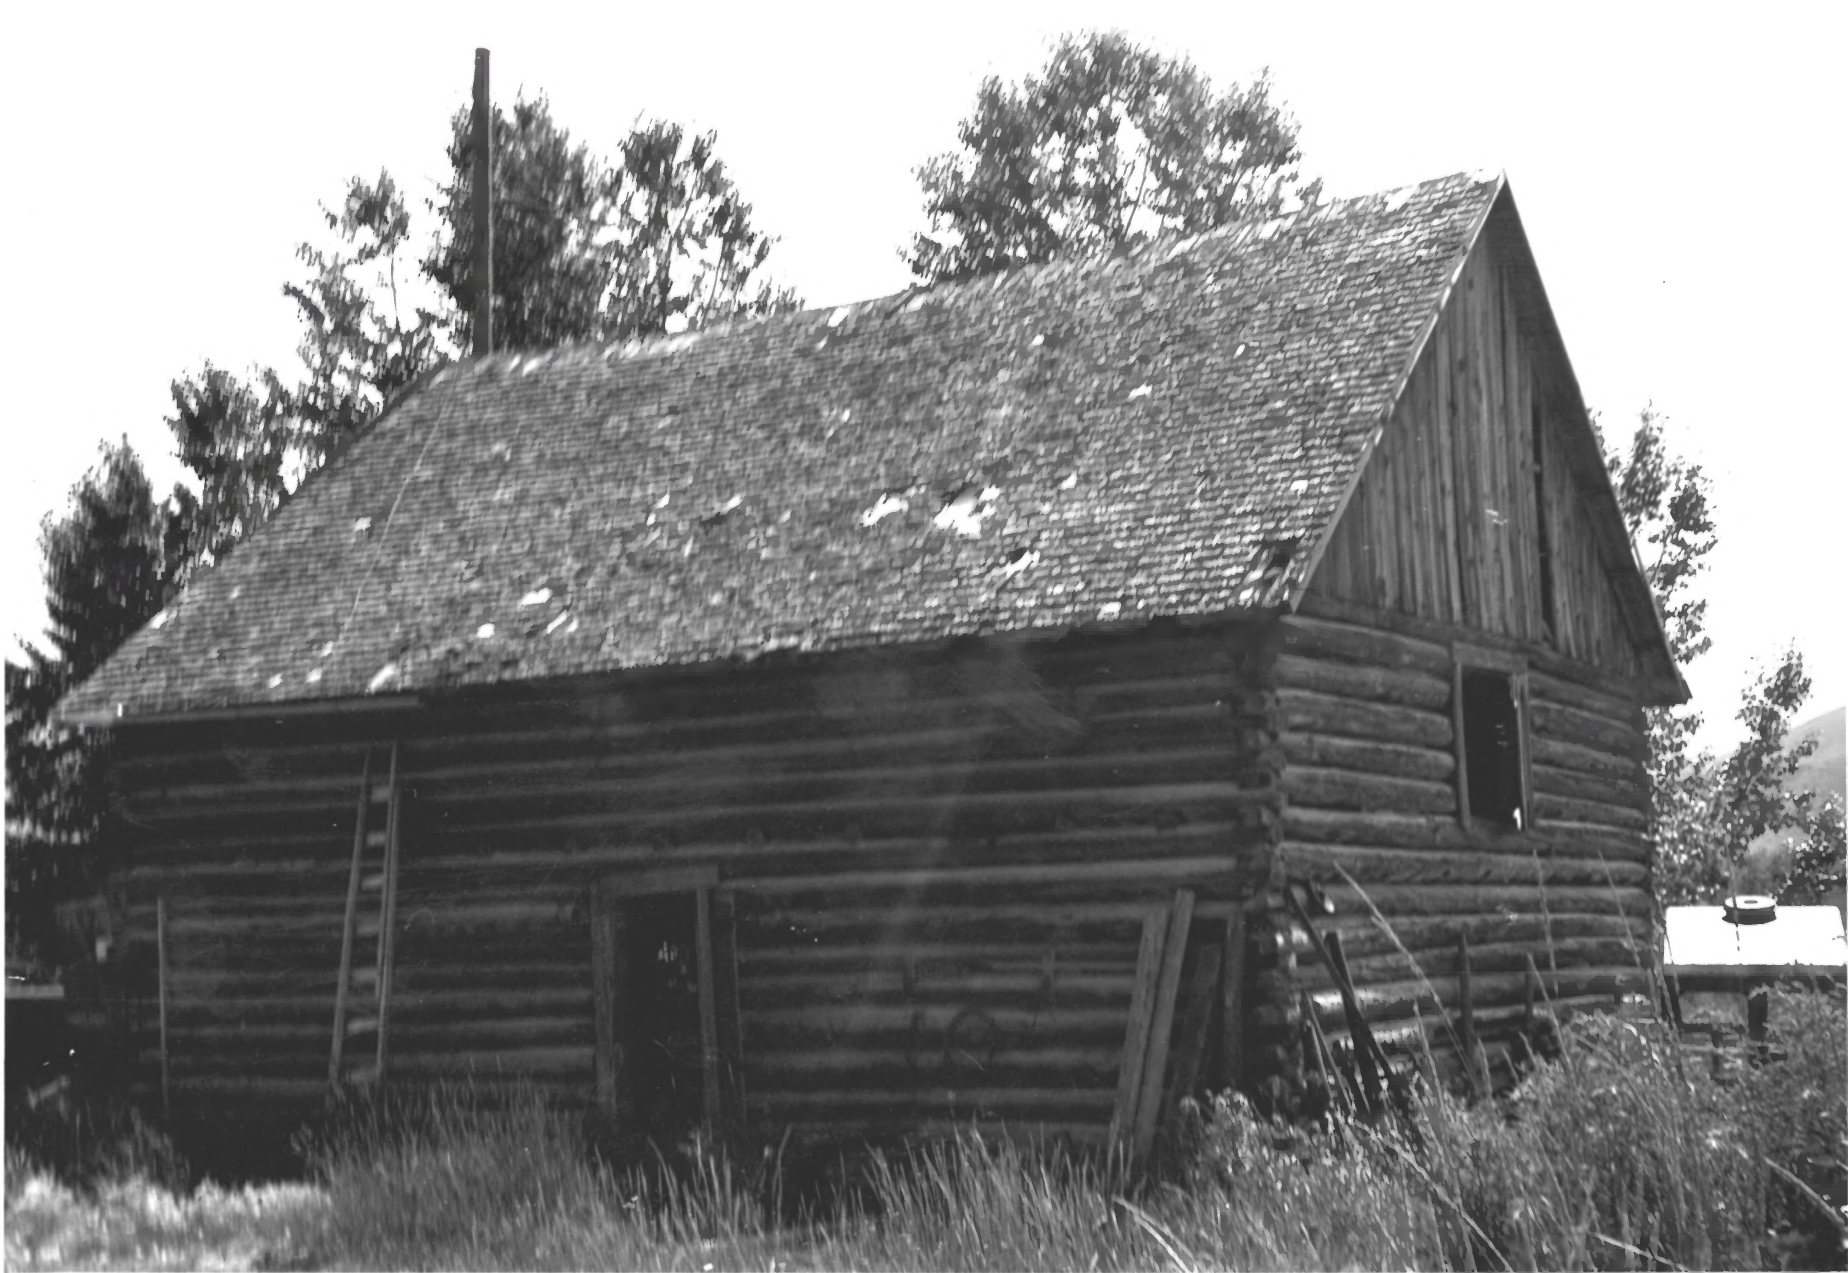
View from Northwest  
2 of 3

Geertson, Lars, Barn  
Geertson Creek  
Vicinity of Salmon, Idaho  
Lemhi County, Idaho

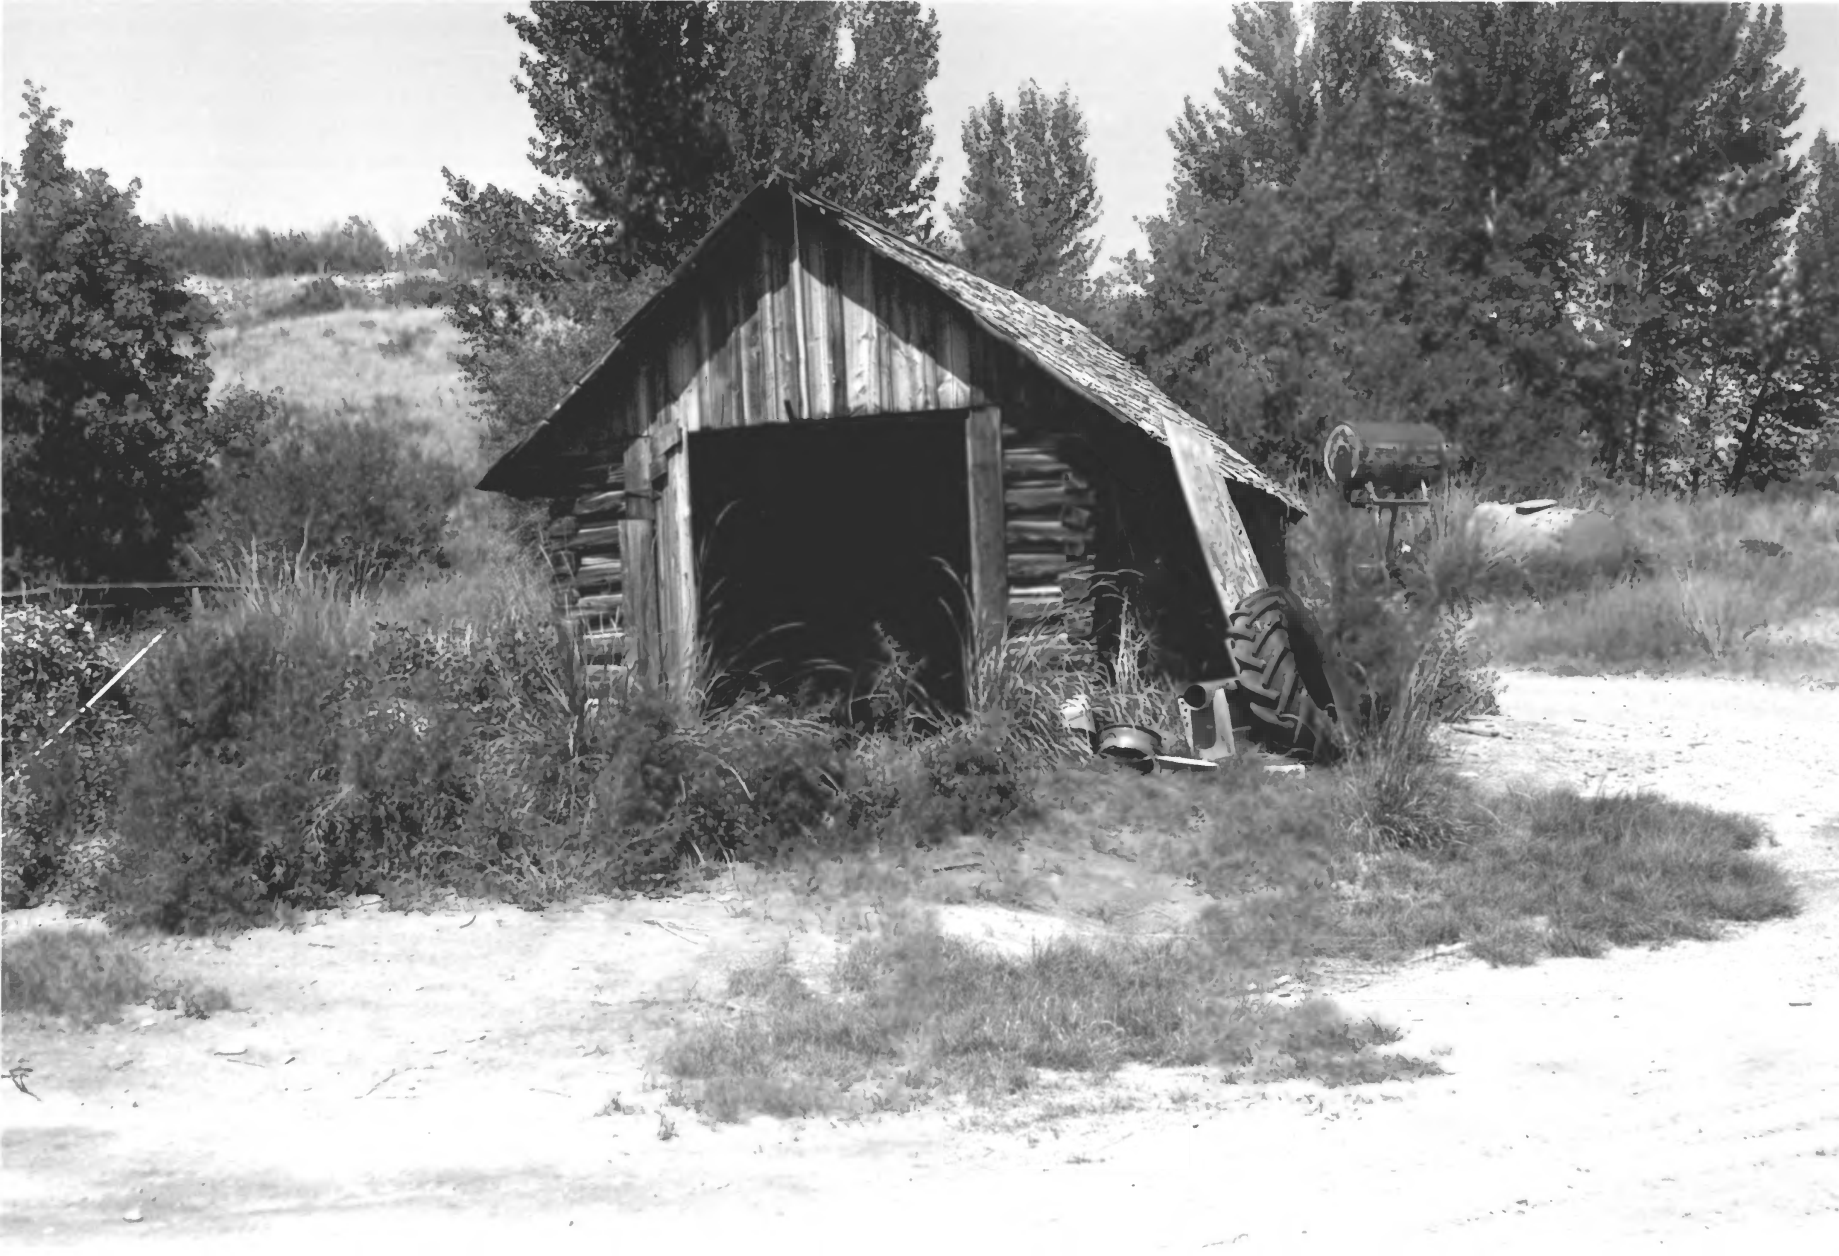
View from South  
3 of 3

*(house)*  
Geertson, Lars, Garage  
Geertson Creek  
Vicinity of Salmon, Idaho  
Lemhi County, Idaho
