INVENTORY SHEET FOR GROUP NOMINATIONS: IDAHO STATE HISTORICAL SOCIETY, BOISE, IDAHO

✓ NOMINATION: (Lava Rock Structures in South Central Idaho TR)

✓ SITE NAME: Johnson, Louis, Barn

SITE NUMBER: 42

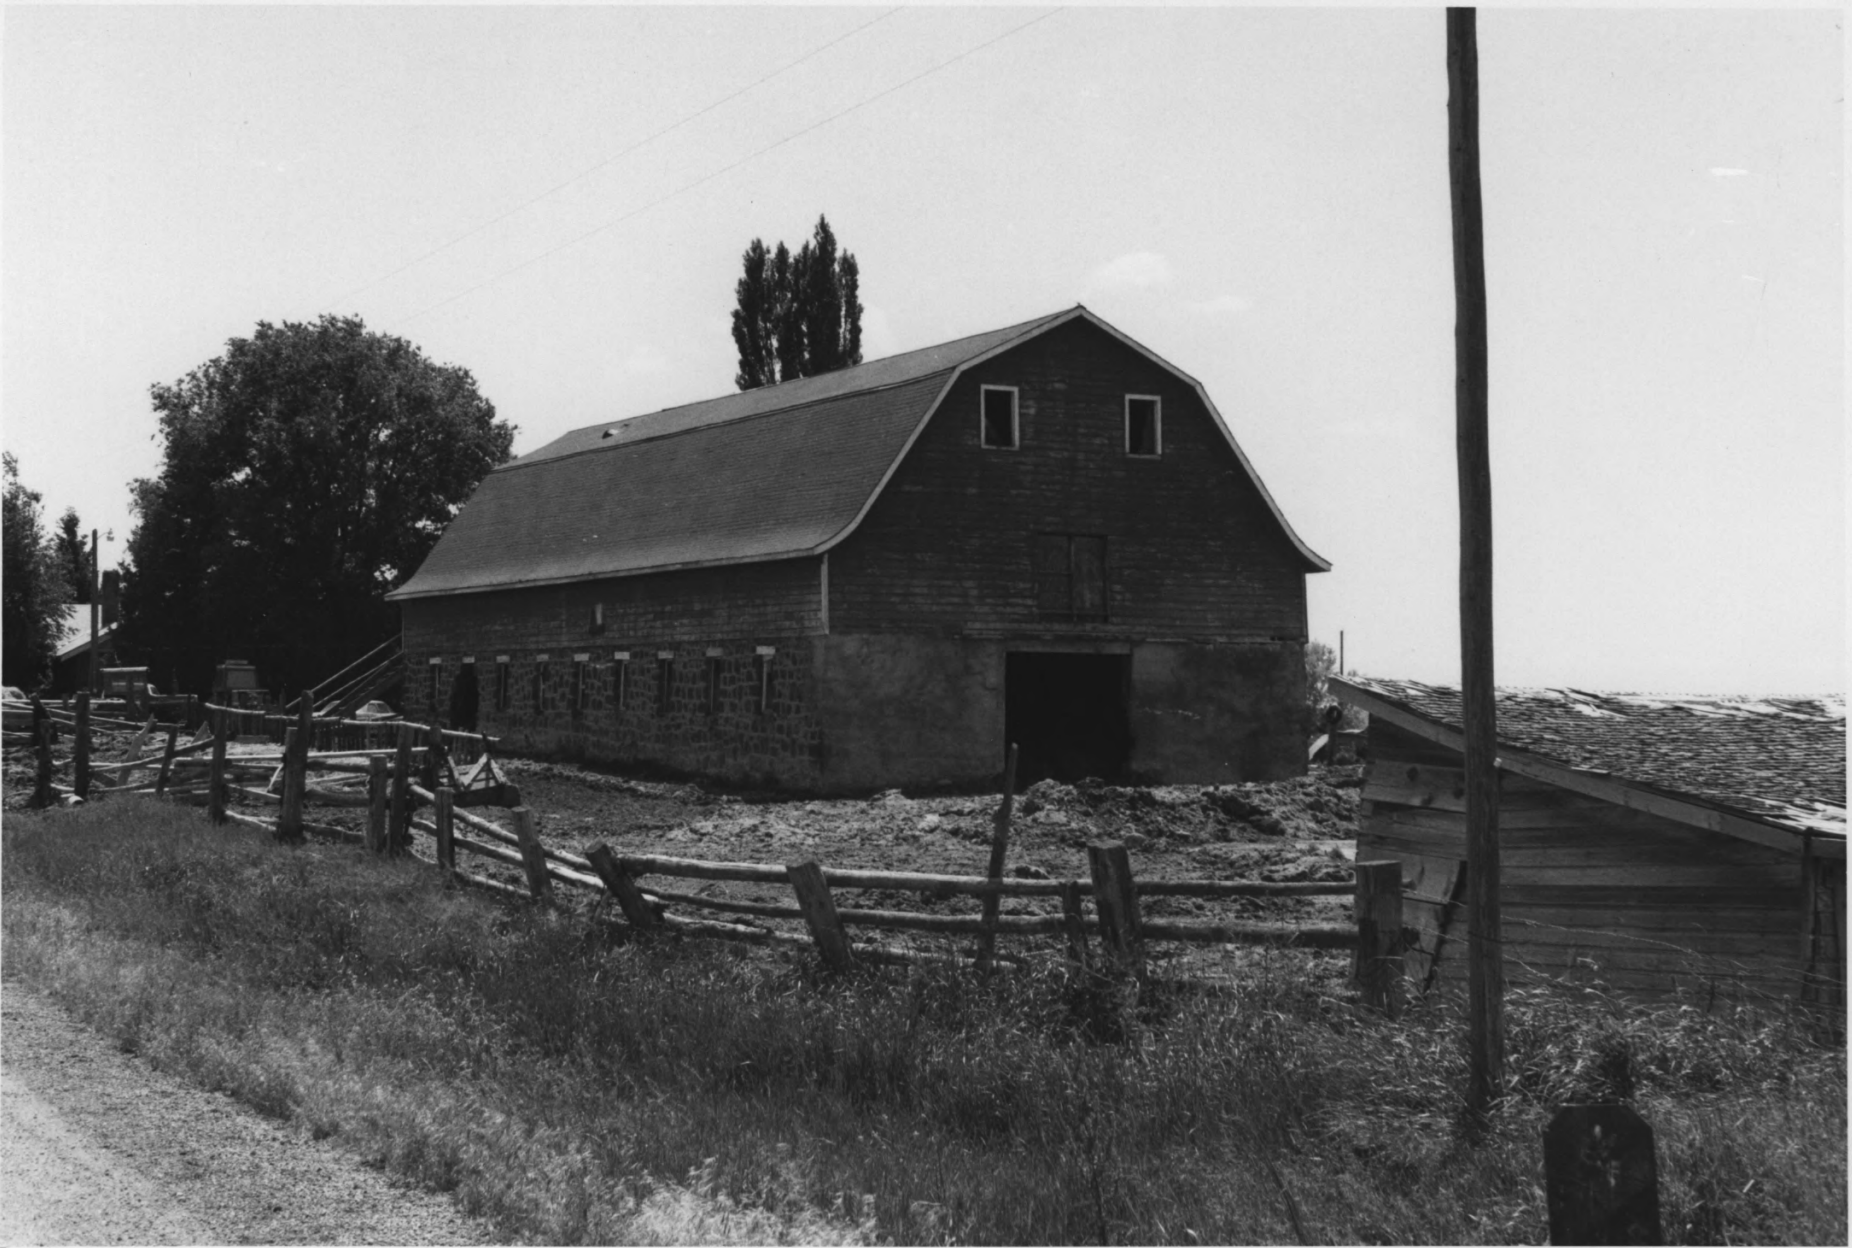
Photograph one of one

Lava Rock Structures in South Central Idaho  
Johnson, Louis, Barn, site 42

View from northeast

The Johnson barn is approximately 39 by 100 feet. It has a shingled gambrel roof with flared, enclosed eaves and a narrow bargeboard. The stone walls are about ten feet tall. The wall is extended upward another six feet with frame construction. There are nine symmetrically-spaced windows on the side walls. The square four-pane windows are placed at the top of the stone wall. A flush wooden beam forms a lintel above each window. Shiplap is in the gables. There are two square windows at the peak of the gable flanking the sliding, rectangular hay door below the pointed hay hood. At the right of the gable is a loft door with an outside staircase supported by poles leading to it. The wall below the second window from the left on the right wall has been roughly opened to allow cows access to the barn and corral. Loosening mortar in the random rubble wall has been repaired with gunite on the left wall.
