✓ NOMINATION: (Lava Rock Structures in South Central Idaho <sup>TR</sup>)

✓ SITE NAME: Murphy, W. H., House

SITE NUMBER: 89

✓ LOCATION: 607 ~~South~~ Greenwood Street, Shoshone, Idaho, 83352

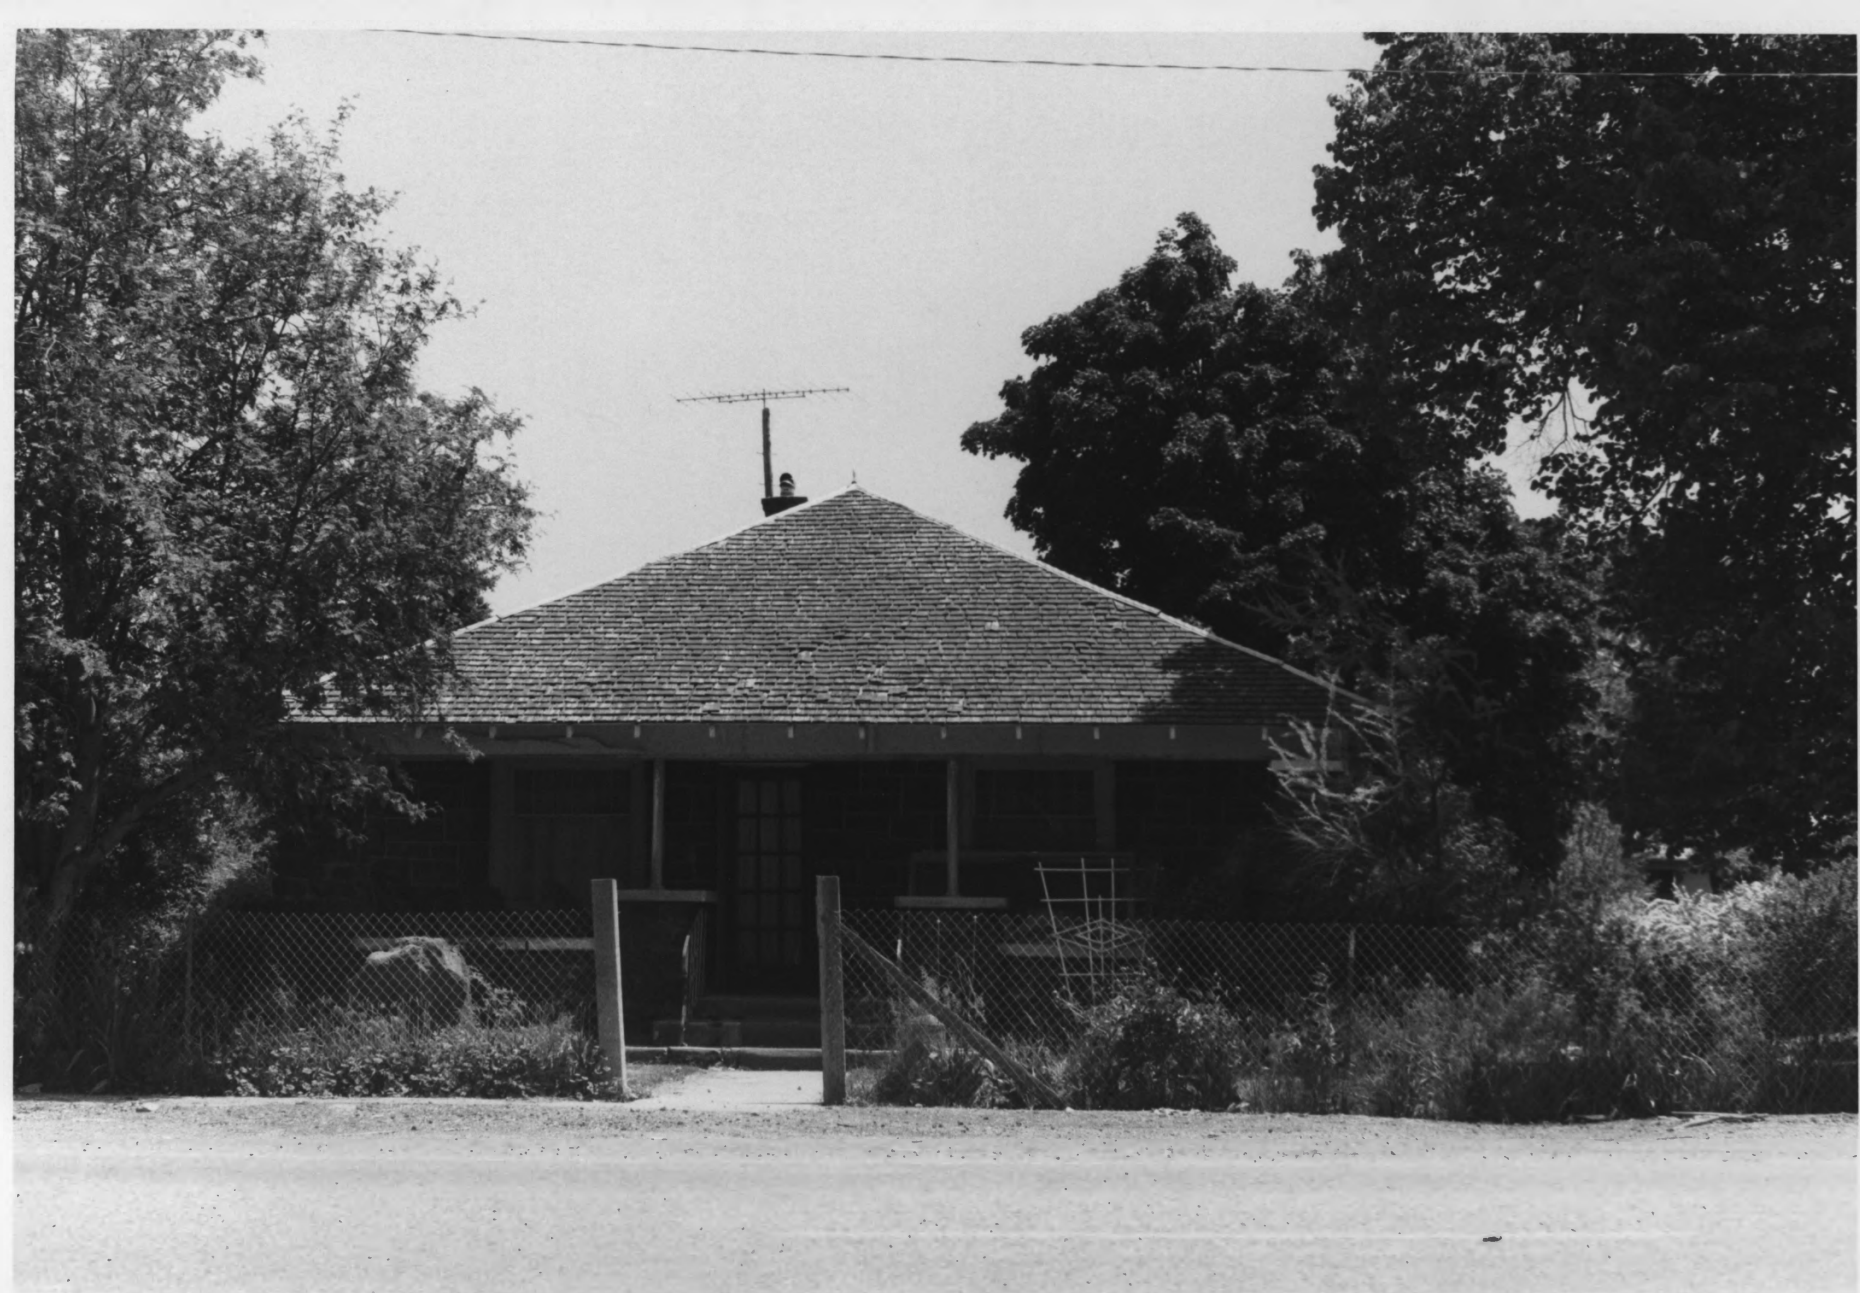
Photograph one of one

View from west

This approximately 28-by-48-foot one-story house has a shingled hipped roof with close eaves and sharply cut, exposed rafter ends. There are curvilinear metal finials on the two points of the roof. A full inset porch approximately eight feet wide is across the facade on the narrower dimension of the house. Full battered piers of rounded stones with weathered faces are on each corner. Square stone piers flank the centered entrance on the porch. Each has a wide square concrete cap about four inches thick and outset about six inches from each side of the top of the piers. A concrete stoop extends from the porch. The low porch walls have concrete coping. A nearly flush concrete lintel approximately twelve inches wide and inset into the stone approximately four inches on each end is above the front door, which is offset to the right of center. It is flanked by two windows. All of the windows in the stone walls are wide double-hung sash windows. The bottom two-thirds of the windows are single panes. Narrower top sections have twelve small panes. The windows are set midway in the walls. The nearly flush concrete window lintels are approximately ten inches wide and are inset into the stone about four inches on each end. The concrete porch trim, the lintels and sills, and the wooden window frames are painted white. The sloping, outset concrete sills are narrower. The broken ashlar walls of dressed stones have tight, nearly flush joints that have been tooled to produce a line of beading which has been painted white. Mortar in the recessed joints of the porch piers is brushed. It appears

that originally there was a full, inset porch across the rear of the house. This has been enclosed with siding and extended by another porch or stoop with low stone walls, which has also been enclosed with wooden siding. Both sections have windows. The rear roof has been extended to cover the second porch. The masonry of the rear porch is random rubble with untooled mortar brought almost out to the face of the stones.
