NATIONAL REGISTER OF HISTORIC PLACES  
REGISTRATION FORM

historic name: Pleasant View School

other name/site number: Knull Grange

Pleasant View School

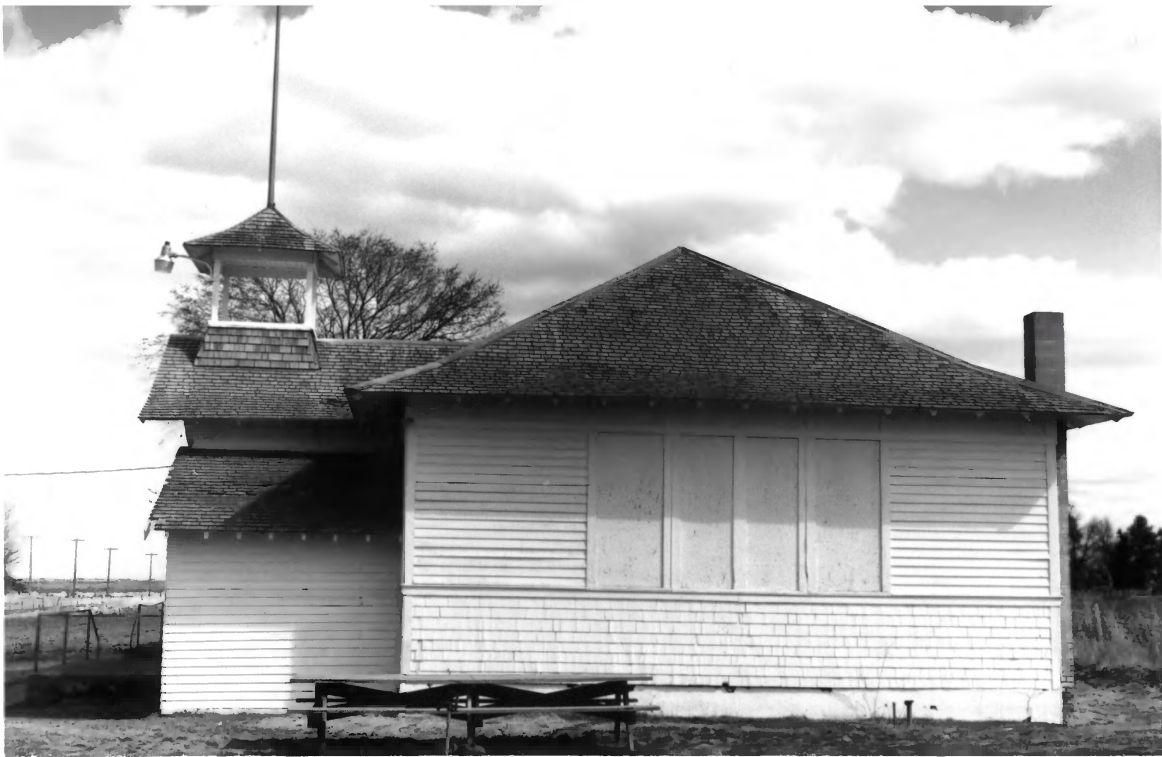
Pleasant View School  
vicinity of Twin Falls, Idaho

view from the west

The walls are divided by a stringcourse. The upper portion is sheathed with clapboards, and the lower section is covered with shingles. Almost all of the windows have been obscured by boards, but their outline is still visible. A bank of windows is located on the west wall; two sets of double-banked and two single windows can be seen on the south elevation. An uncovered, double-hung sash window is located on the north wall at the northeast corner of the school. Four single-paned, fixed windows with a horizontal cast illuminate the hall.

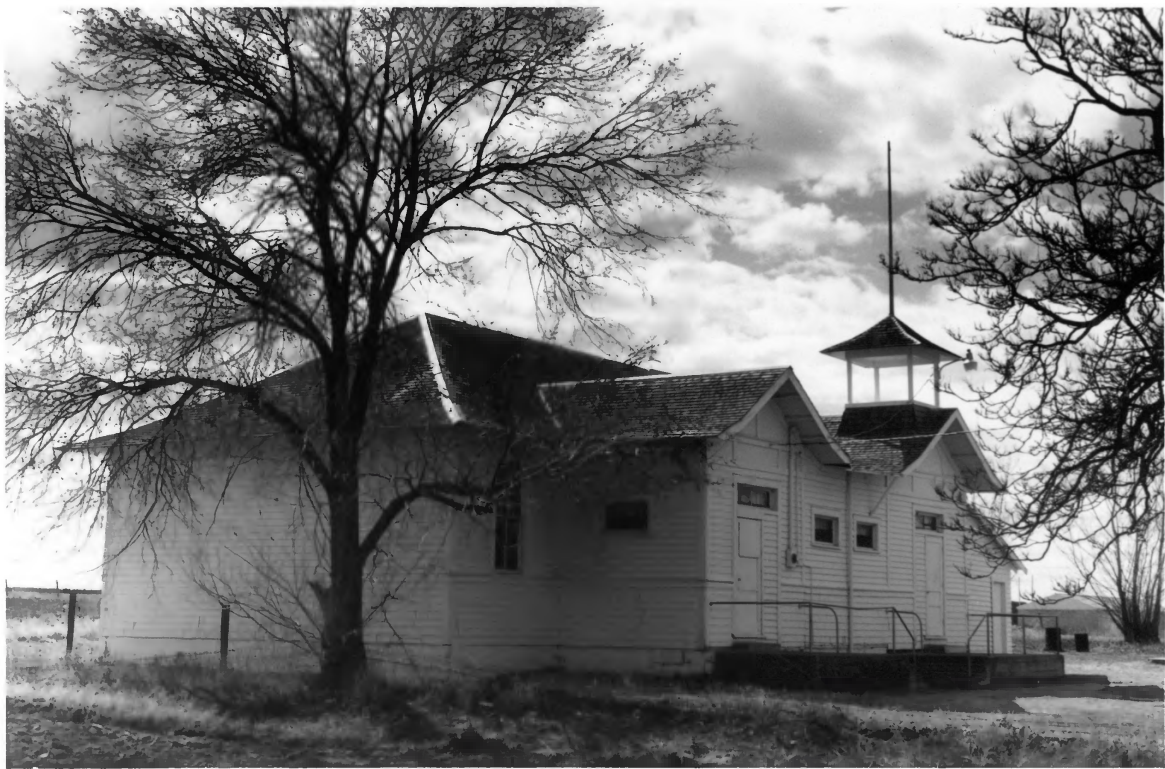
Pleasant View School  
vicinity of Twin Falls, Idaho

view from the northeast

Two single doors, one under the gable on the north wall, provide access to the hall. These doors are not original -- they replaced wooden, double doors. Fixed transoms are located above the doors; concrete porches with metal railings lead to each entrance. These concrete porches are one of the few alterations to the building -- they replaced a long, low, uncovered wooden porch. A storage area is located on the northwest corner; this has a shed roof. At the southwest corner is an exterior, brick chimney. A belfry, unfortunately missing its bell, straddles the porch gable to the west.
