**NATIONAL REGISTER OF HISTORIC PLACES  
INVENTORY -- NOMINATION FORM**

Shoshone Historic District

## 7 DESCRIPTION

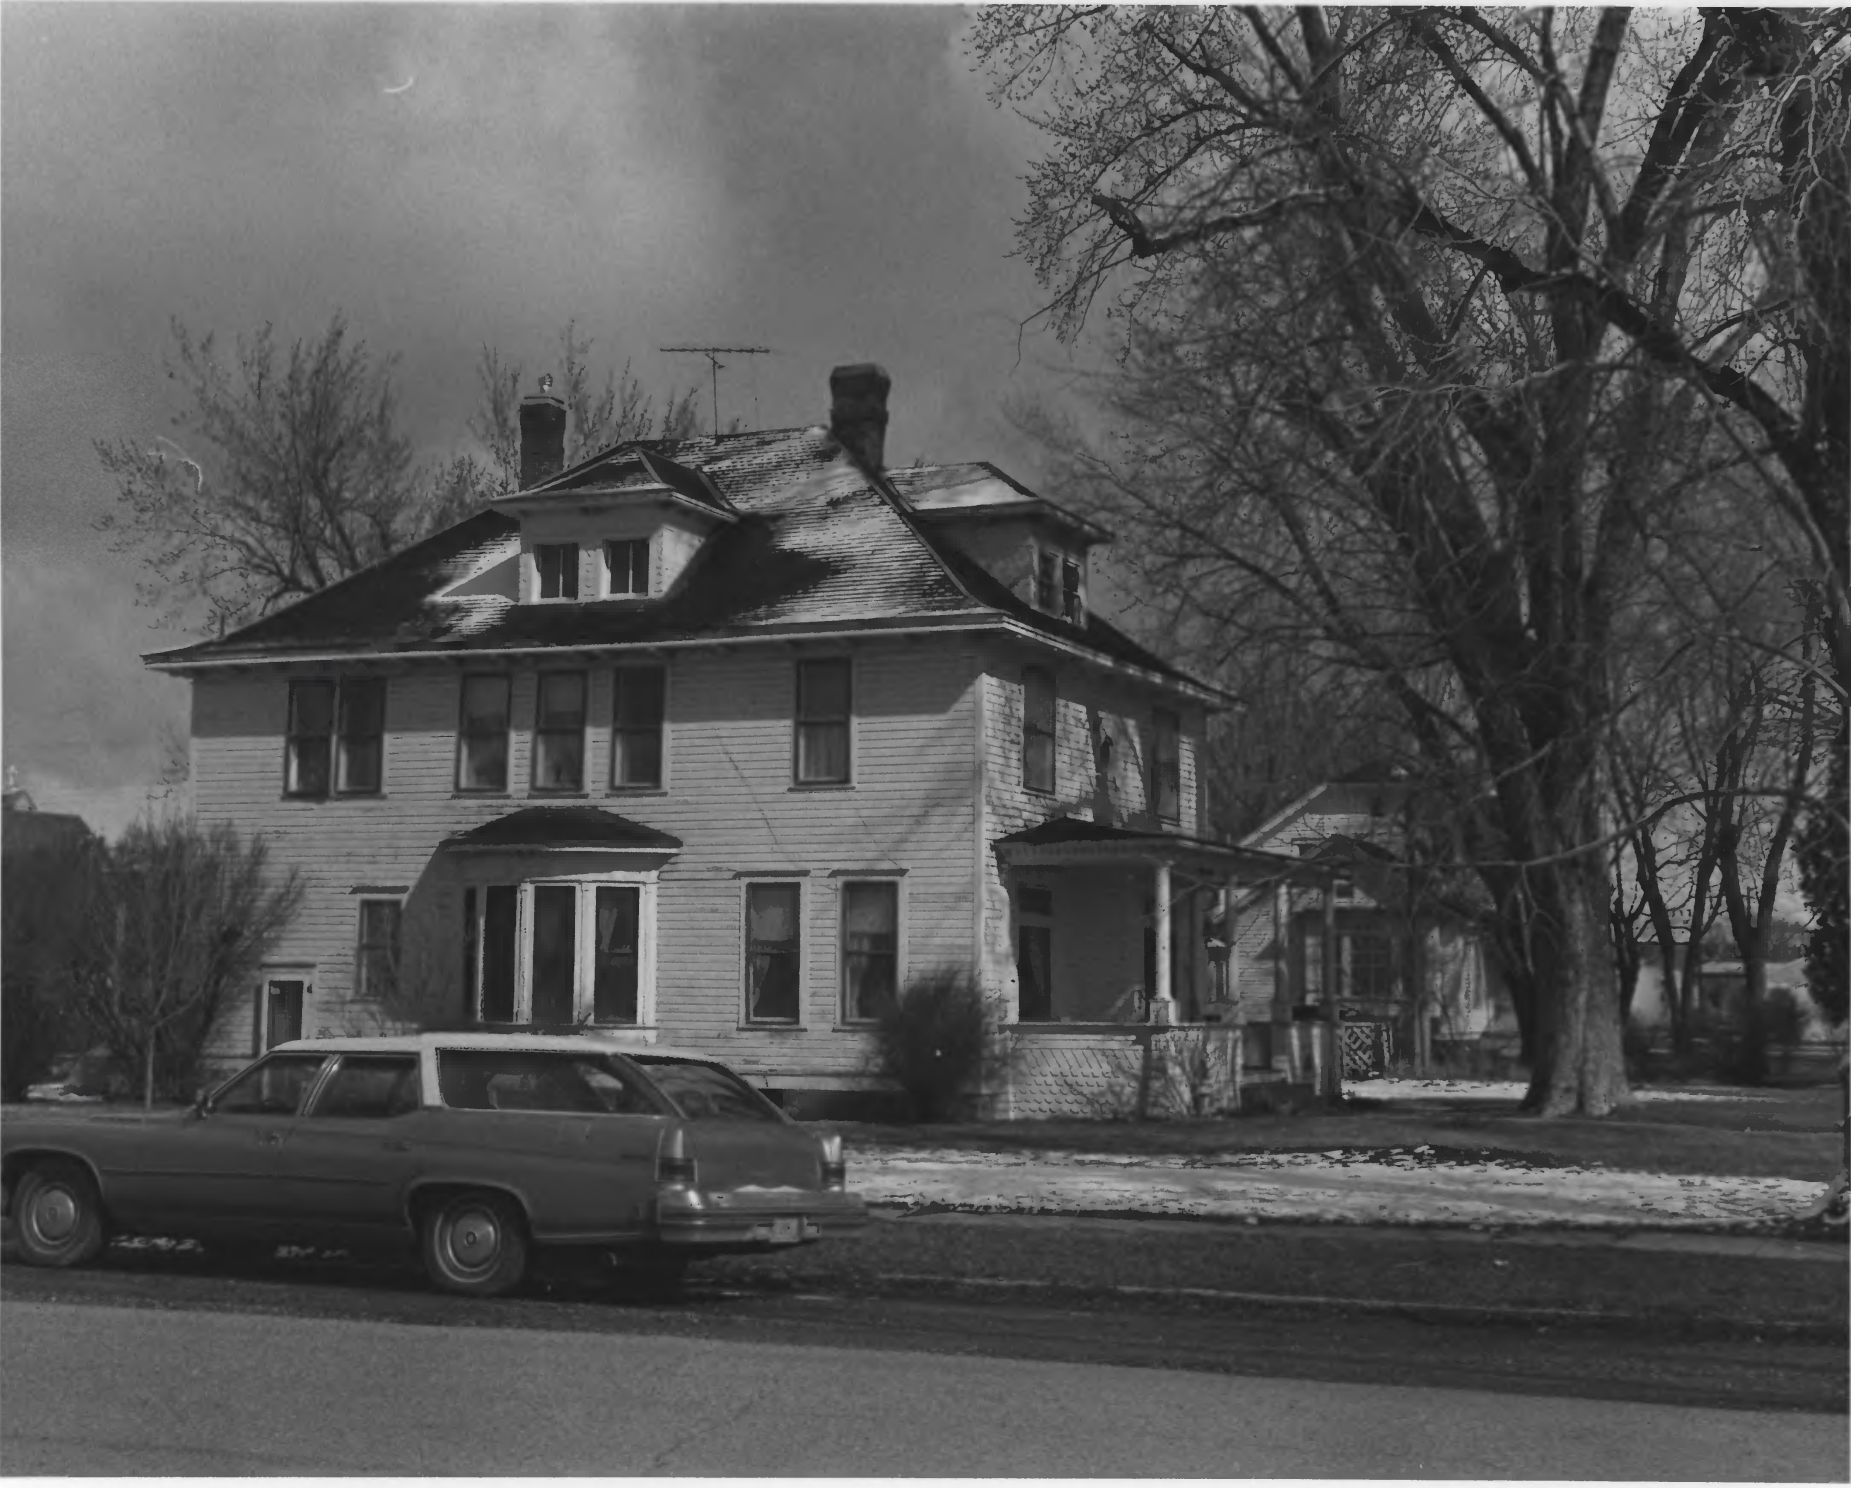
#80814

Called "Colonial" at the time, this large square two story frame house had a hip roof with hip-roofed dormers. There is a porch across the front, also hip-roofed, and a bay window on the south side. Detailing is "Colonial" only in Tuscan porch posts and an ox-eye window in the center of the second story facade. Fancy cut shingles add textural interest to the dormers and porch. The exterior is unaltered and in good condition.

Fred Gooding House, 1901

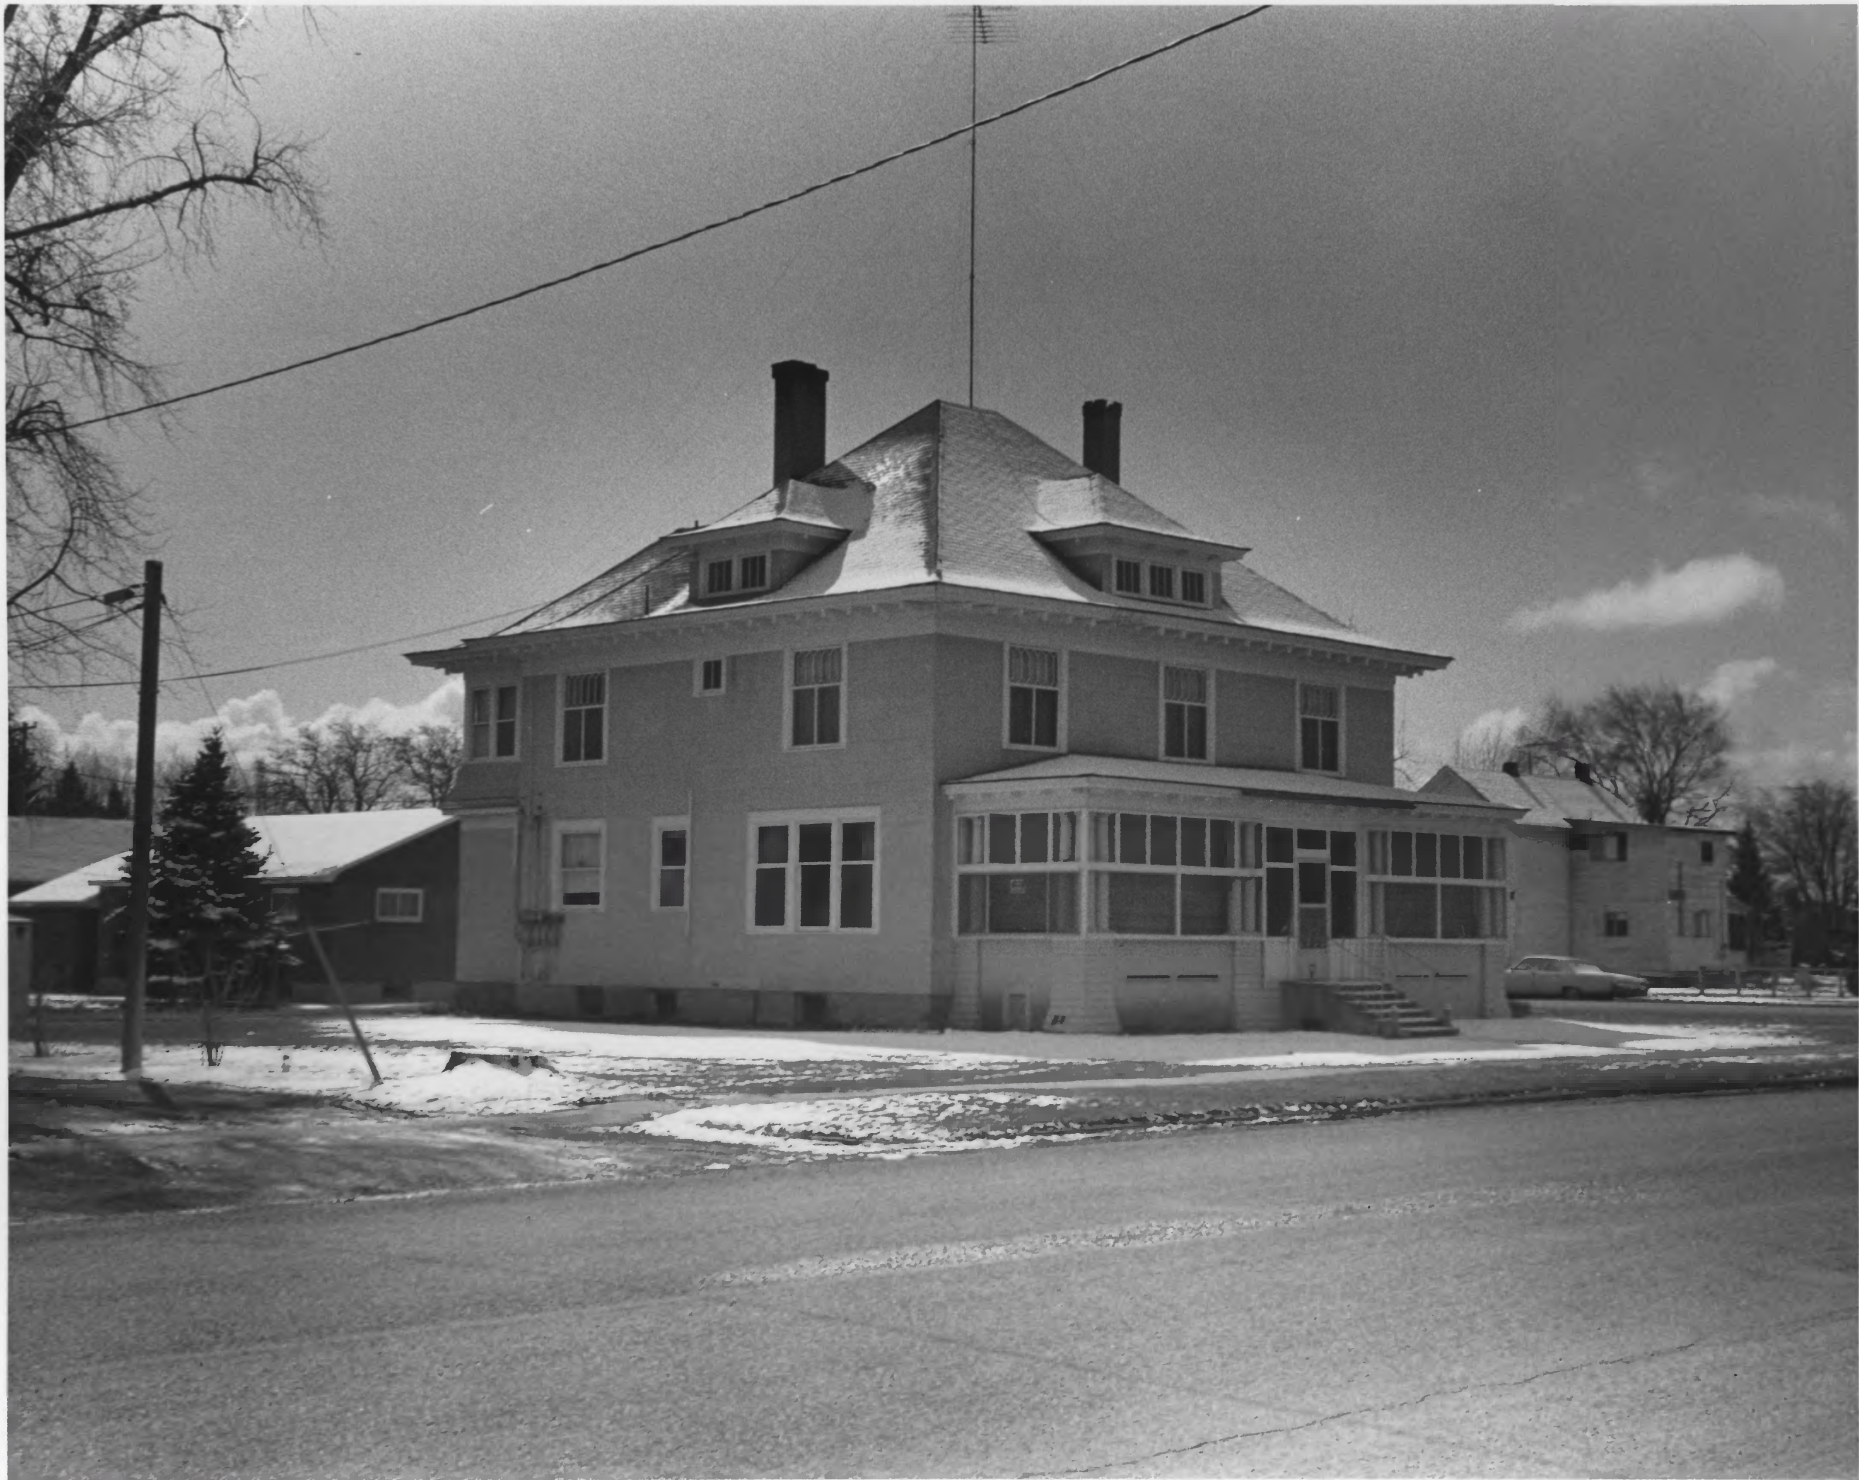
#9214

Most famous of three brothers who built houses in Shoshone, Frank R. Gooding served as Idaho Governor from 1905 until 1908, and United States Senator from 1921 until 1928. The city and county of Gooding are named for him. His house is typical of the big square box-like "Colonials" built in the early years of the century. It much resembles the one built by his brother Fred (see above) but has been altered by the addition of asbestos shingles and the glassing in of the tuscan porch. A feature of the second-story windows is the use of beveled leaded glass in the upper halves. The condition of the house is excellent, with the modifications noted.

Frank R. Gooding House

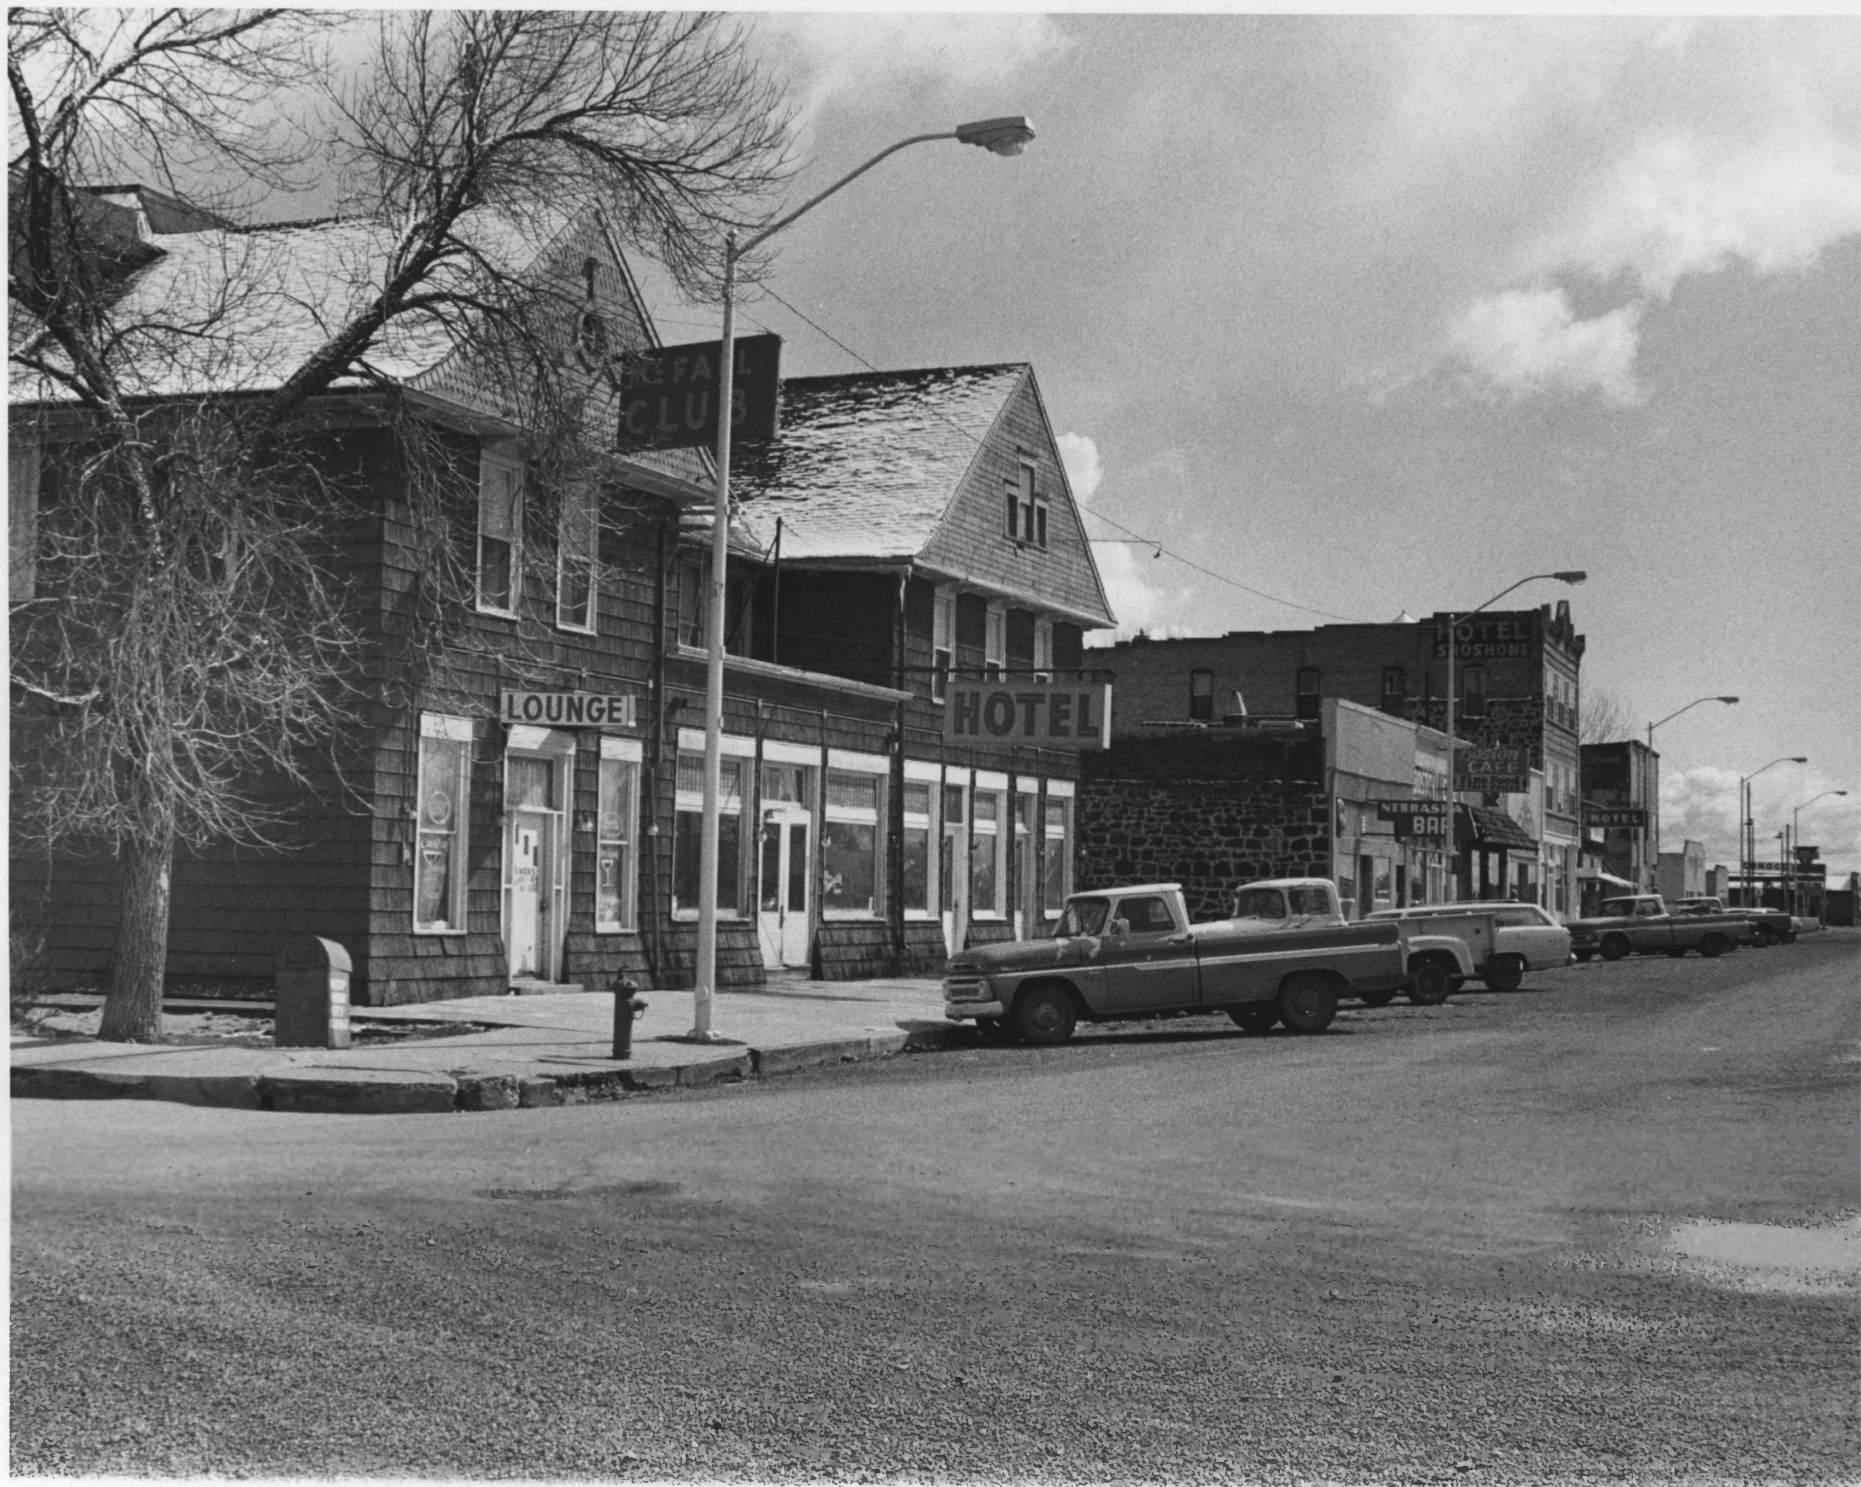
#100814

Once apparently a two-story structure of native basalt, this building now has a third story of brick, with evenly-spaced double-hung sash windows on the sides. The shed roof is concealed by stepped side walls. The front of the building above the first floor store fronts is a facade of cast stone marked by unbroken terra cotta bands at window level of the second and third stories. A wide multi-lined terra cotta cornice with dentils accents the upper facade. At top center is an ornamental terra cotta gable with the date 1901. Basically unaltered.

Although considerable added to through the years, this big shingled wooden hotel retains its "Colonial" character, primarily because of prominently placed details. In the gabled third story facades of two balancing wings are an ox-eye window and a palladian window. The interior is a labyrinth, expressive of the many additions and alterations made in the years when Shoshone was the principal railroad junction from the Oregon Short Line to the Wood River towns of Bellevue, Hailey, and Ketchum, and the stagecoach route to famed Shoshone Falls on Snake River to the south. Condition is fair, but the present owner hopes to do a careful restoration of the exterior to its 1912 state.

Looking northeast  
McFall Hotel, Columbia Hotel, North Rail Street

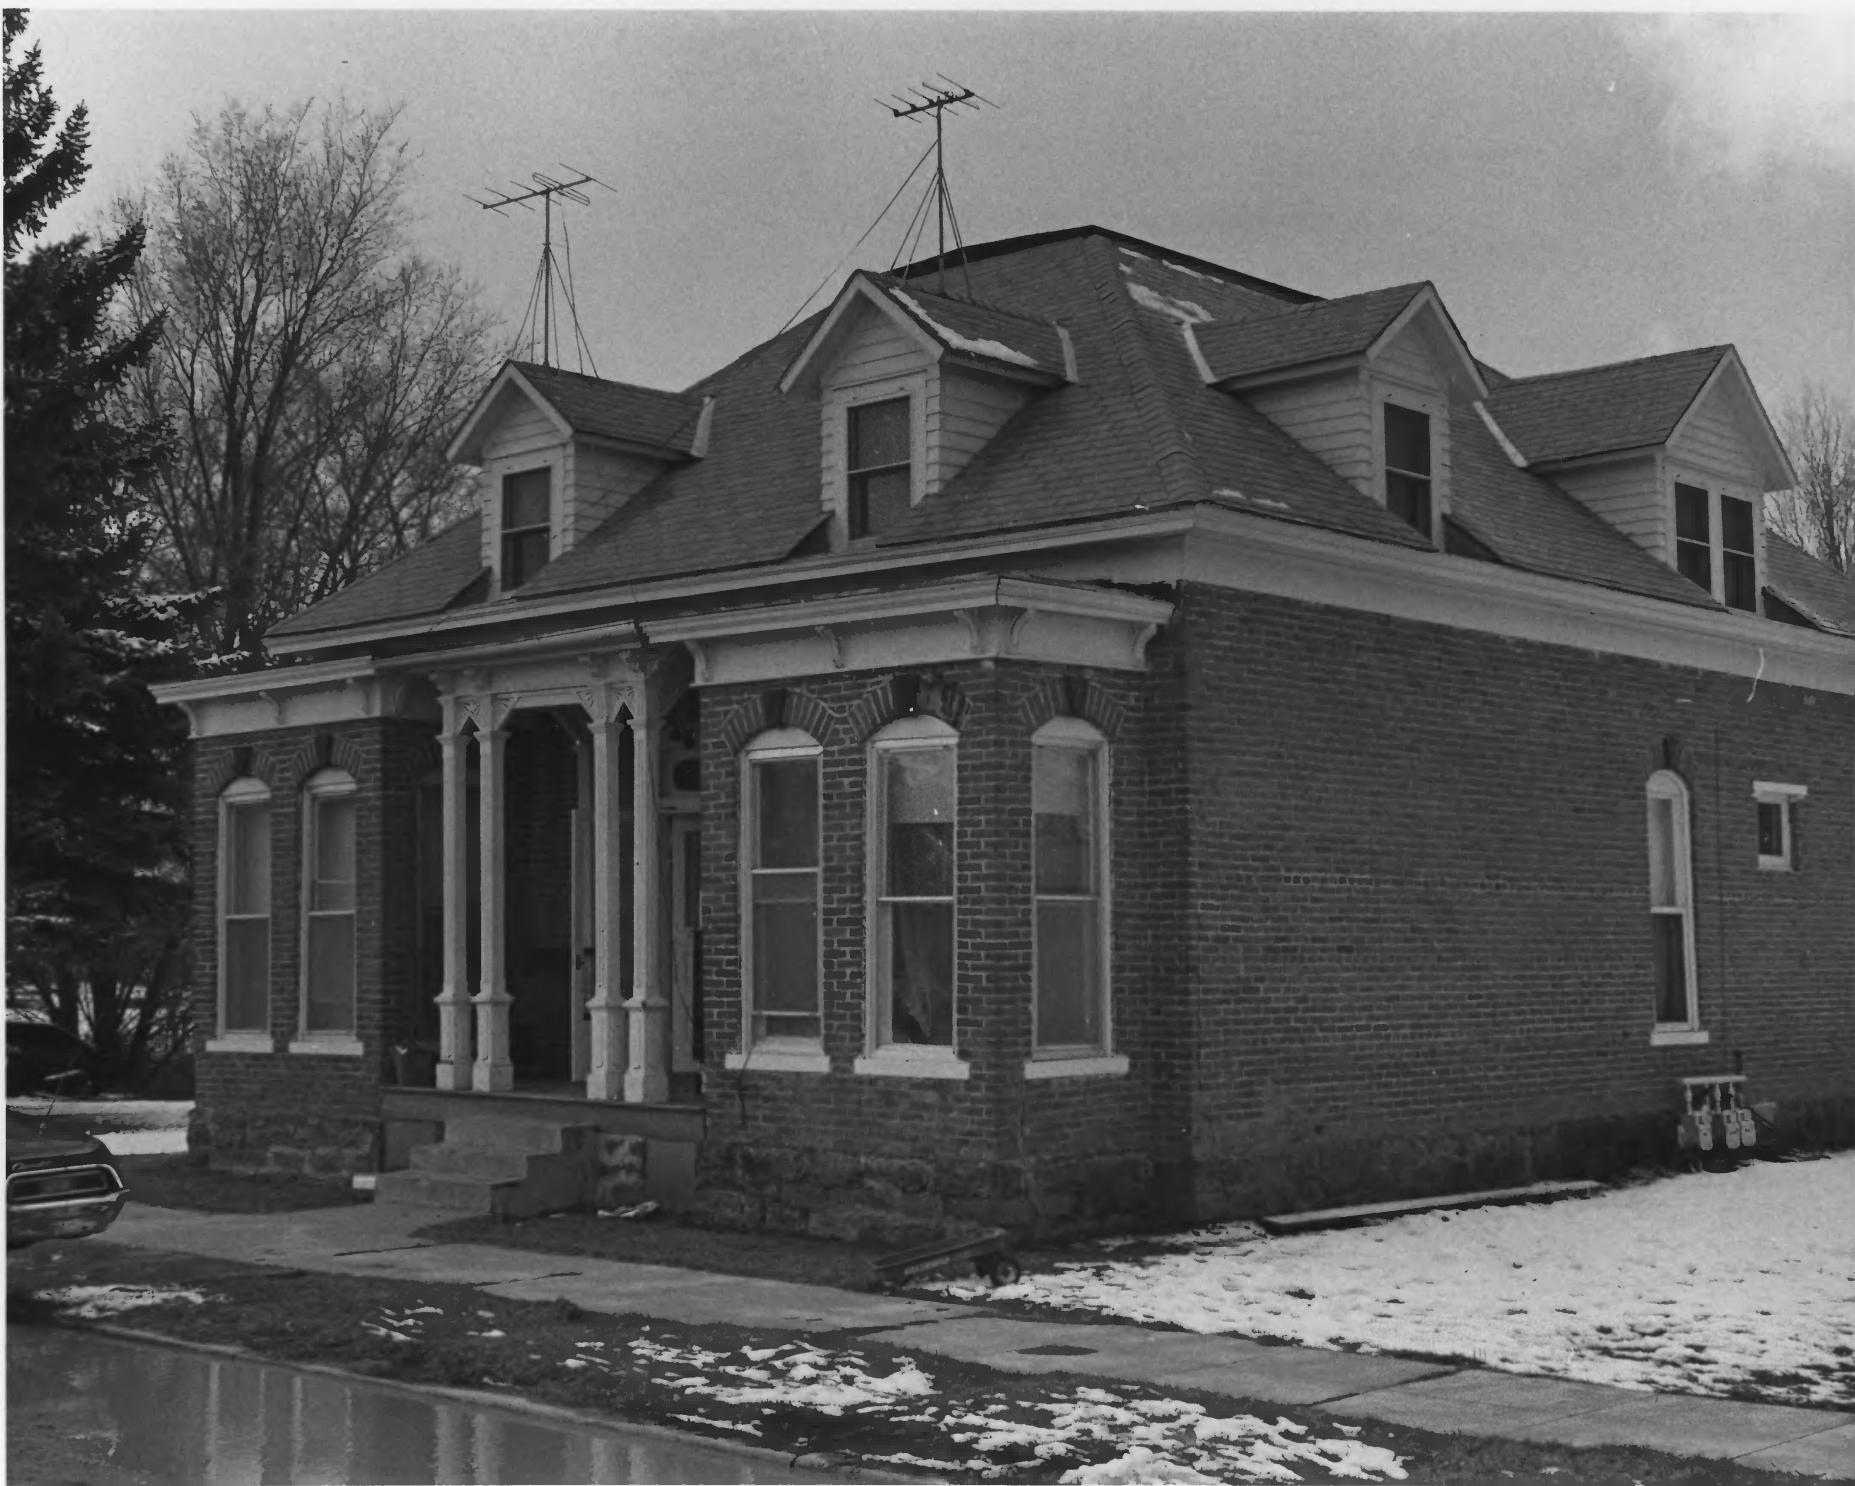
#130814

One of Shoshone's earliest brick houses, this structure dates from the first years of the Oregon Short Line railroad in Idaho, and was built of materials brought in by rail. Essentially a one-and-a-half story house with hipped roof, it gains space by means of two recessed dormer windows on each on the four sides. Balancing square brick bay windows flank the porch, creating a recessed entryway. Detailing in the woodwork of these bays and the porch is Italianate. Local porous basalt is used for foundation, but since brick was not manufactured locally until 1902, we know that this was imported. Segment-arched windows have stone keystones. Since early photos of this building do not exist, one must speculate that the roof detailing is recent, even though there were probably eight dormer windows in the same location as the present ones.

Looking southwest  
Sugg House, 1886
