INVENTORY SHEET FOR GROUP NOMINATIONS: IDAHO STATE HISTORICAL SOCIETY, BOISE, IDAHO

NOMINATION: (Lava Rock Structures in South Central Idaho *TR*)

SITE NAME: Silva, Arthur D., Ranch

SITE NUMBER: 3

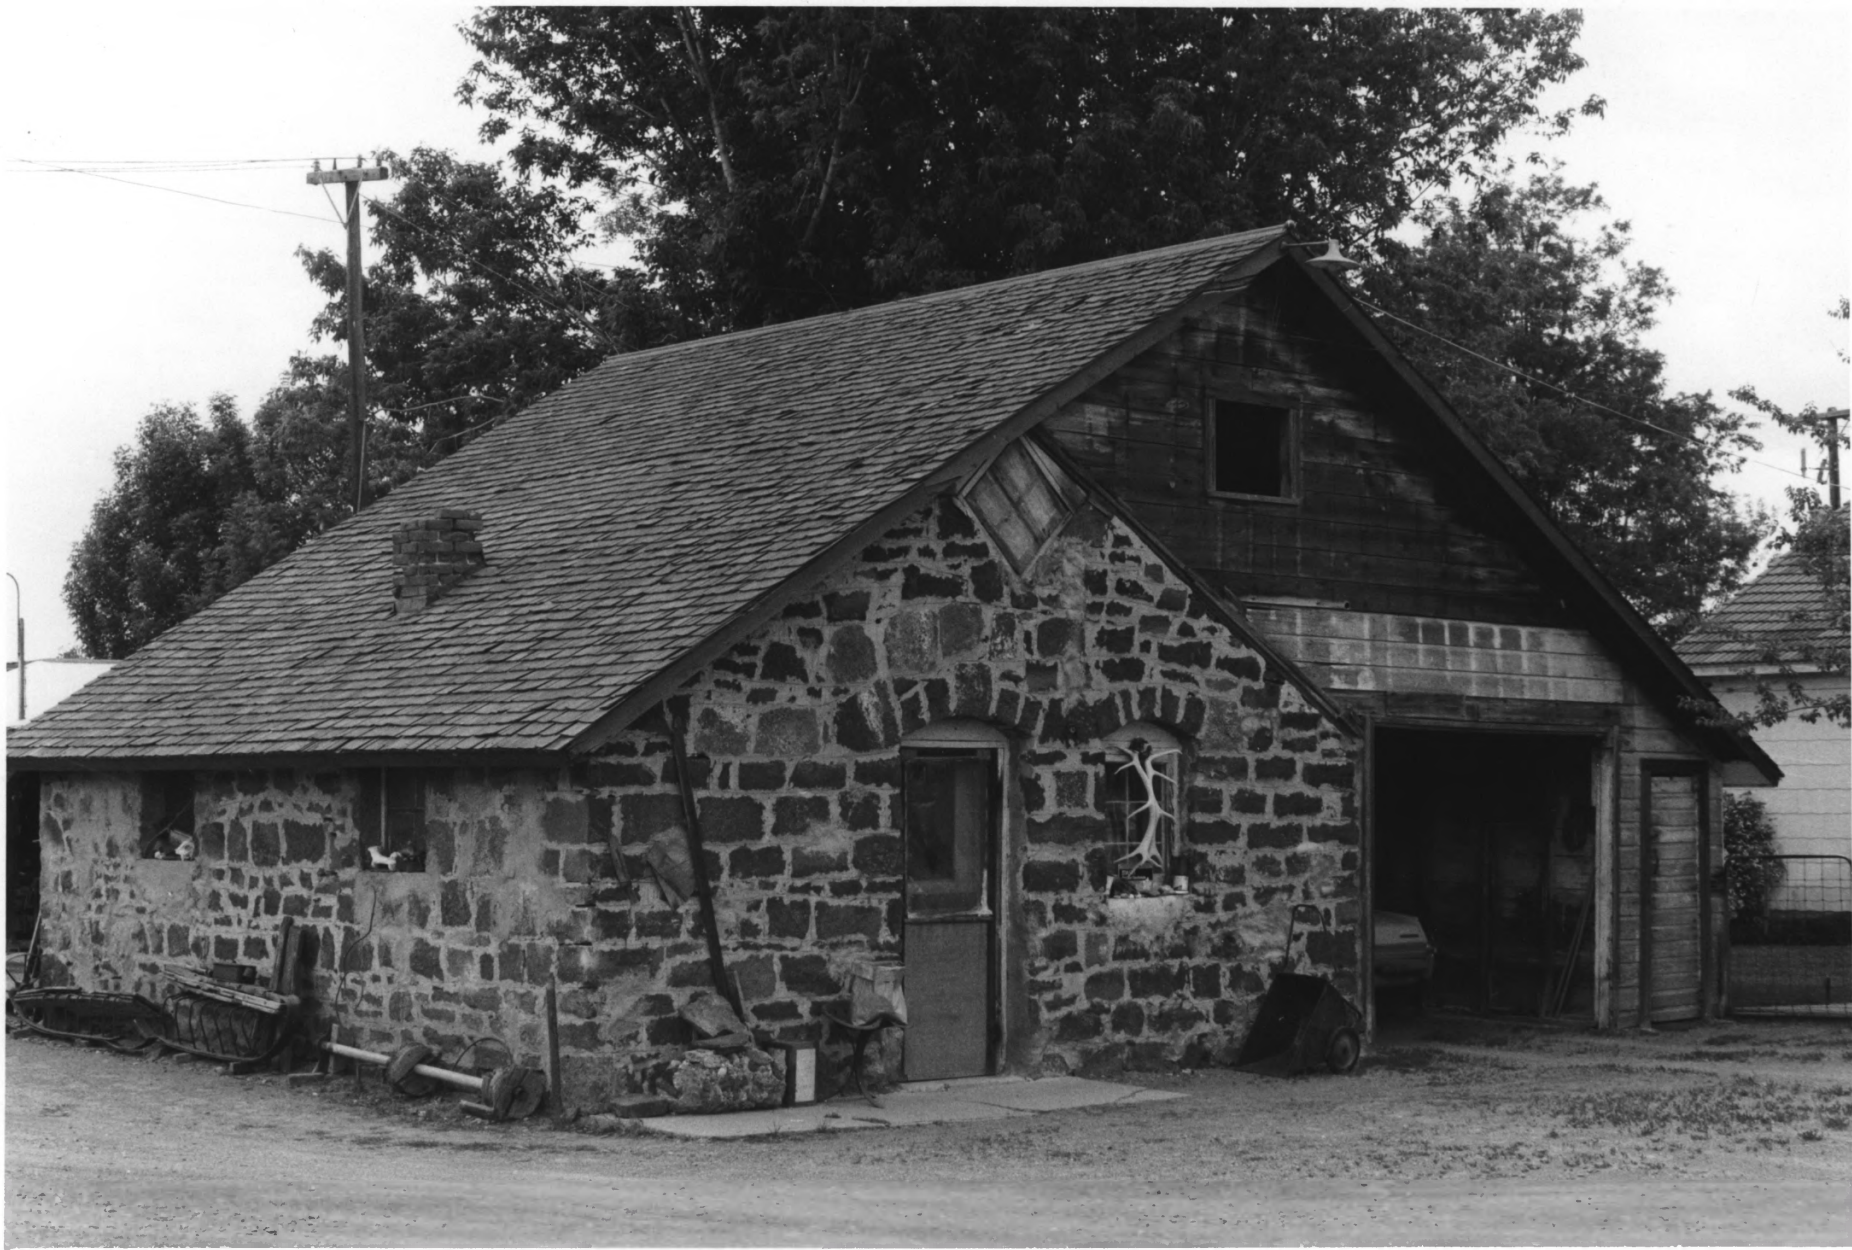
Photograph one of three

Lava Rock Structures in South Central Idaho  
Silva, Arthur D., Ranch, site 3 (shop)

View from southeast

Shop. This small one-story building is approximately 20 1/2 by 24 feet. It has been incorporated into a frame garage added onto its righthand side. The gable facade of the stone building has a door slightly offset to the left and a small window to the right. Connecting relieving arches are above them. Both the door and the window have curved wooden heads. A tipped square four-pane window is in the peak of the gable facade. Two small square windows on the left wall are set about symmetrically into the top of the wall, obviating the need for a lintel. The opening is lined with mortar. A low red pressed-brick chimney intersects the left shingled roof just inside the side wall. The coursed rubble walls have light colored mortar in the almost flush joints, into which a line has been incised. Several larger ox-eye-shaped lighter stones are incorporated into the facade, perhaps for decoration. Where mortar has fallen out, it can be seen that the building was laid up with clay and finished with pointing mortar. An early Delco power plant is in the building.

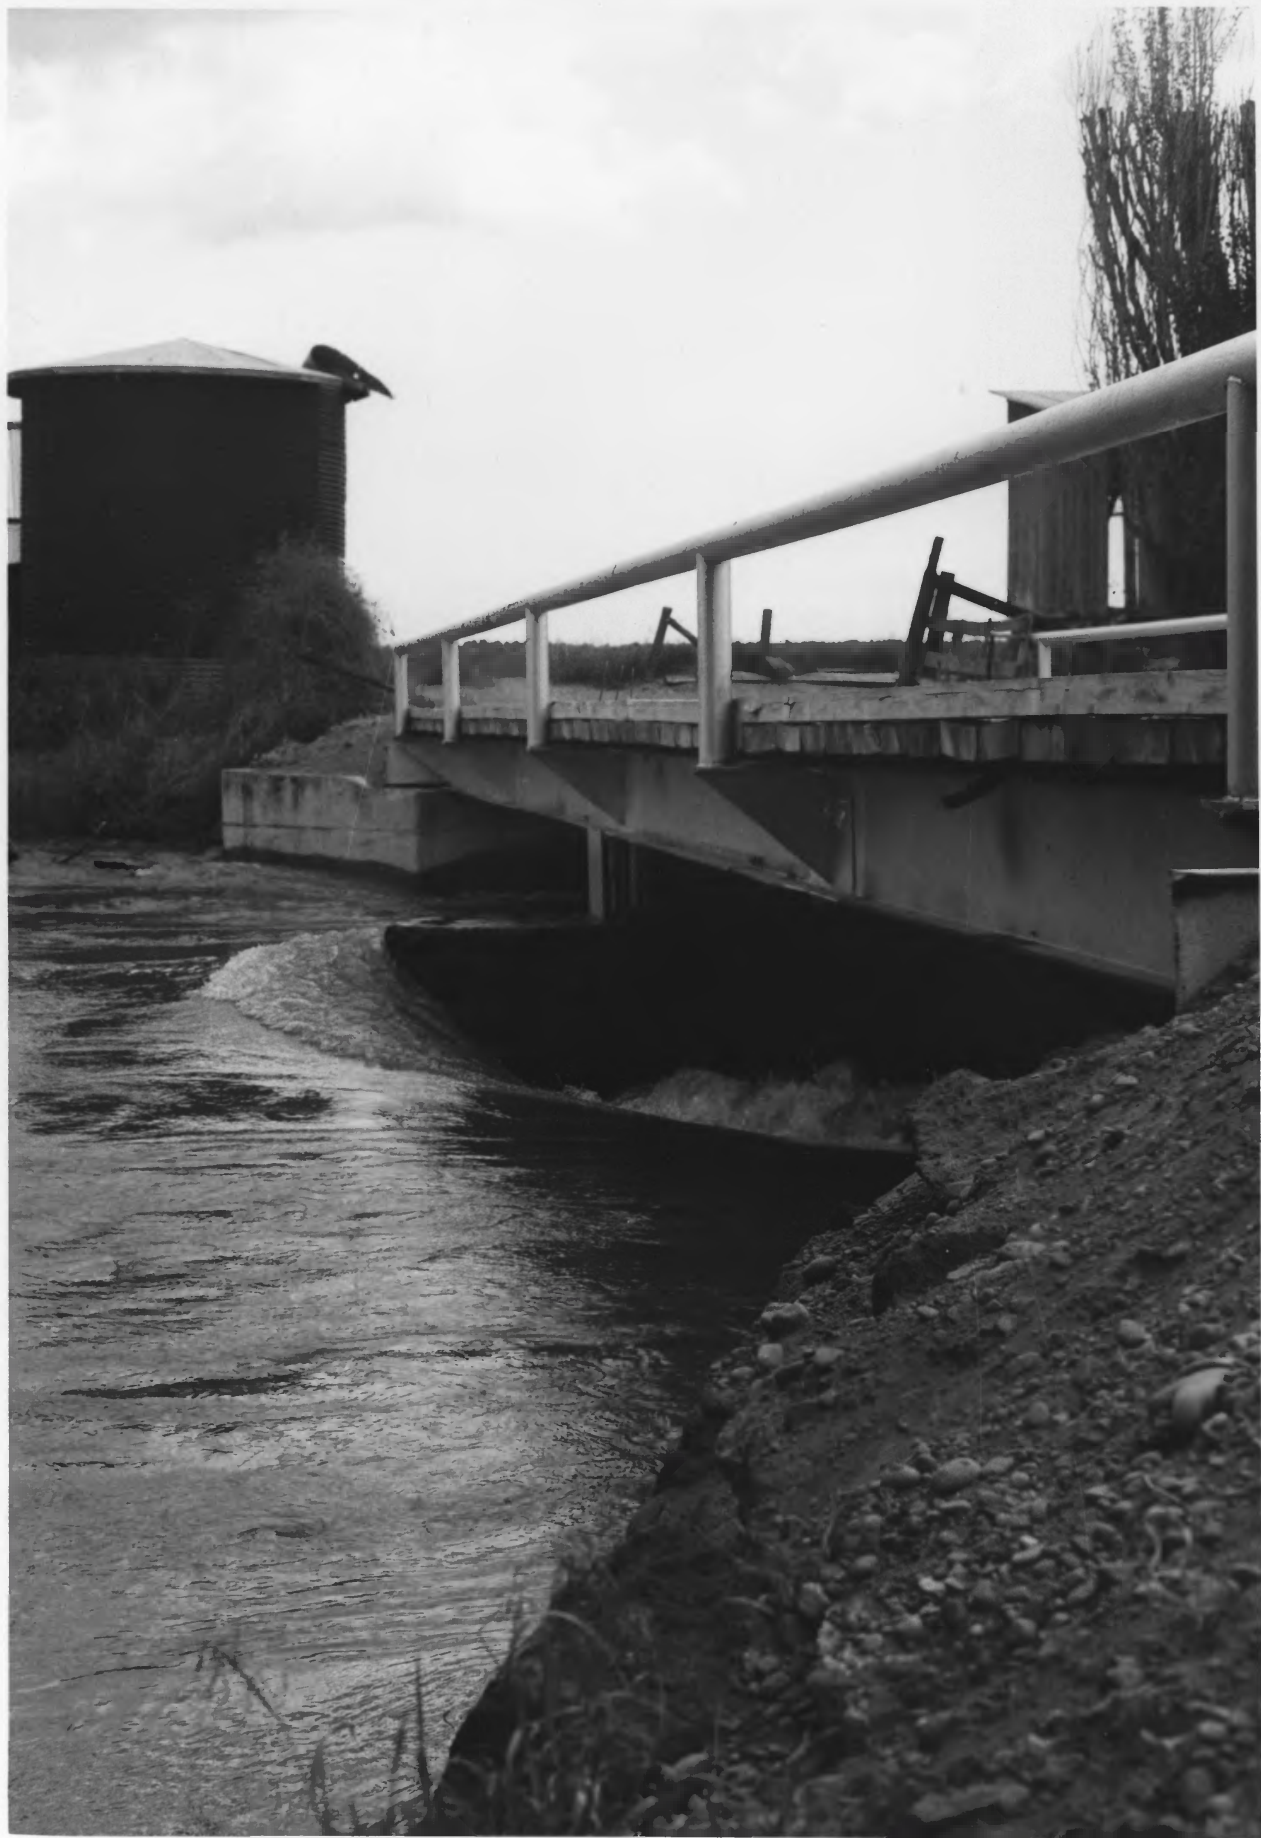
Photograph two of three

Lava Rock Structures in South Central Idaho  
Silva, Arthur D., Ranch, site 3 (bridge piers)

View from northeast

Bridge Piers. A timber and plank bridge leading from the main farm yard across the Big Wood River to the farm buildings and fields on the other side, is supported by three lava piers approximately twenty feet high. Each is about four feet wide and fifteen feet long with rounded ends.

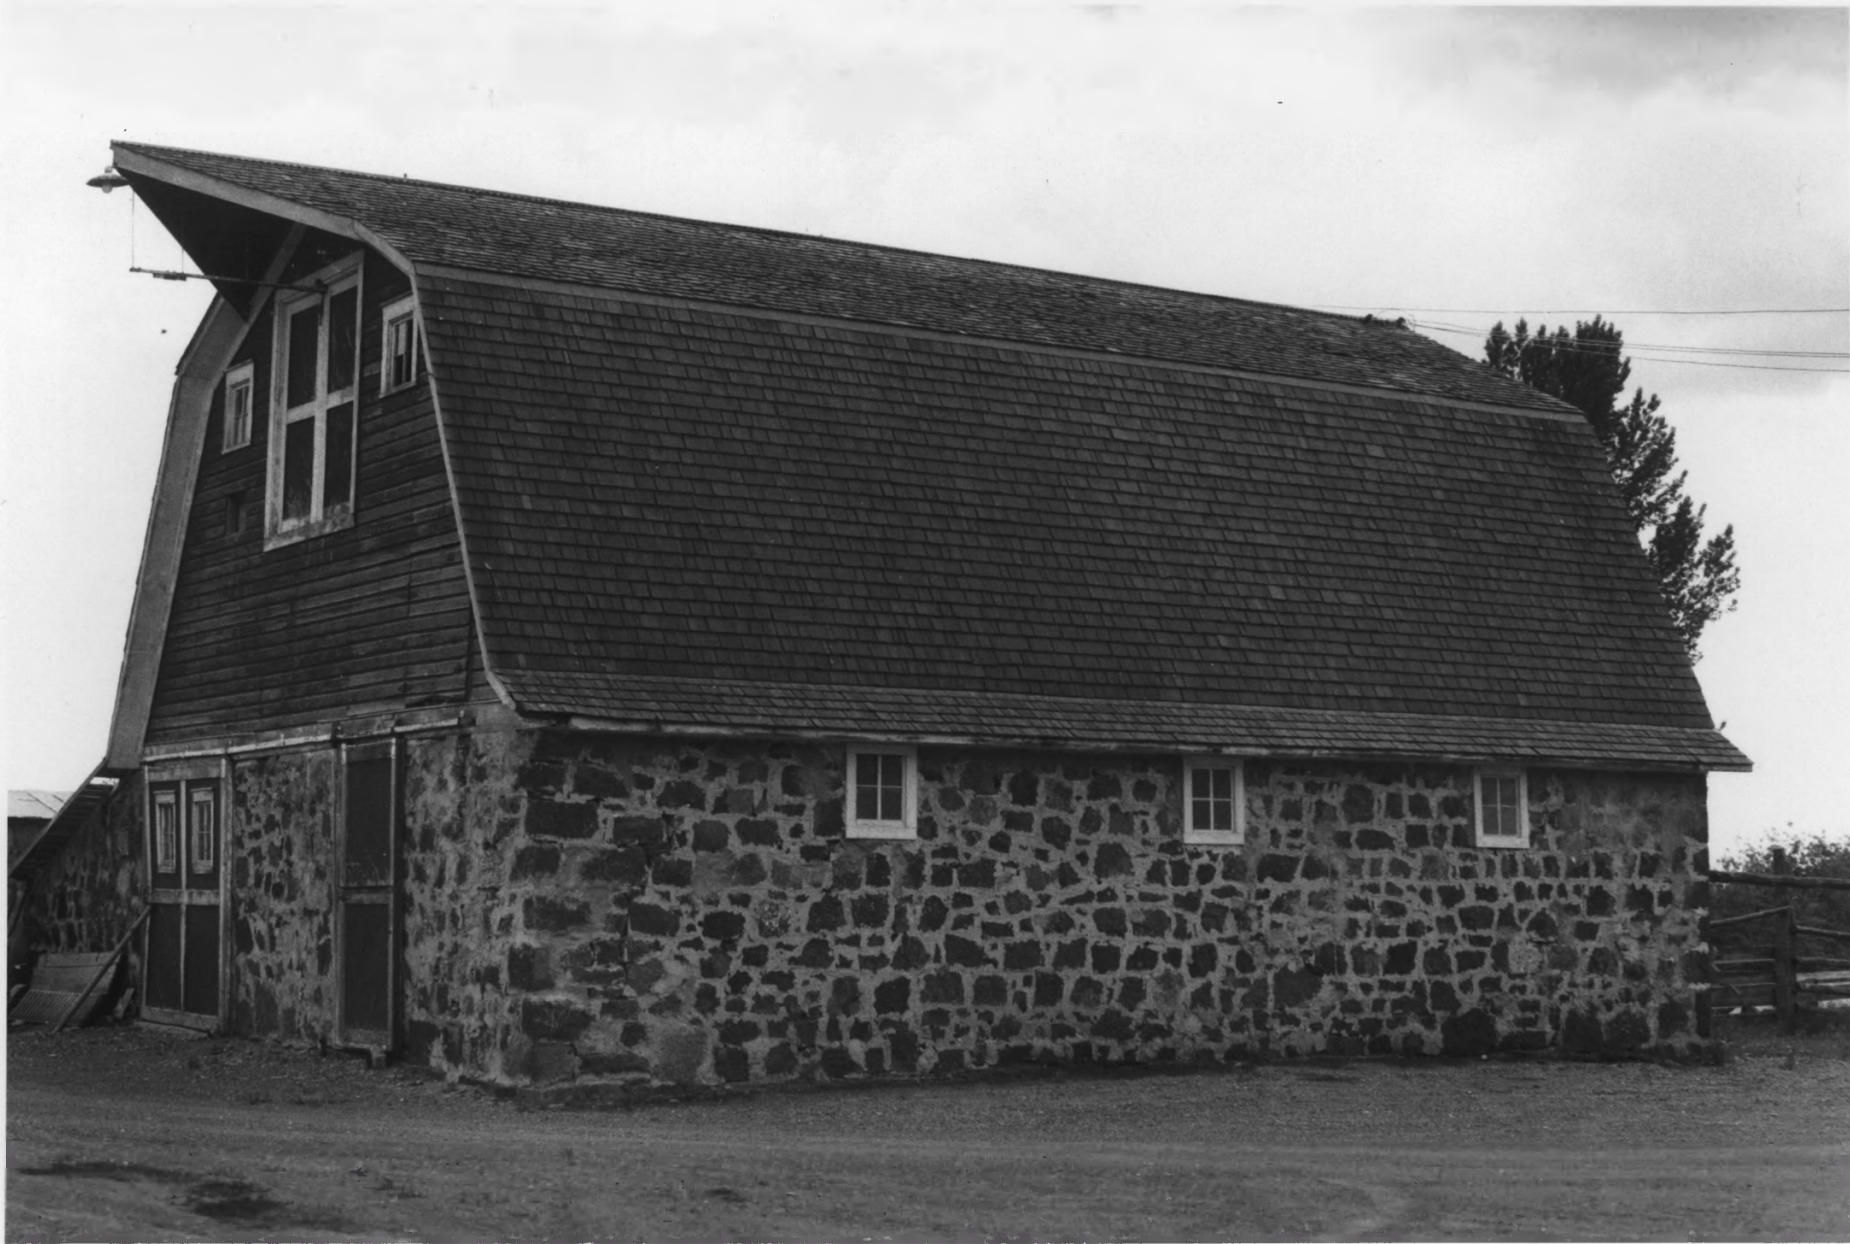
Photograph three of three

Lava Rock Structures in South Central Idaho  
Silva, Arthur D., Ranch, site 3 (barn)

View from northeast

Barn. The barn is approximately 40 by 31 feet. Its high, shingled, lateral gambrel roof has enclosed flared eaves with a narrow bargeboard on the gables. Ship-lap siding is in the gables above the one-story, random rubble stone walls. Sand colored untooled mortar is in the flush, medium-width joints. A pointed hay hook is above the panelled, square hay door, flanked by two small, square four-paned windows in the gable facade. A small square door has been cut offset to the left, just above the wooden molding separating the wood gable from the stone wall. Offset to the right at the ground level is a panelled door, while a panelled double door with two square windows is offset to the left. The same pattern of doors is repeated on the rear wall. The doors were designed to be large enough for a commissary wagon to drive through the barn. On the right wall are three small square windows at the top of the wall. The walls on the left side of the barn have been extended about twelve feet and slope downward to form the side walls of a poultry house. The left roof of the barn has been extended over it to form a shed roof. The low side wall of the chicken house is frame, facing south to provide winter sun. The gable wall and door are painted dark red, while the window and door and other wooden trim on the building is painted white.
