## INVENTORY SHEET FOR GROUP NOMINATIONS: IDAHO STATE HISTORICAL SOCIETY, BOISE, IDAHO

NOMINATION: Historic Resources of Paris (Partial Inventory: Architecture)SITE NAME: Thomas Smedley house (Paris, ID) SITE # 10LOCATION: North side of East First Street North near North Second East, Paris, IDOWNER'S NAME AND ADDRESS: Ida B. Smedley Estate, c/o Lillian Beck, Paris, IDQUADRANGLE AND SCALE: Paris, 7.5 minute ACREAGE: less than one acreVERBAL BOUNDARY DESCRIPTION: Nomination includes the former Smedley house and property on which it stands: T-2113, Fraction of lot 3, block 6, Paris Original Townsite.UTM(S): 12/4, 67, 395/46, 75, 105DATE OR PERIOD: 1870's, 1880, 1930's EVALUATED LEVEL OF SIGNIFICANCE: LocalAREAS OF SIGNIFICANCE: architecture

Thomas Smedley house

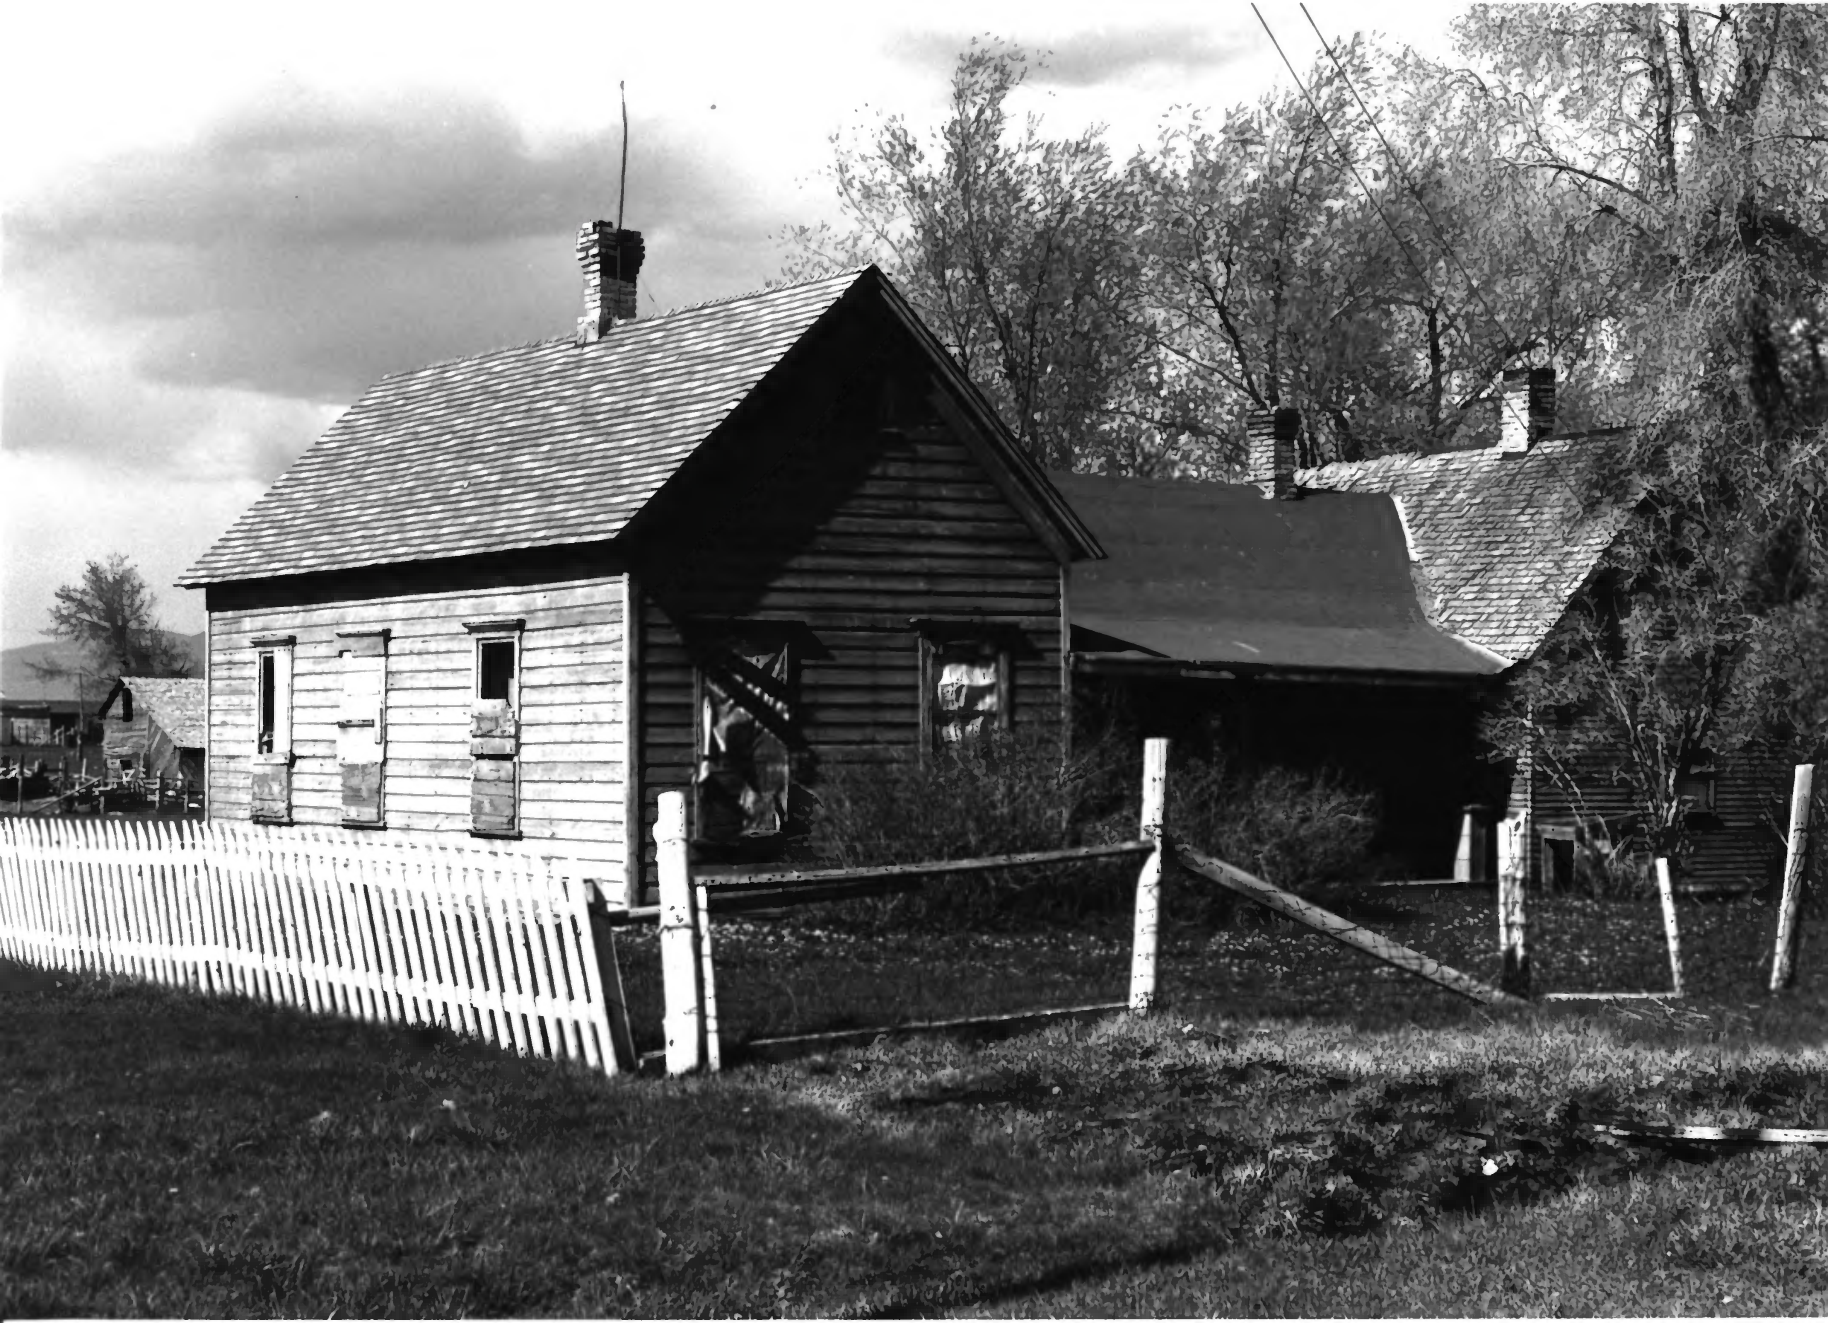
Photograph 1 of 1

The former Smedley house faces south on East First North Street. It is comprised of three main sections which form, in terms of enclosed space, a U-shaped plan. To the left is a rectangular frame cabin of ample proportions, probably with a sleeping loft, its gabled end facing the street. In the center is a lower-pitched lateral wing, with a shed-roofed brick lean-to in the back and shed-roofed porch, supported on square-based posts, in the front. On the right is another front-facing gabled form, its ridgebeam again higher than that of the central section. It is less deep than the gabled section to the right; a shed-roofed rear room takes up the difference in depth.

The left and central sections are lap-sided, the right is clapboarded. The central section has 12-light sash windows in plain plank frames. The left section has lost its glazing but retains molded outset window heads on tall frames, two on the front and three on the west. Central and left sections have corbelled brick chimneys, the right a plain. The central section has, behind its porch, a facade disposed in the typical hall-and-parlor manner, with a centered door and flanking windows; its interior chimney would be in the end interior position, were the ridgebeam not extended to join the west roof slope of the right section. The left section has doors in positions that would be idiosyncratic had it been built first: one in its short east exterior wall, so that it can be entered from the porch, and one entered in the rear wall. The east wing, similarly, has one entrance from the porch and two in the east wall. All of these differing characteristics of form, material and openings among the three sections of the Smedley house are consistent with the report of an oral source that the central section was built first, the left section second, and the right third.

The house is presently vacant and in disrepair, but it appears stable.

View from southwest
