National Register of Historic Places Registration Form

historic name Southern Idaho Timber Protective Association (SITPA) Buildings
other names/site number 015338-015353

street & number State Highway 55
city, town Smiths Ferry
state Idaho code ID county Valley code 085 zip code 83611

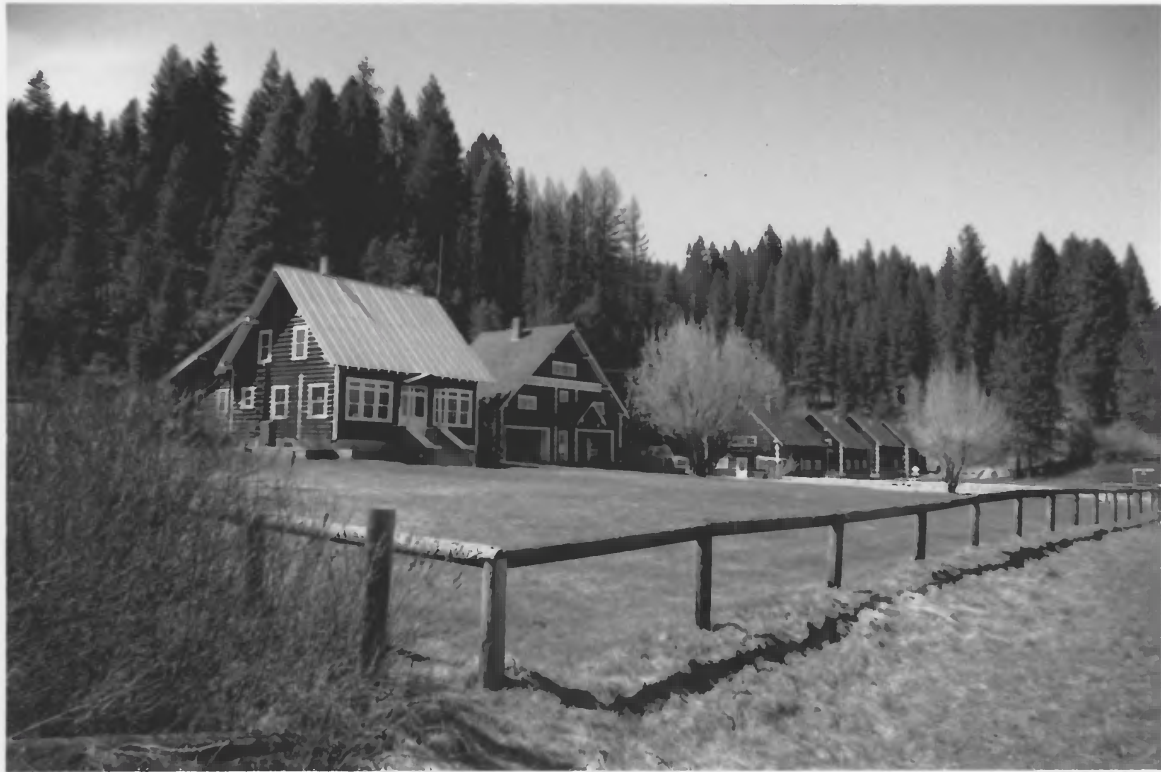
Photo #1:

1. Southern Idaho Timber Protective Association (SITPA) buildings
2. Smiths Ferry, Idaho
3. Elizabeth Eggleston
4. October 4, 1989
5. Idaho State Historical Society
6. Overall view, taken from the southeast

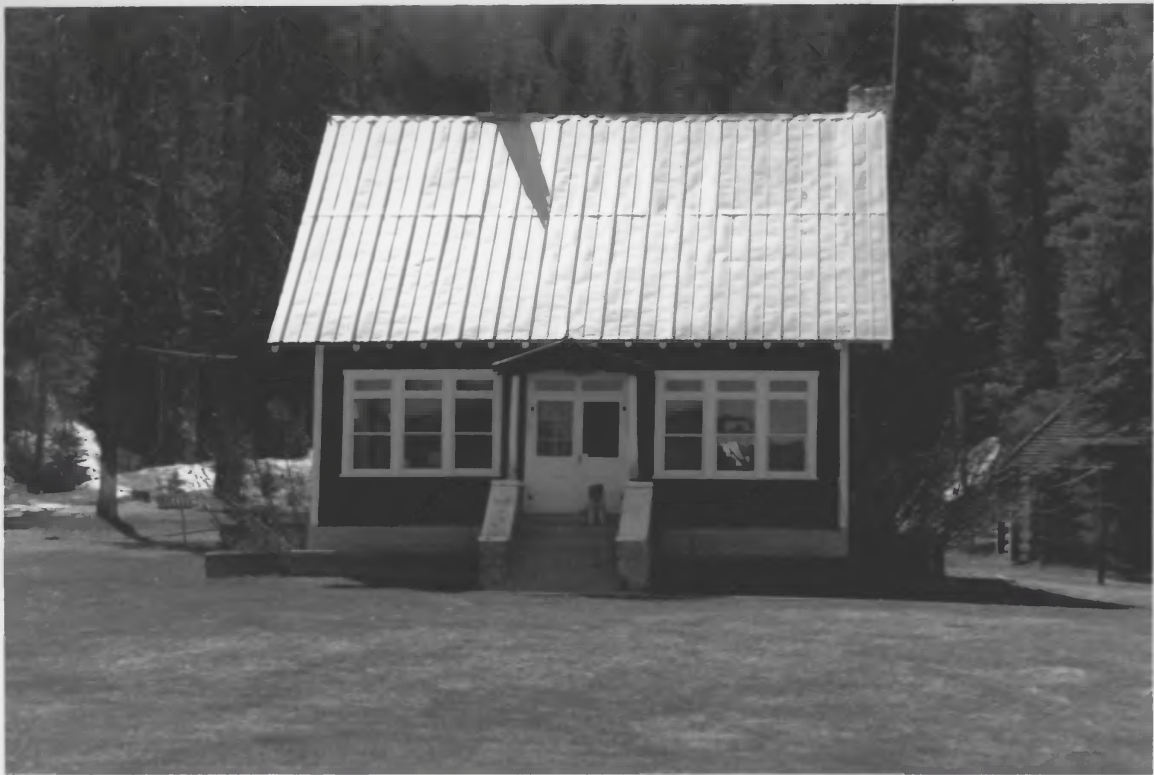
Photo #2

1. Southern Idaho Timber Protective Association (SITPA) buildings
2. Smiths Ferry, Idaho
3. Elizabeth Egleston
4. October 4, 1989
5. Idaho State Historical Society
6. View of residence, taken from the east
7. Building no. 1 on the accompanying sketch map

The addition is of frame construction and is merely sheathed with "log cabin" siding. Dovetail notching was used on the original portion of the house, but the corners have been painted white so that until one looks closely, they appear to be simple box construction. The house has two stories and sits on a concrete raft foundation.

The primary (east) facade can be divided into three bays, and has a symmetrical appearance. The main entrance is located in the center and consists of double doors with six lights. Above is a fixed transom of two narrow, horizontal lights. Concrete steps lead up the porch, which is flanked by low fieldstone walls with concrete capping. Sheltering the porch is a front gabled log roof with a shallow pitch.

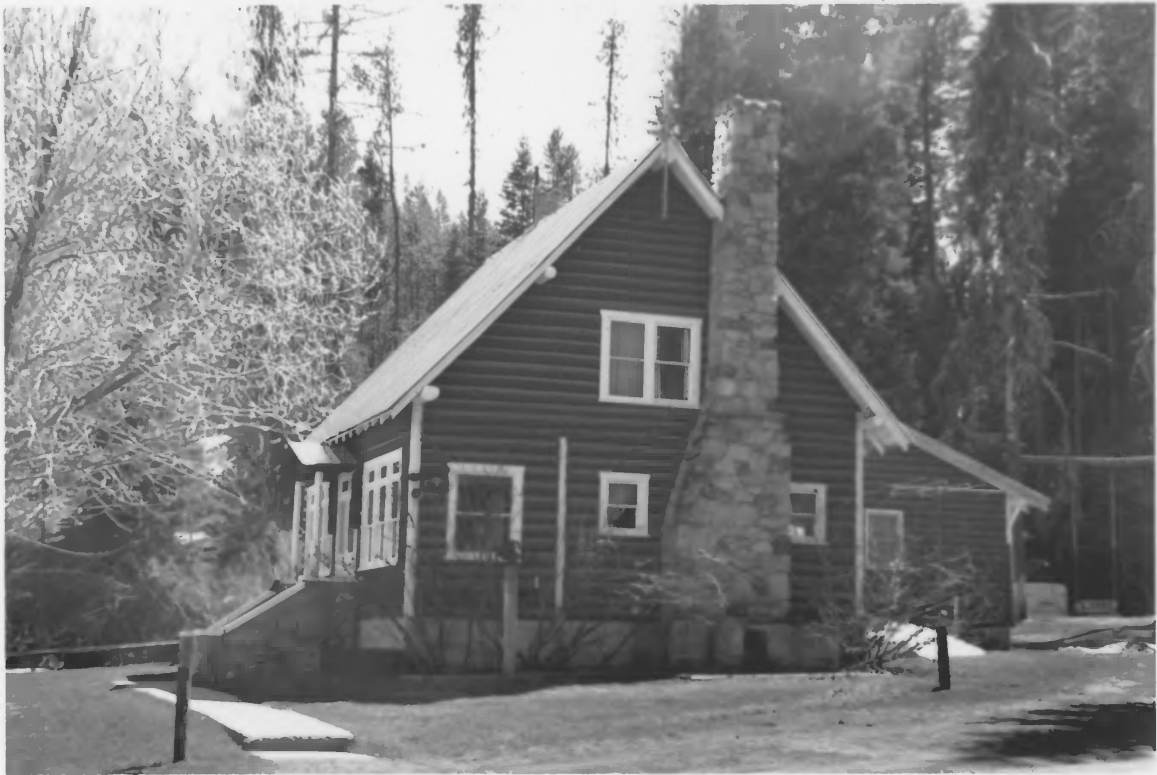
Photo #3

1. Southern Idaho Timber Protective Association (SITPA) buildings
2. Smiths Ferry, Idaho
3. Elizabeth Eggleston
4. October 4, 1989
5. Idaho State Historical Society
6. view of residence, taken from the northeast
7. Building no. 1 on the accompanying sketch map

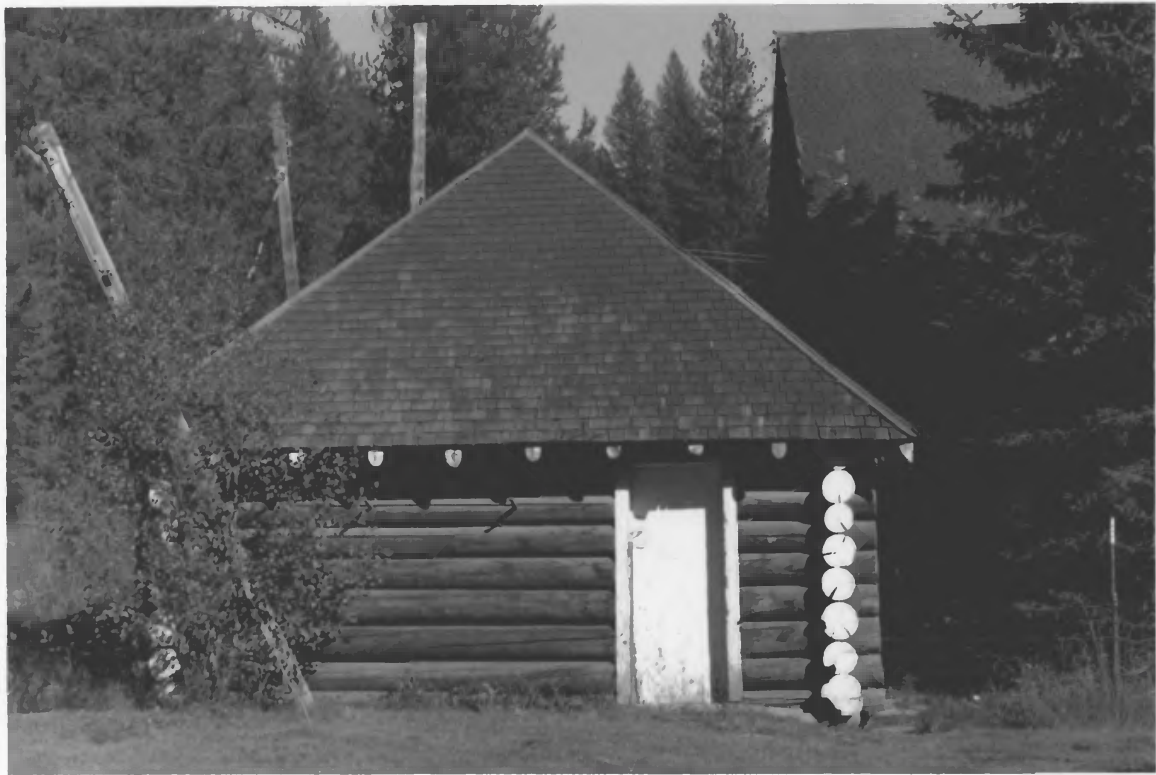
Photo #4

1. Southern Idaho Timber Protective Association (SITPA) buildings
2. Smiths Ferry, Idaho
3. Elizabeth Egleston
4. October 4, 1989
5. Idaho State Historical Society
6. View of hipped roof building, taken from the South
7. Building 4 on the accompanying sketch map

A black and white photograph of a large, dark log cabin with a prominent gable roof. The building features decorative log columns and a central entrance with a small porch. A white banner is stretched across the front of the building. A white pickup truck is parked in the right-hand garage. The building is surrounded by a dense forest of evergreen trees.

This small shed is located between the garage and the residence, and is five feet southwest of the garage. It is one of only two hipped roof buildings in this SITPA complex. The roof is steeply pitched and is sheathed with wood shingles. The log rafter ends can be seen and have been painted white. Round logs were used for its construction and were saddle-notched. No exterior chinking is evident but pegs are visible. It is difficult to discern if the building has a foundation. A plank door provides access on the south elevation; a window is located on the north.

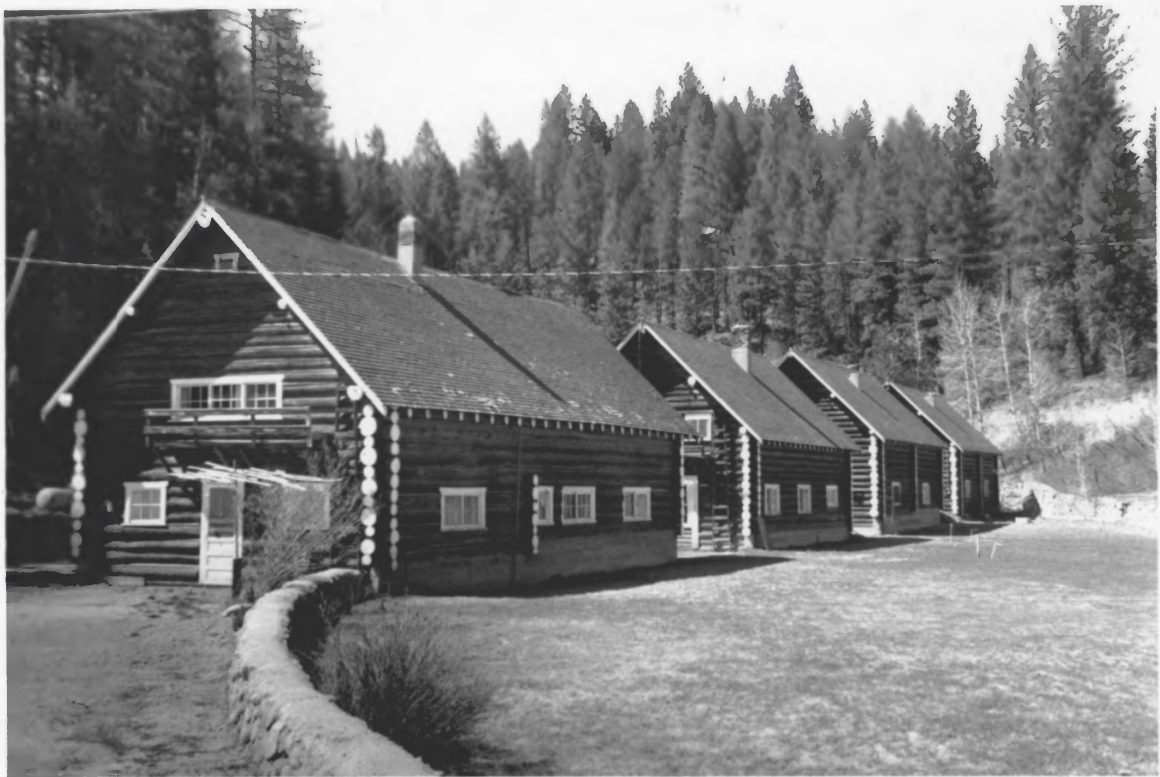
Photo #6

1. Southern Idaho Timber Protective Association (SITPA) buildings
2. Smiths Ferry, Idaho
3. Don watts
4. May 5, 1989
5. Idaho State Historical Society
6. View of the two bunkhouses and two garages, taken from the southeast
7. Buildings 6-9 on the accompanying sketch map

North of the garage are four round-log buildings that are arranged in a linear pattern. They are all one and a half stories. The roof ridge of the buildings all run north and south. The buildings are identical in scale and massing, varying only in fenestration and doorways. Building no. 6 was used as a washroom; building no. 7 was a mess hall. Both of these buildings still serve as bunkhouses. Buildings 8 and 9 north now serve as garages, and the openings for the vehicles have been altered. All four are in good condition, but the chimneys are deteriorating.

Similar characteristics and construction methods include saddle notching with concrete chinking, exposed log rafters and purlins whose ends have been painted, gabled roofs of a moderate pitch that are clad with shingles, and interior brick chimneys that are evident on the east roof slope. All the buildings rest on concrete foundations. Almost all of the windows are three-over-three lights with a sliding sash. The buildings have ladders attached that provide access to the upper story window on the south elevation.

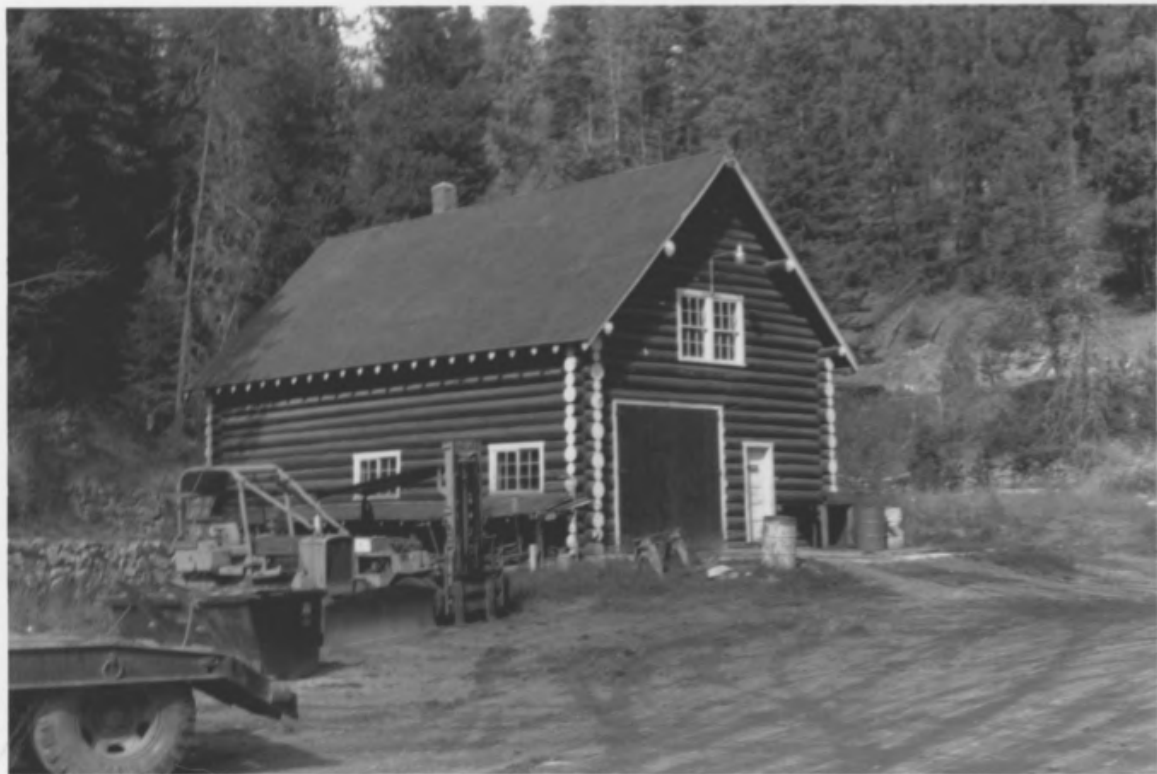
Photo #8

1. Southern Idaho Timber Protective Association
(SITPA) buildings
2. Smiths Ferry, Idaho
3. Elizabeth Eggleston
4. October 4, 1989
5. Idaho State Historical Society
6. View of north garage, taken from the
southeast
7. Building II on the accompanying sketch map

Constructed of round logs with saddle notching, this building is front-gabled, with exposed log purlins and rafters. The interstices are filled with concrete. It faces east, and is one and a half stories. On the primary elevation is a double door, that swings open; to the right of this is a single panelled door.

In the upper story of the building is a double-banked set of six-over-six, double-hung sash windows. On the south and north facades are two and three (respectively) windows. These have a sliding sash and a two-over-two light configuration.

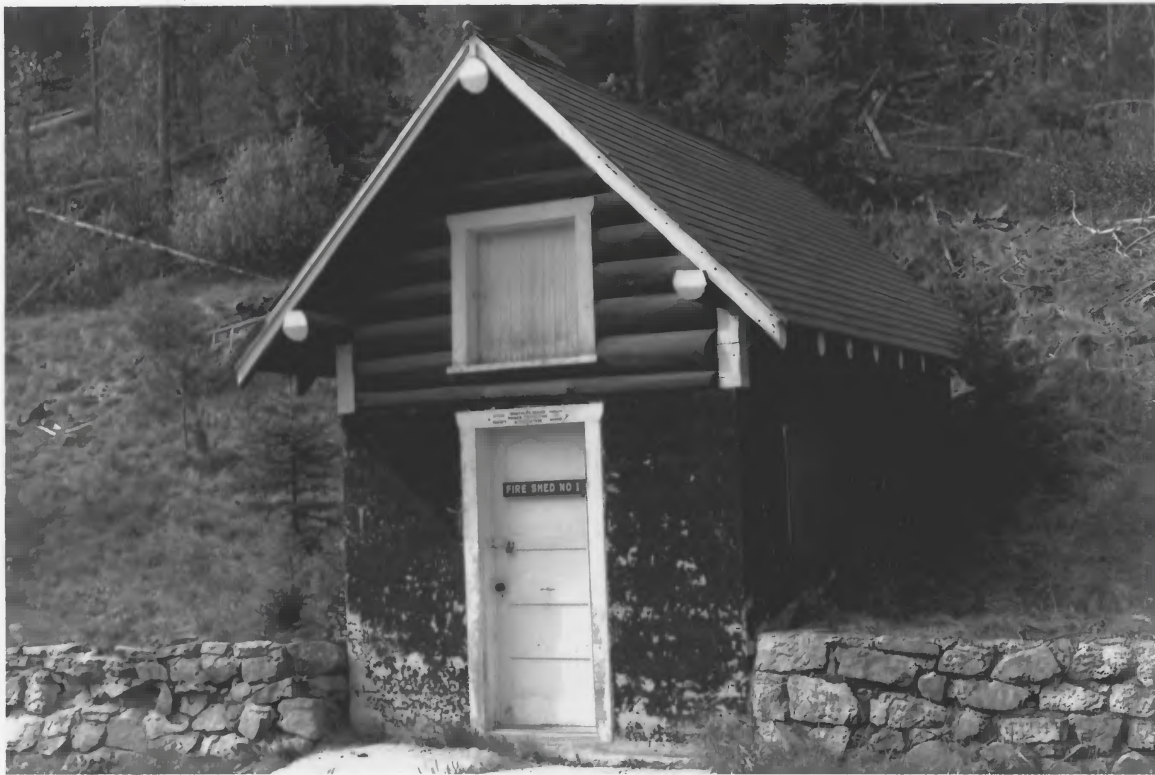
Photo #9

1. Southern Idaho Timber Protective Association (SITPA) buildings
2. Smiths Ferry, Idaho
3. Elizabeth Eggleston
4. October 4, 1989
5. Idaho State Historical Society
6. View of Fireshed No. 1, taken from the northeast
7. Building 14 on the accompanying sketch map

This building is one of the most unusual of the buildings at Smiths Ferry, as it is constructed of concrete block, with the upper portion built of round logs with dovetail notching. It faces east, has a front gable with a moderate-to-steep pitch, and has exposed log purlins and rafters. It is flanked by the low stone retaining wall and is partially embanked into the hillside. It has a small, concrete interior stovepipe or chimney. The east elevation is dominated by a single, panelled door; in the gable is a window with a wood frame. Both the north and south elevations have windows. All three windows, however, have been boarded.
