## National Register of Historic Places Registration Form

historic name Almon W. and Dr. Mary E. Spaulding Ranch

street & number 3805 N. Cole Road

city or town Boise

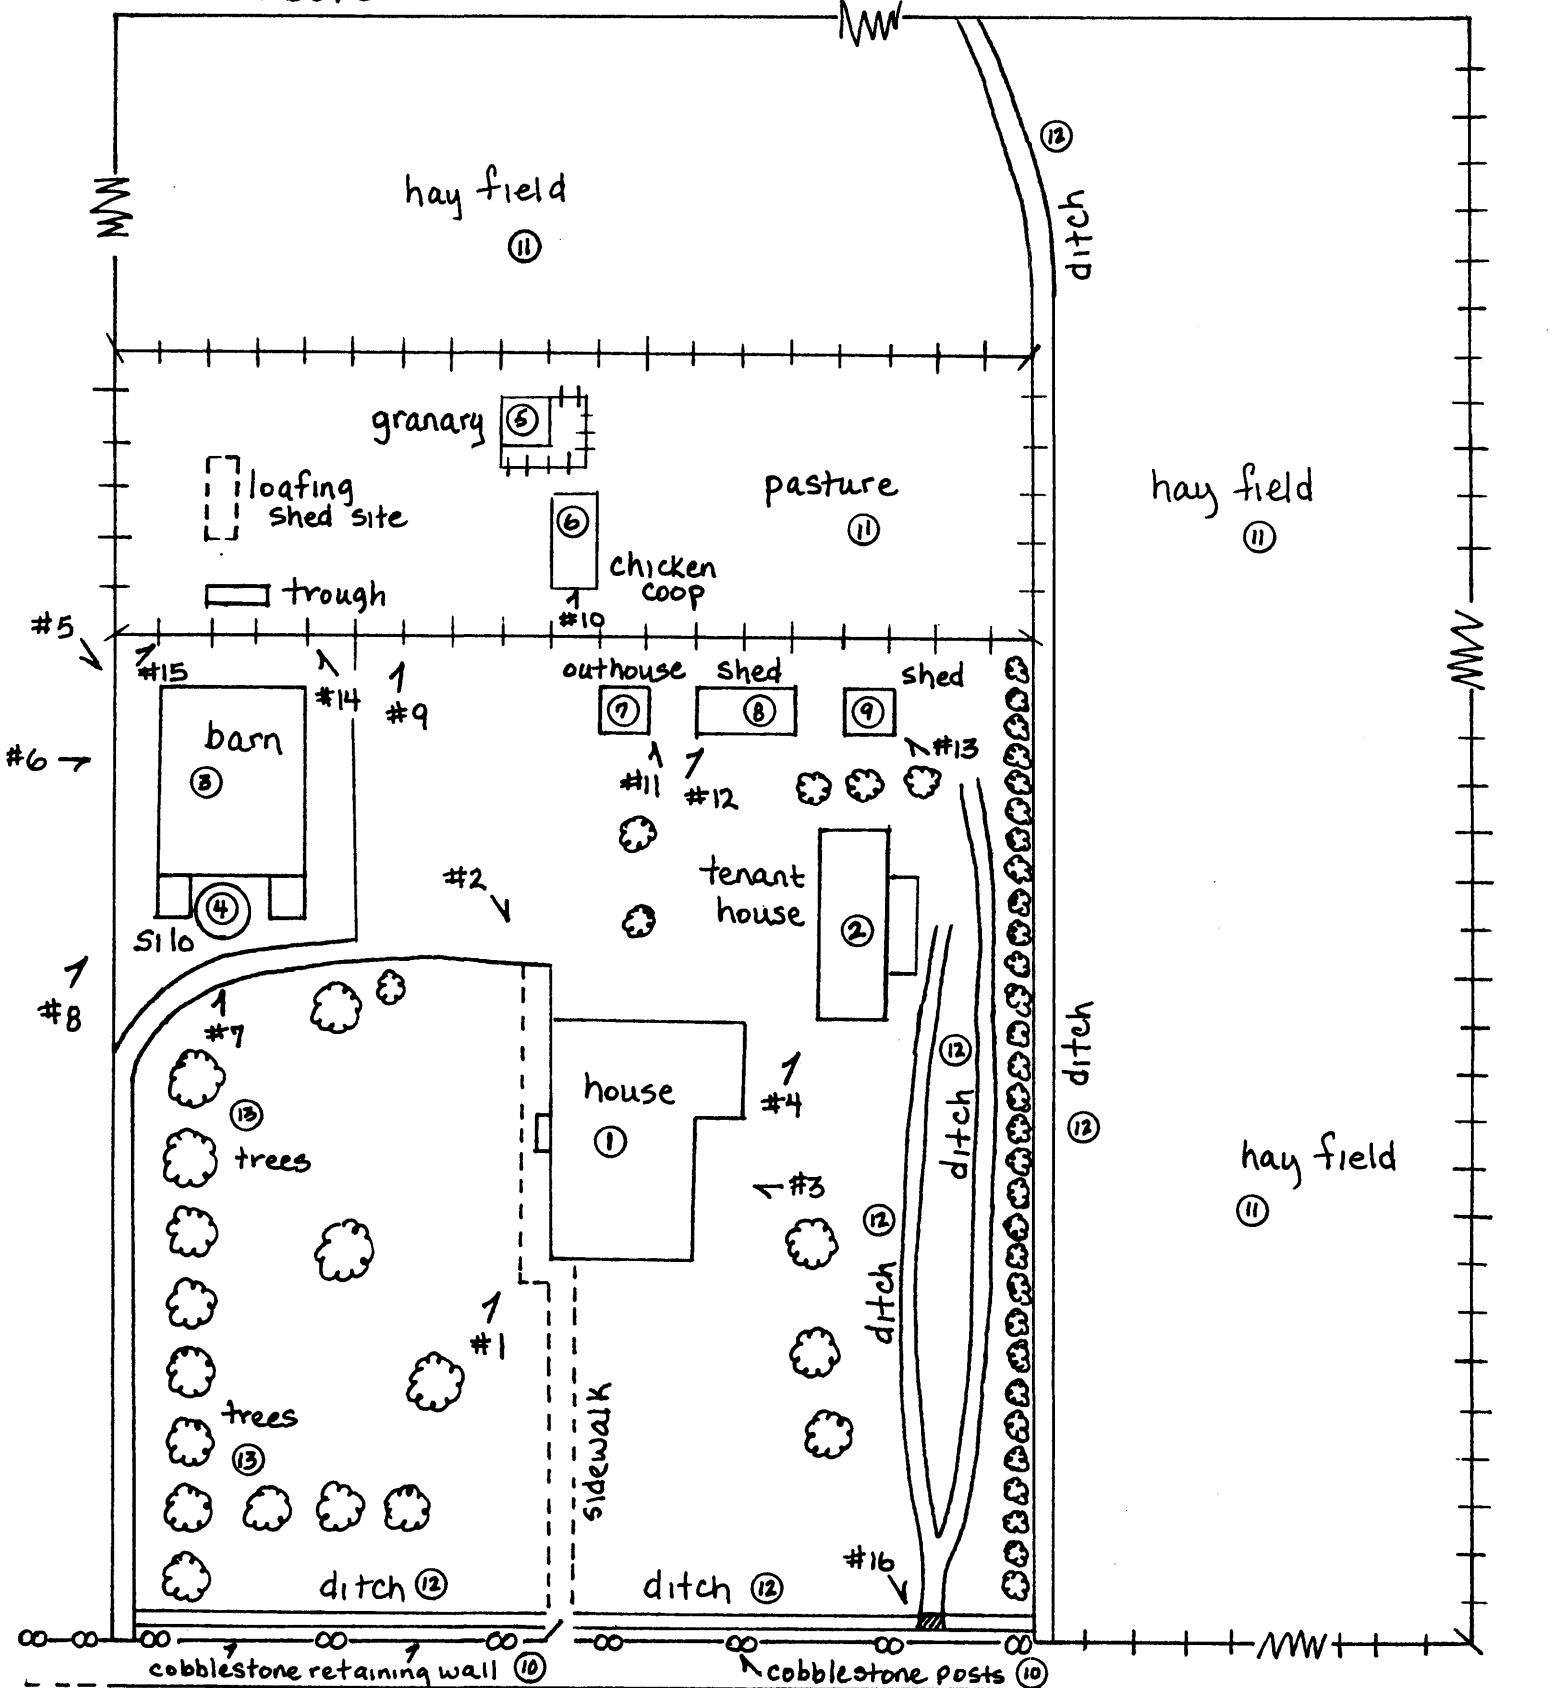
Almon W. and Dr. Mary E. Spaulding Ranch  
Ada County, Idaho

The farm house, outbuildings, and cultural landscape represent different time periods during the farmstead's history, though most were constructed over fifty years ago. What are probably the oldest structures--the barn, main house, and tenant house--create a chevron formation at the middle-front of the property. A granary, corral, chicken coop, WPA outhouse, storage shed, and tack room form an "L" shape to the west and north of the barn. One building and one structure, a loafing shed and hay derrick originally located behind the barn, have been dismantled and removed from the farmstead layout between 1940 and the present. All other buildings remain in the same location and are in good to excellent condition. The main house, tenant house, and barn underwent a few alterations within the last fifty years. A pasture and seasonally harvested hay fields lie to the west behind the barn and other outbuildings. A corn field and apple orchard also originally lay to the west of the outbuildings, but the trees were pulled out in the 1940s. Most of the headgates and ditches that brought (and in some cases, still bring) water to the property still remain. Except for evergreens planted in the back and front yards and the removal of four trees, the ornamental plantings date over fifty years. The trees that line the driveway were young saplings when the Carons moved there in 1940. Decorative cobblestone posts and fences dating from the 1910s separate the yard and house from the roadway; a cobblestone retaining wall runs along the front property line. [See attached Site Map for farmstead layout.]

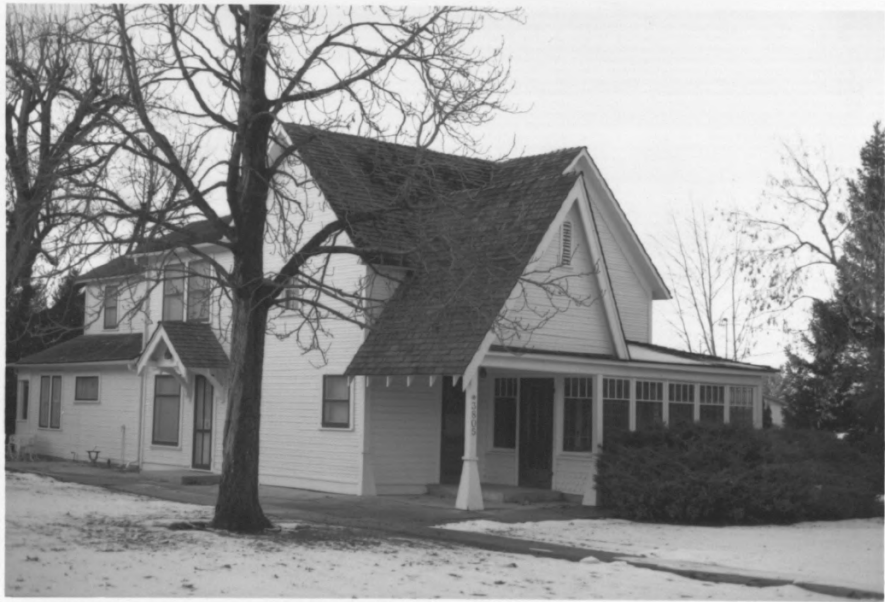
1. Almon W. and Dr. Mary E. Spaulding  
Ranch.
2. Ada County, Idaho
7. Photo #1

The original portion of the house is a one and one-half story wood frame structure with a vernacular gable-and-wing plan and a leanto addition on the back. The 1994 dimensions of the house are 58 feet long and 37 feet wide. It originally had Queen-Anne motifs, with fancy-cut fish scale shingles in the gable eaves and around the base of the house. The shingles were replaced before the 1930s with shiplap siding. Plain moldings and bargeboards frame the house and enclose

Spaulding Farmstead  
Roll 1, Frame 1  
House  
View from SE  
Madeline Buckendorf

the eaves. The roof (the second one on the house) is wood shingle; the original was also wood shingle. The house plan was originally two rooms wide and two rooms long; a shed roof covers an extension on south side to make the house three rooms wide. Later gable and leanto additions were added to the back (west) side of the house. A previously separate garage was attached to the house in the 1930s and used for domestic purposes. A full screened-in porch originally covered the front of the house; the porch was glassed in and a steep-pitched 1930s Cottage-style porch overhang with battered pillars was also added in the 1930s. Other additions to the house were probably completed in the late 1930s, except for a ten-foot addition to the garage and alteration of its doors in the 1970s. The brick chimney shows up in a circa 1915 photo of the house. However, the brickwork pattern in the photo is different from the present pattern, indicating it was rebuilt sometime after the photo was taken. Interior changes include an early (1930s) remodel of the upstairs bathroom, addition of the downstairs bathroom and the later garage remodel. The archway between the kitchen and back sitting room was altered into a Tudor arch in the 1940s. A cistern that lay under the kitchen provided drinking water and a cold-storage area. A water tank replaced the cistern used for domestic purposes. The Carons glassed in the back porch in the 1980s; no other alterations to that section of the house were made. Otherwise, the rooms remain remarkably the same as when the Carons moved there in 1940, including the wallpaper and paint in every room except the upstairs back bedroom.

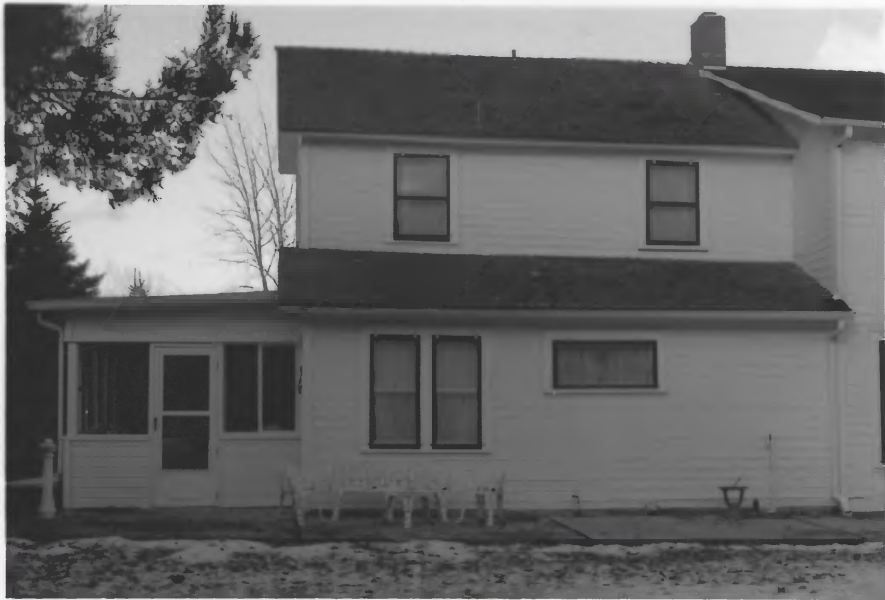
1. Almon W. and Dr. Mary E. Spaulding  
Ranch
2. Ada County, Idaho
7. Photo #2

Spaulding Farmstead  
Roll 1, Frame 3  
House

View from SW  
Madeline Buckendorf

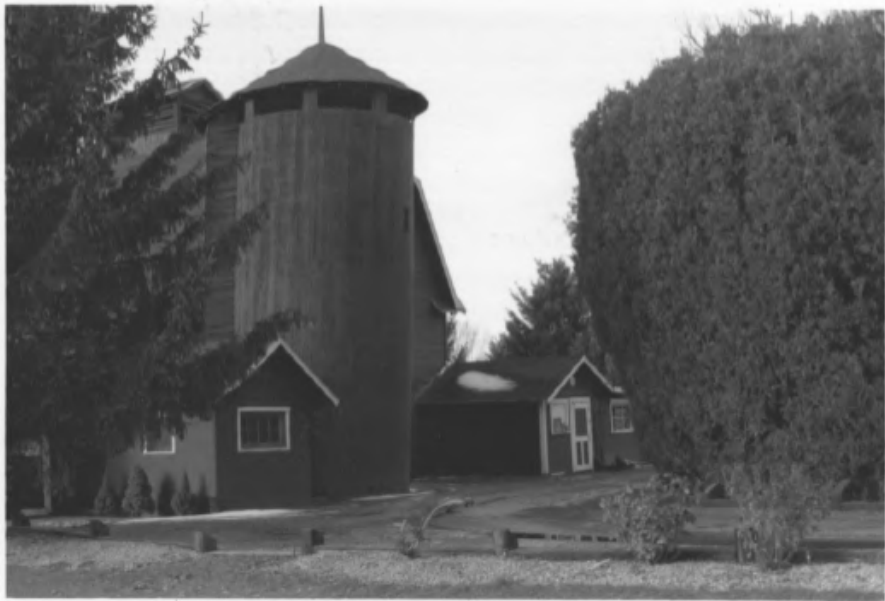
1. Almon W. and Dr. Mary E. Spaulding  
Ranch
2. Ada County, Idaho
7. Photo #8

An unattached wooden stave silo stands directly adjacent to the southeast front facade of the barn. It is cylindrical in shape with a conical wood shingle roof; its circumference equals 39 feet. The silo is built of vertical, narrow tongue-and-groove wood siding. Balloon framing joins together the interior and exterior walls of siding. The framing and walls are attached to a concrete foundation running four to five feet underground. Rectangular openings covered with chicken wire are located at the silo's roof line. A fully covered ladder runs up the outside of the structure close to the barn's front facade.

Spaulding farmstead 3805 N. Cole  
Roll 1, Frame 17 Boise, ID  
Ada County  
Silo, SE view of barn  
Madeline Buckendorf

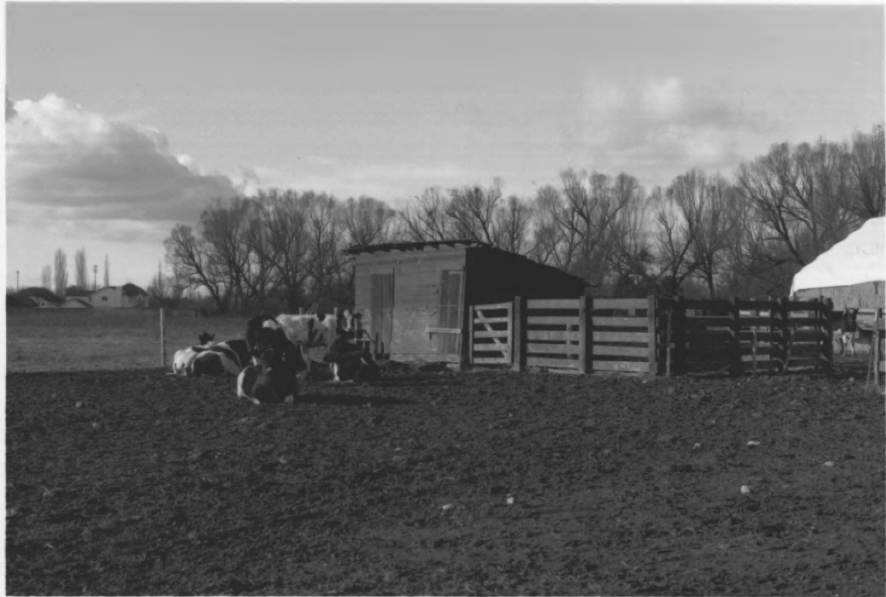
1. Almon W. and Dr. Mary E. Spaulding  
Ranch
2. Ada County, Idaho
7. Photo #9

The granary is a one-story, wood frame structure with a shed roof. It is approximately 12 feet long and twelve feet wide. Vertical studs brace the external beaded board siding of the structure's two ends, similar to "inside-out" granary construction. On the south-facing lateral facade, two solid wood doors cover the entrances to each unit, or crib. The structure is free-standing on wooden studs and could possibly be movable. It is presently painted red to match the barn, and is still used as a granary. A more recent post-and-board corral has been attached to the back and side of the granary.

Spaulding Farmstead  
Roll 1, Frame 12  
granary/corral  
view from SE  
Madeline Buckendorf

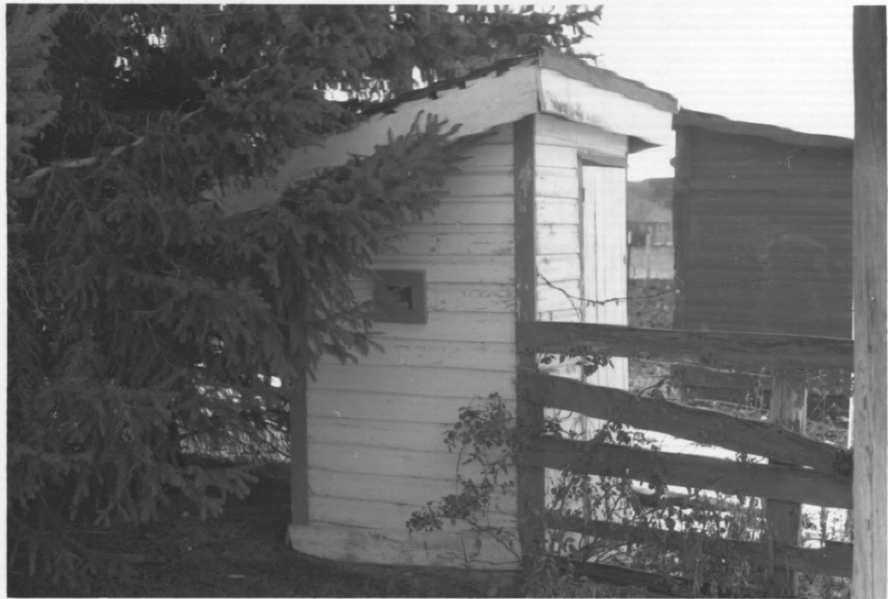
1. Almon W. and Dr. Mary E. Spaulding  
Ranch
2. Ada County, Idaho
7. Photo #11

The outdoor toilet is a one-half story, wood frame, shed roofed building. It is covered with shiplap siding; barge boards enclose the eaves of the composition-shingled roof. The outhouse is a "one-hole" affair with an offset solid wood door. Its dimensions are 4 feet by 4 feet. Small vent holes covered with wire are located on each side of it. The toilet is painted white with green trim around the door, vent holes, and on the corners. Its integrity is excellent.

Spaulding Farmstead 3805 N. Cole  
Roll 1, Frame 21 Boise, ID  
WPA Outhouse Ada County  
View from NE  
Madeline Buckendorf

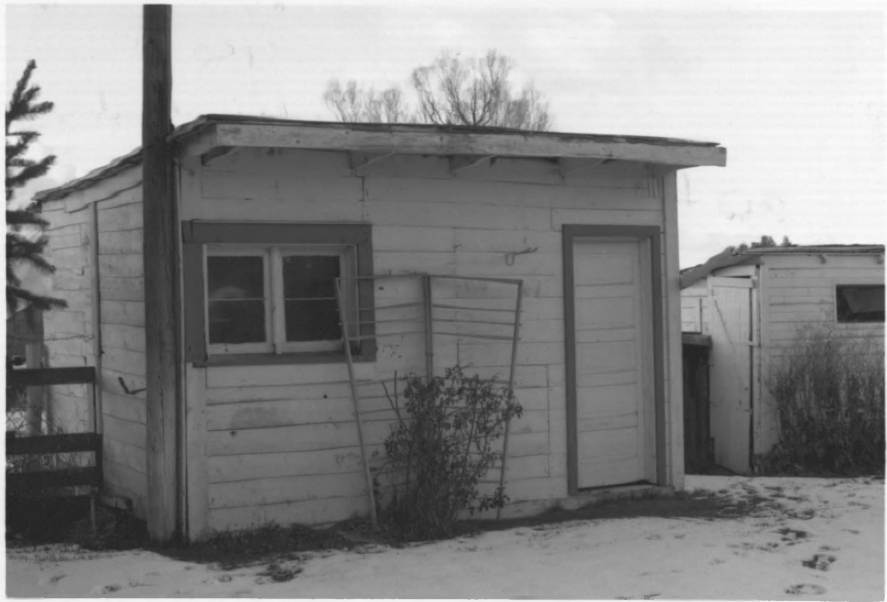
1. Almon W. and Dr. Mary E. Spaulding Ranch
2. Ada County, Idaho
7. Photo #12

The outbuilding is one-story, wood frame, with a shed roof. It is placed on curved wooden boards (slips) in order to be moveable. The shed is 14 feet long by 11 feet wide, and covered by beaded board siding. The front-facing east facade has two casement windows side-by-side consisting of one-over-one lights. A solid wood door is located on the north end of the front facade. Bargeboards enclose the eaves of the wood-shingled roof and each corner. The building is painted white with green trim around the door and windows; it is presently being used as a tool shed.

Spaulding Farmstead 3805 N. Cole  
Roll 1, Frame 10 Boise, ID  
Shed Ada County  
View from SE  
Madeline Buckendorf

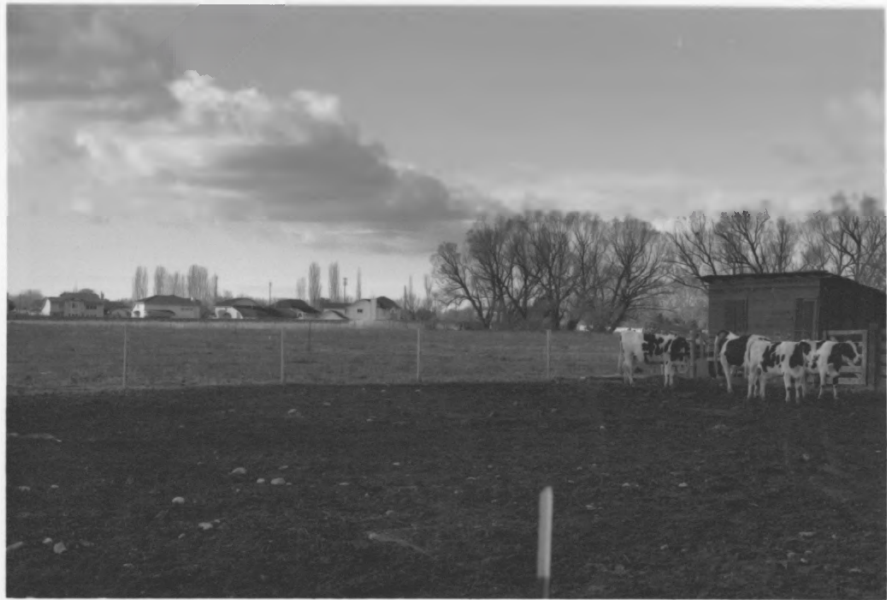
1. Almon W. and Dr. Mary E. Spaulding Ranch
2. Ada County, Idaho
7. Photo # 15

Lying directly south, north and west of the farmstead complex is approximately 20 acres of pasture land and hay field. The pasture is presently occupied by approximately 15-20 head of Holstein cattle, tended by a farmer who rents the land. The hay field follows the ditch line back to dense subdivision and townhouse development. The farmer grew and cut hay in the field as recently as 1993, continuing the land's historic use for almost a century.

Spaulding Farmstead 3805 N. Cole  
Roll 1, Frame 14 Boise, ID  
hay field, ditch line Ada County  
view from SE  
Madeline Buckendorf

A concrete headgate and two ditch lines lie along the northern border of the present property boundary lines. Another ditch running parallel to the eastern boundary line feeds into the headgate. The two northern ditches extend to the barnyard and hay field. Originally one ditch ran underneath the front porch of the tenant house and into the central area of the barnyard; it has since been filled in. Irrigation water still runs through the existing ditches to the hayfield and pasture. The lawn was watered by irrigation ditches until the late 1980s, when Mrs. Caron installed a sprinkling system.

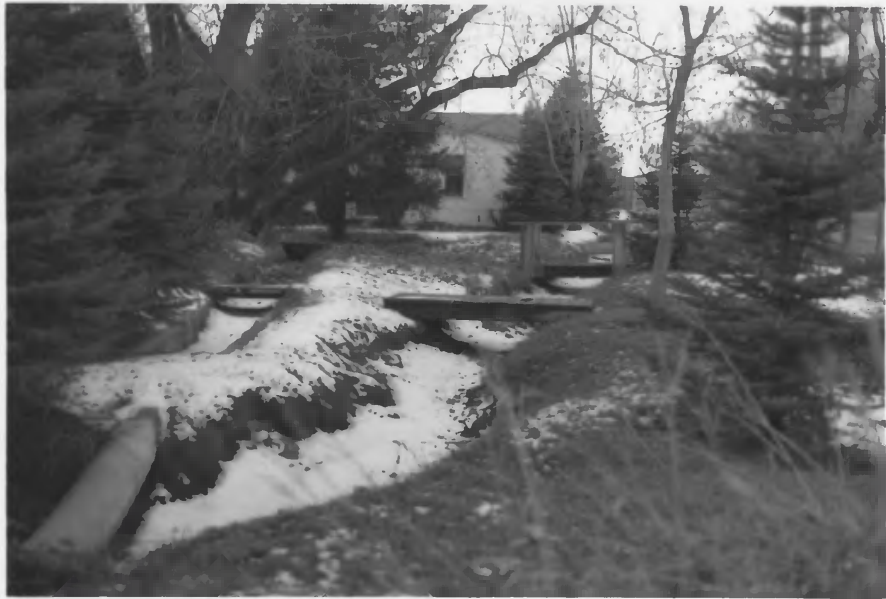
1. Almon W. and Dr. Mary E. Spaulding Ranch
2. Ada County, Idaho
7. Photo #17

Spaulding Farmstead  
Roll 1, Frame 6  
ditches by house  
View from East

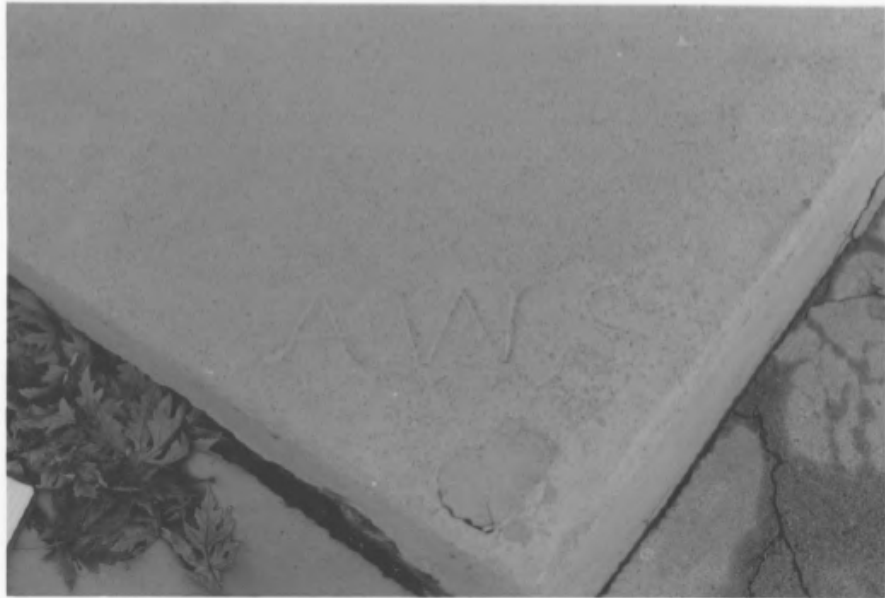
House doorstep - "AWS"
