INVENTORY SHEET FOR GROUP NOMINATIONS: IDAHO STATE HISTORICAL SOCIETY, BOISE, IDAHO

✓ NOMINATION: (Lava Rock Structures in South Central Idaho TR)

✓ SITE NAME: Vipham, Thomas, House

✓ LOCATION: 313 ~~East~~ Avenue D, Jerome, ~~Idaho~~

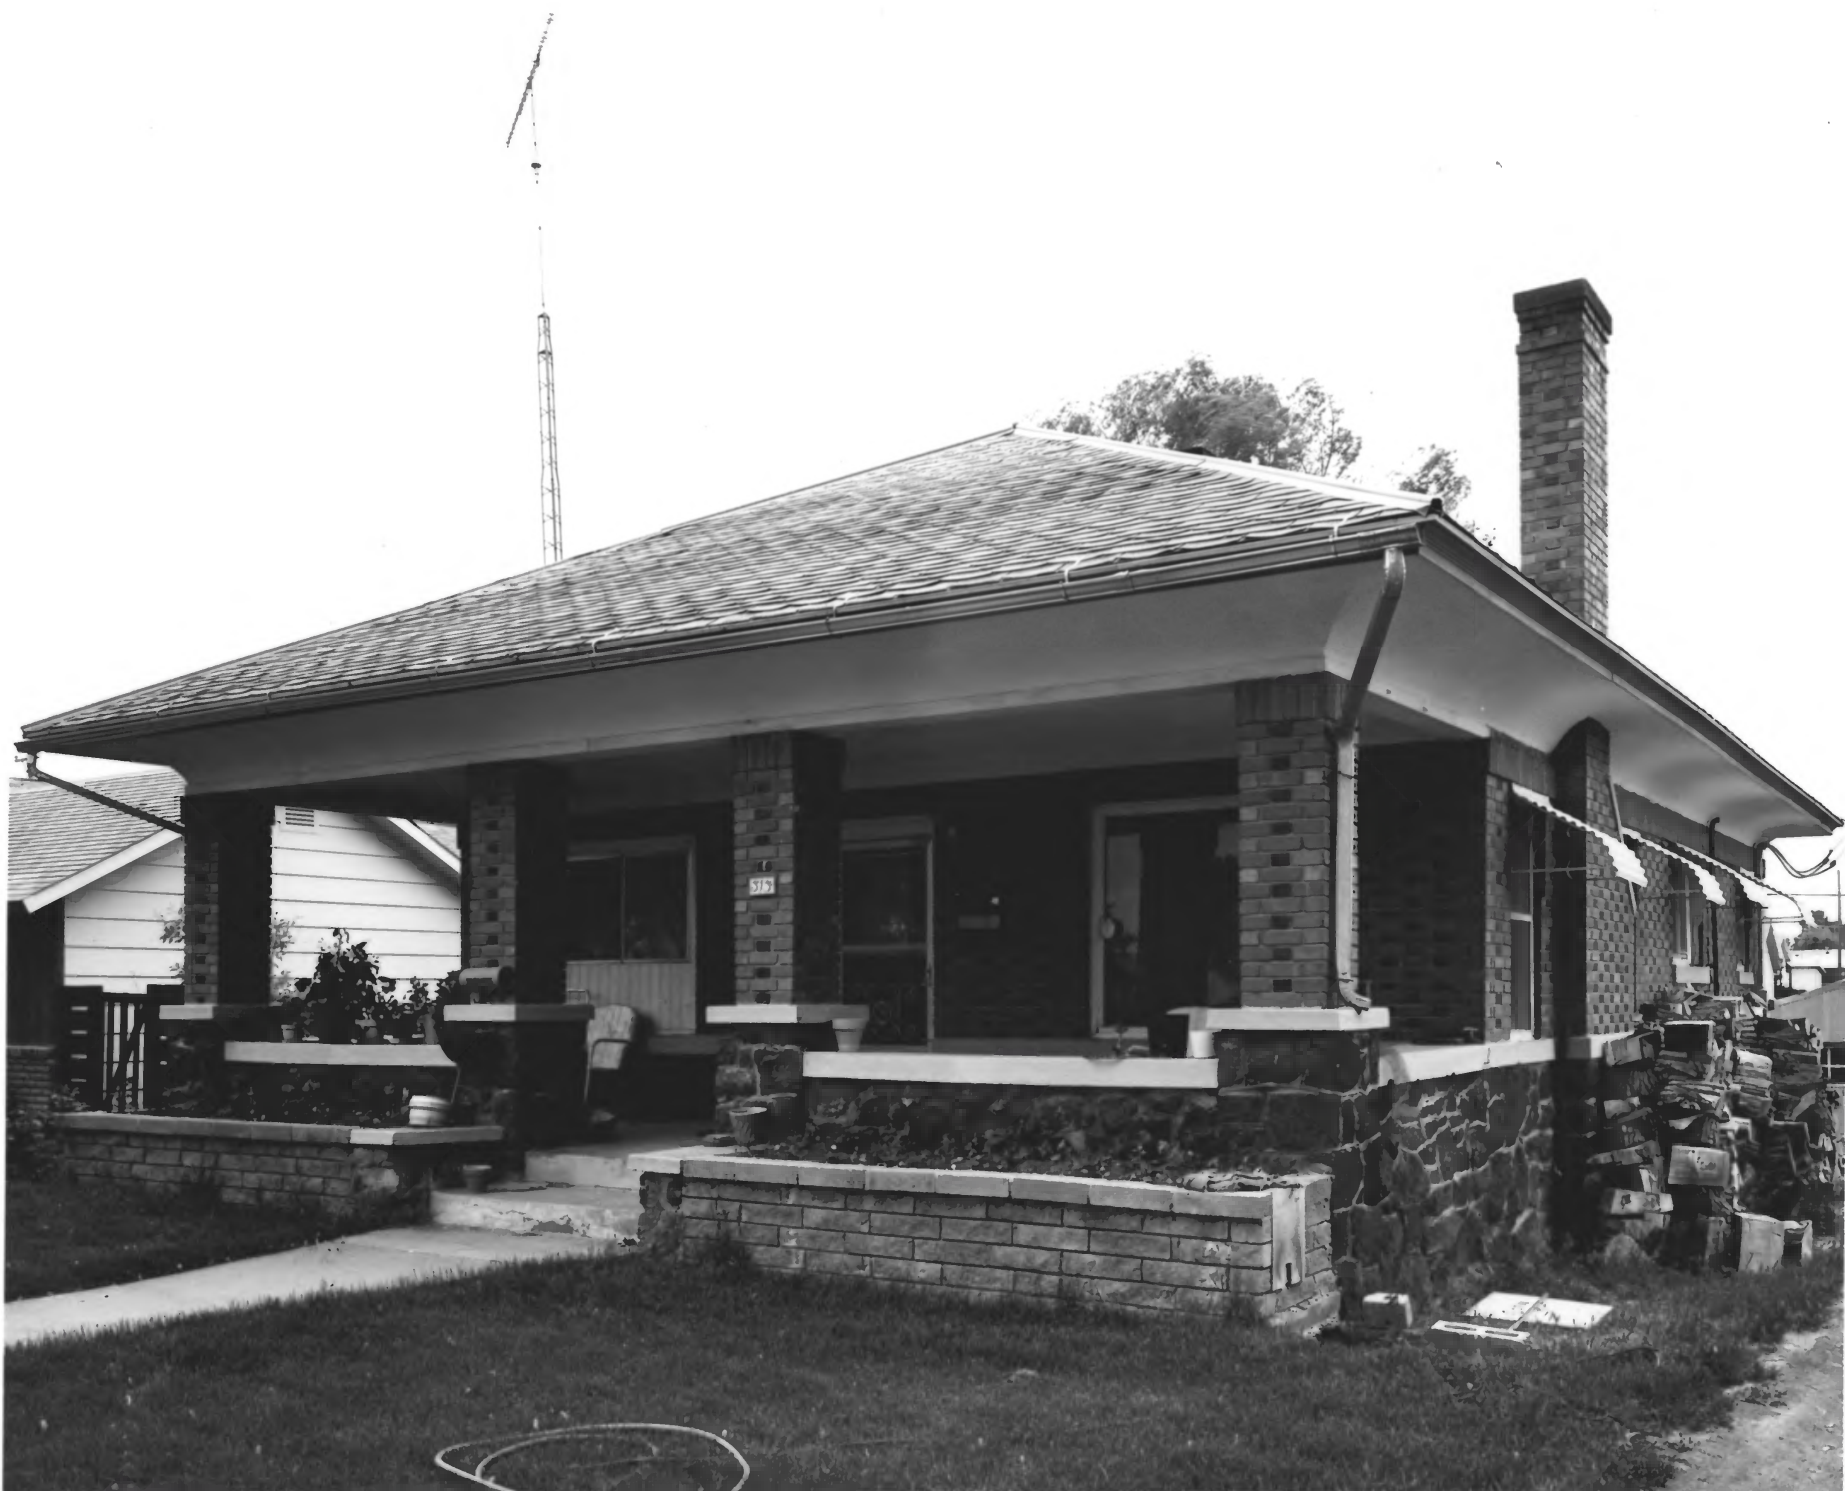
Photograph one of one

View from northwest

This one-story house, approximately 30 feet square, is made of brick on a high lava rock foundation. It is situated on a lot that slopes to the rear so it is one-story at the street level and two stories at the rear. It has a shingled, hipped roof with wide, enclosed, stuccoed eaves. The lava rock foundation wraps around to the front of the house forming low porch walls for the full inset porch. There are slightly higher piers at each corner and beside the entrance. A narrow, concrete belt course divides the stone portion from the brick and becomes coping for the porch walls. The piers also have concrete caps. The coursed rubble masonry has nearly flush medium width joints painted white. There are stone relieving arches above the basement windows. The brick is laid in Flemish bond in a decorative pattern alternating light- and medium-red bricks with dark-red glazed bricks. There is dark gray mortar in the medium-sized, slightly raked joints. There is a tall, square interior tall brick chimney with a corbelled cap. A larger outset chimney is offset to the left of the side wall and intersects the eaves. It, too, has a corbelled cap. There are four square brick columns supporting the porch across the front of the house. The lintels and sills in the brick section of the house are concrete. Brick planter boxes, later additions, are at ground level at each side of the centered concrete porch steps. One of the front windows has been partially blocked with siding to create space for an aluminum-framed window.
