UNITED STATES DEPARTMENT OF THE INTERIOR  
NATIONAL PARK SERVICENATIONAL REGISTER OF HISTORIC PLACES  
INVENTORY -- NOMINATION FORM

Wallace Historic District

Wallace

Idaho

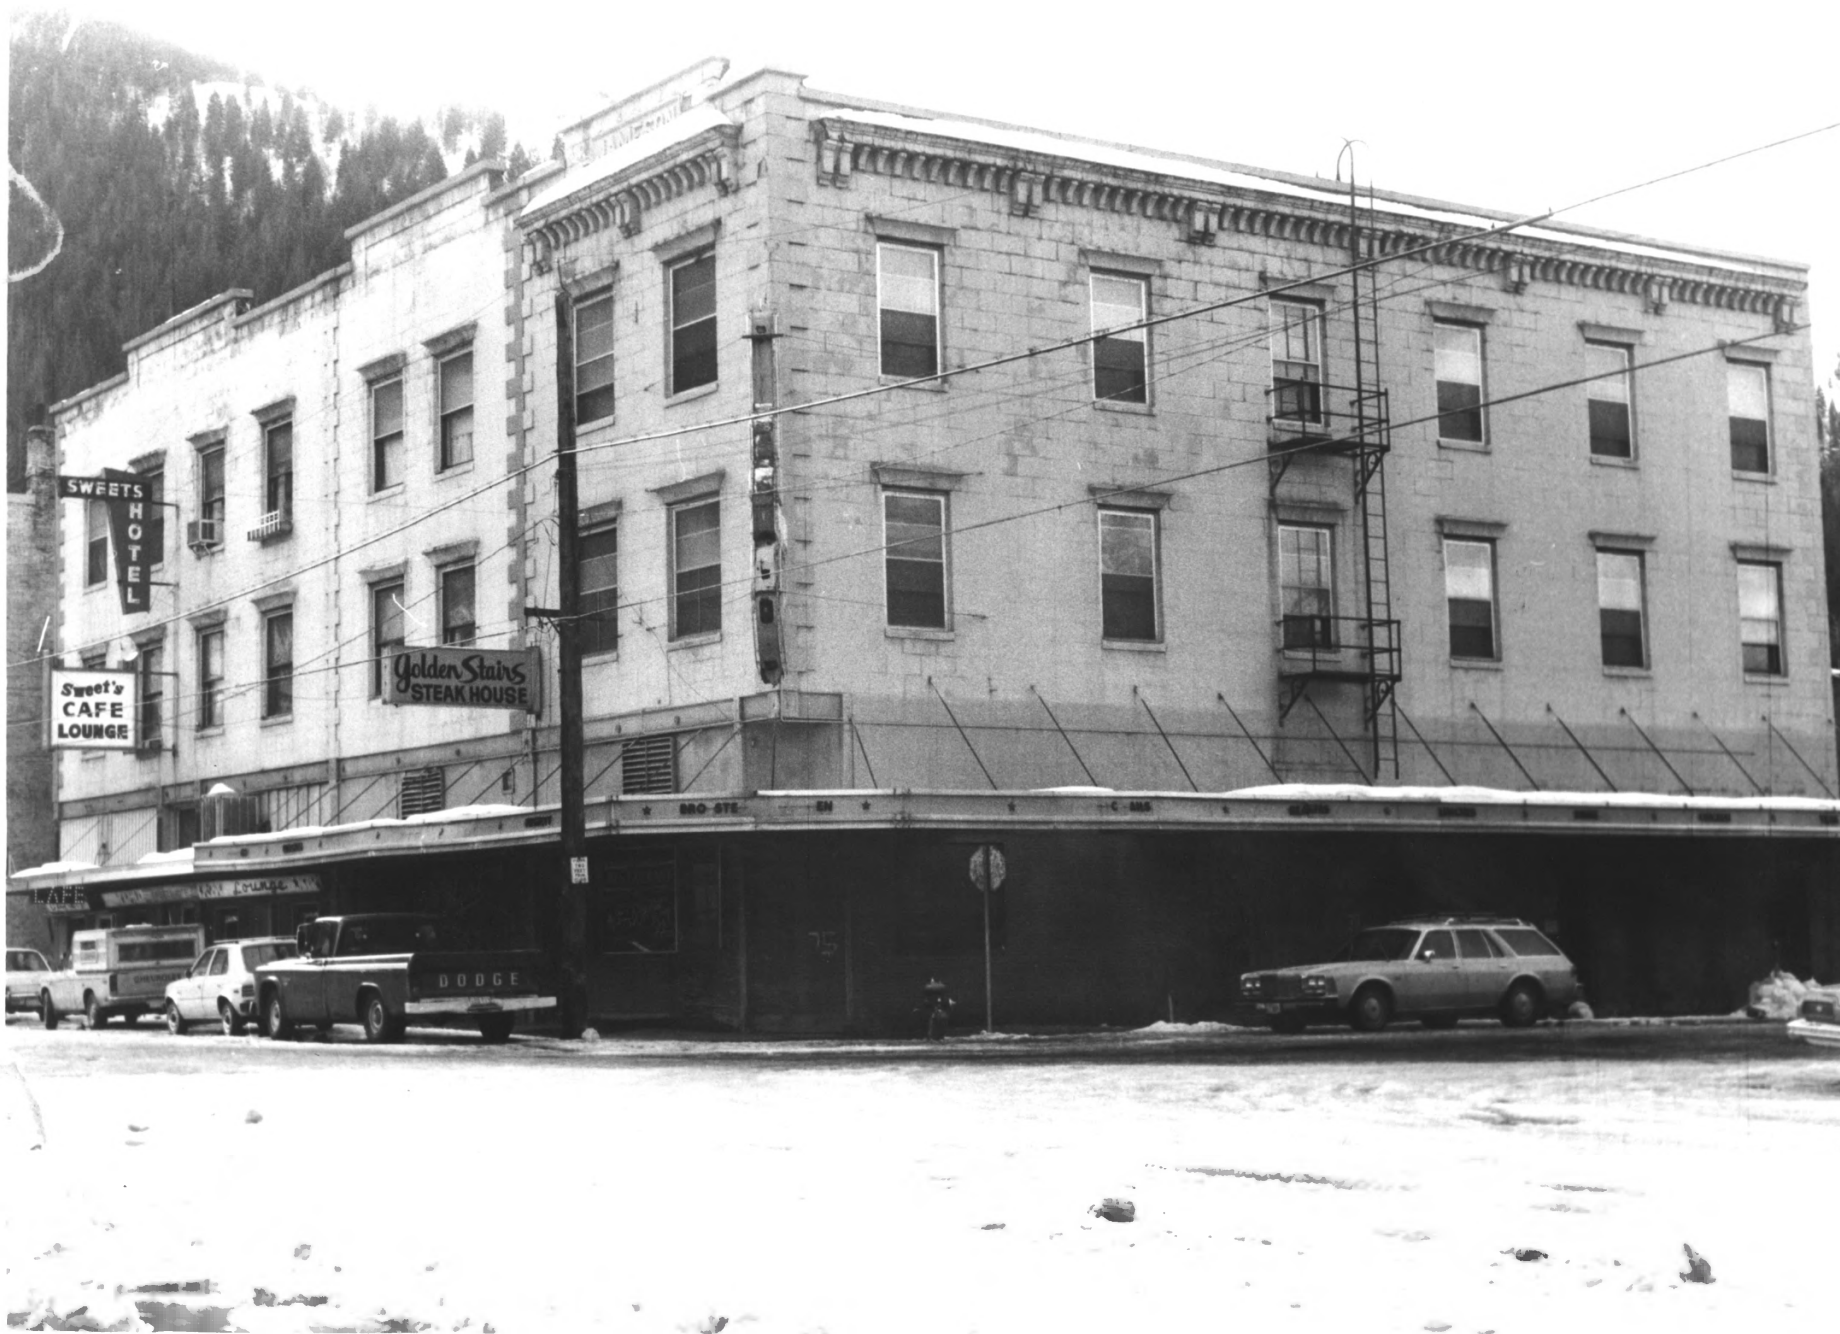
View of building #7 from north-  
east

- 7) The Jameson and Sweet's Hotel buildings date from the first decade of the century. They are sibling three-story structures of stone (now painted) which originally had matching stone cornices (only the Jameson section retains these) across the four bays of the facade under a parapeted roofline. There is interest in restoring these structures.
